BRIDGE NO.01213

52980 - NEWTOWN
INTERSTATE 84 EASTBOUND
over
HRRC & BOULEVARD ROAD

Routine Inspection

3/27/2017

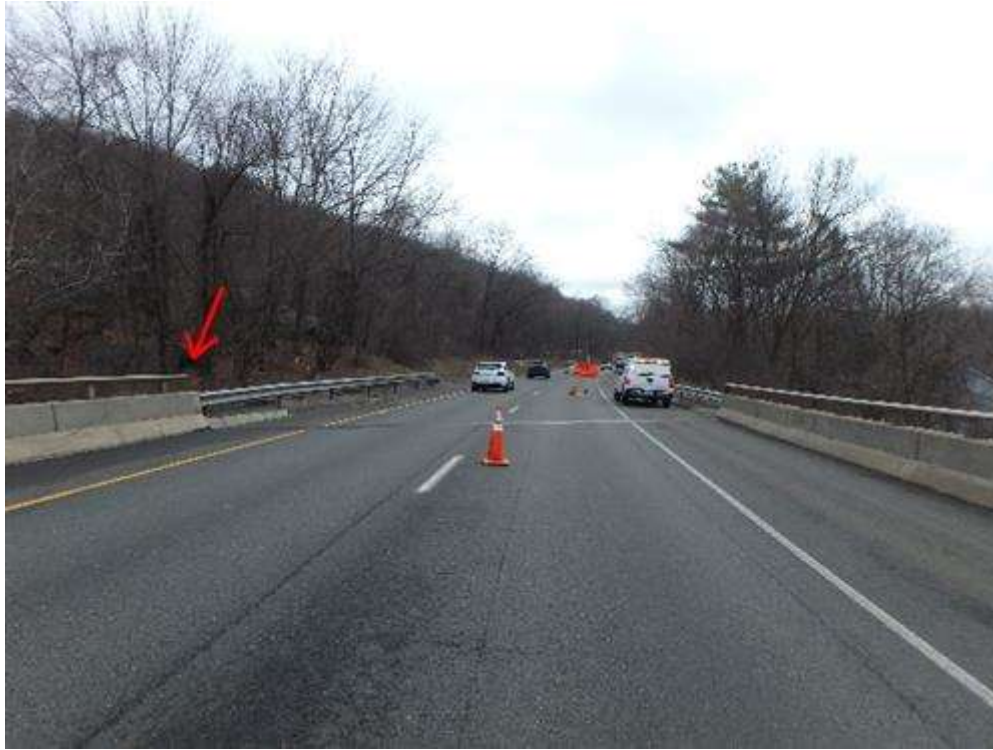
Photo Number: 7

East approach from bridge.
Note: The tapered end of the north railing is missing.

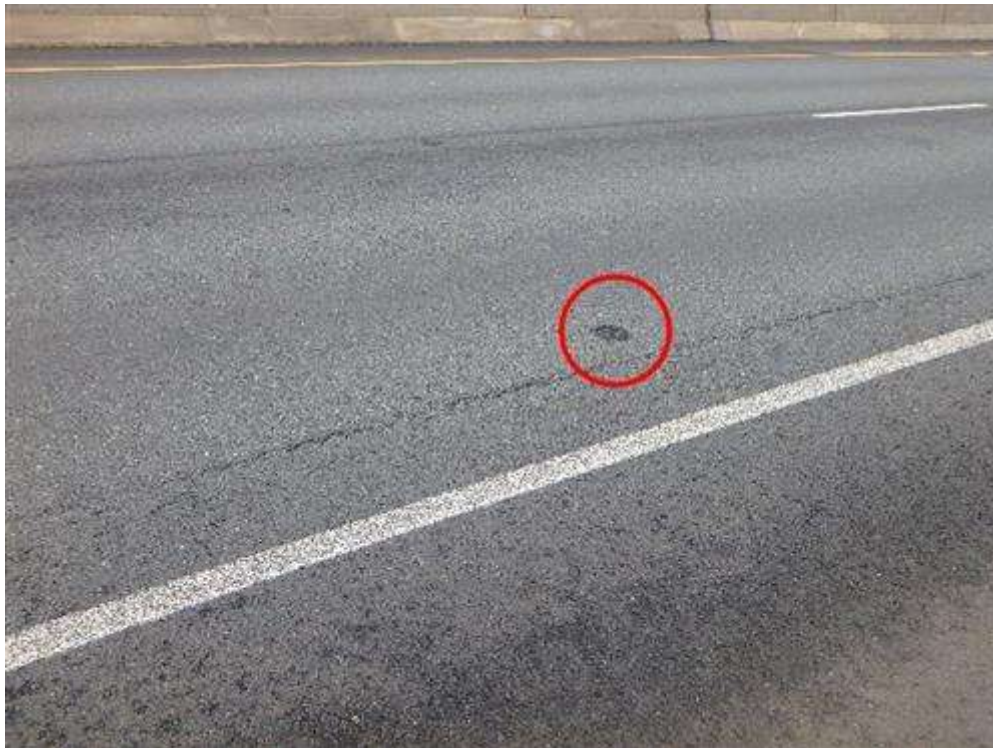
Photo Number: 8

Overlay:	7	Bituminous overlay: - Paving seams are slightly open. - Random filled core holes. See sheets 21-24 and photo 8.
Deck - Str. Condition:	7	Underside of deck: - Random transverse hairline cracks with and without efflorescence. - Span 1, bay 3 & 4 have areas of hairline map cracking up to 6' x 8'. - Span 2 has random areas of dampness in bays 2 & 3. See sheets 26, 27 & 29 and photos 9 & 10.
Curbs:	7	Sloped granite curbs have areas of chipping, scrapes & stains. Average curb reveal along both sides is 2-1/2". See sheets 21-24 and photo 11.
Median:	N	
Sidewalks:	N	
Parapet:	7	Concrete parapets: - Areas of light to moderate scaling & a few scrape marks. - Random vertical hairline cracks; some extend across the top. Span 3, south parapet near mid-span has 2' x 1' x 1/4" deep impact scrapes. See sheets 21-24 and photos 11 & 12.
Railing:	6	Single aluminum extruded railings: - Random minor scrape marks and gouges. - North railing, east tapered end is broken-off/missing. - South railing has a fully cracked weld at the west tapered end. Both anchor bolts are slightly backed off. See sheets 21-24 and photos 7, 11 & 13.

Typical condition of bituminous overlay. Paving seams are slightly open. There are random filled core holes. Span 1 shown.

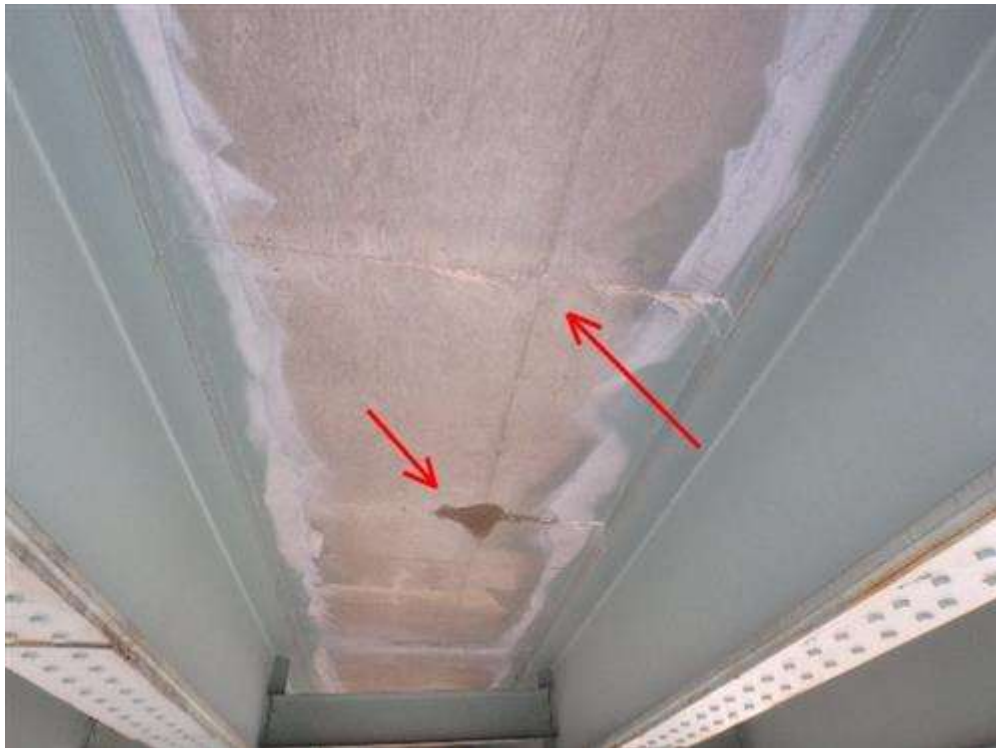
Photo Number: 10

Typical underside of deck condition with random transverse hairline cracks with and without efflorescence. Note there are random areas of dampness.

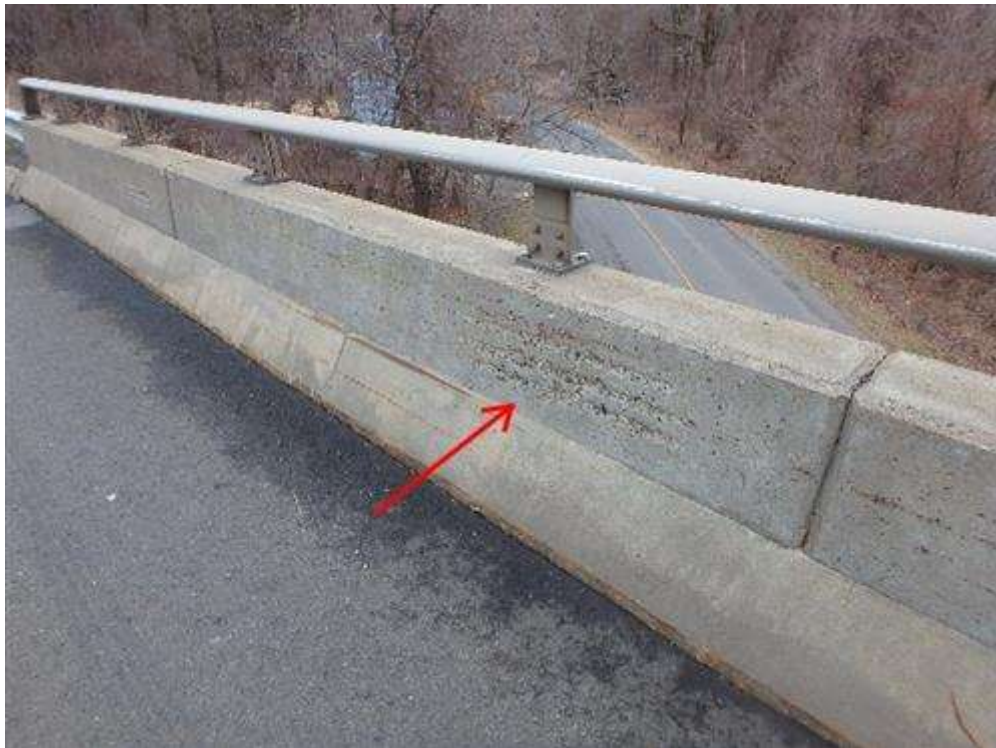
Photo Number: 12

Span 3, south parapet has impact scrapes near mid-span.

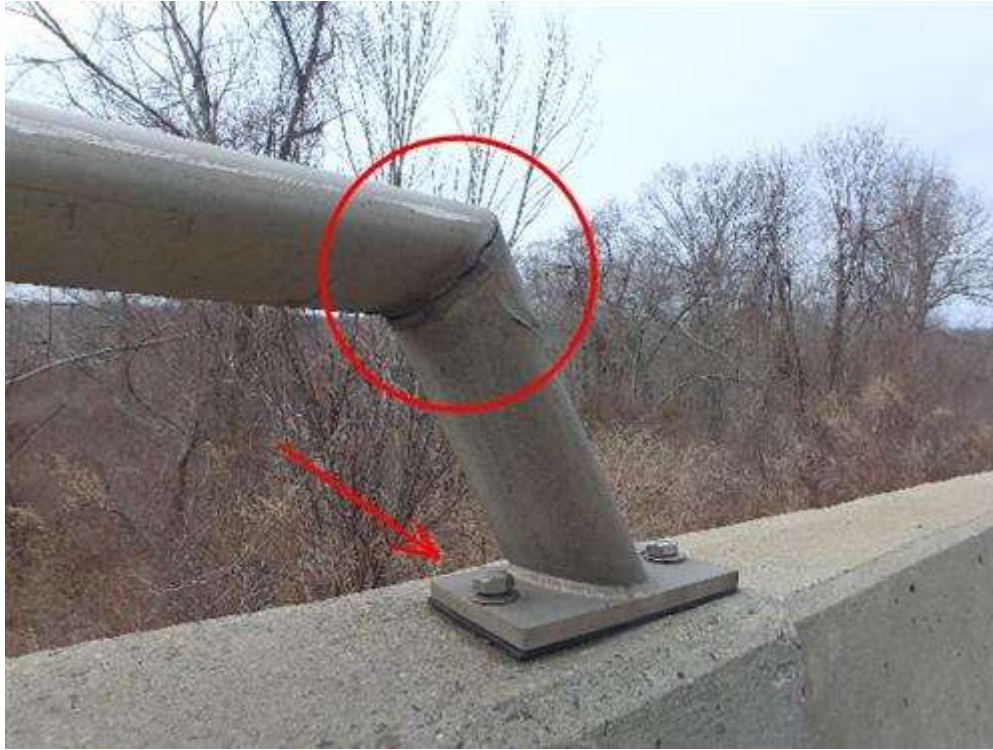
Photo Number: 13

South railing at the west end has a fully cracked weld at the tapered end. Anchor bolts are slightly backed off.

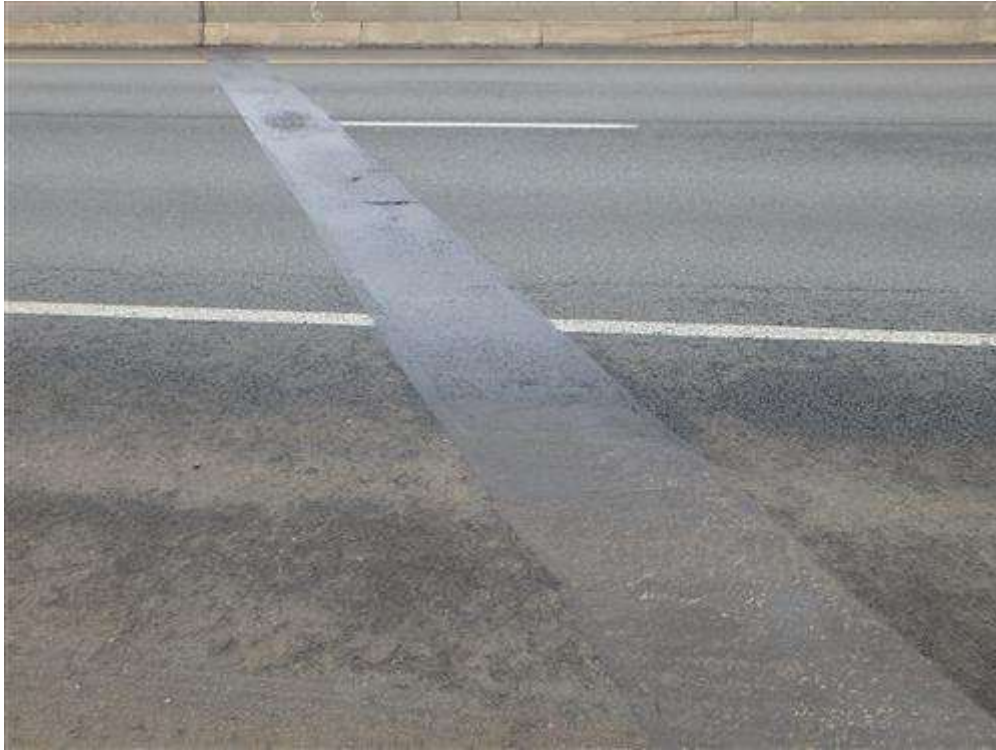
Photo Number: 15

Expansion Joint: 6 Asphaltic plug joints at abutments and piers are in place since last inspection.
- Isolated areas of exposed aggregate with small voids up to 20' long x up to full width.
Abutment 1 joint has a few voids up to 1' long x 2" wide x 1/2" deep.
Abutment 2 joint has a full length x up to 1/8" wide adhesion crack on the approach side. Areas of active leakage were noted below.
See sheets 21-24 and photos 15-18.

Abutment 1 asphaltic plug joint, looking north. New joints are in place since the last inspection.

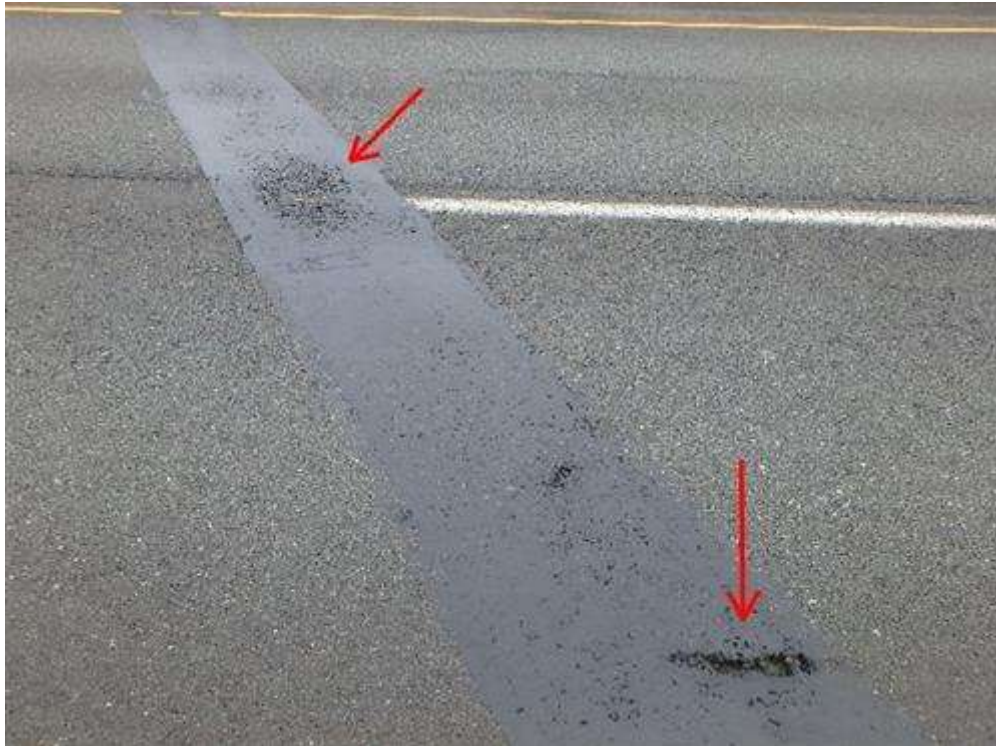
Photo Number: 16

Close-up of previous photo in the right lane. There are areas of exposed aggregate and small voids.

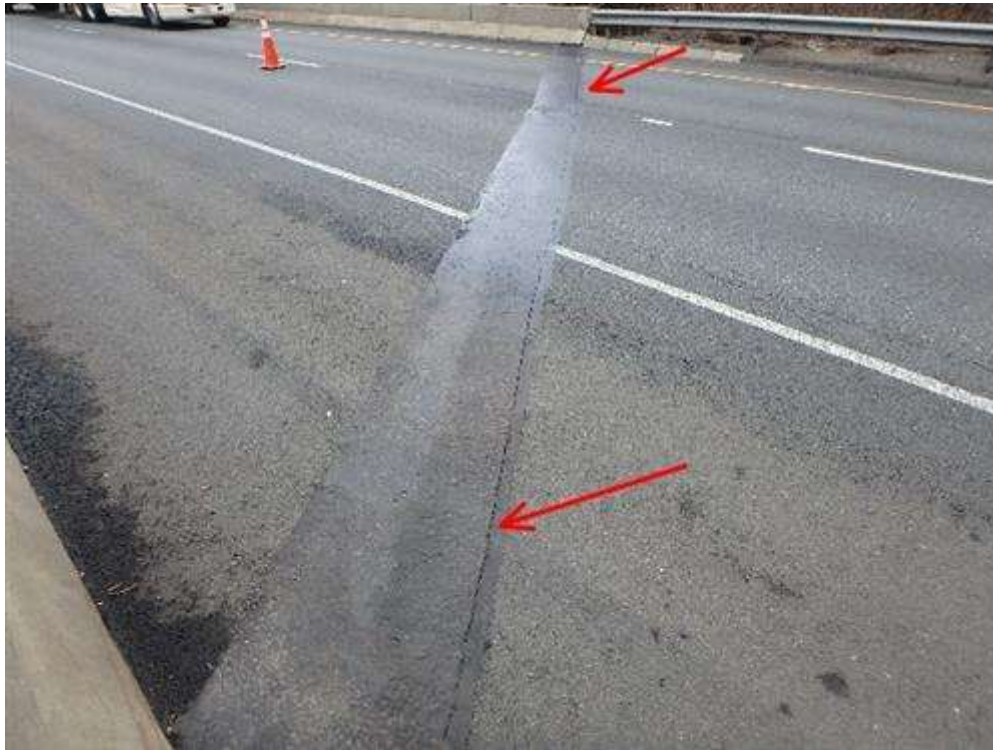
Photo Number: 17

Abutment asphaltic plug joint, looking north, has a full length adhesion crack on the approach side.

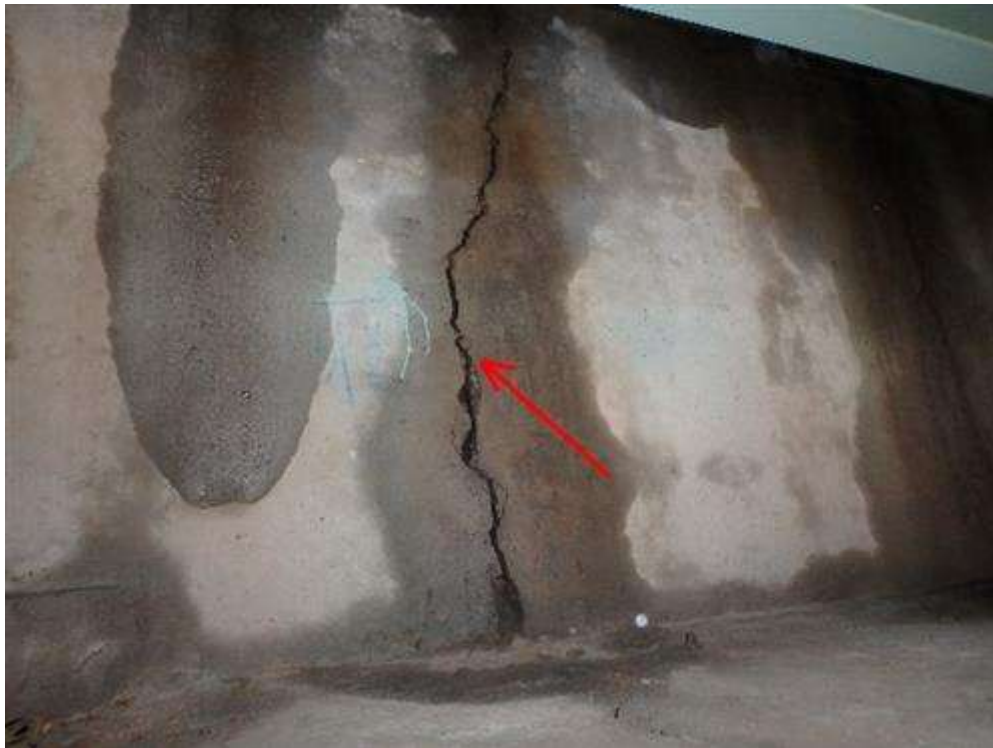
Photo Number: 18

Abutment 2 backwall in bay 3 has active leakage through joint at the time of inspection. Note the full height vertical crack in the backwall that extends into stem.

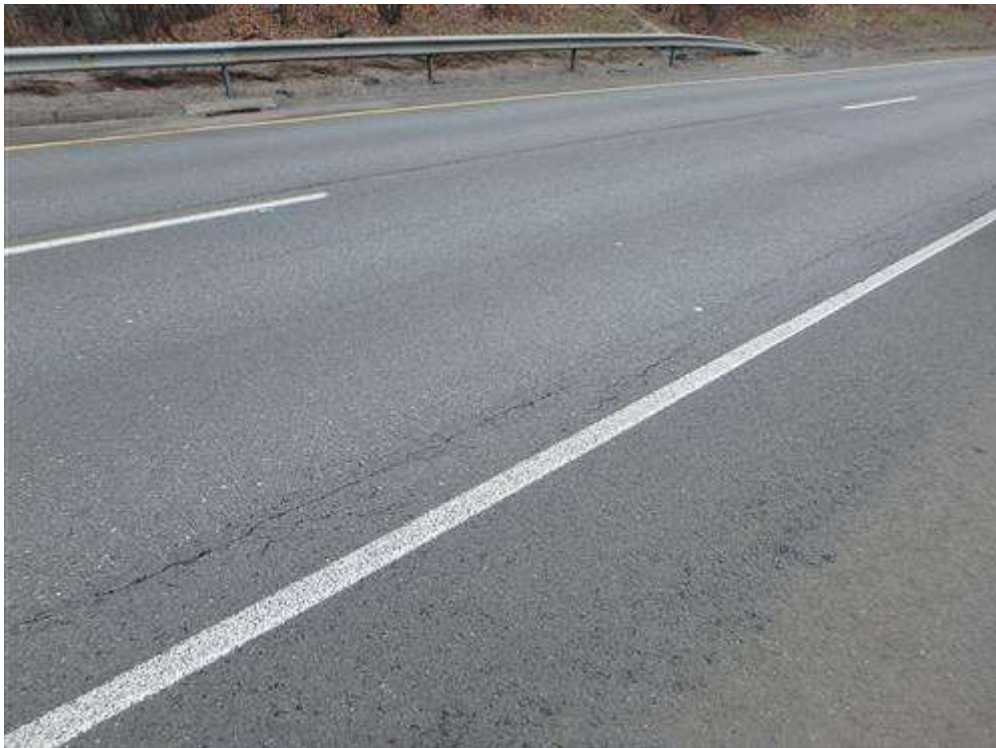
Photo Number: 22

East approach bituminous pavement. Typical condition with open paving seams.

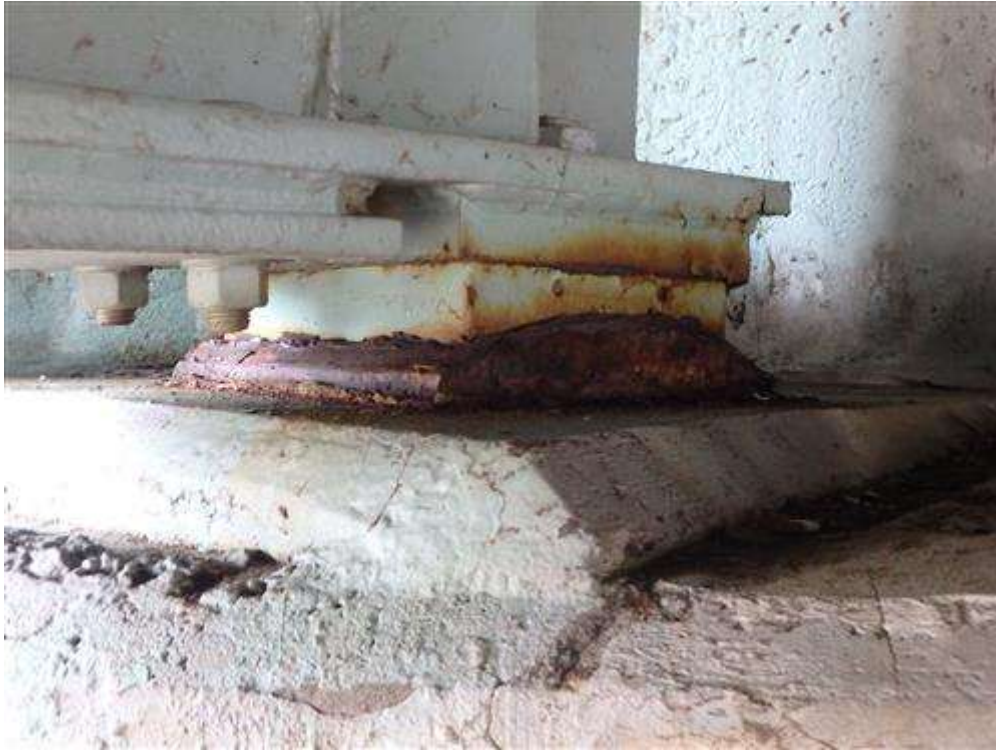
Photo Number: 23

Typical condition of the sliding expansion bearings at Abutment 1 with areas of peeling paint and light to moderate rust. Girder G6 bearing shown.

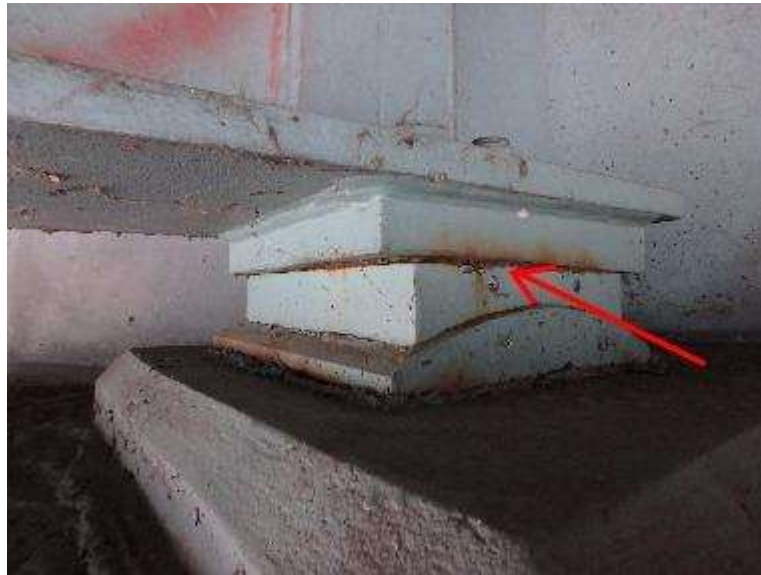
Photo Number: 24

Girder G5 sliding bearing at Abutment 1 has pack rust between sole and sliding plates.

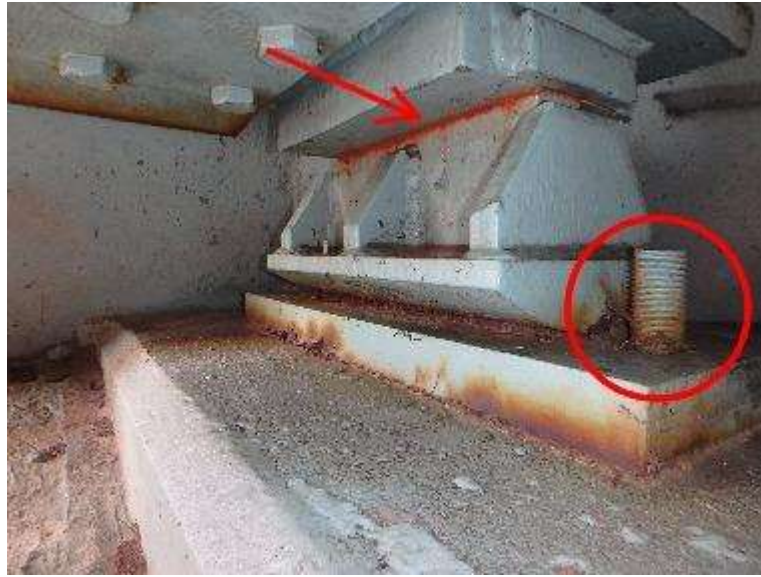
Photo Number: 25

Typical condition of the rocker expansion bearings with areas of peeling paint and light to moderate rust. Girder G1 bearing at Abutment 2 shown. There is abrasion rust between the rocker and sole plate. South anchor bolt nut is missing.

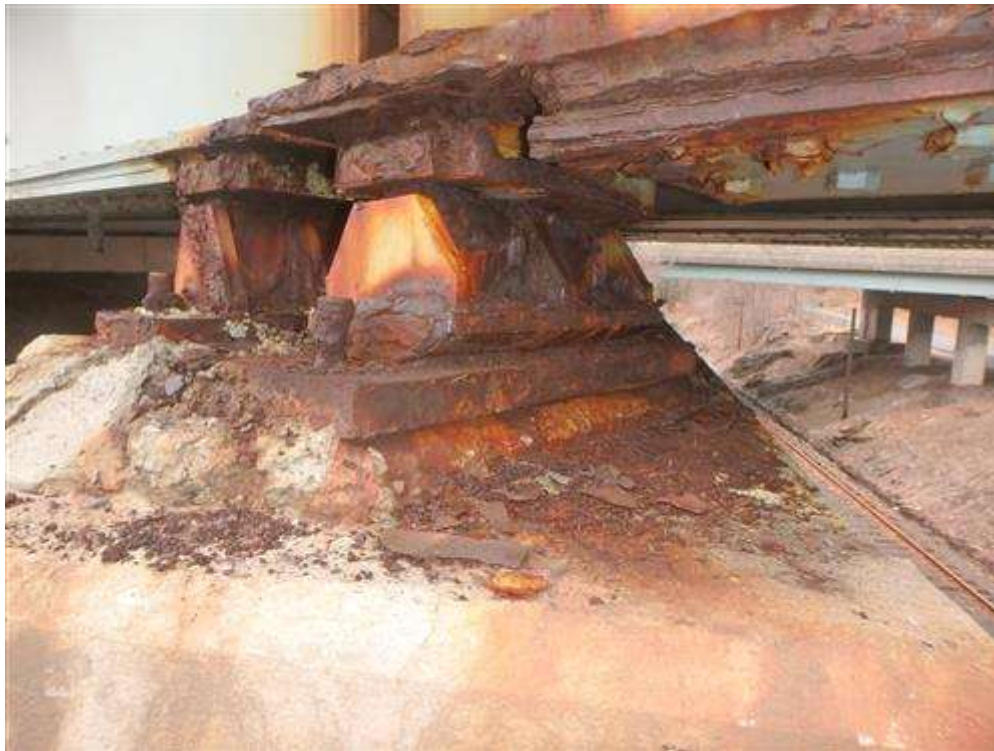
Photo Number: 26

Span 2, girder G6 expansion rocker bearing at Pier 1 has heavy laminated rust. South anchor bolt nut has 100% section loss. Note that the pedestal has severe scaling on south side but no undermining was noted.

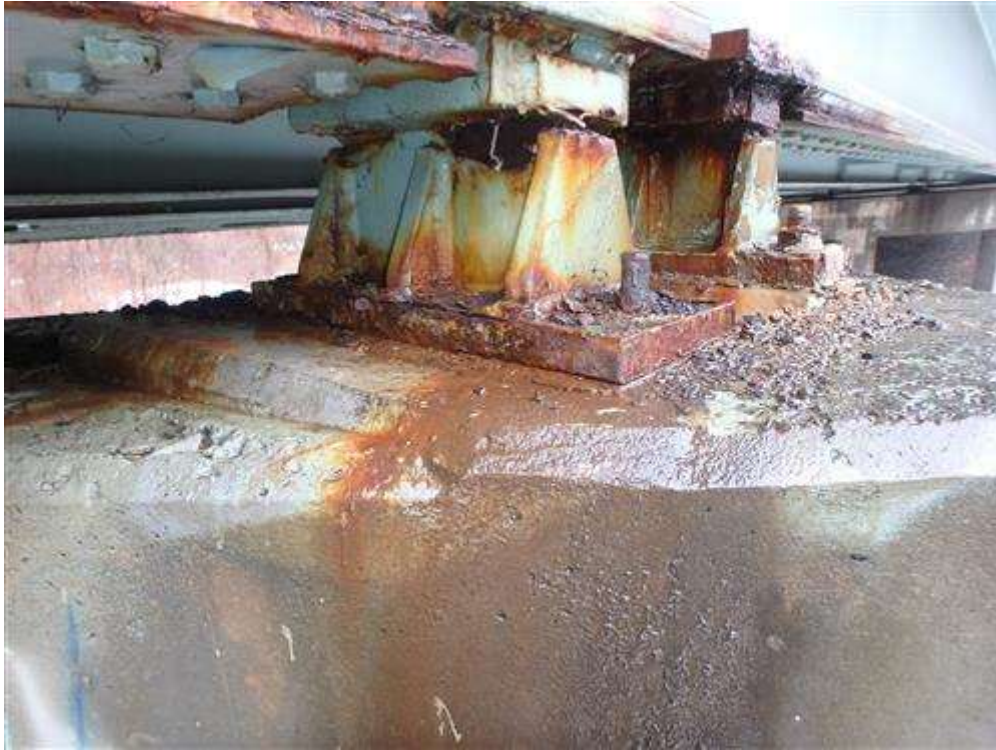
Photo Number: 27

Typical condition of the fixed bearings at Pier 2 with areas of peeling paint and light to heavy rust. Girder G1 bearing shown. North anchor bolt nut has 100% section loss.

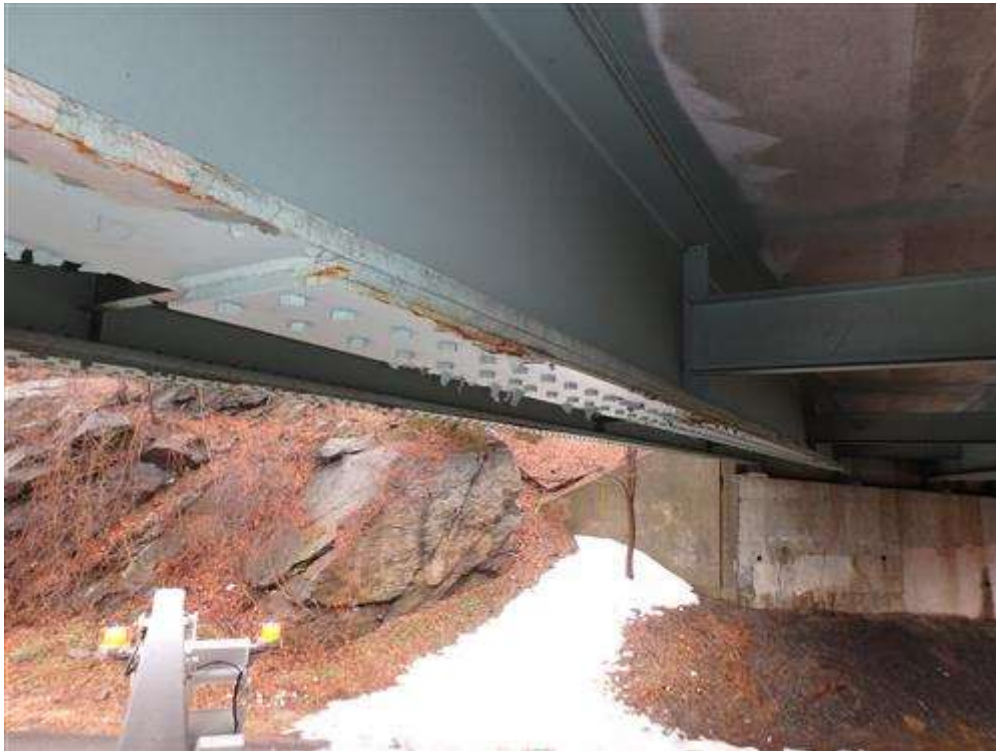
Photo Number: 28

Typical condition of girders with bolted cover plate retrofits. There are areas of peeling paint and light to moderate rust. Span 3, girder G2, south elevation shown.

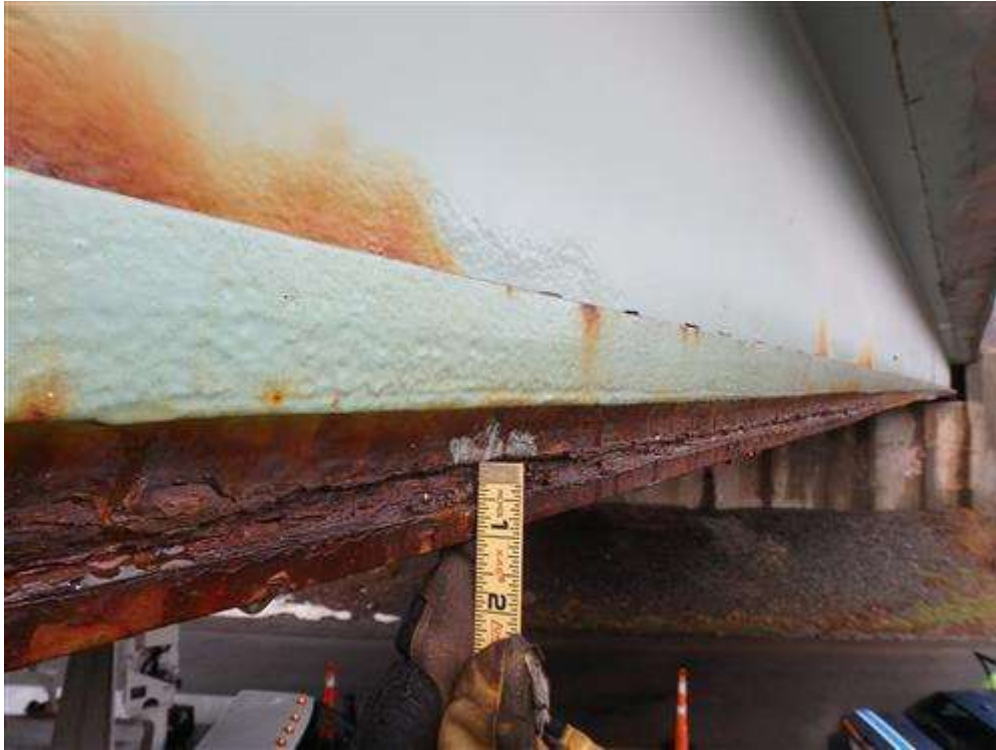
Photo Number: 29

Typical random areas of pack rust between the girder bottom flange cover plate and bolted retrofit plate.

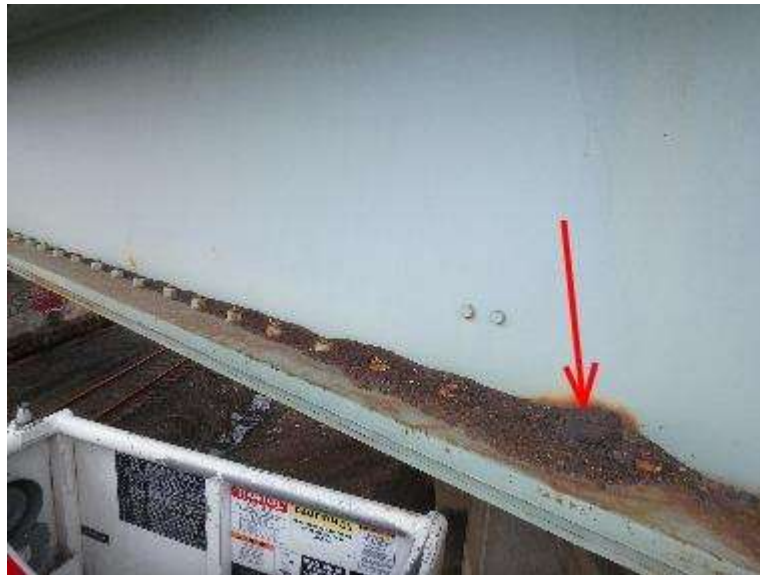
Photo Number: 30

Span 2, south side of girder G6 bottom flange has a moderate accumulation of debris and an area of heavy laminated rust.

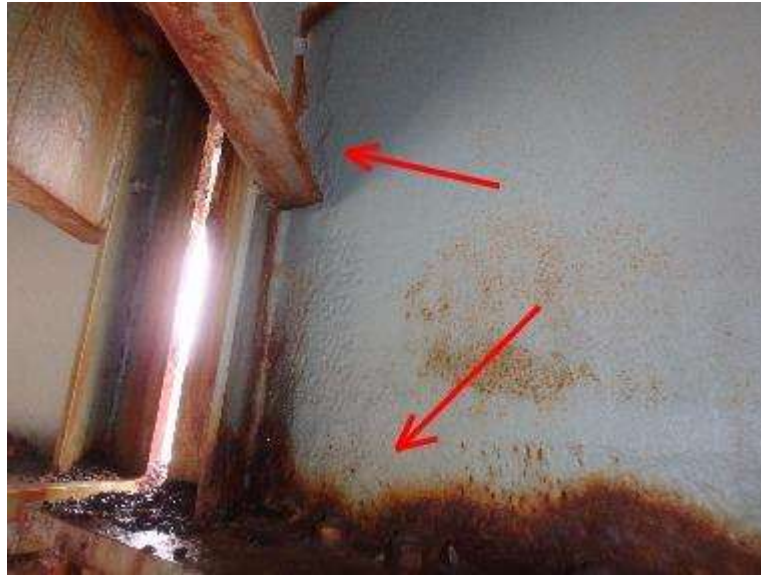
Photo Number: 31

Span 2, north side of girder G6 at Pier 2 has painted over section loss with recurring light to heavy rust.

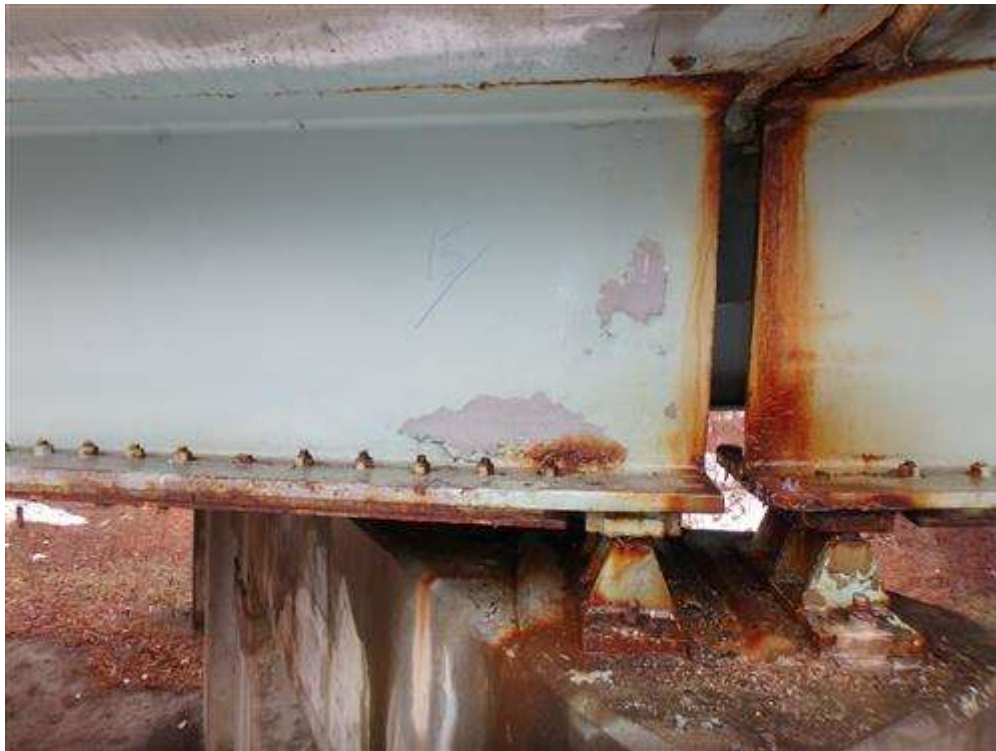
Photo Number: 32

Typical condition of fascia girders with areas of light to moderate rust. North side of girder G1 at Pier 2 shown.

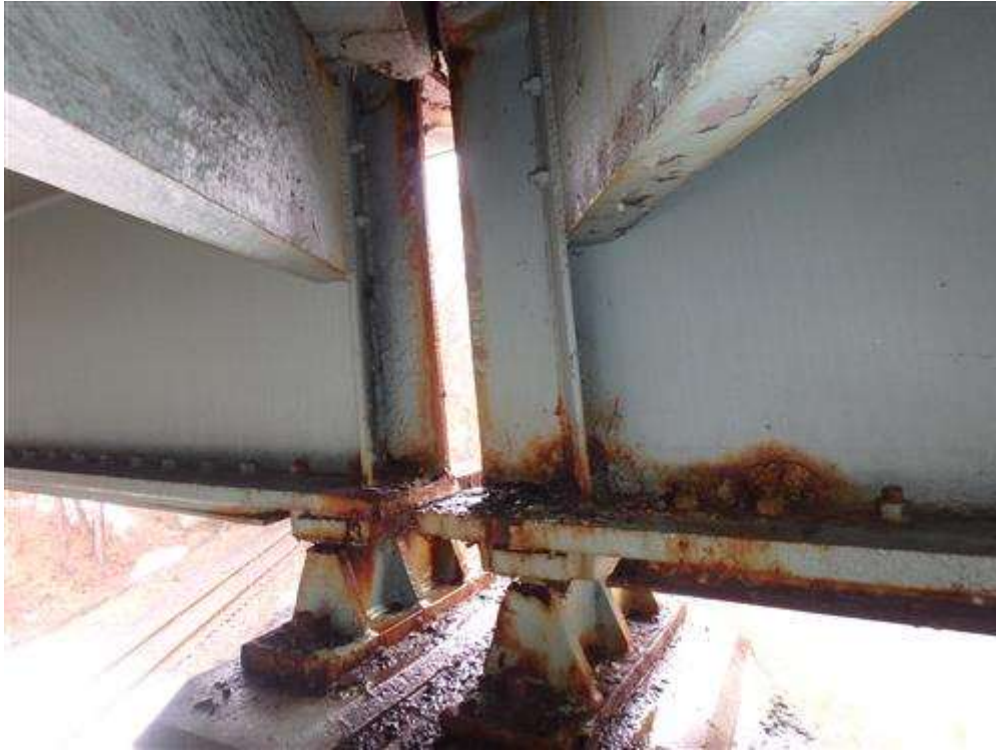
Photo Number: 33

Same location as Photo #32. South side of Span 3, girder G1 has painted over laminated rust with negligible loss.

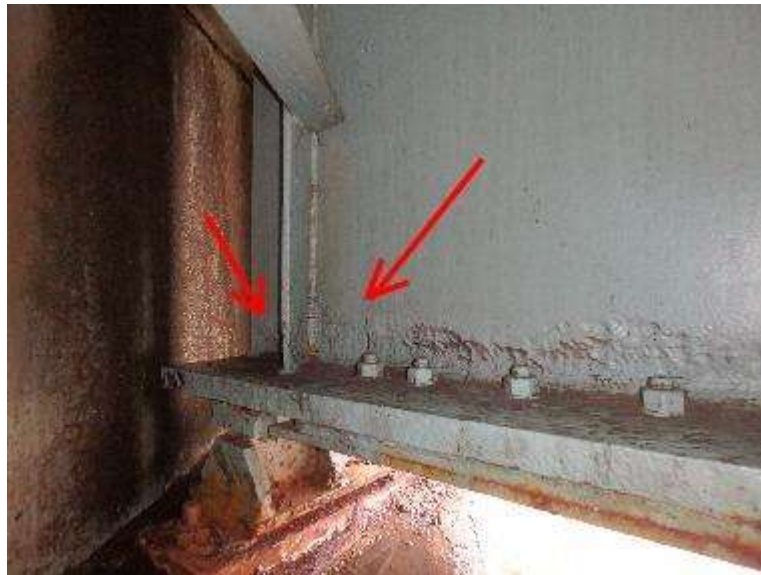
Photo Number: 34

Span 3, north side of girder G6 at Abutment 2 has painted over section loss at the bottom of the web and diaphragm connection plate.

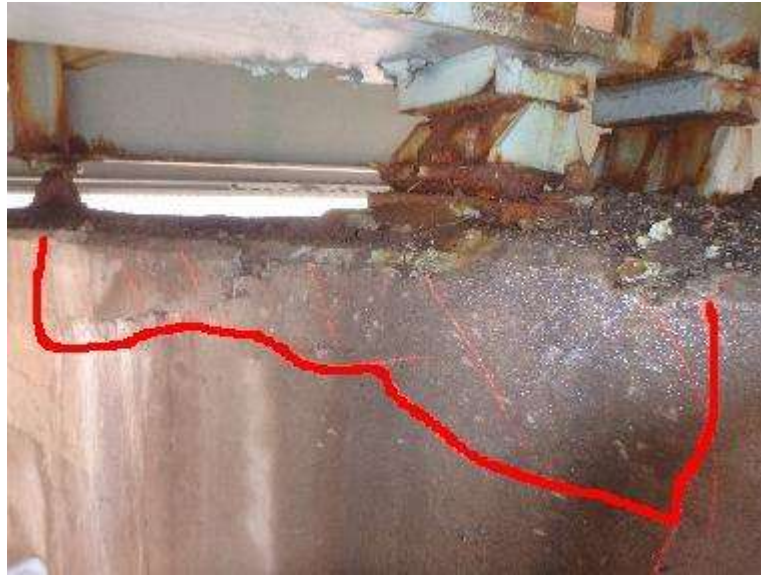
Photo Number: 43

Pier 1 cap below girder G2 in Span 2 has a hollow area with cracks and light efflorescence.

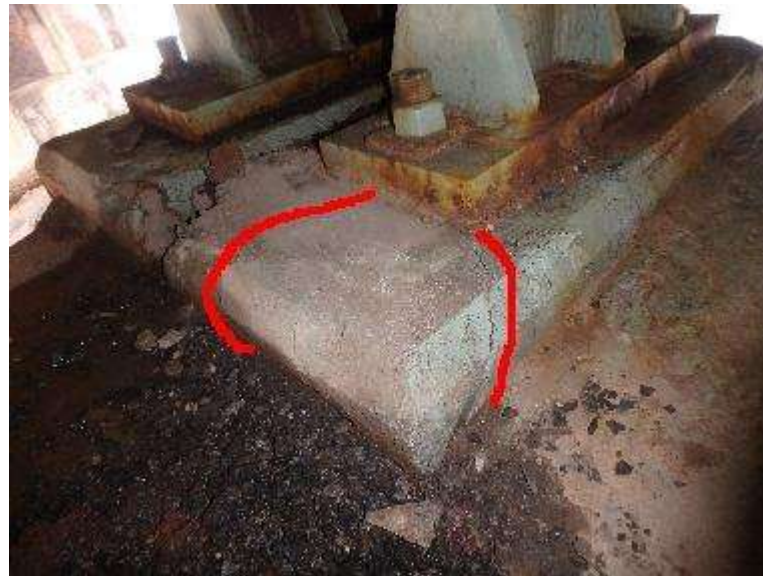
Photo Number: 46

Pier 2, girder G5 pedestal in Span 3 has a hollow area with cracks on the south side.

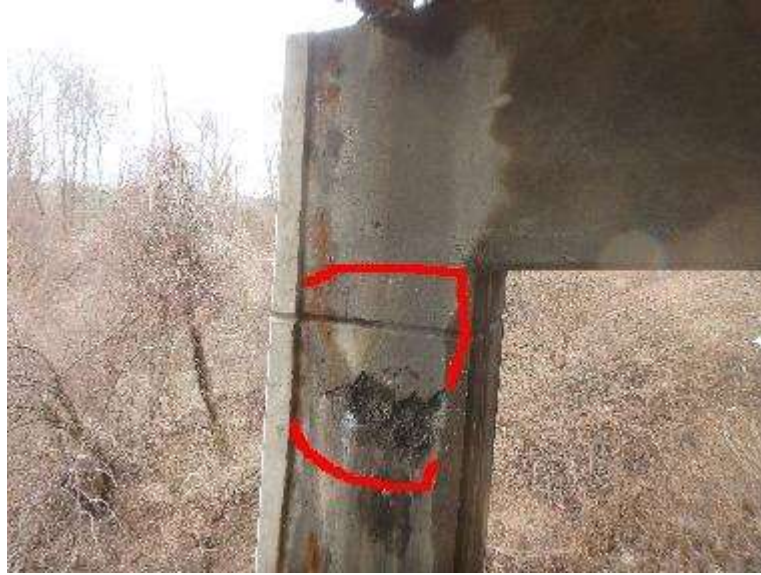
Photo Number: 47

Pier 1, Column 4, east side, has a hollow area with spall.

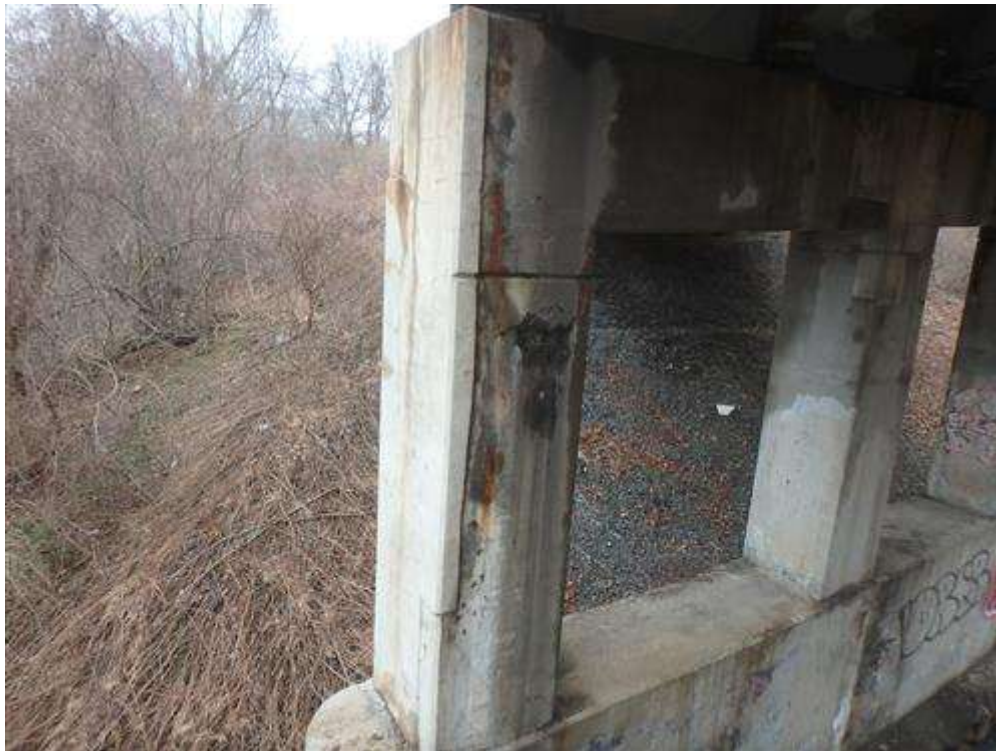
Photo Number: 48

Same location as previous photo. Concrete patch on the south side of cap and column has hairline map cracks.

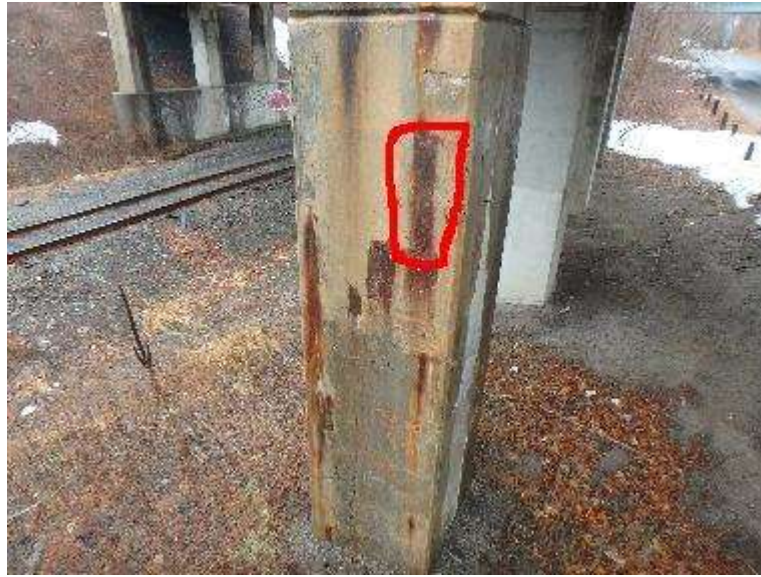
Photo Number: 49

Pier 2, Column 4, south side has a hollow area and random cracks with and without rust stains & efflorescence.
