BRIDGE NO.01211

52980 - NEWTOWN
INTERSTATE-84 WB
over
HANOVER ROAD

In-Depth and Routine Inspection

11/16/2016

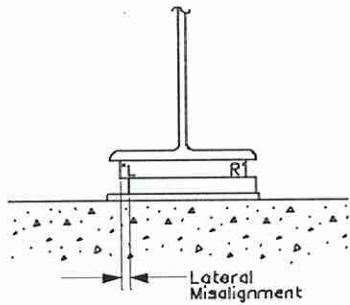
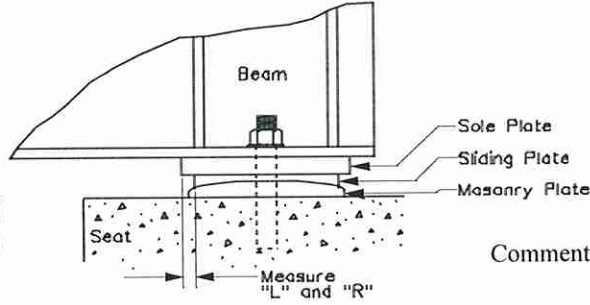
Span No. = 2

Brg	Movement				Condition			Comments
	" L "	" R "	Mode Exp. or Contr.	Lateral Misalign.	Bearing Frozen?	Normal Mov't	Rust ? H/M/L	
1	7/16"	5/8"	E	1/4"		Normal Mov't	L	
2	1/2"	1/2"	E	1/4"		Normal Mov't	L	
3	5/16"	1/4"	E	0"		Normal Mov't	L	
4	1/2"	1/2"	E	0"		Normal Mov't	L	
5	7/16"	1/4"	E	1/4" South		Normal Mov't	M	Light blush rust & pack rust between masonry plate & sole plate.
6	7/16"	5/8"	E	3/16" South		Normal Mov't	M	Spotty blush rust to masonry & sole plate, & 1/16" pack rust between plates.
7	1/2"	1/2"	E	1/16" South		Normal Mov't	H	3/16" pack rust between sole & bronze plates, & 1/8" pack rust between Bronze and Masonry plate.

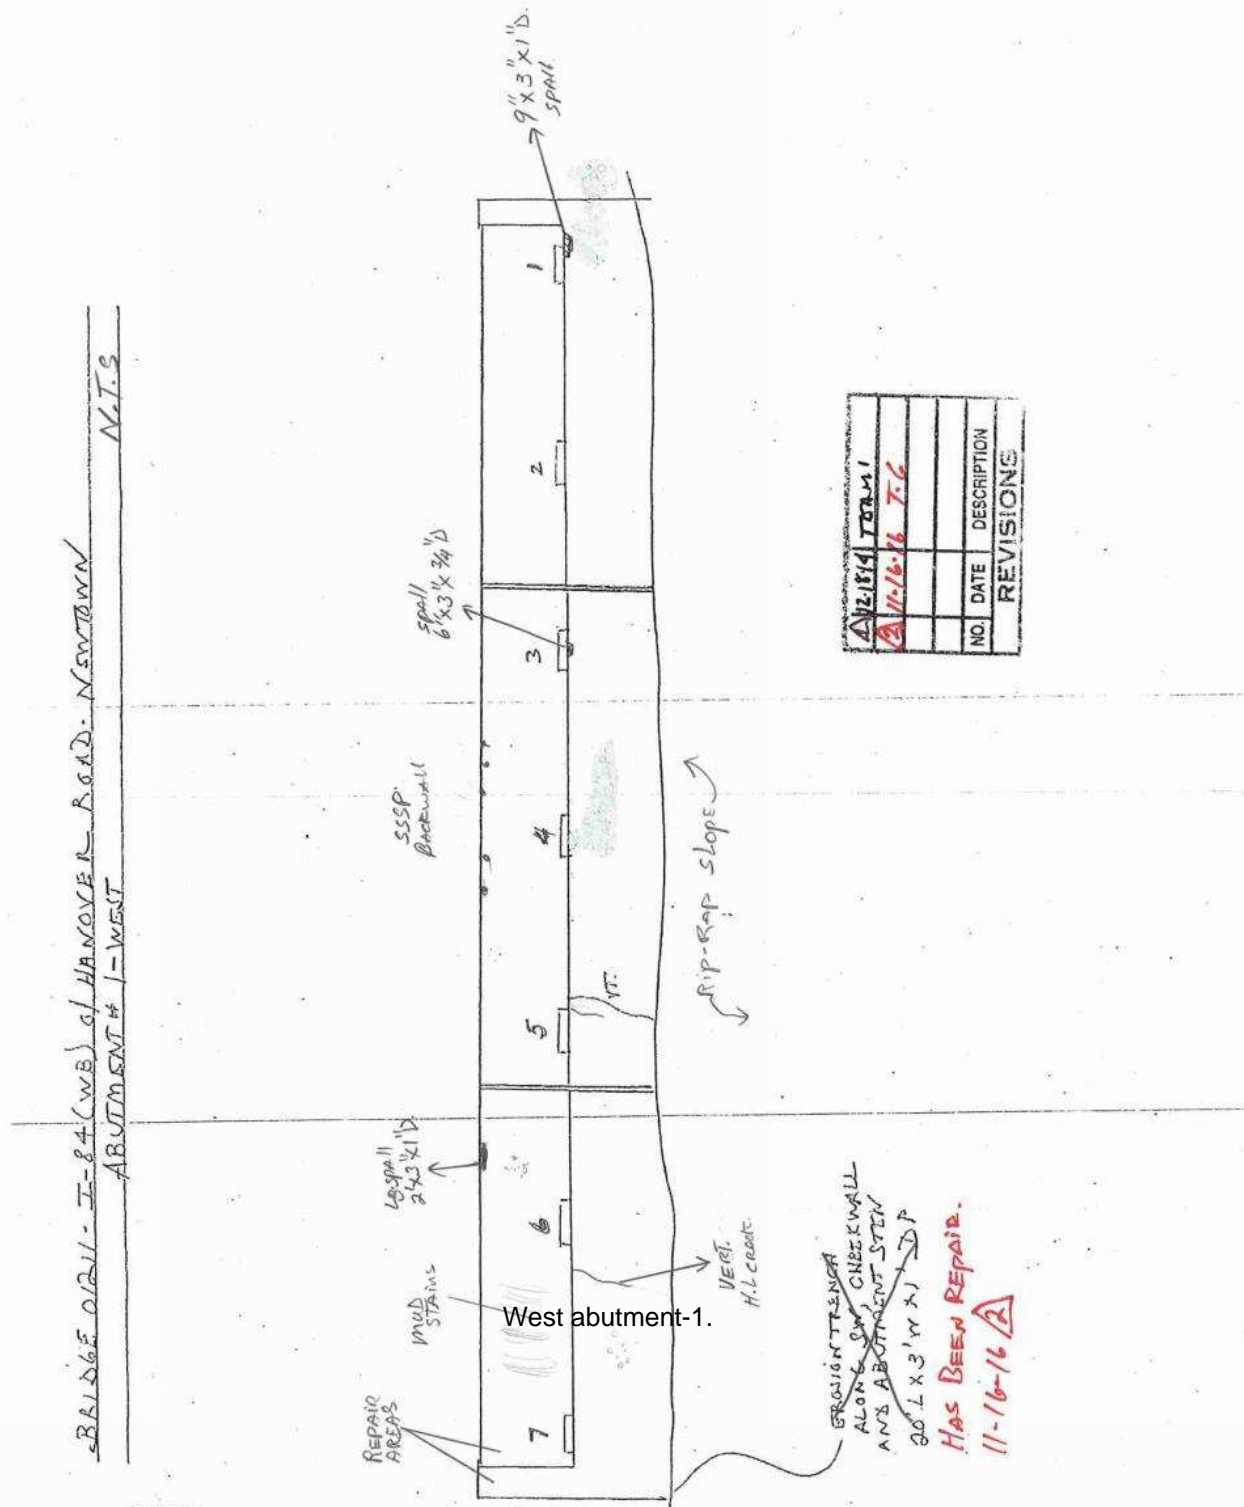
STRENGTHENING
ALONG ON CURB WALL
AND ABUTMENT STEIN
20' L X 3' W X 1' D
HAS BEEN REPAID.
11-16-16 A

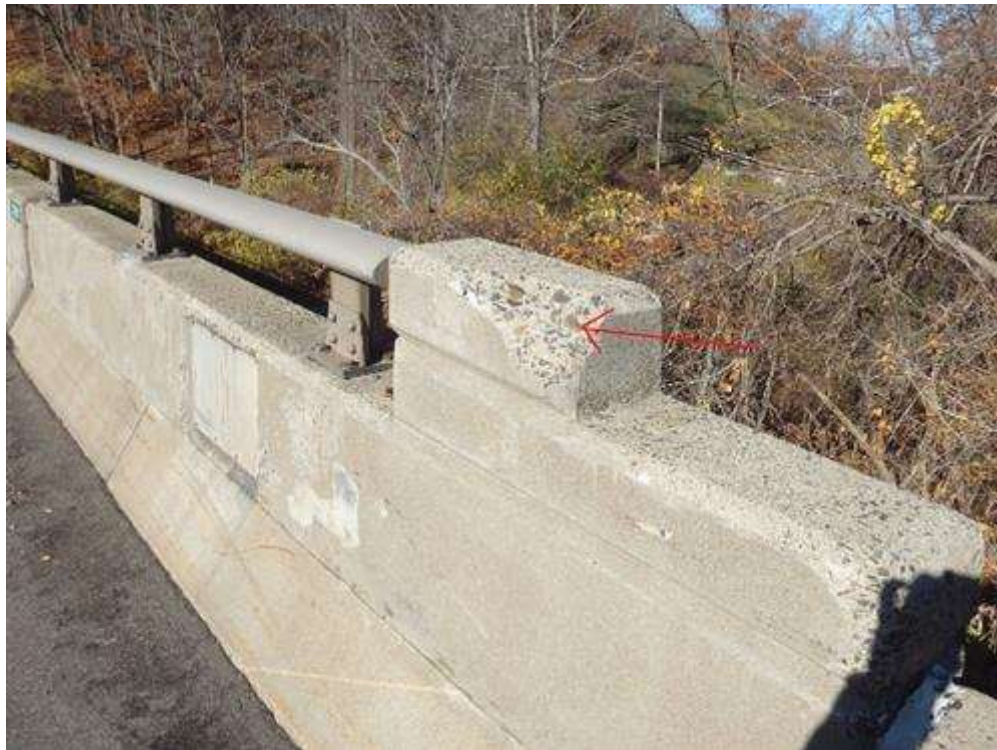
Photo Number: 4

Large spall at approach parapet northeast corner.

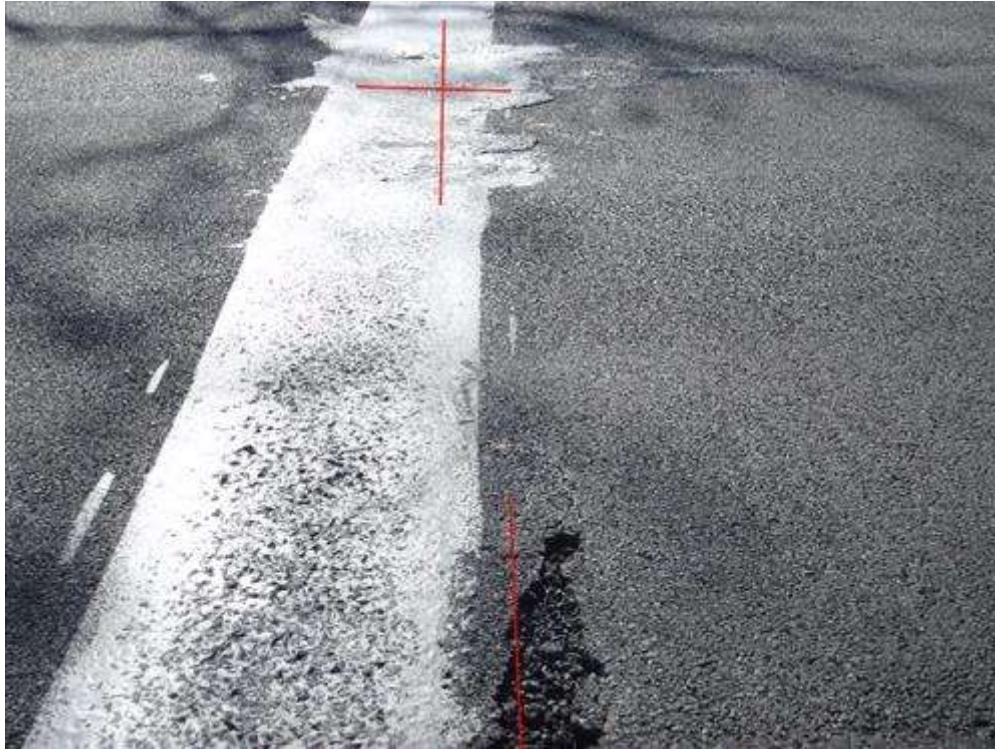
Photo Number: 9

Expansion Joint: 6 Asphaltic Plug Joints :
Joint over pier # 1 shows adjacent pot hole on span 2 side.
Joint over pier # 2 shows Three large depression.
Right lane adjacent to double skip line, one depression 1' X 2' & adjacent pot hole closed to white shoulder line.
Middle lane adjacent to double skip line, one depression 2' X 2' with a 4" diameter pot hole.
Middle lane adjacent to single skip line, one depression 2' X 2' with 1' diameter pot hole.

Settlement pot holes on joint & pot holes on span-2 adjacent to A.P.J over pier # 2.

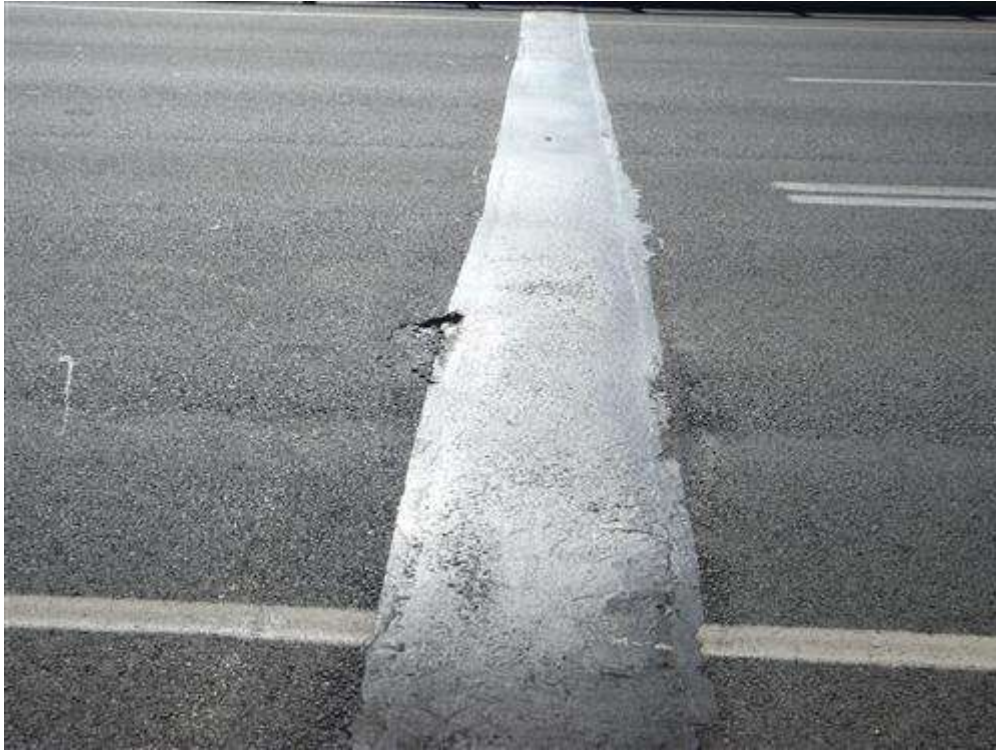
Photo Number: 11

A.P.J over pier-1 W/B, and small pot hole on span-2 Adjacent to A.P.J over pier-1.

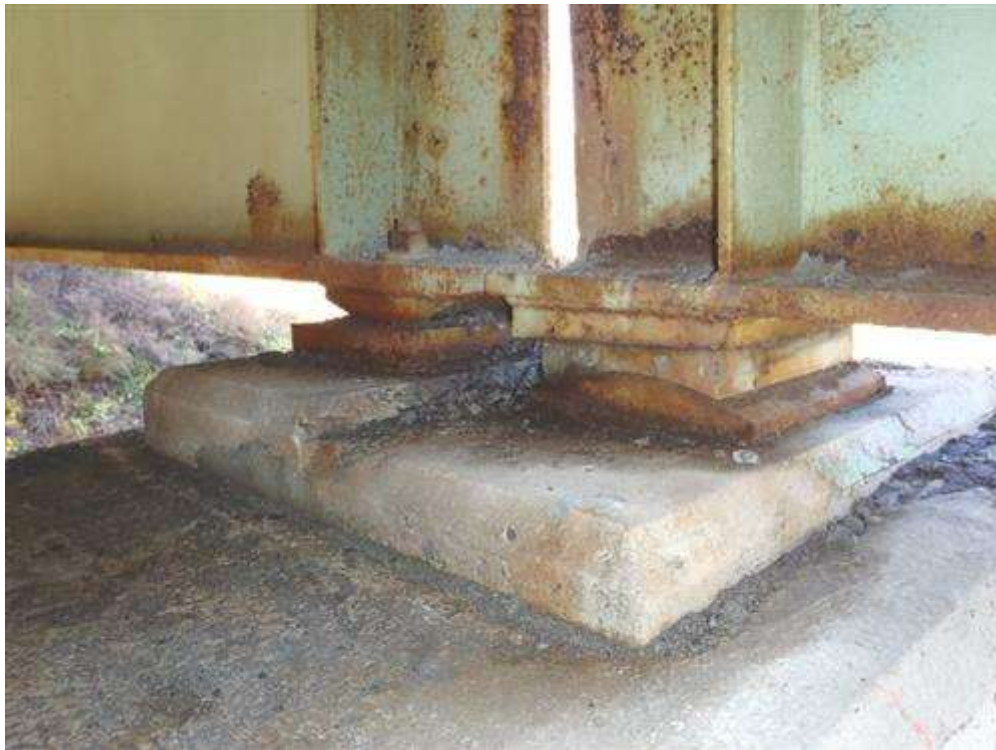
Photo Number: 22

Bearing Devices: 4	<p>Steel plates :</p> <p>Abutment # 1 & 2 are steel expansion bearings with steel keepers angles.</p> <p>Bearings are lubricated and show signs of movement.</p> <p>Pier # 1,span # 1 are curved plate fixed bearings with impacted rust between the plates.</p> <p>Medium rust on the bearings.</p> <p>Pier #1, span # 2 are steel expansion bearings without steel keepers.</p> <p>The anchor bolts were cut and the holes were plated.</p> <p>There is impacted rust between the sole and sliding plate and medium rust on the bearings which causes a gap.</p> <p>Also, some powdered rust between the bronze and masonry plate.</p> <p>Show little signs of movement.</p> <p>These bearings needs to be lubricated.</p> <p>Pier # 1, spans 2 & 3 are curved plate fixed bearings with impacted rust between the plates.</p> <p>Medium rust on the bearings.</p> <p>Bearing # 7 are the worse condition with heavy rust.</p> <p>The nut on bearing # 7, pier #2 span # 3 has rusted away.</p> <p>Anchor nuts have severe rose budding and section loss.</p> <p>All bearings on pier # 2 show heavy rust.</p> <p>Note: there is concrete debris around most bearings at both pier caps that needs to be removed.</p> <p>See photos.</p>

Typical bearings pier 1.

The expansion bearings at pier 1,span two need to be lubricated.

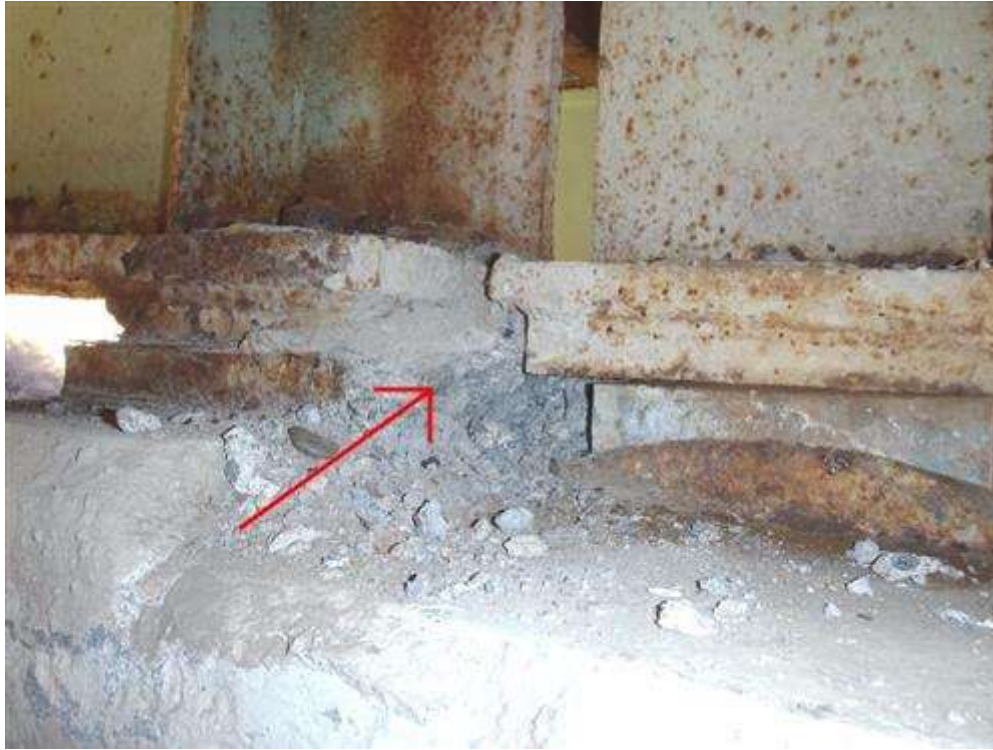
Photo Number: 23

Concrete Crack - Spall: 6	See items above.
Steel Corrosion: N	
Paint: N	
Timber Decay: N	
Collision Damage: 8	
Debris: 5	Shows concrete debris several inches deep on both pier caps from joint installation. The debris needs to be removed. Photos.

Bearing 2 pier 1 concrete between beams.

The debris on both pier caps needs to be removed.

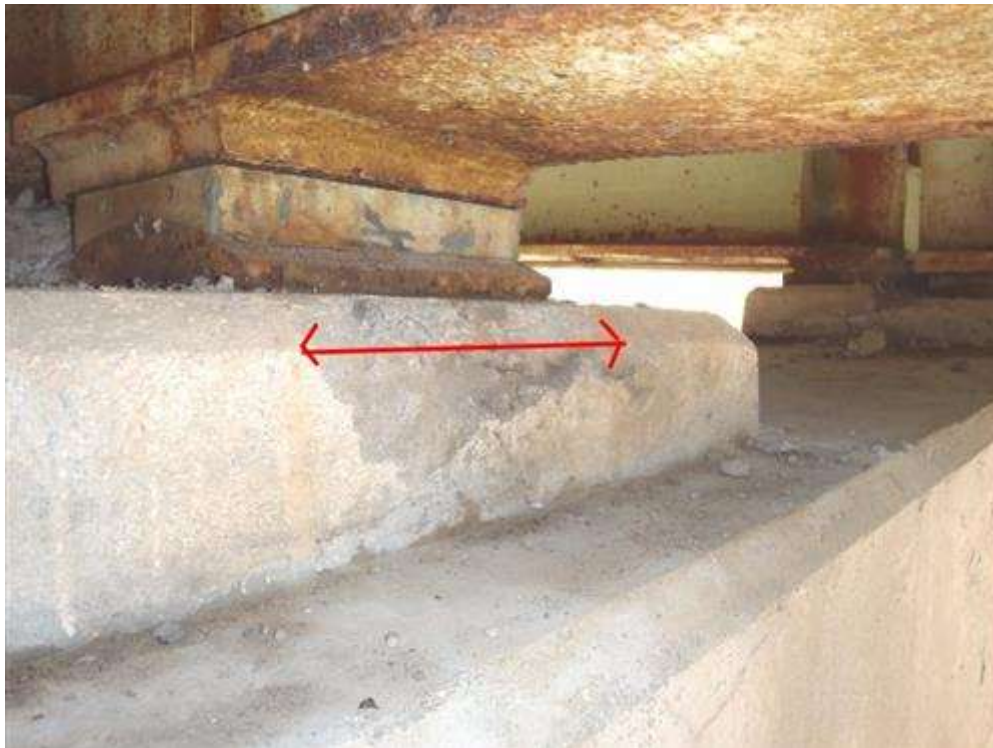
Photo Number: 24

Large spall pedestal 3 pier 1, span 2 east side.

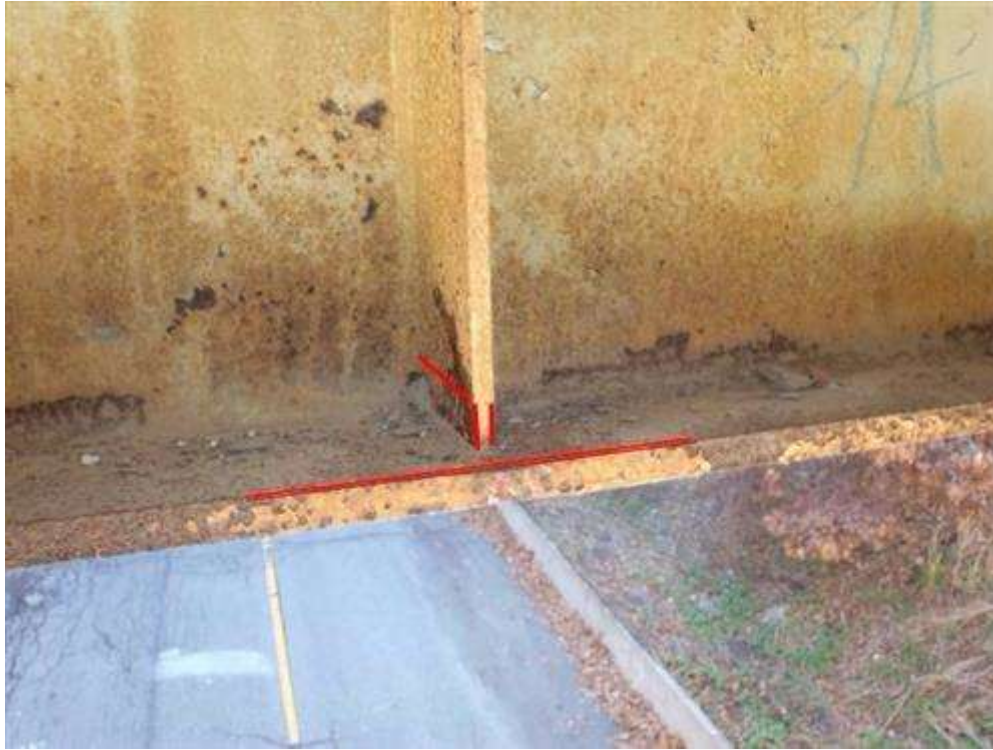
Photo Number: 25

Beam # 7, span # 2 has an isolated area of section loss on the north side on the bottom flange taken at mid-span,Original,7/8", measured 3/4", N/C during the 2016 inspection.

Beam # 7, span-2 south side at the bottom flange & bottom of stiffener mid-span shows isolated area of section loss.

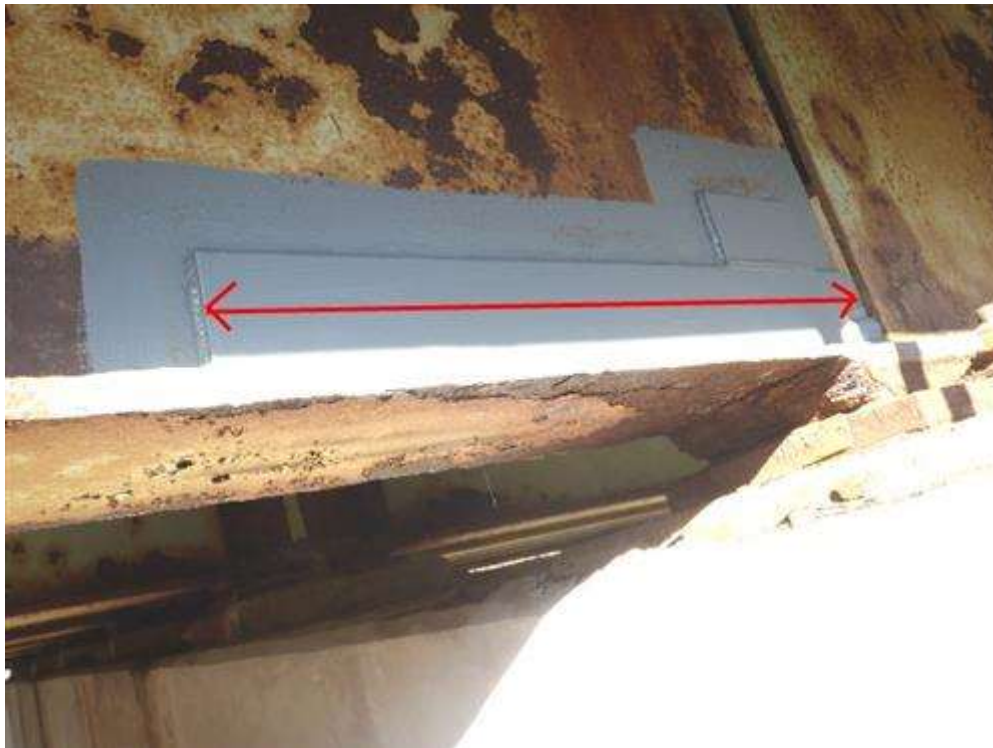
Photo Number: 26

Beam # 7, pier # 2, span # 2, section loss measured on the bottom flange edges 2' from the center line of the bearing.

South side, original 7/8", measured 5/16".

North side, original 7/8", measured 5/16".

Beam 7 south side span 2 at pier 2, repairs have been made to bottom flange & beam end.

Beam # 7, pier # 2, span # 2 has a perforation at the top & bottom of the web of beam end , 5" long X 2" high has beam repaired with welded plate, see photo.

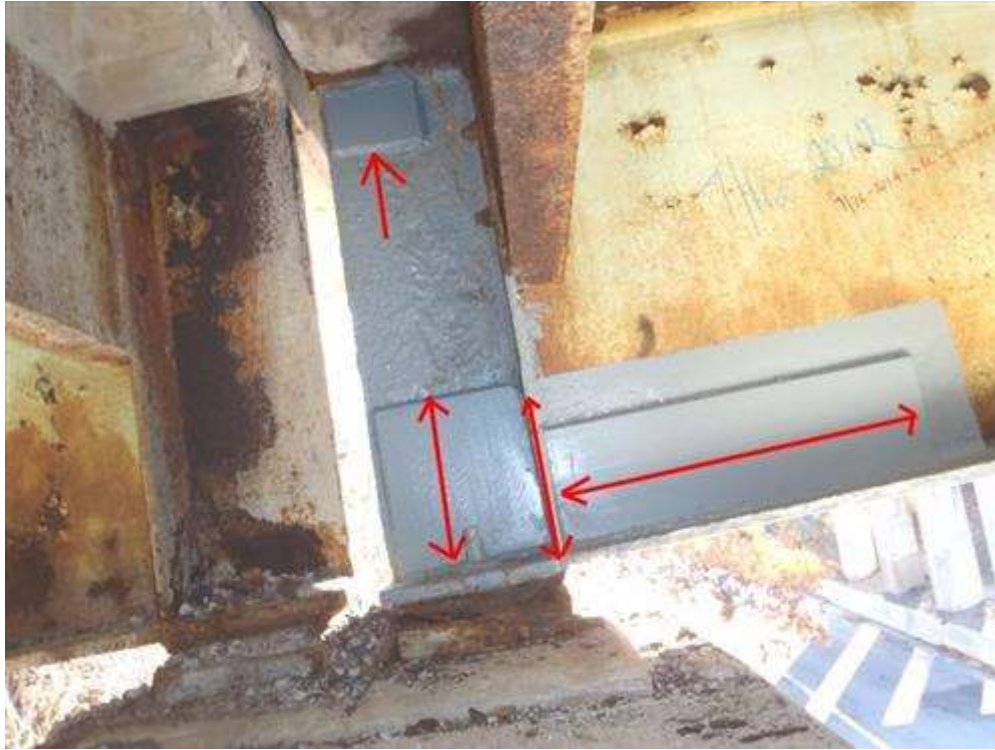
Photo Number: 27

Beam #7 north side at pier 2, repairs have been made to beam end & vertical bearing stiffener and bottom of web.

Beam # 7, pier # 2, span # 2 there is a perforation at the base of the vertical bearing stiffener, 2" high X 1" wide has been repaired with welded plate see photo.

Beam # 7, pier # 2 repairs have been made to bottom of web on south & north sides with welded plates, see photos.

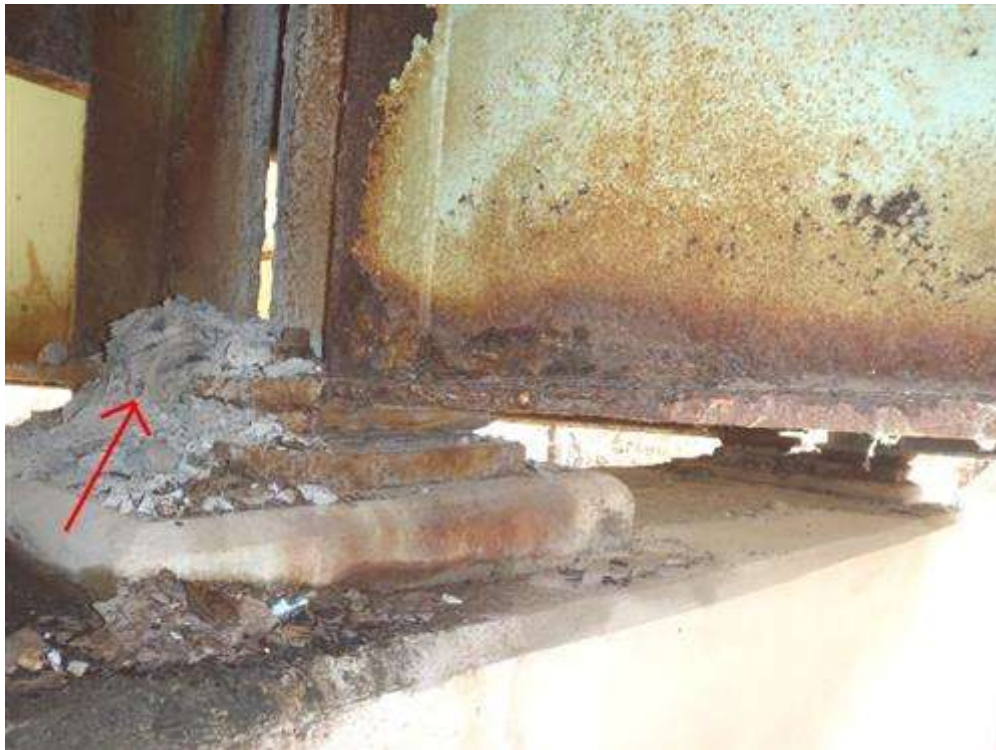
Photo Number: 30

Pier 2, concrete between beam ends.

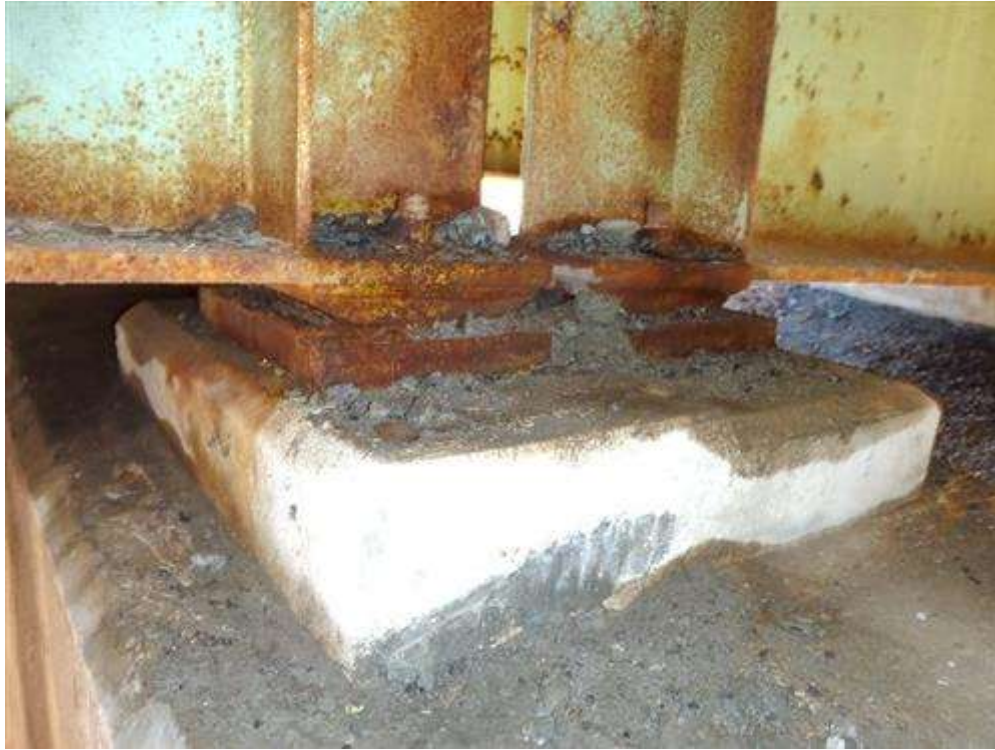
Photo Number: 31

Typical bearings pier 2.
