PROJECT No. 301-0175
PROJECT LOCATION
MILFORD CULVERT
REPLACEMENT

Drainage Path Downstream of Culvert
at Railroad Mile Post 65.60

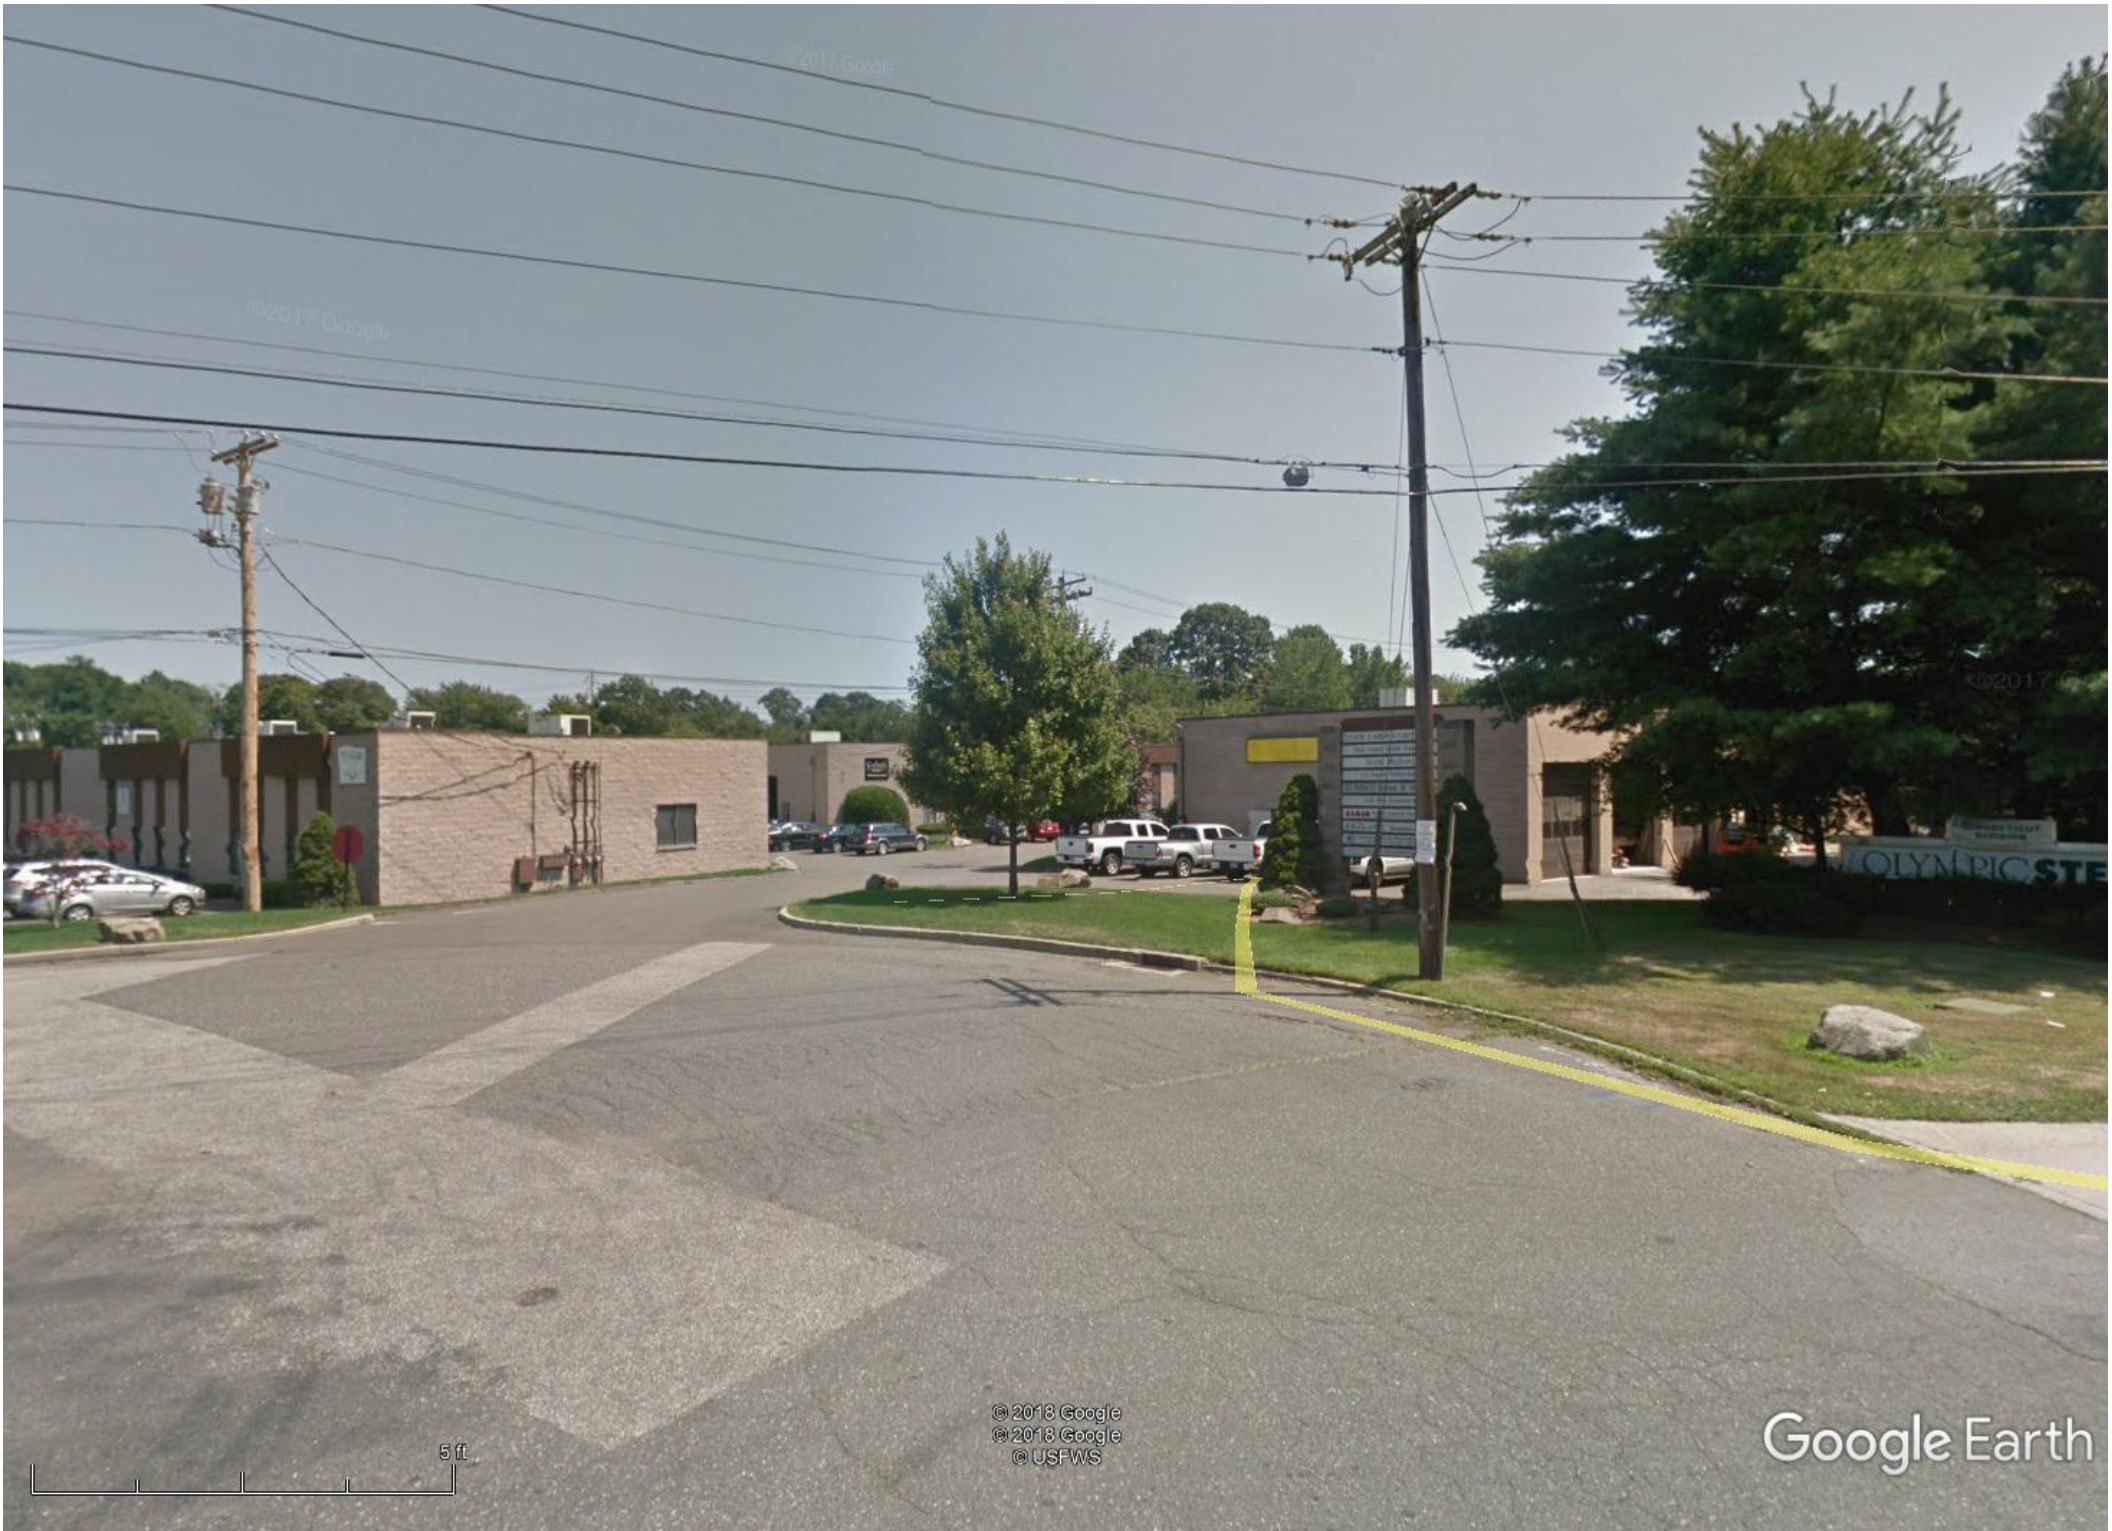
View from the cul-de-sac at the end of Eastern Steel Road towards the access path that will lead down to the railroad culvert location.

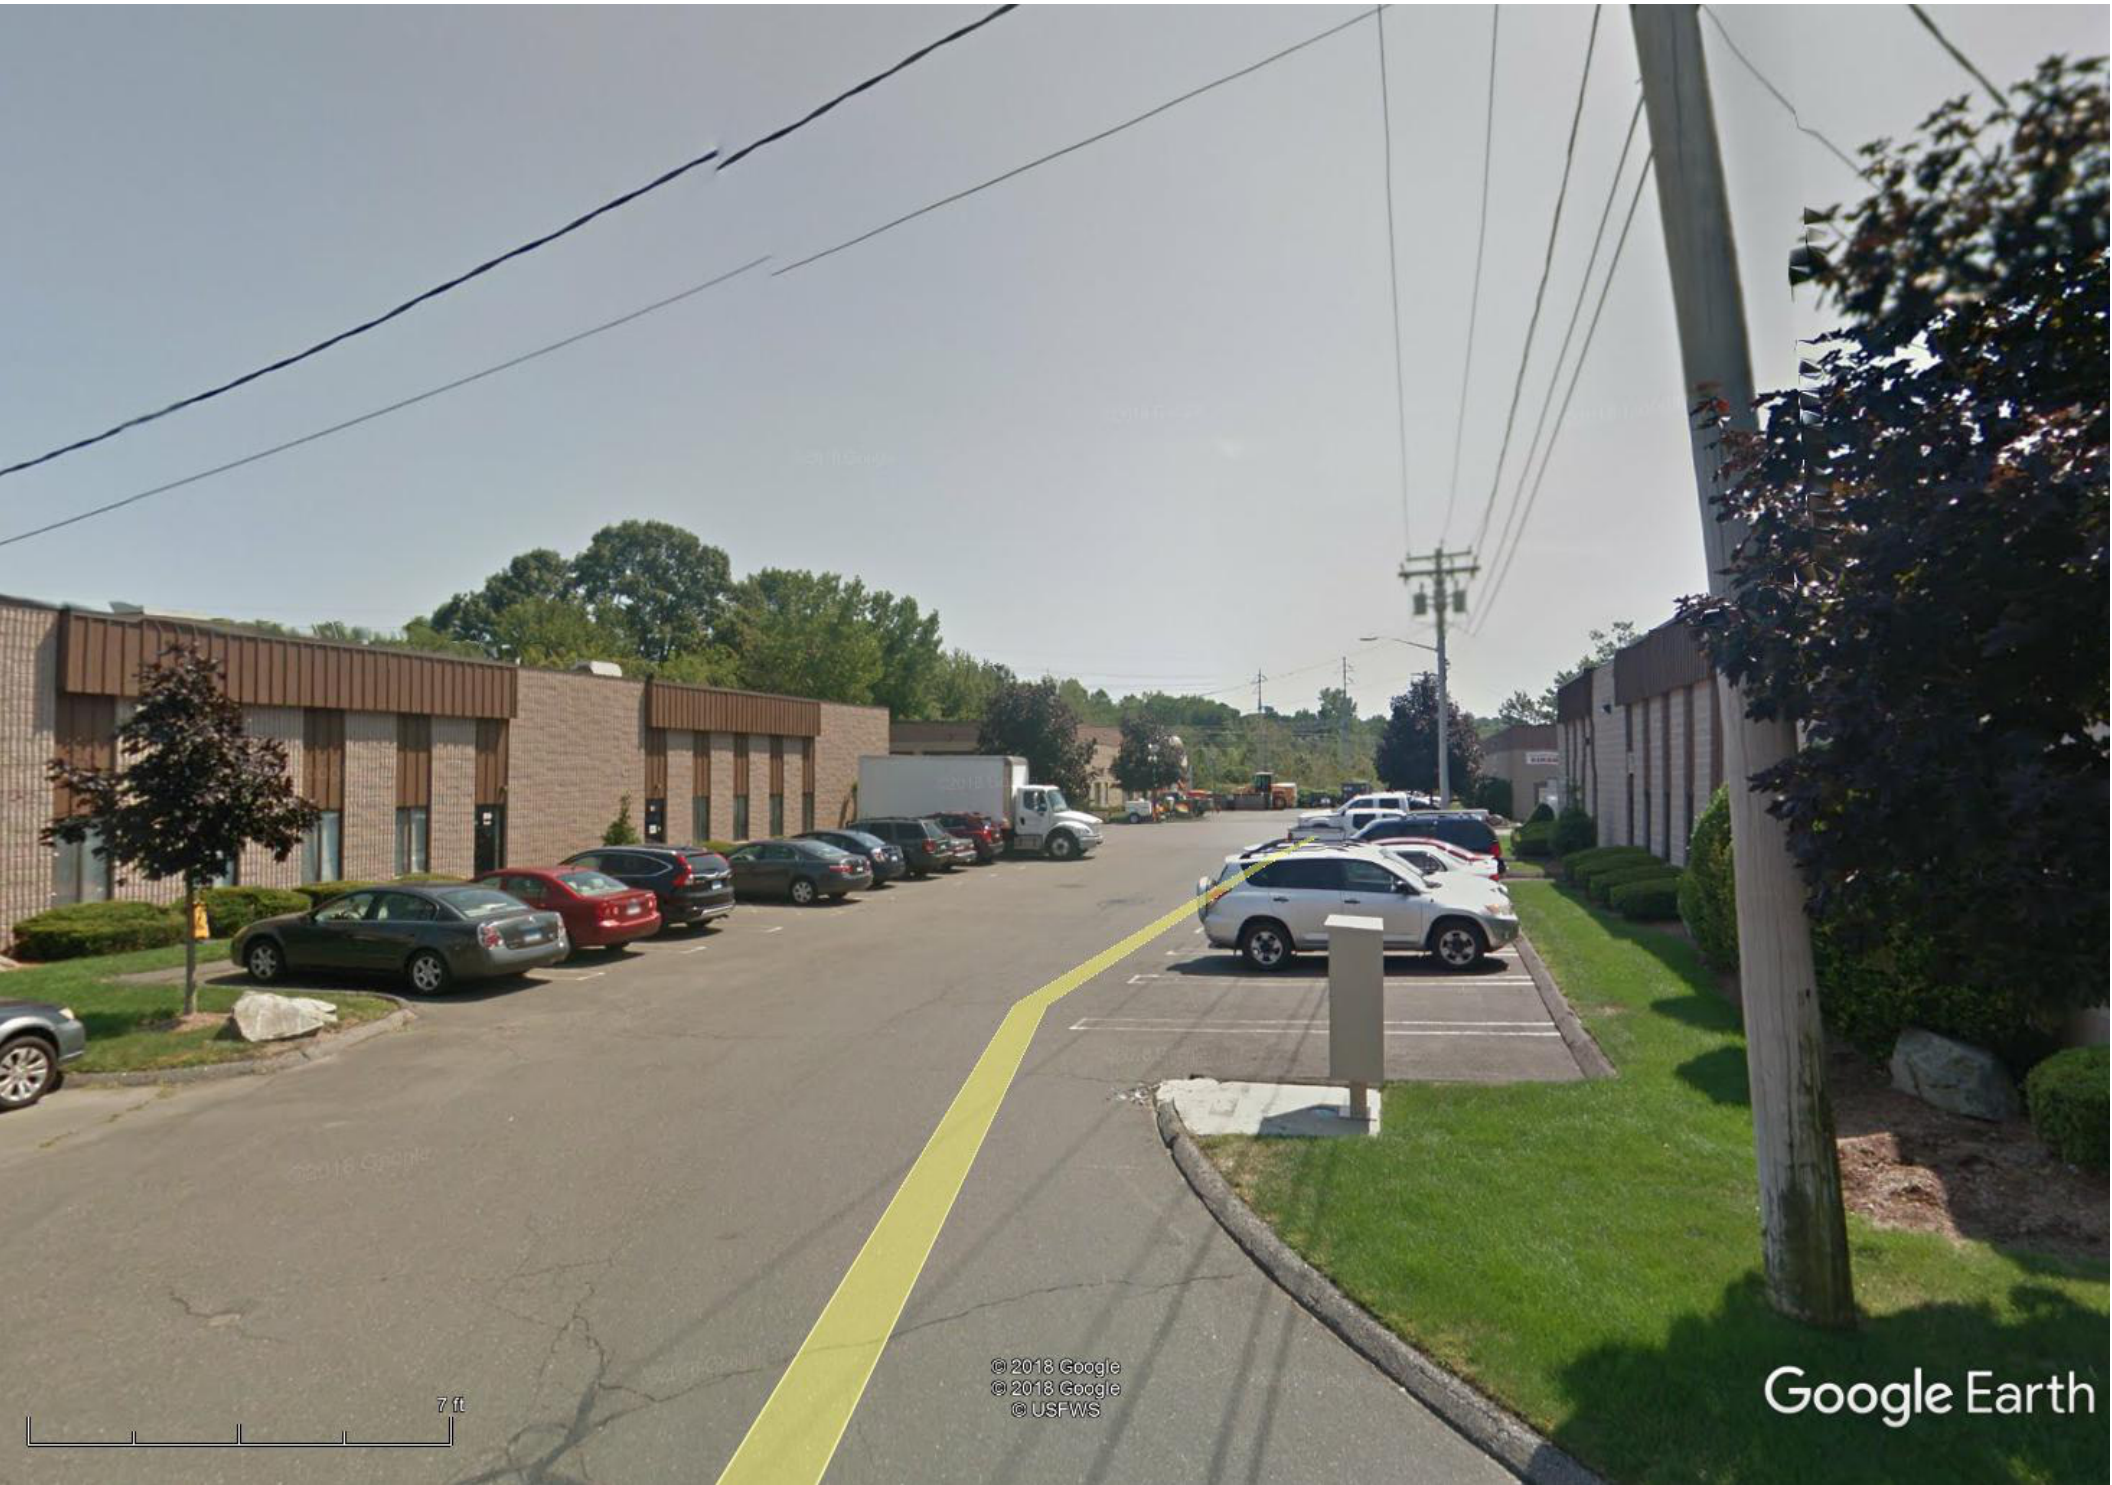
View heading through the complex at the end of Eastern Steel Road, half way down the access path to the railroad culvert location.

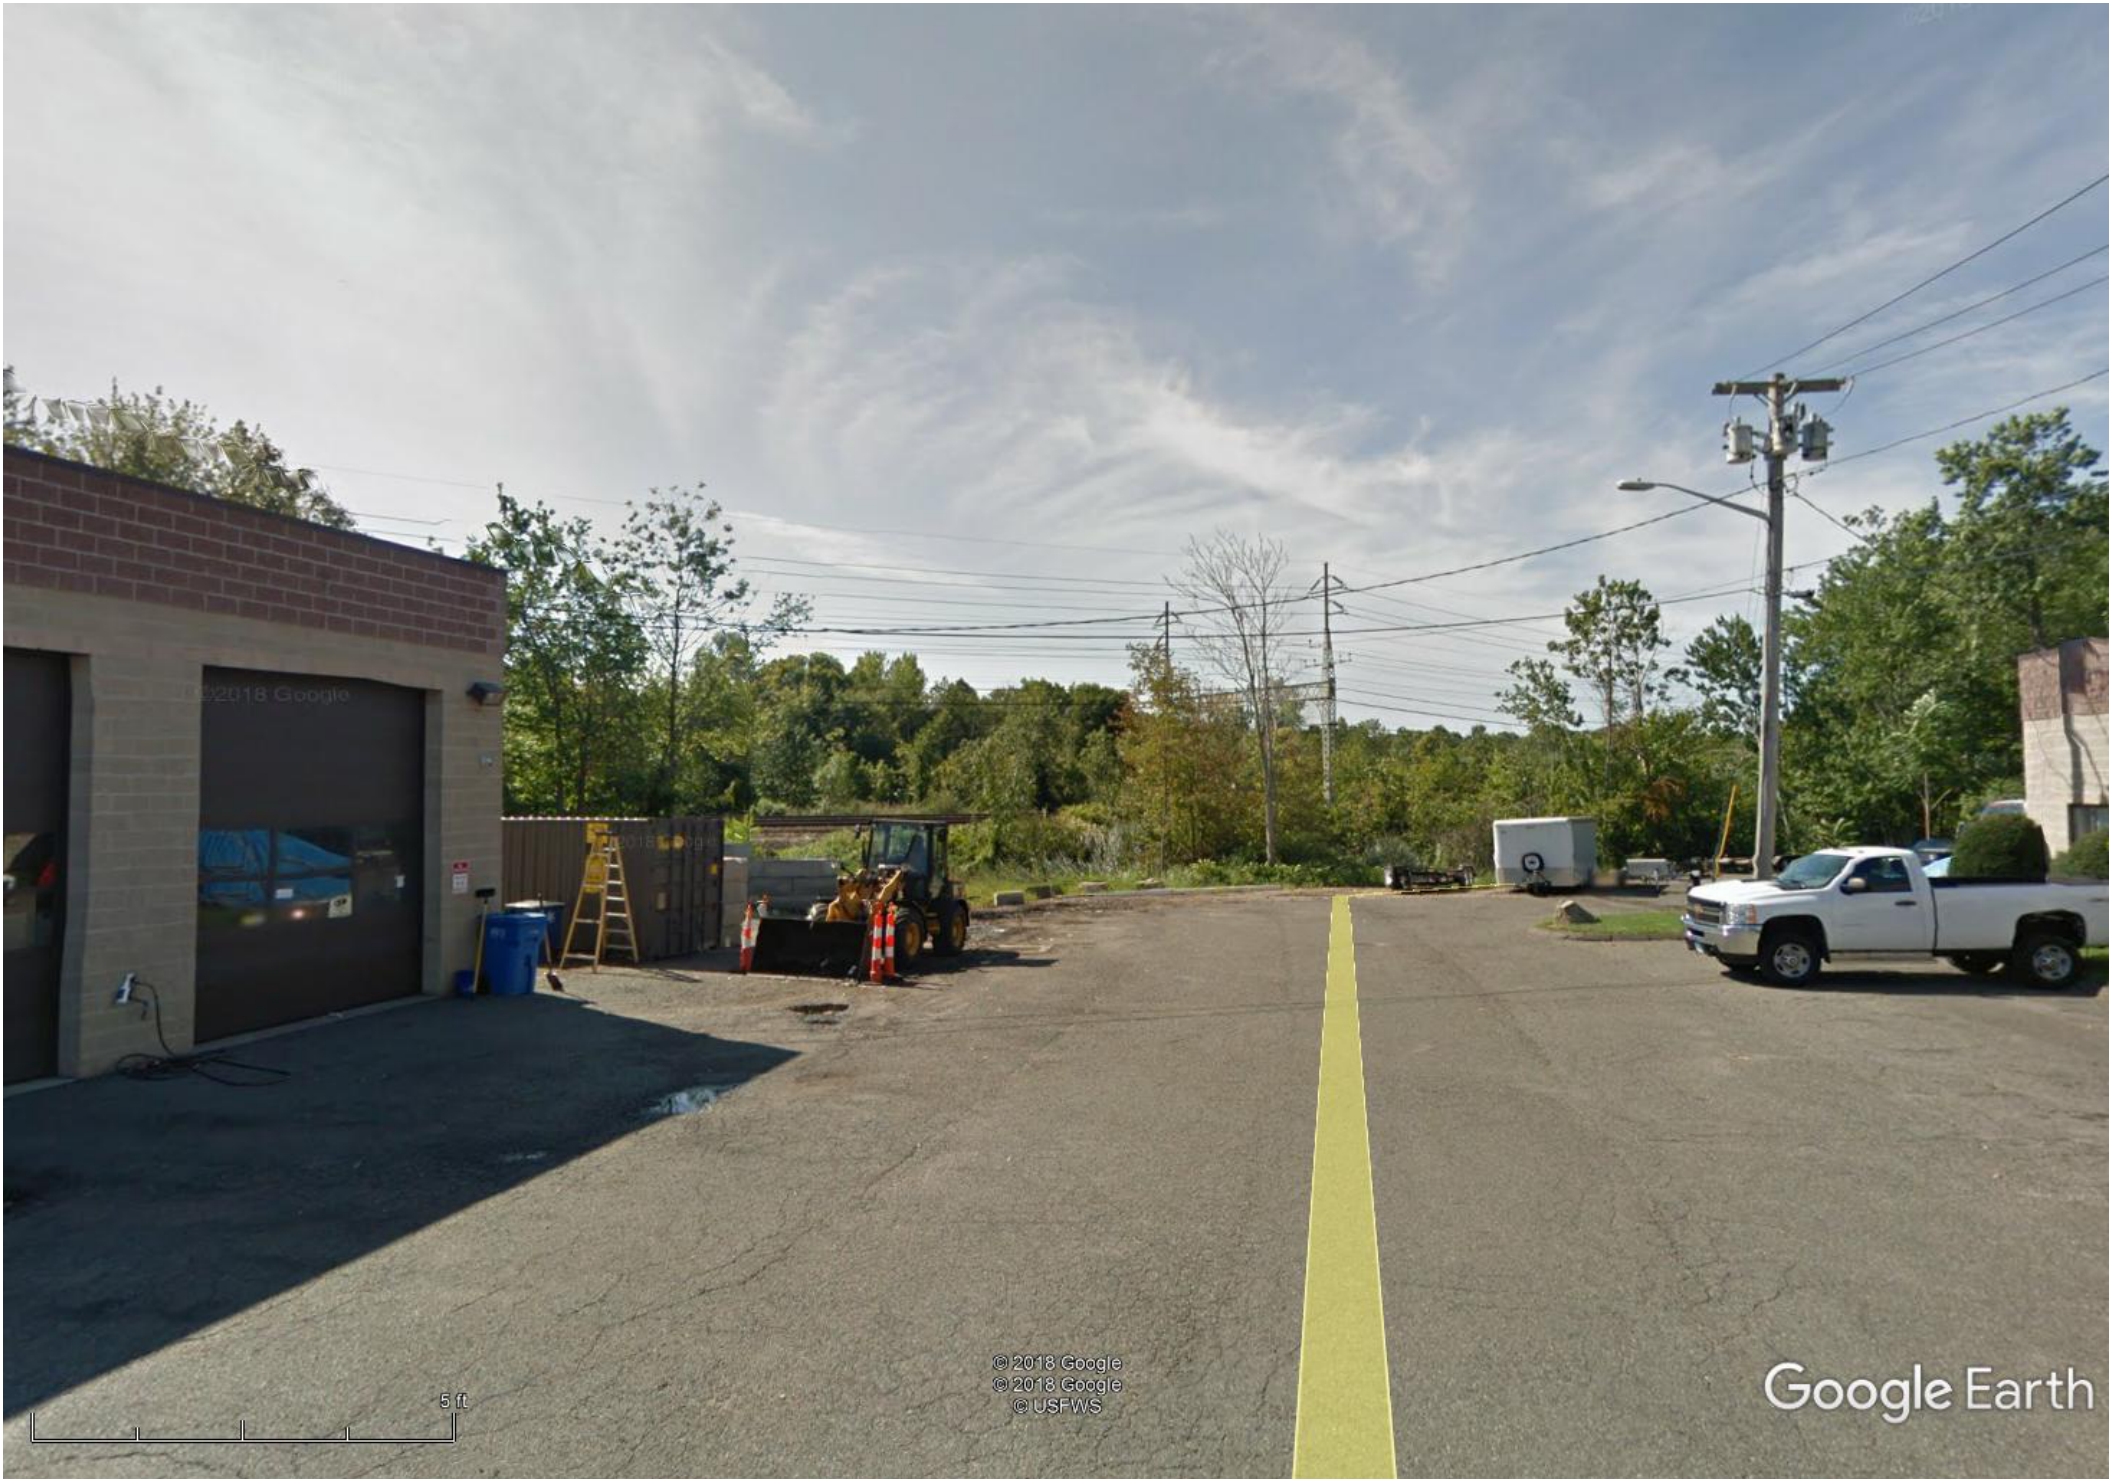
View 3/4 of the way down the access path through the complex, almost to the north side of the railroad at the inlet of the railroad culvert.

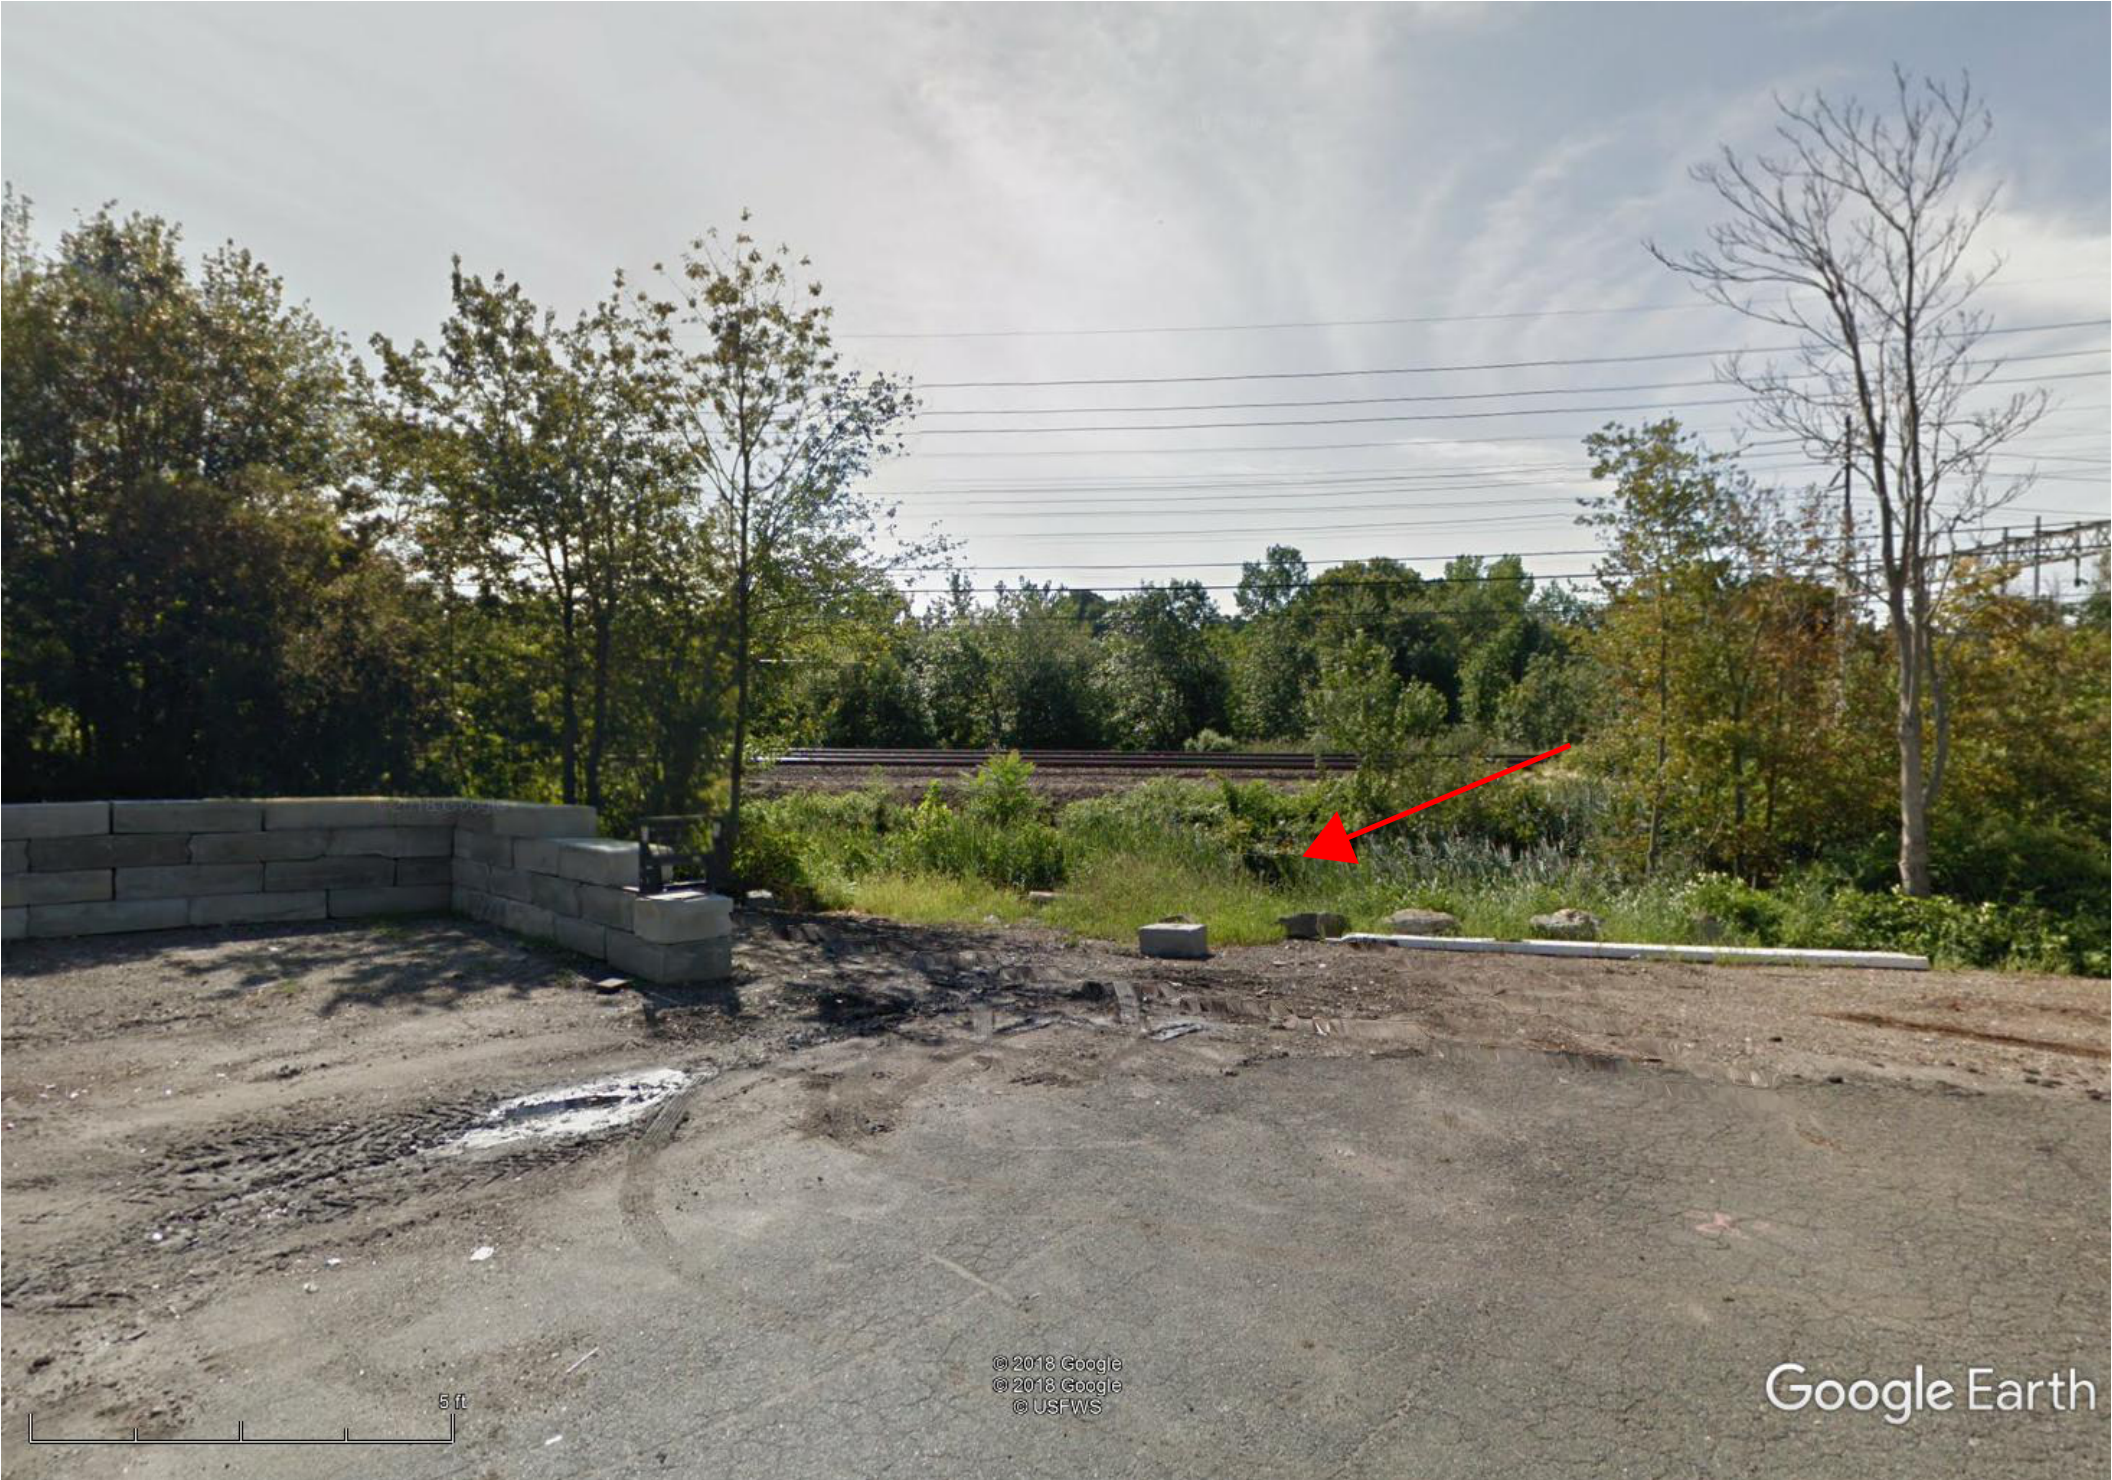
View of the general area for staging at the inlet end of the railroad culvert.

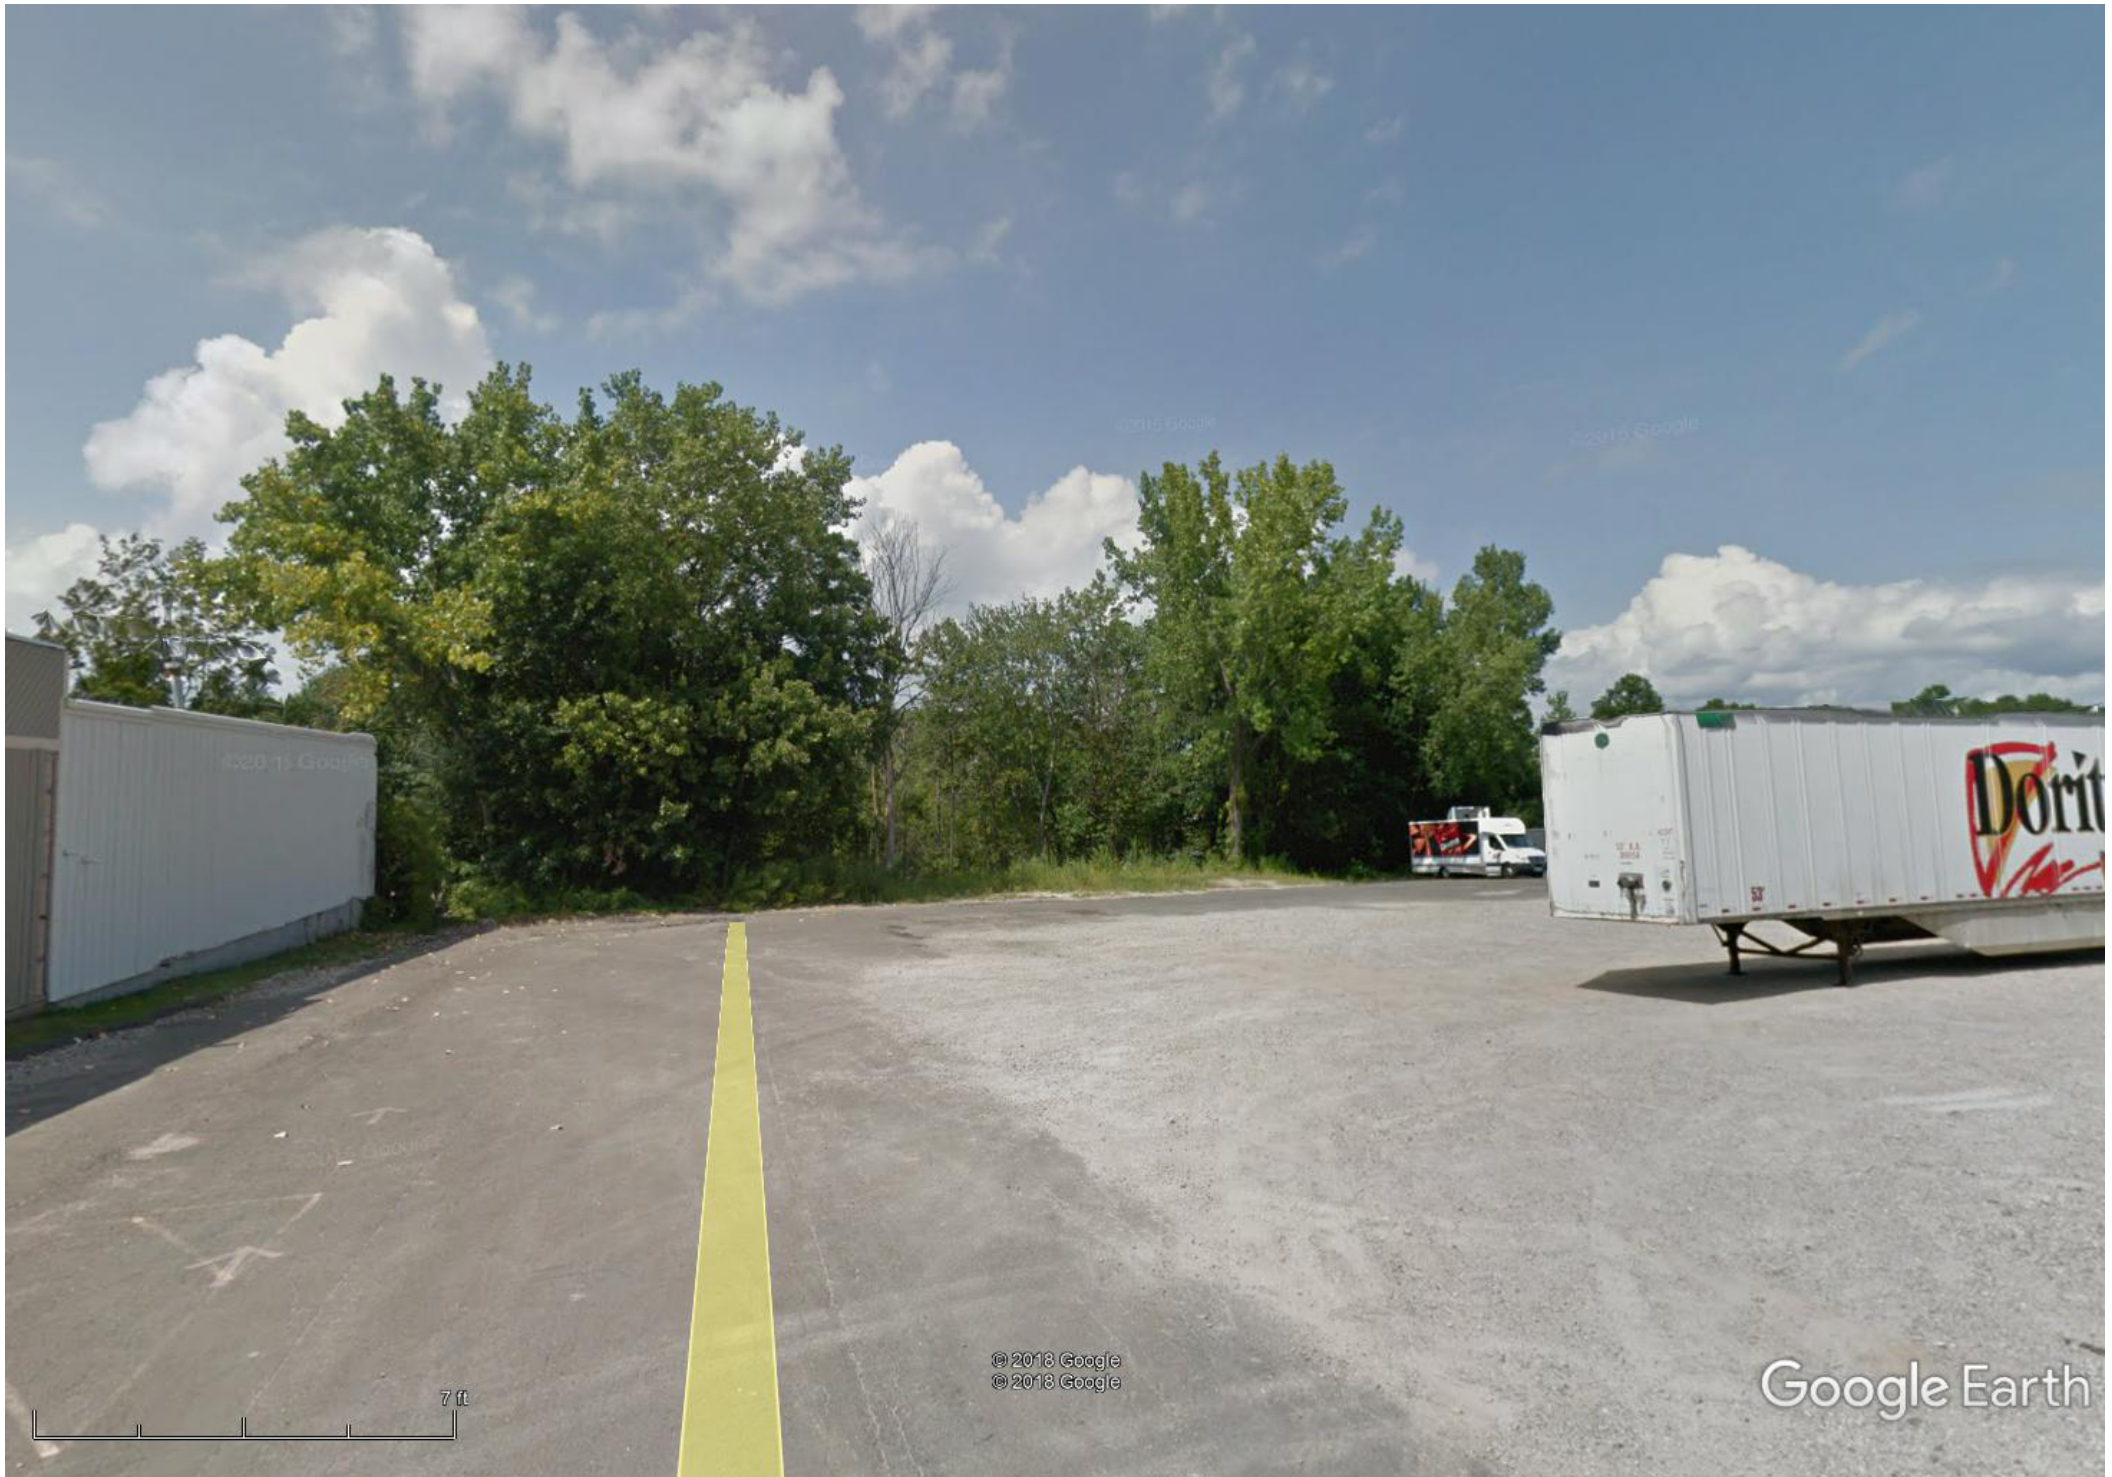
View from the entrance driveway off of 198 Pepes Farm Road adjacent the Frito Lay distribution facility. This is the access path starting point to the south side of the railroad, leading eventually to the culvert's outlet.

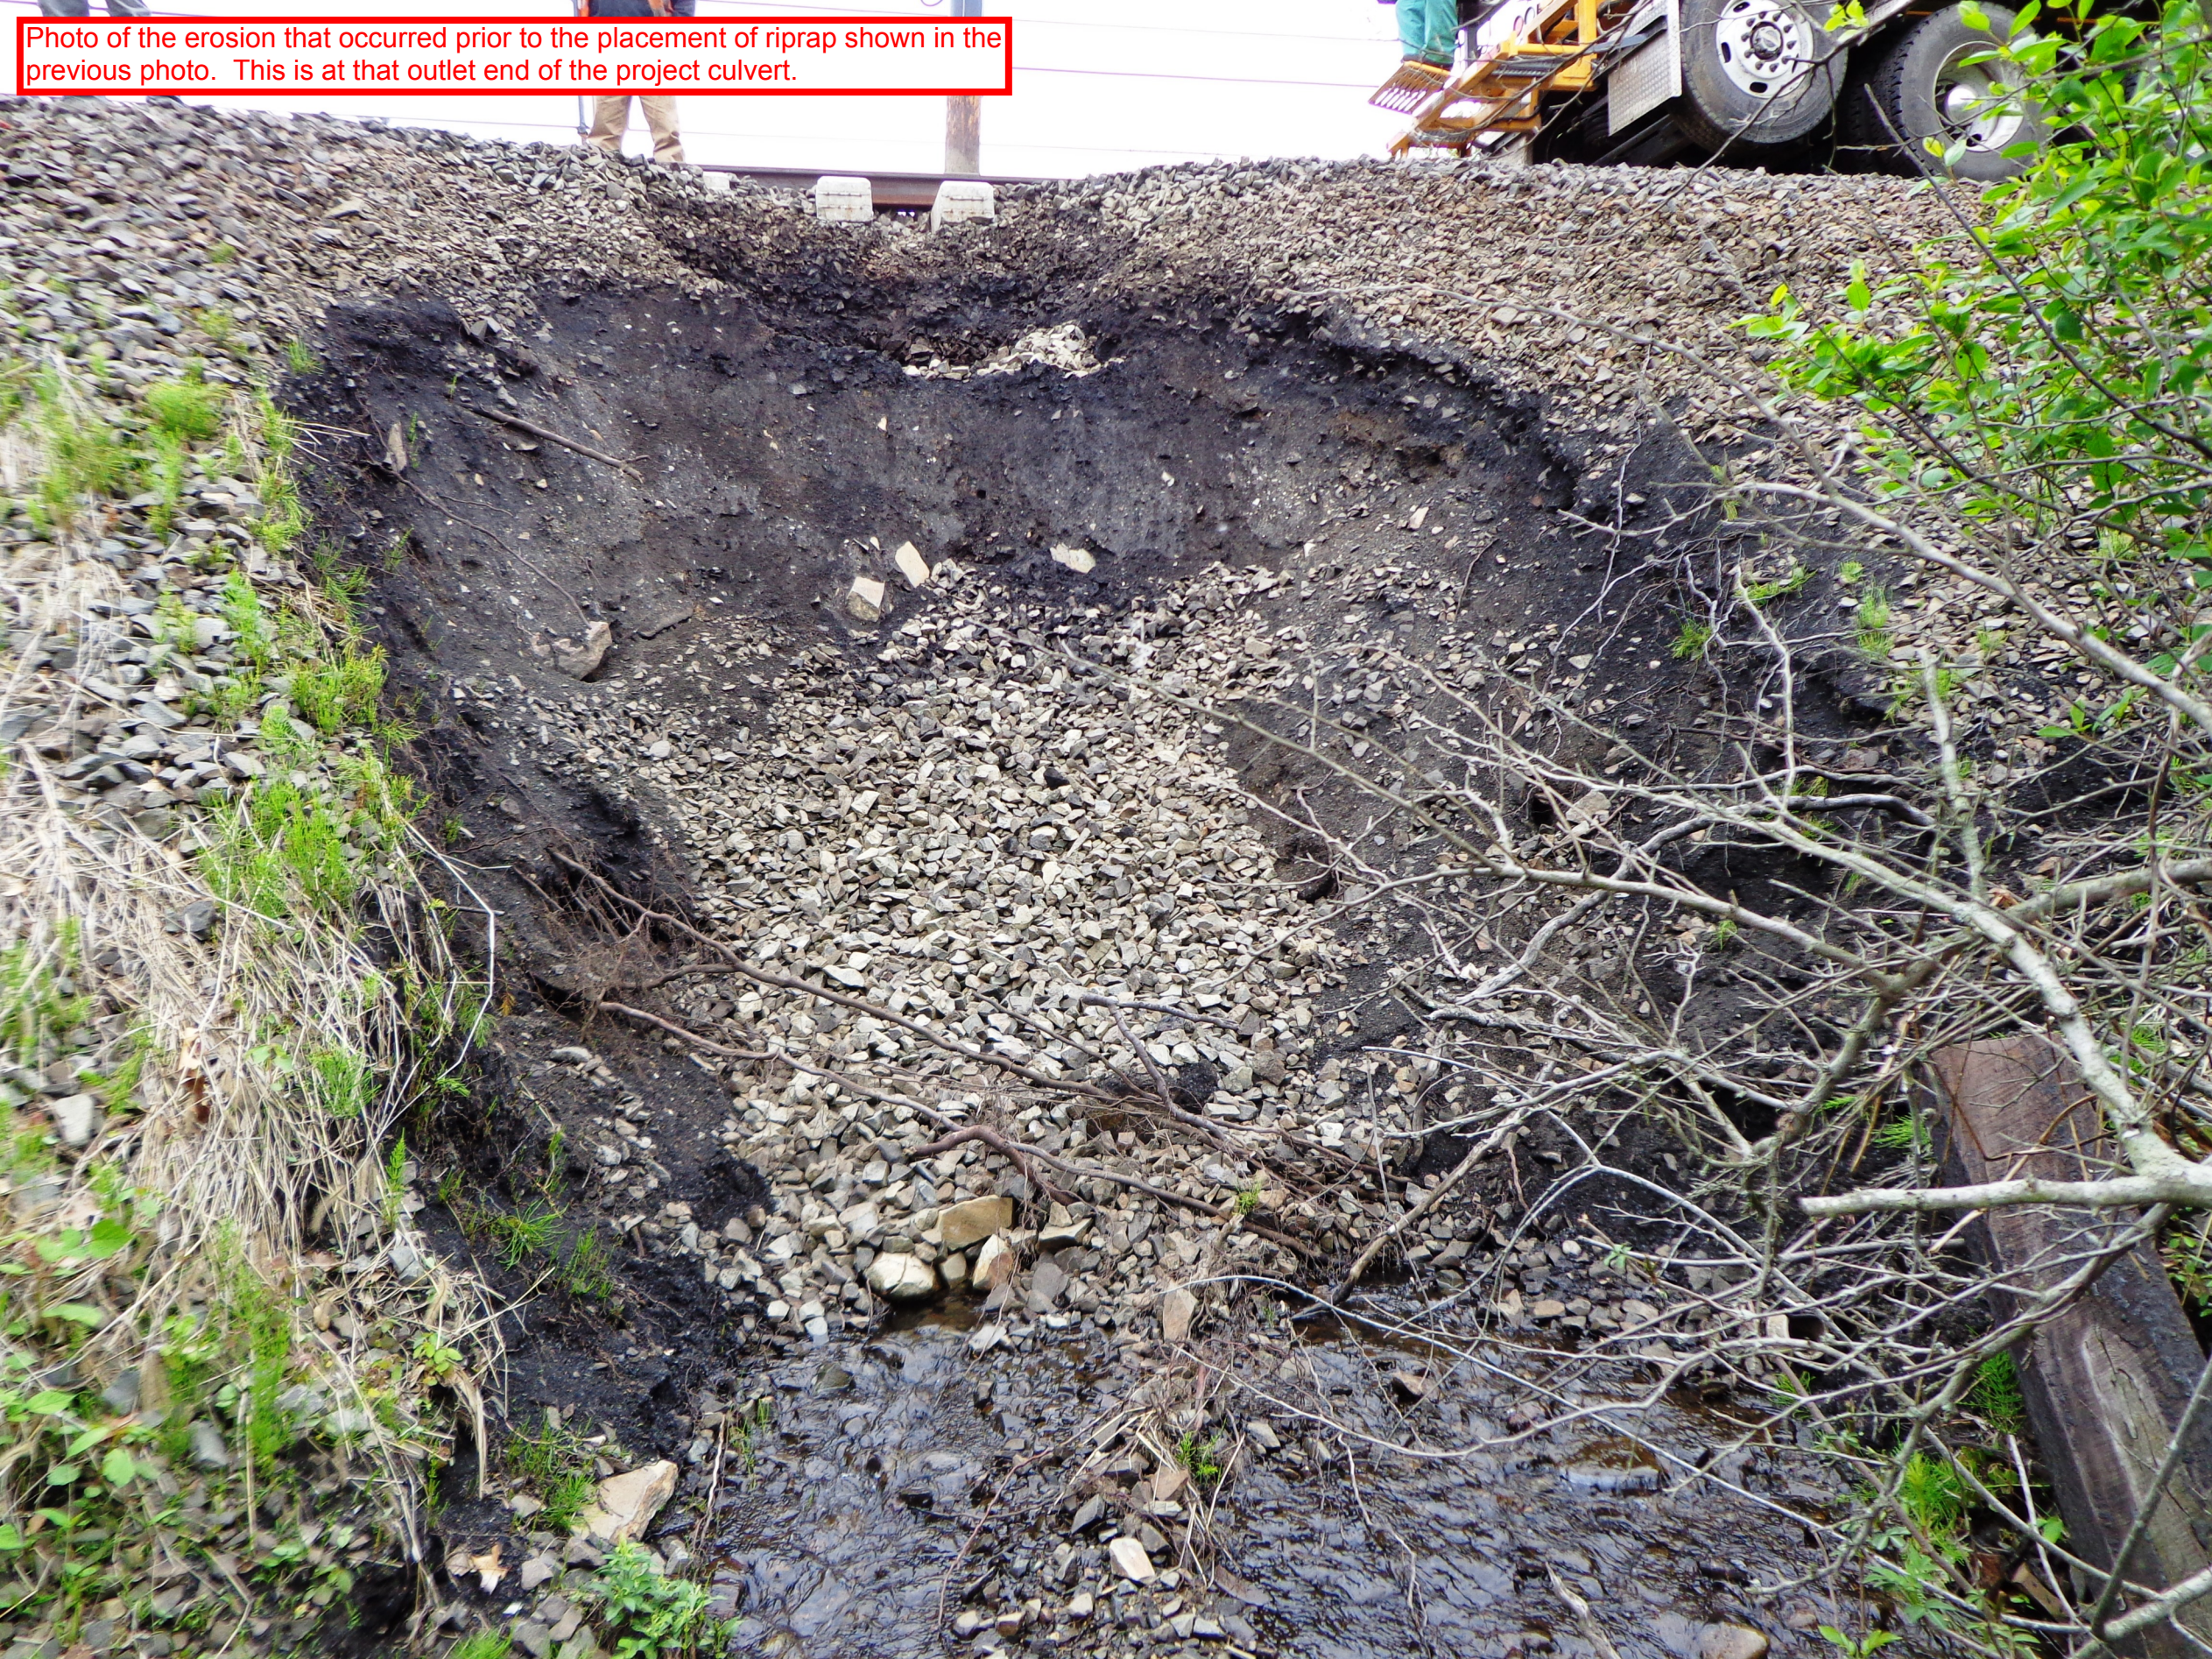
Photo of the erosion that occurred prior to the placement of riprap shown in the previous photo. This is at that outlet end of the project culvert.

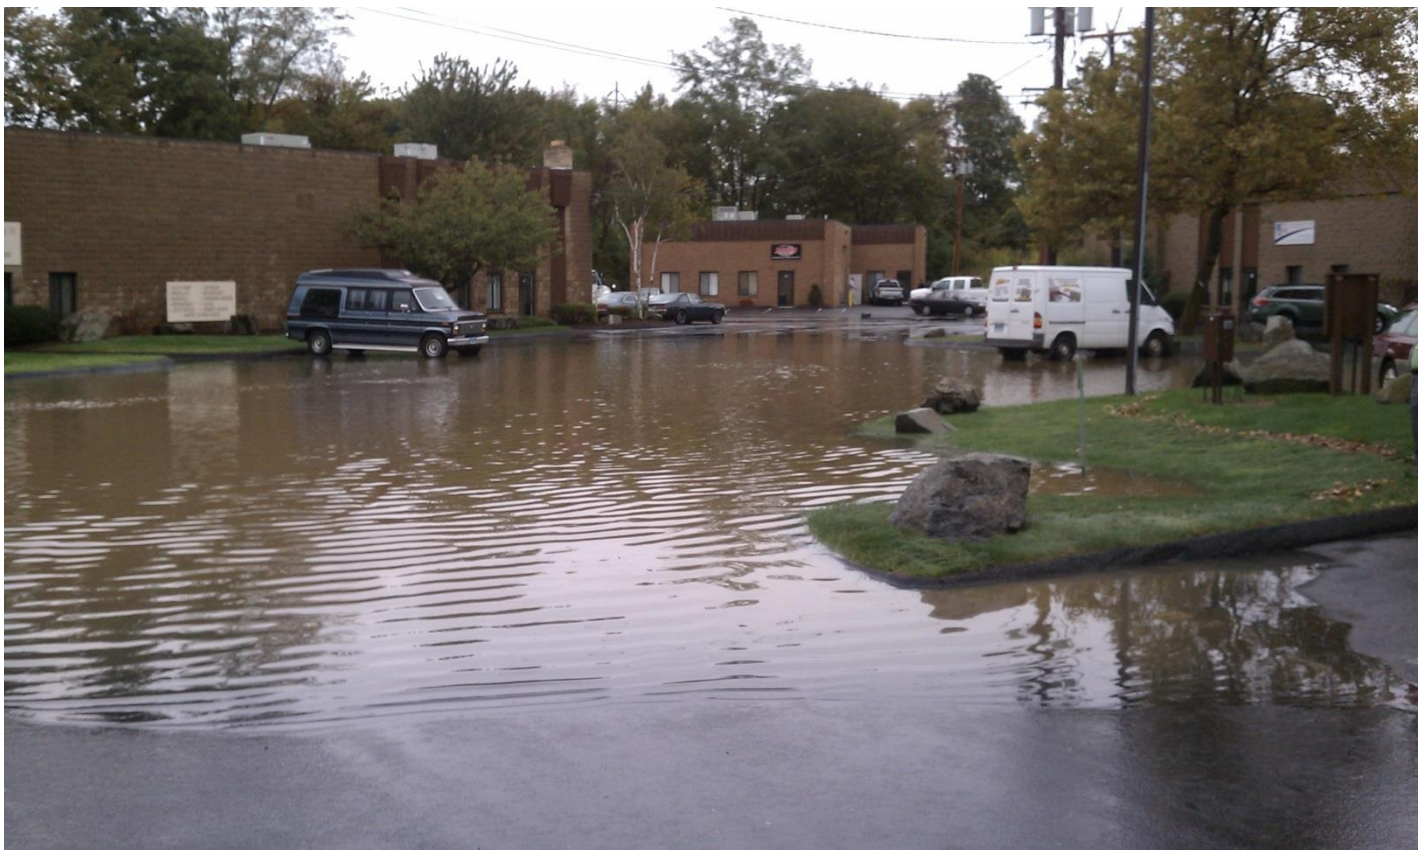
4. Flooding Upstream

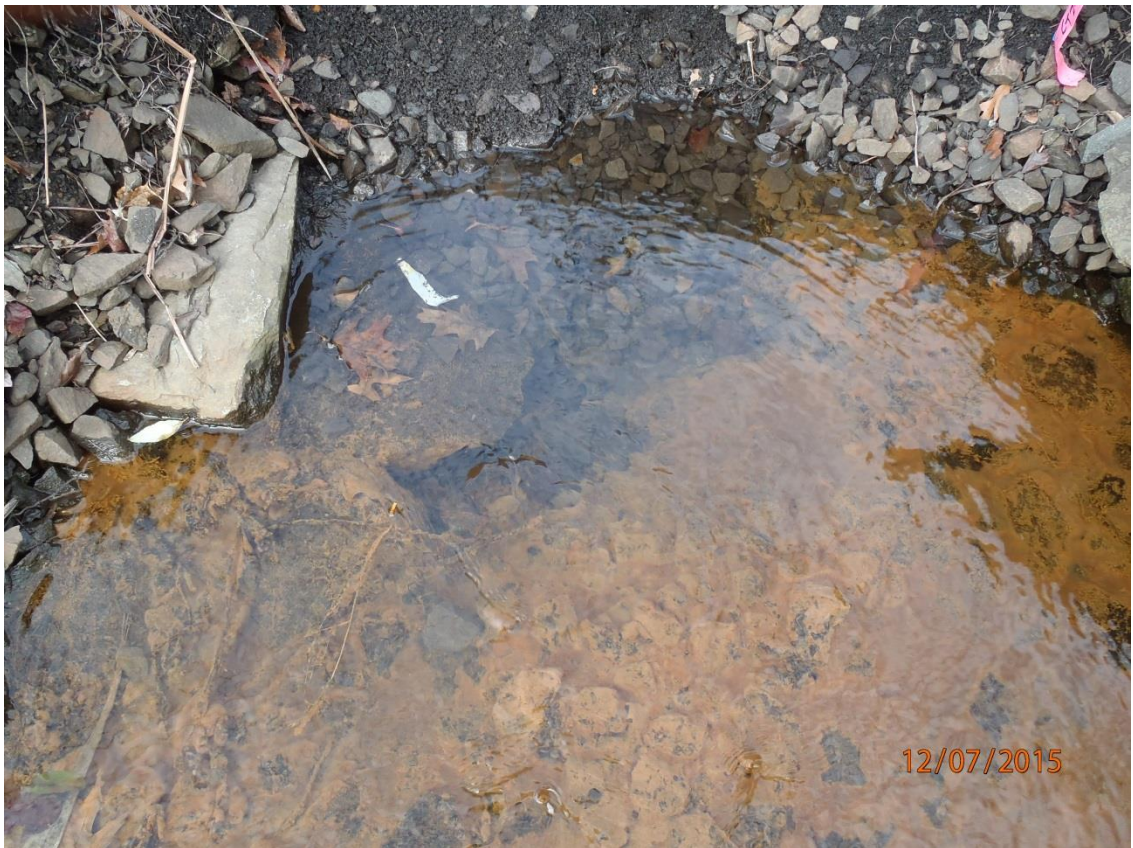
8. Close Up of Outlet.

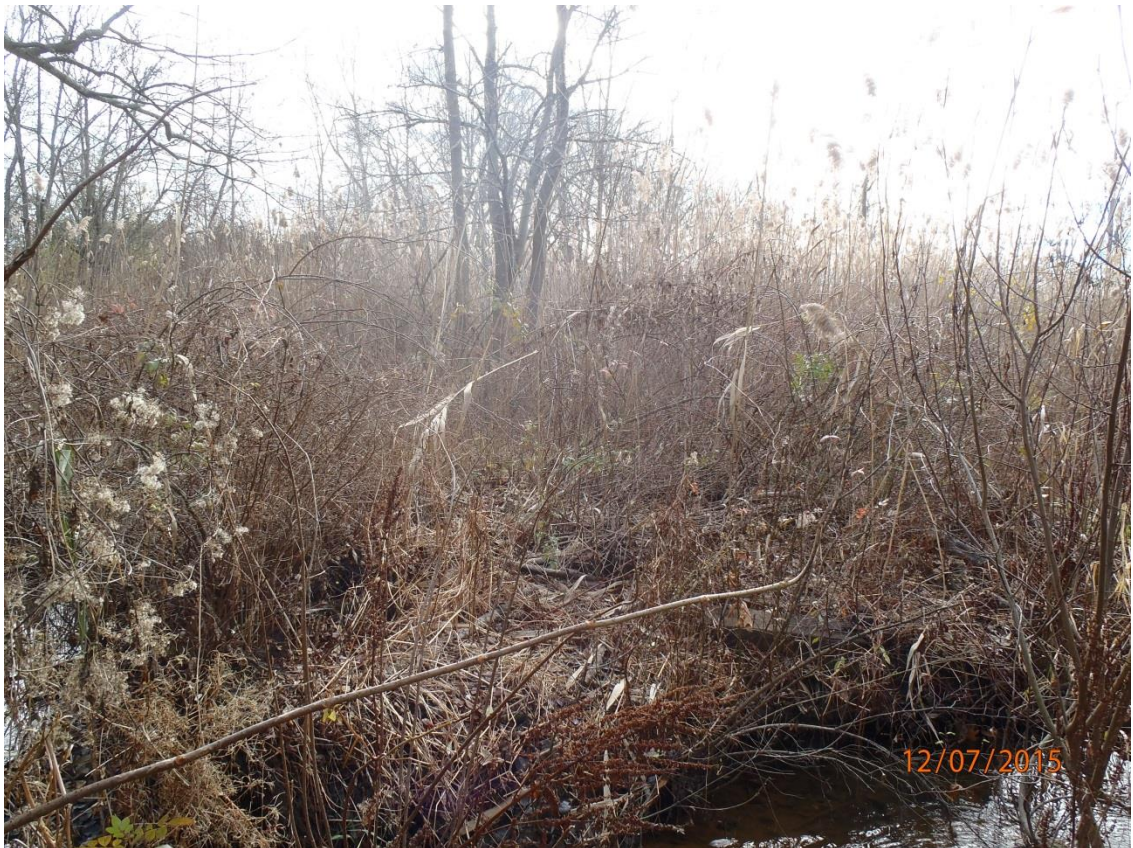
10. Typical Vegetation to be Removed Downstream.
