**TOWN OF GLASTONBURY  
REQUEST FOR QUALIFICATIONS  
RPGL-2019-25  
ROOFING STUDY OF GLASTONBURY SCHOOLS  
ADDENDUM NO. 1  
January 25, 2019**

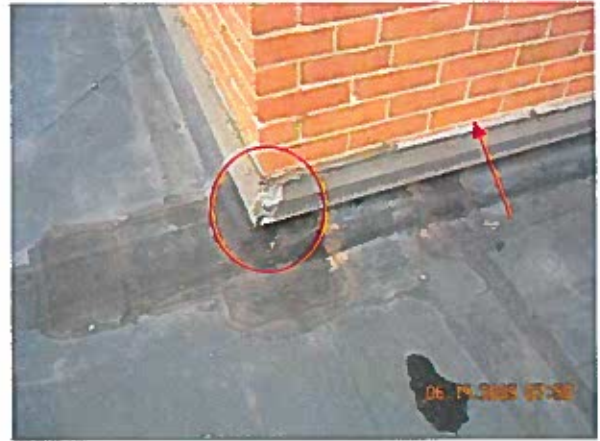
Area 1—Anamoly  
Deteriorated sealants at top edge of surfaced mounted counter-flashings with open sheet metal miters

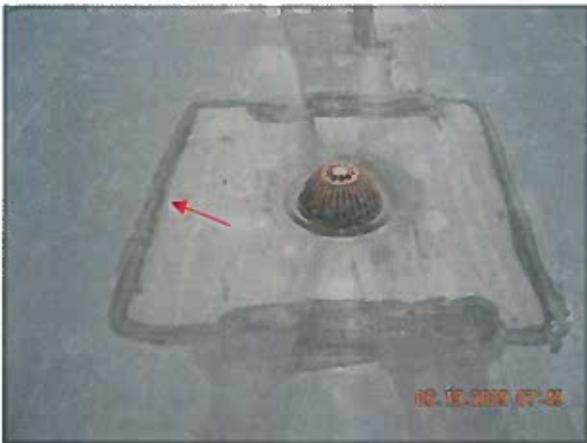
Area 1—Anamoly  
Splice laps are delaminating at some roof drain targets

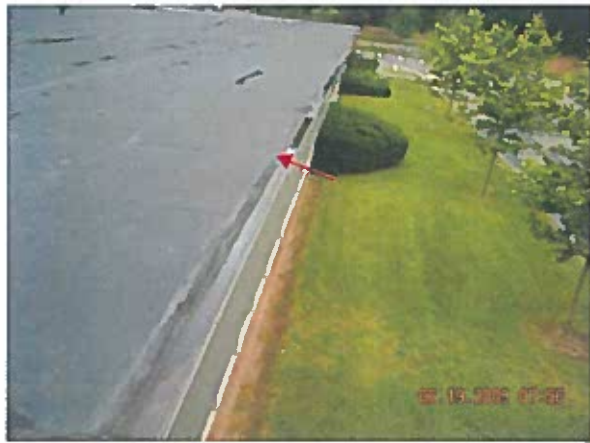
Area 1—Anamoly  
Cover strips at edge metal transitions are lifting. Remedial repairs were conducted where moisture wasn't present

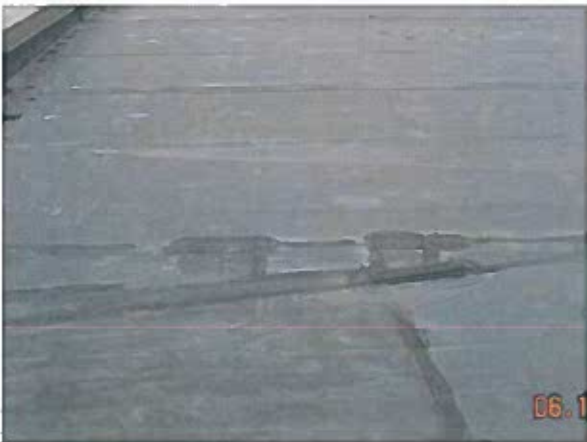
Area 1—Anamoly  
Splice patches throughout roof area are delaminating around the edges. NOTE: This condition is typical at all roof locations

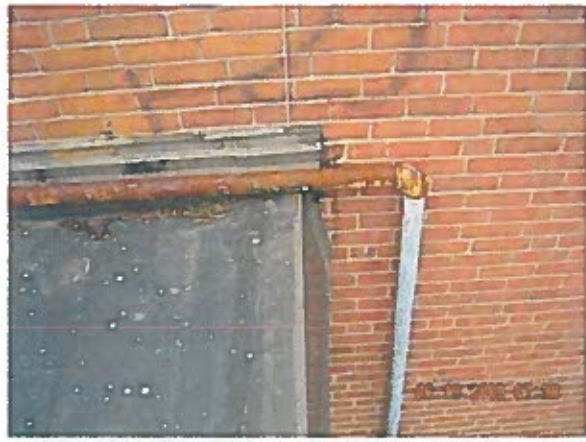
Area 1—Observation  
Terminations appear to be in satisfactory condition

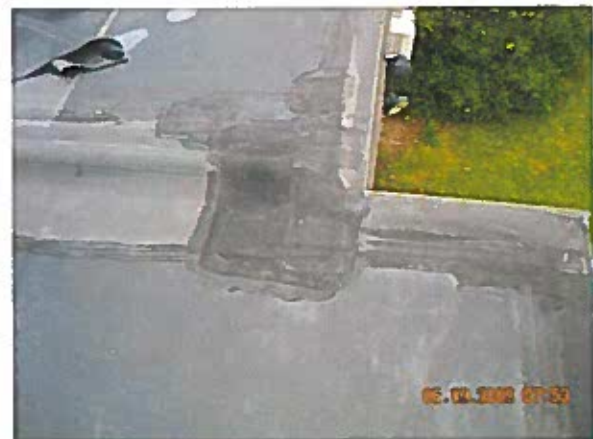
Area 2—Observation  
Terminations appear to be in satisfactory condition

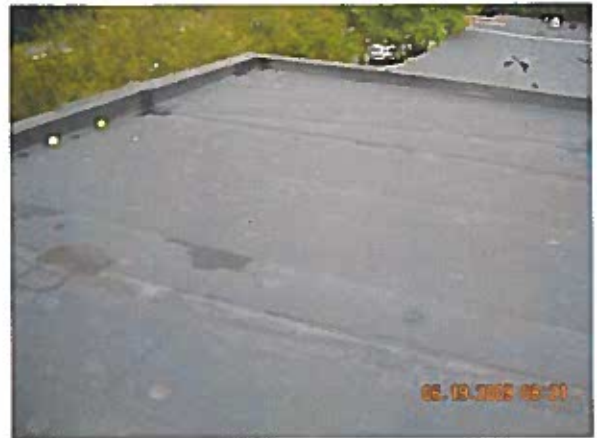
Splice patches at edge metal transitions are delaminating, splice patches in the field of the roof are delaminating and counter-flashing sealants are deteriorating

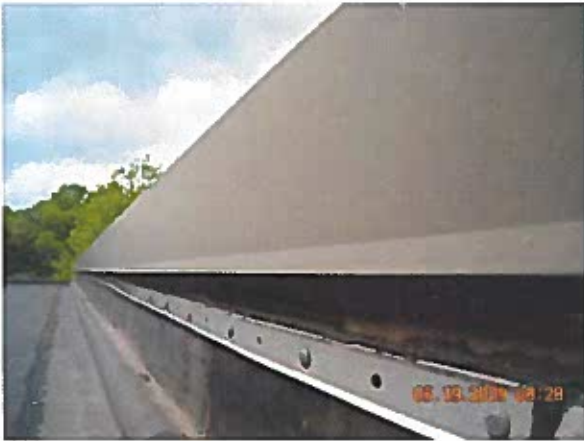
Area 6—Anomalies  
Splice patches in the field of the roof are delaminating and counter-flashing sealants are deteriorating

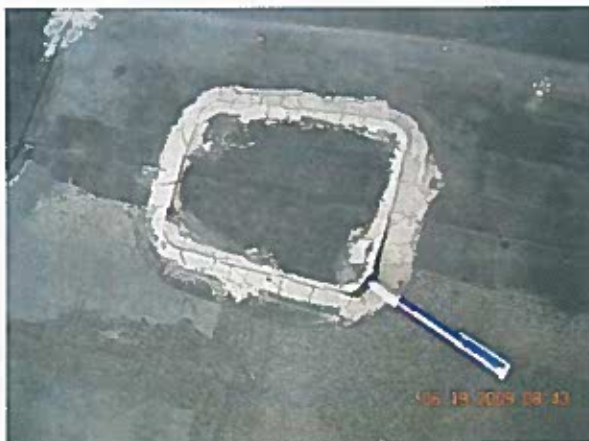
Area 8 — Anomalies  
Splice patches at edge metal transitions are delaminating, splice patches in the field of the roof are delaminating and counter-flashing sealants are deteriorating

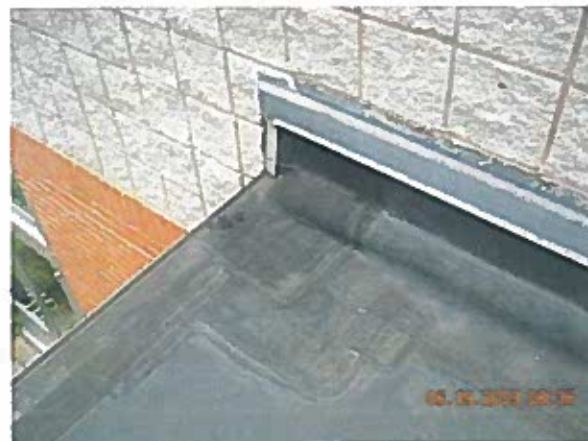
Area 8—Observations  
Terminations appear to be in satisfactory condition

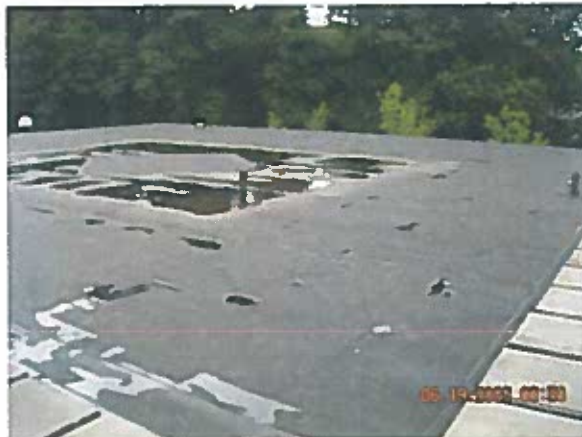
Area 11 — Overview  
NOTE: Excessive ponding was observed

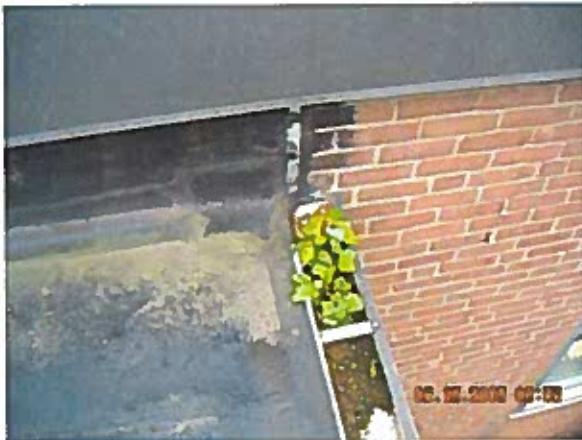
Area 12—Observations  
Terminations appear to be in satisfactory condition.  
Gutters were cleared of debris

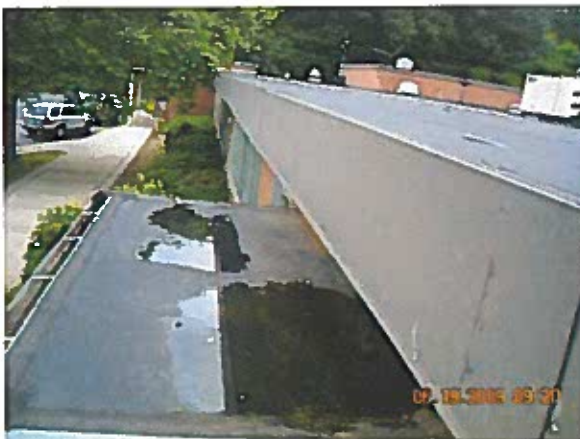
Area 13— Overview and Observations  
Terminations appear to be in satisfactory condition.  
Some delamination of splice seams/patches were observed.

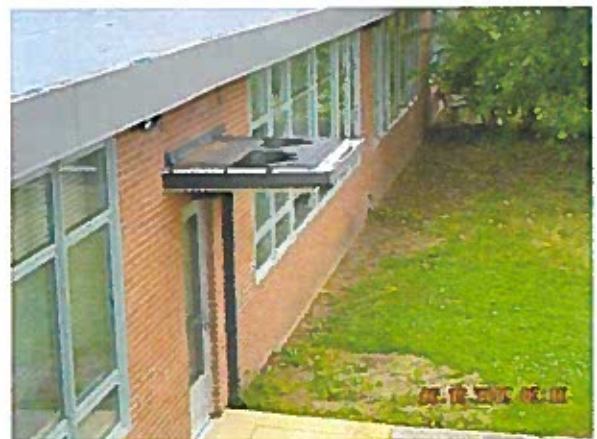
Area 14— Overview and Observations  
Terminations appear to be in satisfactory condition.  
Some delamination of splice seams/patches were observed.

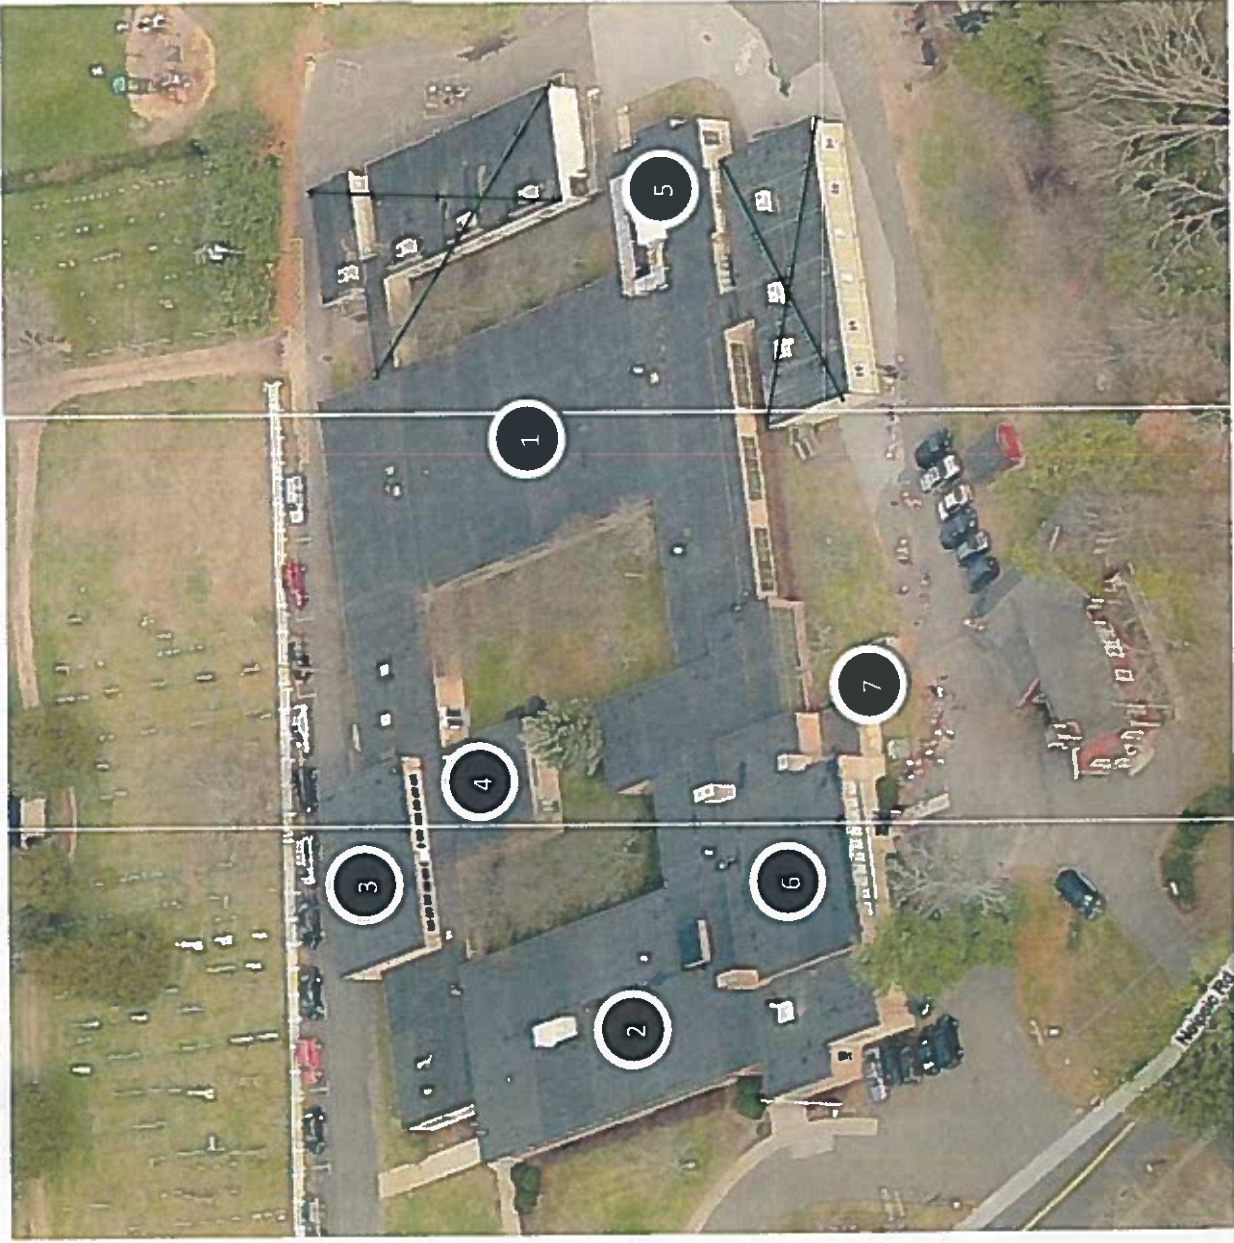
Eastbury ES  
Neipsic Rd., Glastonbury, CT

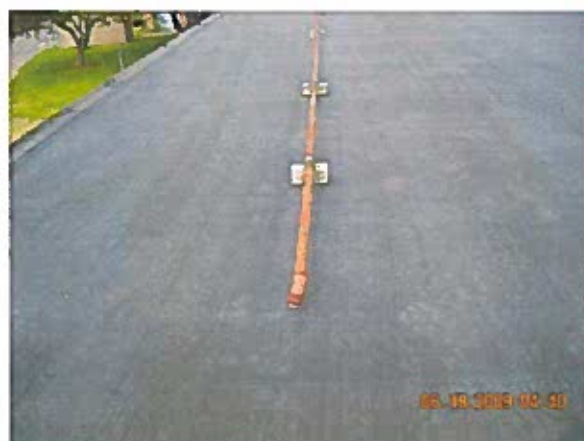
Area 1—Observation  
Unused utility pipe—Recommend removal

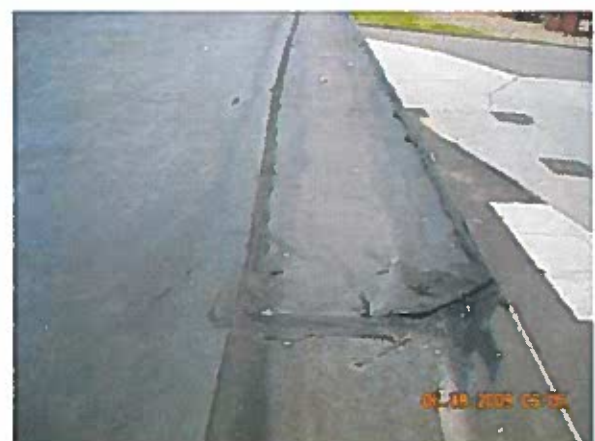
Area 1—Anomaly  
Metal edge strip-in delaminating from gravel guard

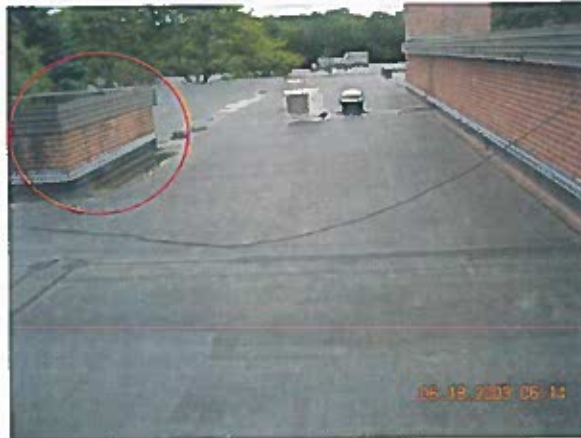
**Area 2—Overview**  
NOTE: Small raised roof area ponds water and has failed edge metal strip-in flashings around perimeter

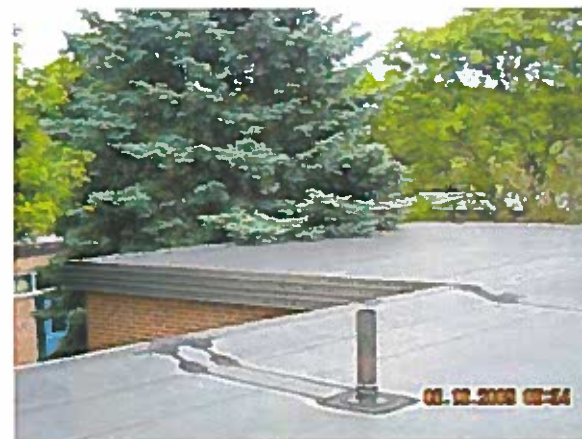
Field seams are delaminating in some areas

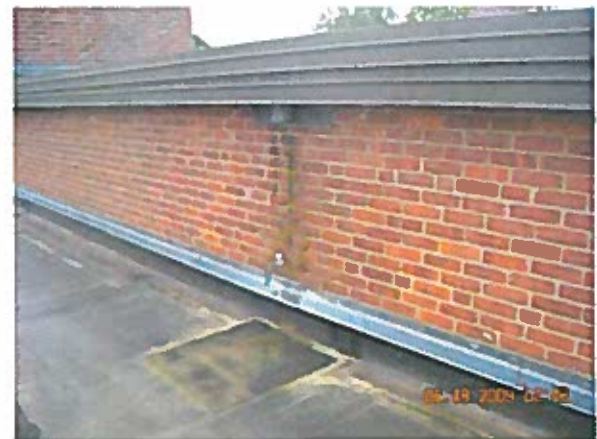
NOTE: Recommend removal of tree branches from roof area

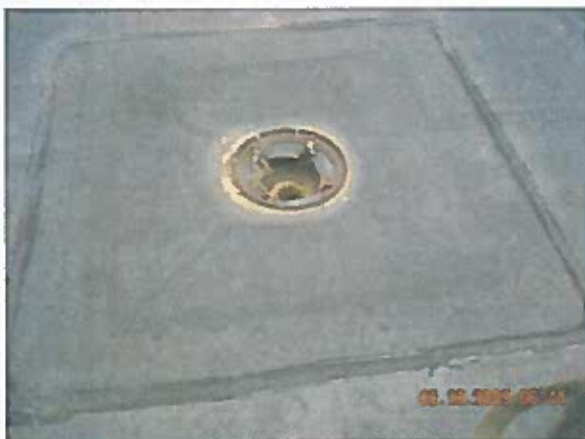
Area 6 — Anomaly  
Missing roof drain strainers, splice laps are delaminating at some roof drain targets, many splice patches are delaminating and edge metal cover strips are splitting or delaminating

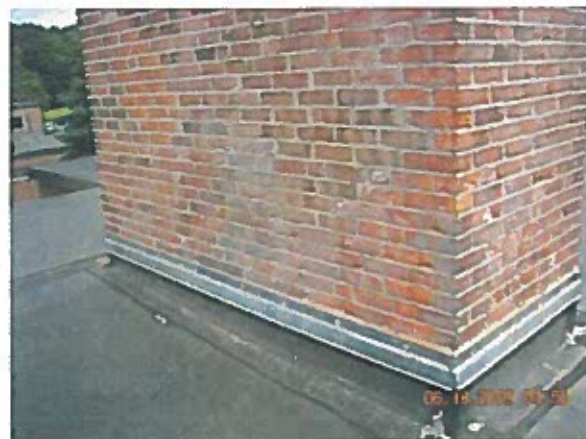
Area 6 — Anomaly  
Brick tuck-pointing recommended

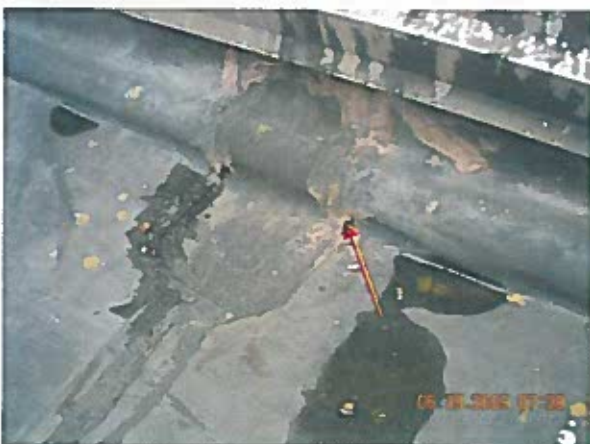
Area 1—Anomaly  
Openings in splice patches. Remedial repairs were conducted in these areas.

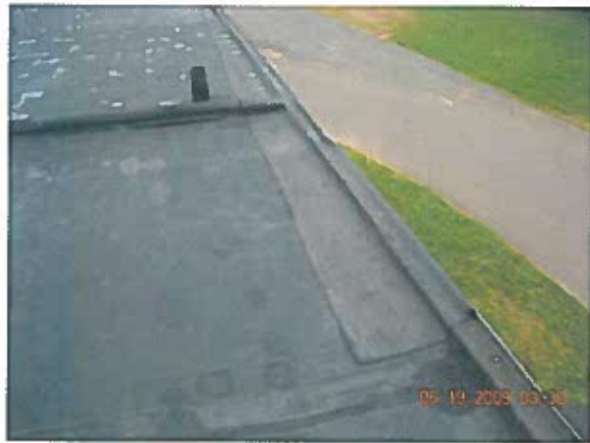
Area 2— Anomaly  
View of roof repair where building was modified.  
Splice patch appears open at termination points

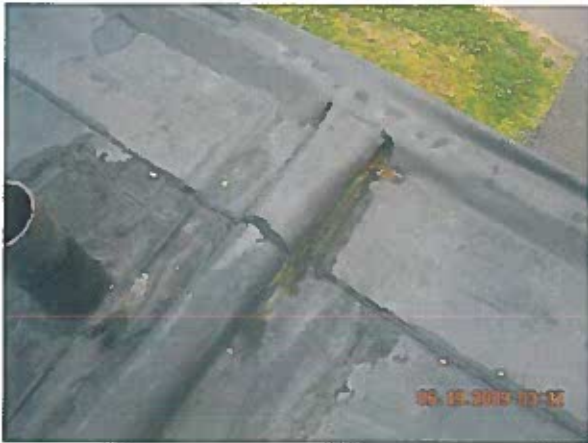
Area 2—Anomaly  
Repair patch was not flashed into the expansion joint

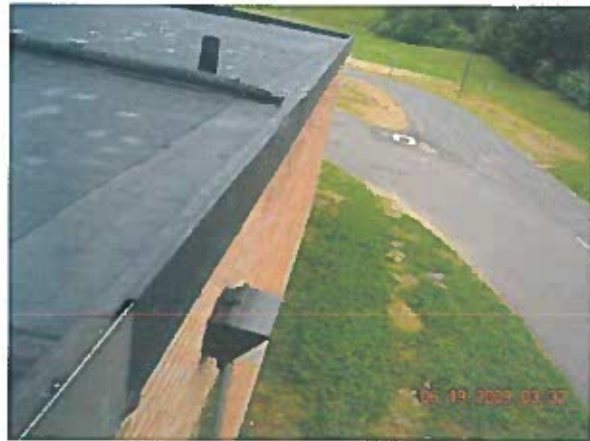
Area 2—Observation  
View of roof repair at roof modification

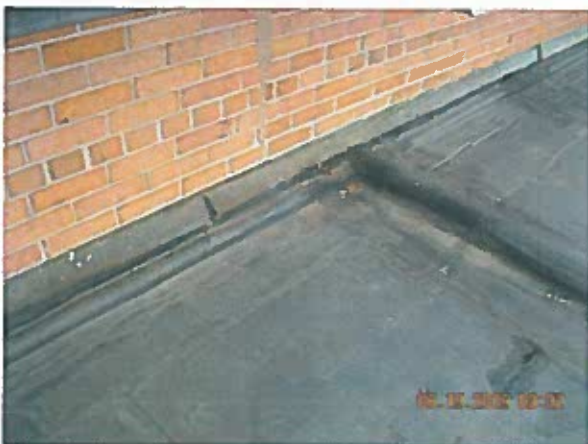
Area 2—Observation  
View of expansion joint at wall transition

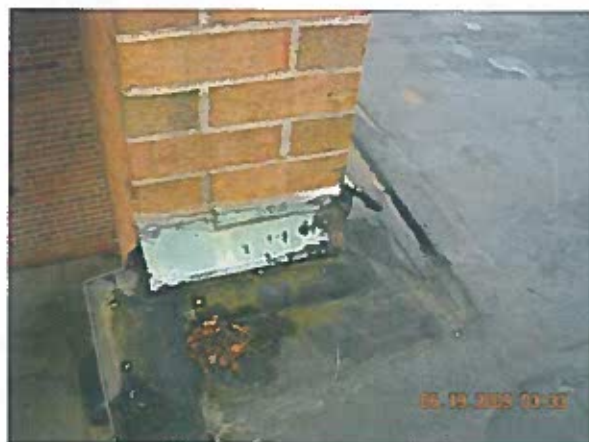
Area 2—Anomaly  
Metal counter flashing in poor condition

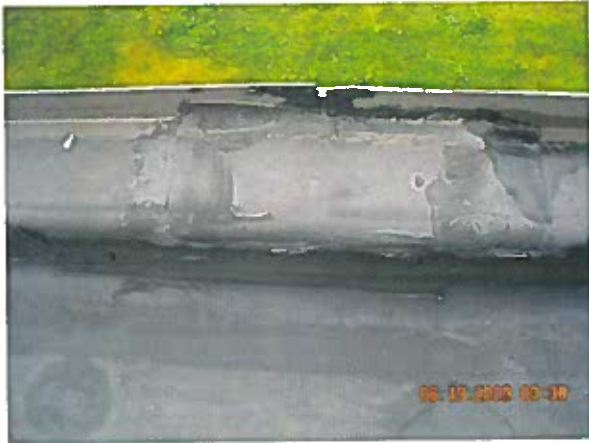
Area 2—Anomaly  
Splice patches repaired where applicable

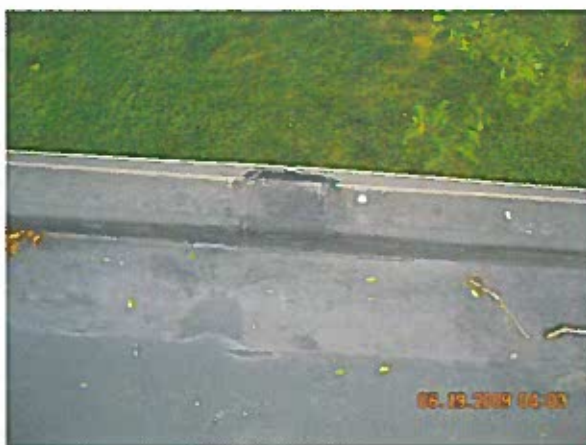
Area 4— Anomaly  
Splice patches at roof perimeters are open at metal junctions. These areas received remedial repairs where applicable.

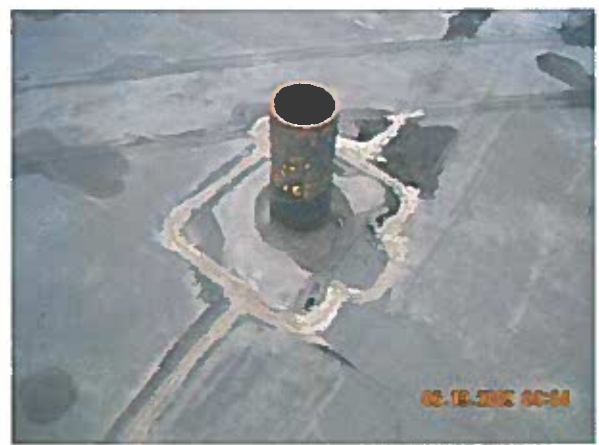
Area 4— Anomaly  
Target patches at roof projections are delaminating at many areas.

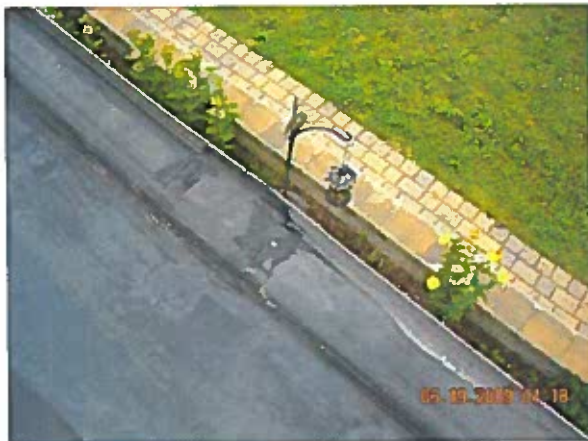
Area 5— Anomaly  
Splice patches at roof perimeters are open at metal junctions. These areas received remedial repairs where applicable.

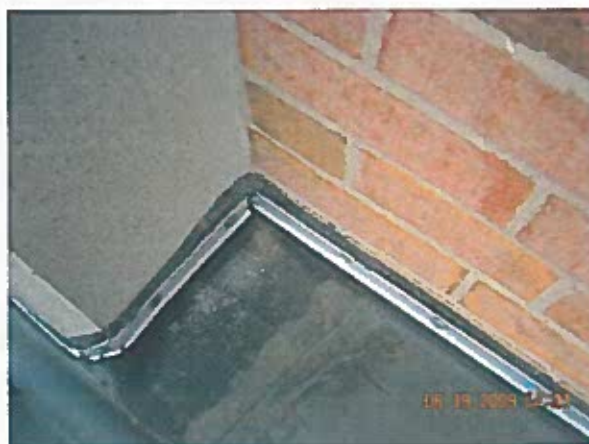
Area 6—Anomaly  
Sealant deterioration at termination bar

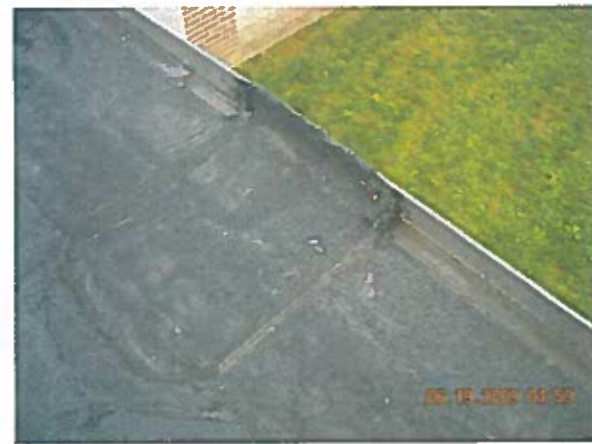
Area 6—Anomaly  
Surface splice open at roof to vertical transition

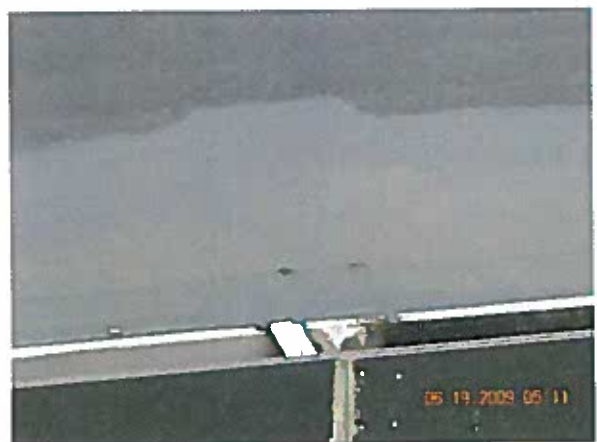
Area 8—Overview  
Sealants appear to be deteriorating at gutter laps.

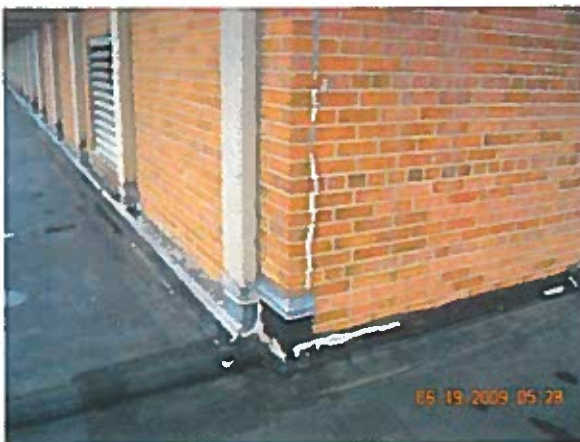
Area 10— Observation  
Wall crack was typically repaired in the past. Current sealants are deteriorating.

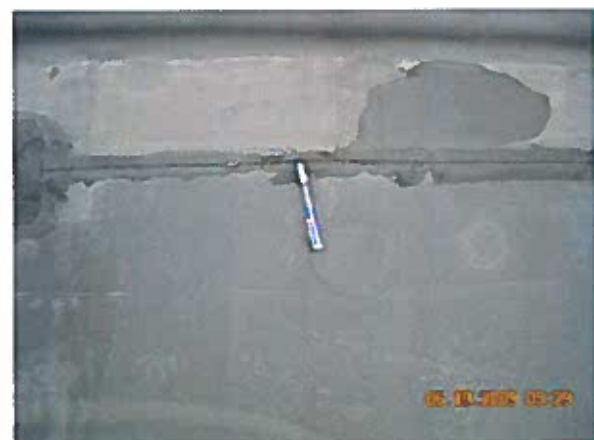
Area 10—Anomaly  
Expansion joint cover strip is delaminating in areas

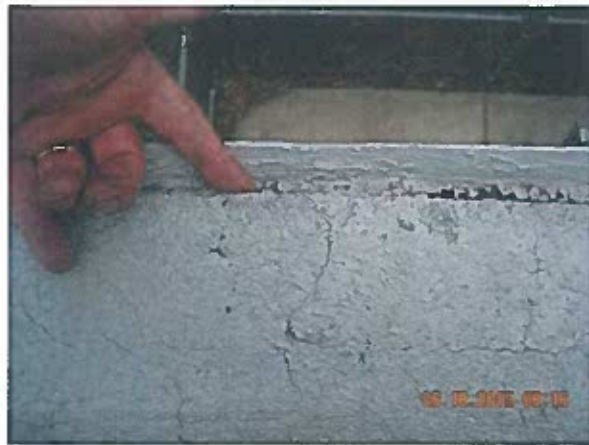
Area 1— Anomaly  
Strip-in flashings were un-adhered to the edge metal in many location. Where identified, remedial repairs were conducted to these locations

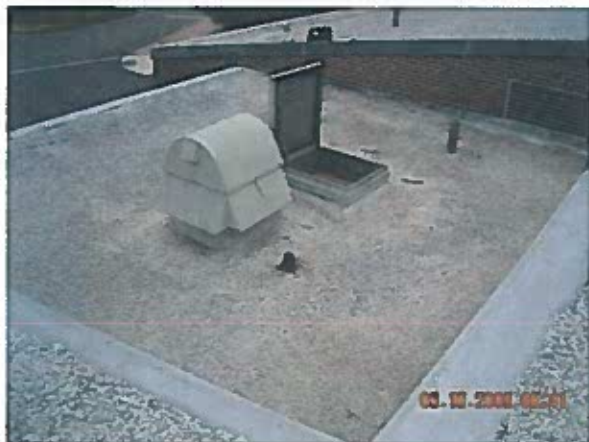
Area 2— Overview  
No apparent anomalies were observed at this roof area

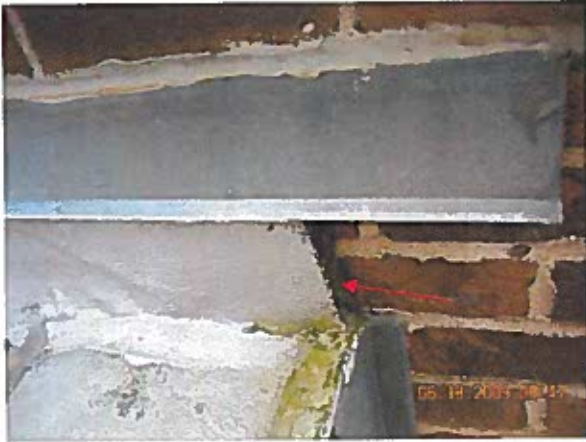
Area 3 — Anomaly  
Termination securement missing at this location

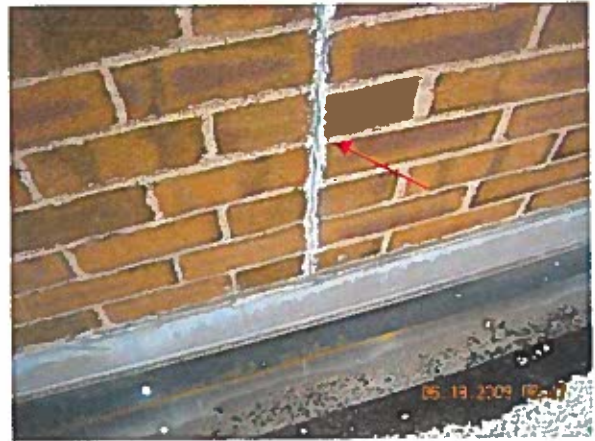
Area 3 — Anomaly  
Deteriorated sealant joints were observed

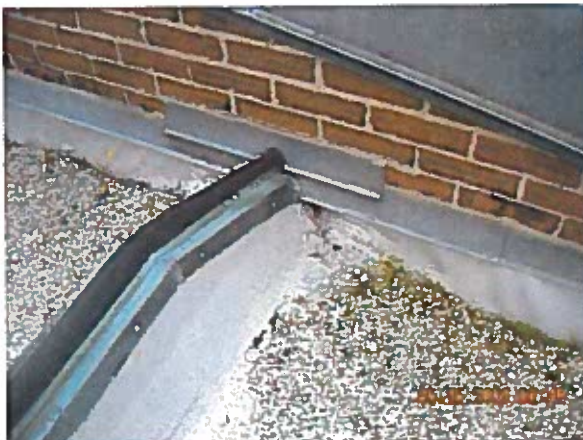
Area 3 — Observation  
Termination appears satisfactory

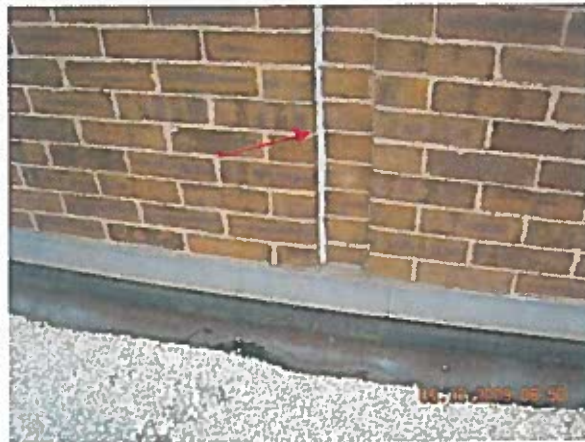
Area 4 — Anomaly  
Deteriorated joint sealant

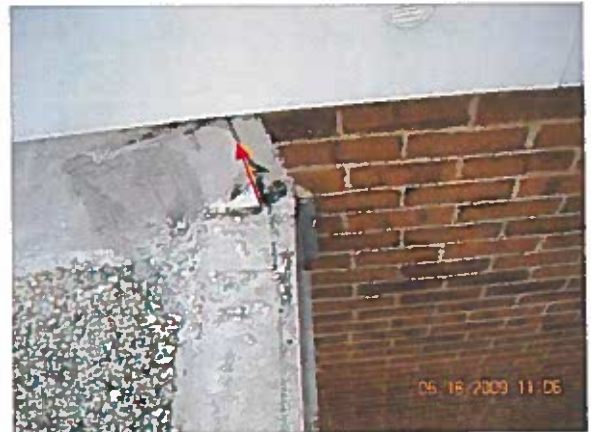
Area 6 — Anomaly  
Missing termination on base flashing

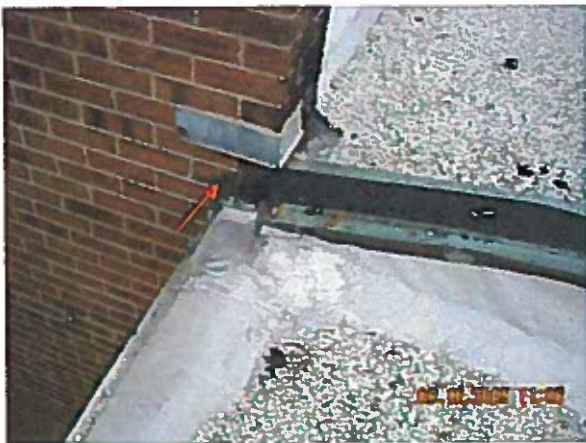
Area 6 — Anomaly  
Expansion joint does not extend past metal edge

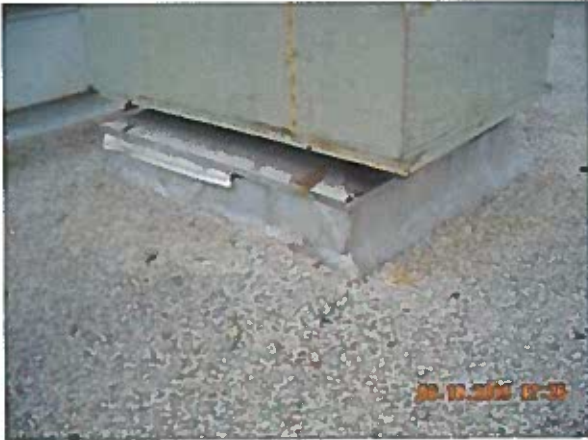
Area 7 — Anomaly  
Loose base flashings around ventilators

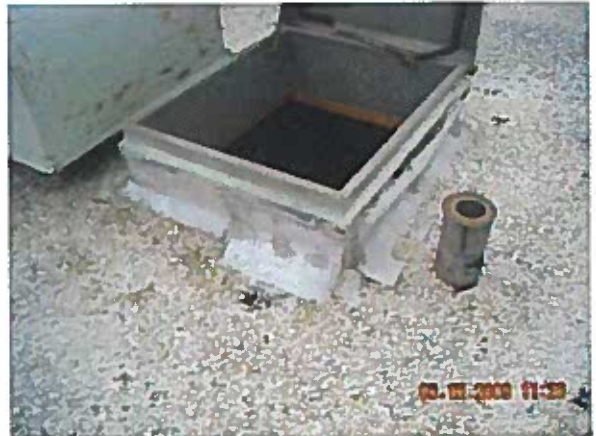
Area 7 — Anomaly  
Poor base flashing installation at roof hatch

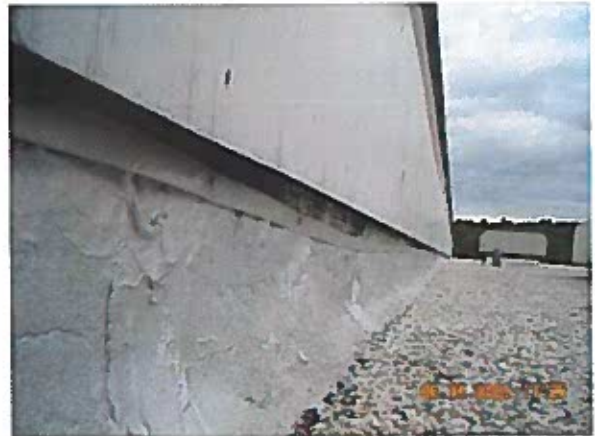
Area 7 — Anomalies  
Open termination at base flashings  
NOTE: Base flashings appear to be in poor condition

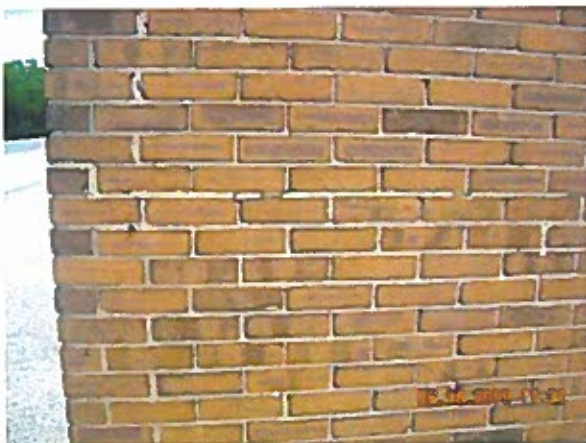
Area 7 — Anomaly  
Mortar beds for brick in poor condition

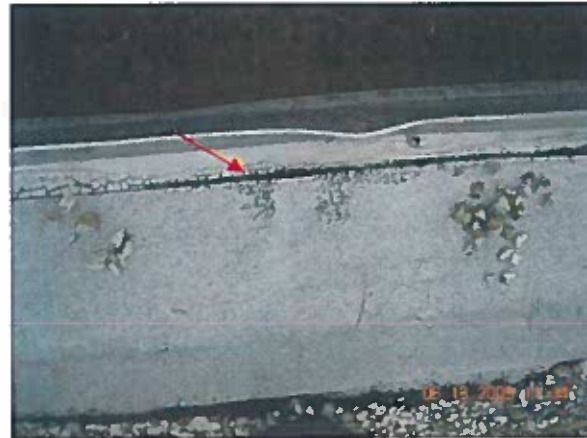
Area 8 — Anomaly  
Strip-in delaminating from edge metal  
Remedial repairs conducted to these areas

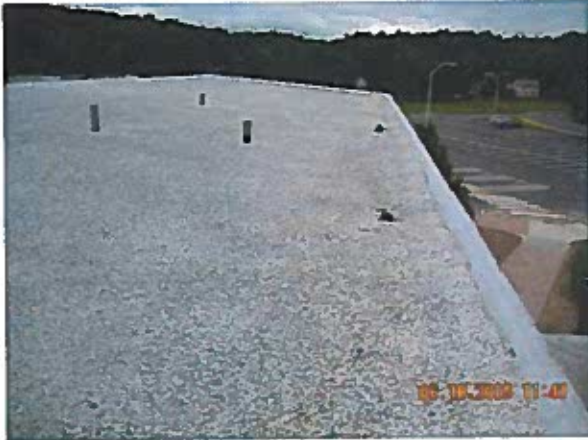
Area 9—Overview  
No apparent anomalies were observed

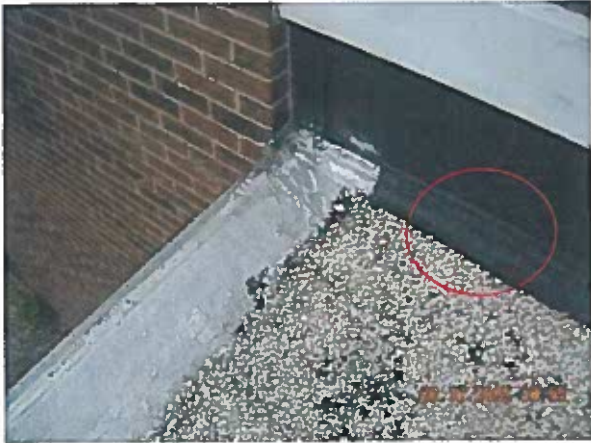
Area 11 — Anomaly  
Expansion joint material is deteriorated

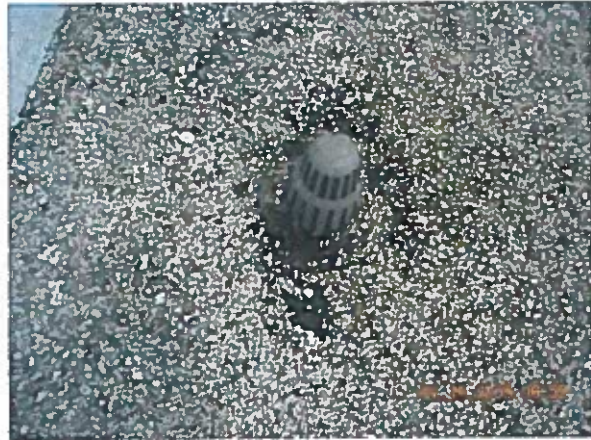
Area 11 — Anomaly  
Broken roof drain strainer

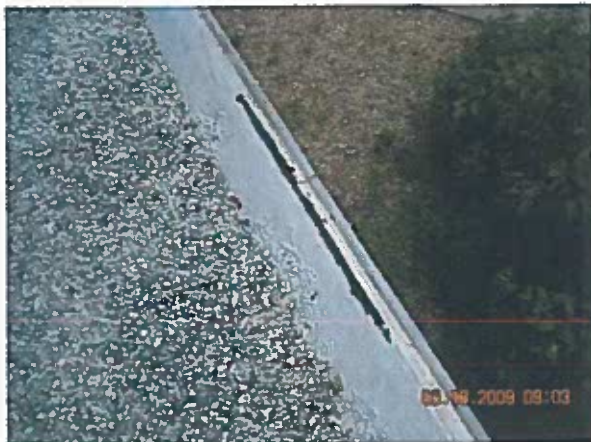
Area 11 — Anomaly  
Remedial repairs were conducted to the strip-in at locations delaminated from edge metal

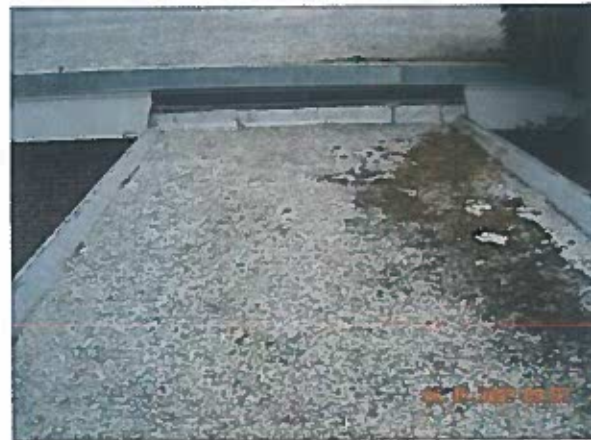
Area 11 — Anomalies  
Debris was removed from the roof surface

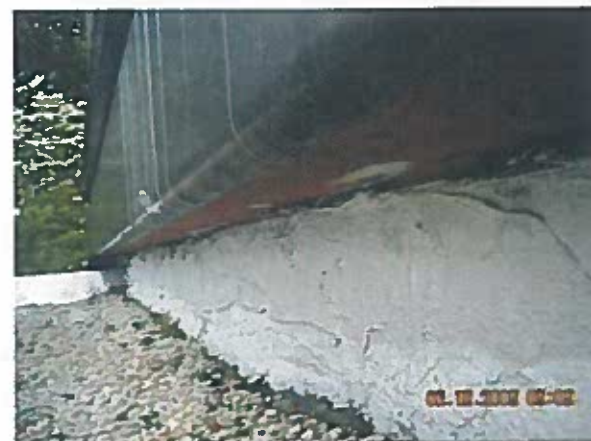
Area 11 — Observation  
Base flashings appear to be in satisfactory condition

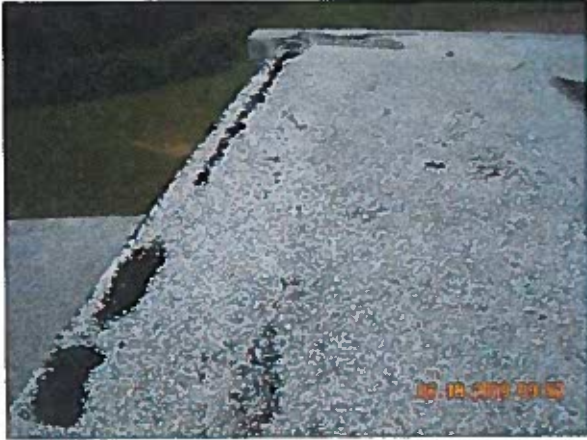
Area 12 — Overview  
NOTE: Exposed membrane along perimeter edge

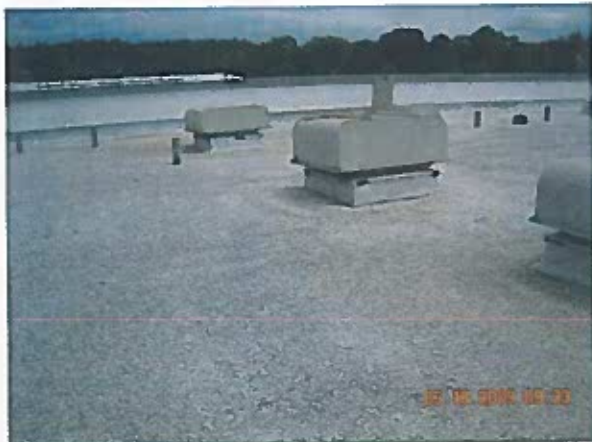
Area 13 —Observations  
Terminations appear to be in satisfactory condition.  
Gutters were cleared of debris

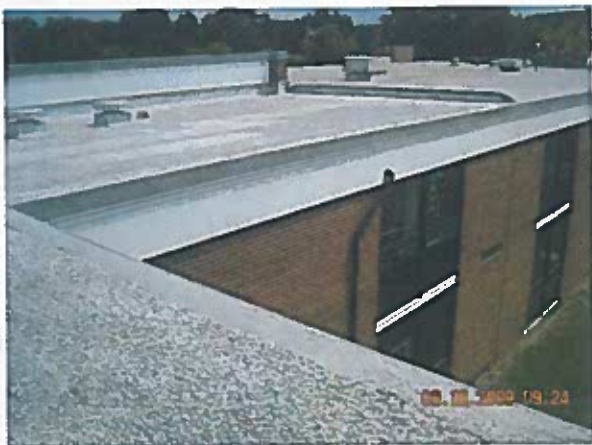
Area 13 — Overview and Observations  
Terminations appear to be in satisfactory condition.  
Some delamination of splice seams/patches were observed.

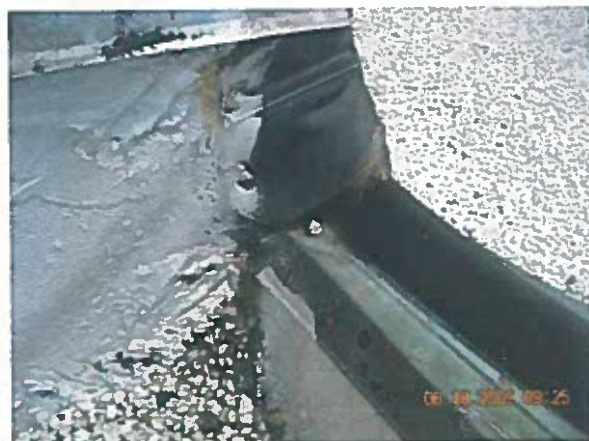
Area 13 — Anomaly  
Poor expansion joint tie-in

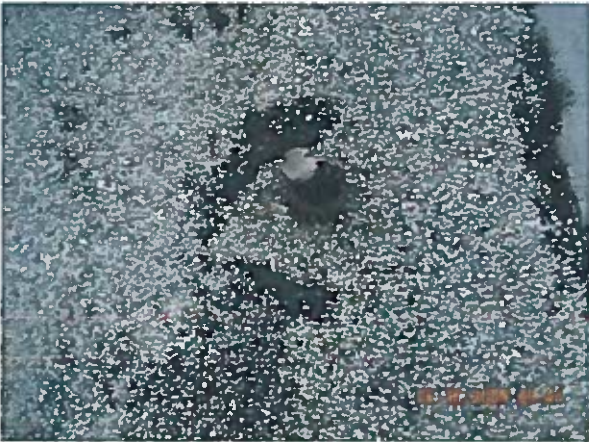
Area 14 — Anomaly  
Exposed membrane and broken roof drain strainer

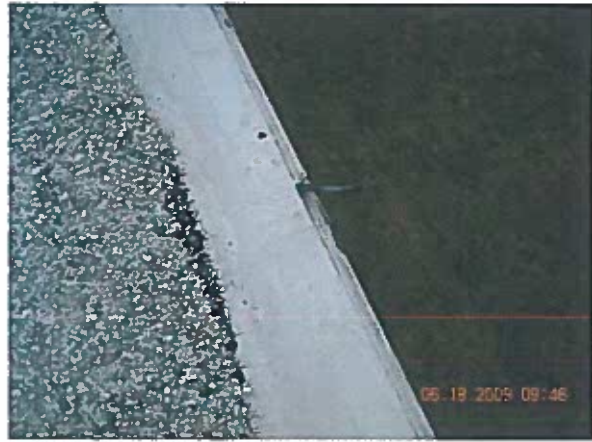
Area 14 — Anomaly  
Strip-in membrane along perimeter is not adhered to edge metal. Remedial repairs were conducted at these locations

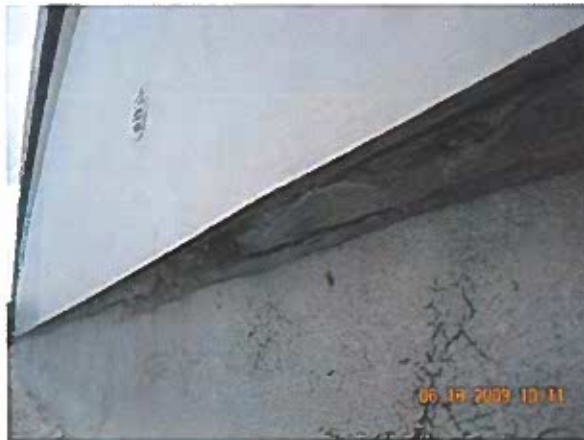
Area 17 — Anomaly  
Base flashing missing termination securement

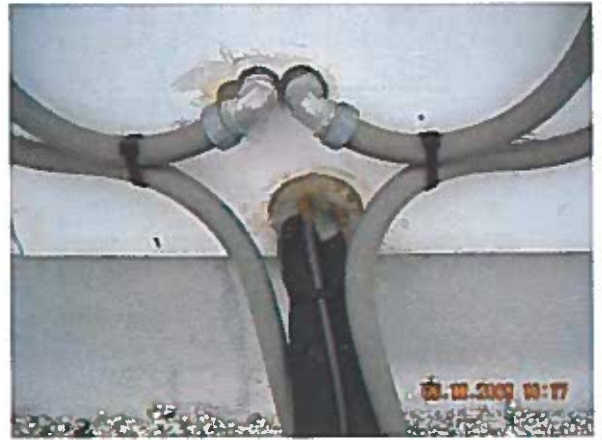
Area 17 — Anomaly  
Conduits are not sealed at through wall locations

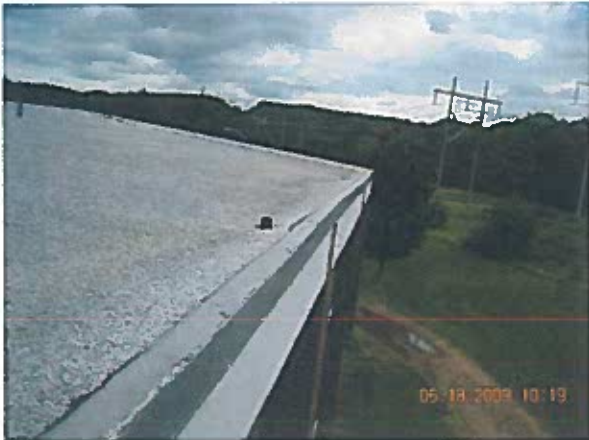
Area 18 — Observations  
Some minor strip-in flashings are un-adhered to the edge metal. Remedial repairs were conducted at these locations.

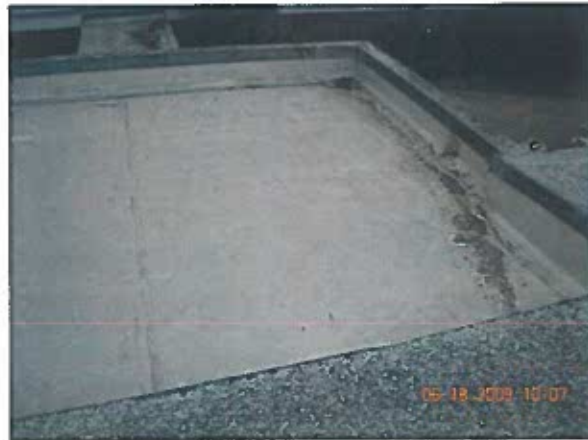
Area 19 — Overview  
Gravel was removed from the membrane surface

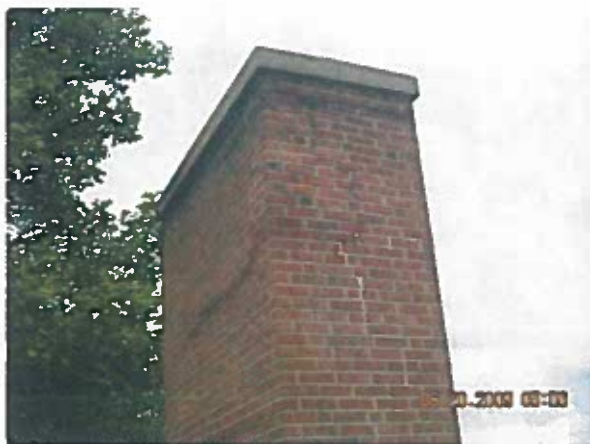
Area 2—Observation  
Mortar joints on brick work failing

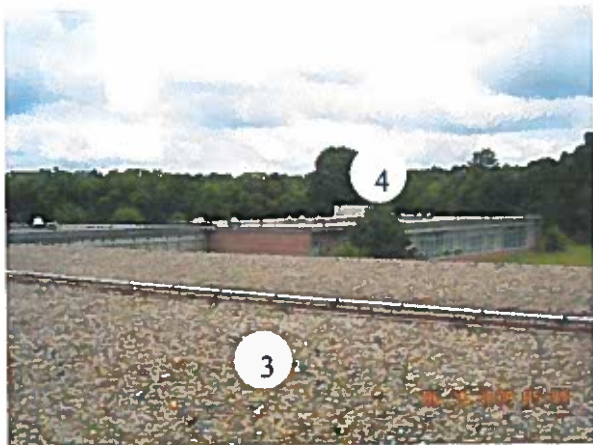
Areas 3 & 4 —Overview

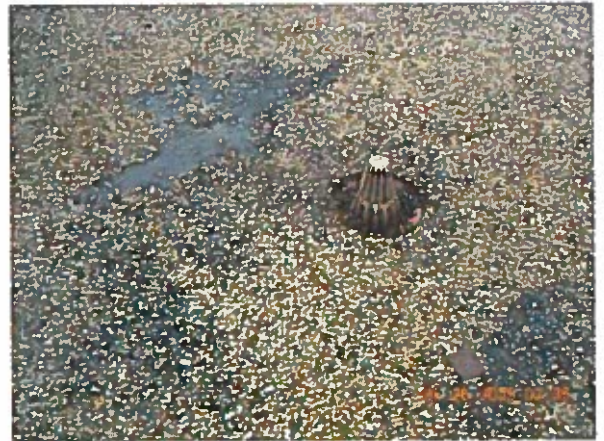
Area 1— Anomalies  
Exposed membrane felts at roof drain. Similar exposed felt conditions appear around perimeter edges

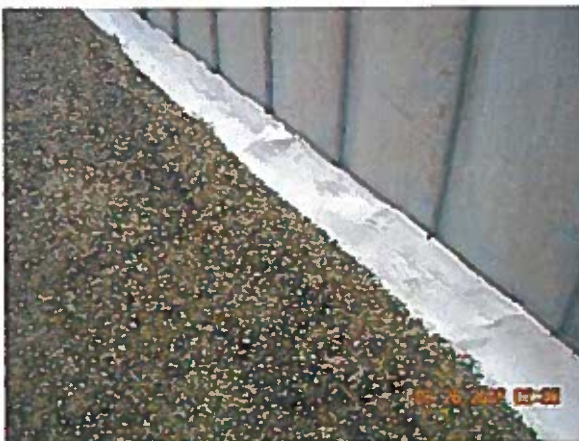
Area 1— Anomaly  
Apparent loose base flashings

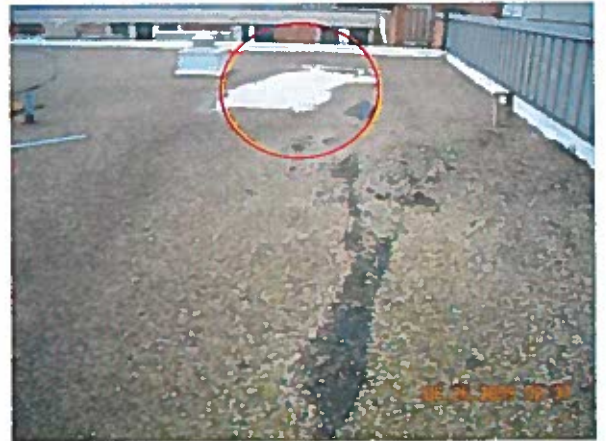
Area 1— Anomalies  
Additional areas of exposed membrane. Circle indicates a restricted roof drain leader

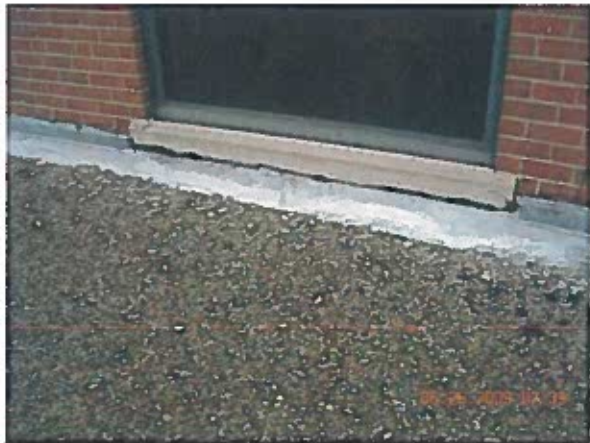
Area 2 — Anomaly  
Missing termination bar beneath window support sill

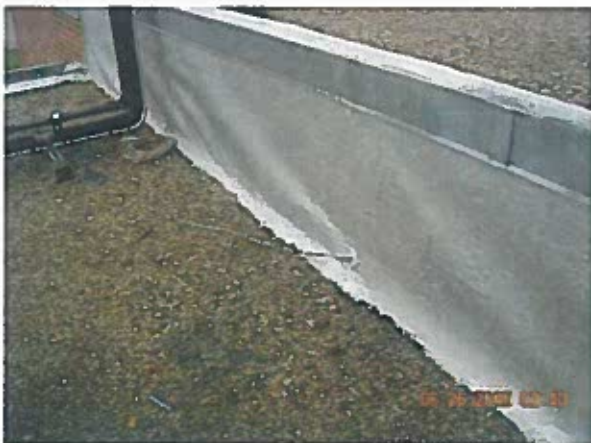
Area 2—Anomaly  
Apparent loose base flashings

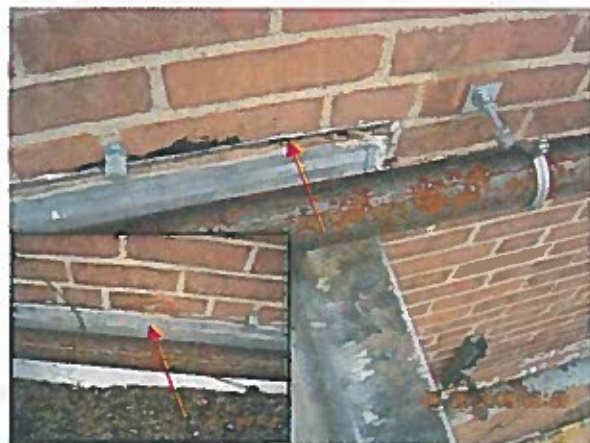
Area 2—Anomaly  
Missing sealant at counter flashing reglet

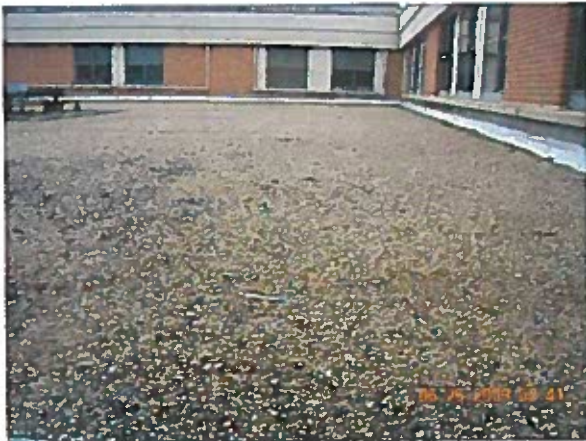
Area 3— Overview  
Splice laps are delaminating at some roof drain targets

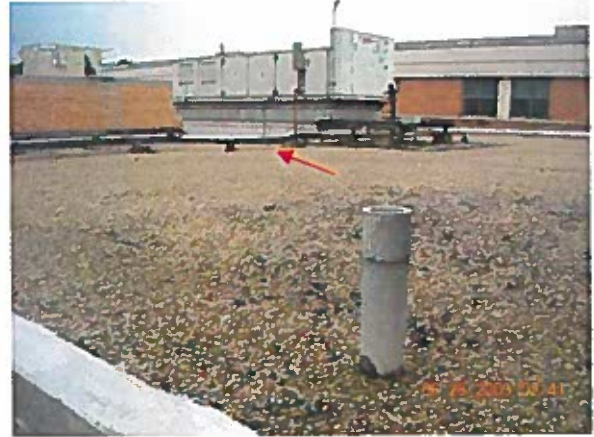
Area 3— Overview  
Cover strips at edge metal transitions are lifting. Remedial repairs were conducted where moisture wasn't present

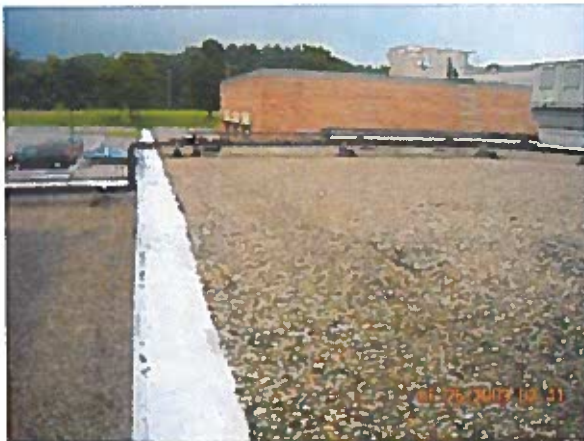
Area 3— Overview  
Splice patches throughout roof area are delaminating around the edges. NOTE: This condition is typical at all roof locations
