**TOWN OF GLASTONBURY  
REQUEST FOR QUALIFICATIONS  
RPGL-2019-25  
ROOFING STUDY OF GLASTONBURY SCHOOLS  
ADDENDUM NO. 1  
January 25, 2019**

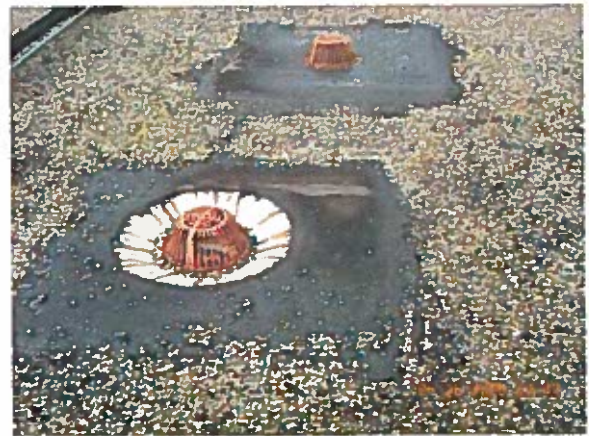
Area 3— Anomaly  
Apparent exposed membrane at roof drains

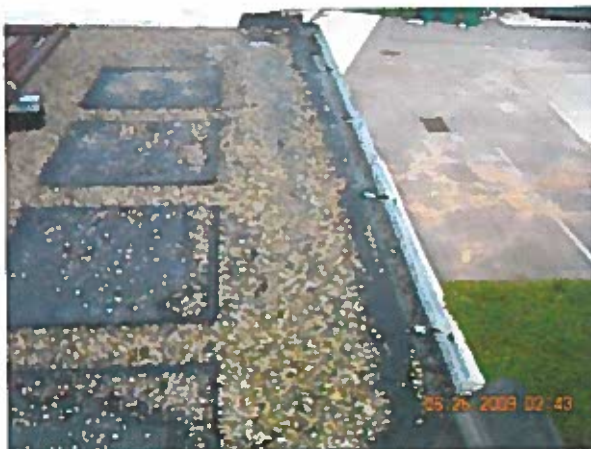
Area 3— Anomaly  
Damaged strip-in at edge metal

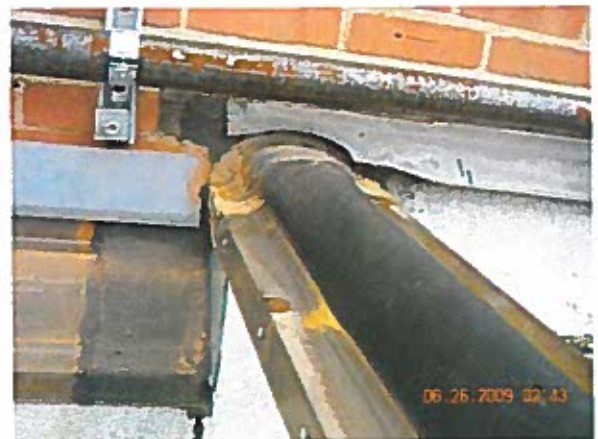
Area 3— Anomaly  
Open sealant at expansion joint termination

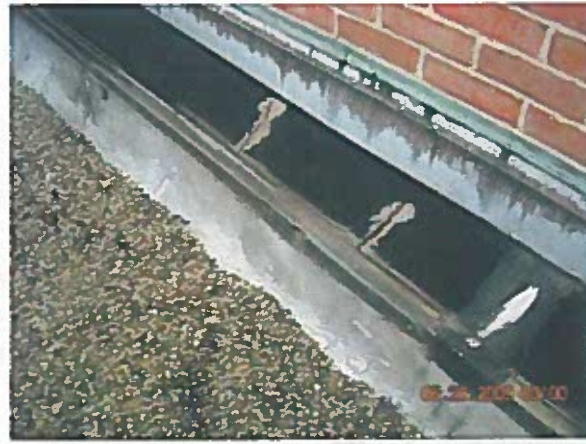
Area 4 — Anomaly  
Expansion joint is deteriorated

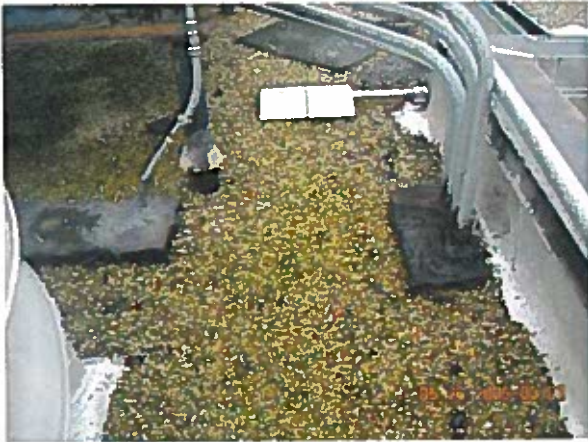
Area 4 — Anomaly  
Pipe penetrations are clustered

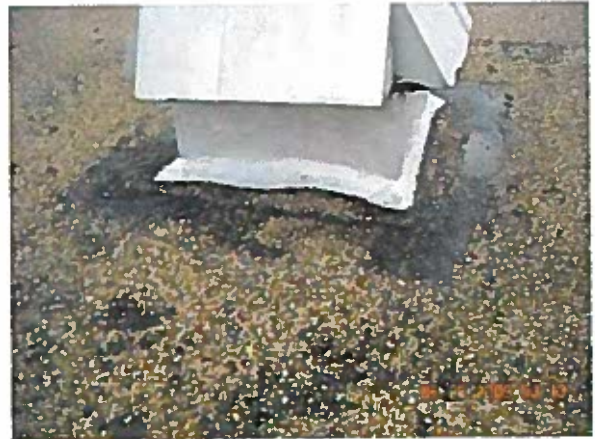
Area 4 — Anomaly  
Base flashings are damaged around curb unit

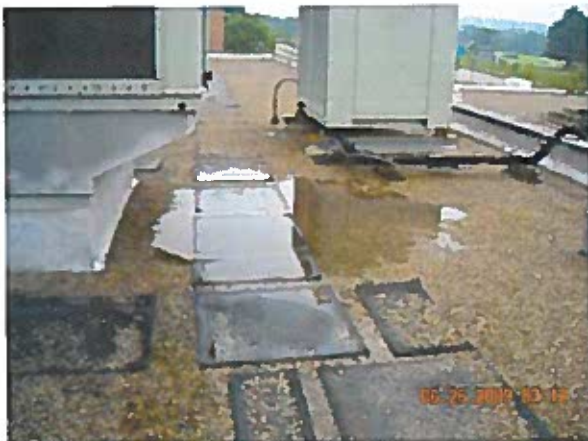
Area 4 — Anomaly  
Apparent restricted roof drain with missing drain strainer

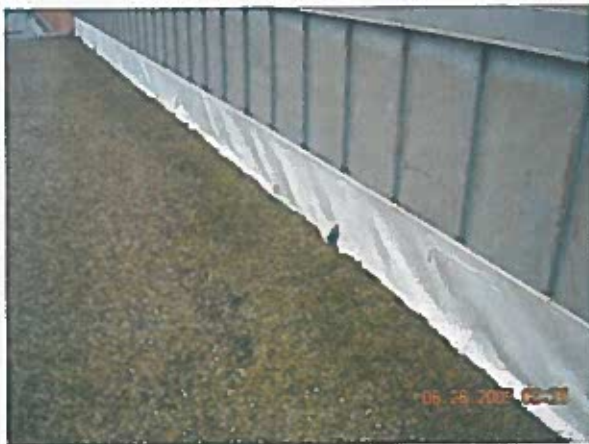
Area 5 — Anomaly  
Loose base flashings along wall

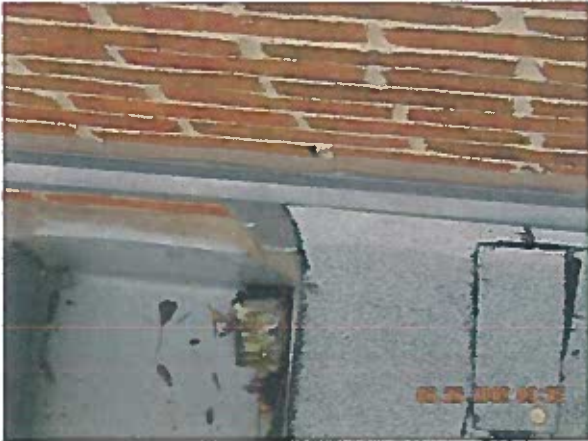
Area 5c — Overview  
NOTE: Roof area appears to be in satisfactory condition

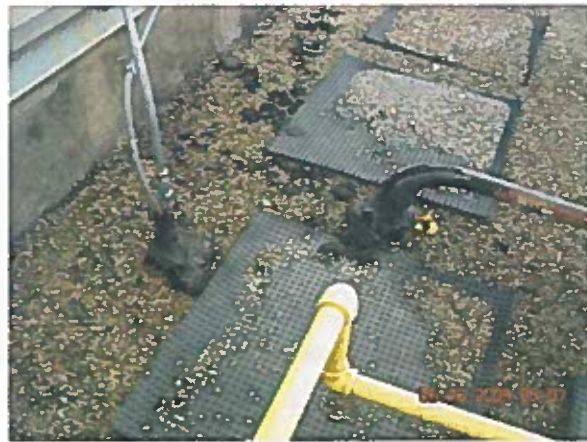
Area 6a — Anomaly  
Pipe penetration pockets are clustered with deteriorated fillers (typical)

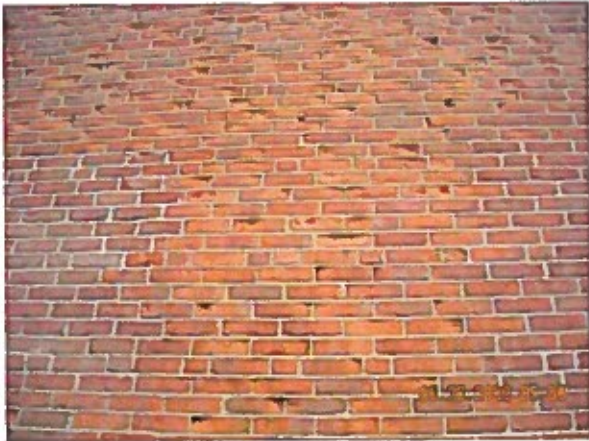
Area 6a — Observation  
Brick work deteriorating from moisture intrusion

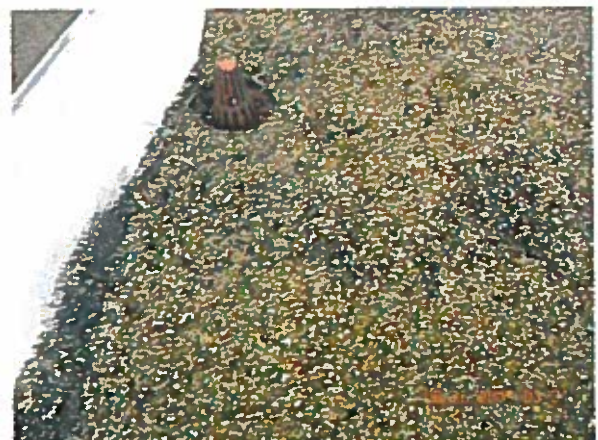
Area 7 — Anomaly  
Some exposed membrane was observed around roof drains

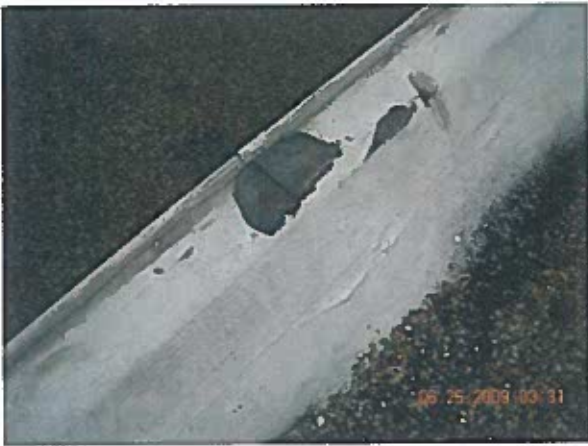
Area 7 — Anomaly  
Some splits in the strip-in flashings were observed around the perimeter

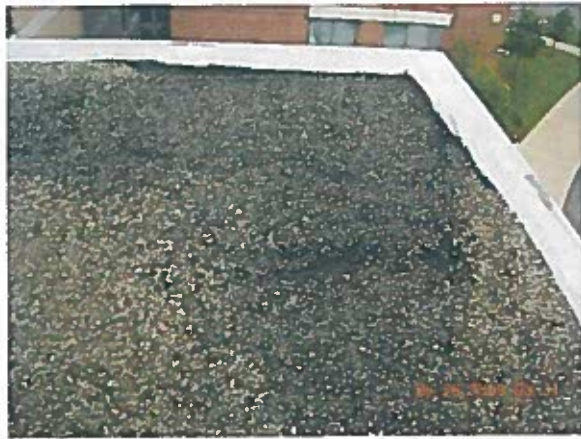
Area 7 — Anomaly  
Some exposed membrane was observed around roof drains

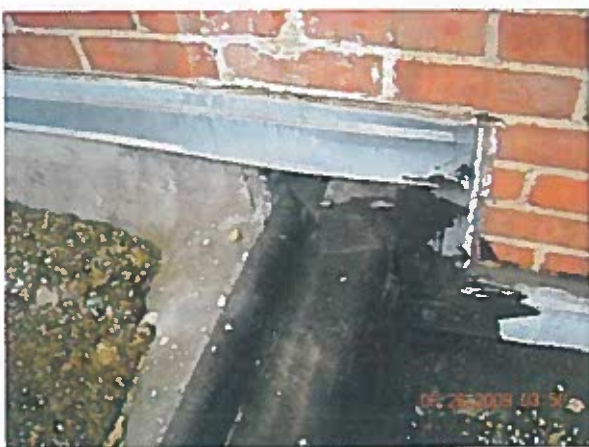
Area 8 — Anomaly  
Open terminations were observed along with open inside corners on sheet metal work

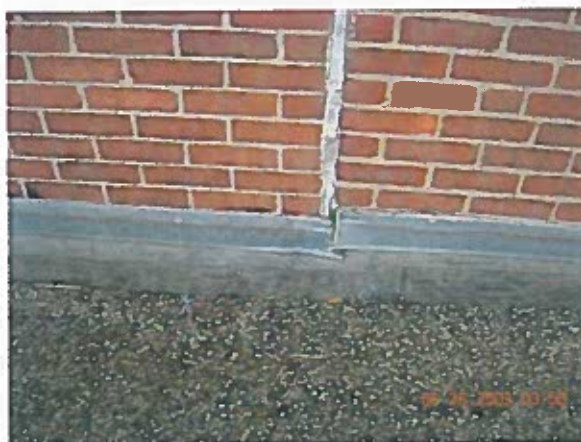
Area 8 — Observation  
Wall joints sealants are deteriorated

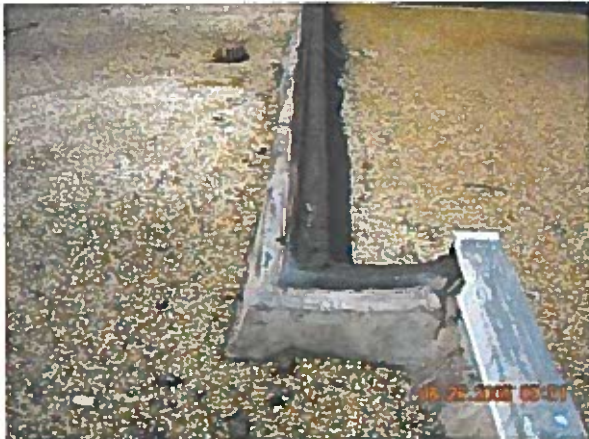
Area 9 — Anomaly  
Base flashings are in poor/deteriorated condition

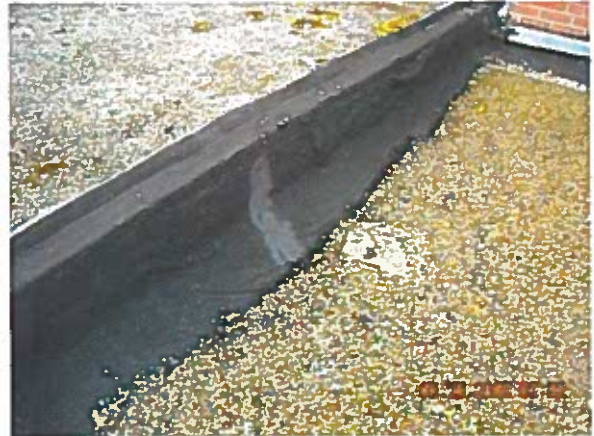
Area 9 — Anomaly  
Base flashings are in poor/deteriorated condition

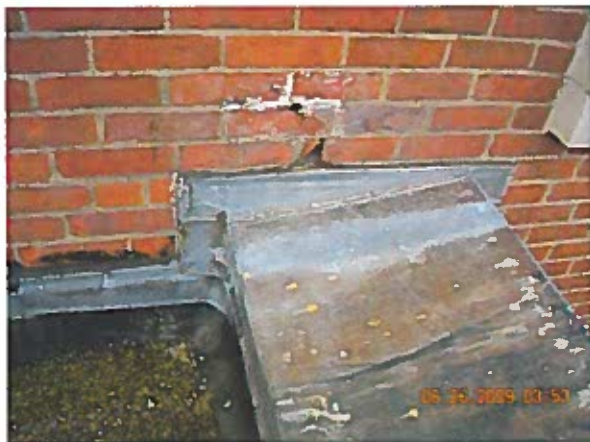
Area 9 — Observation  
Brick work damage at coping termination

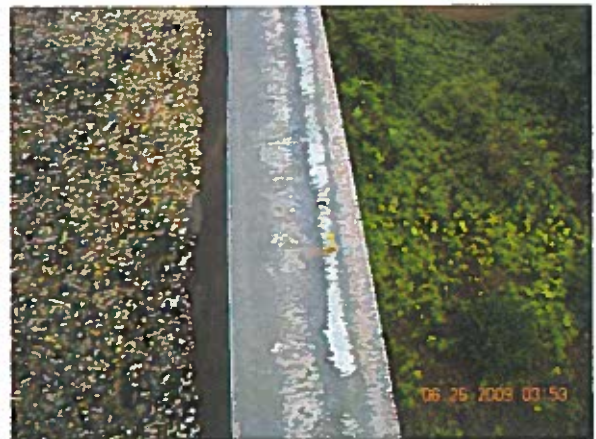
Area 9 — Anomaly  
Physical damage was observed at the metal coping

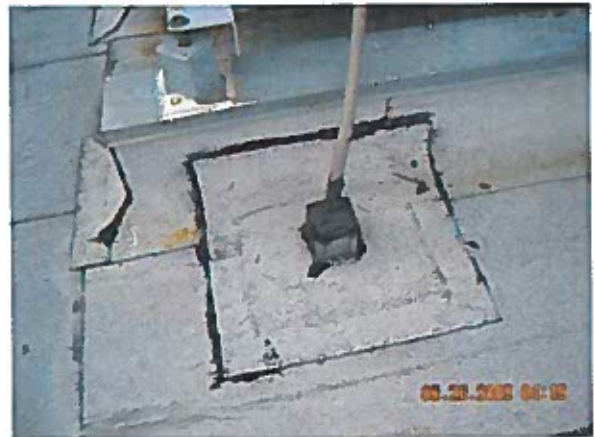
Area 9b — Anomaly  
Plastic conduits are not recommended to penetrate a penetration pocket

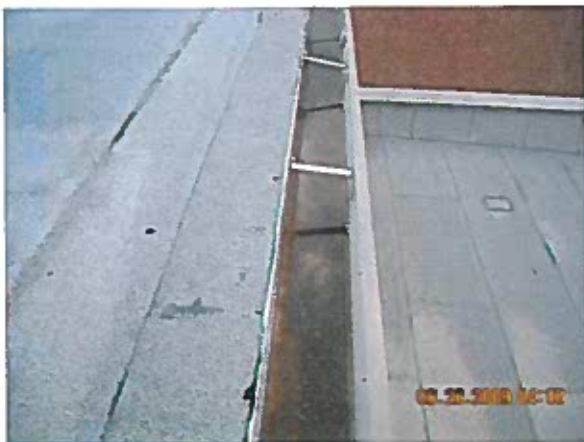
Area 9b — Overview  
Gutter detail on penthouse roof

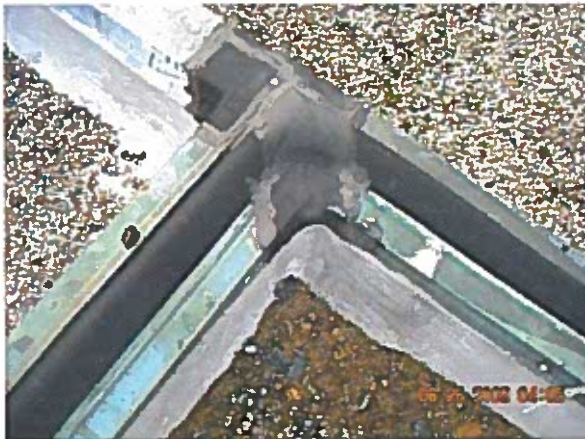
Area 10 — Anomalies  
Sealants deteriorating at expansion joint transitions

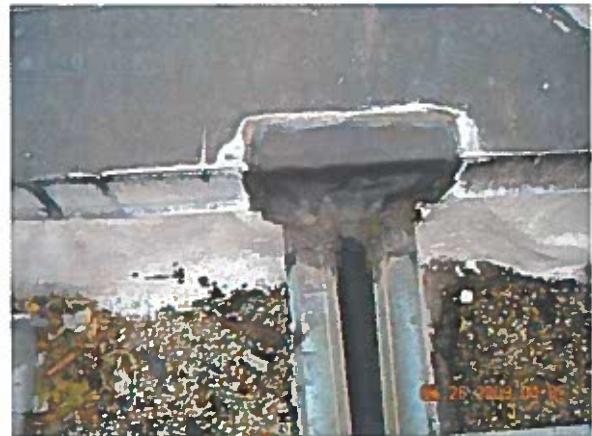
Area 10 — Anomalies  
Sealants deteriorating at expansion joint transitions

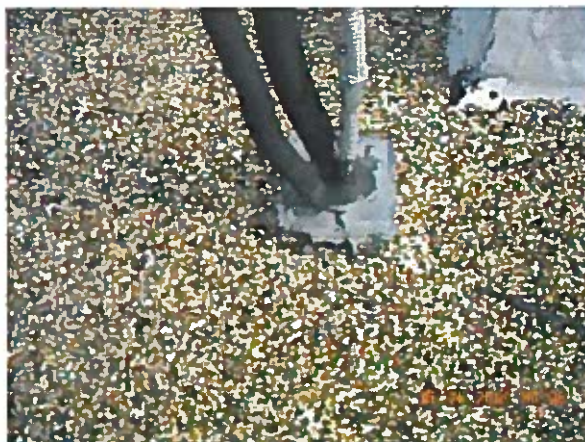
Area 10 — Anomaly  
Penetration pipes mastic deteriorating are clustered along with

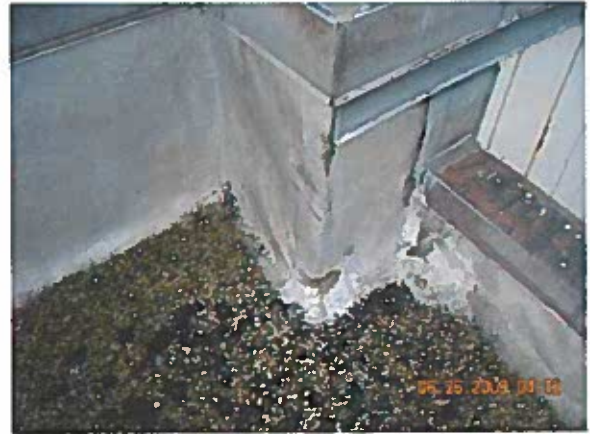
Area 12 — Anomaly  
Damaged base flashing

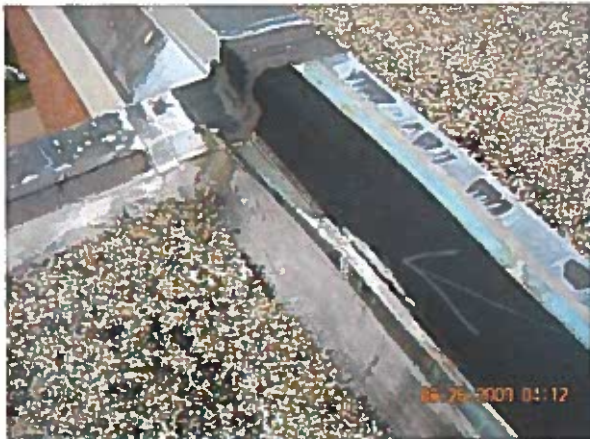
Area 12 — Anomaly  
Expansion joint damage

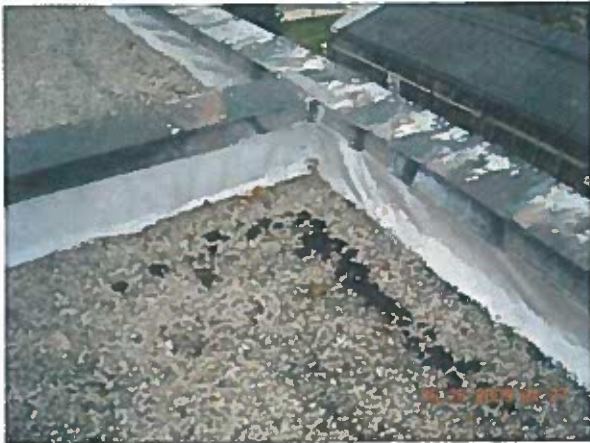
Area 13 — Anomaly  
Base flashings loose at inside corner

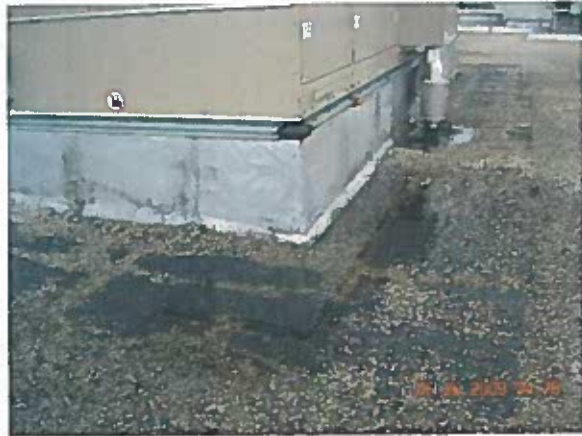
Area 13 — Observation  
Ponding water at base of A/C unit

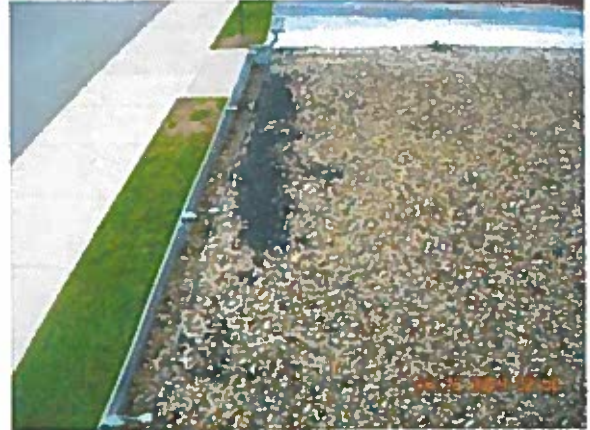
Area 14 — Anomaly  
Exposed membrane was observed in many areas around the perimeter edge metal

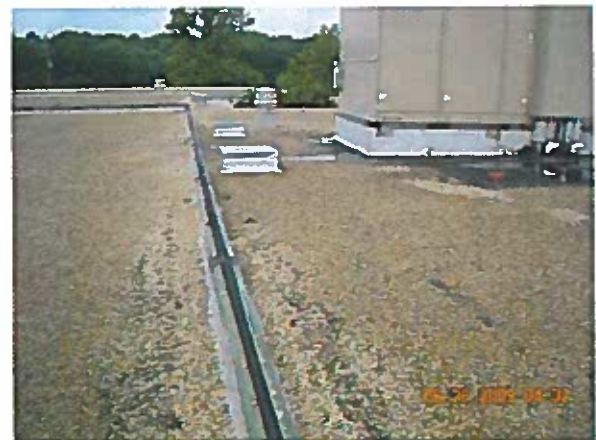
Area 15 — Observations  
Major repair was conducted around large A/C unit

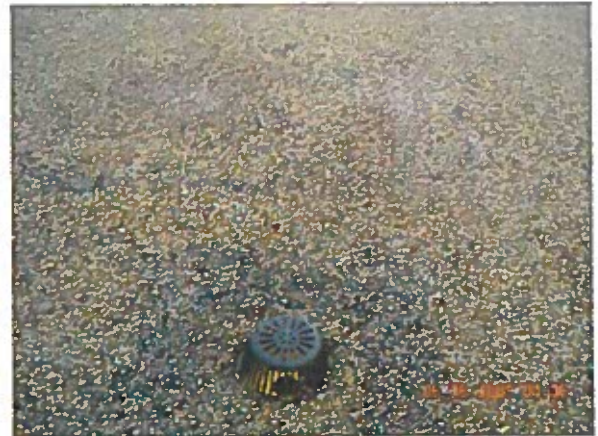
Area — anomaly  
Exposed membrane was observed around roof drain areas

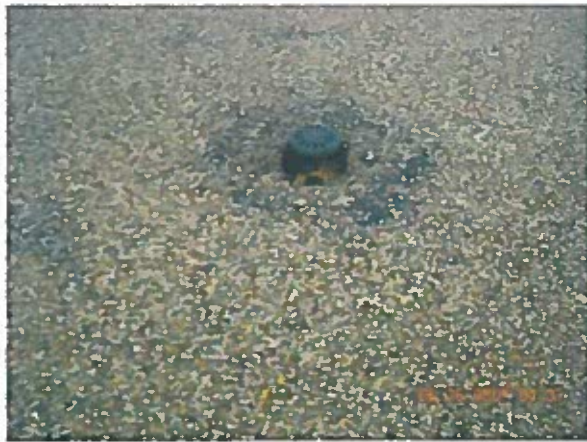
Area 18 — Anomaly  
Exposed membrane was observed around roof drain areas

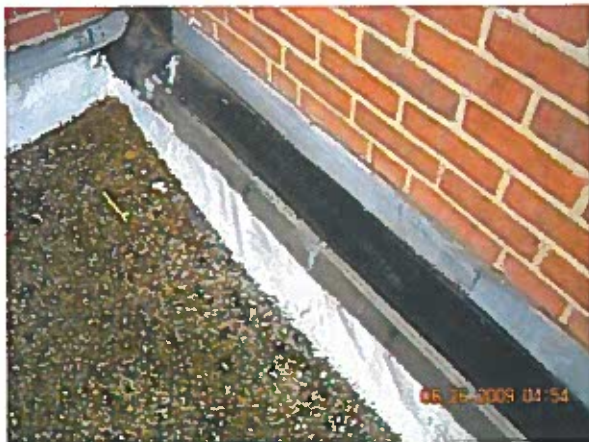
Area 19 — Anomaly  
Expansion joint cover is deteriorated

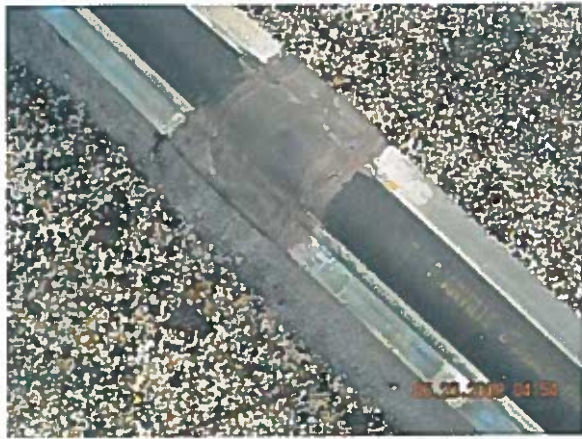
Area 20 — Anomaly  
Expansion joint cover strips are loose

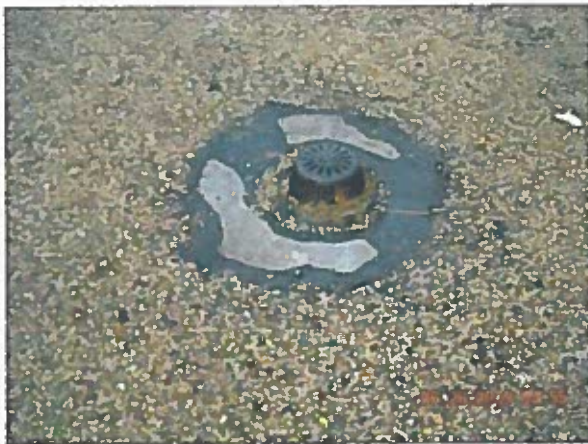
Area 20 — Anomaly  
Drain flashings membrane is exposed

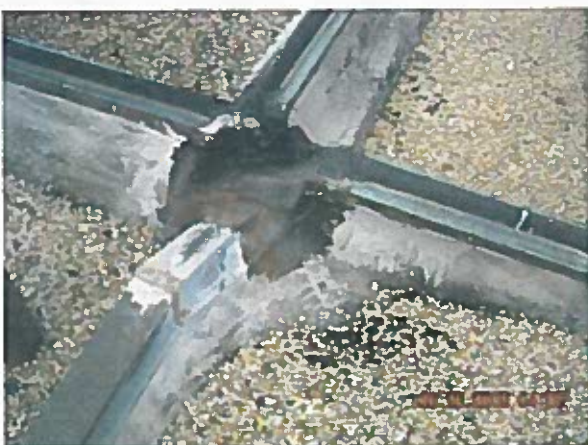
Area 20 — Anomaly  
Expansion joint transitions are in poor condition

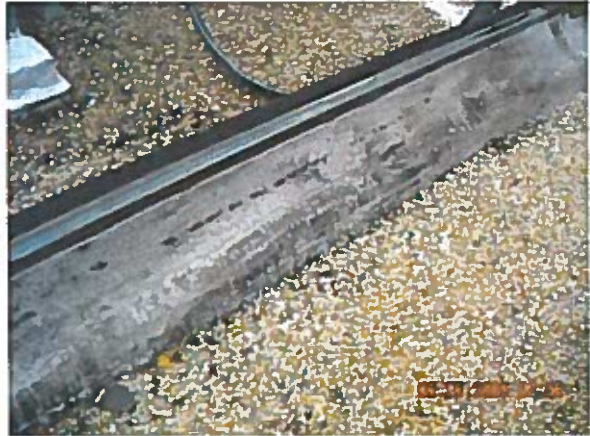
Area 21— Anomaly  
Base flashings are on poor condition

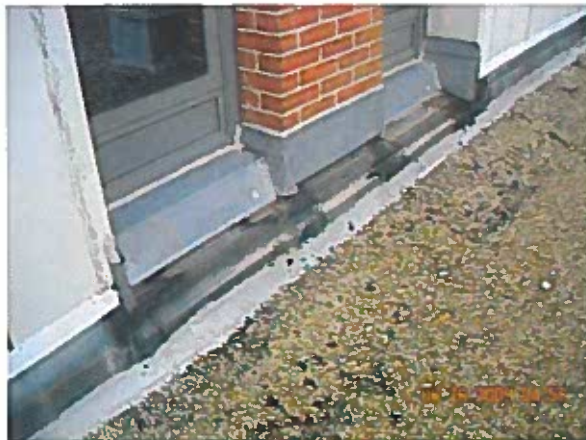
Area 21— Anomaly  
Several open cover strips at window area

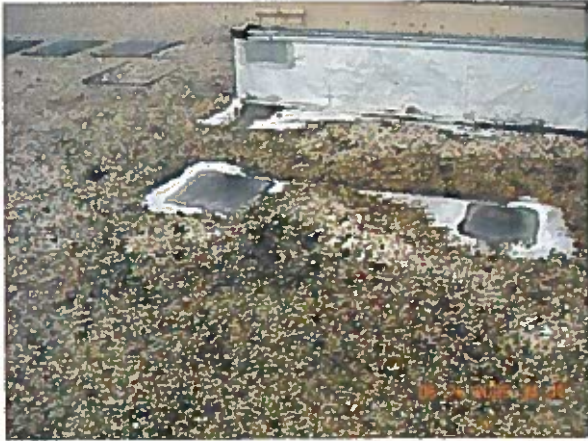
Area 22 — Anomaly  
Repairs are in poor condition at penetration removal area

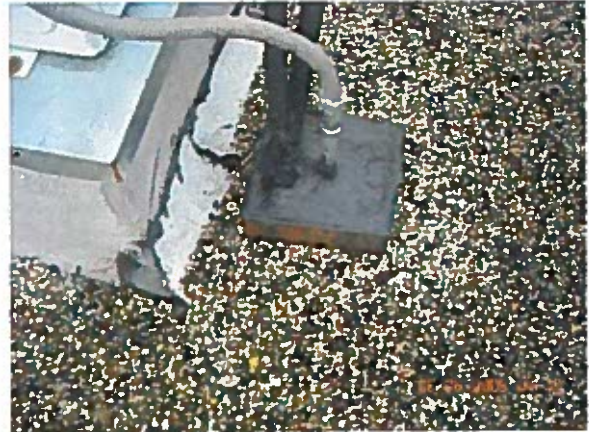
Area 22—anomaly  
Insulated pipe installed into penetration pocket

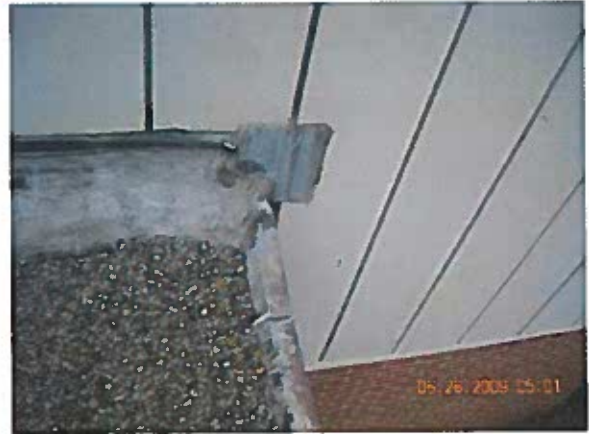
**Area 24—Observation**  
Base flashing terminations appear to be in satisfactory condition

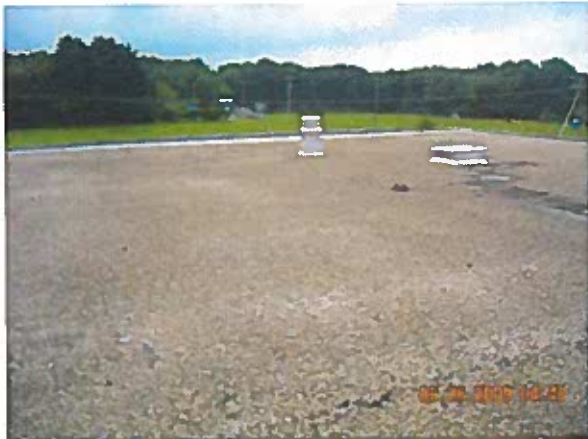
**Area 25—Overview**

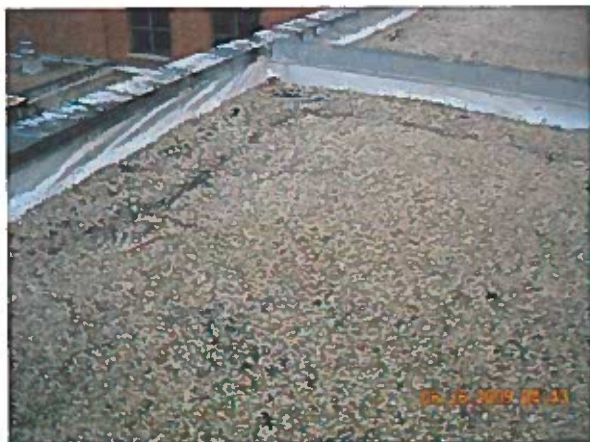
**Area 25—Anomaly**  
Base flashings are loose at perimeter wall

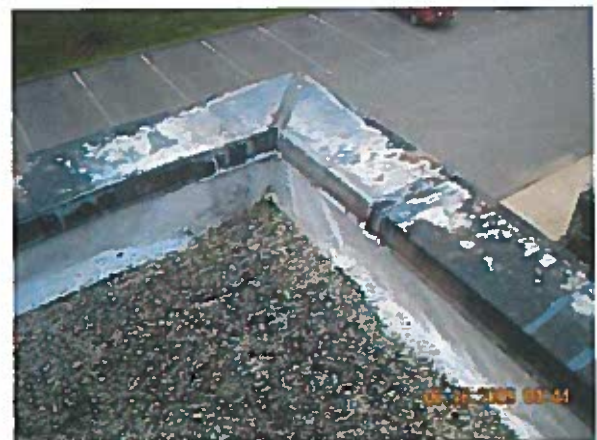
**Area 25—Anomaly**  
Base flashings are loose at perimeter wall

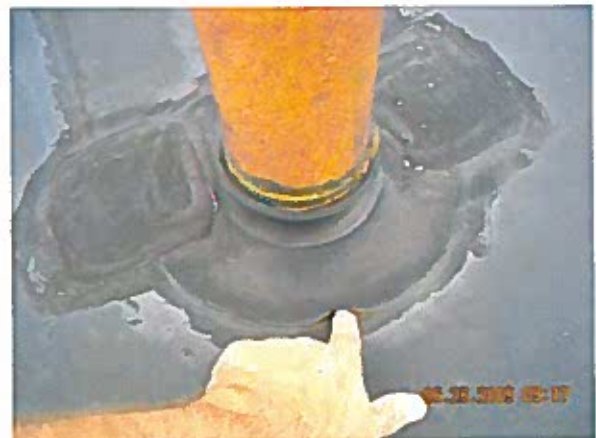
Gymnasium Area I—Anomaly  
Some pipe boots are deteriorated with delaminating splices

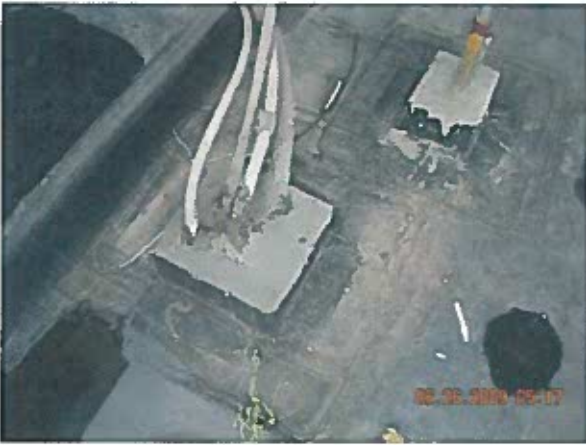
Gymnasium Area 1—Anomaly  
Plastic coated conduits are not recommended for penetration pockets

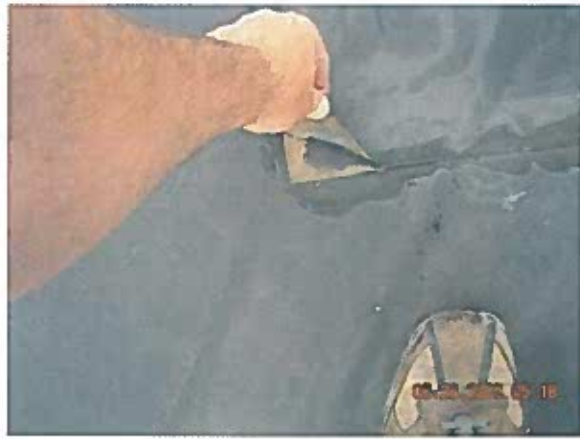
Gymnasium Area 1—Anomaly  
Many splice patches are delaminating

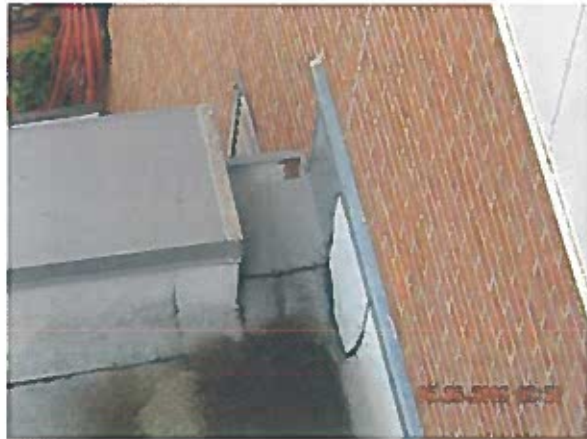
Gymnasium Area 1—Overview  
Scupper detail appears in satisfactory condition

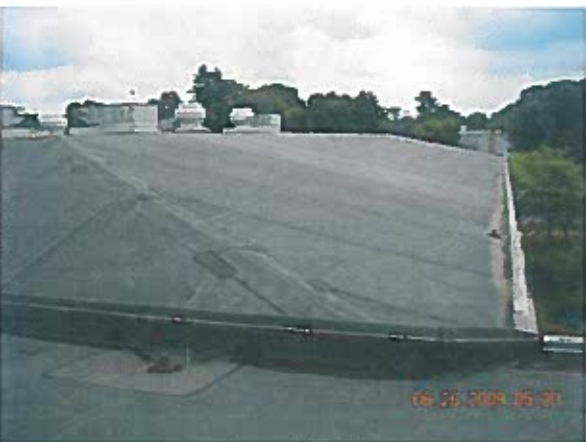
Gymnasium Area 2—Overview

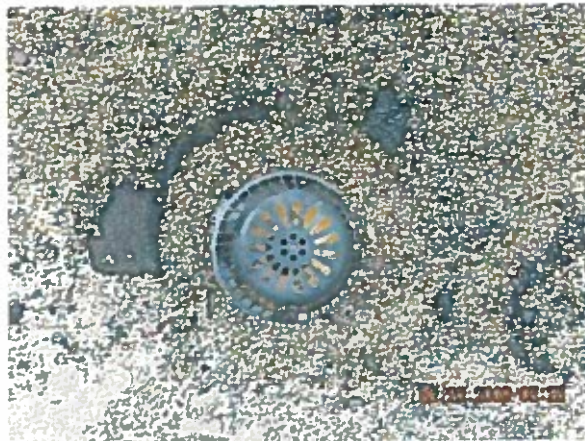
Gymnasium Area 3— Anomaly  
Exposed membrane was observed around roof drain

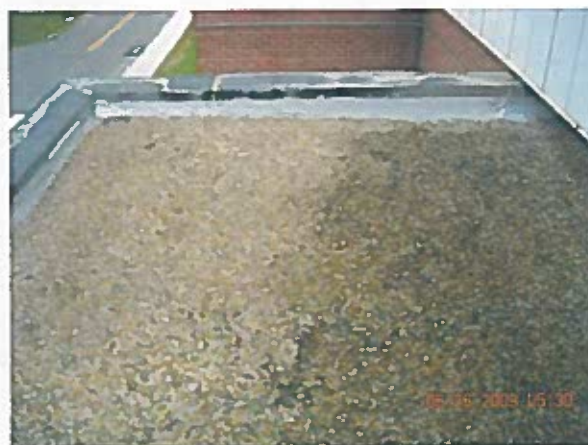
Gymnasium Area 4— Overview

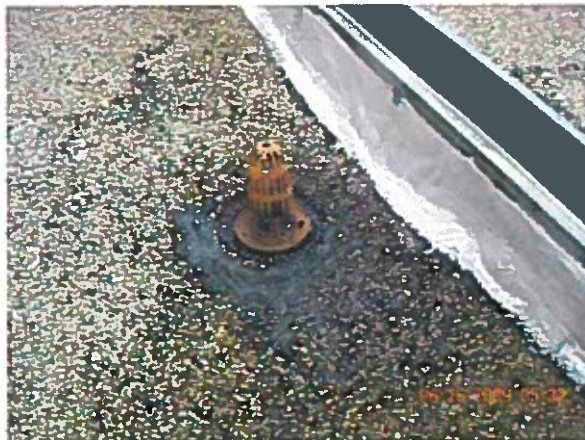
Gymnasium Area 5 — Anomaly  
Exposed membrane was observed at roof drain

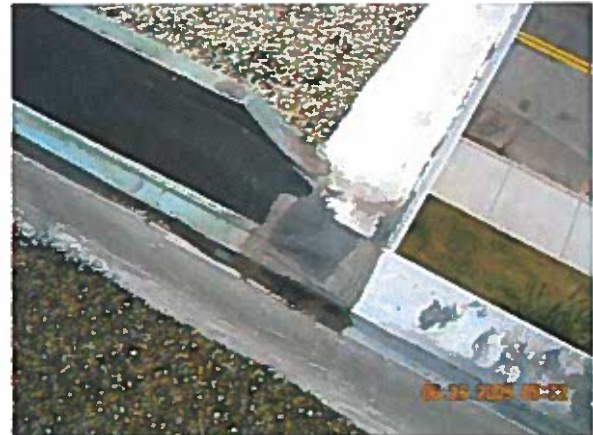
Gymnasium Area 5 — Observation  
Expansion joint detail does not extend to outside edge

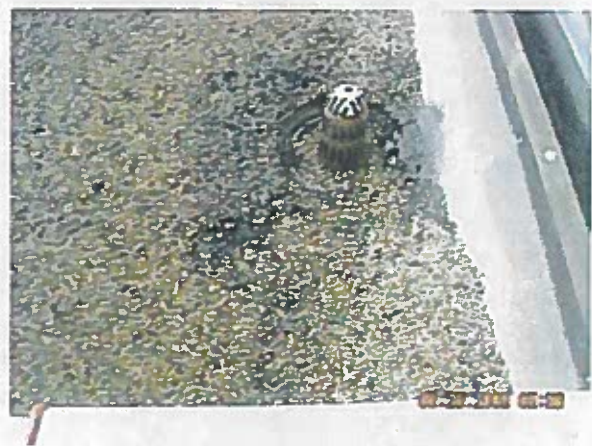
Gymnasium Area 5 — Anomaly  
Exposed membrane observed at roof drain

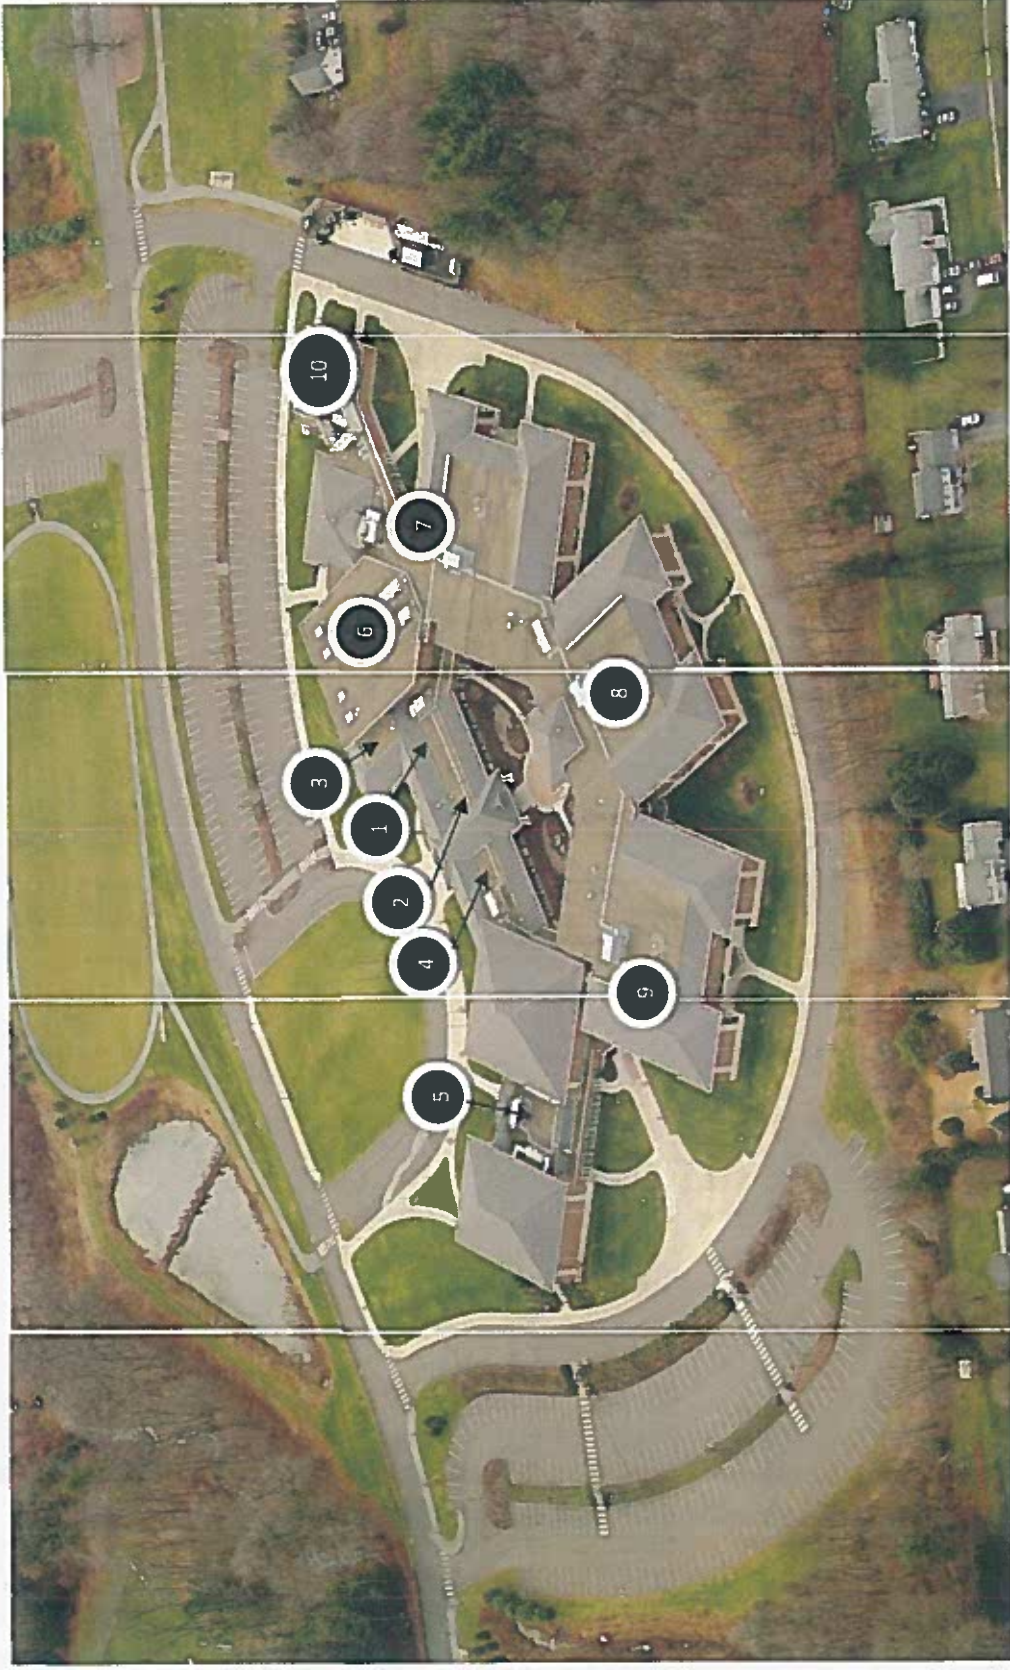
Smith MS  
Addison Rd., Glastonbury, CT

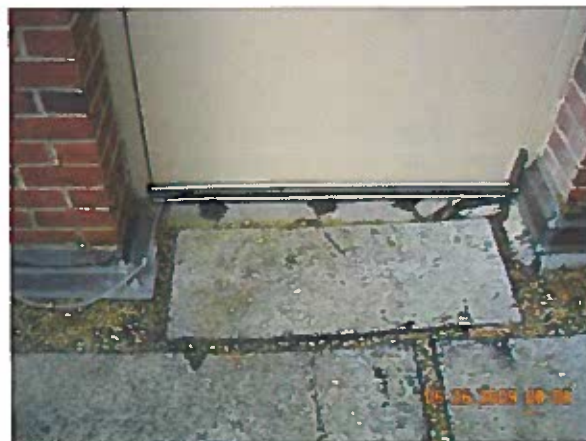
Area 1—Anomaly  
Low flashing height with topical repairs

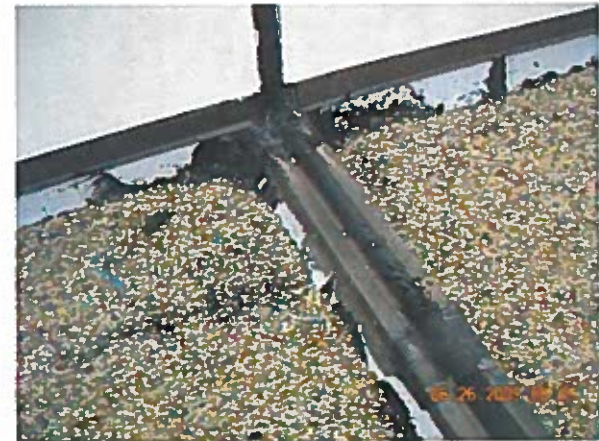
Area 1—Observation  
View of expansion joint at wall transition

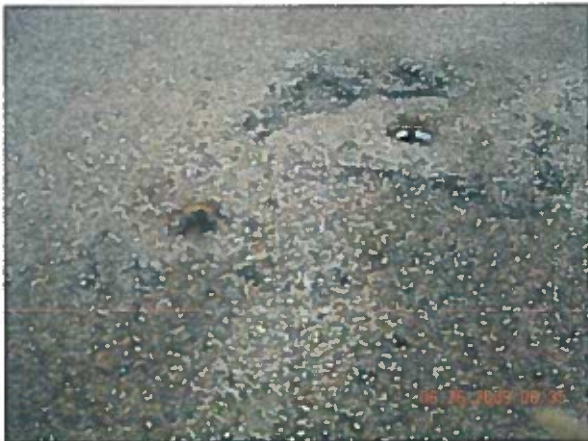
Area 9—Anomaly  
Missing drain strainers

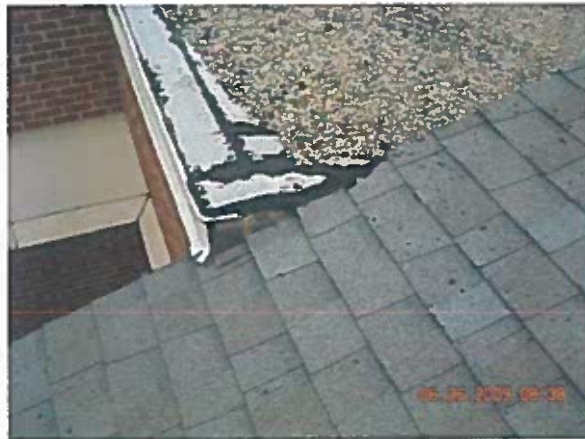
Area 9—Anomaly  
Poor tie-in detail at built-up to shingle transition

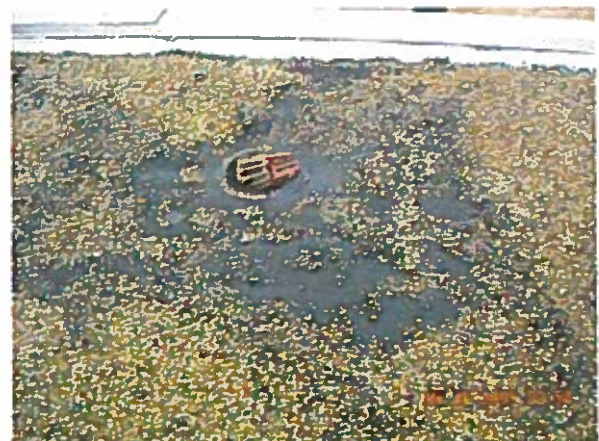
Area 1—Anomaly  
Broken drain strainer along with exposed membrane felts

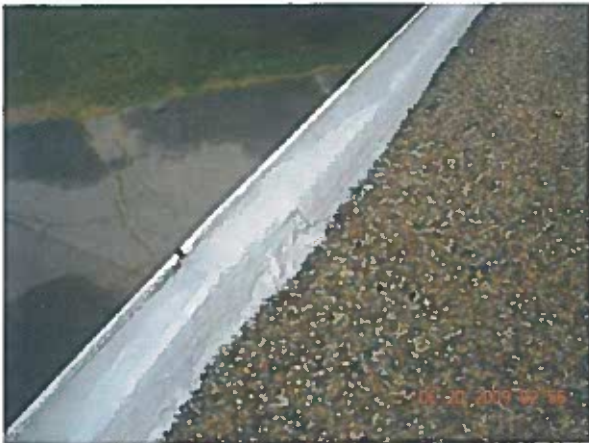
Area 1—Observation  
Outside perimeter edge repaired

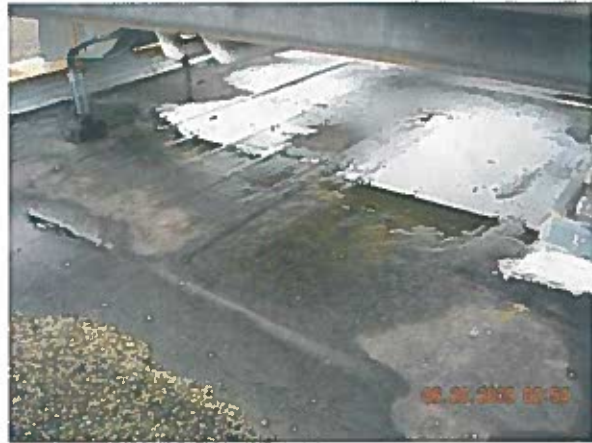
Area 1— Observation  
Repair patch installed beneath unit

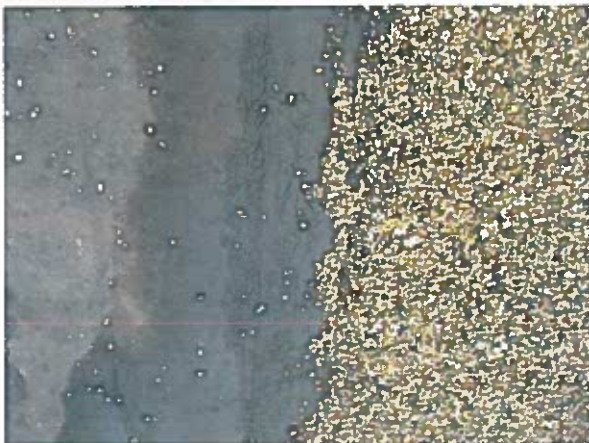
Area 1— Anomaly  
Tie-in on repair beginning to deteriorate

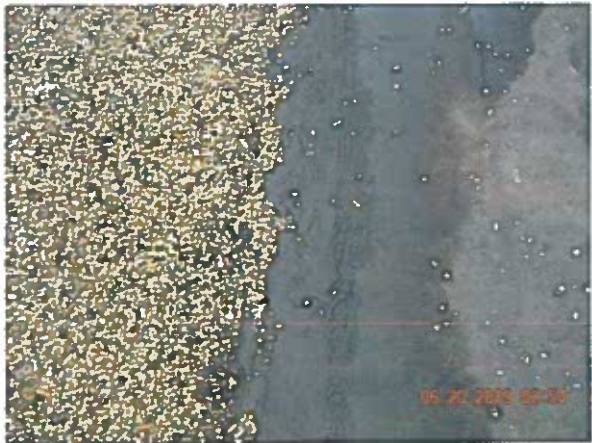
Area 1— Anomaly  
Tie-in on repair beginning to deteriorate

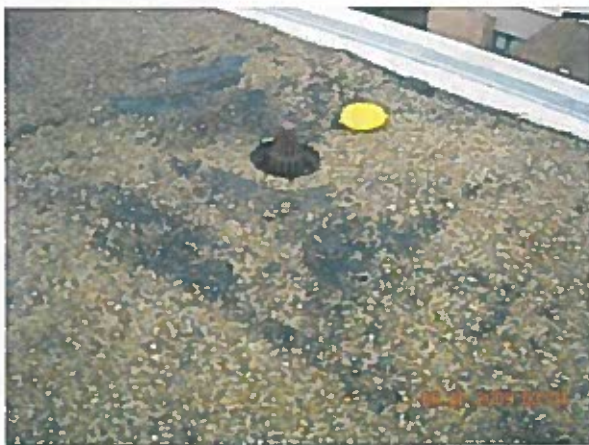
Area 1—Anomaly  
Exposed membrane felts around roof drains

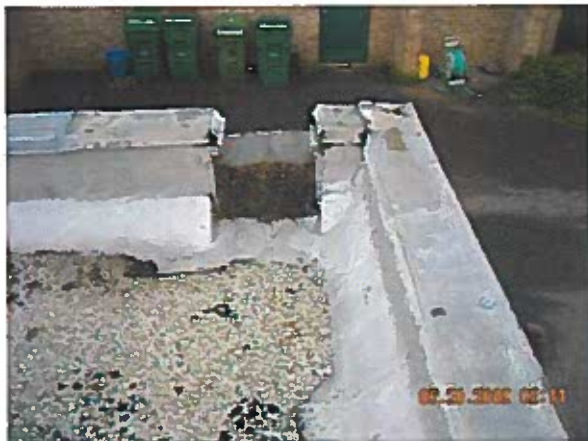
Area 2— Anomaly  
Scupper metal damaged

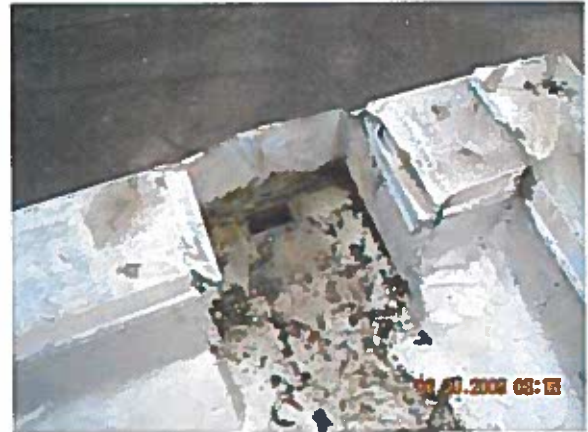
Area 2— Anomaly  
Scupper metal damaged

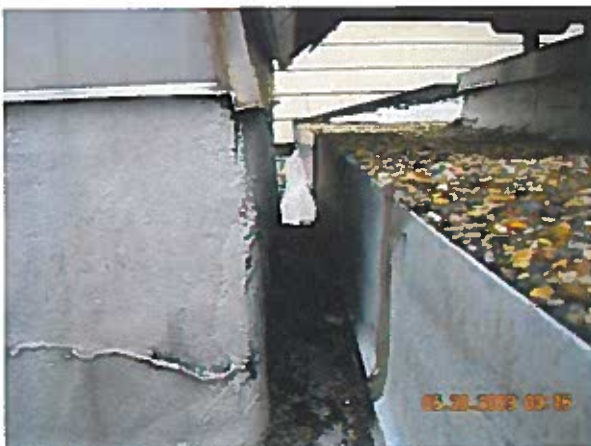
Area 2— Observation  
Limited flashing access

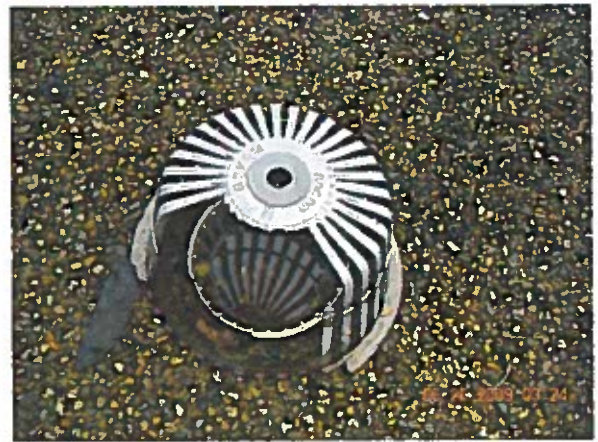
Area 3—Anomaly  
Broken drain strainer

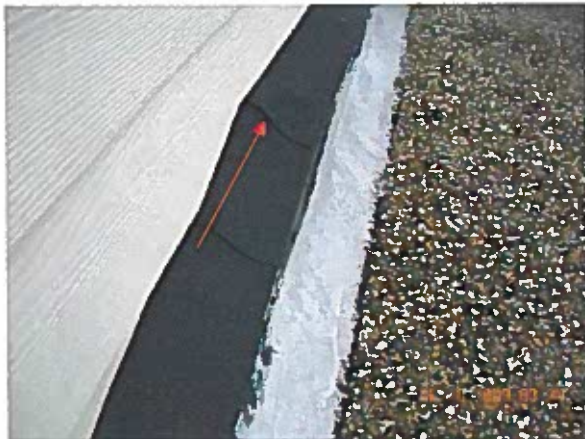
Area 3—Anomaly  
Open expansion joint laps

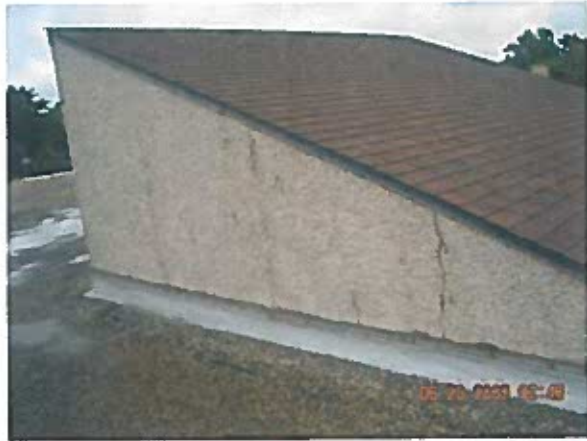
Area 4—Anomaly  
Cracked cementitious board on skylight

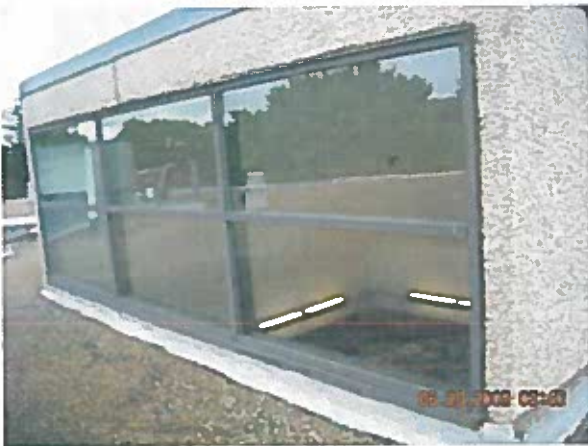
Area 4—Anomaly  
Cracked cementitious board on skylight

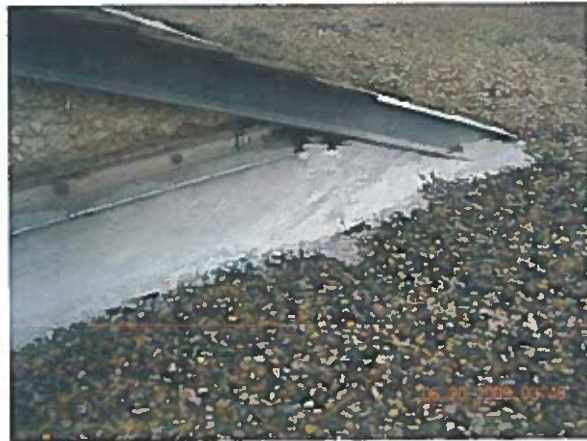
Area 4— Observation  
View of transition flashing

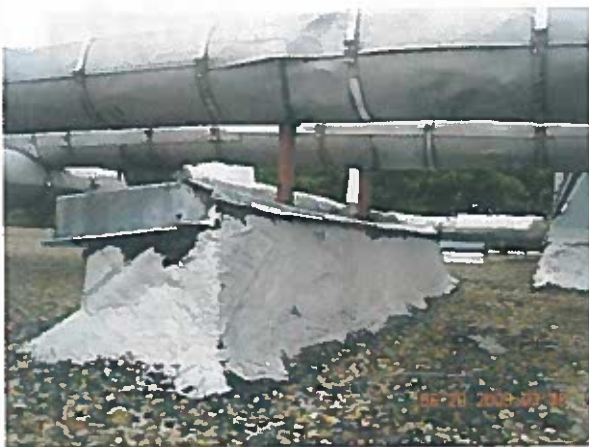
Area 4—Anomaly  
Damaged curb flashing a support stand

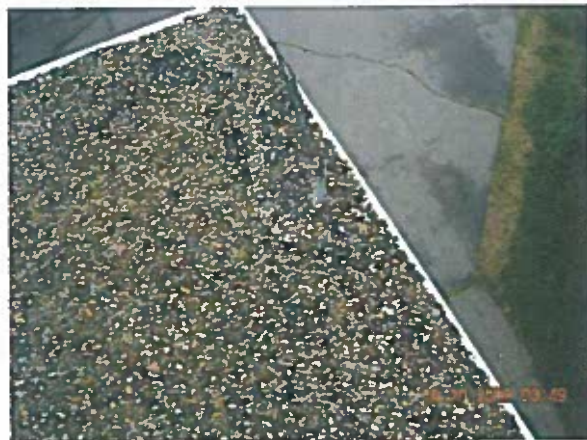
Area 4—Anomaly  
Support screwed into roof system

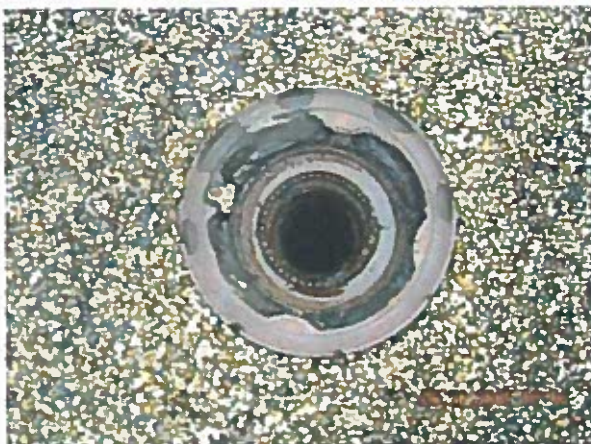
Area 11—Anomaly  
Missing drain strainer

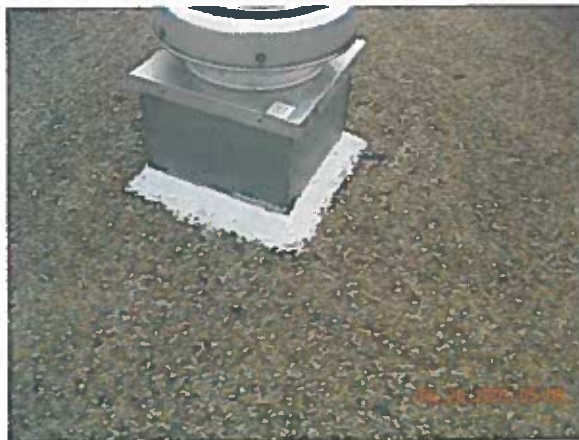
Area 11—Anomaly  
Missing curb flashing
