**TOWN OF GLASTONBURY  
REQUEST FOR QUALIFICATIONS  
RPGL-2019-25  
ROOFING STUDY OF GLASTONBURY SCHOOLS  
ADDENDUM NO. 1  
January 25, 2019**

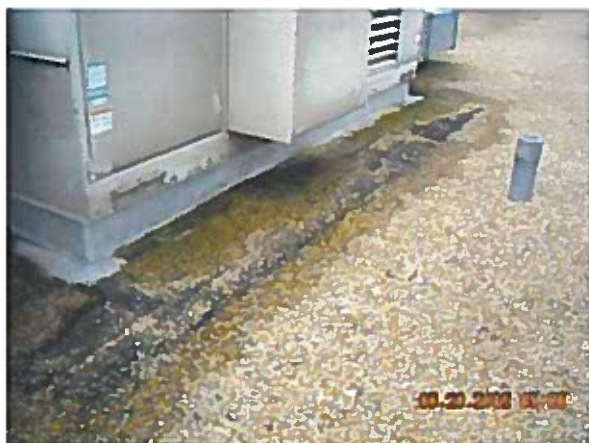
Area 11—Anomaly  
Roof repair is showing indications of deterioration

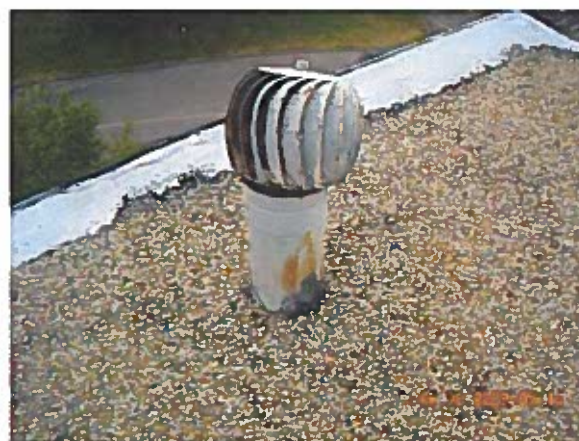
Area 12—Anomaly  
Turbine vent is broken

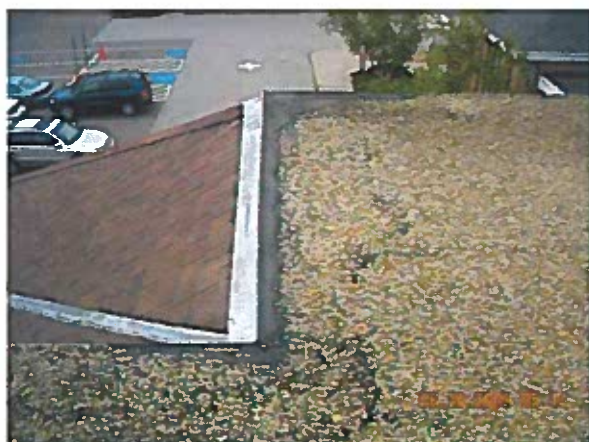
Area 12—Anomaly  
Strip-in repair indicating signs of deterioration

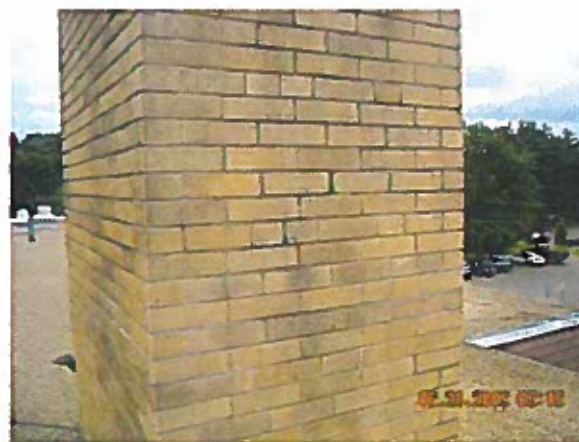
Area 12—Anomaly  
Chimney mortar joints in need to repair

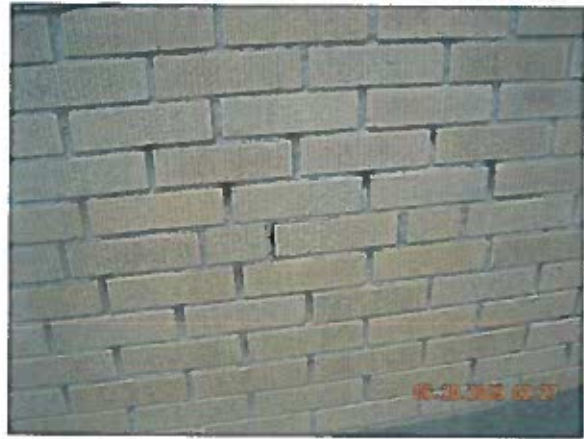
Mortar joints appear to be deteriorating

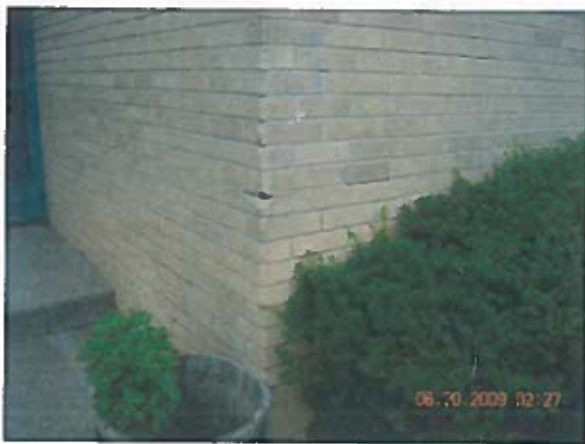
Some damaged brick was observed

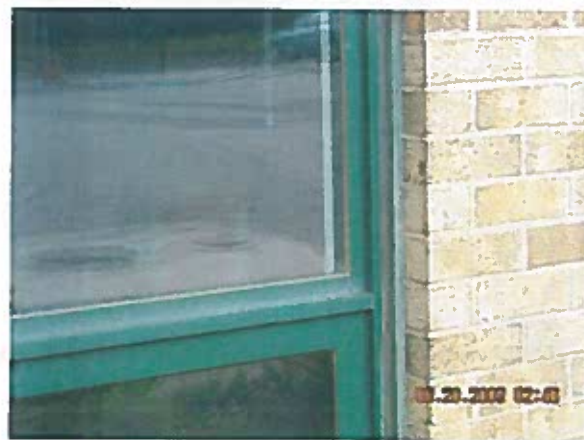
Window perimeter sealants in poor condition

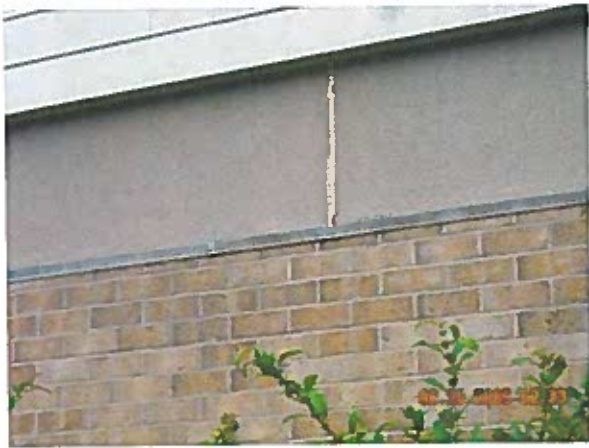
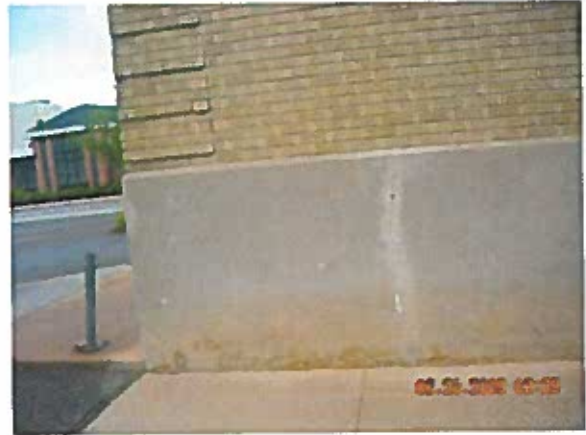
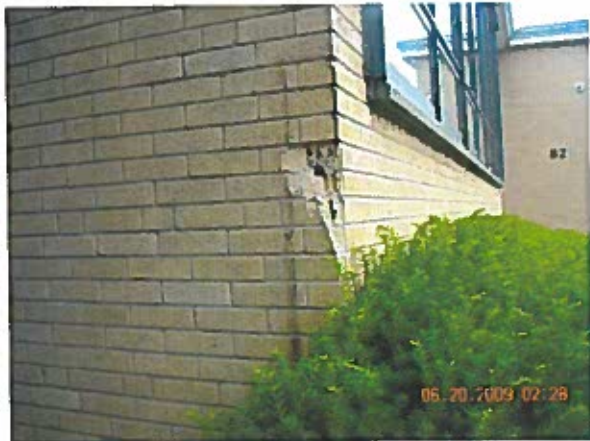
Damaged brick observed

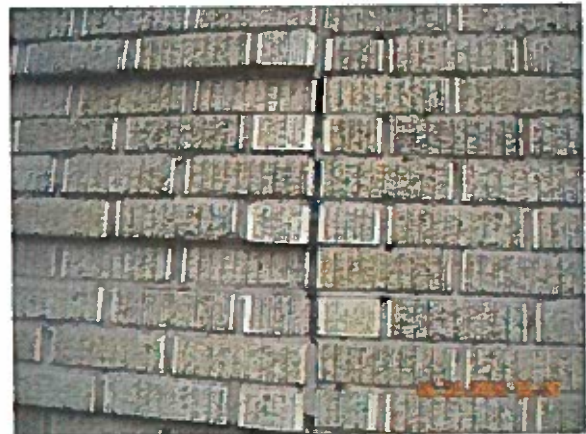
Wall joints in need of repair

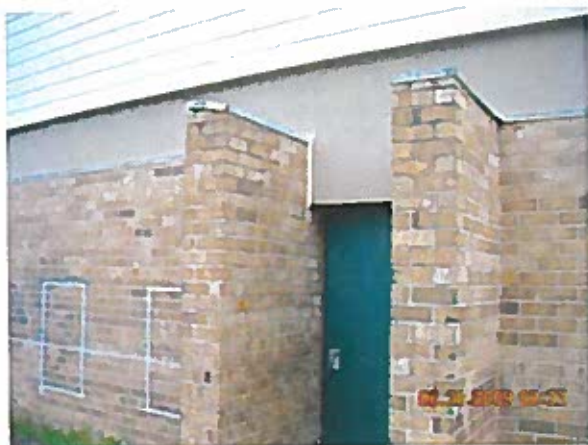
Option No. 3—Metal cap repairs (typ.)

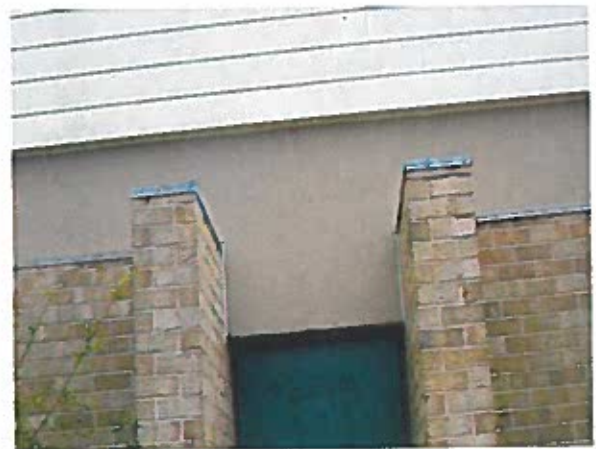
Option No. 3—Metal cap repairs (typ.) NOTE: Metal caps secured around perimeter of building.
