**PRE-RENOVATION
INVESTIGATIVE SURVEY FOR
HAZARDOUS BUILDING MATERIALS**

**MARLBOROUGH MAINTENANCE
FACILITY
MARLBOROUGH, CONNECTICUT**
Project No. 41-119

Issued
November 2018

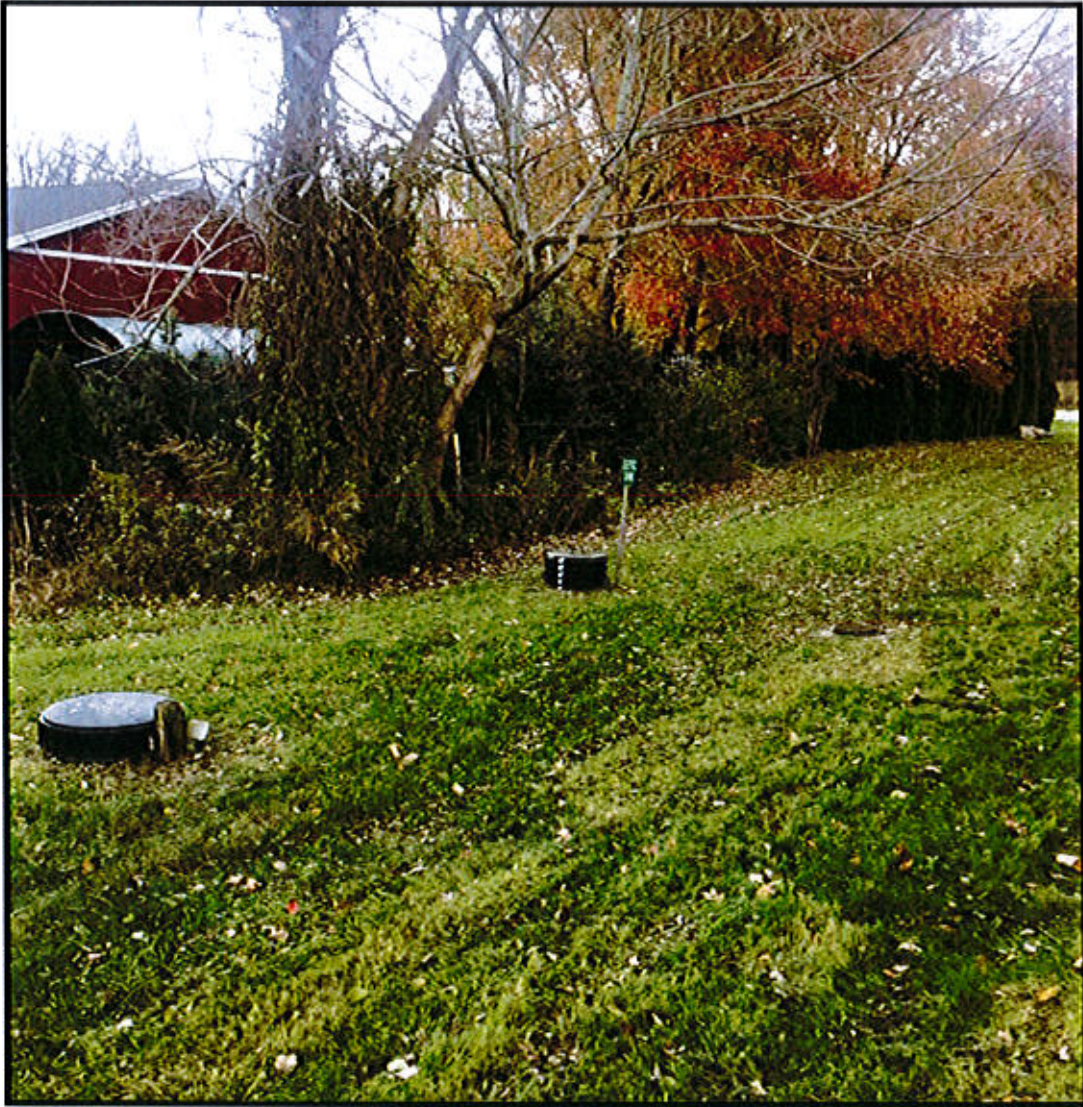
PHOTO 5. D-side Septic Tank & Monitoring Wells.

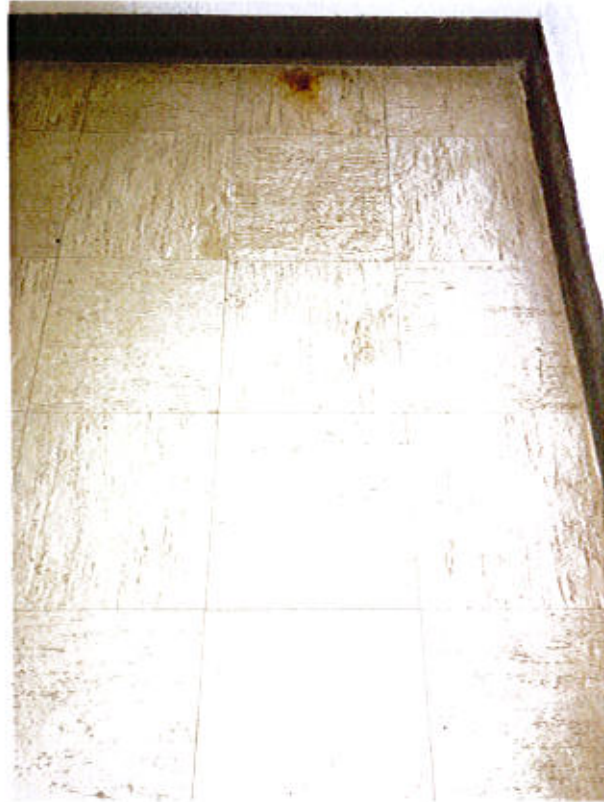
Women's Bathroom

(2), FT, 1, 12"x12", Tan w/Lt & Dk Brown Streaks FT & Black Mastic

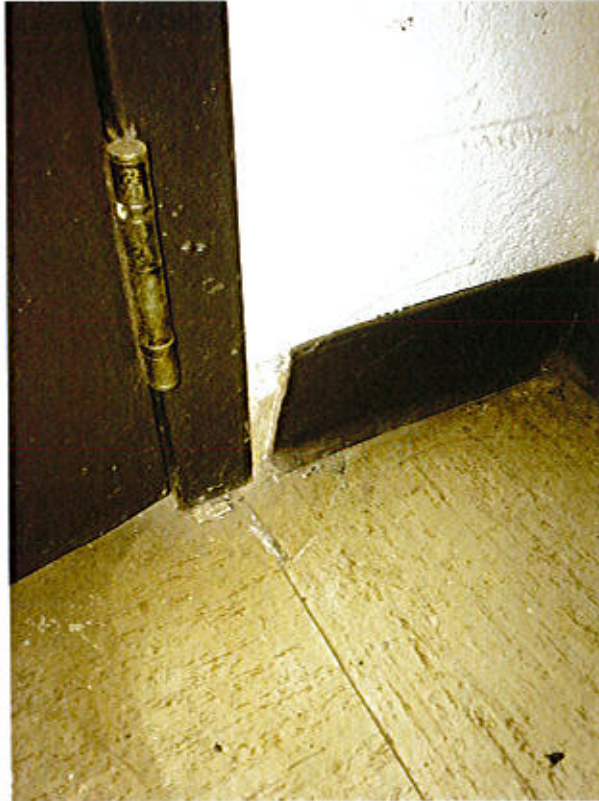
Women's Bathroom

(1), CB, 1, 4" Brown Covebase & Cream Glue

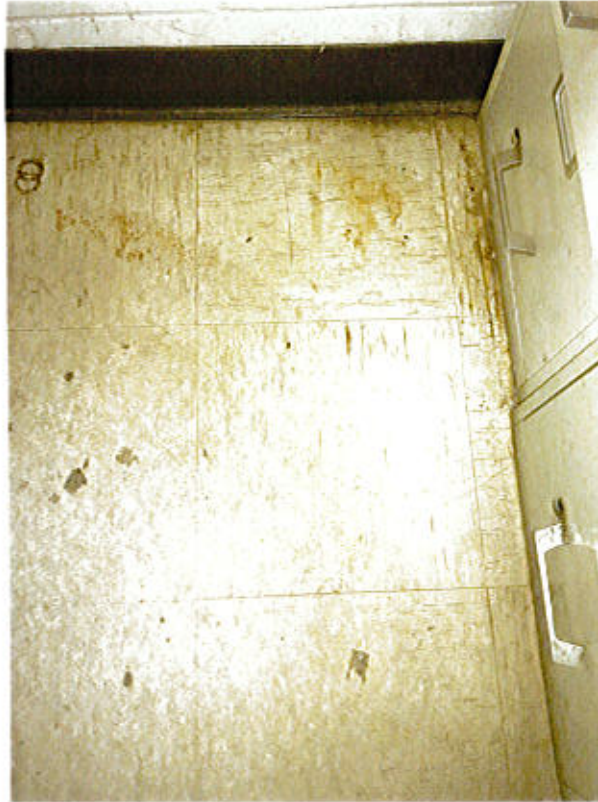
Office

(1), FT, 2, 12"x12", Cream w/Thin Brown Streaks FT & Yellow Mastic

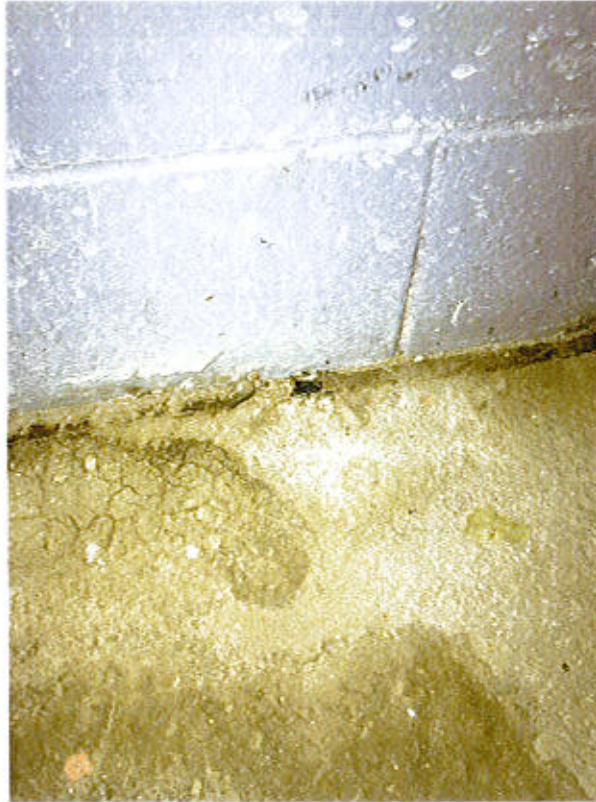
Base of Ext Wall C-Side by Rest Area

(1), EJ1, Black Tar-Like Floor Expansion Jt Pad

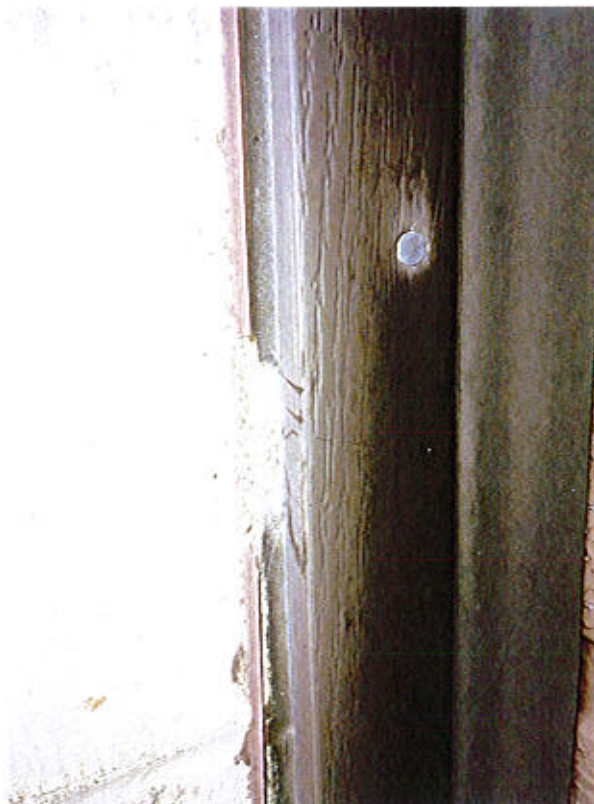
Bay 2 Ext Roll-Up Door Frame

(1), C, 1, Grey Rubbery Ext Window/Roll-Up Door Caulk

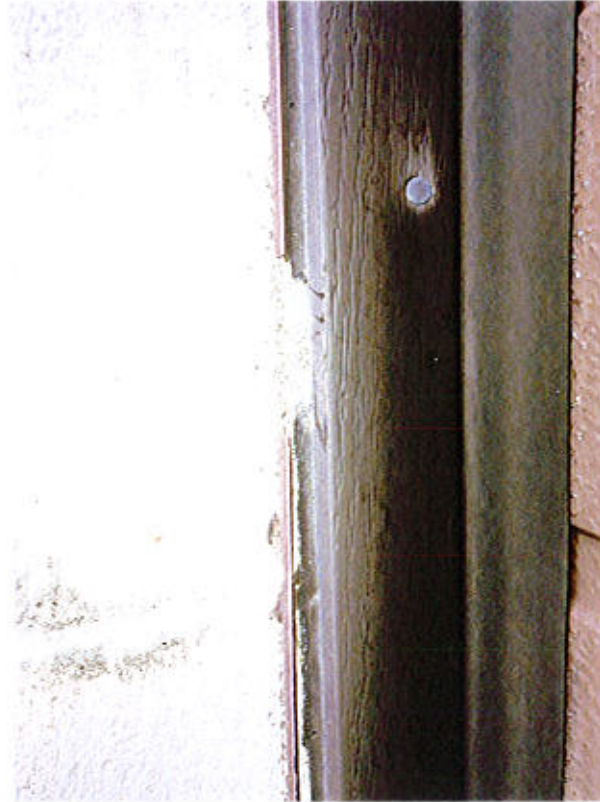
Bay 2 Ext Roll-Up Door

(1), C, 2, Brown Rubbery Ext Roll-Up Door Caulk

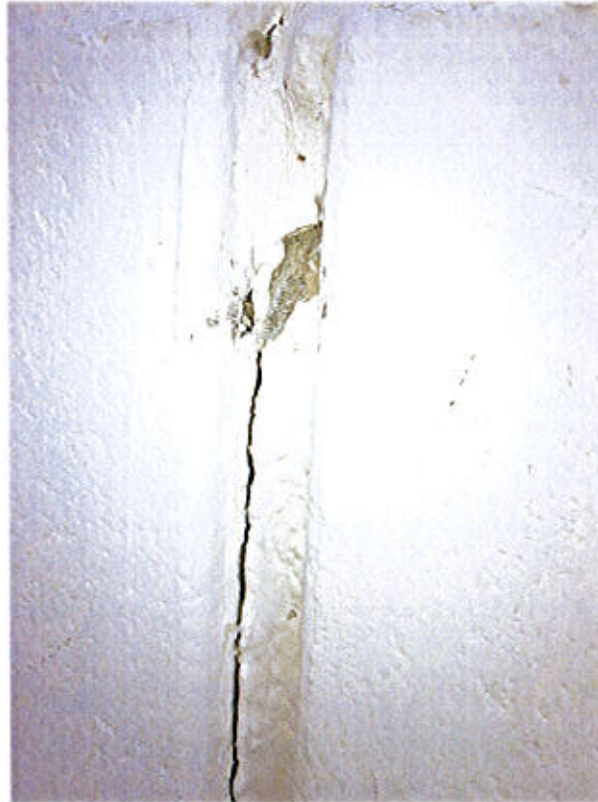
Ext D-Side by Men's Bathroom

(1), C, 3, White Pliable Ext Bldg Caulk

Sampled or Assumed?	Sampled
Material Acronym	C, 3
Material Description	White Pliable Ext Bldg Caulk
Is Material a Non-Friable Organically Bound (NOB)	Yes
Homogeneous Area	Ext D-Side Wall Expansion Jts
Total Approximate Quantity	30 LF
Notes	Material was added to fill cracks in mortar joints so is not in all joints.
Total Count	(1)

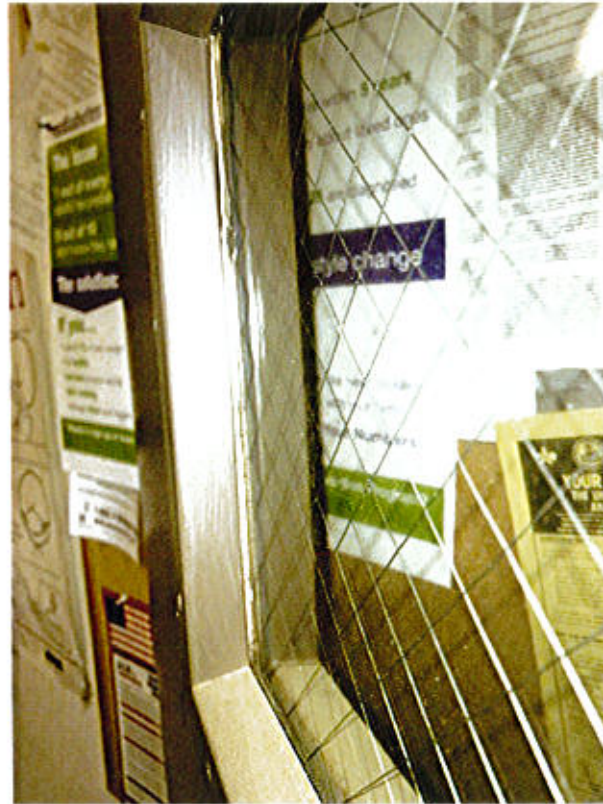
Hall Door to Break Area

(2), DWG, 1, Grey Sticky/Gummy Metal Door Window Glaze

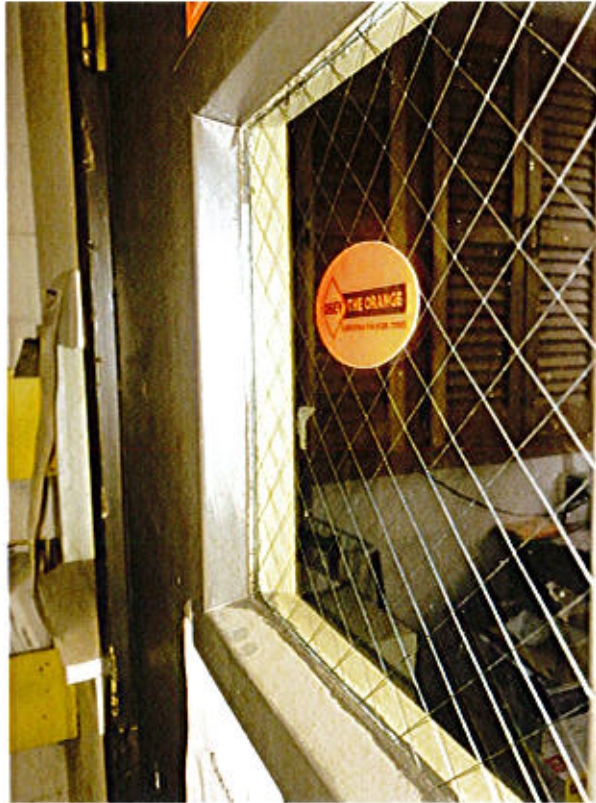
Office Door

(2), DWG, 2, Lt Grey Gummy Wood Door Window Glaze
