BRIDGE NO. 00032

73070 - STAMFORD
I-95 & I-95 RAMPS
over
MNRR & LOCAL ROADS

Fracture Critical and Routine Inspection

10/15/2018

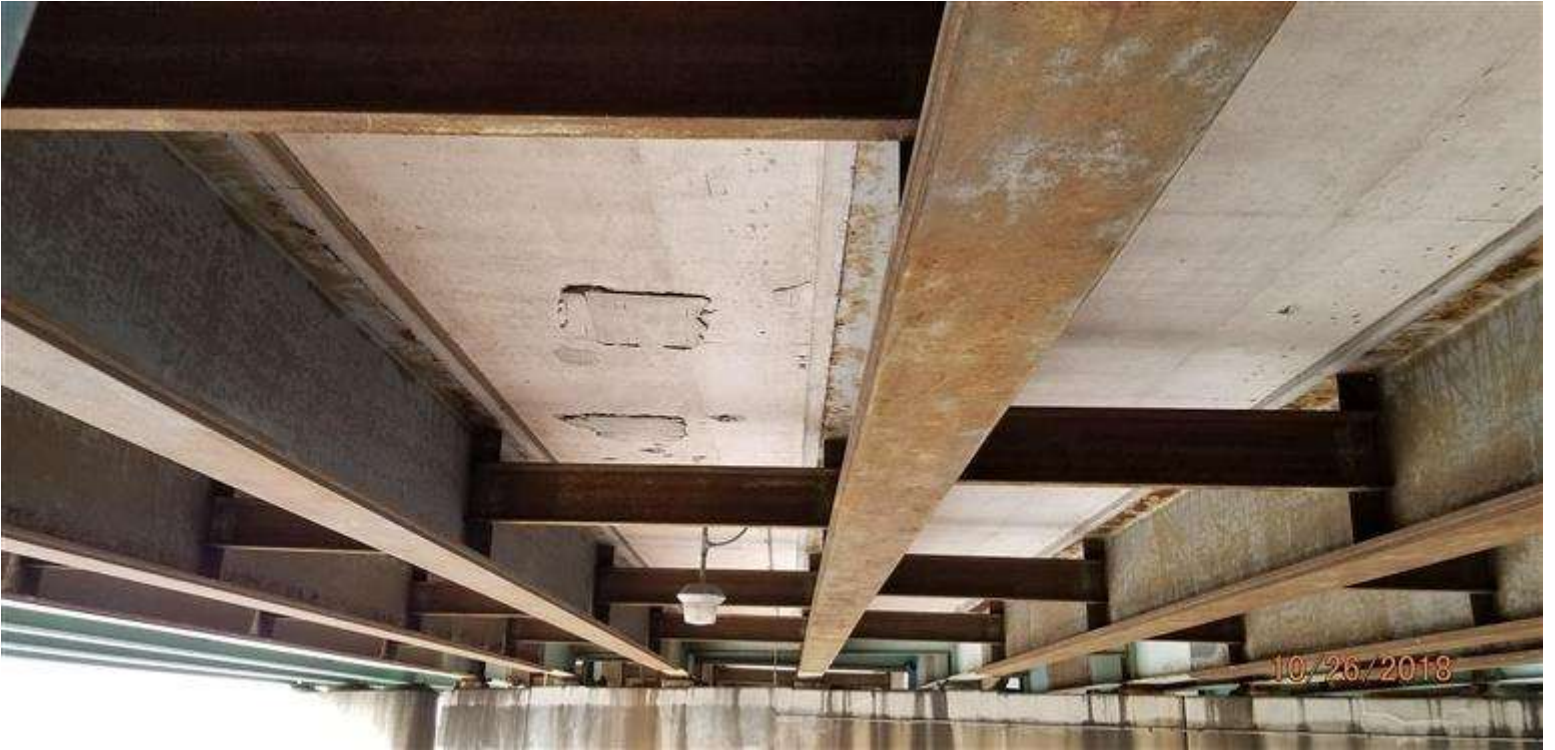
Photo Number: 13

Underside of deck at mid-span of span 16 with spalls and concrete patches.

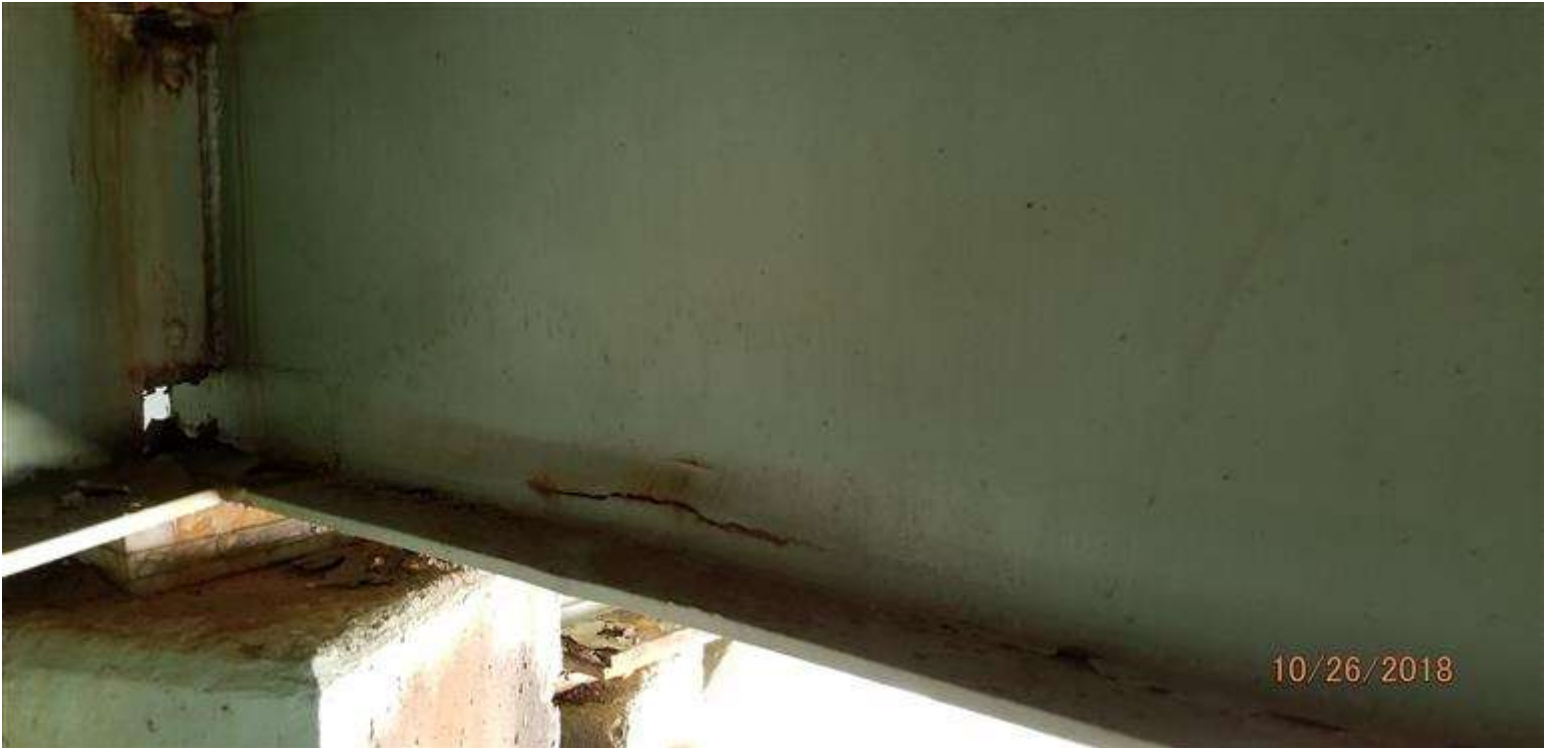
Girder 1, west elevation, at pier 6 in span 6 exhibits section loss to the web.

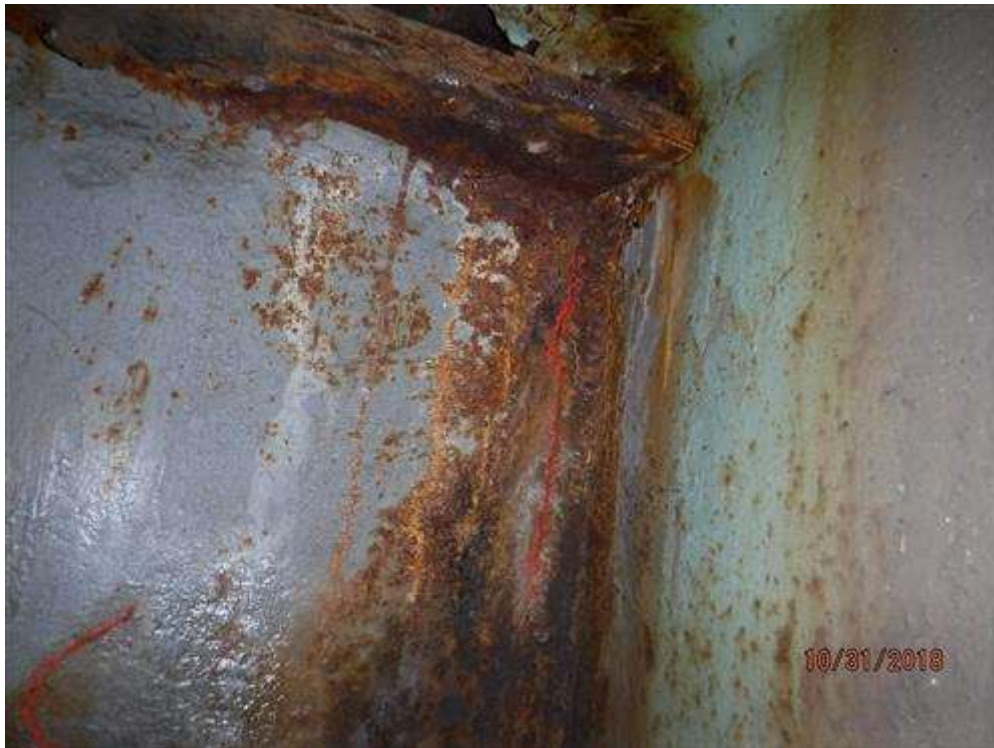
Span 15, end diaphragm in bay 11 with a crack in the web.

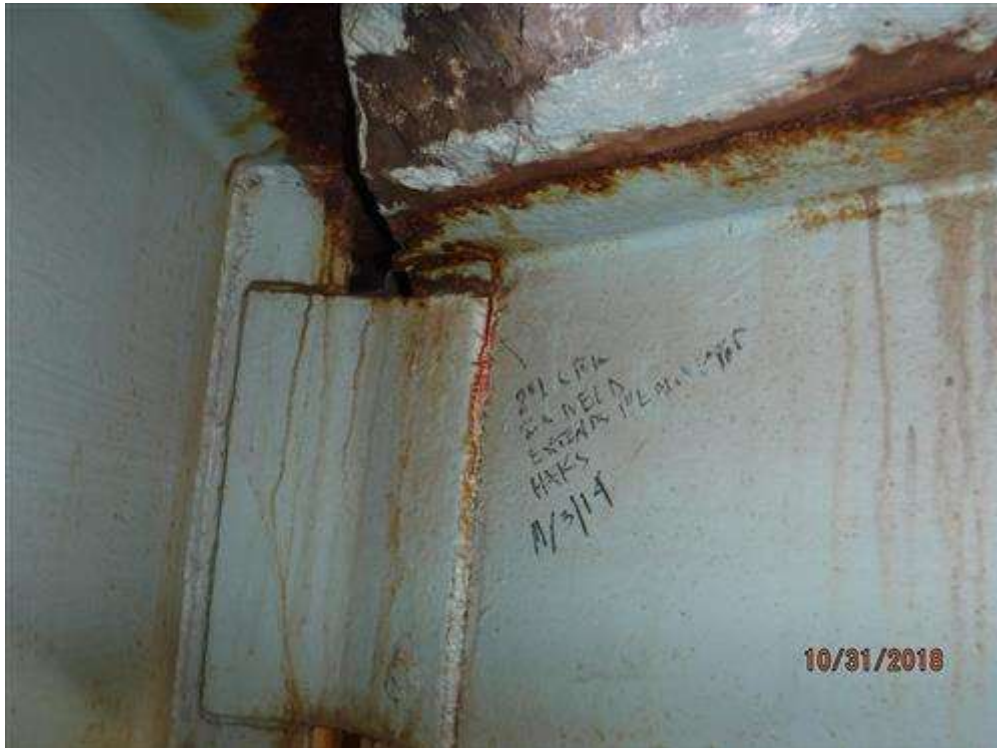
Span 15, end diaphragm in bay 10 over pier 14, adjacent to girder 11. The bearing stiffener is cracked through the web and bottom flange.

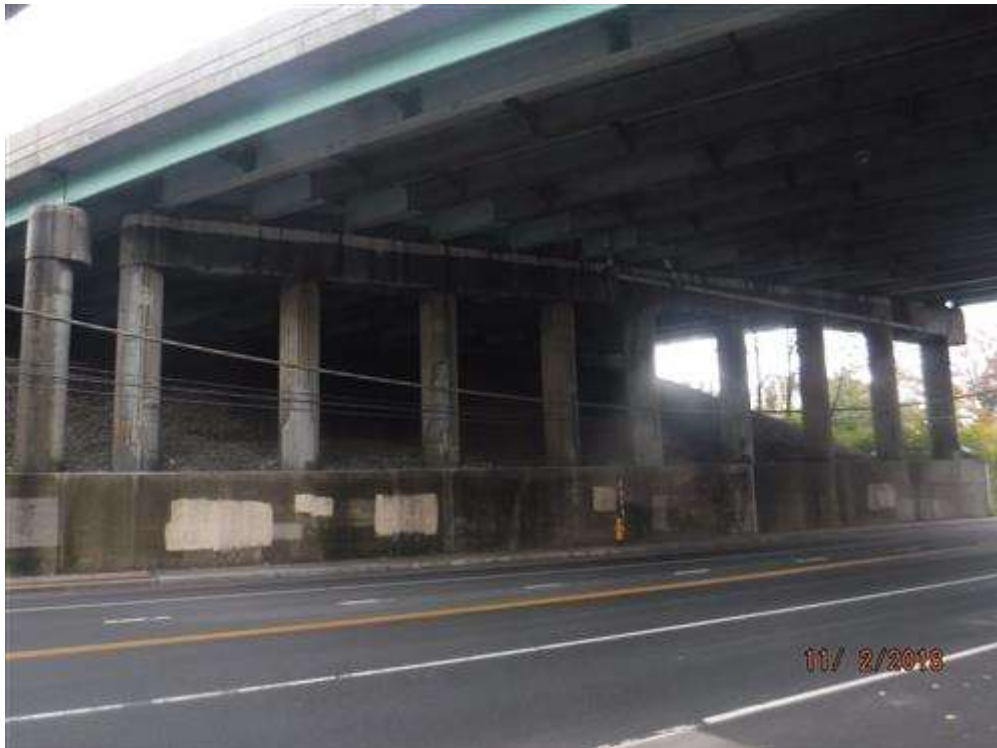
| Abutments - Footings: | 6 | <p>The abutment 1 footing at the west end is exposed 4' long x 3' wide x 1' high and has a spall 1' long x 1' wide x 3" deep.</p> <p>See the Abutment sketches and photo 41.</p> |

Exposed footing at west end of abutment 1 with a corner spall.

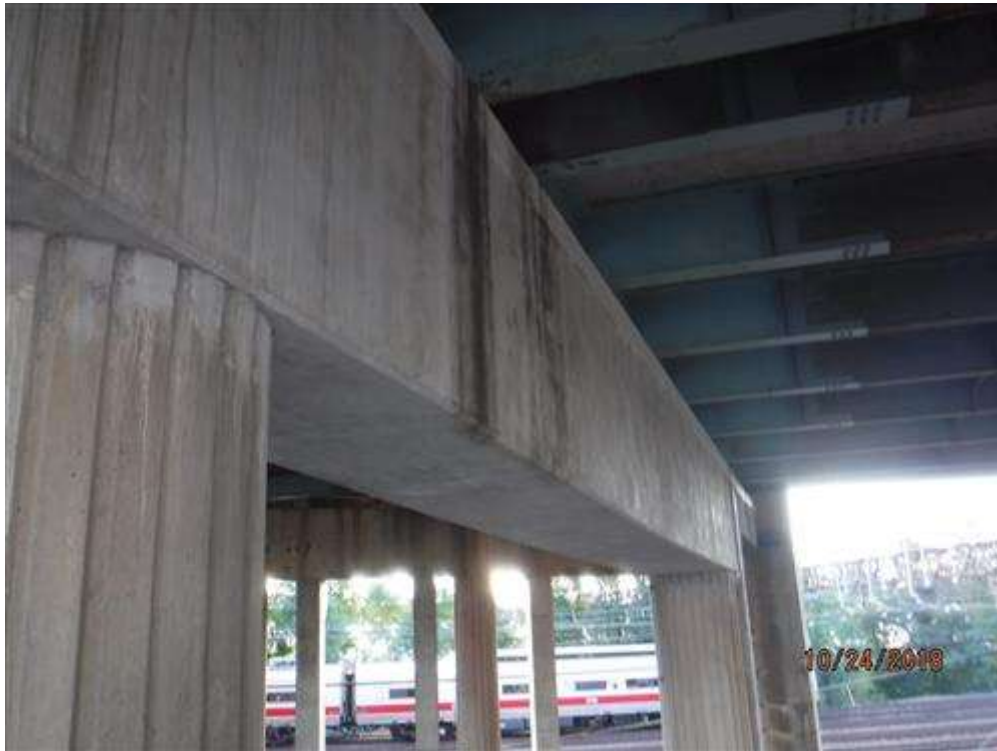
South elevation of pier 3 over South State Street. The previously noted spalls and hollow areas have been repaired since the previous inspection.

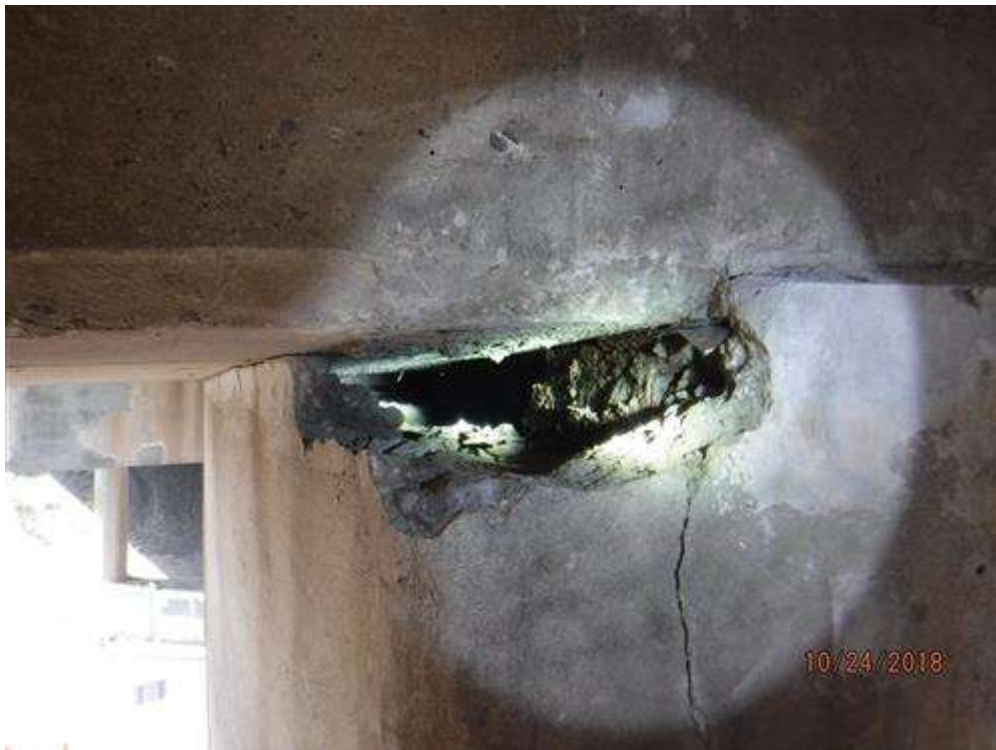
South face of pier 3 cap between bays 10 and 11. The previously noted spalls with exposed rebar have been repaired since the previous inspection.

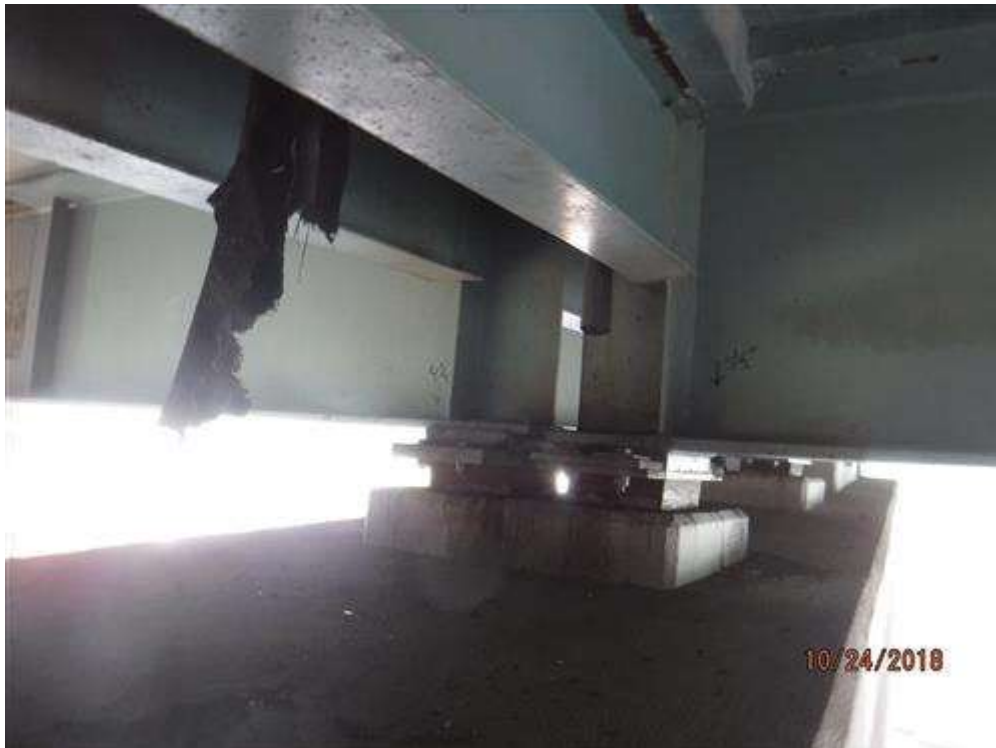
Photo Number: 47

North elevation of pier 7 to pier 8 connection exhibits hollow areas and spalls around the column and cap.
