BRIDGE NO.00032

73070 - STAMFORD
I-95 & I-95 RAMPS
over
MNRR & LOCAL ROADS

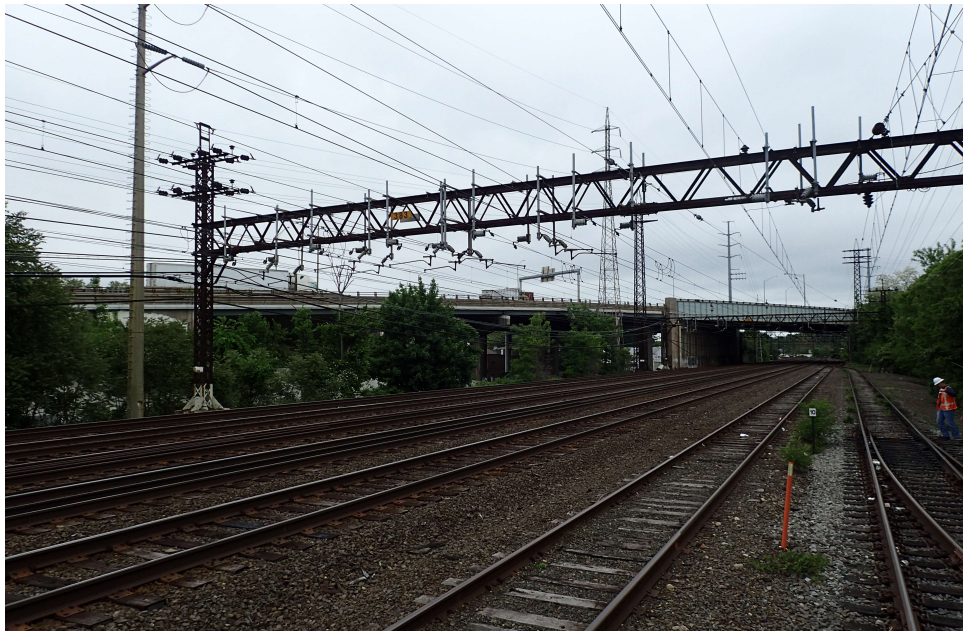
Inspected by: AI Engineers

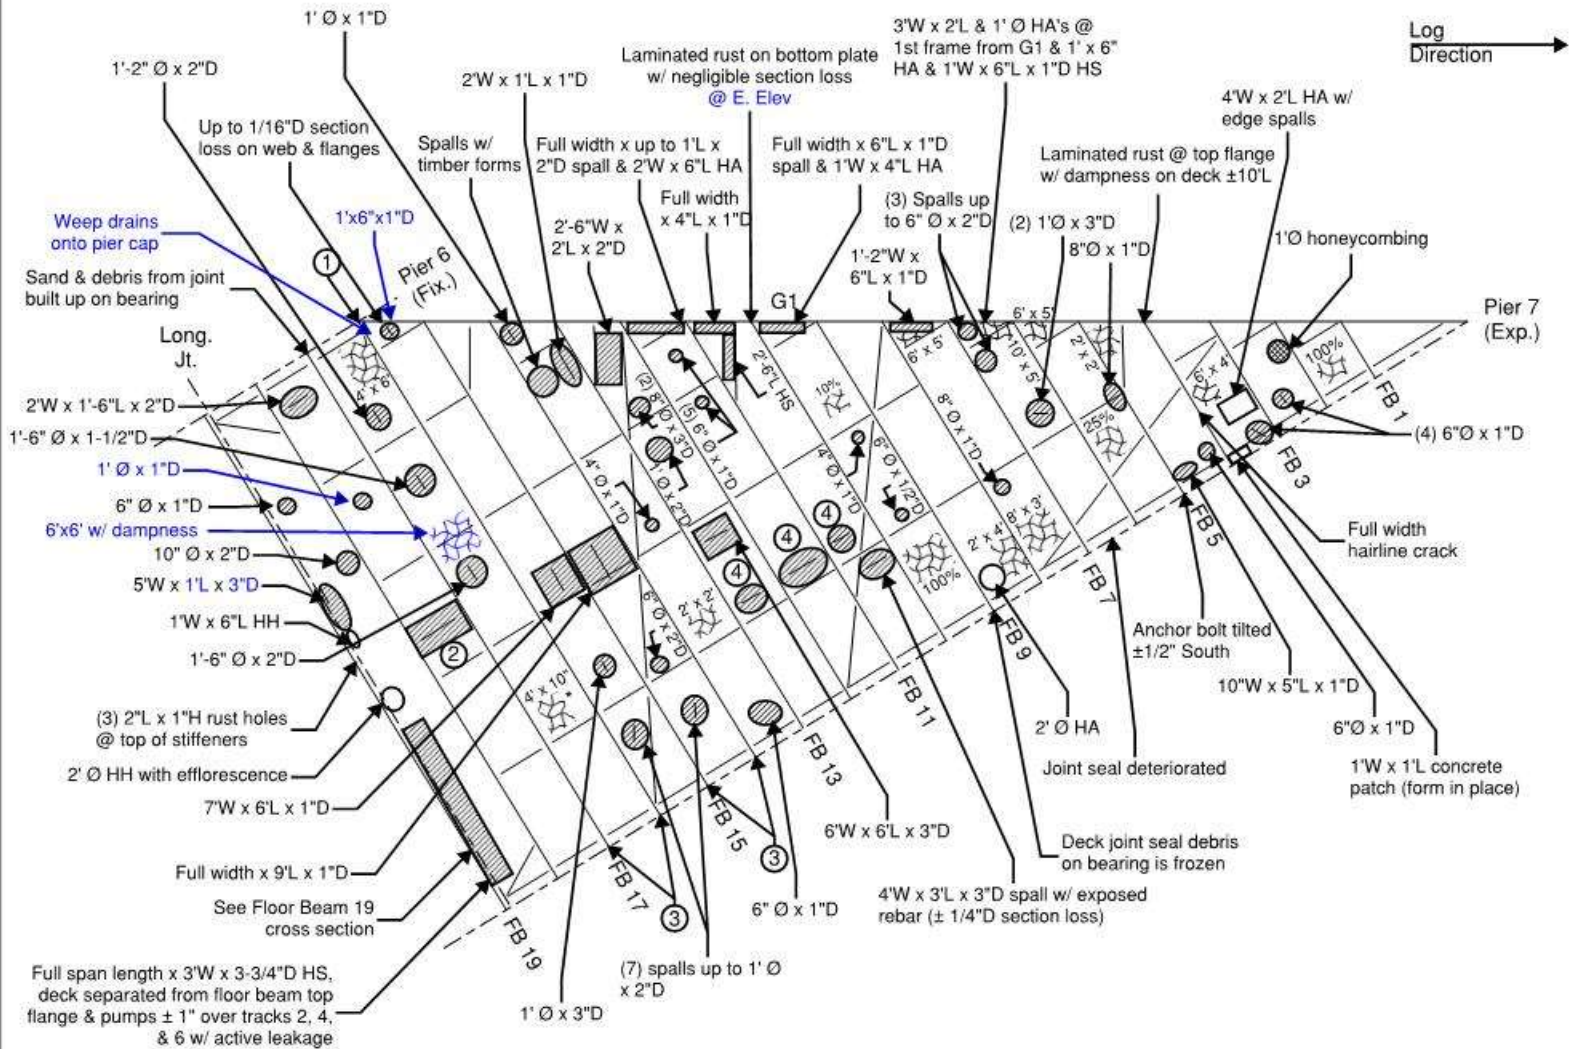
Deterioration Notes:

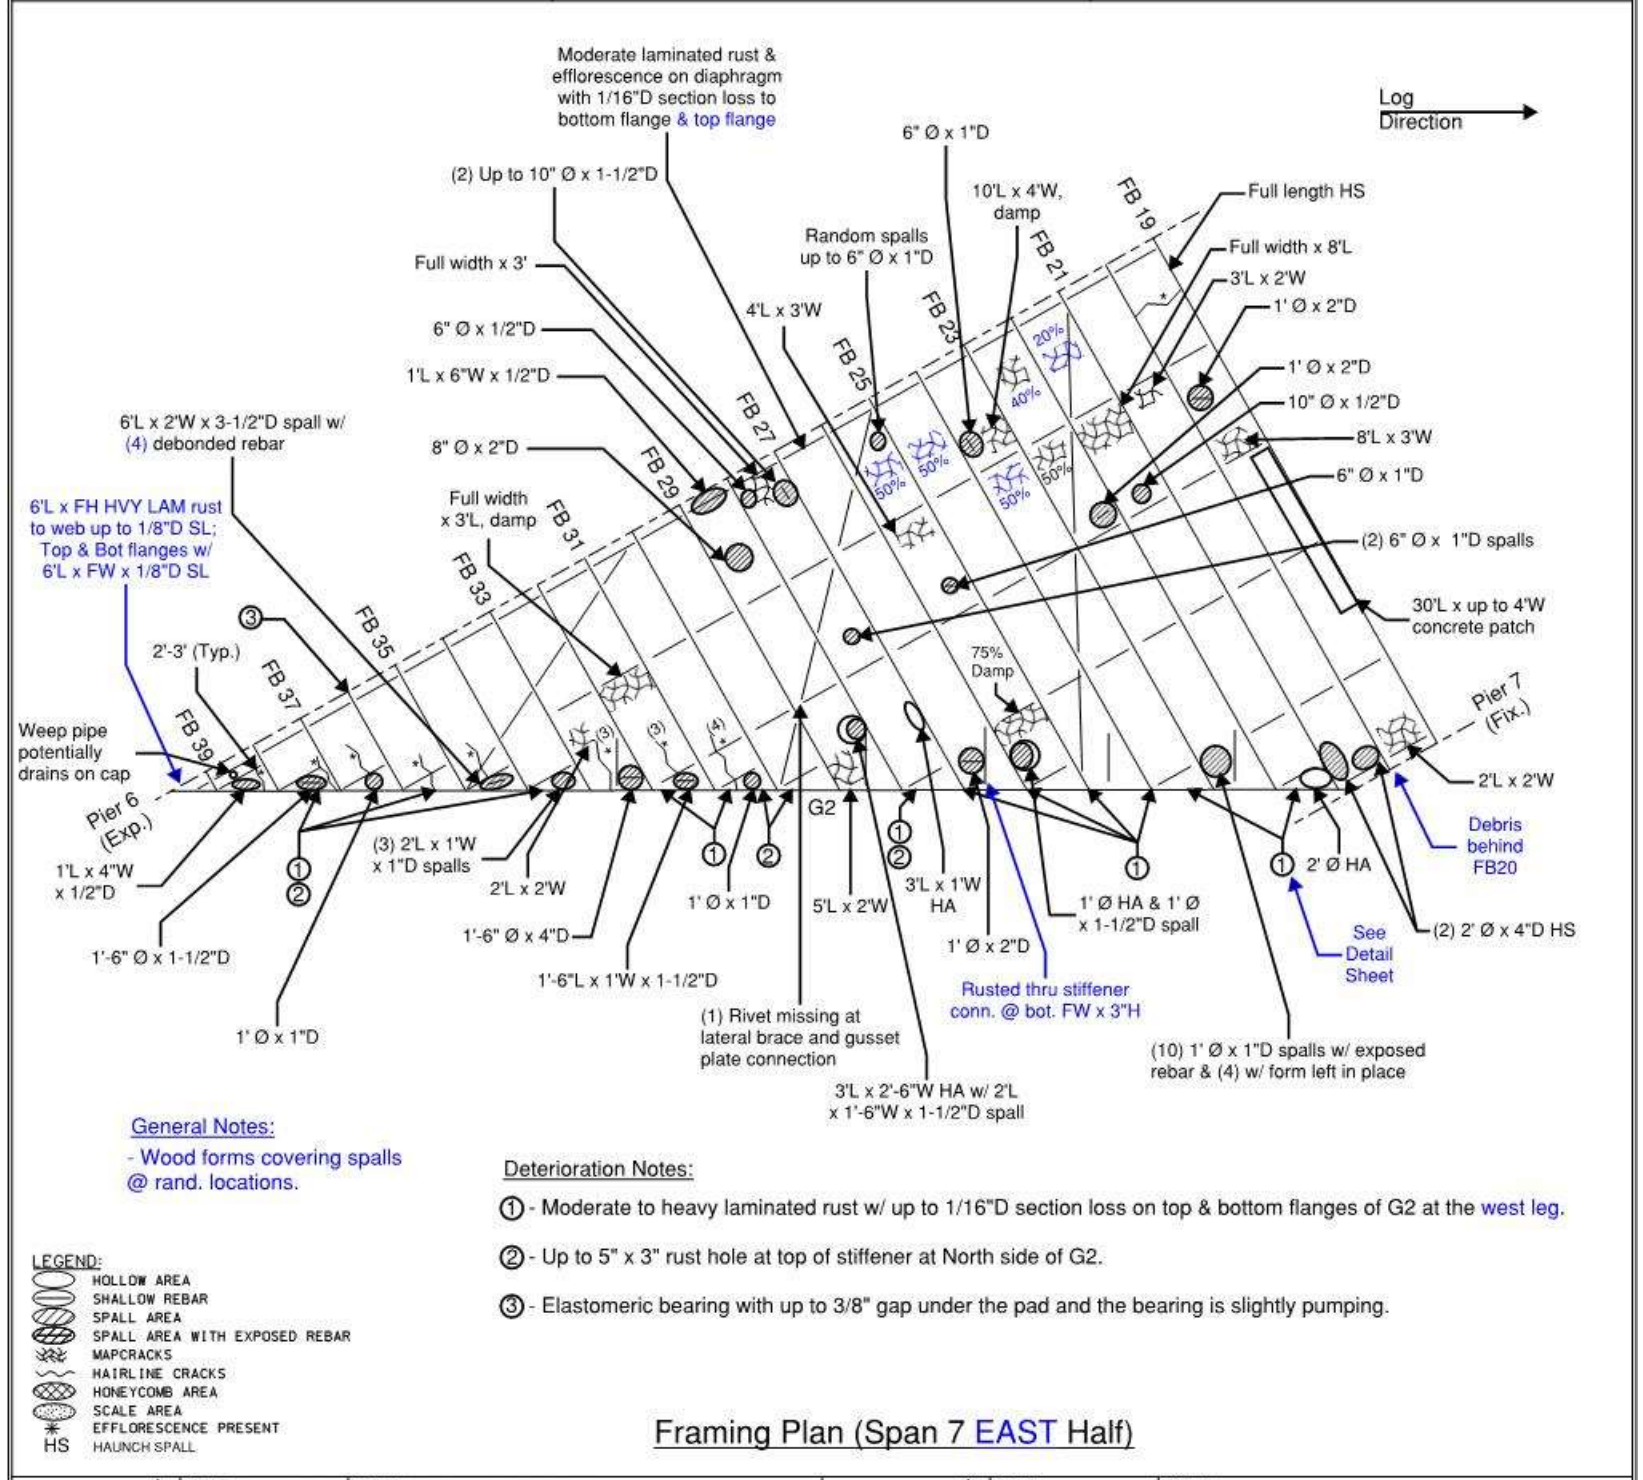
General Notes:
 - Wood forms covering spalls @ rand. locations.

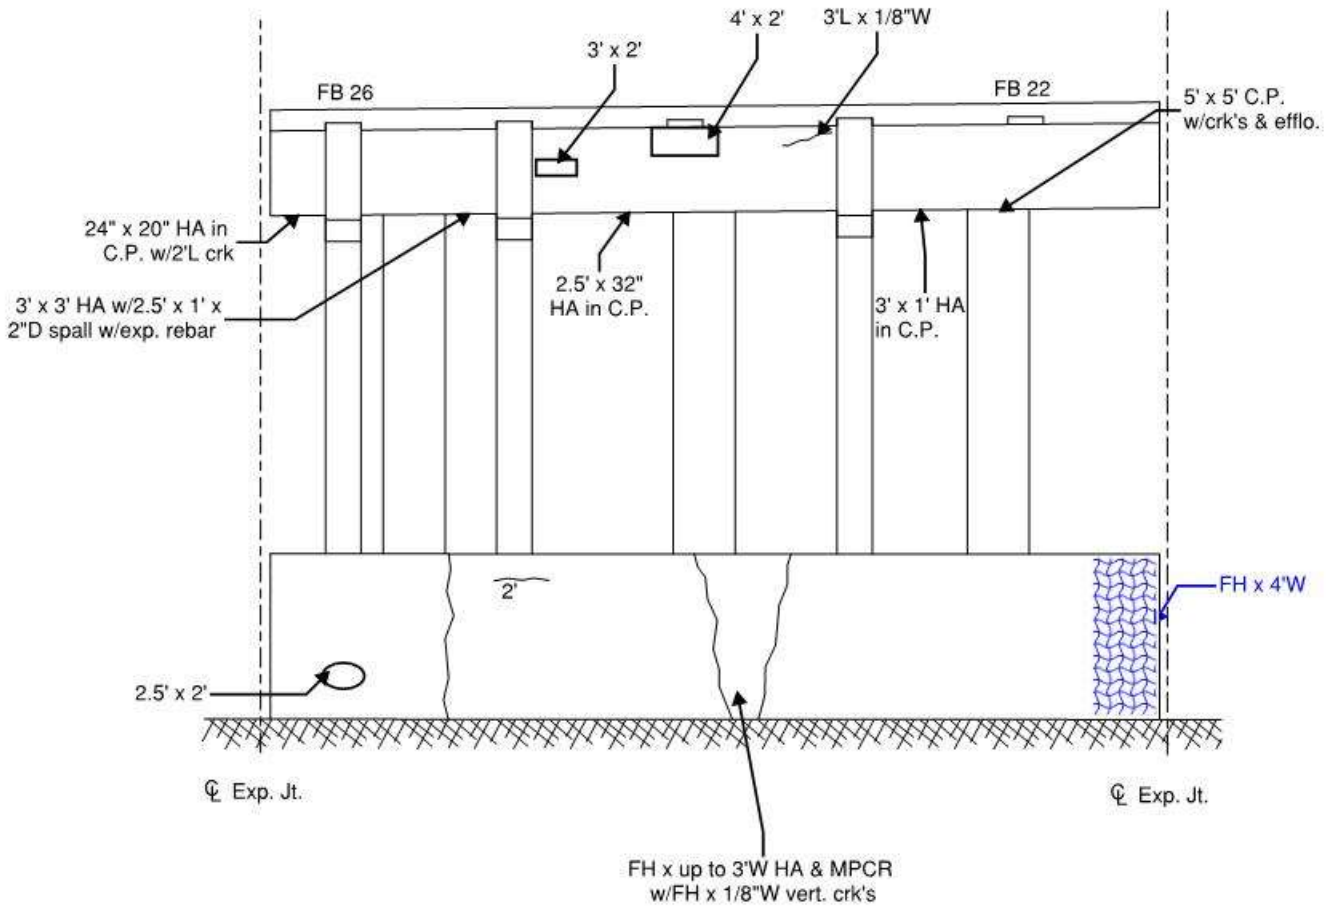
General Notes:
 - See Pier 6 - North Elevation (W. Quarter) General Notes

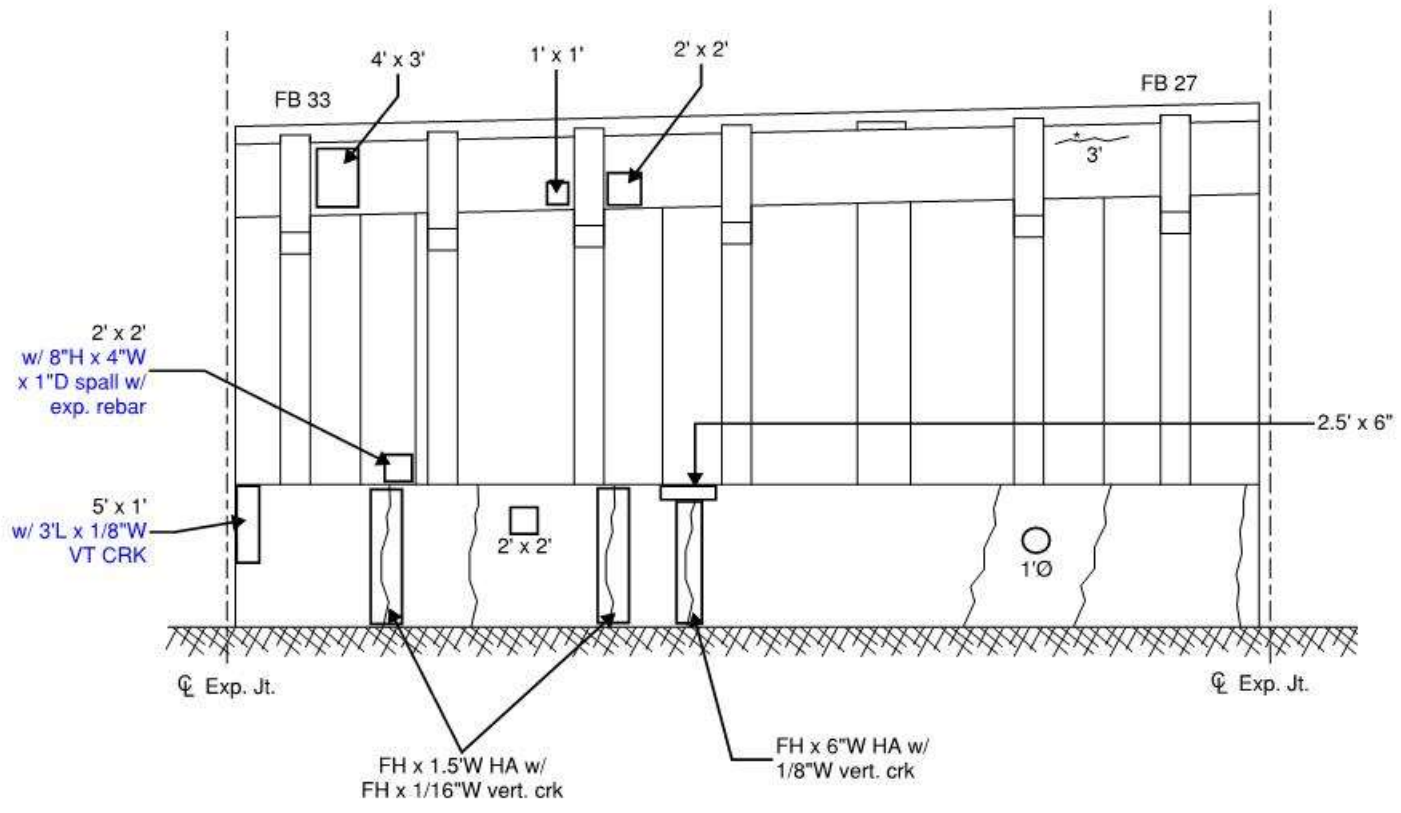
General Notes:
 - See Pier 6 - North Elevation (W. Quarter) General Notes

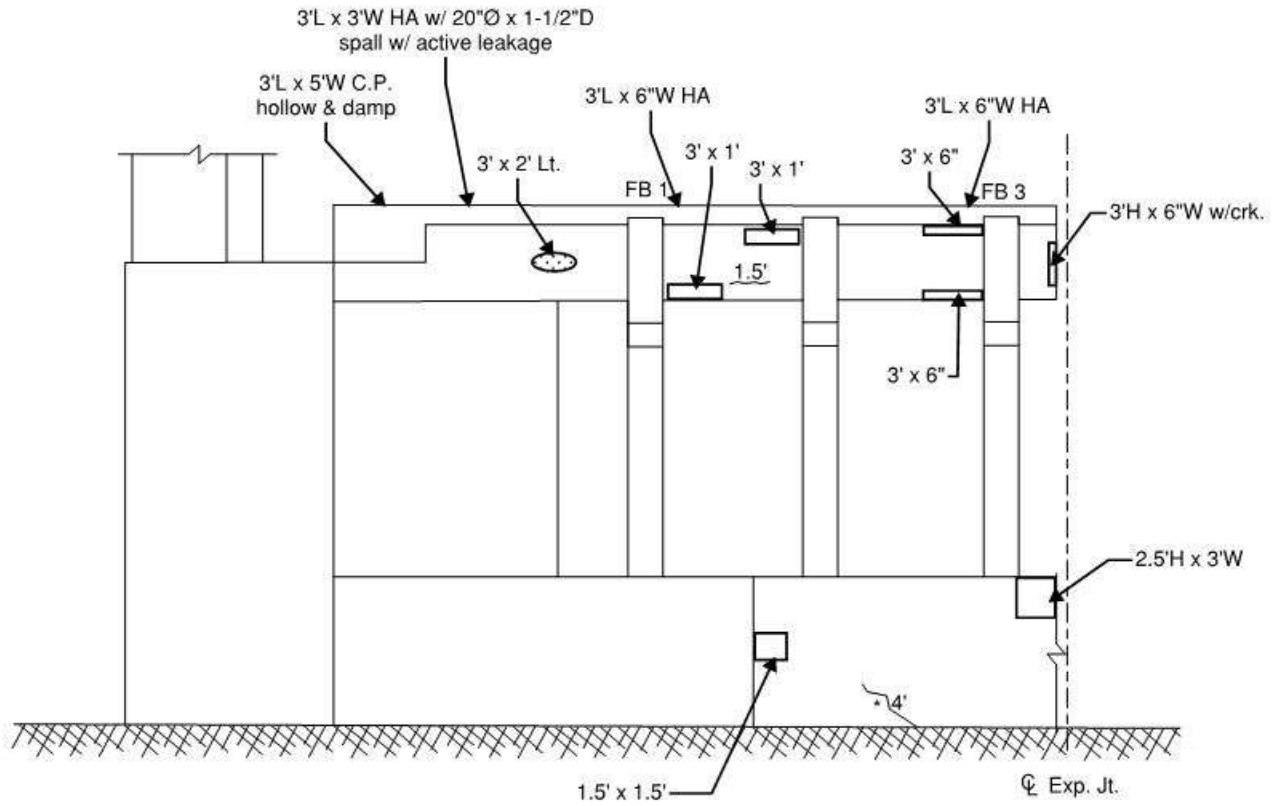
CREW : AMP, JSM (TSC)	DATE : 7/18/17	BRIDGE NO. : 00032
-----------------------	----------------	--------------------

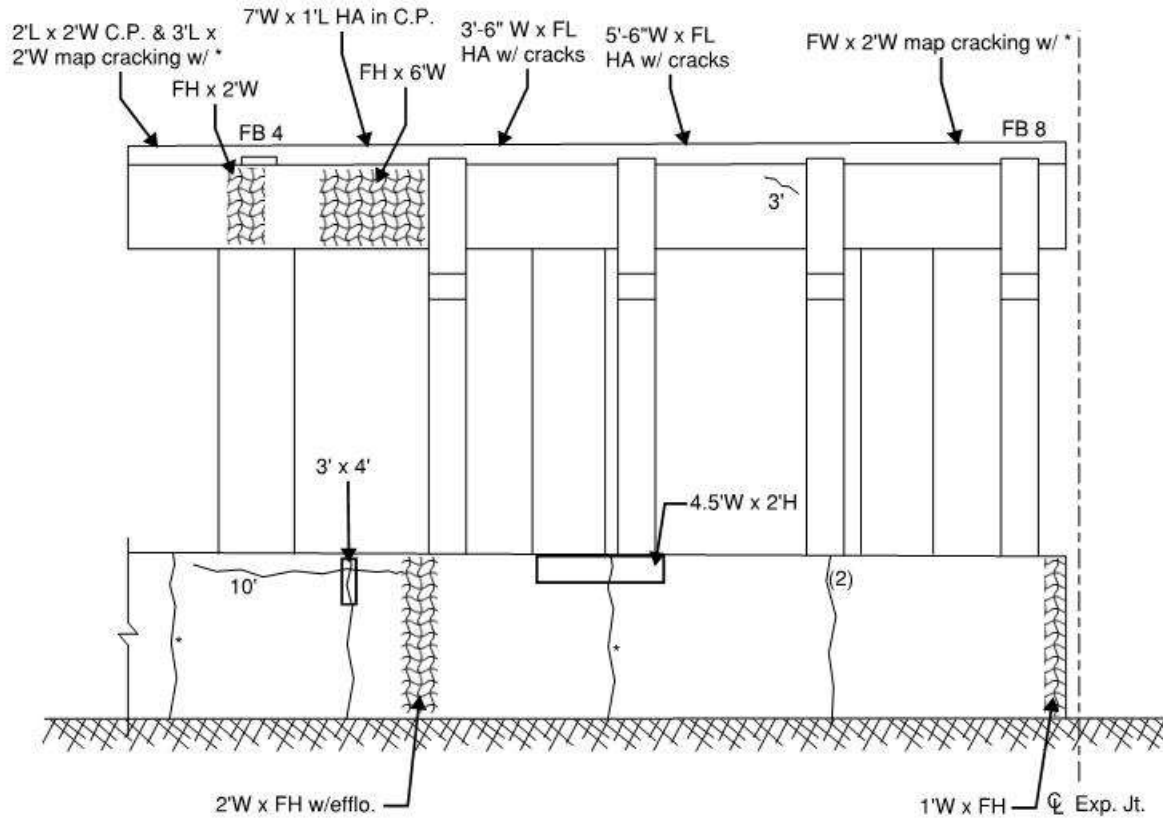
CREW: AMP, JSM (TSC)	DATE: 7/18/17	BRIDGE NO.: 00032
----------------------	---------------	-------------------

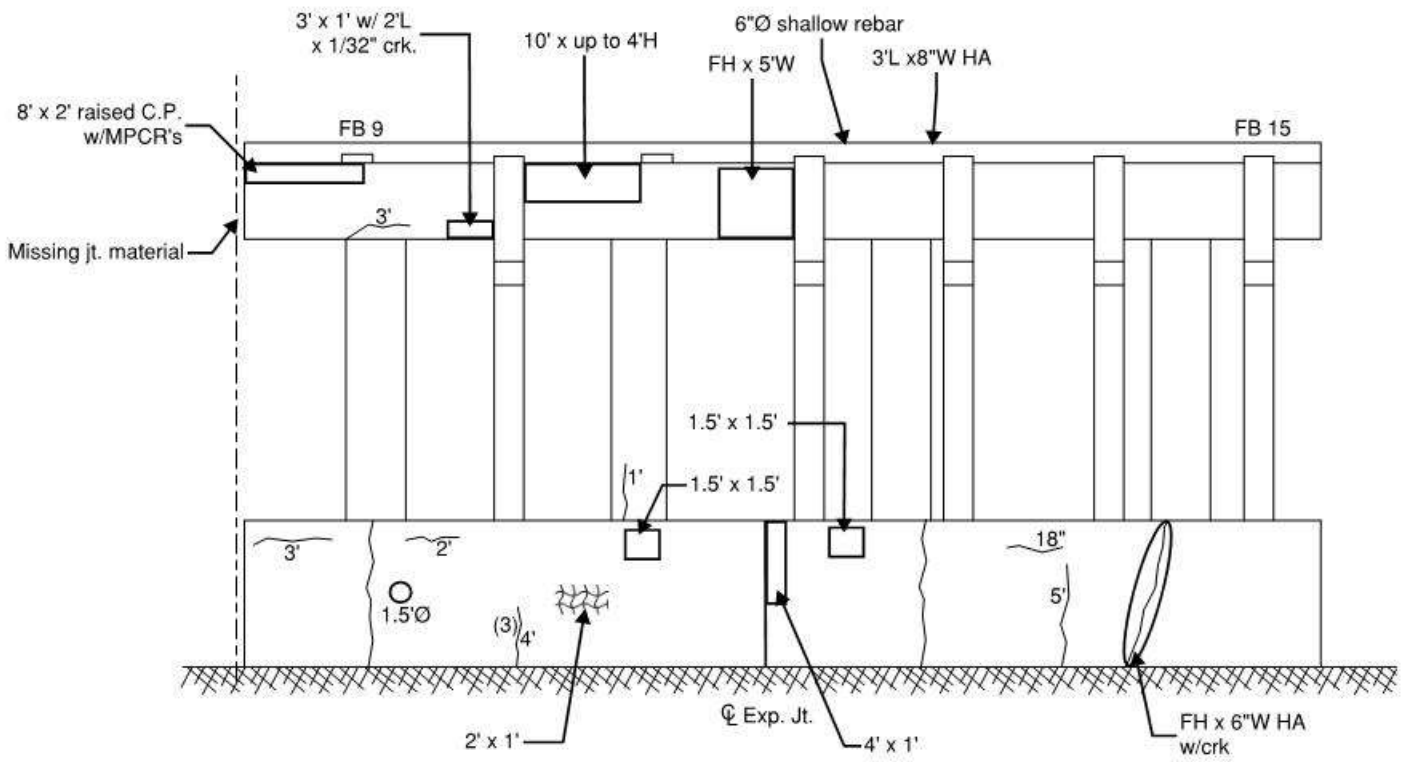
General Notes:
 - See Pier 6 - North Elevation (W. Quarter) General Notes
 - There are hollow areas and shallow rebars on top of pier base

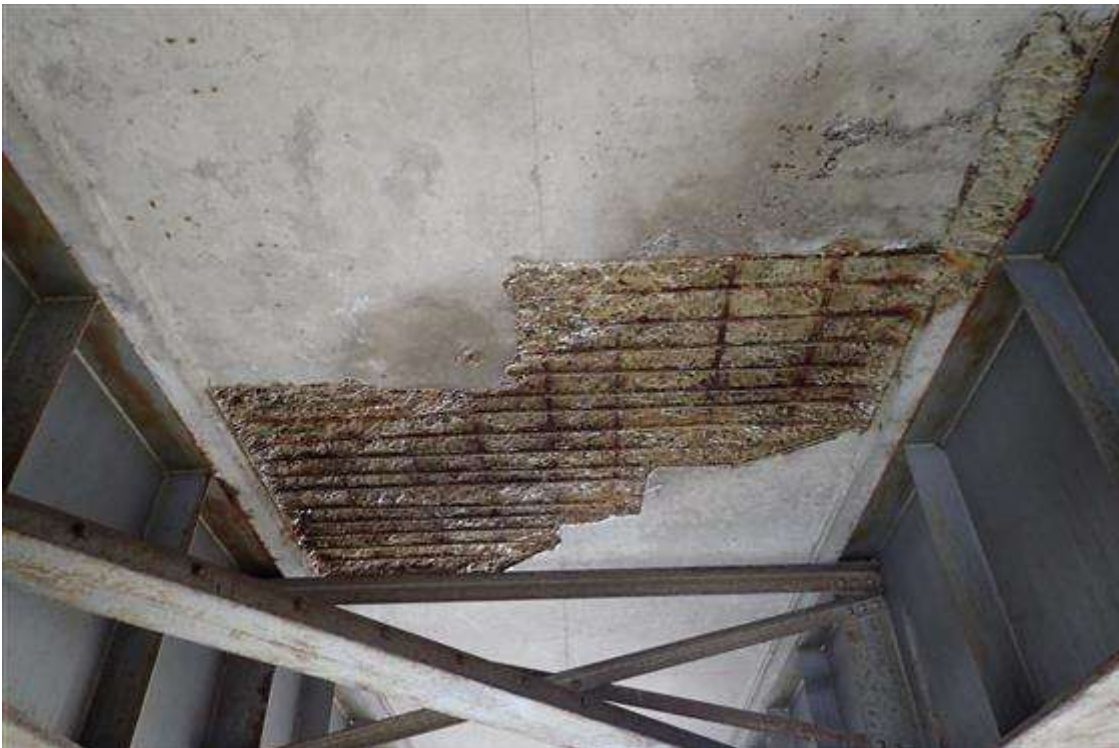
Span 7, bays 10-12 near pier 7, underside of deck exhibits spalls with exposed rebar with section loss to the rebar.

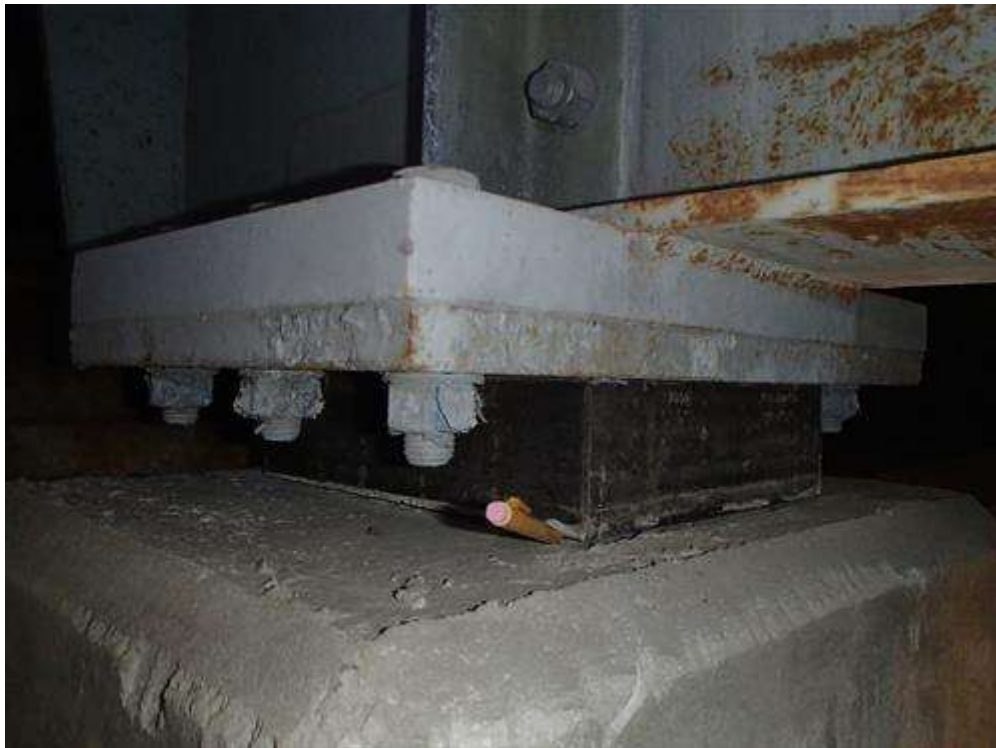
Span 7, bay 20 at pier 7, floorbeam FB 20 haunch exhibits spall.

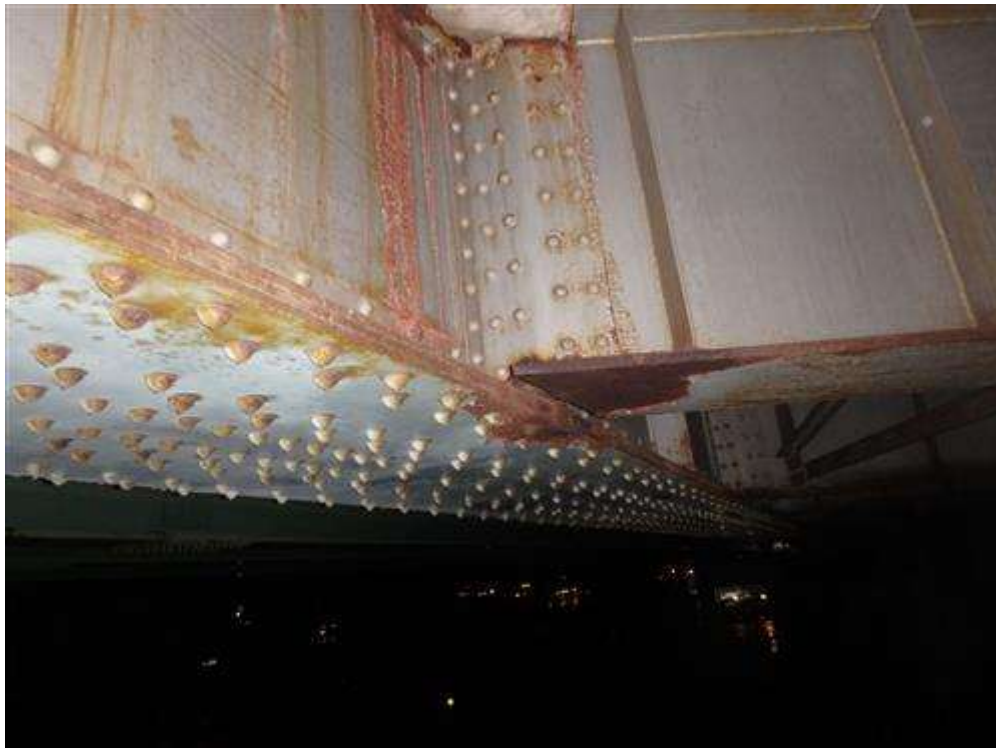
Span 7, girder G1 expansion rocker bearing at pier 7 with heavy rust.

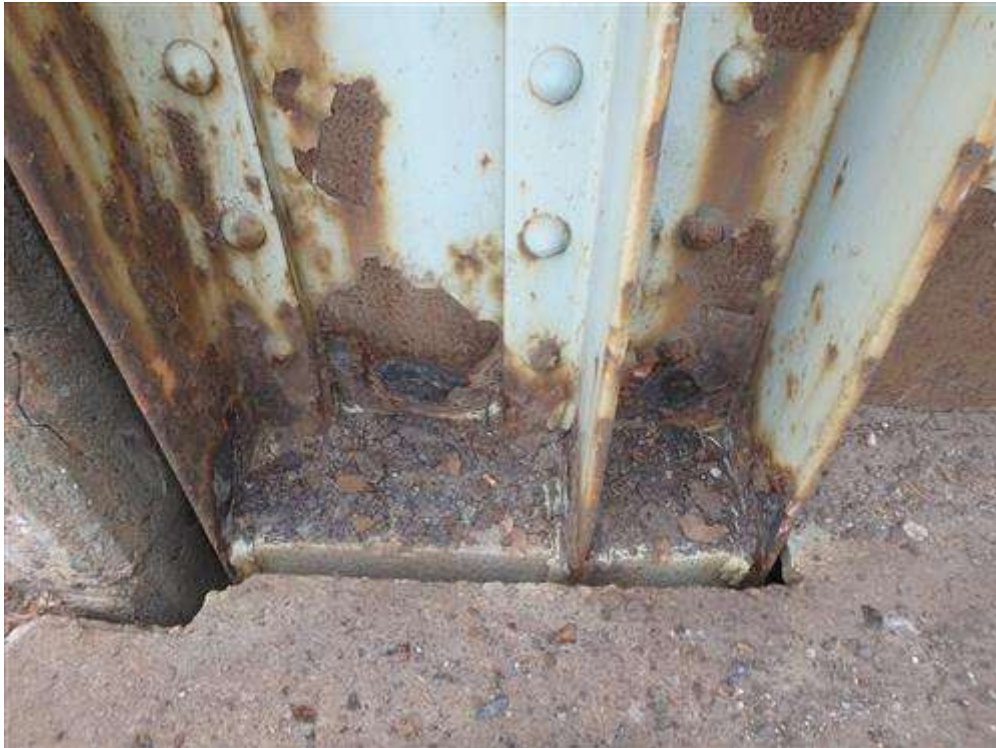
Girder G2 outside face above deck exhibits rust with section loss at web and stiffeners.

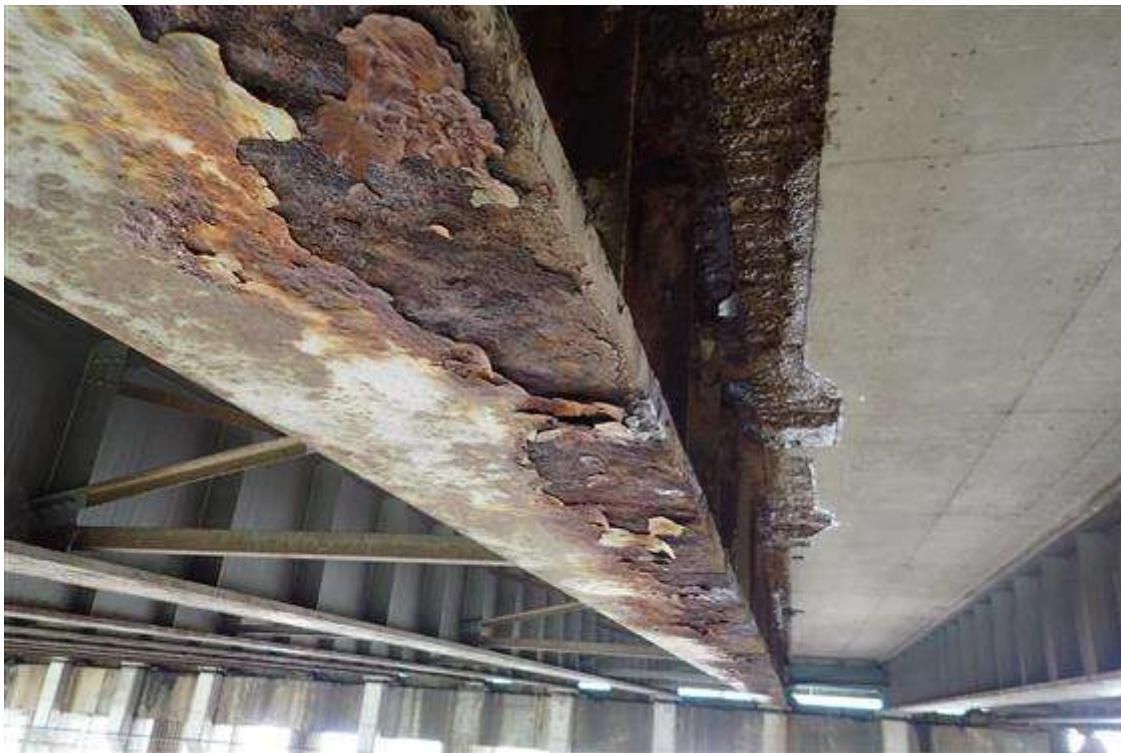
Span 7, floorbeam 19, north elevation, near midspan with heavy laminated rust and section loss to web and bottom flange. Note the spall with exposed rebar in the underside of deck.

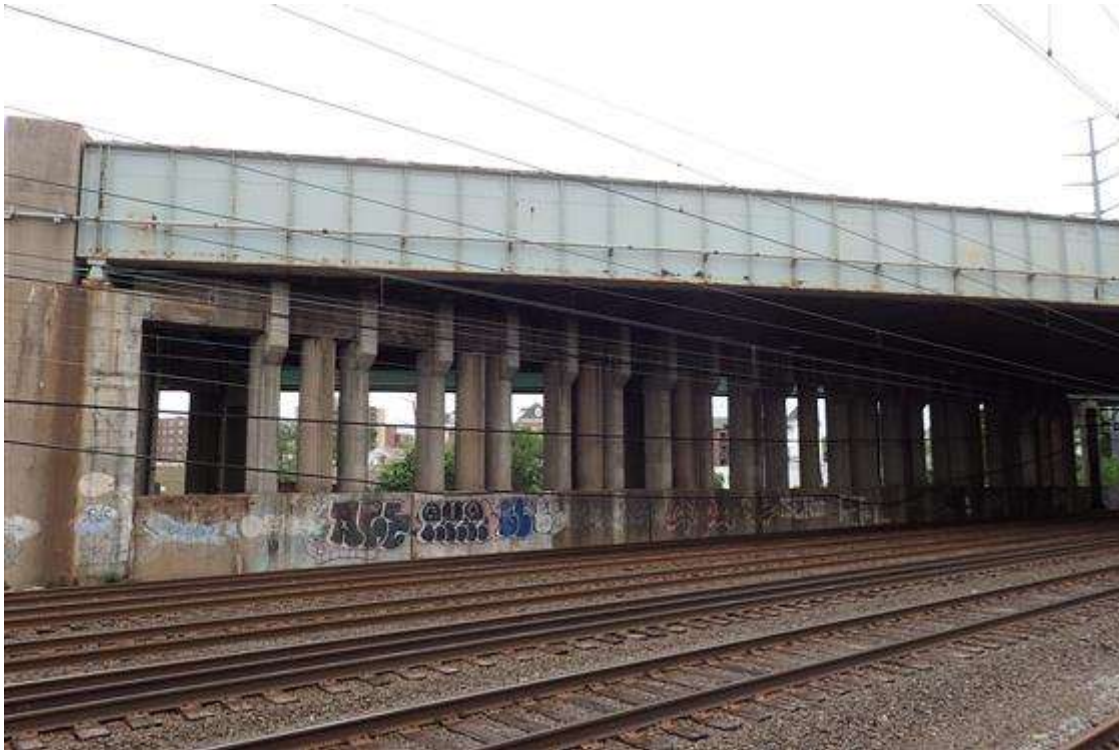
Span 7, bay 26 at pier 6, end diaphragm with laminated rust and efflorescence.

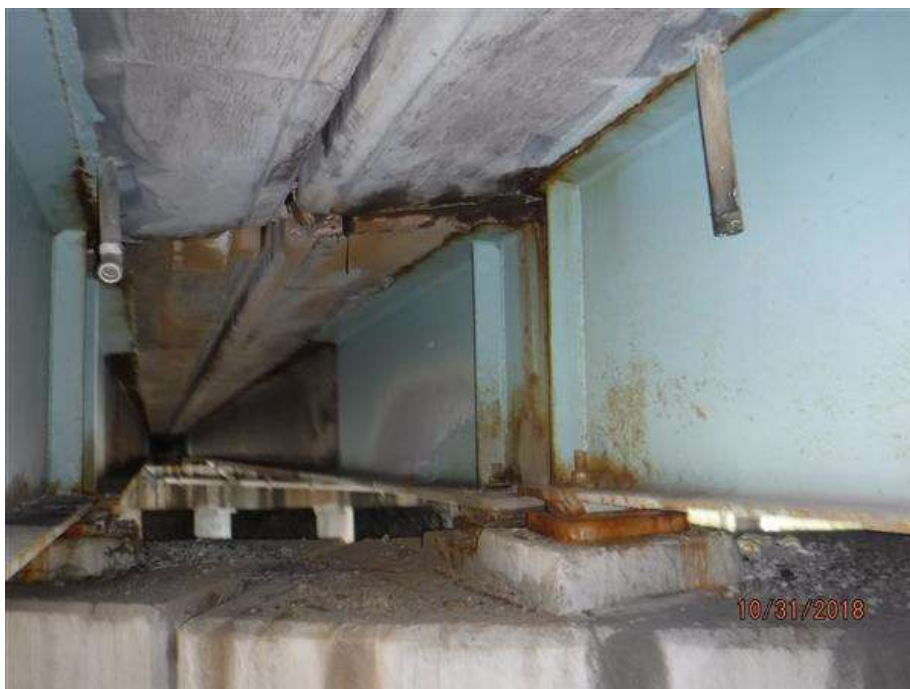
Short weeps in span 15, bay 7. Note the leakage from the median joint onto the superstructure and substructure.

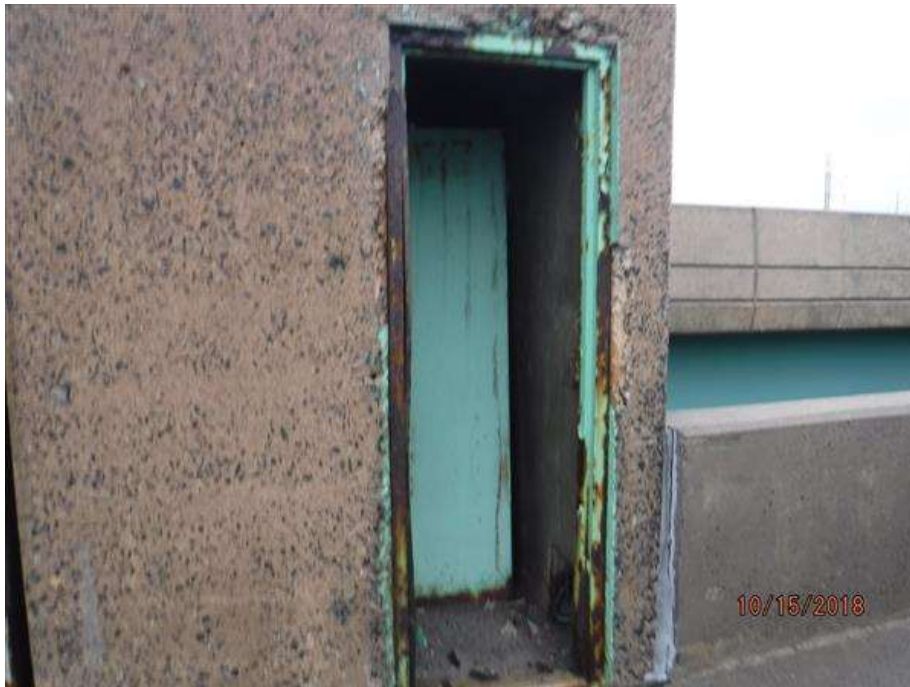
Girder 1 at the north end of span 7 with a broken access door.

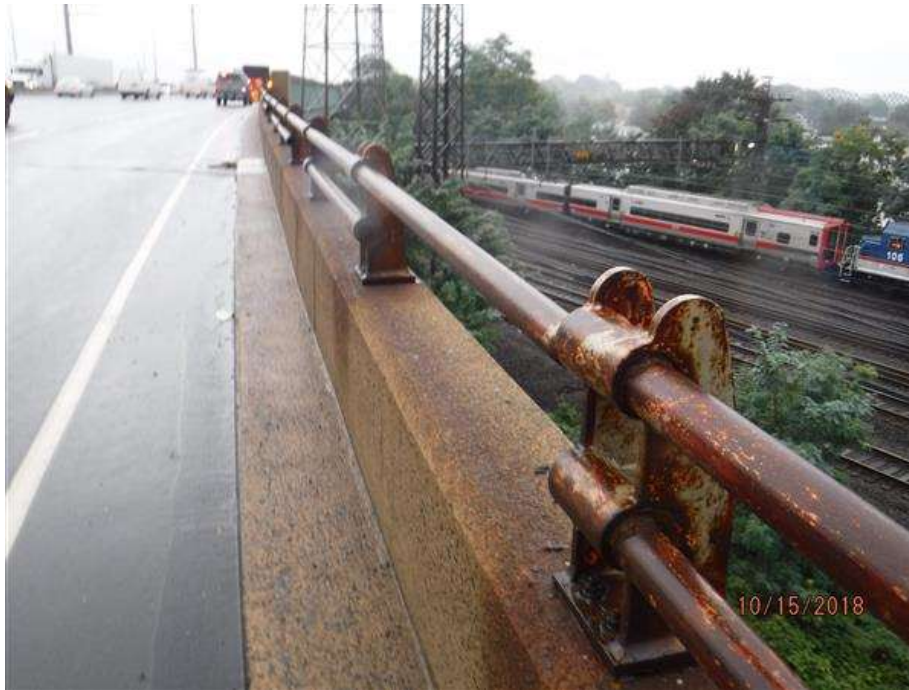
East parapet in span 1 with missing bottom rails.

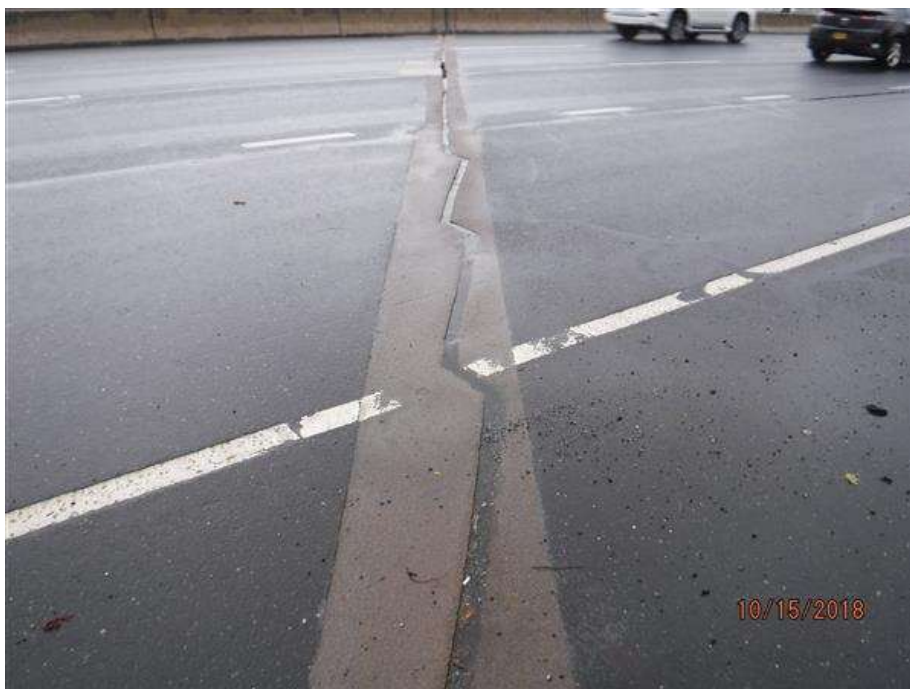
Pier 16 deck joint with missing joint material on the northbound side.

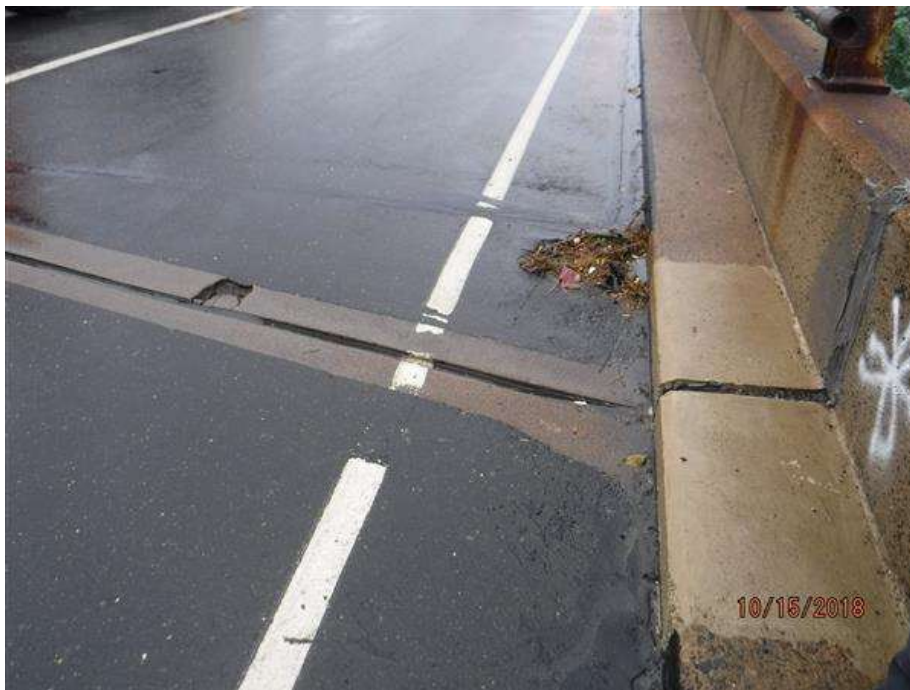
Clogged drain at pier 1 in span 2 along the east parapet and spall in concrete header.

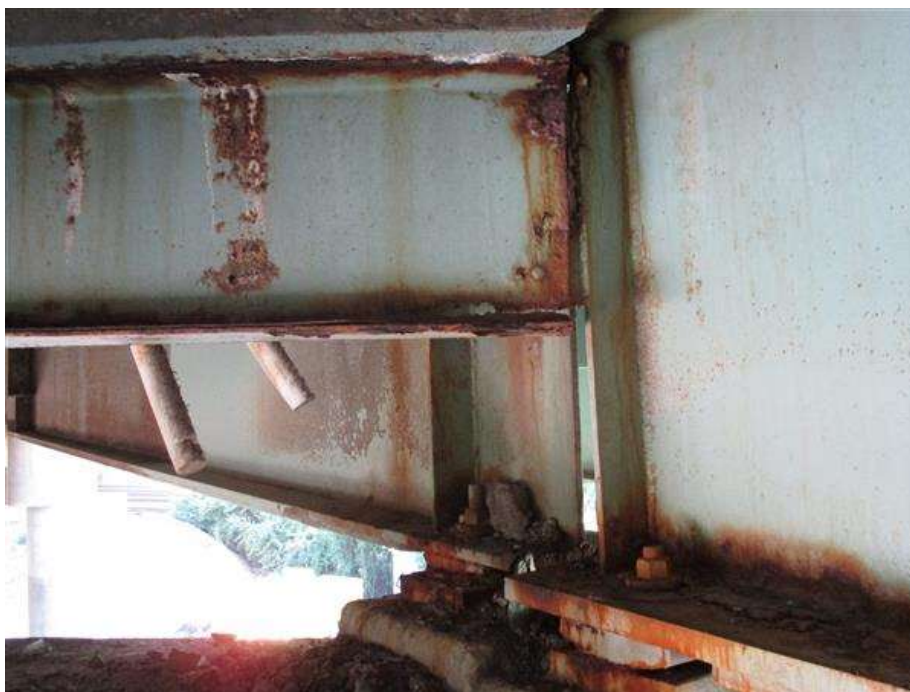
Span 16, bay 2 at pier 15 end diaphragm with areas of heavy rust and perforations in the bottom flange and web. Note the short weeps draining onto the pier cap.
