Subject: On-Call Asbestos, Lead, Air Quality & Demolition Compliance
Agreement No.: 8.07-01 (18)
HazMat Inspection - Bridge No. 00032, I-95 over MNRR & Local Roads, Stamford, CT
ConnDOT Assignment No. 519-5852
ConnDOT Project No. 135-334
TRC Project No. 289951.5852.0710

TRC performed a limited survey for hazardous building materials associated with the rehabilitation of Bridge No. 00032, I-95 over MNRR & Local Roads in Stamford, Connecticut. Results of the survey identified lead paint to be present on the structural steel/metal bridge components and metal railings of Bridge No. 00032. Results obtained from TCLP waste stream sampling and analysis for leachable lead from the paint on the structural steel/metal bridge components and metal railings characterized the two paint waste streams at Bridge No. 00032 as CTDEEP/RCRA hazardous waste. Light grey barrier caulk, black tar expansion joints, tan abutment rocker paper & black road tar were sampled and found to be non-ACM. No bird/pigeon guano accumulations, hazardous/regulated items or items of bloodborne pathogens (BBP) concern were identified. Associated laboratory data, inspector notes, TRC Mobile Data Solutions report and project

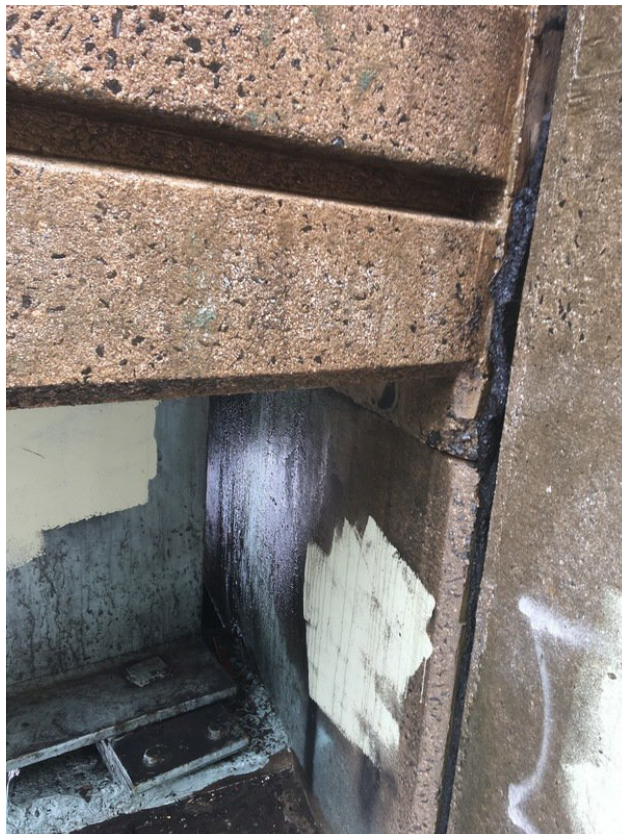
(2), EJ1, Black Tar expansion joint , 2

Sampled or Assumed?	Sampled
Material Acronym	EJ1
Material Description	Black Tar expansion joint

Is Material a Non-Friable Organically Bound (NOB)	Yes
Total Count	(2)
Total Count (number only)	2

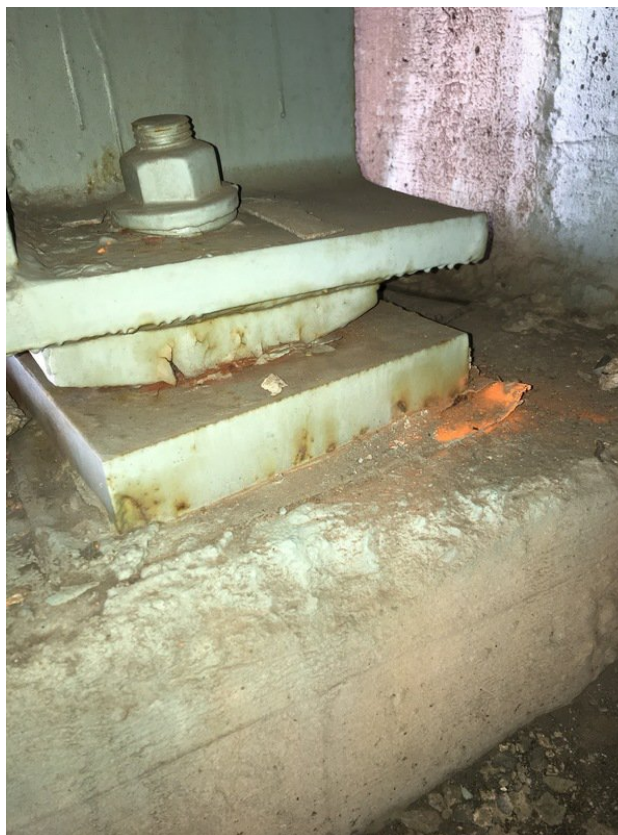
North abutment rocker paper

(2), RP1, Tan abutment rocker paper, 2

Sampled or Assumed?	Sampled
Material Acronym	RP1

Material Description	Tan abutment rocker paper
Is Material a Non-Friable Organically Bound (NOB)	No
Total Count	(2)
Total Count (number only)	2

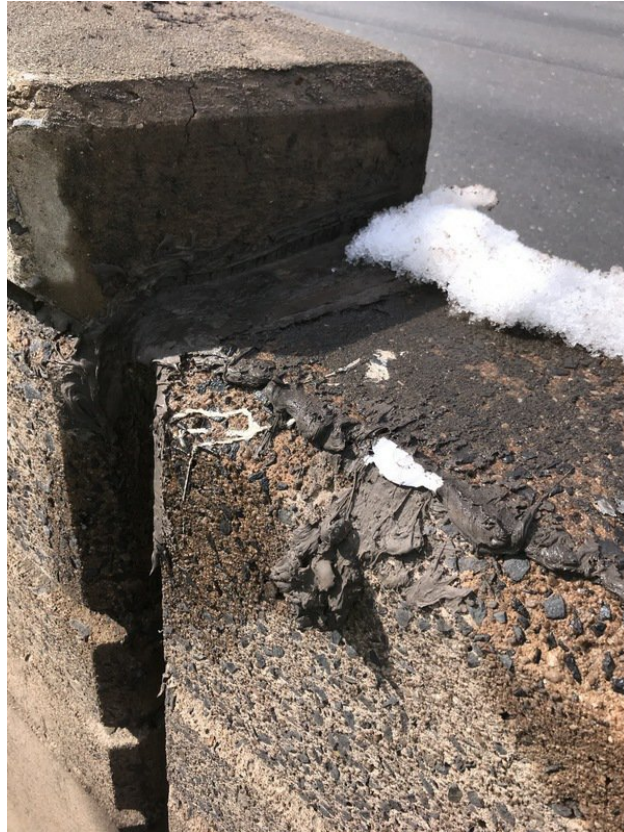
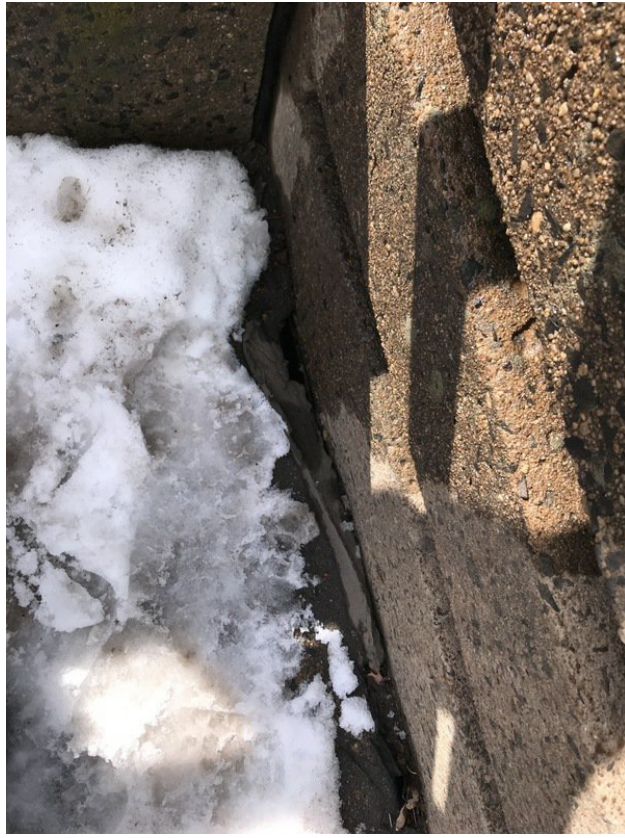
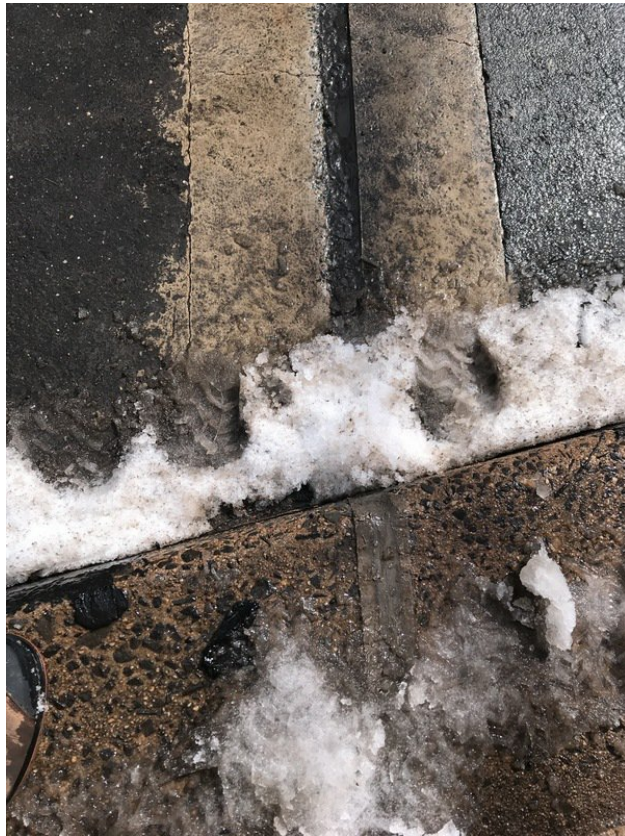
(2), C, 1, Light grey barrier caulk , 2

Sampled or Assumed?	Sampled
Material Acronym	C, 1
Material Description	Light grey barrier caulk
Is Material a Non-Friable Organically Bound (NOB)	Yes
Total Count	(2)
Total Count (number only)	2

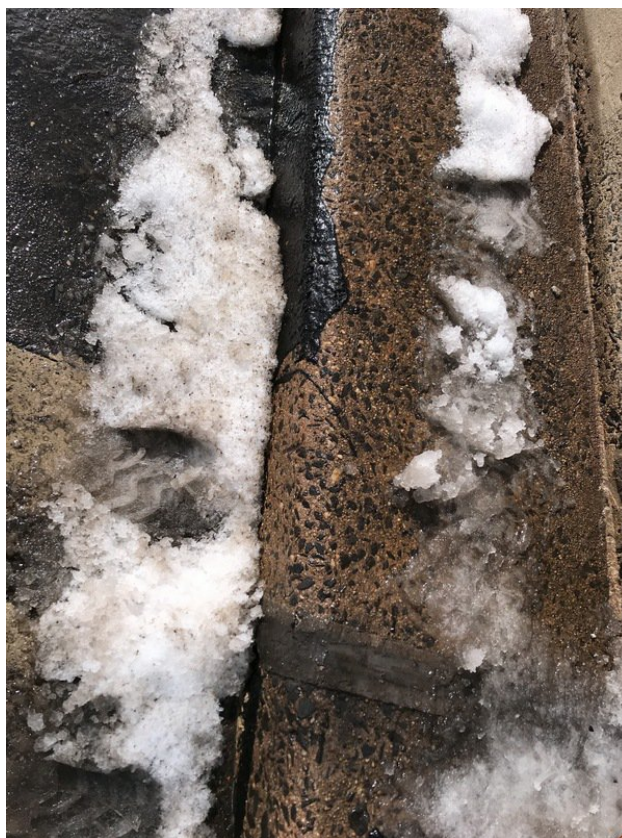
East ramp

(2), RT1, Black road tar, 2

Sampled or Assumed?	Sampled
Material Acronym	RT1
Material Description	Black road tar
Is Material a Non-Friable Organically Bound (NOB)	Yes
Total Count	(2)
Total Count (number only)	2
