Bridge No. 00980B  
Interstate-84 TR 826 over Connecticut River  
Hartford

Date: 11/19/2018

**EXECUTIVE SUMMARY**  
**11-19-18**

A special inspection was performed on the superstructure.

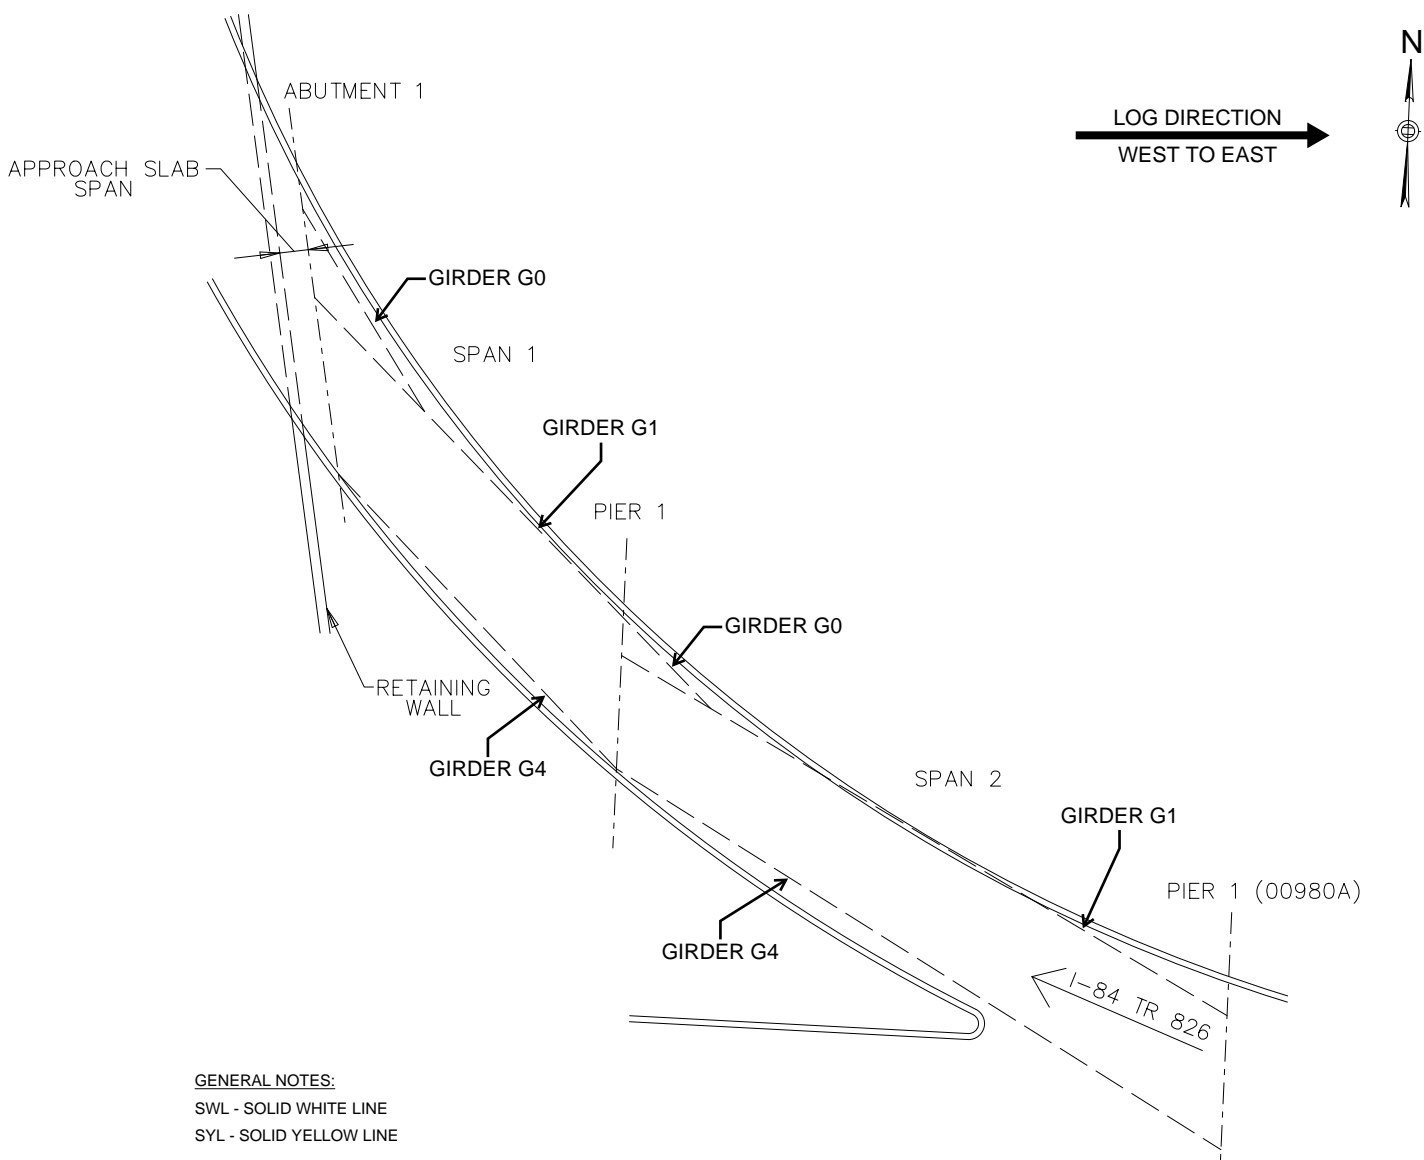
**DETERIORATION NOTES:**

- [1] = Web with negligible section loss; both bearing stiffeners with FWx3"Hx1/8" dp SL.
- [2] = Full diaph. section along G1 w/ 50% SL; lower horiz. w/ 1.5"Ø hole; channel web w/ 3"Ø hole; 1 of 3 Conn. bolts & nuts @ G1 w/ 80% SL; Conn. PL's w/ 1/8"-3/16"dp SL.
- [3] = See Girder Detail Sketch.

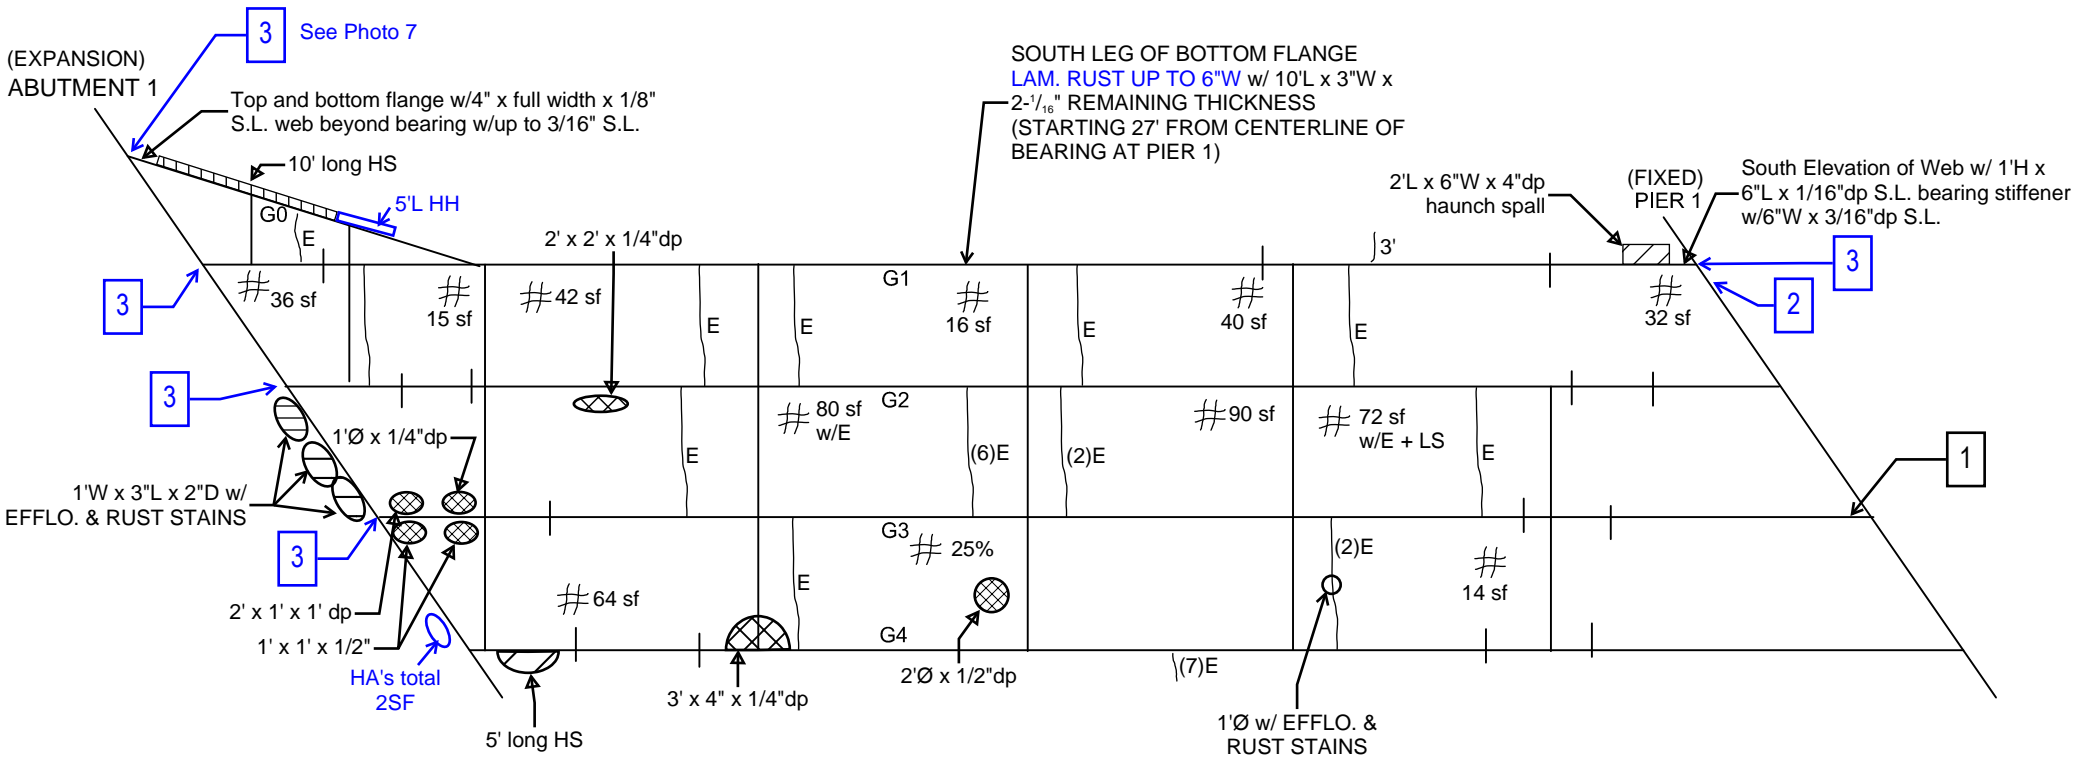
**UNDERSIDE OF DECK & FRAMING PLAN - SPAN 1**

- End diaphragms with heavy rust and 1/8" deep section losses.
- Bottom flanges near Abutment 1 (non-critical zone) with heavy rust and <1/16" deep section loss.
- Underside of the deck near Abutment 1 with light scale.
- Deck joint material hanging down at pier 1 at random locations.
- Fixed bearings with lam rust and up to 5/8" IR between plates.
- Pipe conduit rope tied to diaphragm and laying on abutment seat.

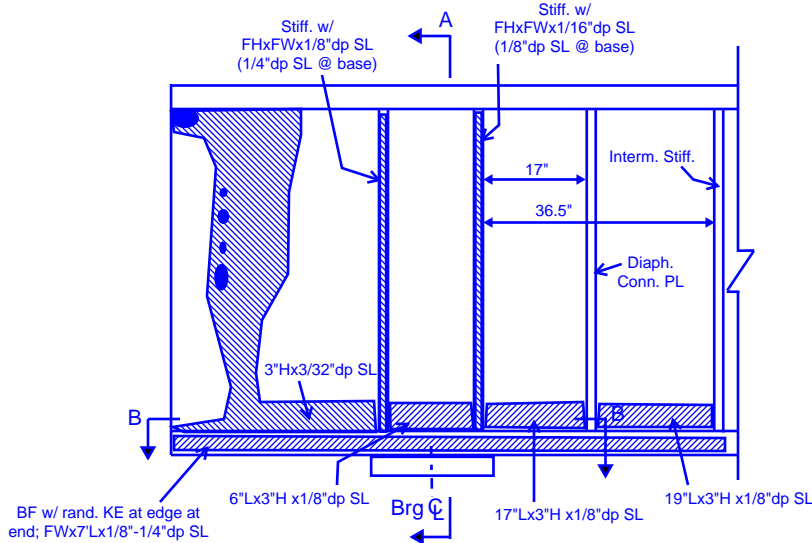
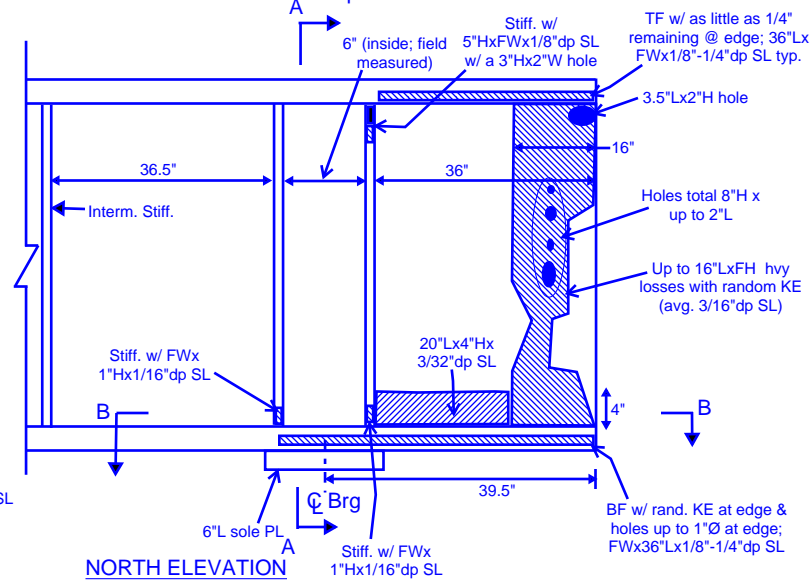
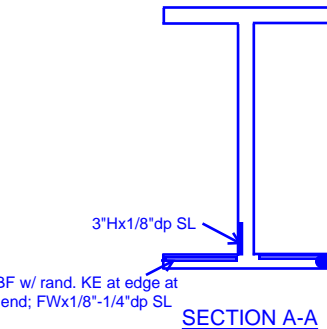
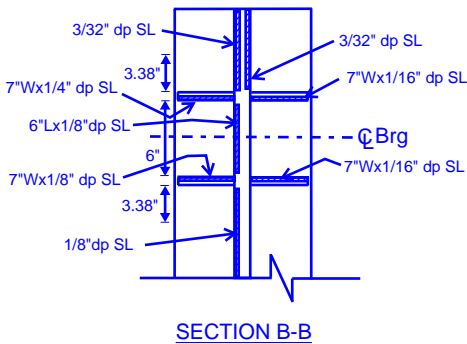
GIRDER G0, SPAN 1, ABUTMENT 1  
 (N.T.S.)

SHEAR LOSS @ A-A:

Orig. Area =  $54 \times 3/8$   
 = 20.25 sq.in.

Area Loss =  $3 \times 1/8 = 0.375$  sq.in.

% Loss =  $0.375/20.25 = 1.9\%$

BEARING LOSS @ B-B:

Orig. Area =  $4 \times \text{Stiff's} + (7 + 2 \times 9 \times \text{tw})(\text{tw})$  (9tw=3.38)  
 =  $4 \times 6 \times 1/2 + (7 + 2 \times 9 \times 3/8)(3/8)$   
 = 17.16 sq.in.

Area Loss =  $7 \times 1/16 + 7 \times 1/16 + 7 \times 1/4 + 7 \times 1/8 + 6 \times 1/8$   
 +  $3.38 \times 1/8 + 3.38 \times 3/32 + 3.38 \times 3/32 = 5.31$  sq.in.

% Loss =  $5.31/17.16 = 30.9\%$

SHEAR LOSS @ PERFORATIONS:

Area Loss =  $8 \times 3/8 + 44 \times 3/16 = 11.25$  sq.in.

% Loss =  $11.25/20.25 = 55.6\%$

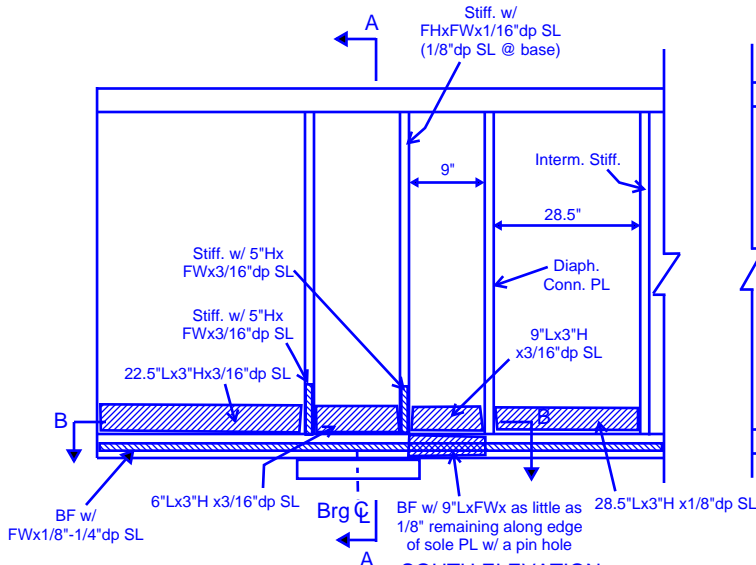
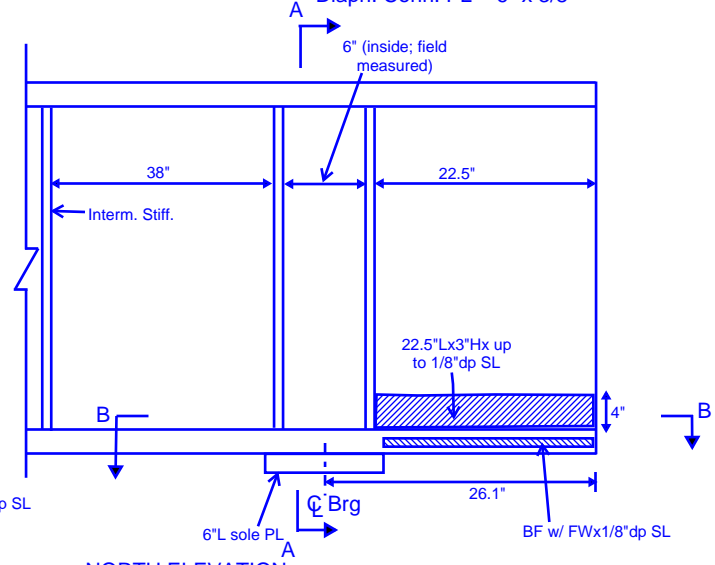
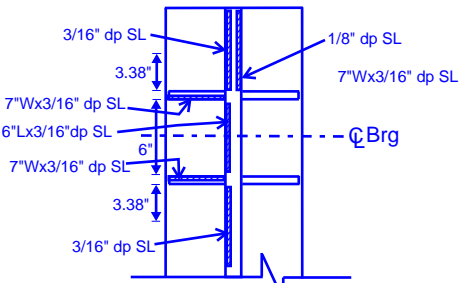
**GIRDER G1, SPAN 1, ABUTMENT 1**  
 (N.T.S.)

**SHEAR LOSS @ A-A:**

Orig. Area =  $60 \times 3/8 = 22.5$  sq.in.  
 Area Loss =  $3 \times 3/16 = 0.563$  sq.in.  
 % Loss =  $0.563/22.5 = 2.5\%$

**BEARING LOSS @ B-B:**

Orig. Area =  $4 \times \text{Stiff's} + (6 + 2 \times 9 \times \text{tw}) (\text{tw})$  (9tw=3.38)  
 $= 4 \times 7 \times 5/8 + (6 + 2 \times 9 \times 3/8)(3/8)$   
 $= 22.28$  sq.in.  
 Area Loss =  $7 \times 3/16 + 7 \times 3/16 + 6 \times 3/16 + 3.38 \times 3/16 + 3.38 \times 3/16 + 3.38 \times 1/8 = 5.44$  sq.in.  
 % Loss =  $5.44/22.28 = 24.4\%$

**SHEAR LOSS @ END:**

Orig. Area = 22.5 sq.in.  
 Area Loss =  $3 \times 3/16 + 3 \times 1/8 = 0.963$  sq.in.  
 % Loss =  $0.963/22.5 = 4.3\%$

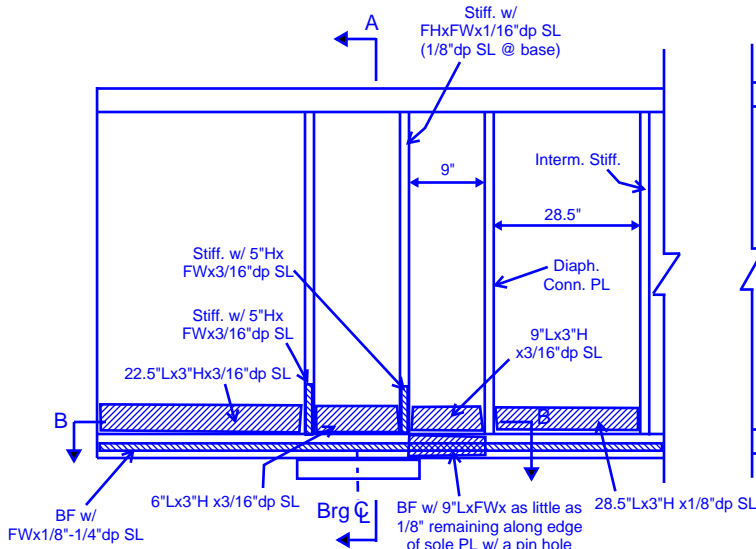
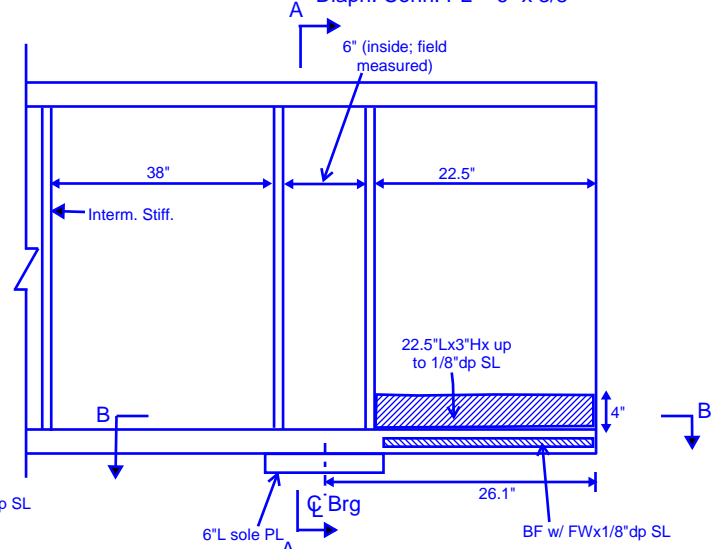
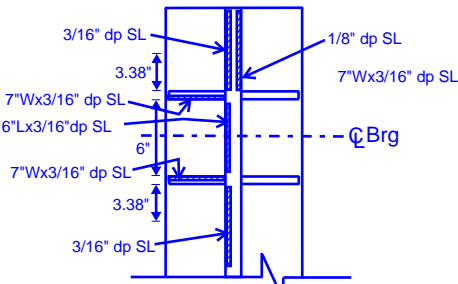
GIRDER G2, SPAN 1, ABUTMENT 1  
 (N.T.S.)

SHEAR LOSS @ A-A:

Orig. Area =  $60 \times 3/8 = 22.5$  sq.in.  
 Area Loss =  $3 \times 3/16 = 0.563$  sq.in.  
 % Loss =  $0.563/22.5 = 2.5\%$

BEARING LOSS @ B-B:

Orig. Area =  $4 \times \text{Stiff's} + (6 + 2 \times 9 \times \text{tw}) (\text{tw})$  (9tw=3.38)  
 $= 4 \times 7 \times 5/8 + (6 + 2 \times 9 \times 3/8)(3/8)$   
 $= 22.28$  sq.in.  
 Area Loss =  $7 \times 3/16 + 7 \times 3/16 + 6 \times 3/16 + 3.38 \times 3/16 + 3.38 \times 3/16 + 3.38 \times 1/8 = 5.44$  sq.in.  
 % Loss =  $5.44/22.28 = 24.4\%$

SHEAR LOSS @ END:

Orig. Area = 22.5 sq.in.  
 Area Loss =  $3 \times 3/16 + 3 \times 1/8 = 0.963$  sq.in.  
 % Loss =  $0.963/22.5 = 4.3\%$

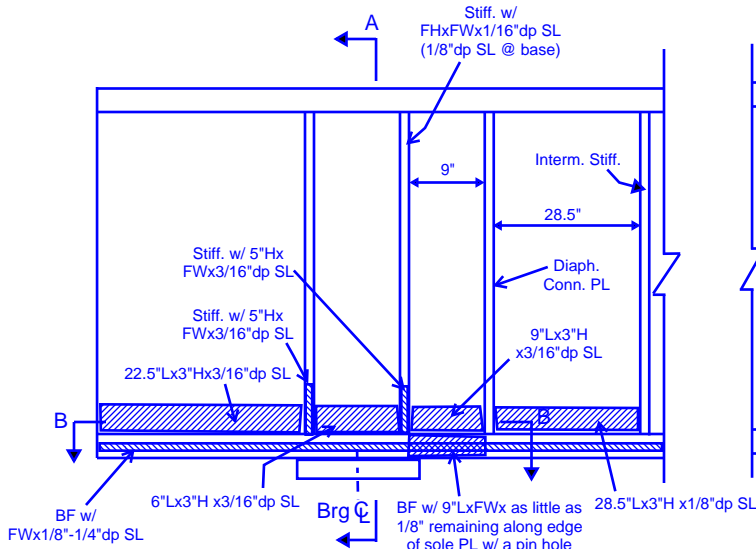
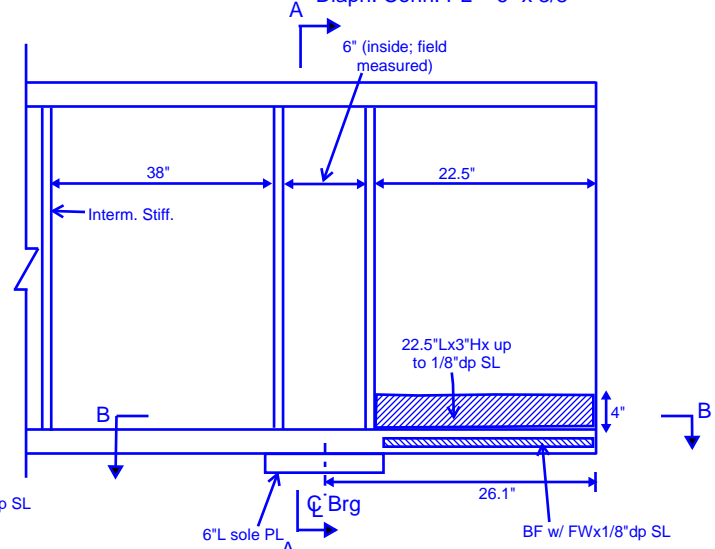
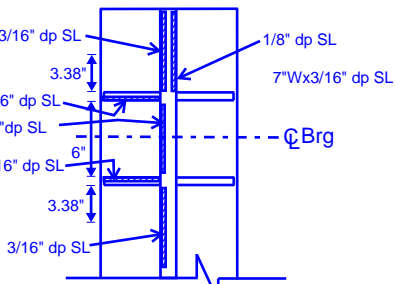
GIRDER G3, SPAN 1, ABUTMENT 1  
 (N.T.S.)

SHEAR LOSS @ A-A:

Orig. Area =  $60 \times 3/8 = 22.5$  sq.in.

Area Loss =  $3 \times 3/16 = 0.563$  sq.in.

% Loss =  $0.563/22.5 = 2.5\%$

BEARING LOSS @ B-B:

Orig. Area =  $4 \times \text{Stiff's} + (6 + 2 \times 9 \times \text{tw}) (\text{tw})$  (9tw=3.38)  
 $= 4 \times 7 \times 5/8 + (6 + 2 \times 9 \times 3/8)(3/8)$   
 $= 22.28$  sq.in.

Area Loss =  $7 \times 3/16 + 7 \times 3/16 + 6 \times 3/16 + 3.38 \times 3/16 + 3.38 \times 3/16 + 3.38 \times 1/8 = 5.44$  sq.in.

% Loss =  $5.44/22.28 = 24.4\%$

SHEAR LOSS @ END:

Orig. Area = 22.5 sq.in.

Area Loss =  $3 \times 3/16 + 3 \times 1/8 = 0.963$  sq.in.

% Loss =  $0.963/22.5 = 4.3\%$

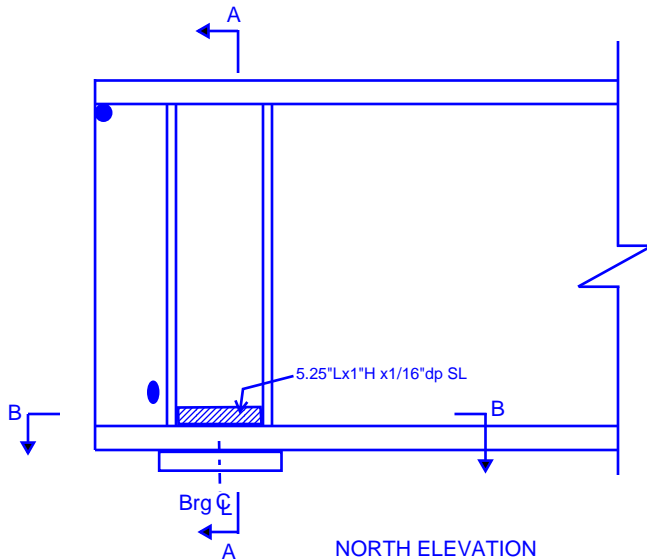
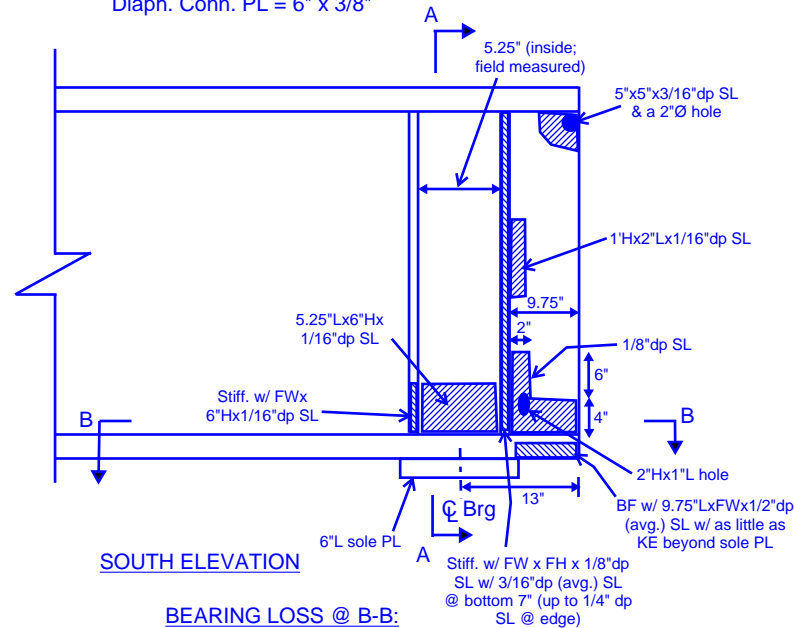
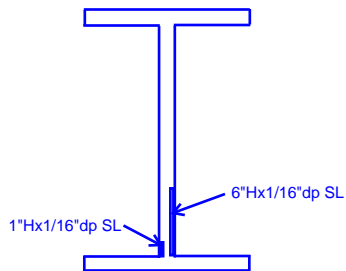
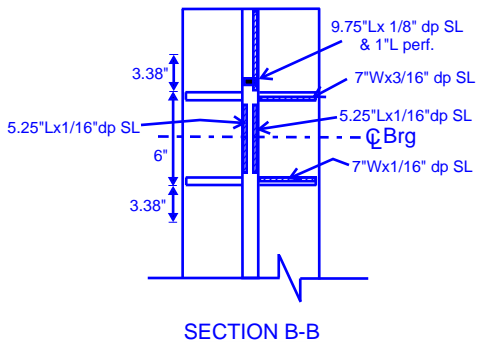
GIRDER G1, SPAN 1, PIER 1  
(N.T.S.)

## SHEAR LOSS @ A-A:

$$\text{Area Loss} = 6 \times 1/16 + 1 \times 1/16 = 0.438 \text{ sq.in.}$$

$$\% \text{ Loss} = 0.438/22.5 = \boxed{1.9\%}$$

## BEARING LOSS @ B-B:

$$\text{Area Loss} = 7 \times 1/16 + 7 \times 3/16 + 5.25 \times 1/16 + 5.25 \times 1/16 + 2.38 \times 1/8 + 1 \times 3/8 = 3.08 \text{ sq.in.}$$

$$\% \text{ Loss} = 3.08/22.28 = \boxed{13.8\%}$$

## SHEAR LOSS @ PERFORATION:

$$\text{Area Loss} = 12 \times 1/16 + 8 \times 1/8 + 2 \times 3/8 = 2.5 \text{ sq.in.}$$

$$\% \text{ Loss} = 2.5/22.5 = \boxed{11.1\%}$$

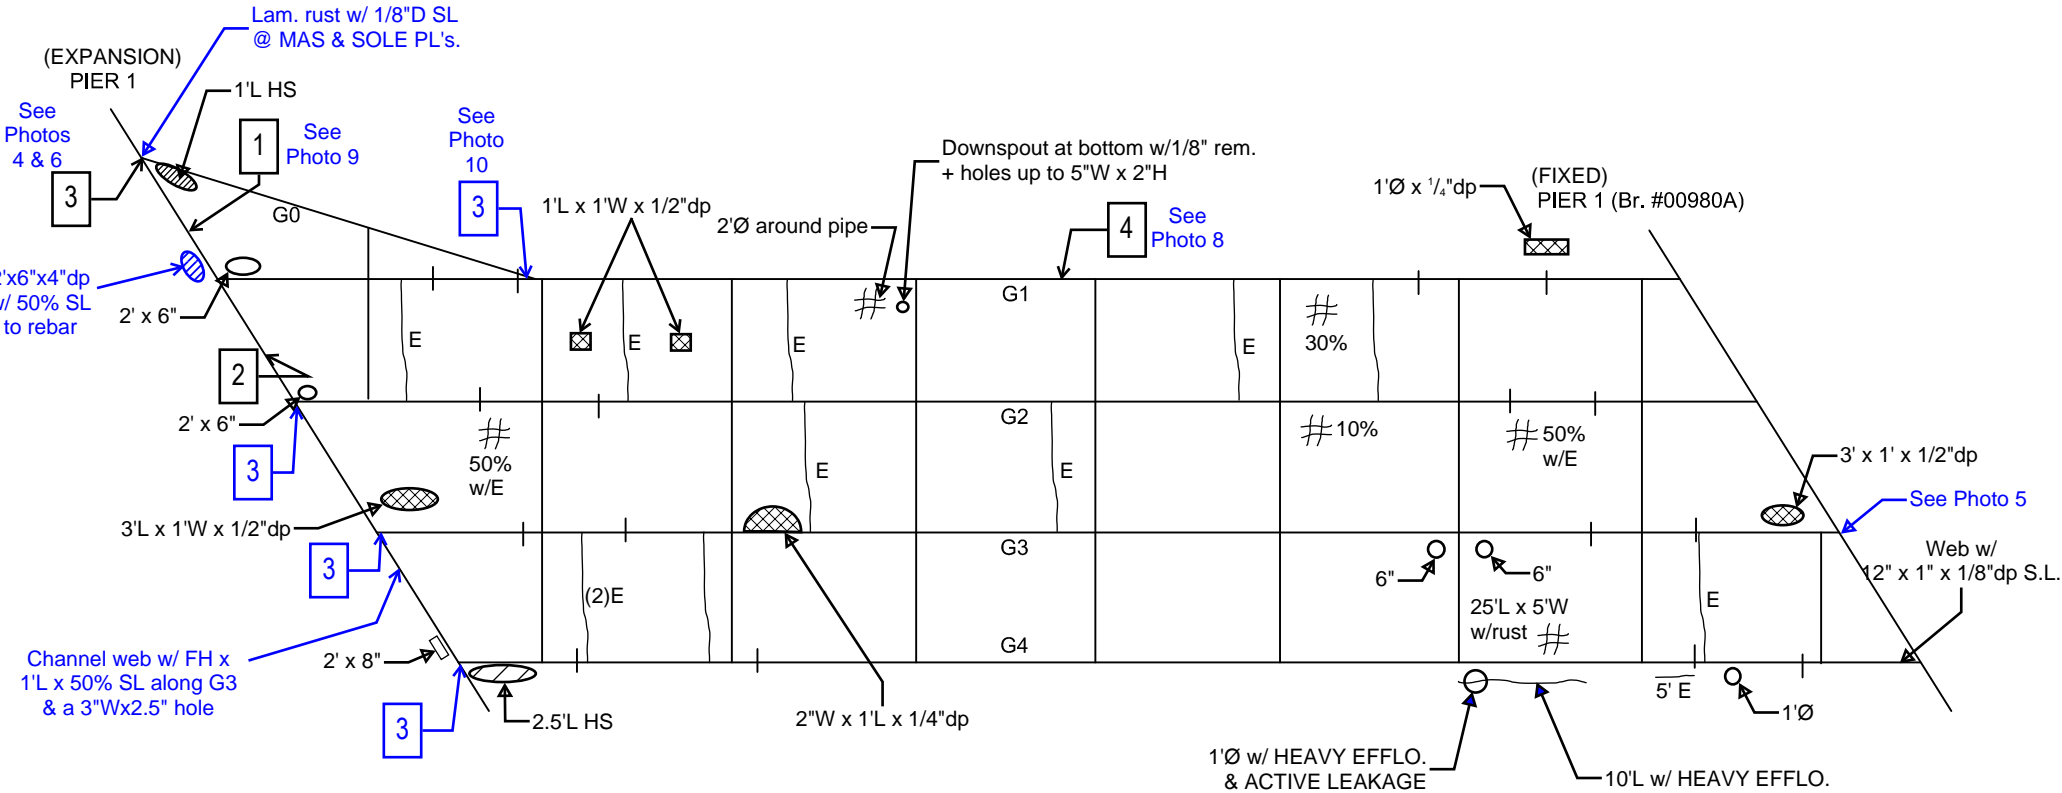
**UNDERSIDE OF DECK & FRAMING PLAN - SPAN 2**

**DETERIORATION NOTES:**

- 1 = Horizontal leg of lower structural angle with 1/8" remaining x full width with 1-1/2"L x 7/8"W perforation in lower middle Conn. PL; Diagonal member with 1/8" dp SL thru-out and is short & only partially welded to Conn. PL @ G0; upper channel web has holes totaling 1' L x up to 3" H; channel web & BF have up to 50% SL to cross section; Conn. PL's w/ 1/8"-3/16" dp SL & isolated 2" x 1.5" hole at lower Conn. PL @ G0.
- 2 = Structural angle bent up to 1/2" over 2'.
- 3 = See girder detail sketch.
- 4 = Bottom flange at mid-span with 10' x 7" x 5/16" dp section loss (20" x 2-1/4" orig.) (5% loss); bottom web w/laminated rust + negligible losses; bottom of web stiffeners w/laminated + S.L. up to full width x 6" x 3/16"D remaining.

- Underside of deck with concrete patches.
- Underside of deck with isolated areas of honeycombing up to 1'Ø x 1" dp.
- Fixed bearings w/light rust.
- Girders with peeling paint and heavy rust.
- Heavy rust on end diaphragms with up to 1/16" dp S.L.
- Isolated areas of pigeon waste on BF's.
- Up to 3/8" impact rust between end diaphragms and deck.
- Girder end with spotty lam rust and neg. section losses.
- End diaph's @ pier 1 with laminated rust with areas of 1/8" dp SL (U.O.N.).

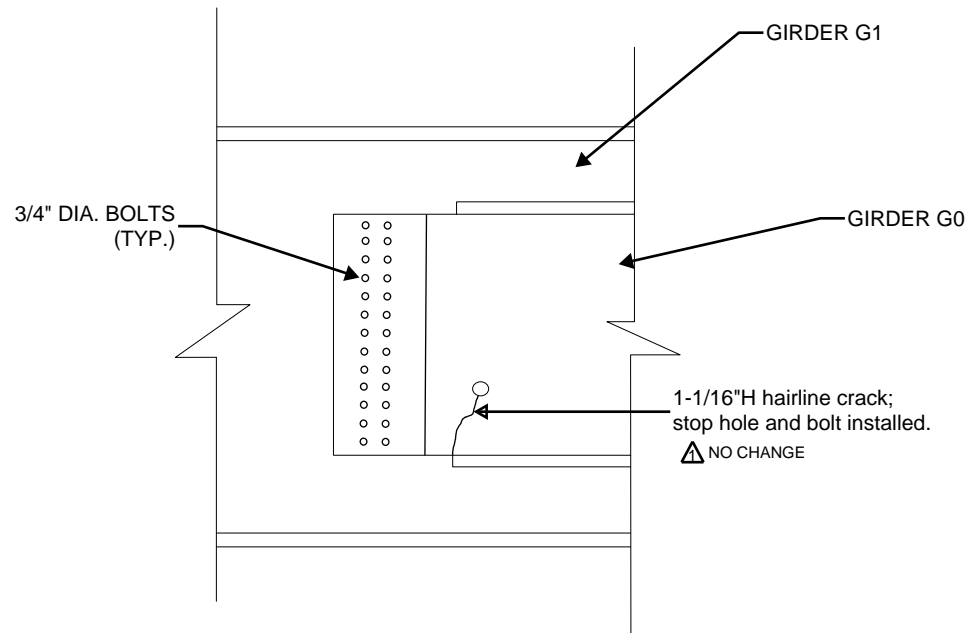
SPAN 2, GIRDER G0 AND GIRDER G1 CONNECTION , NORTH ELEVATION

**SHEAR LOSS @ A-A:**

Orig. Area =  $54 \times 3/8$   
 = 20.25 sq.in.

Area Loss =  $15 \times 1/16 + 39 \times 7/32 = 9.47$  sq.in.

% Loss =  $9.47/20.25 = 46.8\%$

**SHEAR LOSS @ D-D:**

Orig. Area = 20.25 sq.in.

Area Loss =  $2.5 \times 3/8 + 2.5 \times 11/32 = 1.80$  sq.in.

% Loss =  $1.80/20.25 = 8.9\%$

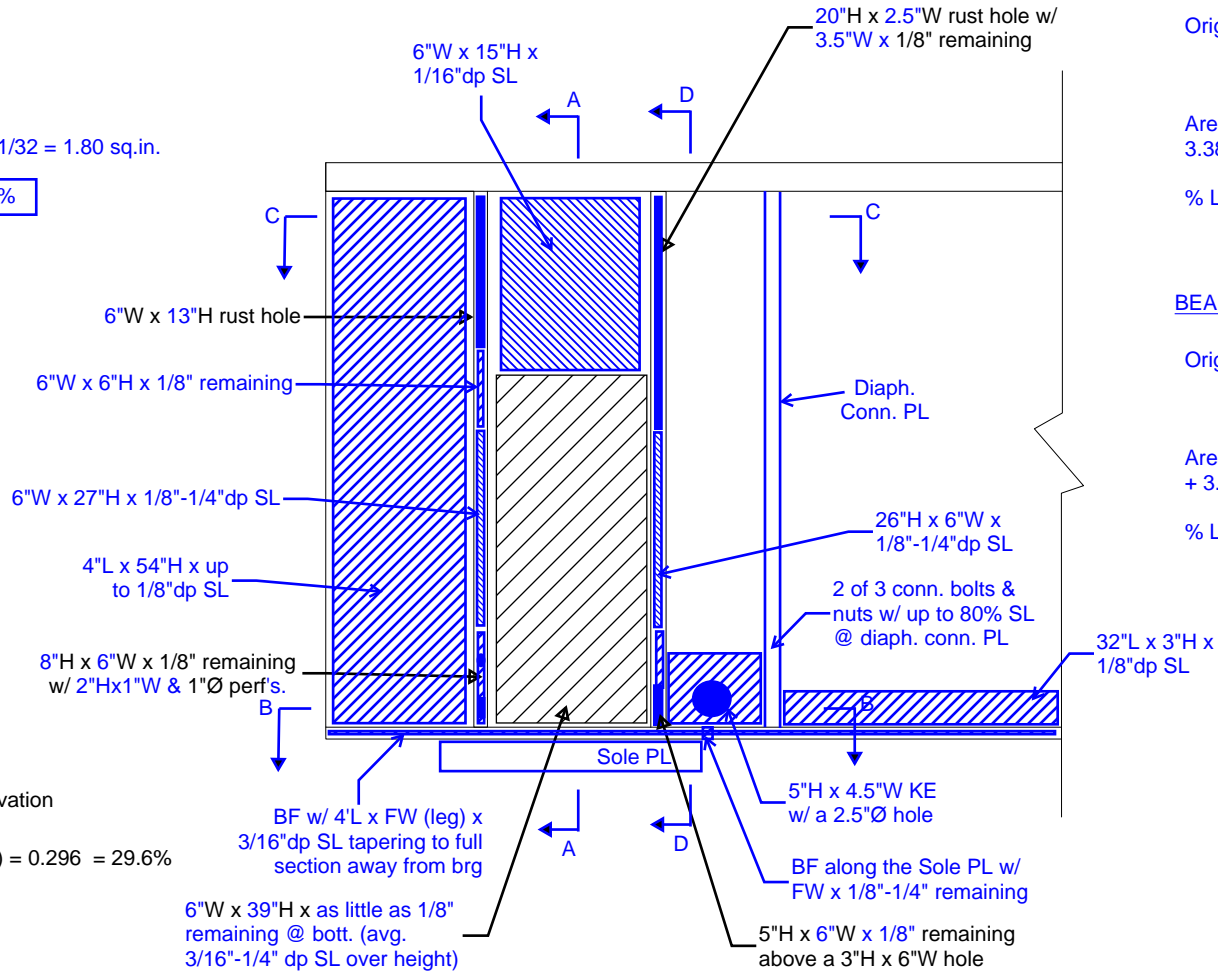
SPAN 2, GIRDER 0 AT PIER 1, SOUTH ELEVATION

Shear Loss - No loss noted on N.elevation

$1 - ((54 \times 3/8) - (48" \times 1/8")) / (54" \times 3/8) = 0.296 = 29.6\%$

**BEARING LOSS @ B-B:**

Orig. Area =  $4 \times \text{Stiff's} + (6 + 2 \times 9 \text{tw})(\text{tw})$   
 =  $4 \times 7 \times 5/8 + (6 + 2 \times 9 \times 3/8)(3/8)$   
 = 22.28 sq.in.

Area Loss =  $1 \times 1/2 + 5 \times 3/8 + 6 \times 1/2 + 6 \times 1/4 + 3.38 \times 1/8 + 2.5 \times 3/8 + 0.83 \times 11/32 = 3.08$  sq.in.

% Loss =  $3.08/22.28 = 38.2\%$

**BEARING LOSS @ C-C:**

Area Loss =  $6 \times 1/2 + 2.5 \times 1/2 + 3.5 \times 3/8 + 6 \times 1/16 + 3.38 \times 1/8 = 6.36$  sq.in.

% Loss =  $6.36/22.28 = 28.5\%$

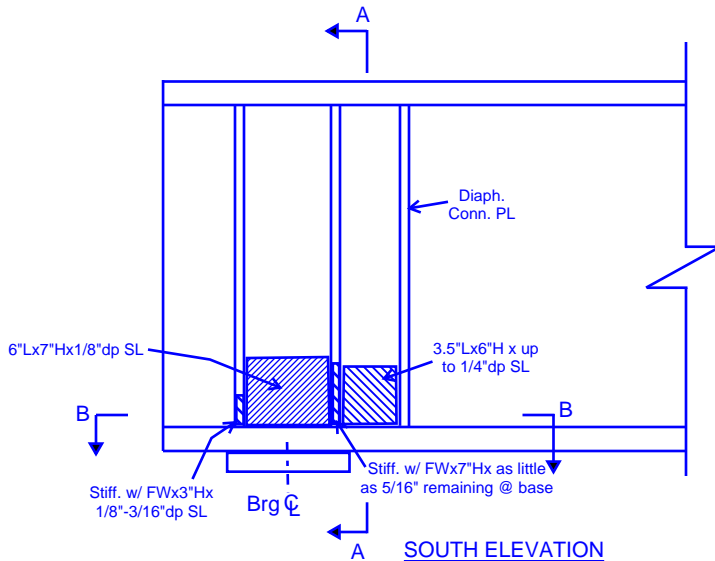
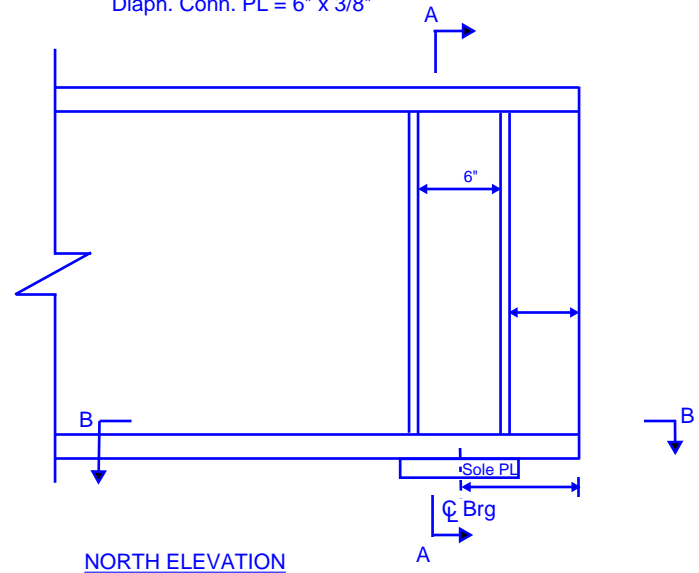
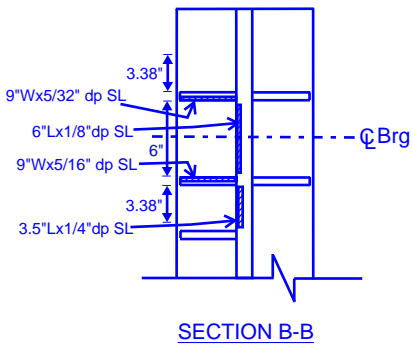
**GIRDER G2, SPAN 2, PIER 1**  
(N.T.S.)

**SHEAR LOSS @ A-A:**

$$\text{Area Loss} = 6 \times 1/4 = 1.5 \text{ sq.in.}$$

$$\% \text{ Loss} = 1.5/22.5 = \boxed{6.7\%}$$

**BEARING LOSS @ B-B:**

$$\text{Area Loss} = 9 \times 5/16 + 9 \times 5/32 + 6 \times 1/8 + 3.38 \times 1/4 = 5.81 \text{ sq.in.}$$

$$\% \text{ Loss} = 5.81/23.53 = \boxed{24.7\%}$$

**SHEAR LOSS @ OVER BEARING:**

$$\text{Area Loss} = 7 \times 1/8 = 0.88 \text{ sq.in.}$$

$$\% \text{ Loss} = 0.88/22.5 = \boxed{3.9\%}$$

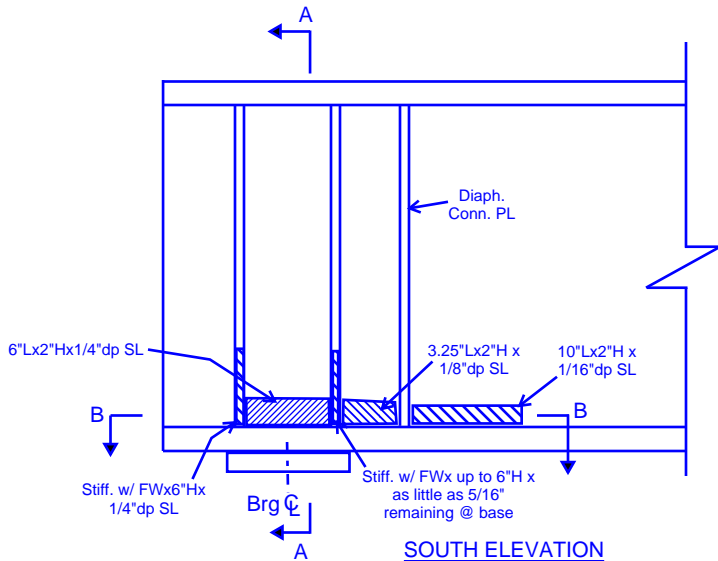
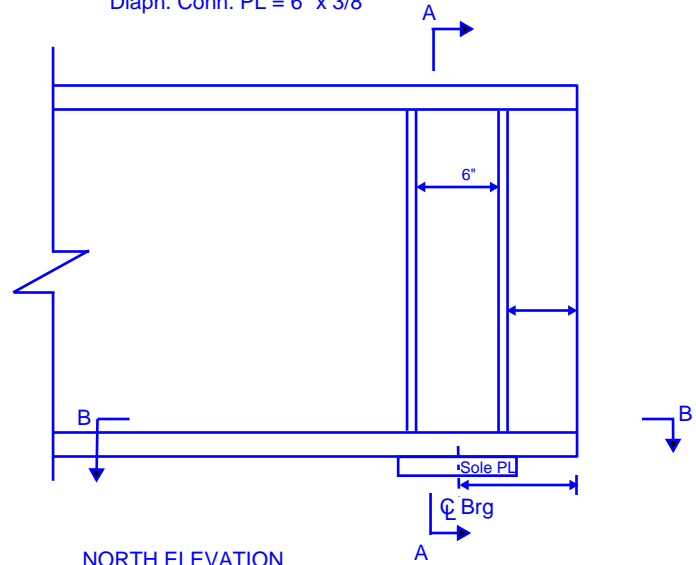
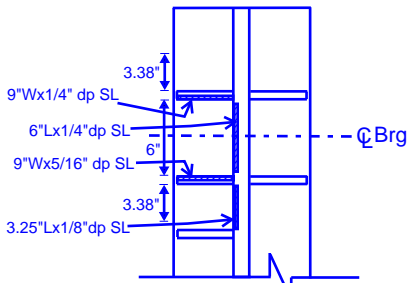
**GIRDER G3, SPAN 2, PIER 1**  
 (N.T.S.)

**SHEAR LOSS @ A-A:**

Area Loss = 2x1/4 = 0.5 sq.in.

% Loss = 0.5/22.5 = **2.2%**

**BEARING LOSS @ B-B:**

Area Loss = 9x5/16 + 9x1/4 + 6x1/4 + 3.25x1/8 = 6.97 sq.in.

% Loss = 6.97/23.53 = **29.6%**

**SHEAR LOSS IN FRONT OF BEARING:**

Area Loss = 2x1/8 = 0.25 sq.in.

% Loss = 0.25/22.5 = **1.1%**

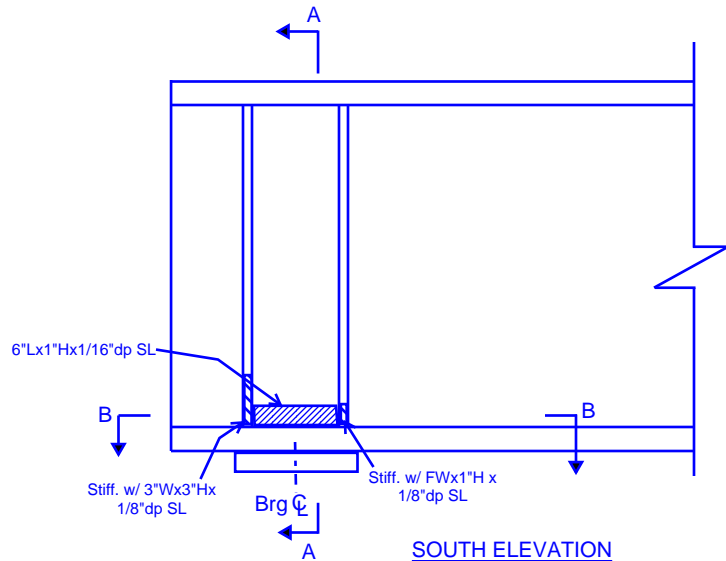
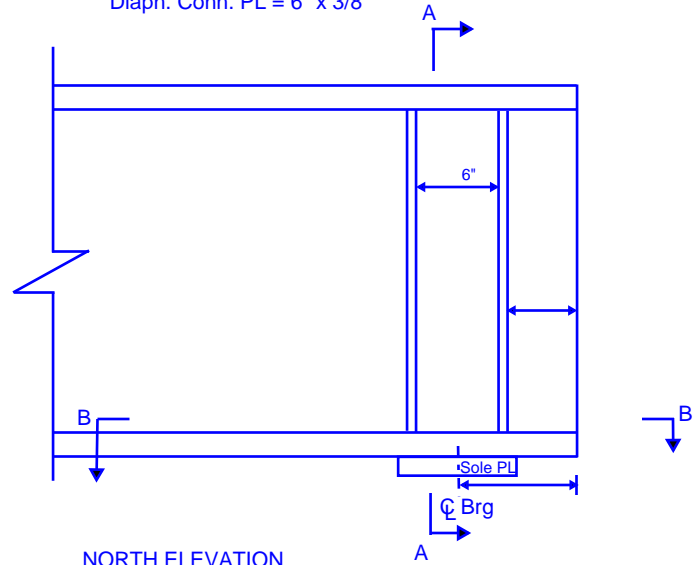
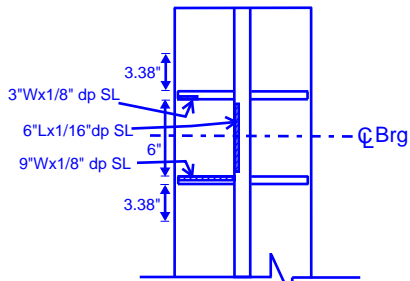
GIRDER G4, SPAN 2, PIER 1  
 (N.T.S.)

SHEAR LOSS @ A-A:

Orig. Area =  $60 \times 3/8 = 22.5$  sq.in.  
 Area Loss =  $1 \times 1/16 = 0.06$  sq.in.  
 % Loss =  $0.06/22.5 = 0.3\%$

BEARING LOSS @ B-B:

Orig. Area =  $4 \times \text{Stiff's} + (6 + 2 \times 9 \times \text{tw})(\text{tw})$  (9tw=3.38)  
 $= 4 \times 9 \times 5/8 + (6 + 2 \times 9 \times 3/8)(3/8)$   
 $= 23.53$  sq.in.  
 Area Loss =  $9 \times 1/8 + 3 \times 1/8 + 6 \times 1/16 = 1.88$  sq.in.  
 % Loss =  $1.88/23.53 = 8.0\%$

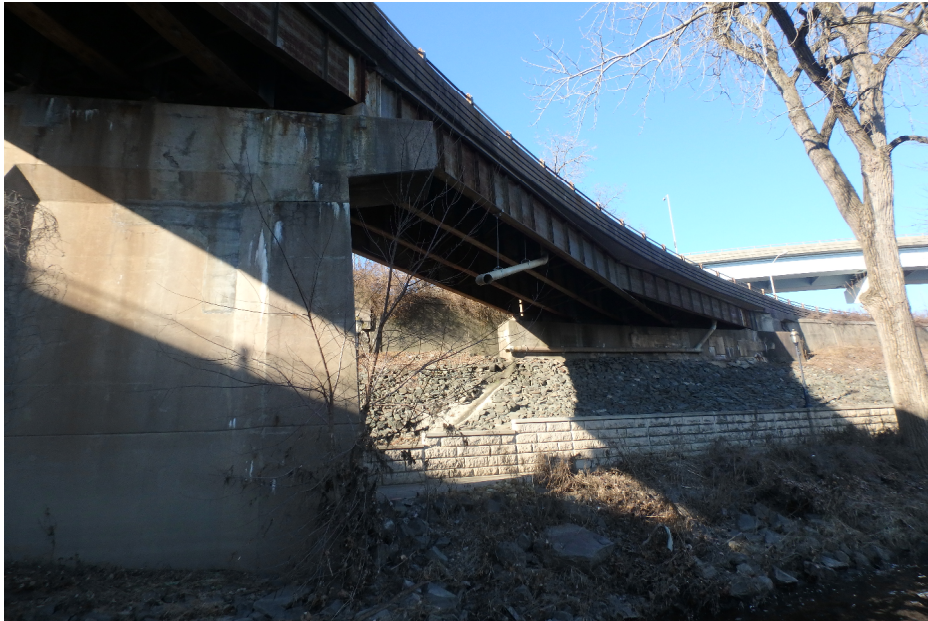
**Photo # 1:** North elevation of Span 1.

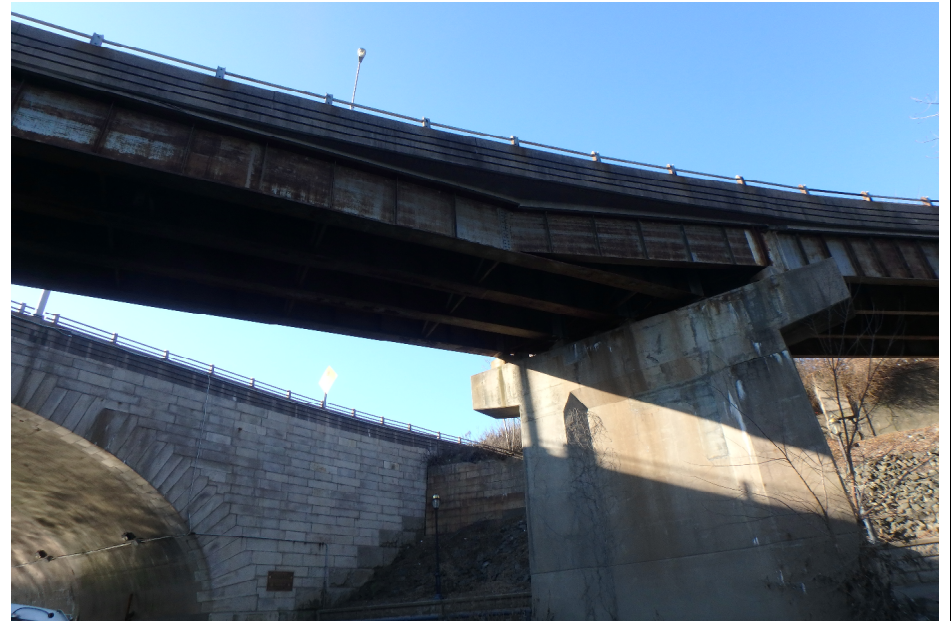
**Photo # 2:** North elevation of Span 2 at Pier 1.

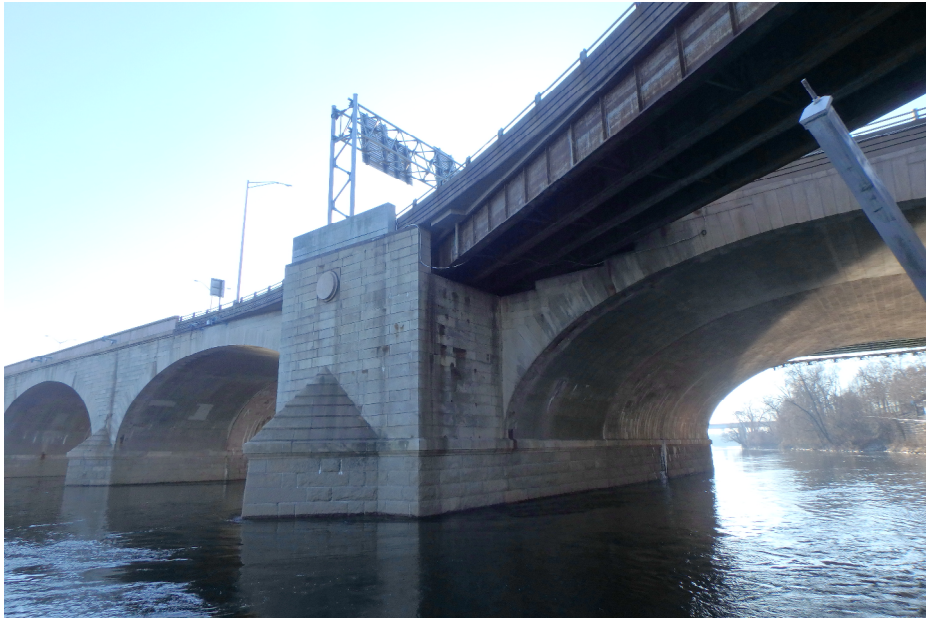
**Photo # 3:** North elevation of Span 2 at Pier 1 (Br. #00980A).

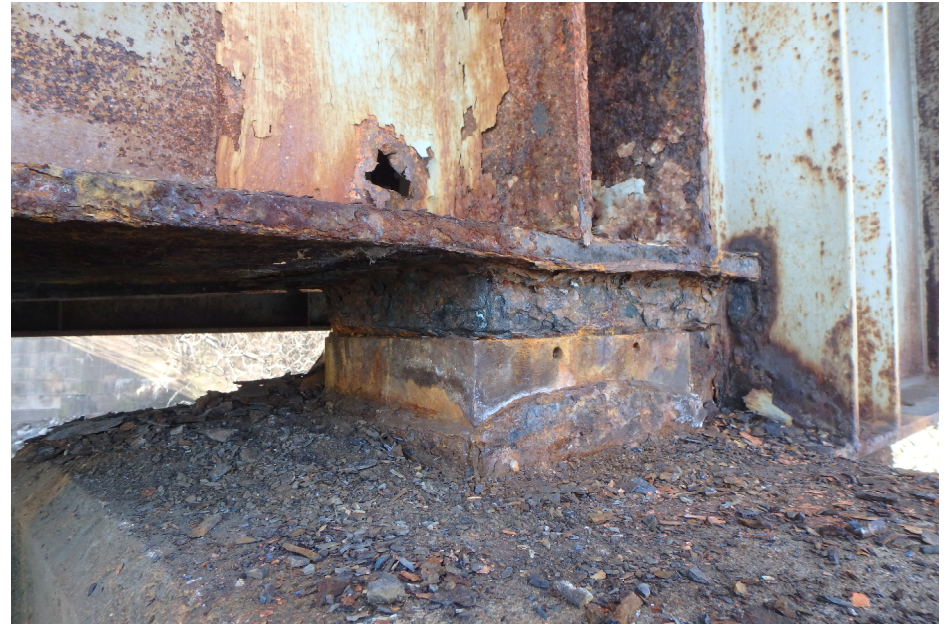
- There is light to heavy surface rust with up to 3/16" thick pack rust between the sole and sliding plates.
- Girder G0 bearing at Pier 1 in Span 2 exhibits laminated rust with 1/8" deep section loss at masonry and sole plates. See photo 4.

- o Maximum bearing loss: Span 2, girder G0 at Pier 1 exhibits 5" high x 4.5" wide knife edging with a 2.5" rusted through hole and stiffeners with 1/8" remaining and rusted through holes, resulting in up to 38.2% bearing loss. See photos 4 & 6-7.

**Photo # 4:** Girder G0 expansion sliding plate bearing at Pier 1 in span 2 exhibits laminated rust with section loss at masonry and sole plates. Note rusted through hole in girder web, north elevation.

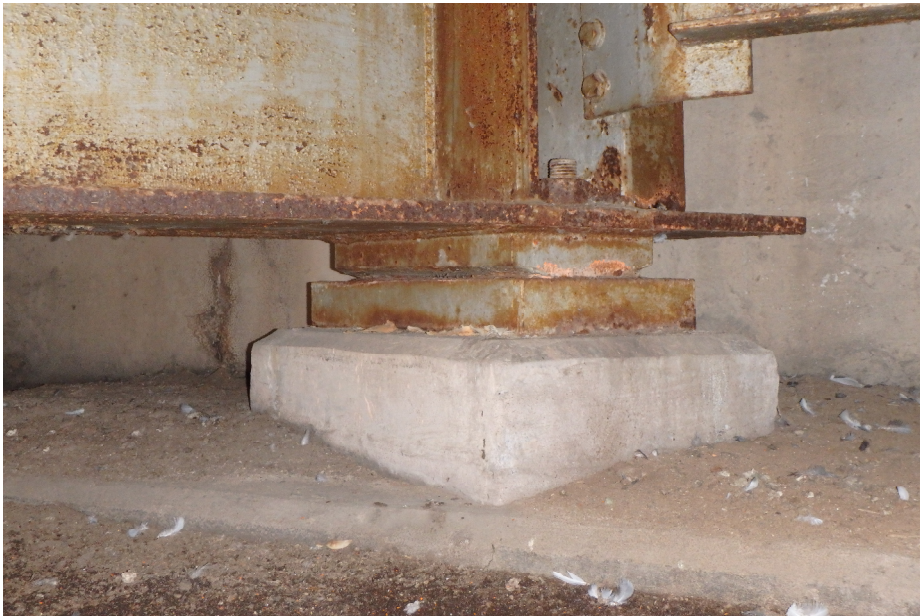
- The bearings in Span 1 over Pier 1 have random laminated rust with negligible section loss and up to 5/8" thick pack rust between the sole and masonry plates. See photo 5.

**Photo # 5:** Girder G3 fixed bearing at Pier 1 (Br. #00980A) in Span 2.

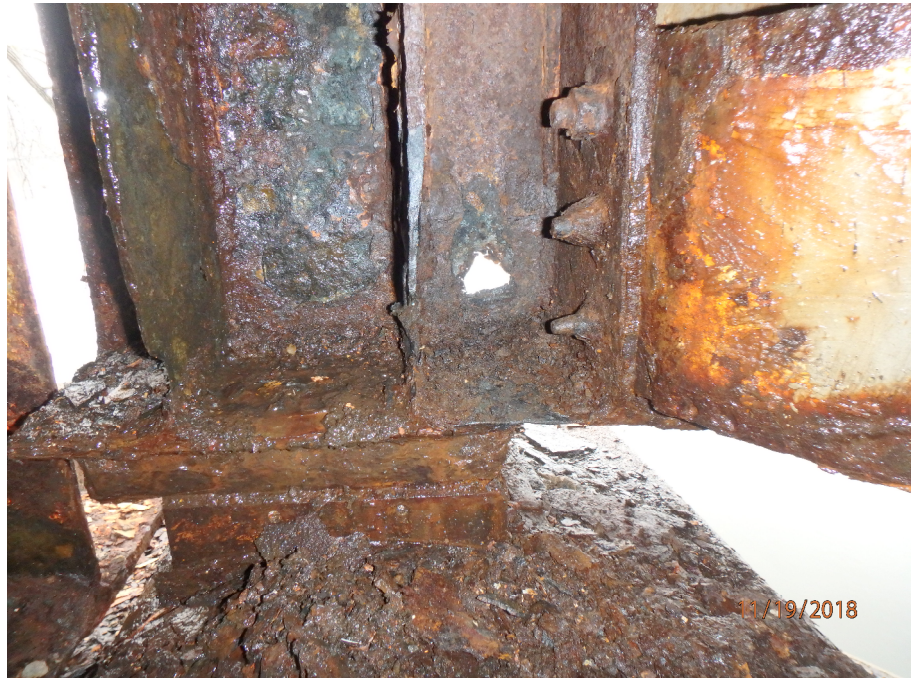
- o Span 1, abutment 1, girders G0-G3.
  - o Span 1, pier 1, girder G1.
  - o Span 2, pier 1, girders G0 & G2-G4.
  - o Maximum shear loss: Span 2, girder G0 at Pier 1 exhibits 39" high x 6" wide x 7/32" deep section loss between stiffeners over bearing, resulting in up to 46.8% shear loss.

**Photo # 6:** Girder G0, south elevation, at Pier 1 in Span 2 exhibits laminated rust with section loss at web, stiffeners and bottom flange.

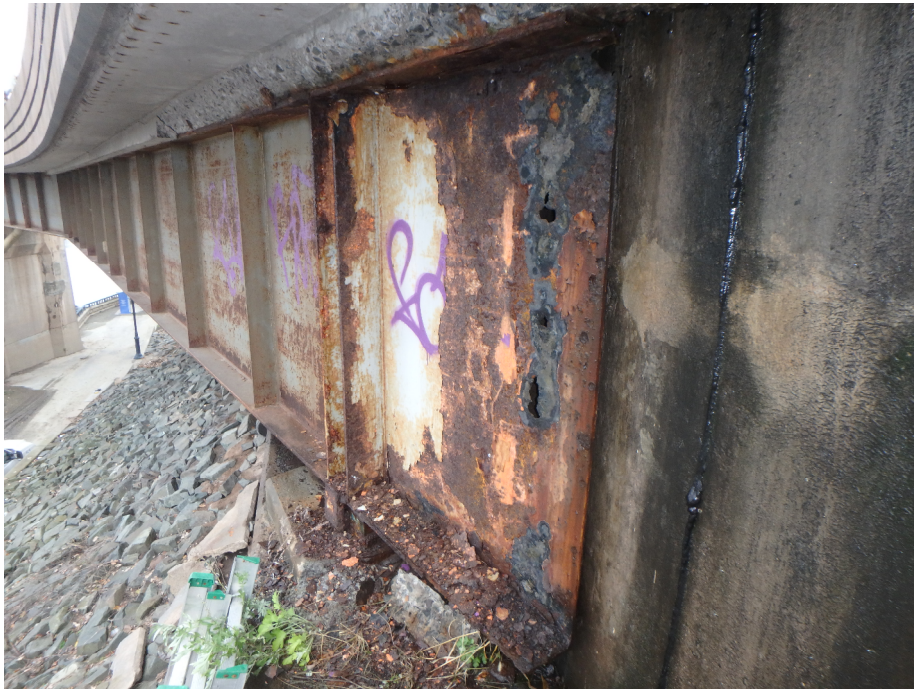
**Photo # 7:** Girder G0, north elevation, at Abutment 1 in Span 1, exhibits laminated rust with section loss at web and bottom flange. Note rusted through holes in web.

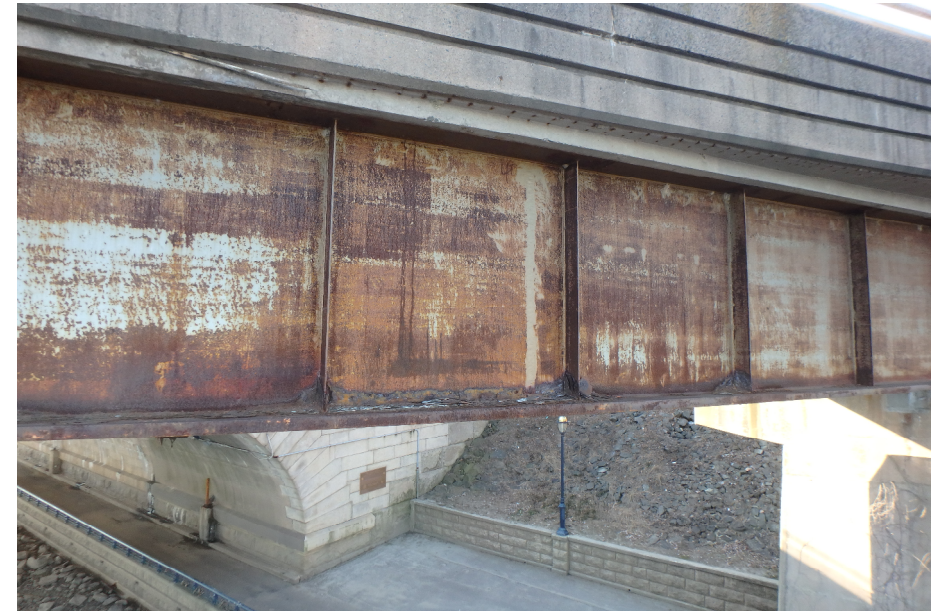
- Girder G1 bottom flanges at mid span of both spans have section loss up to 10' long x 7" high x 5/16" deep, resulting in up to 5% loss of cross sectional area. See photo 8.

**Photo # 8:** Girder G1, north elevation, at mid-span in Span 2 exhibits laminated rust with section loss at base of web, stiffeners and bottom flange.

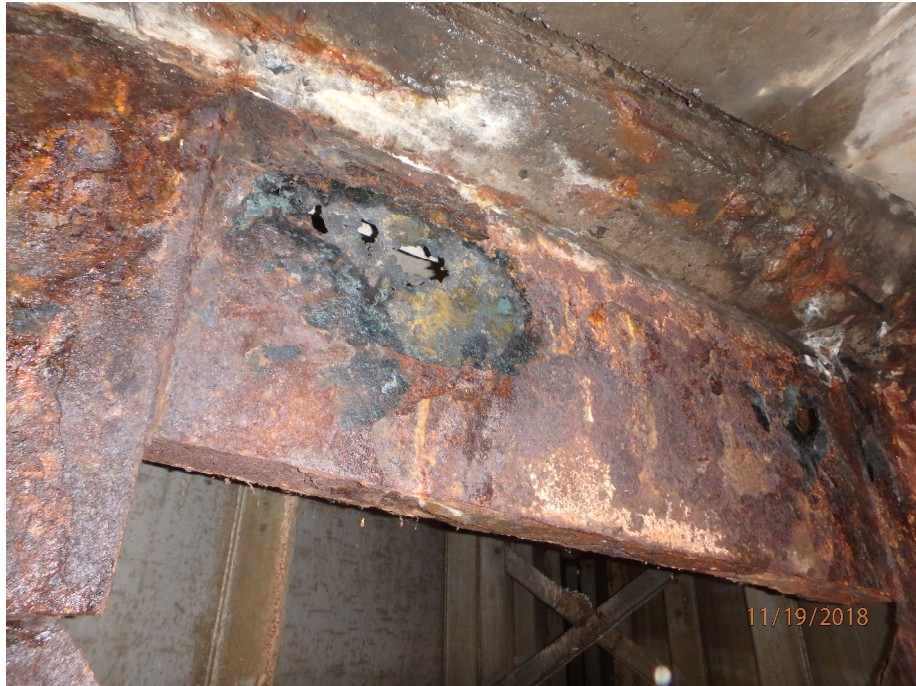
end cross frame at Girder G0 over Pier 1 in Span 2 has rust holes totaling 1' long x 3" wide. The channel web and bottom flange at this location have up to 50% section loss to the cross section, and connection plates exhibits up to 3/16" deep section loss and an isolated 2" x 1.5" rusted through hole at the lower connection plate. See photo 9. There is up to 3/8" thick pack rust between the top flange cross frames and the deck slab.

**Photo # 9:** End diaphragm in bay 0 at Pier 1 in Span 2 exhibits laminated rust with section loss and rusted through holes.
