Bridge No. 00980B  
Interstate-84 TR 826 over Connecticut River  
Hartford

Date: 11/19/2018

**EXECUTIVE SUMMARY**  
**11-19-18**

A special inspection was performed on the superstructure.

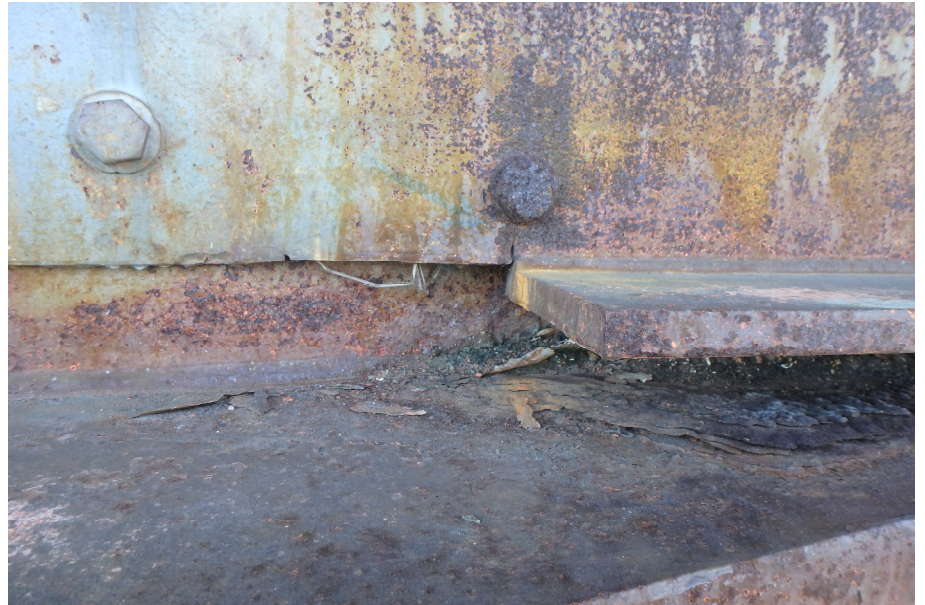
- Welds – Cracks: There is a 1-1/16" long crack with a stop hole and a bolt installed along the bottom of Girder G0 web cope at the connection to Girder G1 in Span 2 (no change this inspection). See photo 10. Girder G0 has a 3/8" overcut in the cope at the top of the web at the same connection to Girder G1. Neither condition has changed since the previous inspection.
- Member Alignment: The lower angle of end cross frame is bent up to 1/2" over 2' length in Span 2, Bay 1 over Pier 1.

**Photo # 10:** Girder G0 web cope connection to girder G1 in Span 2 exhibits crack with stop hole and a bolt installed previously.
