Subject: On-Call Asbestos, Lead, Air Quality & Demolition Compliance  
Agreement No. 8.07-01 (18)  
HazMat Inspection – Bridge No. 02812 (Bridge/Culvert/ACCOMPA), West  
Stafford Road & Orcuttville Road, Stafford Springs, CT  
ConnDOT Assignment No. 519-6167  
ConnDOT Project No. 134-147  
TRC Project No. 289951.6167.0710

TRC performed a limited hazardous materials site investigation associated with the planned rehabilitation of Bridge No. 02812 (Bridge/Culvert/ACCOMPA) in Stafford Springs, Connecticut. Lead paint was identified on the metal bridge railing surfaces on the West Stafford Road section of the site. The black tar material in the bridge wall beneath the road on the West Stafford Road section of the site was sampled and found to contain no detectable amounts of asbestos. However, the black tar material and membrane inside the corrugated metal culvert pipes on the Orcuttville Road section of the site were both sampled and found to be asbestos containing materials. No other suspect materials were identified. XRF data, laboratory results, site sketch, TRC Mobile Data Solutions report and site description/site map are attached.

## ConnDOT, Stafford Culvert, Tolland, , Staff

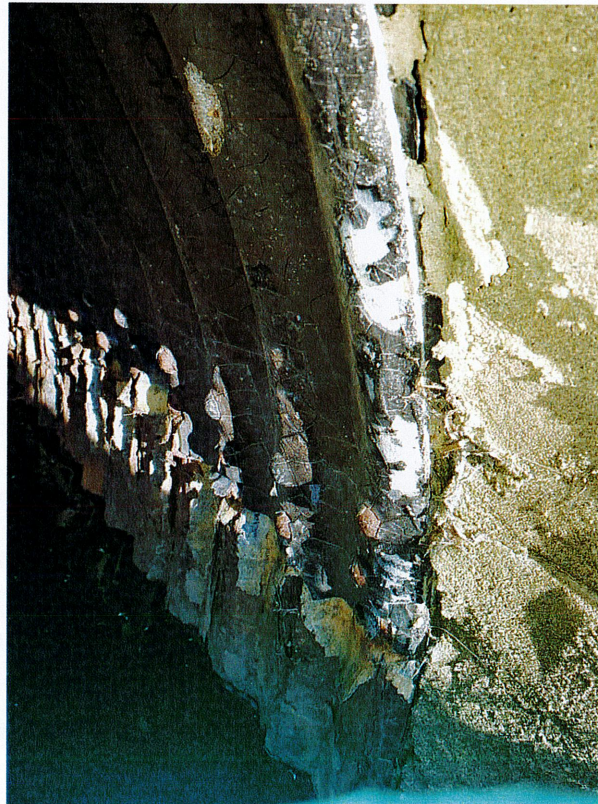
( 3 ), T1, Black tar coating , 3

Material Acronym	T1
Material Description	Black tar coating
Is Material a Non-Friable Organically Bound (NOB)	Yes
Total Approximate Quantity	300 sqft
Total Count	( 3 )
Total Count (number only)	3

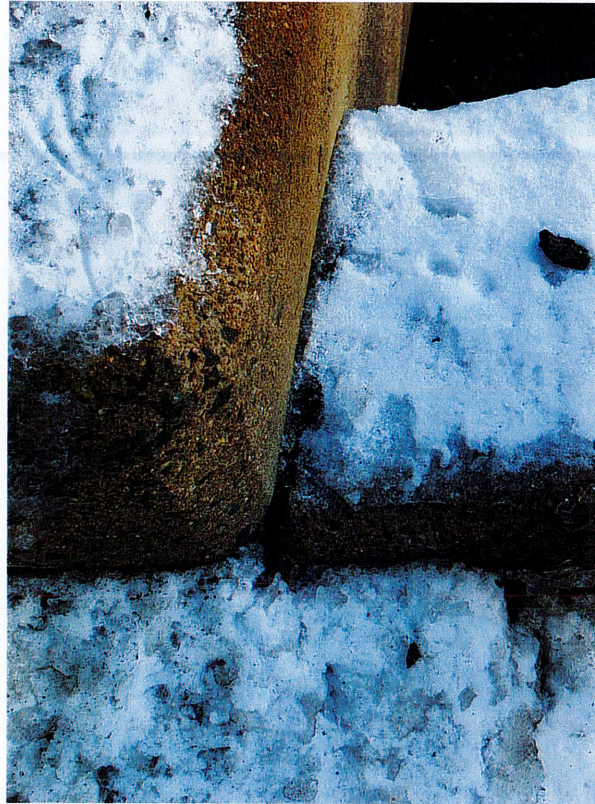
**( 2 ), T 2, Black tar in bridge wall underneath road , 2**

Sampled or Assumed?	Sampled
Material Acronym	T 2
Material Description	Black tar in bridge wall underneath road
Is Material a Non-Friable Organically Bound (NOB)	Yes
Homogeneous Area	West Stafford Rd under bridge
Total Approximate Quantity	~ 10 LF
Total Count	( 2 )
Total Count (number only)	2
