August 31, 2018

Subject: Hazardous Material Inspection Report for the Replacement of Bridge No. 04744, Town of North Stonington, Connecticut and Westerly, Rhode Island.  
TRC Project Number 31004.0001.0000

## **INSPECTOR NOTES/SKETCHES**

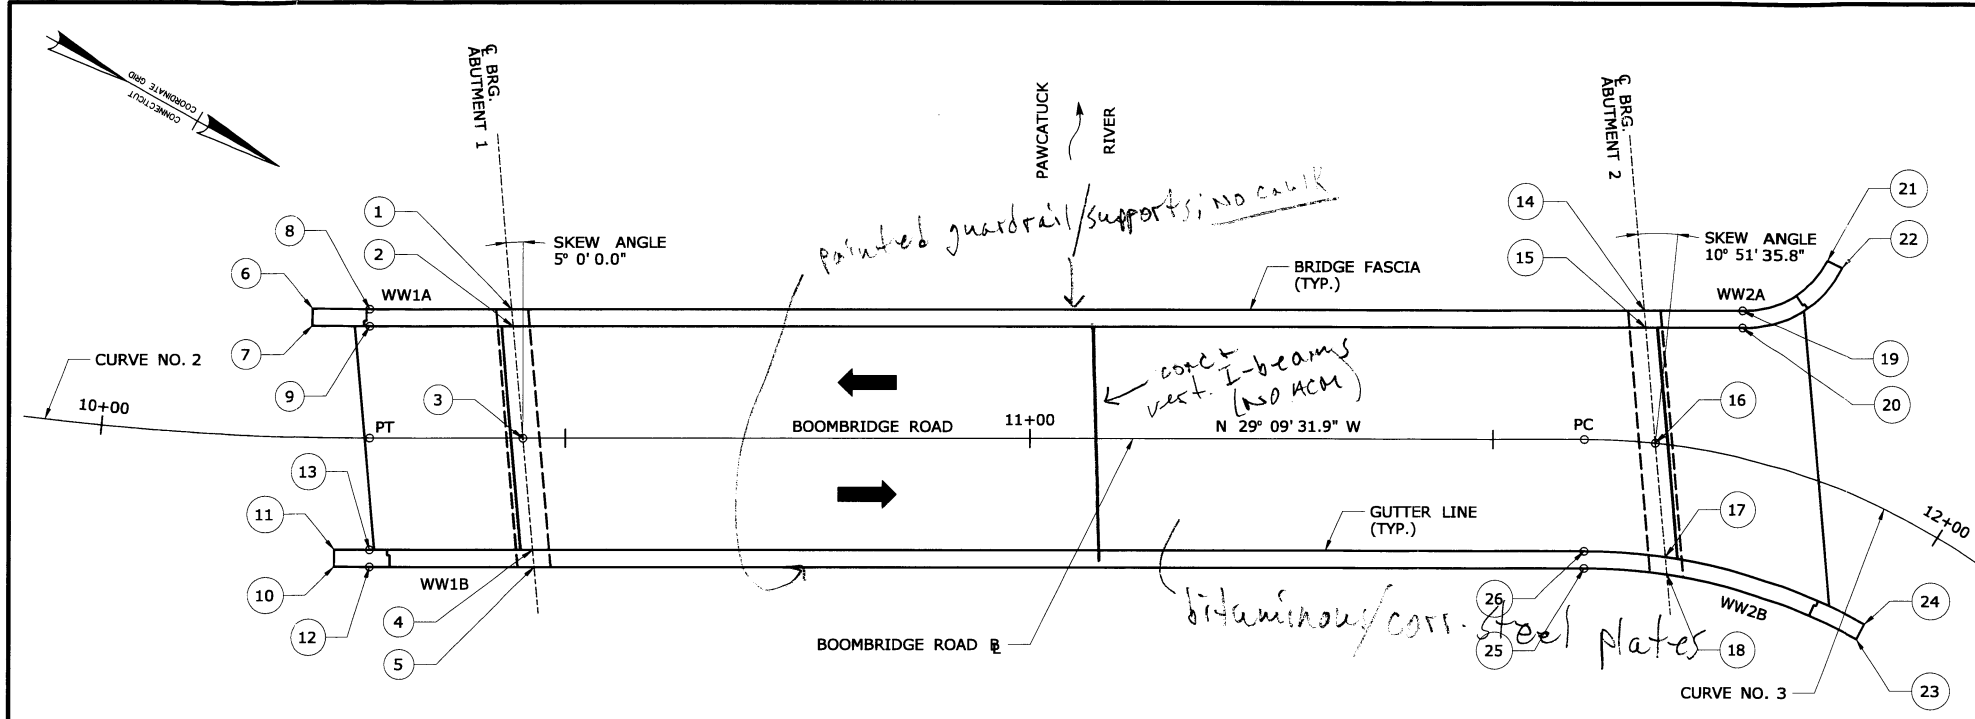
**LAYOUT PLAN**  
SCALE: 1" = 10'

\* NO susp ACM\*
