CONTAMINATED WATER PIPING REPLACEMENT

**HEBRON ELEMENTARY SCHOOL
92 CHURCH STREET
HEBRON, CT 06248
STATE PROJECT NO. 067-0042 CV
BID #2020-03**

Limited Hazardous Building Materials Inspection

Re: Limited Hazardous Building Materials Inspection
Water Remediation Project
Hebron Elementary School, 92 Church Street, Hebron, Connecticut
Fuss & O'Neill Project No. 20160168.W30

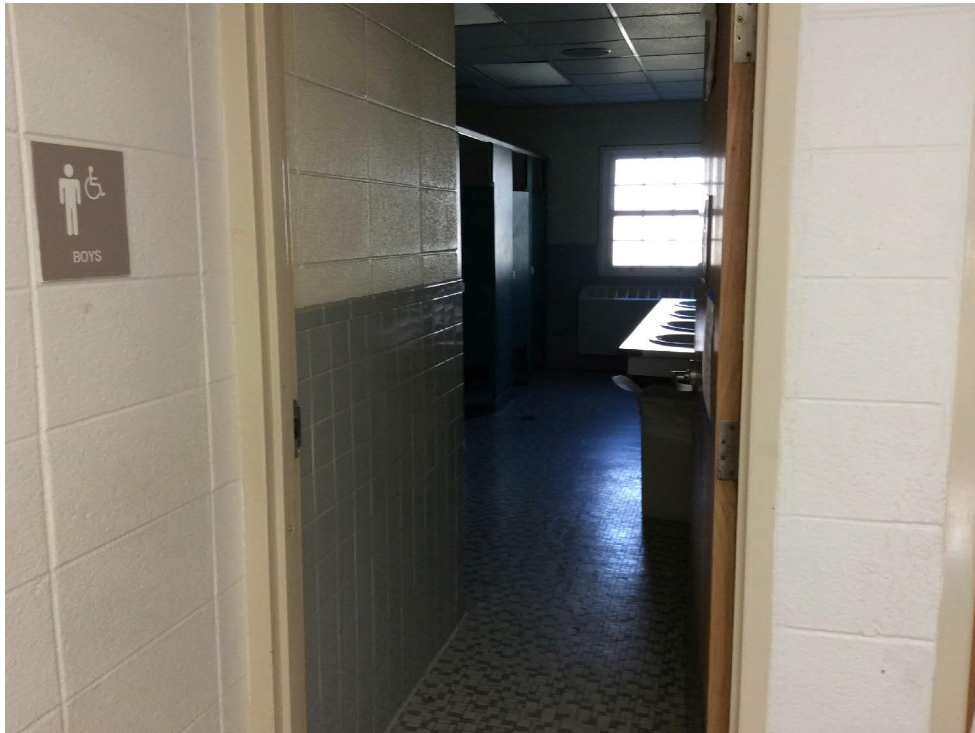
Lead Containing Blue Ceramic Wall Tile – 1963 Wing Boys' Lavatory

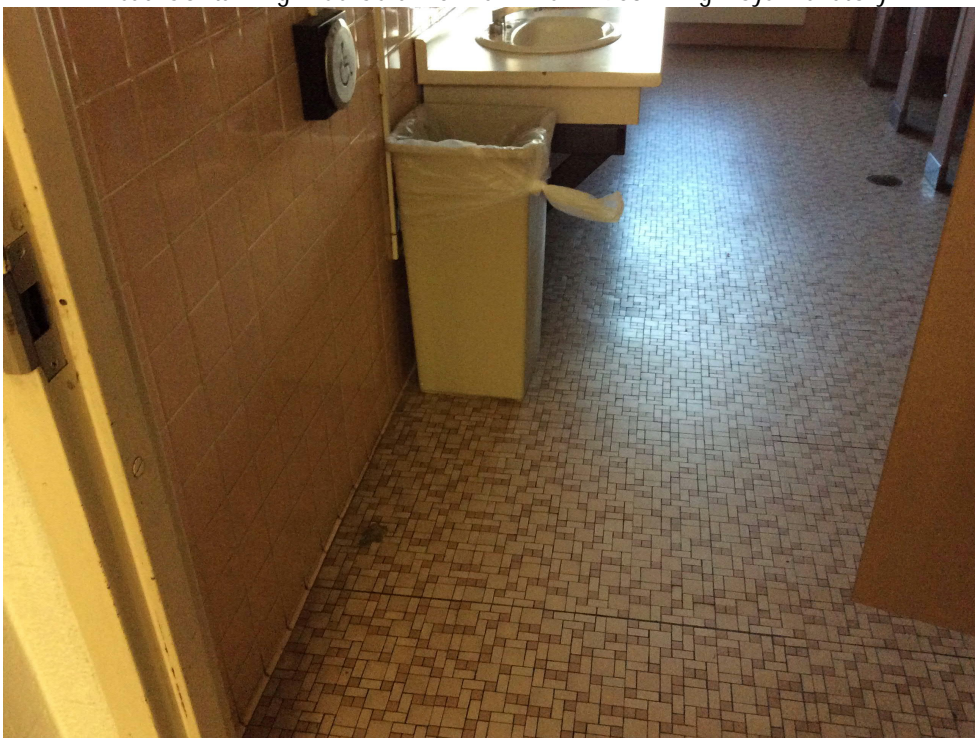
Lead Containing Pink Ceramic Wall Tile – 1963 Wing Girls' Lavatory

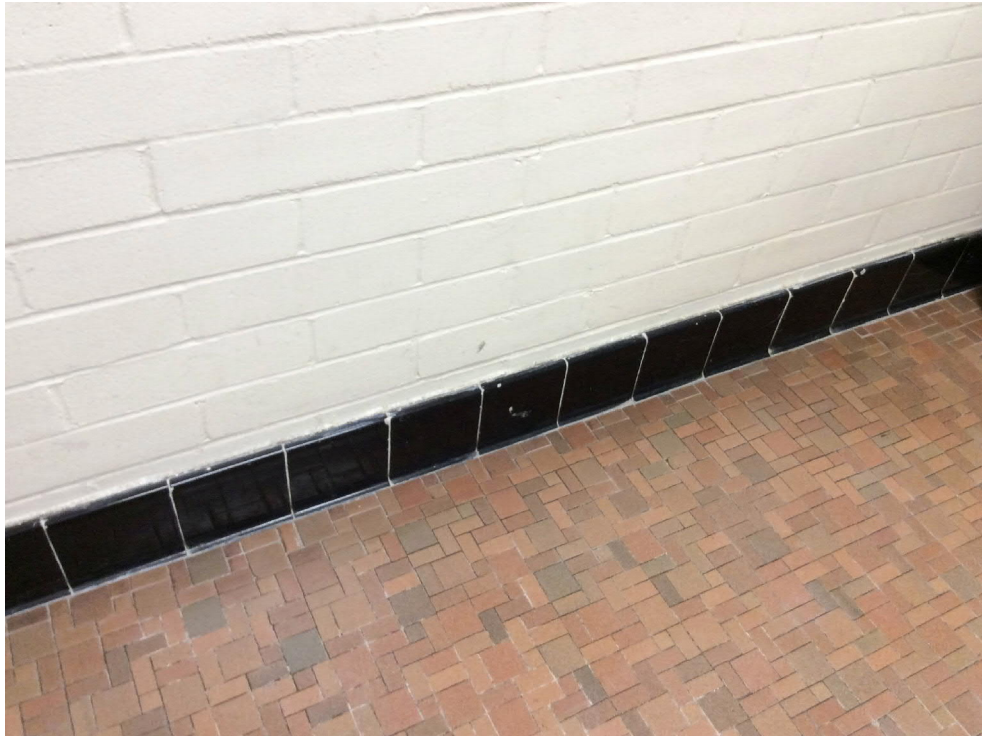
Lead containing black ceramic cove base tiles

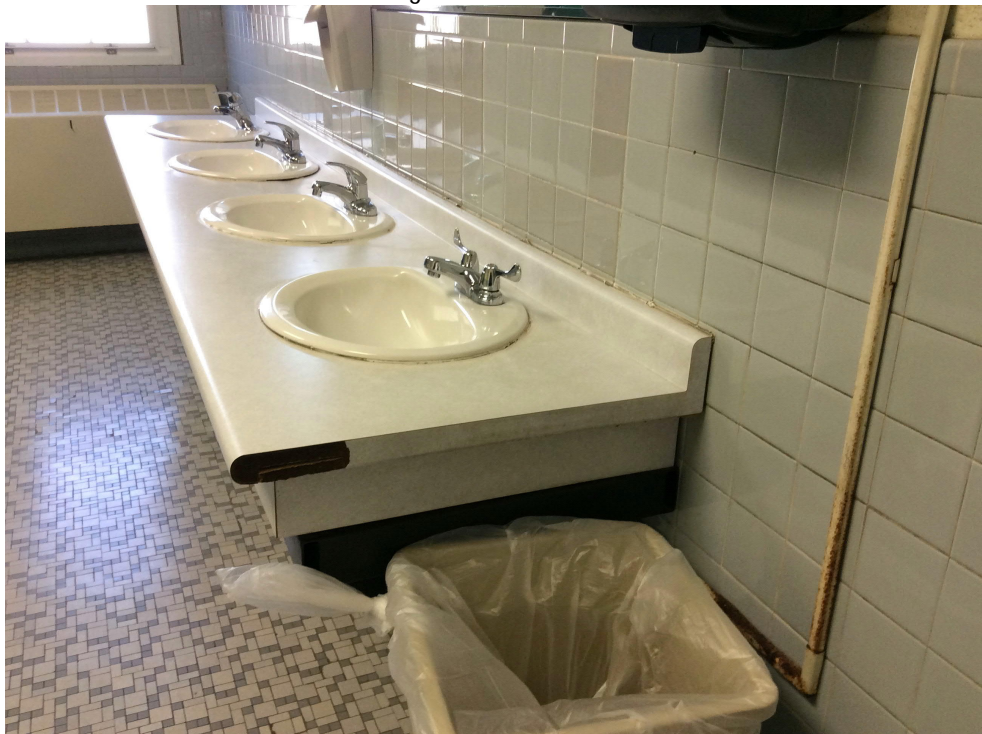
Asbestos-containing white caulking at sink unit counter in Boys' Lavatory

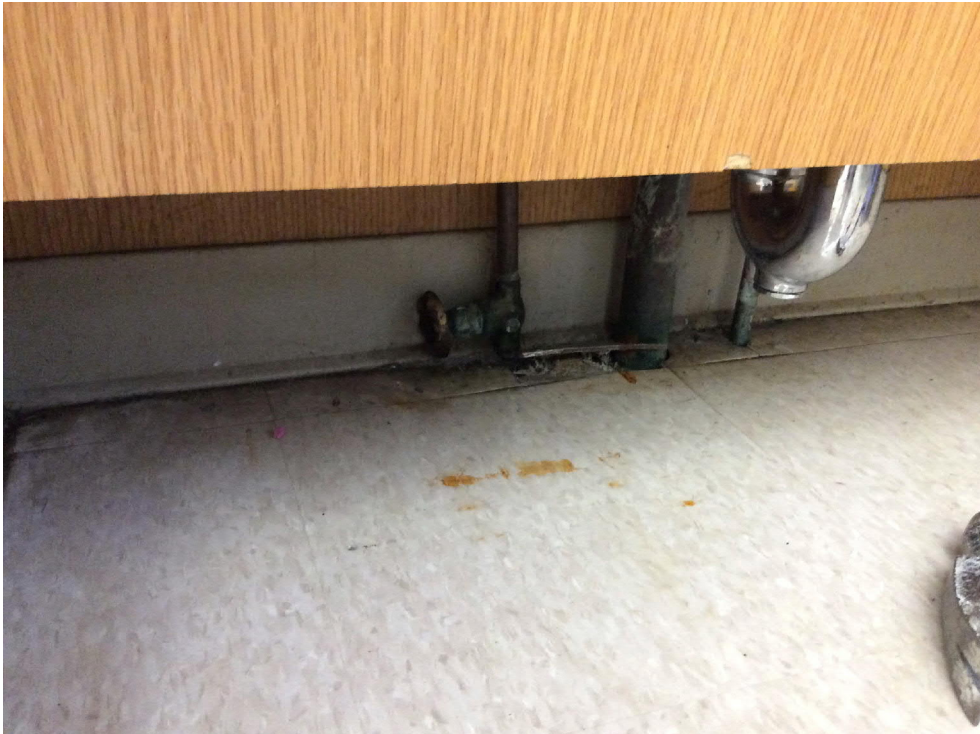
Assumed asbestos-containing air cell at concrete floor plumbing penetration

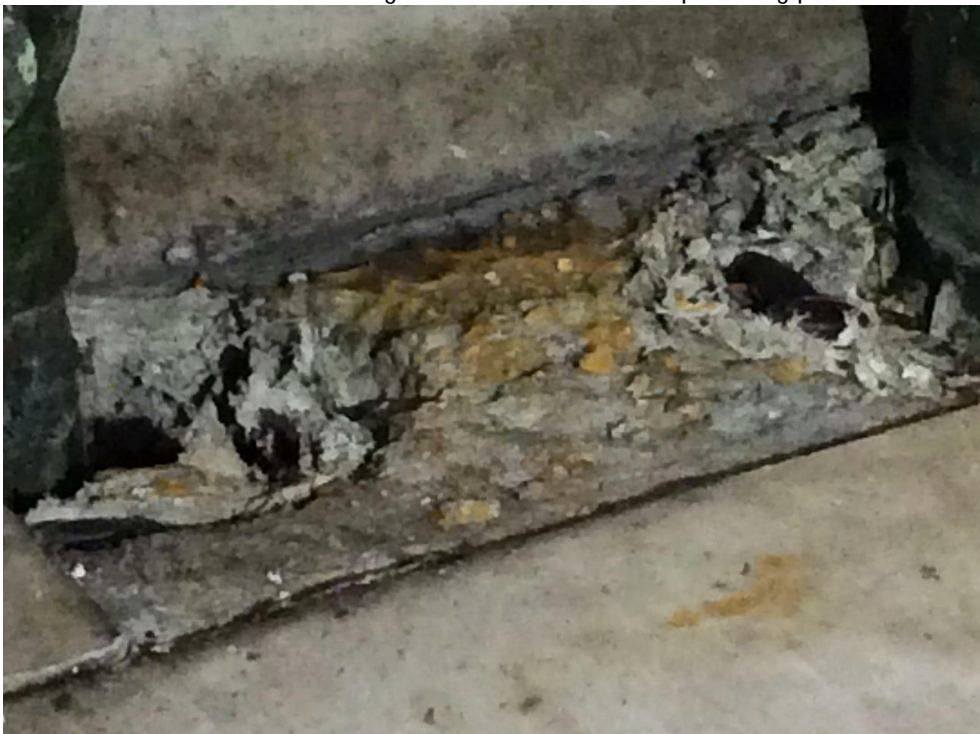
Assumed air cell pipe insulation at concrete floor pipe penetration (close up)
