**PRE-RENOVATION  
INVESTIGATIVE SURVEY FOR  
HAZARDOUS BUILDING MATERIALS**

**WINDSOR MAINTENANCE FACILITY  
ROOF REPLACEMENT PROJECT  
WINDSOR, CONNECTICUT**  
Project No. 164-241

Issued  
September 2019

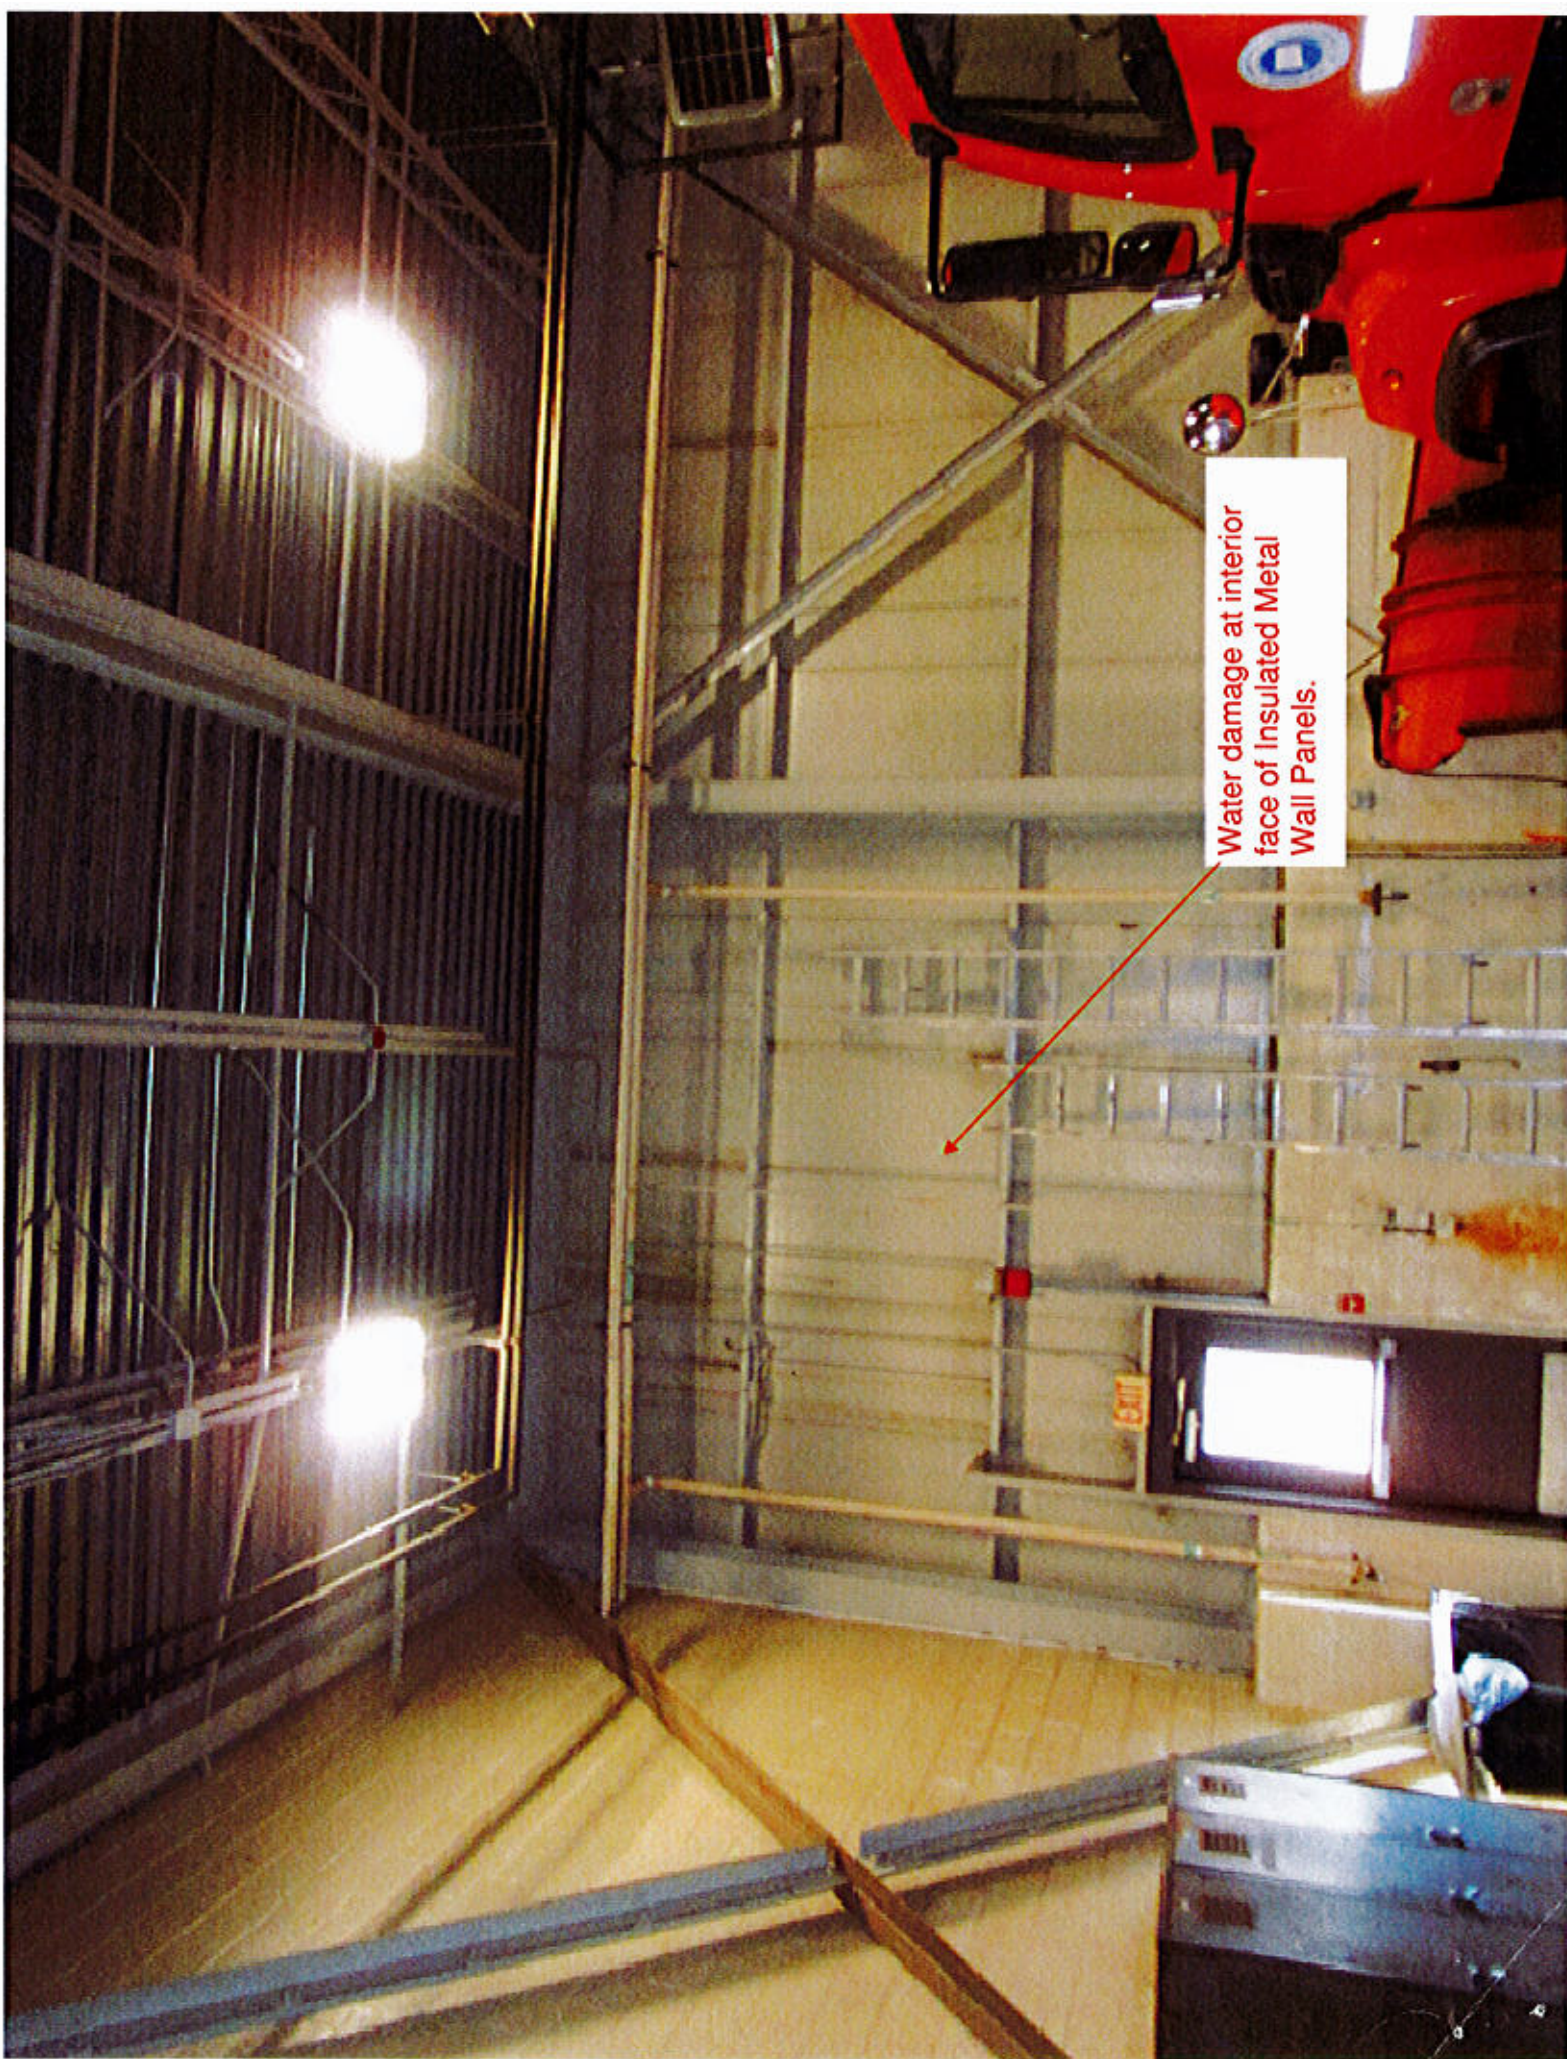
Water damage at interior face of Insulated Metal Wall Panels.

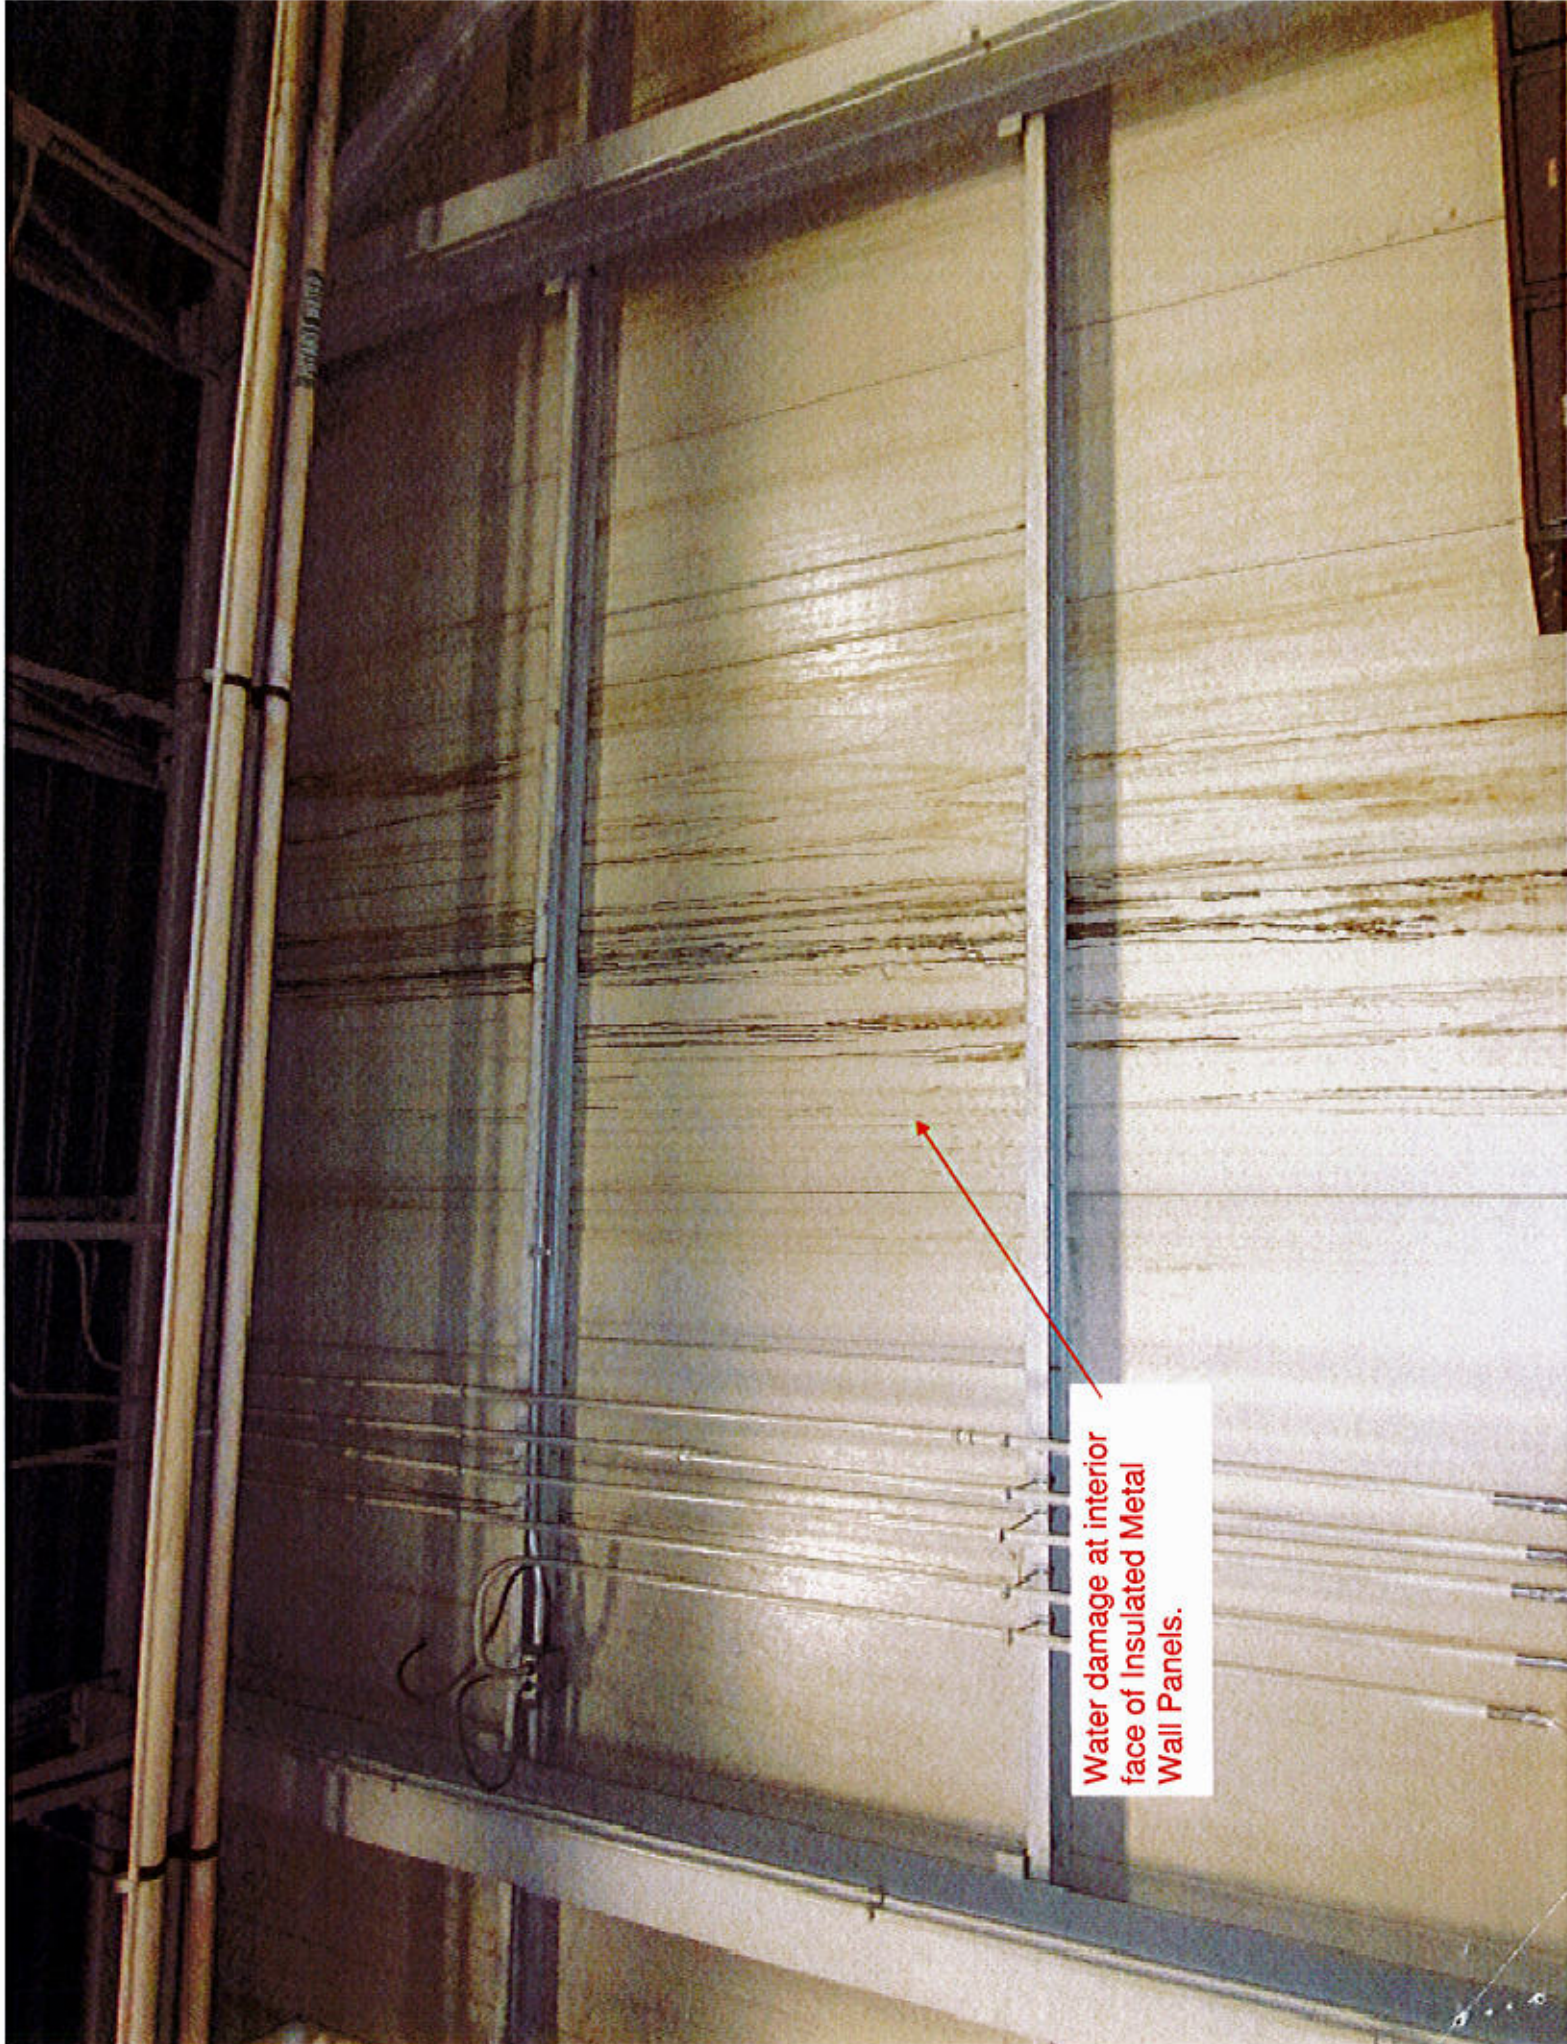
Water damage at interior face of Insulated Metal Wall Panels.

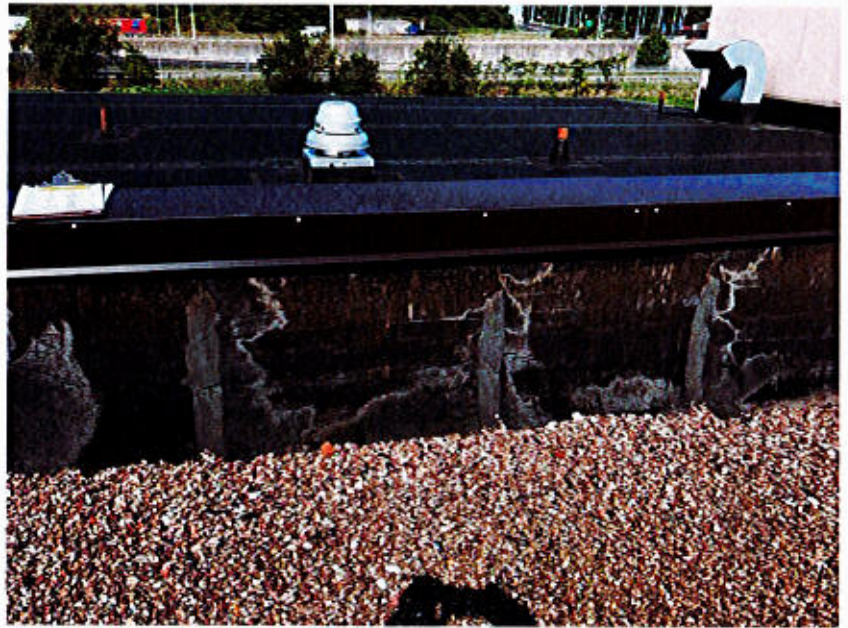
Sampled or Assumed?	Assumed
Accessibility	Accessible
Material Acronym	FL, 1
Material Description	Gray/beige parapet roof flashing coping joint sealant
Is Material a Non-Friable Organically Bound (NOB)	Yes
Homogeneous Area	Roof 2
Total Approximate Quantity	405F
Total Count	( 1 )
Total Count (number only)	1

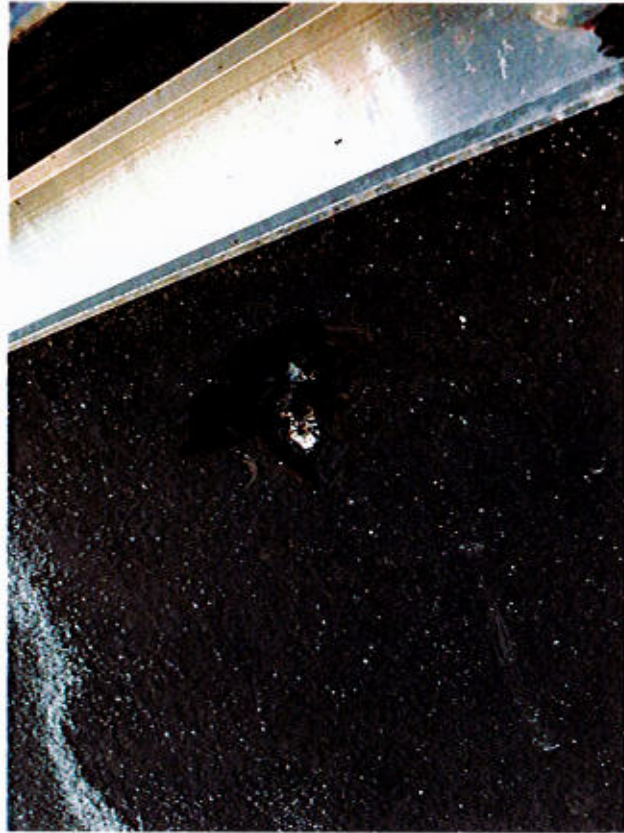
Sampled or Assumed?	Assumed
Material Acronym	FL, 2
Material Description	Silver painted roof flashing paper, first and second layers on roof 2
Is Material a Non-Friable Organically Bound (NOB)	Yes
Homogeneous Area	Roof 2
Total Count	( 1 )
Total Count (number only)	1

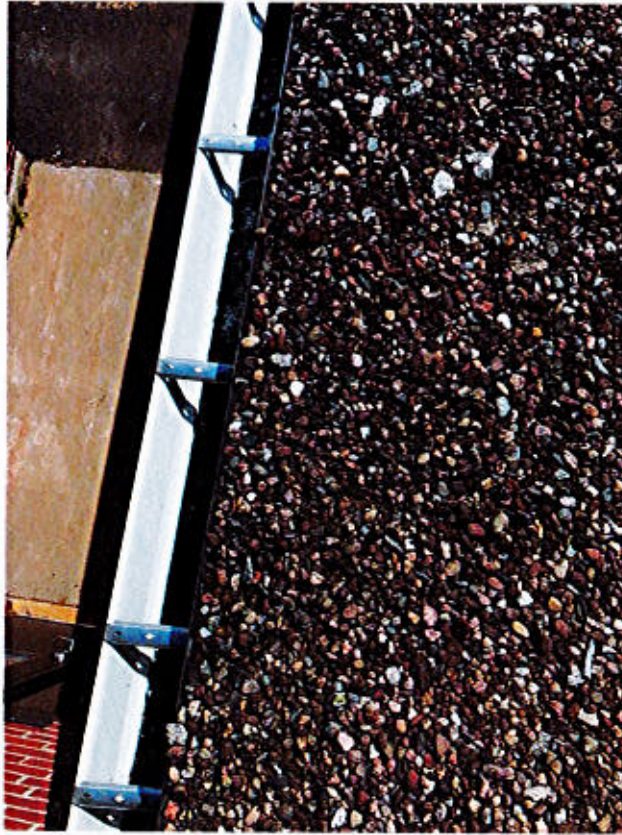
Sampled or Assumed?	Assumed
Material Acronym	FL, 3
Material Description	Black roof flashing cement
Is Material a Non-Friable Organically Bound (NOB)	Yes
Homogeneous Area	Roof 2
Total Approximate Quantity	400 SF
Total Count	( 1 )
Total Count (number only)	1

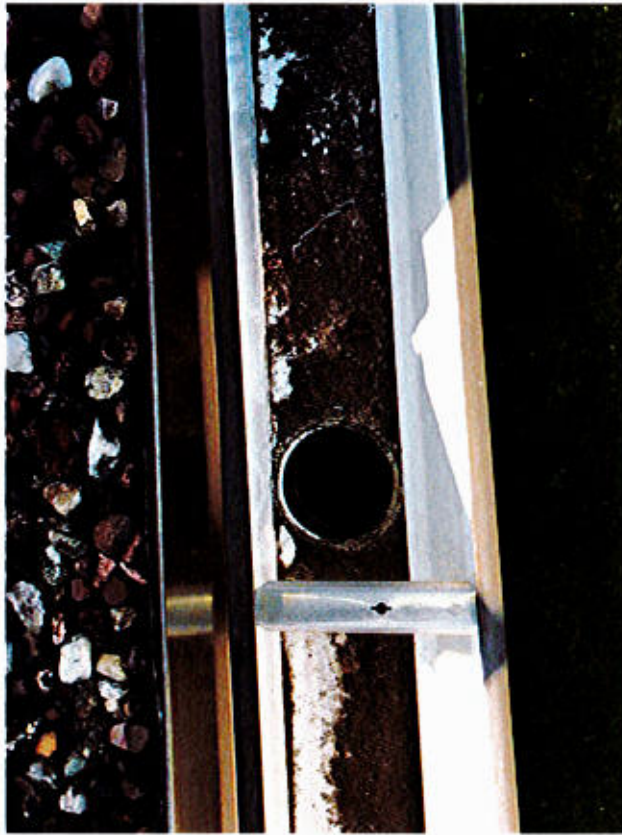
Sampled or Assumed?	Assumed
Accessibility	Inaccessible
Material Acronym	FL, 4
Material Description	Down spout sealant
Is Material a Non-Friable Organically Bound (NOB)	Yes
Homogeneous Area	Down spout on Roof 2
Notes	Not there. Downspouts are new
Total Count (number only)	0

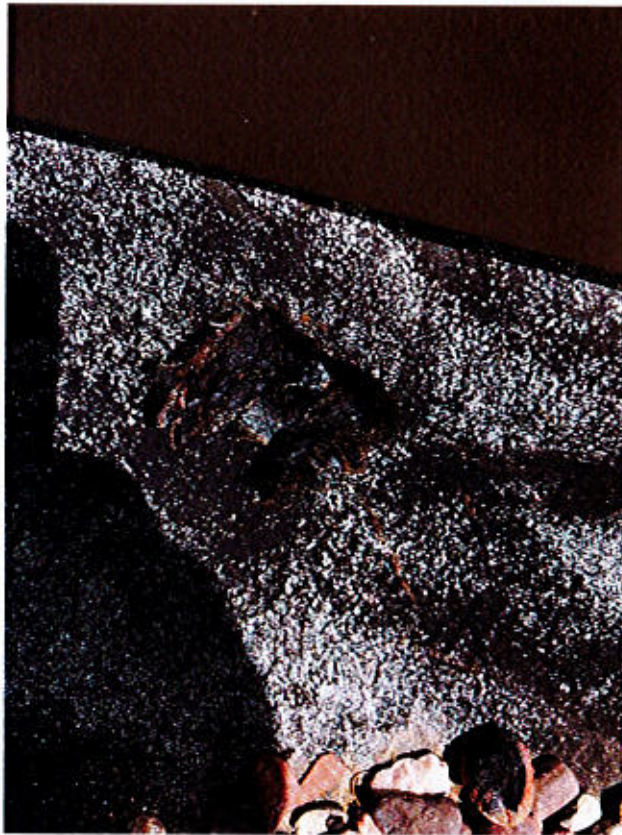
Sampled or Assumed?	Assumed
Accessibility	Accessible
Material Acronym	FL, 5
Material Description	Silver painted roof flashing paper first and second layers on chimney
Is Material a Non-Friable Organically Bound (NOB)	Yes
Homogeneous Area	Roof 2 chimney
Total Approximate Quantity	75F
Total Count (number only)	0

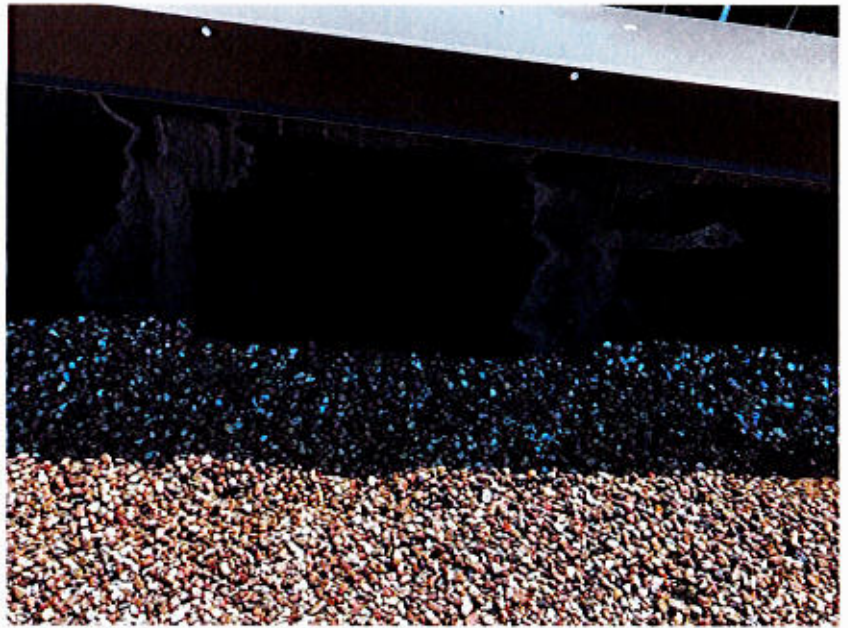
Sampled or Assumed?	Assumed
Accessibility	Accessible
Material Acronym	PC-1
Material Description	Gray patching cement
Is Material a Non-Friable Organically Bound (NOB)	Yes
Homogeneous Area	Roof
Total Approximate Quantity	5 SF
Total Count (number only)	0

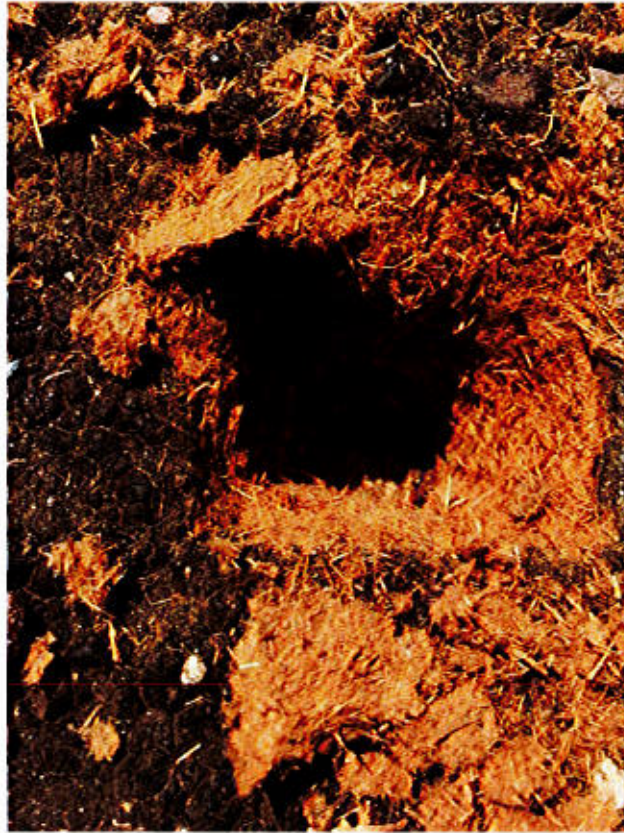
Partical board layers with a tar coating over concrete roof

Sampled or Assumed?	Sampled
Material Acronym	RF, 1
Material Description	Built up roofing, partial board layers with a tar coating over concrete roof base
Is Material a Non-Friable Organically Bound (NOB)	No
Homogeneous Area	Roof 2
Total Count	( 1 )
Total Count (number only)	1
