BRIDGE NO.01218

52980 - NEWTOWN
INTERSTATE 84 EASTBOUND
over
HOUSATONIC RIVER

Fracture Critical and Routine Inspection

9/10/2018

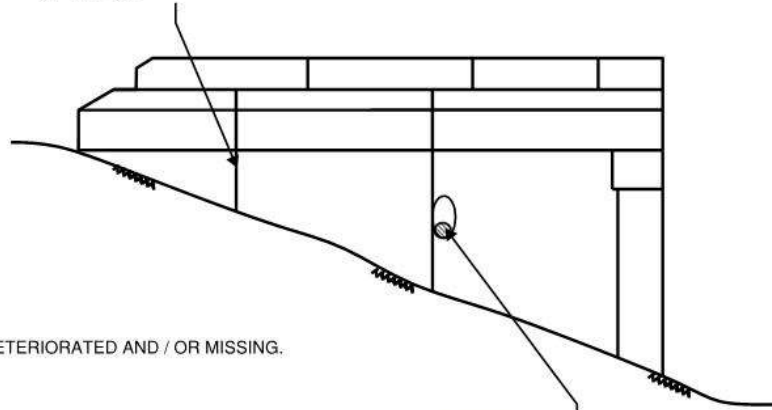
WINGWALL 1B
NTS

JOINT OPEN 3/4"; WING IS MISALIGNED 13/16" AT THE BASE OF THE JOINT AND 1-3/4" AT THE TOP

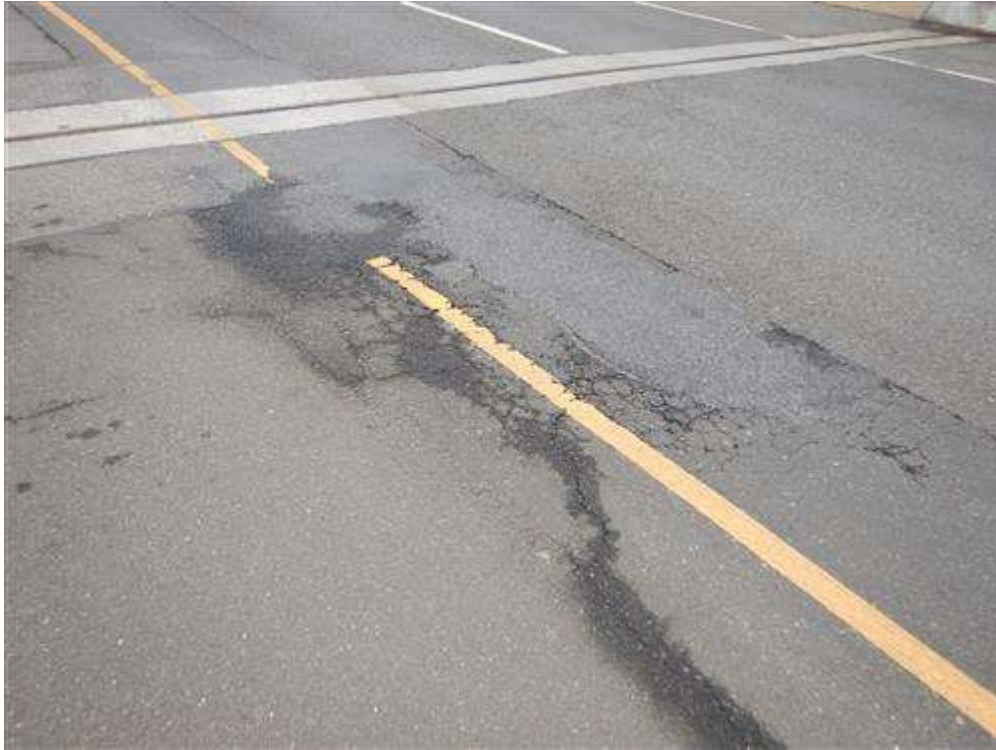
Photo Number: 7

- Paving seams are open slightly.
- Spans 1 and 2 have random longitudinal cracks up to 25' long x up to 1/8" wide in the left shoulder.
- Span 4 in the Left Lane near Abutment 2 has an area of map cracking 5' long x 3' wide with a pothole 6" long x 4" wide x 1-1/2" deep with exposed deck (See Photo 7).

Span 4 Bituminous Concrete Overlay

Note: 5' long x 3' wide map cracks.

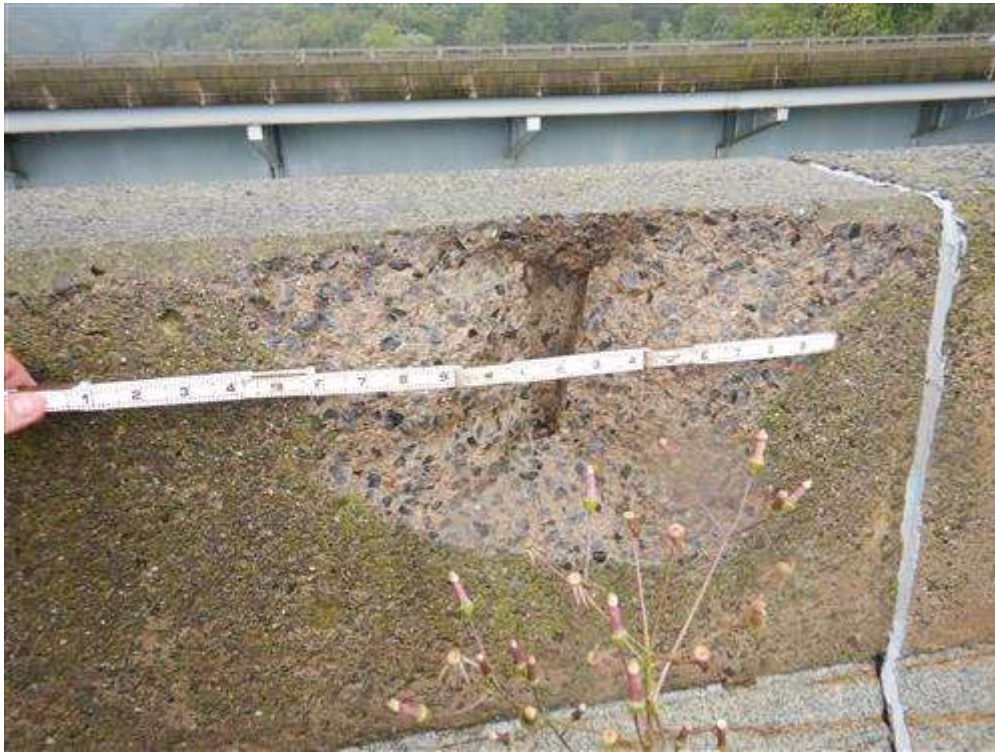
Photo Number: 15

Left Parapet, Span 4 at Pier 3

Note: Spall 18" long x 1' high x 3" deep.

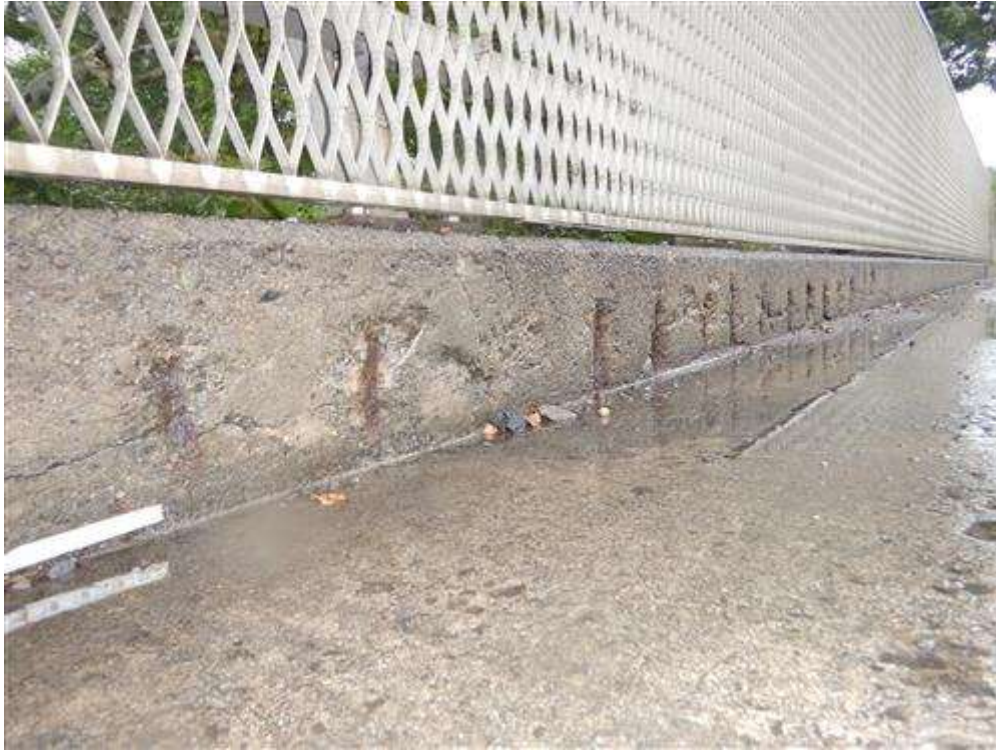
Photo Number: 17

Right Fence Base, Span 1

Note: Several spalls up to 8" high x 3' long x 1-1/2" diameter.

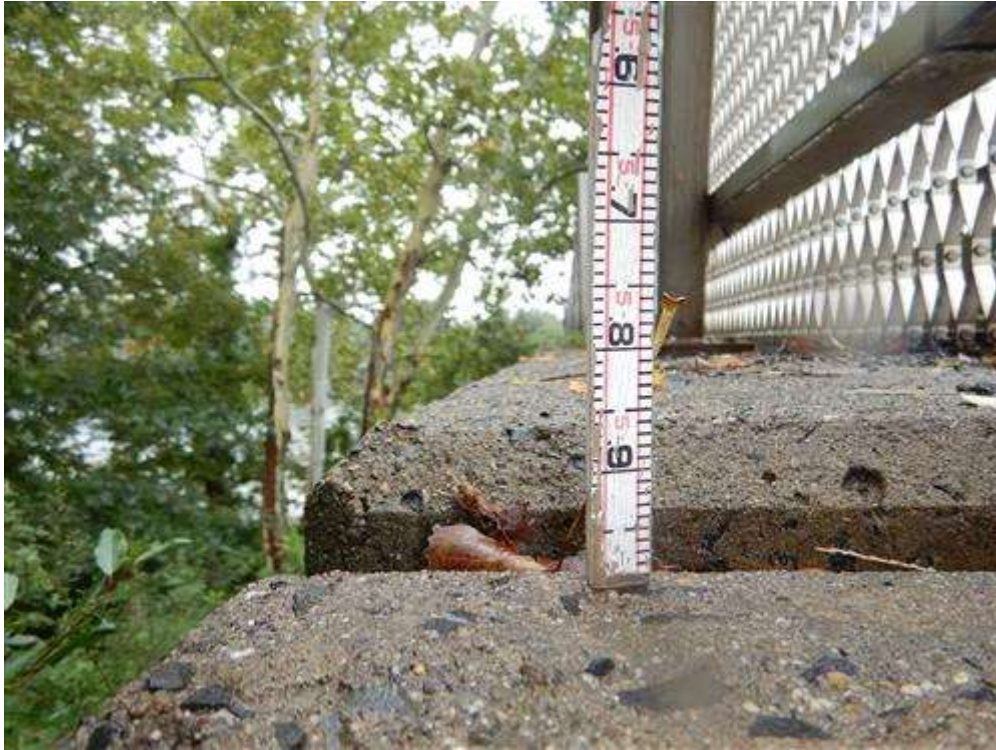
Photo Number: 19

Wingwall 2B

Note: Vertical/lateral misalignment.

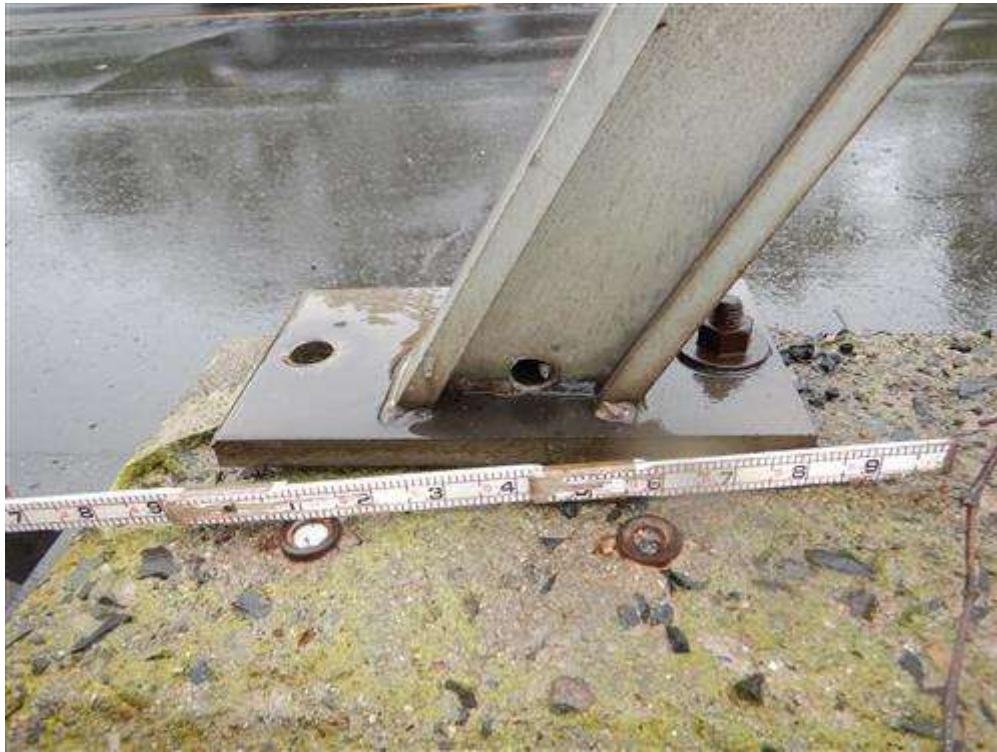
Photo Number: 21

- Random collision scrapes.
- Left Rail in Span 2 has a 3" long x 1" wide tear (See Photo 20).
- Right Rail Post in Span 2 near Pier 2 is undermined due to a spall exposing two anchor bolts.
- Span 4 Left and Right Rail Posts have isolated locations of loose and missing anchor bolt nuts (See Photo 21).

Left Railing at Abutment 2

Note: 1 of 2 anchor bolts missing at end.

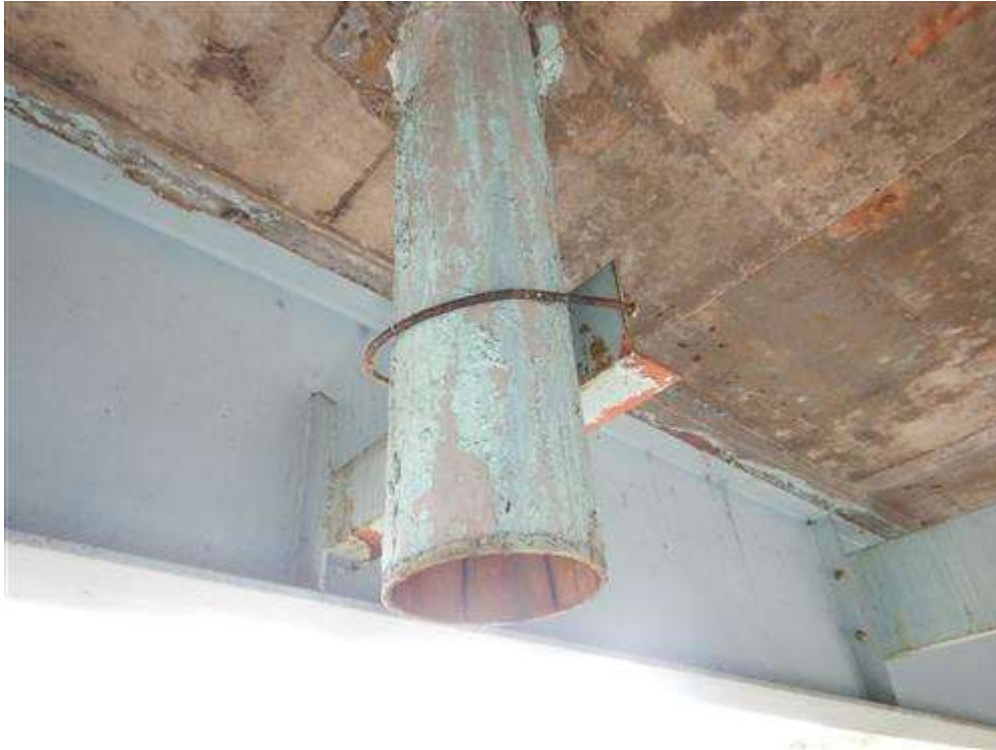
Photo Number: 23

Scupper Adjacent to Stringer 1 Between Floor Beam 23 and 24

Note: Broken u-bolts at connection.

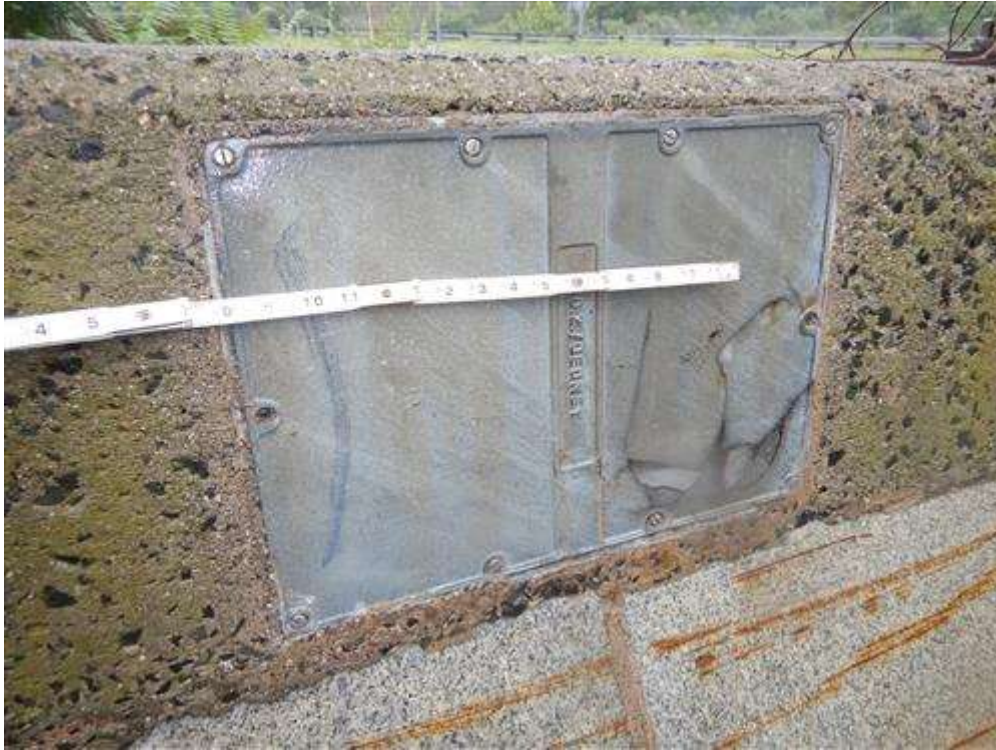
Photo Number: 25

- Span 1, Left (West) Parapet junction box has (1) screw that is not fully tightened.
- Span 1, Right (East) Parapet junction box cover has is missing (6) of (10) screws.
- Span 2, Left (West) Parapet junction box is missing (2) of (10) screws.
- Left (West) Parapet in the North Approach has a junction box cover that is cracked with (2) of (10) screws missing (See Photo 25).

Junction Box Cover at Northwest Approach Pavement

Note: Cracked/dented with 2 missing screws.

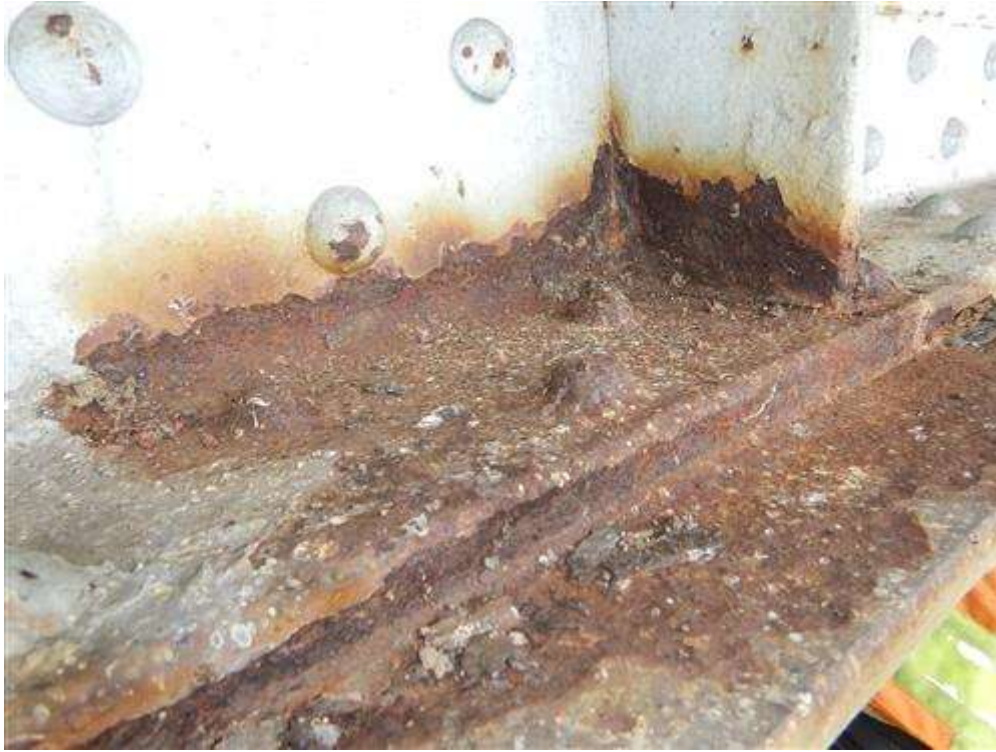
Photo Number: 49

Girder 2 East Face at Floor Beam 21

Note: Bottom flange section loss.

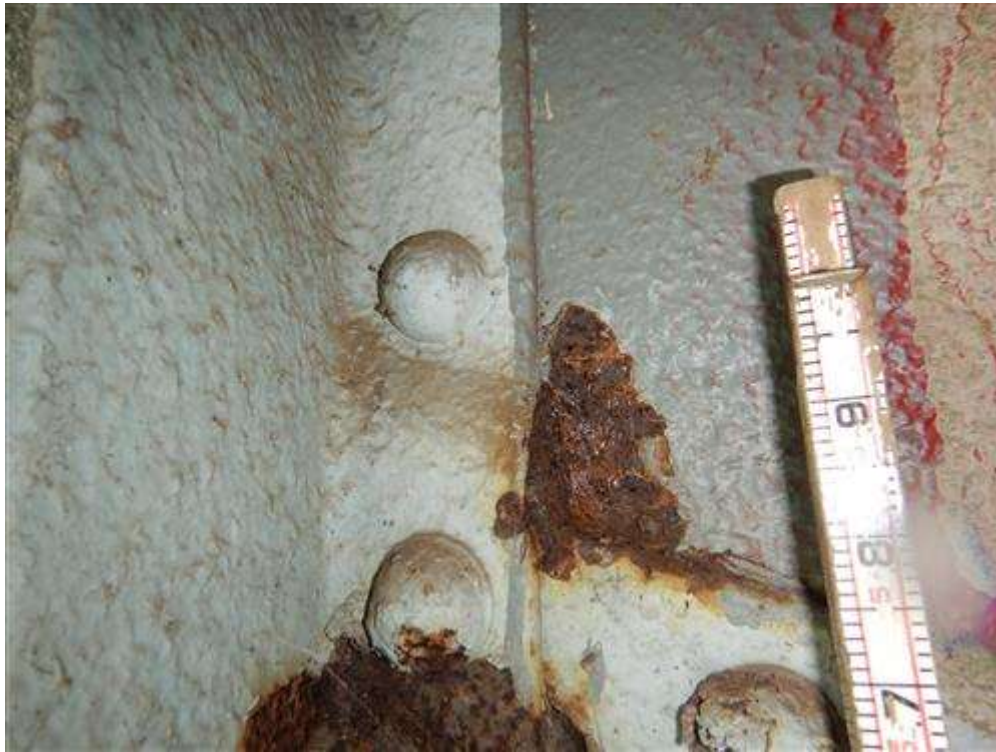
Photo Number: 53

Floor Beam 1, North Face, Under Stringer 7

Note: Web section loss 2" diameter x 1/4" diameter with pinhole at base.
