## BRIDGE NO.01218

52980 - NEWTOWN  
INTERSTATE 84 EASTBOUND  
over  
HOUSATONIC RIVER

Underwater Inspection  
7/18/2018  
Inspected by: Infrastructure

**Project No.:** 170-3339 (Underwater Inspections – NHS)

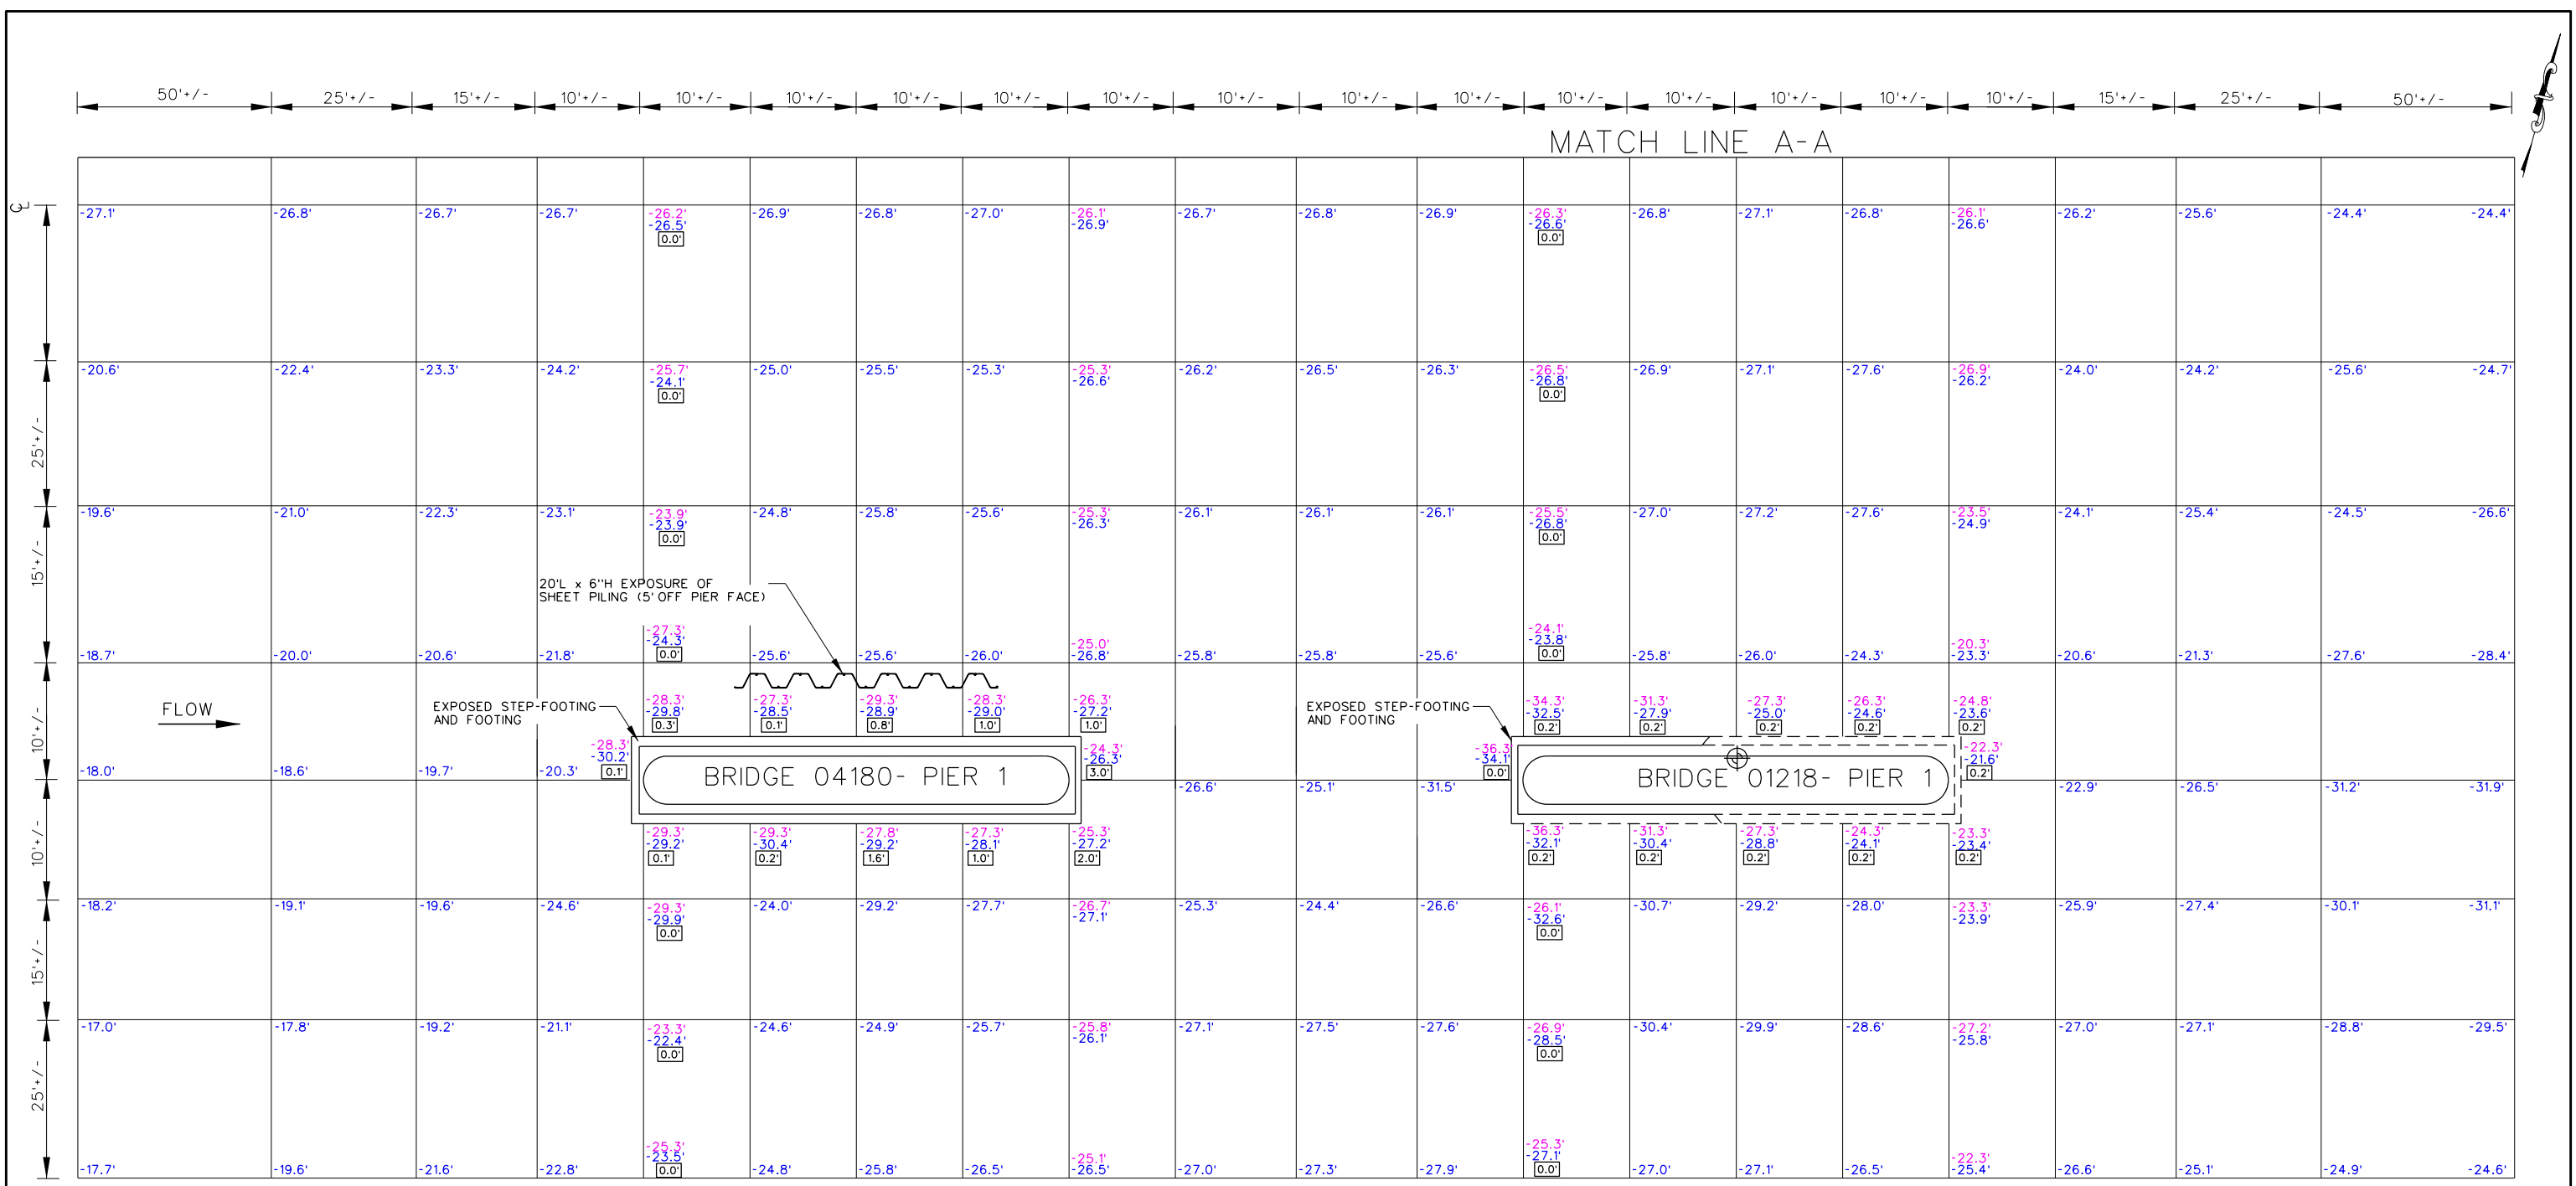
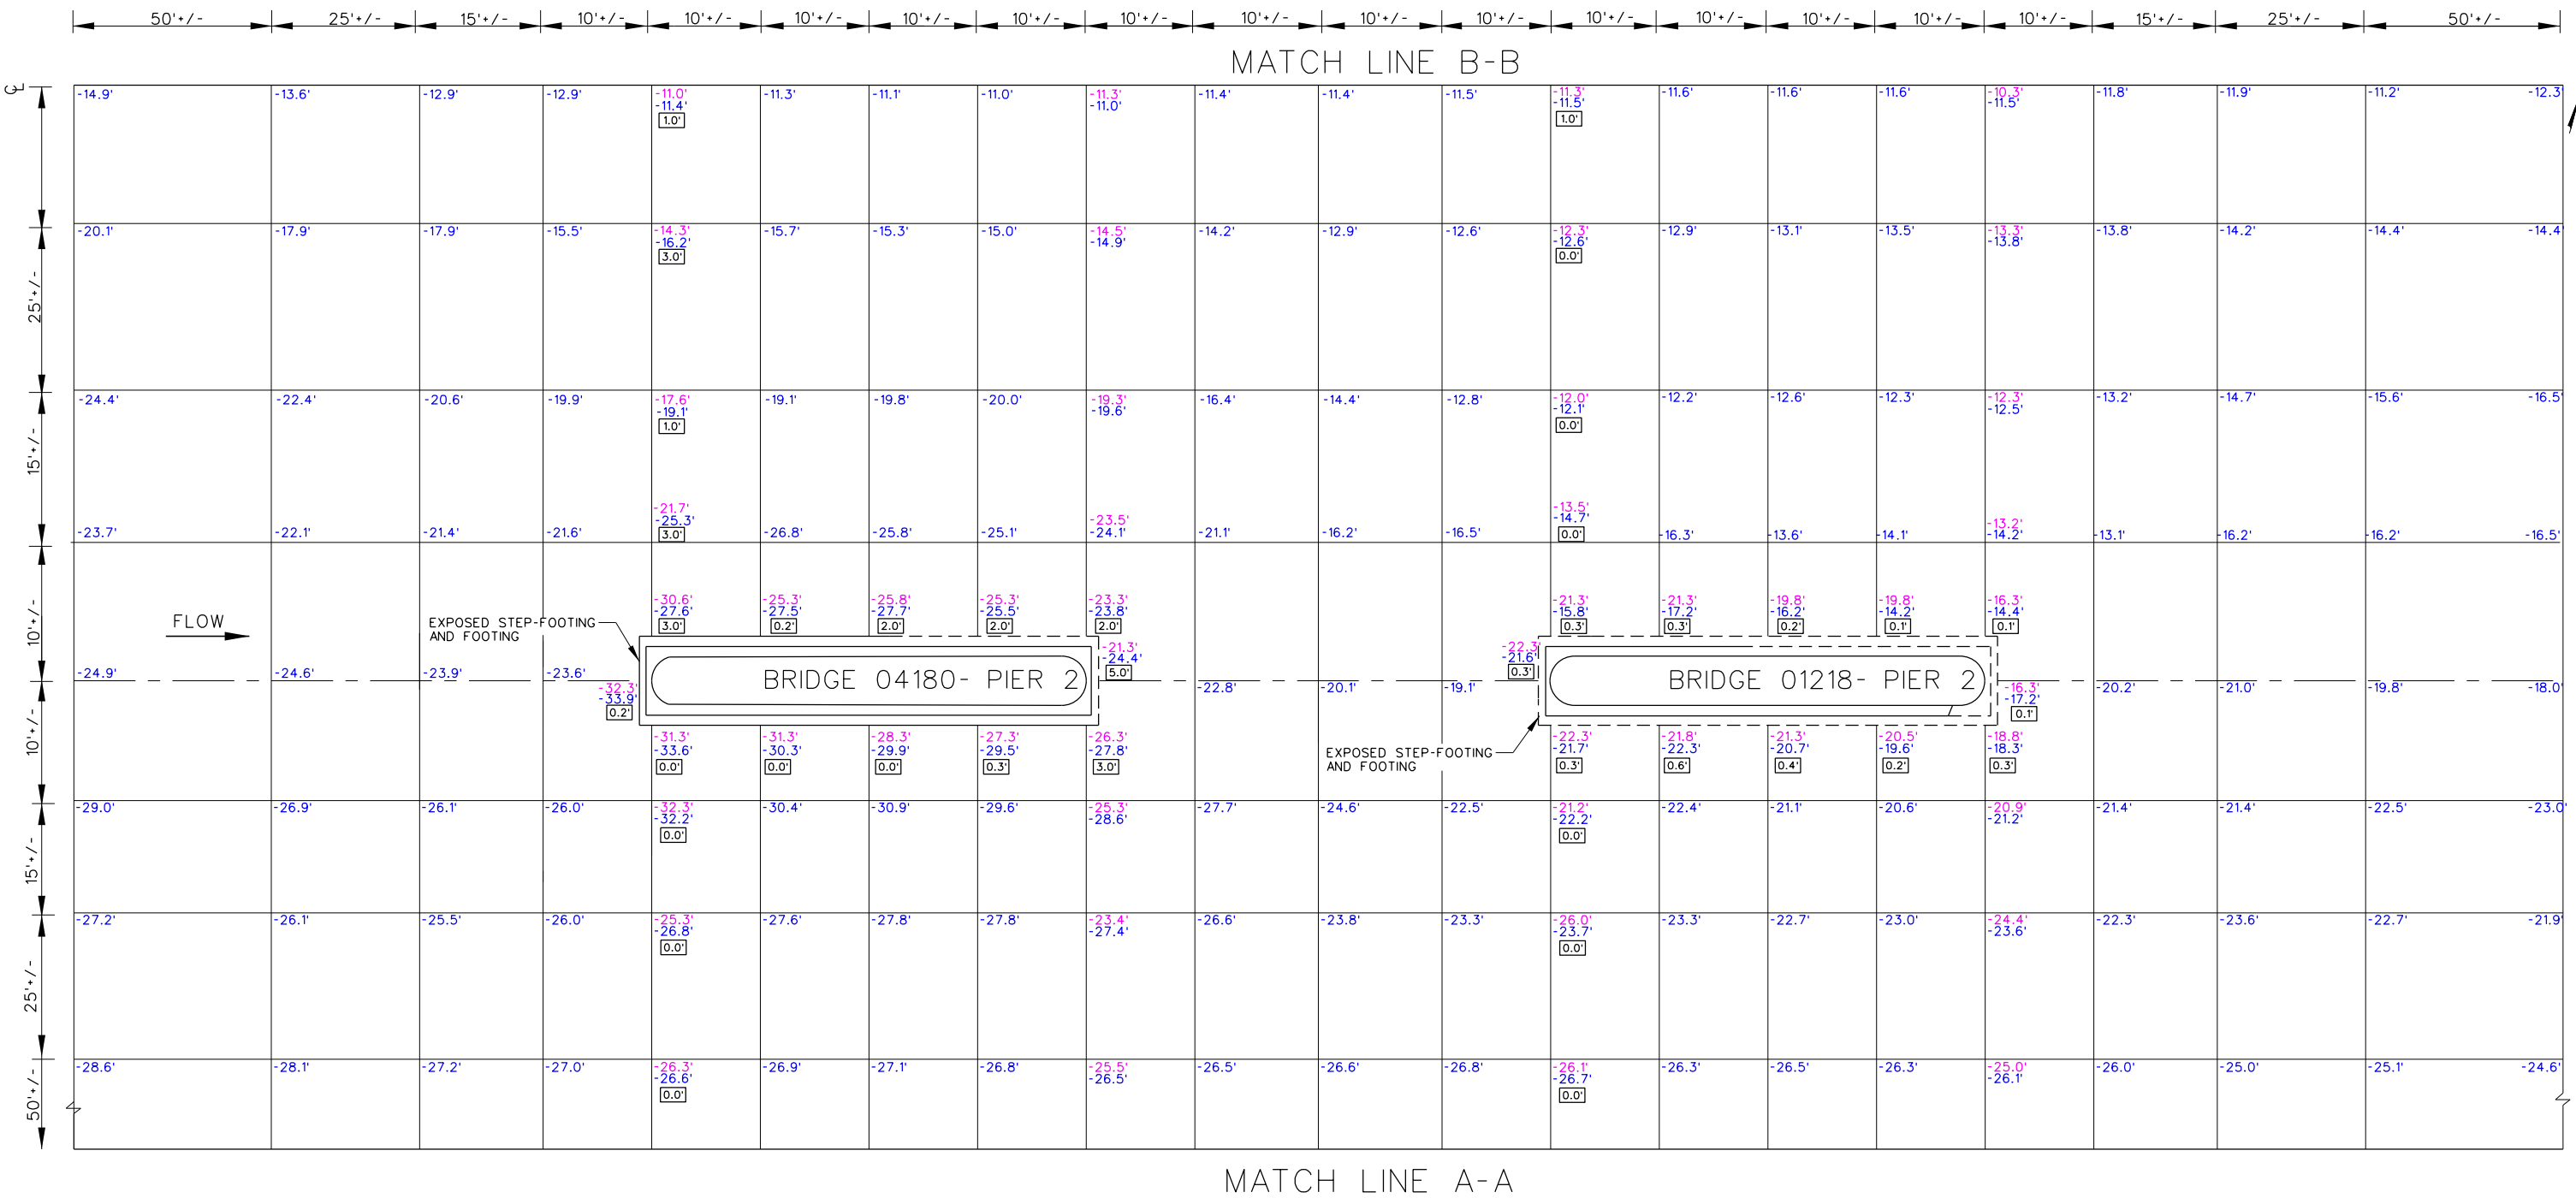
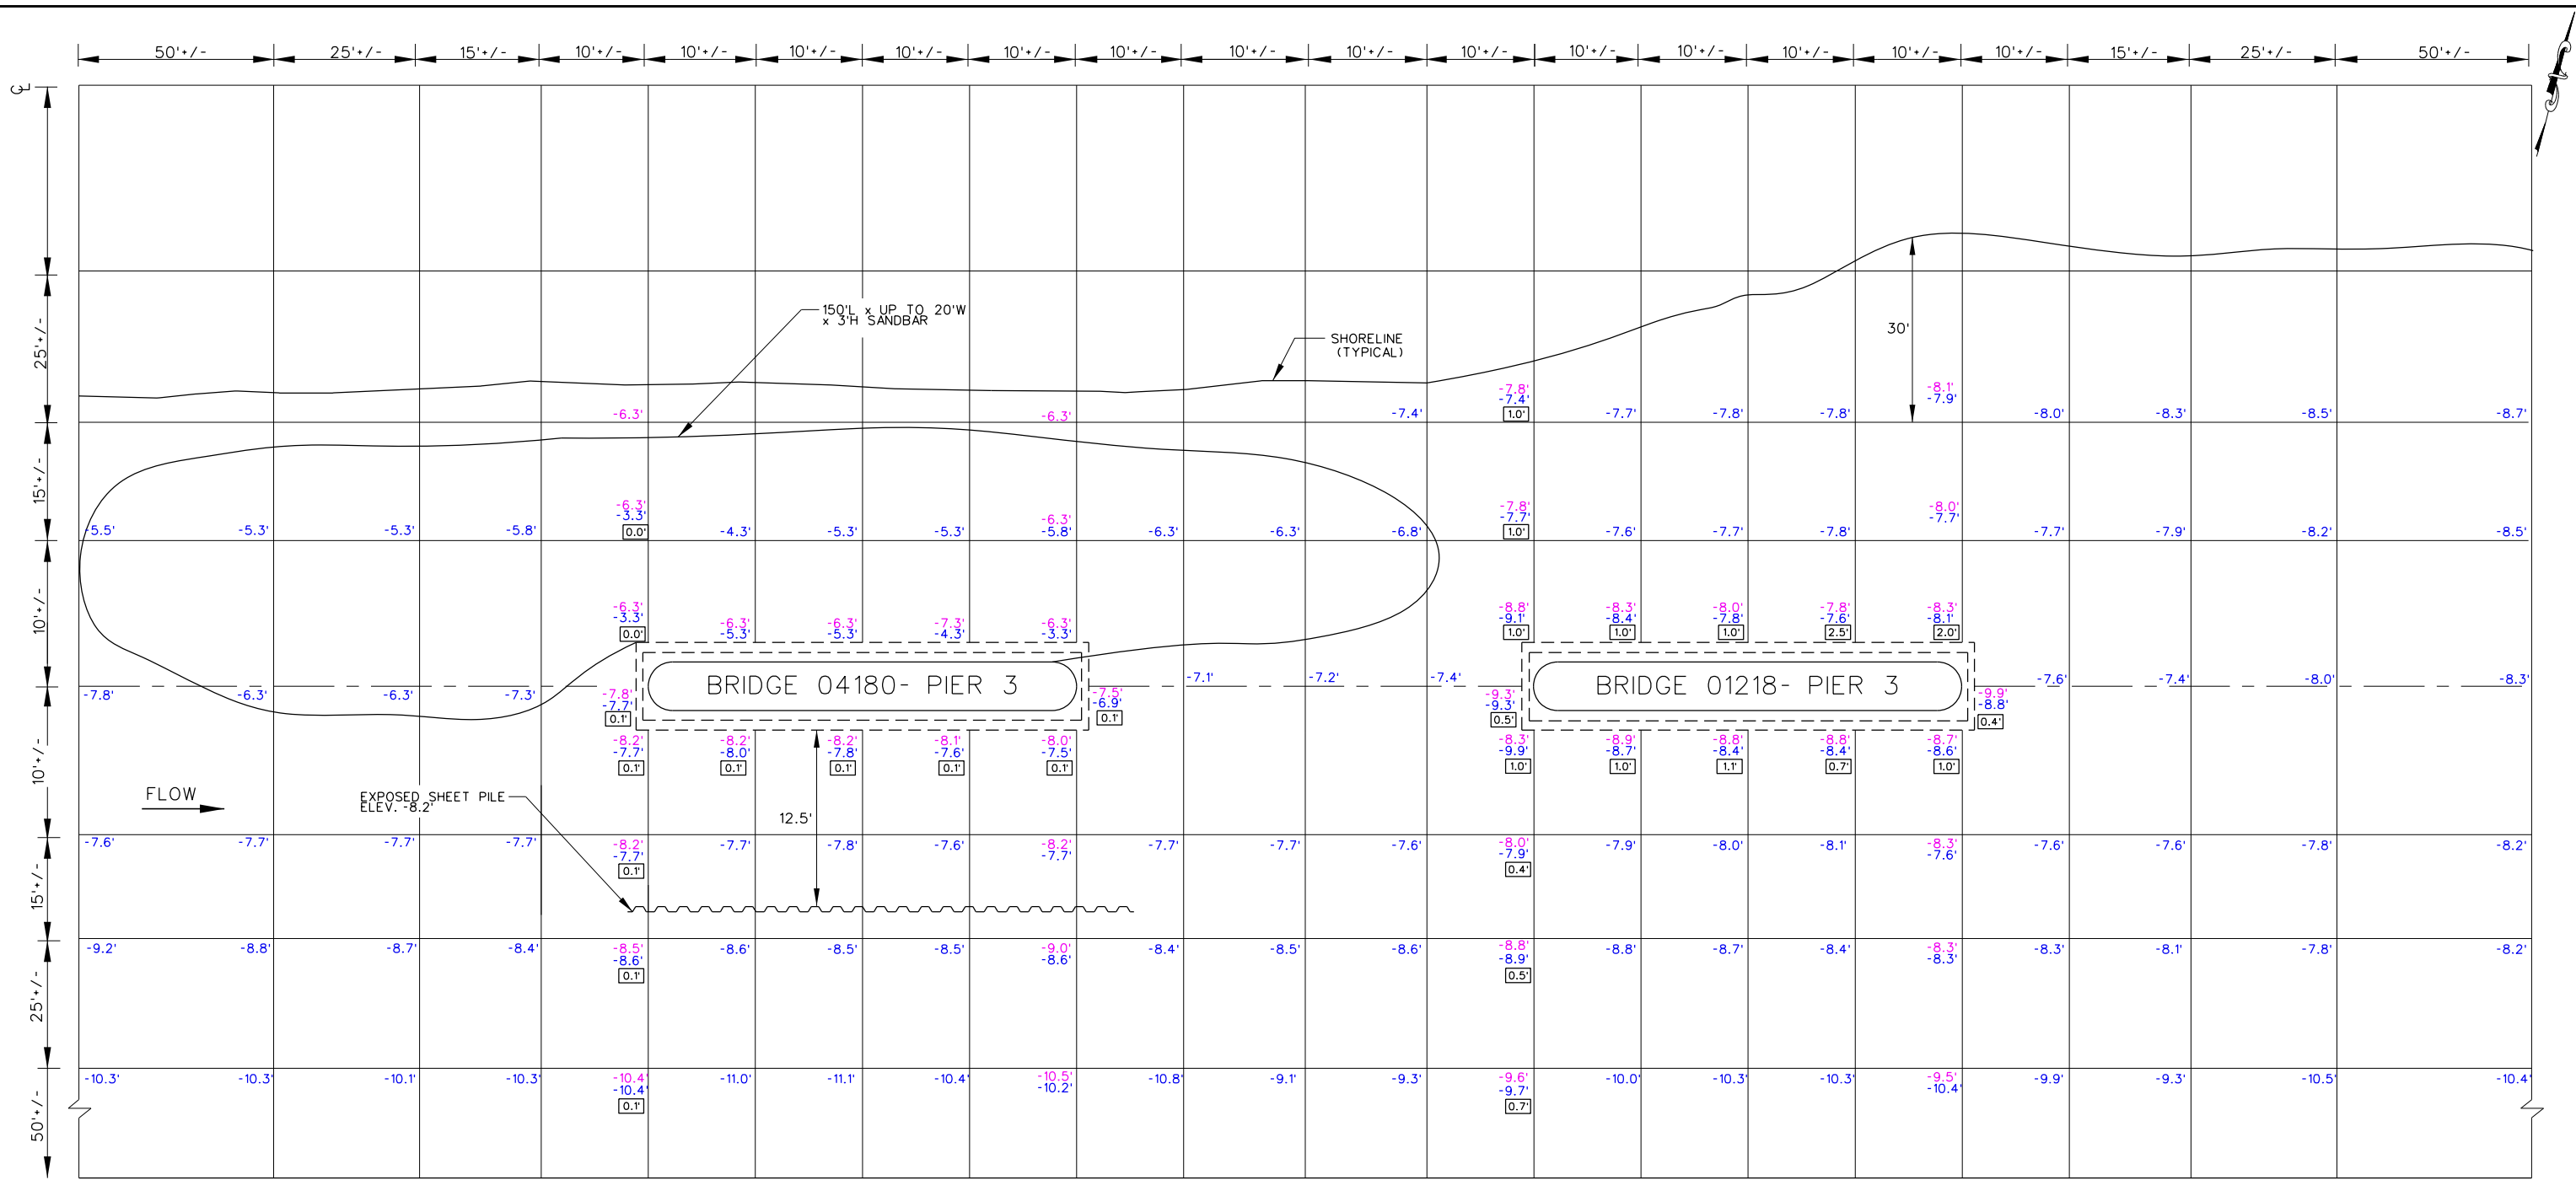
| CHANNEL SCOUR | 5 | <ul style="list-style-type: none"><li>• The channel bottom along Pier 1 primarily at the nose and North face has had scour up to 4.1' high since the 2016 Underwater Inspection.</li><li>• The channel bottom along Pier 2 North face has had scour up to 5.6' high since the 2016 Underwater Inspection.</li><li>• The channel bottom along Pier 3 has remained relatively unchanged (less than 1.1' variations) since the 2016 Underwater Inspection.</li><li>• The channel bottom along the up and downstream fascias have had random areas of mostly aggradation up to 6.5' high since the 2016 Underwater Inspection.</li><li>• At Pier 1, the step footing is exposed up to 32' long x up to full-height (5.9' high) along both faces of the pier and the footing has been exposed up to 6.8' high (previously 5.0' high) over a length of 30' on the South face and 8' on the North face near the Upstream (West) end of the pier.</li><li>• At Pier 2, the step footing is exposed up to 26' long x 2.1' high (previously 2.0' high) on the South face of the pier and along the Upstream (West) nose.</li><li>• There is no exposure of the footings at Pier 3.</li></ul> <p>(See UW Drawings 1 - 10)</p> |
| DEBRIS | 6 | <ul style="list-style-type: none"><li>• There are three 30' long x 1' diameter fallen trees in the channel South of Pier 3.</li><li>• There is a 30' long x 12' high x 2' diameter area of timber debris on the Upstream (West) nose of Pier 1.</li></ul> <p>(See UW Drawings 1 - 10)</p> |
| CHANNEL CHANGE | 6 | <ul style="list-style-type: none"><li>• There is no apparent change to the channel orientation.</li><li>• Bridge No. 04180 is located approximately 40' Upstream (West) of the bridge.</li><li>• There is approximately a 150' long x 20' wide x 3' high sandbar/area of aggradation located northwest of Pier 3 near Bridge No. 04180.</li></ul> <p>(See UW Drawings 1 - 3 and Photos 13 - 14)</p> |

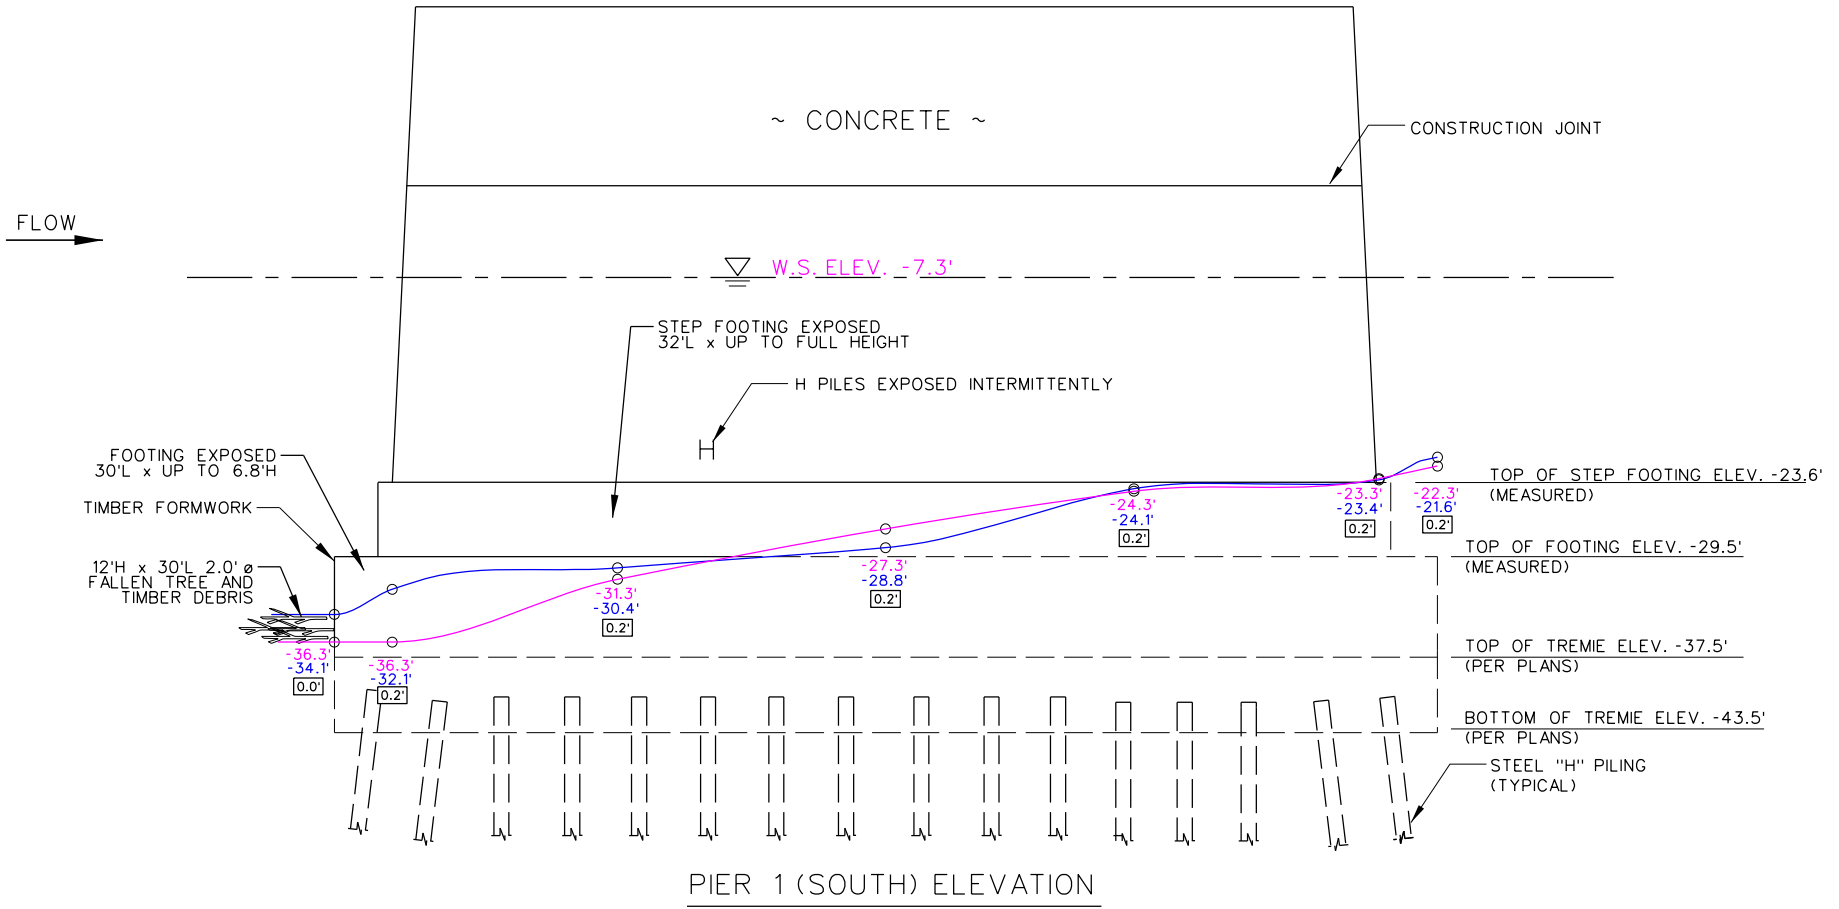
UW DRAWING 5

| ITEM | RATING | REMARKS |
|---|---|--|
| STEM | 7 | The reinforced concrete pier has the following deficiencies:<br><br><ul style="list-style-type: none"> <li>• 5' high band of abrasion up to 1/4" deep extending from 1' above to 4' below the water surface.</li> <li>• There are steel H-piles intermittently extending out of the stem located above the step footing (formwork left in place from construction).</li> <li>• Random areas of zebra mussels up to 50% coverage x 1" thick on underwater substructure.</li> </ul> (See UW Drawings 5 & 6 and Photos 4 & 5) |
| FOOTING | 7 | The step footing and footing have the following deficiencies:<br><br><ul style="list-style-type: none"> <li>• Step footing exposed up to 32' long x up to full-height (5.9' high) along both faces of the pier.</li> <li>• Footing exposed up to 6.8' vertically (previously 5' high) over a length of 30' on the South face and 8' on the North face near the Upstream (West) end of the pier with no undermining.</li> <li>• Exposed surfaces of the step footing and footing have abrasion up to 1/8" deep.</li> </ul> (See UW Drawings 5 & 6 and Photos 6 & 7) |

| SCOUR | 5 | <ul style="list-style-type: none"><li>The channel bottom along Pier 1 primarily at the Upstream (West) nose and North face has had scour up to 4.1' high since the 2016 Underwater Inspection.</li><li>Step footing exposed up to 32' long x up to full-height (5.9' high) along both faces of the pier.</li><li>Footing exposed up to 6.8' vertically (previously 5' high) over a length of 30' on the south face and 8' on the north face near the Upstream (West) end of the pier with no undermining.</li></ul> <p>(See UW Drawings 5 &amp; 6 and Photos 6 &amp; 7)</p> |

1. BAND OF ABRASION UP TO 5'H x 1/4"D FROM 1' ABOVE WATERLINE TO 4' BELOW.
2. ISOLATED AREAS OF ABRASION UP TO 1/8" DEEP ON EXPOSED STEP FOOTING AND FOOTING.
3. RANDOM AREAS OF ZEBRA MUSSELS UP TO 50% COVERAGE x 1" THICK ON UNDERWATER SUBSTRUCTURE.
4. FOOTING 1' WIDE.

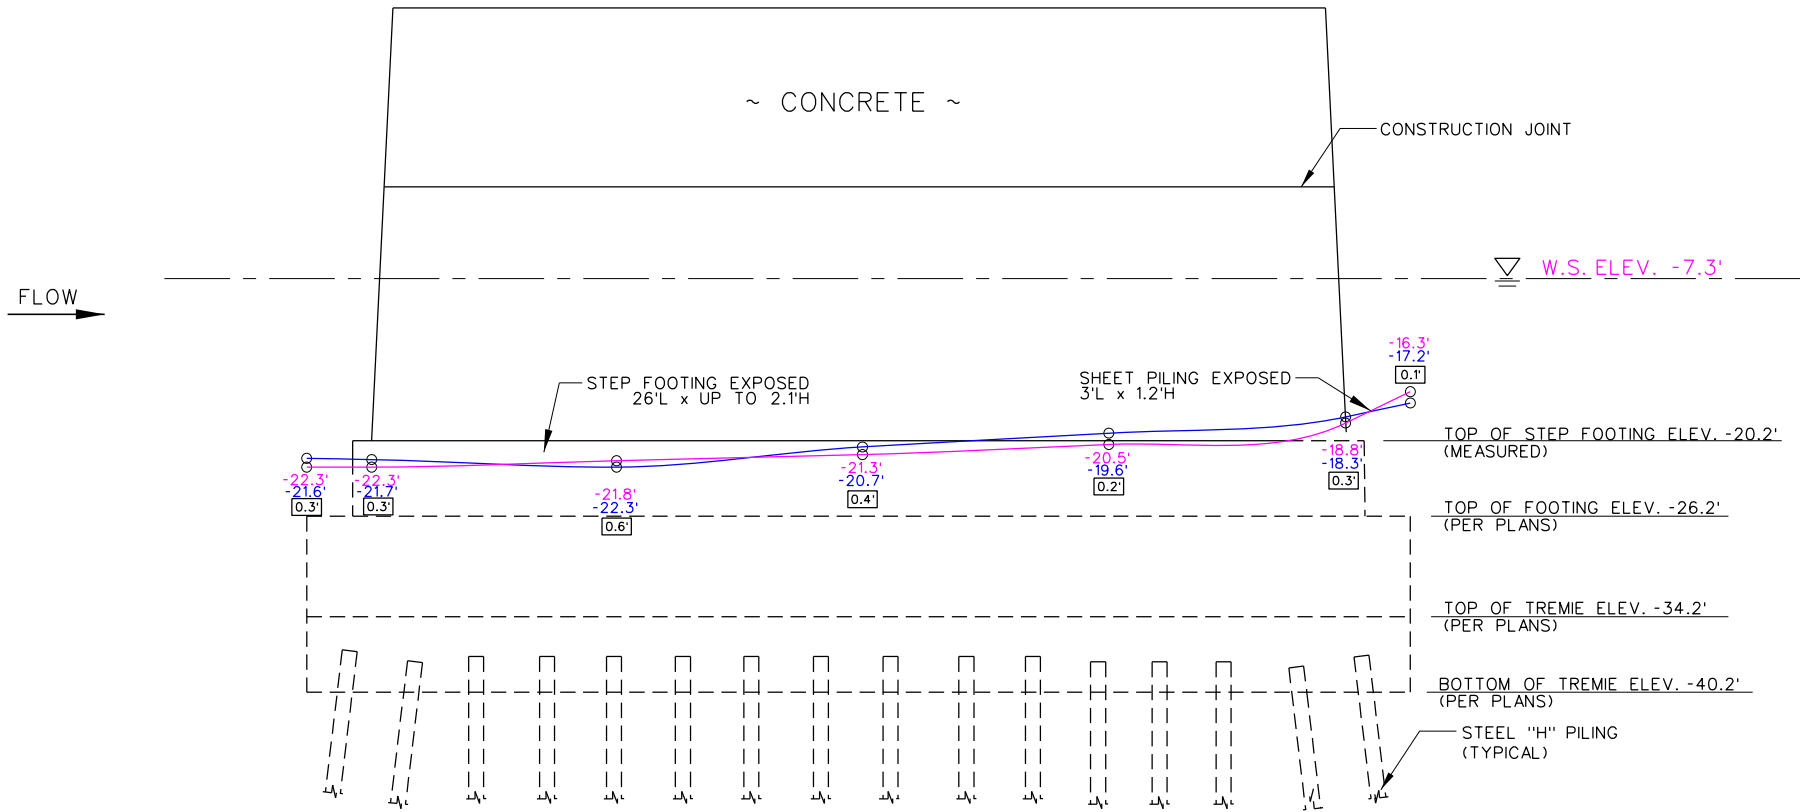
PIER 2 (SOUTH) ELEVATION  
N.T.S.

| STEM | 7 | <p>The reinforced concrete pier has the following deficiencies:</p> <ul style="list-style-type: none"><li>5' high band of abrasion up to 1/4" deep with isolated areas up to 3/4" deep extending from 1' above to 4' below the water surface.</li><li>Random areas of zebra mussels up to 50% coverage x 1" thick on underwater substructure.</li></ul> <p>(See UW Drawings 7 &amp; 8 and Photos 8 &amp; 9)</p> |
| FOOTING | 7 | <ul style="list-style-type: none"><li>The step footing is exposed up to 26' long x 2.1' high (previously 2' high) on the South face of the pier and along the Upstream (West) Nose.</li><li>Exposed surfaces of the step footings footing exhibit scaling up to 1/8" deep.</li><li>Step footing has random chamfer spalls up to 6" long x 3" wide x 1" deep.</li></ul> <p>(See UW Drawings 7 &amp; 8 and Photo 10)</p> |
| SCOUR | 5 | <ul style="list-style-type: none"><li>The channel bottom along Pier 2 North face has had scour up to 5.6' high since the 2016 Underwater Inspection.</li><li>The step footing is exposed up to 26' long x 2.1' high (previously 2' high) on the South face of the pier and along the Upstream (West) Nose</li><li>The Southwest corner has exposed sheet piling 3' long x 1.2' high.</li></ul> <p>(See UW Drawings 7 &amp; 8 and Photo 10)</p> |

- BAND OF ABRASION 5' HIGH x UP TO 1/4" DEEP WITH ISOLATED AREAS UP TO 3/4" DEEP FROM 1' ABOVE WATERLINE TO 4' BELOW.
- RANDOM CHAMFER SPALLS ON EXPOSED STEP FOOTING UP TO 6" LONG x 3" WIDE x 1" DEEP.
- RANDOM AREAS OF ZEBRA MUSSELS UP TO 50% COVERAGE x 1" THICK ON UNDERWATER SUBSTRUCTURE.
- FOOTING 1' WIDE.

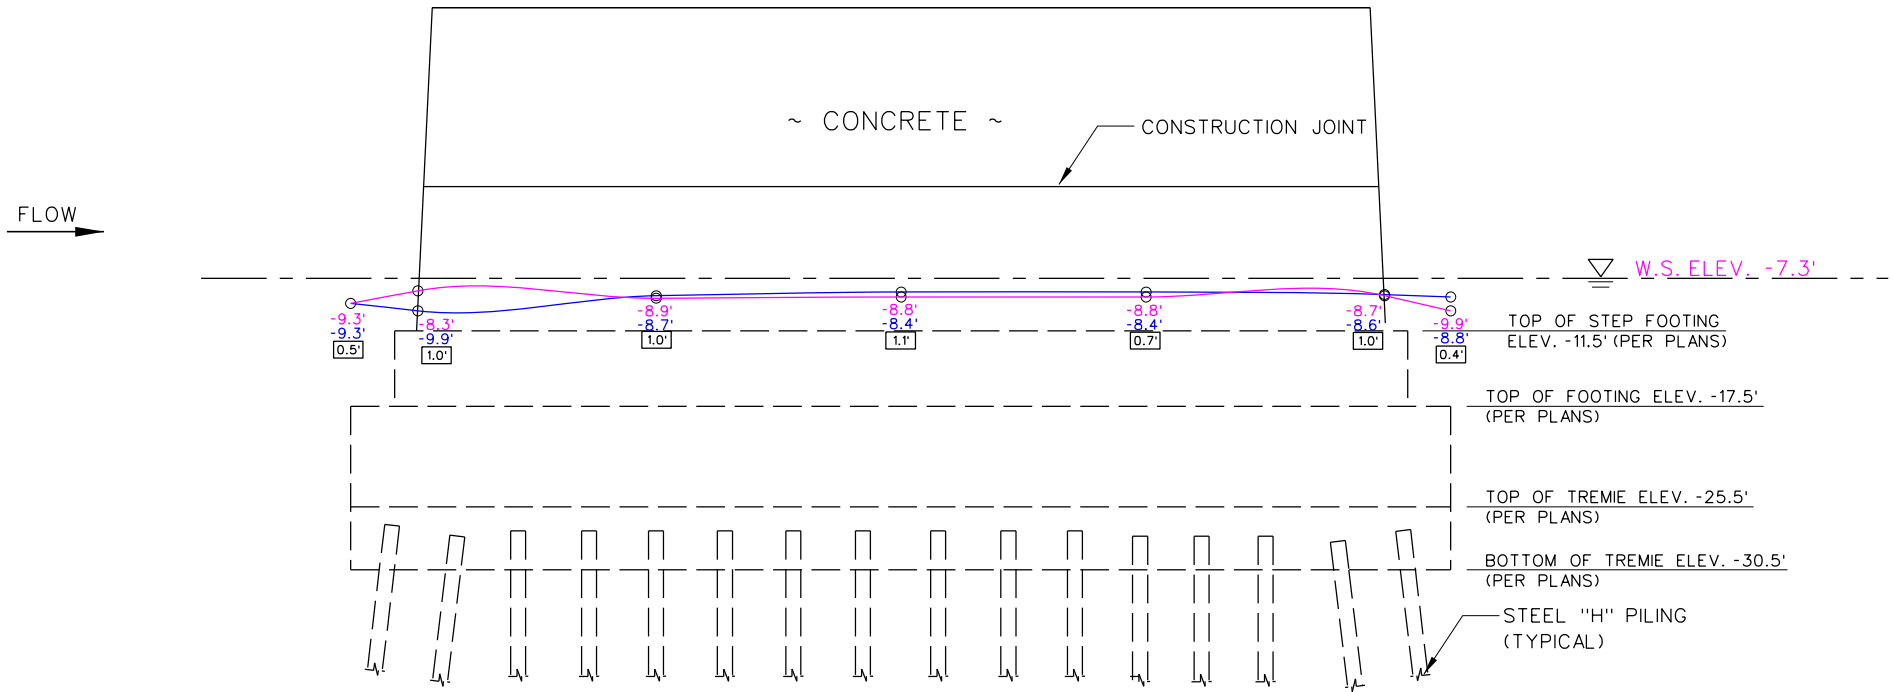
UW DRAWING 9

| STEM | 7 | <p>The reinforced concrete pier has the following deficiencies:</p> <ul style="list-style-type: none"><li>Band of abrasion up to 1/2" deep extending from 1' above the water surface down to the channel bottom.</li><li>There are a few vertical hairline cracks up to 1.5' long near the water surface of the pier.</li></ul> <p>(See UW Drawings 9 &amp; 10 and Photos 11 &amp; 12)</p> |
| SCOUR | 7 | <ul style="list-style-type: none"><li>The channel bottom along Pier 3 has remained relatively unchanged (less than 1.1' variations) as compared to the 2016 Underwater Inspection.</li></ul> <p>(See UW Drawings 9 &amp; 10)</p> |

1. ABRASION UP TO 1/2" DEEP FROM MUDLINE TO 1' ABOVE WATERLINE.
2. A FEW RANDOM VERTICAL HAIRLINE CRACKS UP TO 1.5' LONG NEAR WATER SURFACE.

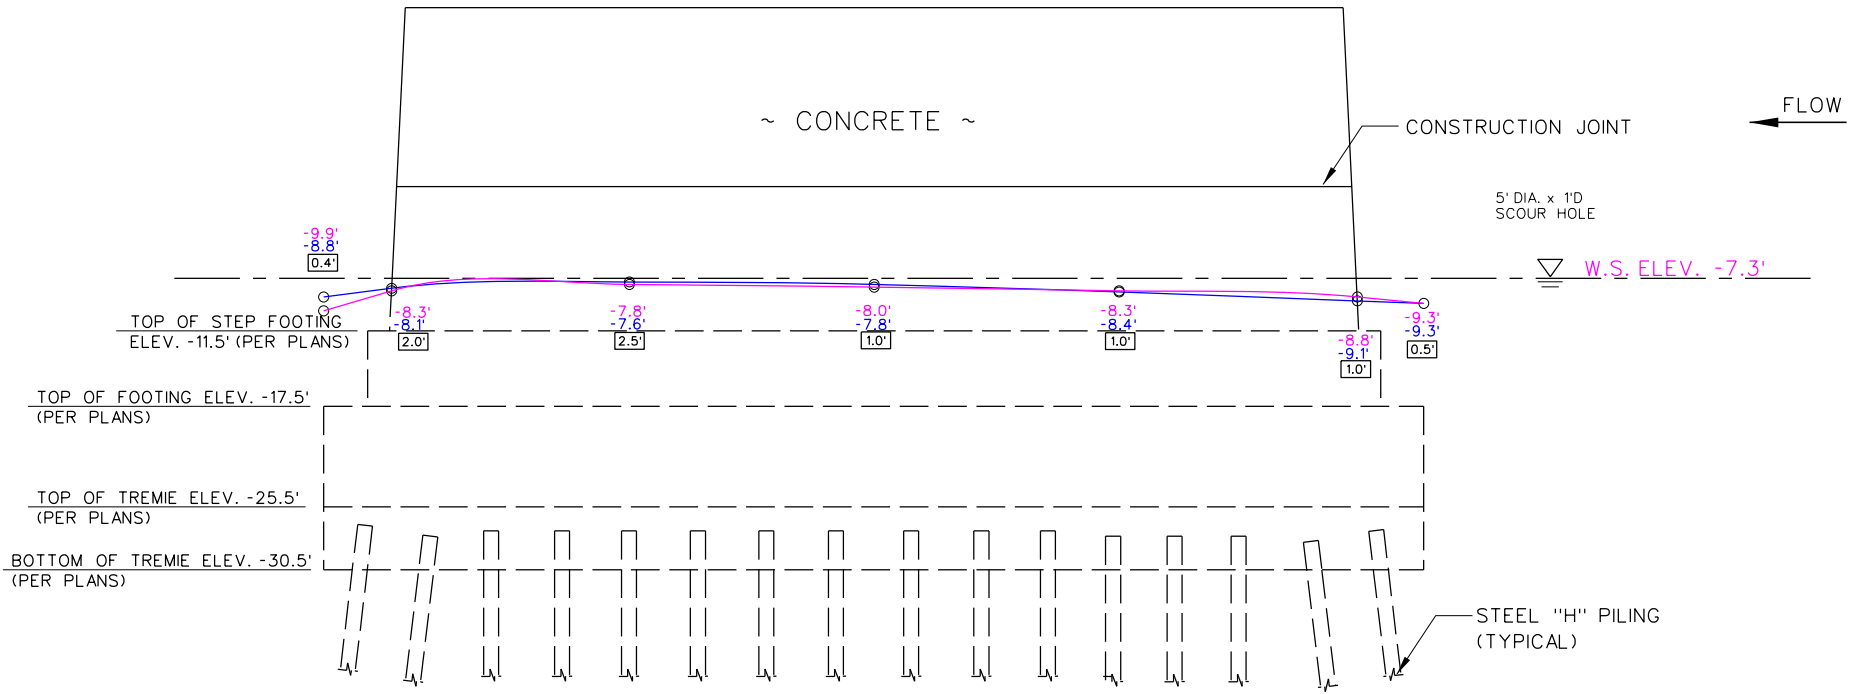
1. ABRASION UP TO 1/2" DEEP FROM MUDLINE TO 1' ABOVE THE WATERLINE.
2. A FEW RANDOM VERTICAL HAIRLINE CRACKS UP TO 1.5' LONG NEAR WATER SURFACE.

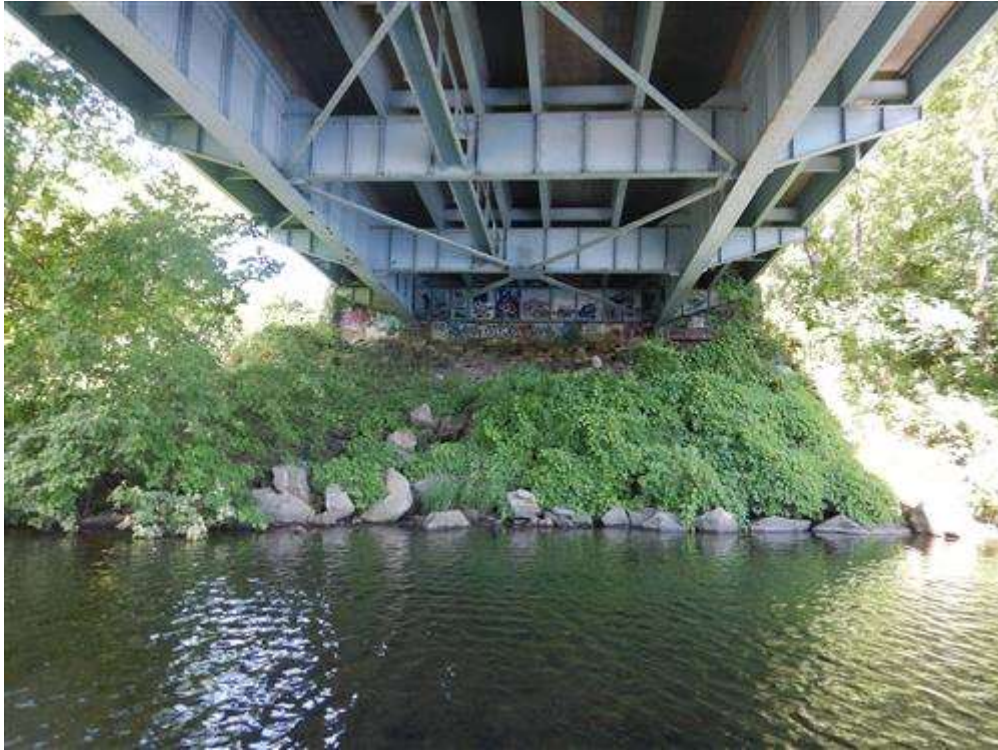
Photo Number: 3

| ITEM | RATING | REMARKS |
|---|---|--|
| <b>ABUTMENT 2:</b> | N | North Abutment. Located out of the channel.<br>(See Photo 3) |

Abutment 2

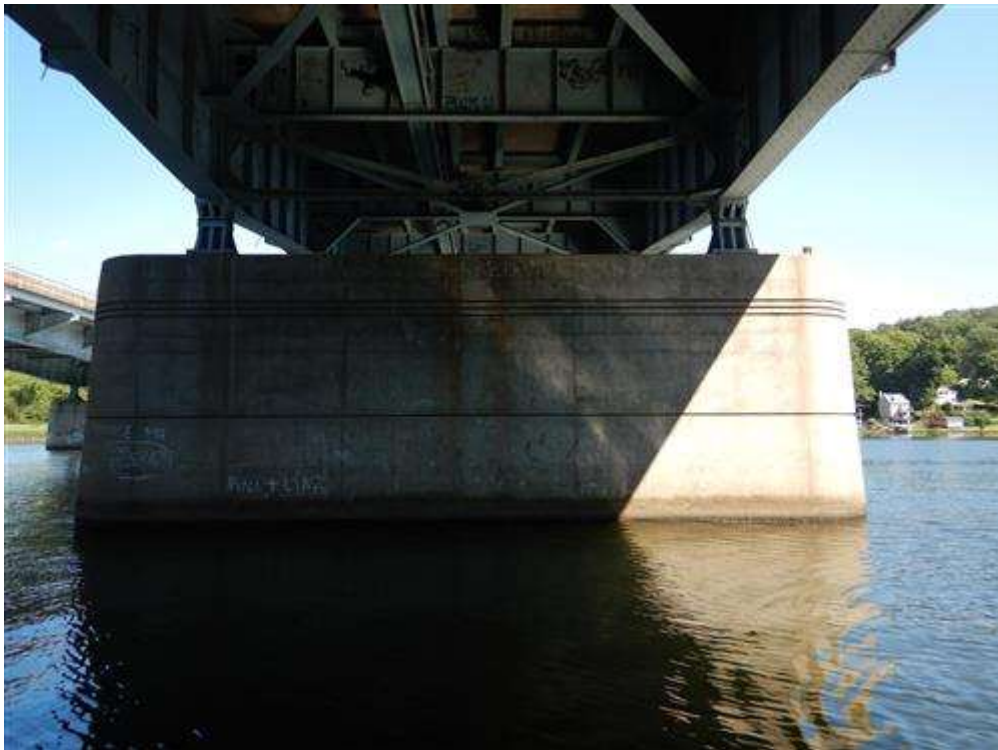
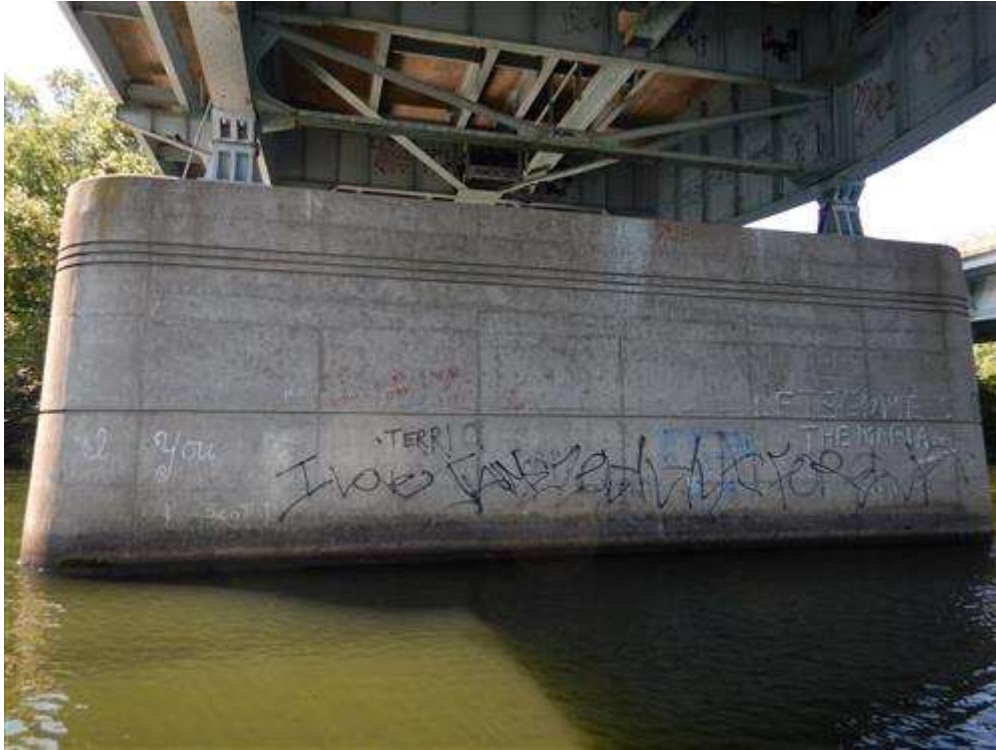
Pier 1 North Elevation

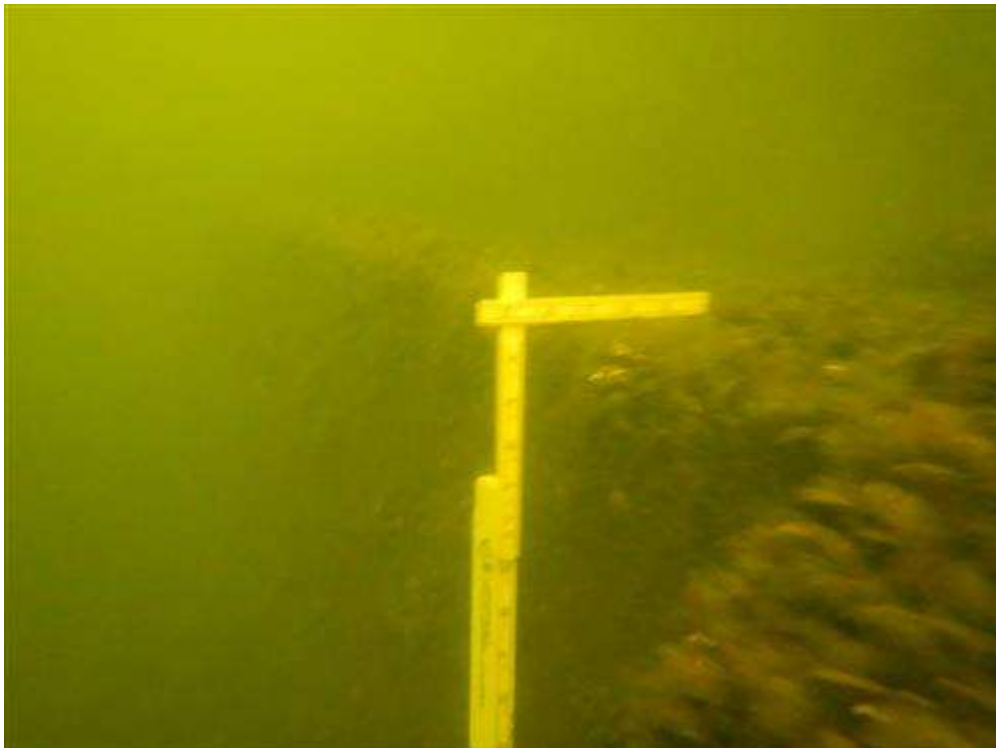
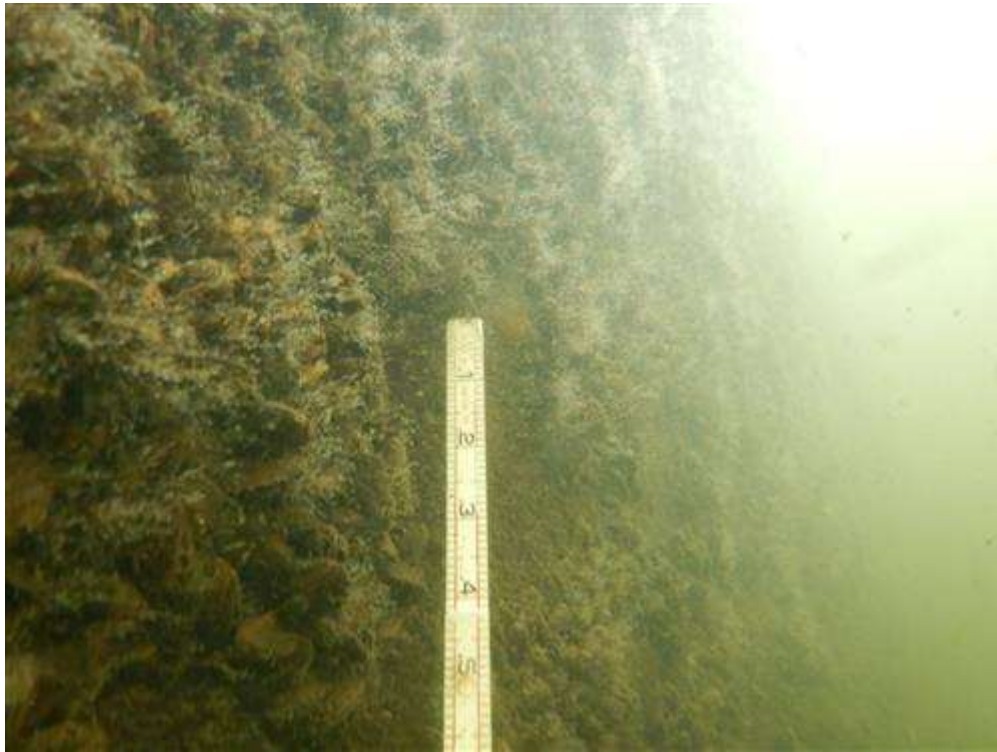
Pier 1 Footing

Note: Up to 1" of zebra mussels.

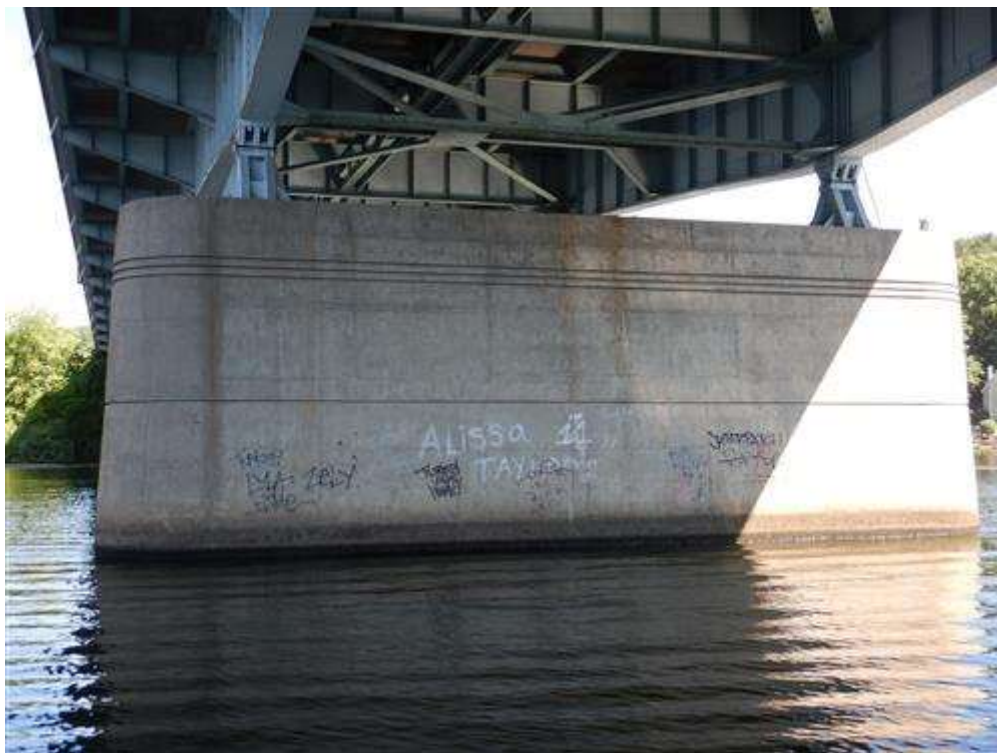
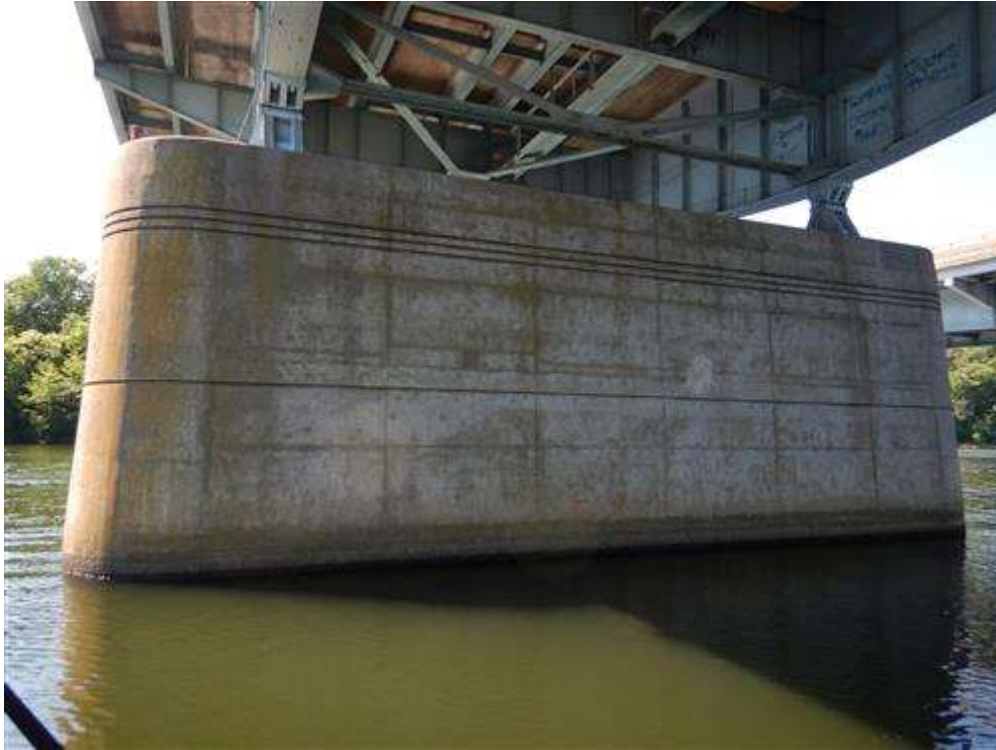
Pier 2 South Elevation

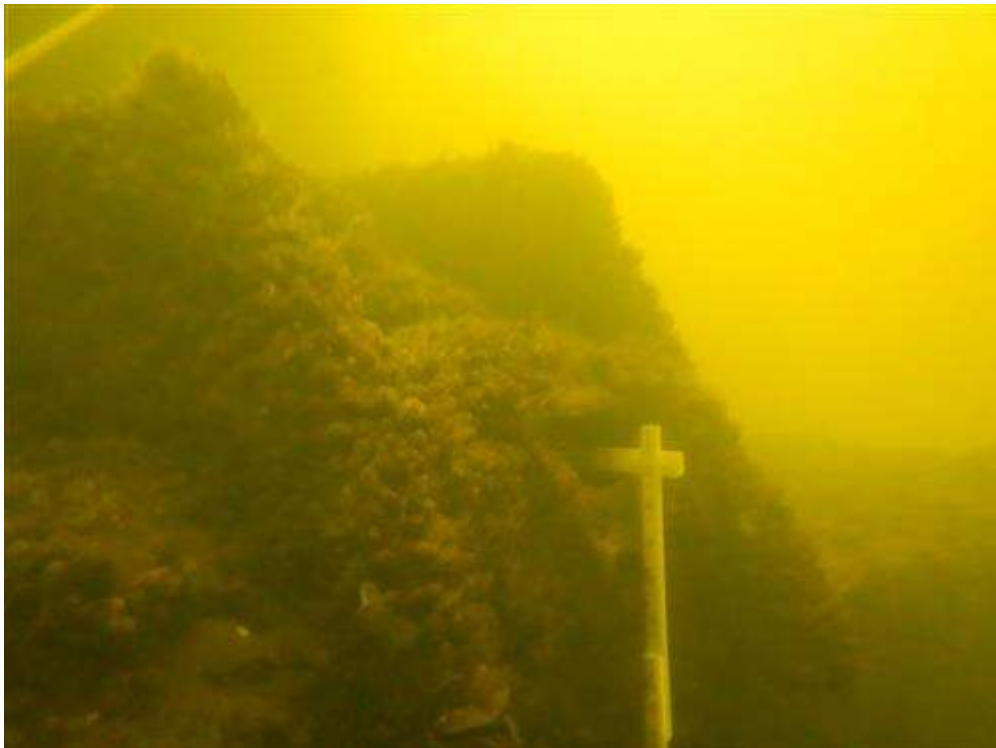
Photo Number: 10

Pier 2
