## BRIDGE NO.01218

52980 - NEWTOWN  
INTERSTATE 84 EASTBOUND  
over  
HOUSATONIC RIVER

Underwater Inspection  
7/18/2018  
Inspected by: Infrastructure

**Project No.:** 170-3339 (Underwater Inspections – NHS)

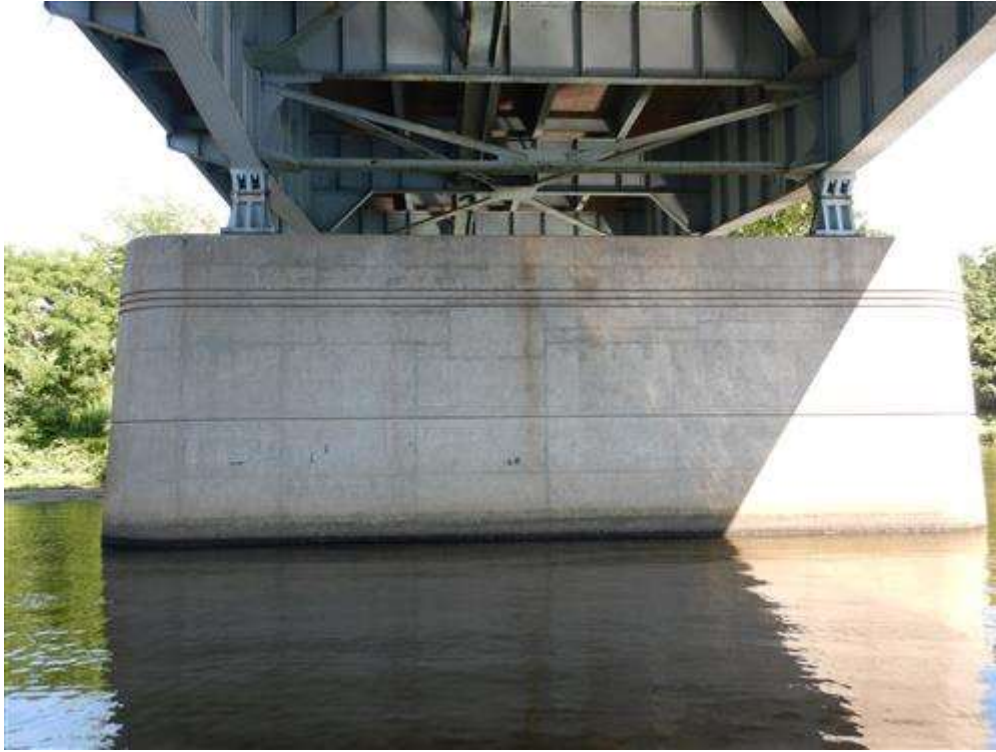
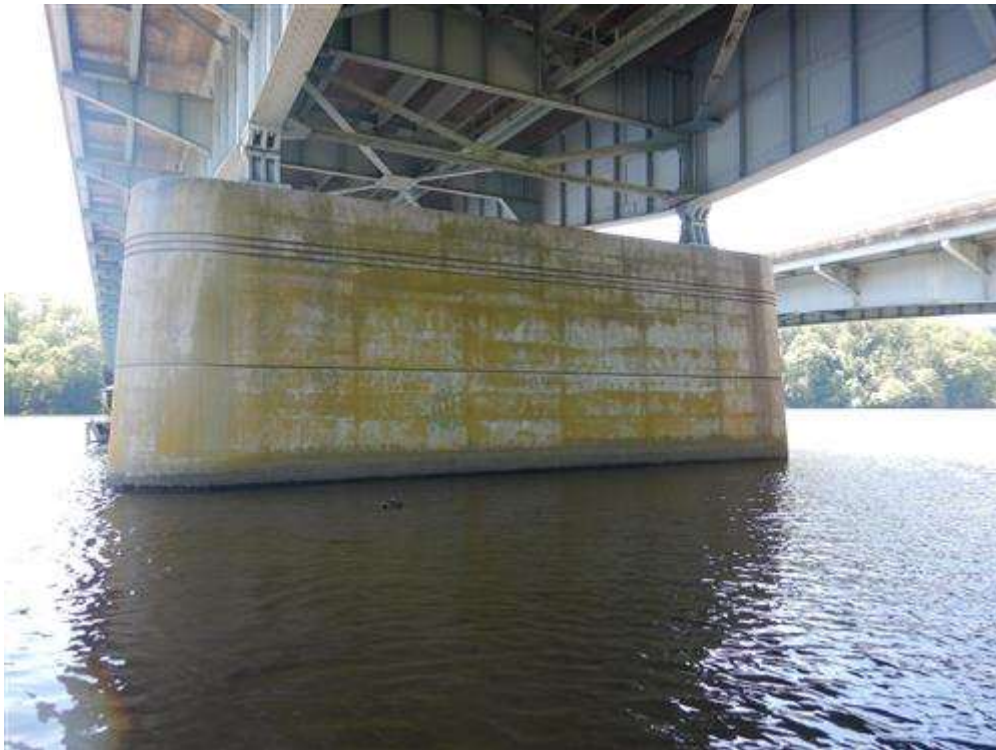
| STEM | 7 | <p>The reinforced concrete pier has the following deficiencies:</p> <ul style="list-style-type: none"><li>Band of abrasion up to 1/2" deep extending from 1' above the water surface down to the channel bottom.</li><li>There are a few vertical hairline cracks up to 1.5' long near the water surface of the pier.</li></ul> <p>(See UW Drawings 9 &amp; 10 and Photos 11 &amp; 12)</p> |

Pier 3 South Elevation

Pier 3 North Elevation

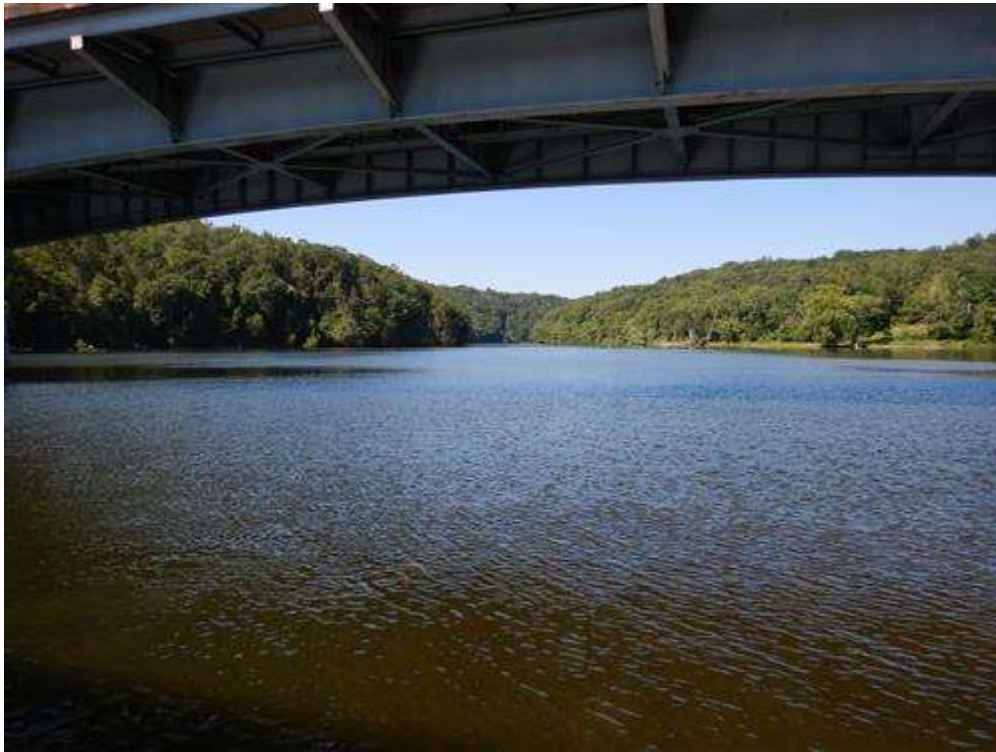
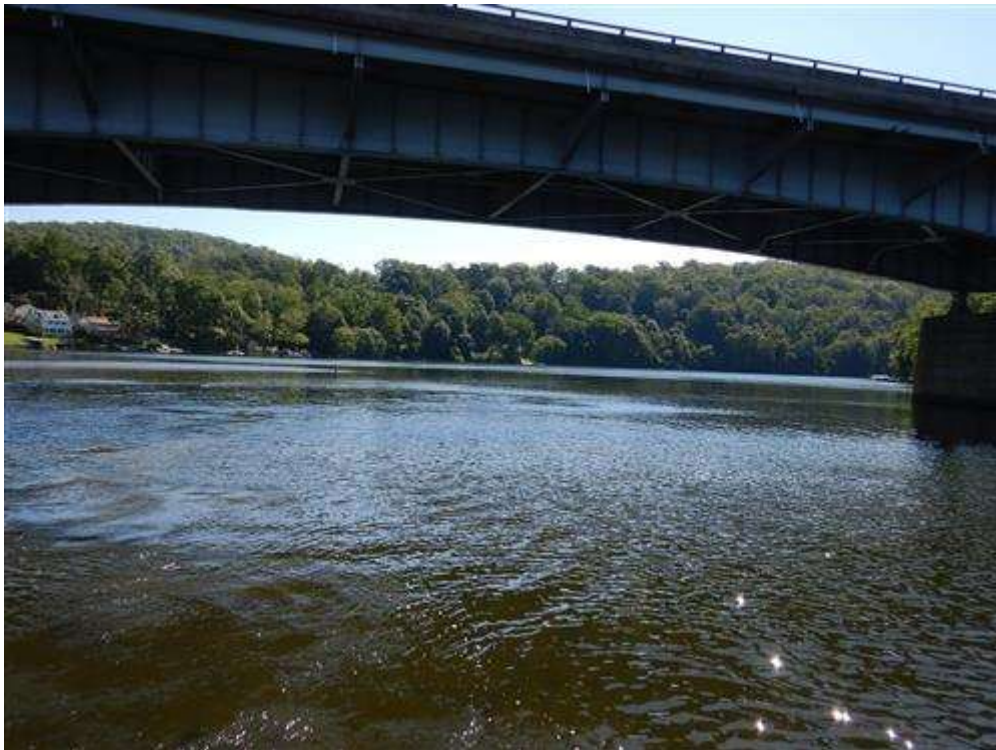
| CHANNEL CHANGE | 6 | <ul style="list-style-type: none"><li>• There is no apparent change to the channel orientation.</li><li>• Bridge No. 04180 is located approximately 40' Upstream (West) of the bridge.</li><li>• There is approximately a 150' long x 20' wide x 3' high sandbar/area of aggradation located northwest of Pier 3 near Bridge No. 04180.</li></ul> <p>(See UW Drawings 1 - 3 and Photos 13 - 14)</p> |

Channel Looking Upstream (West)

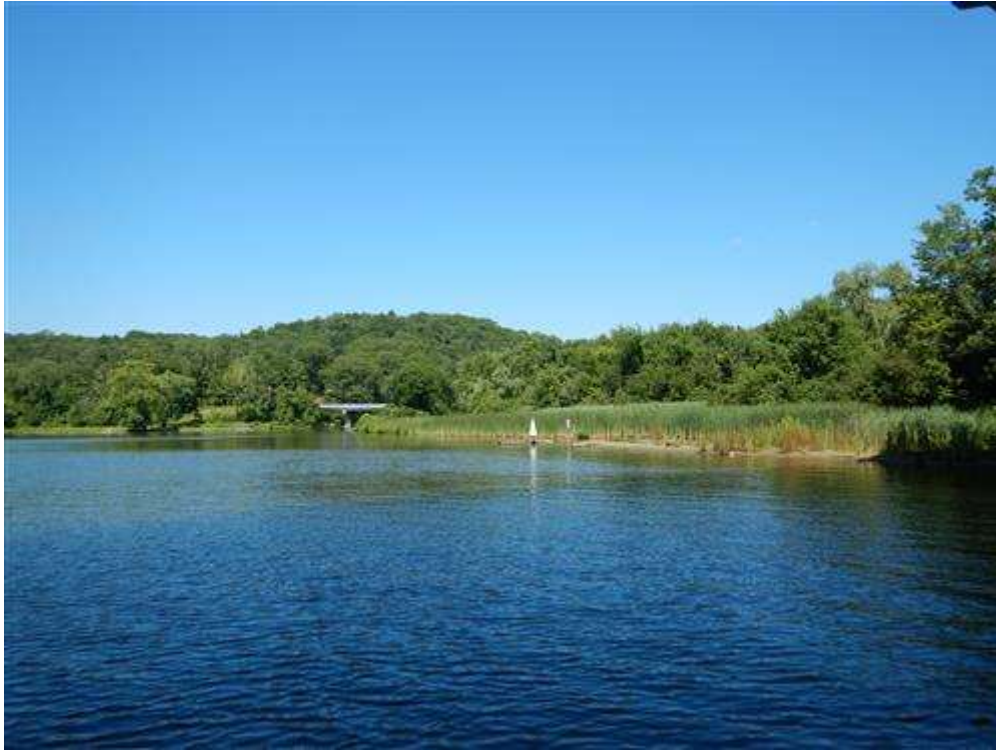
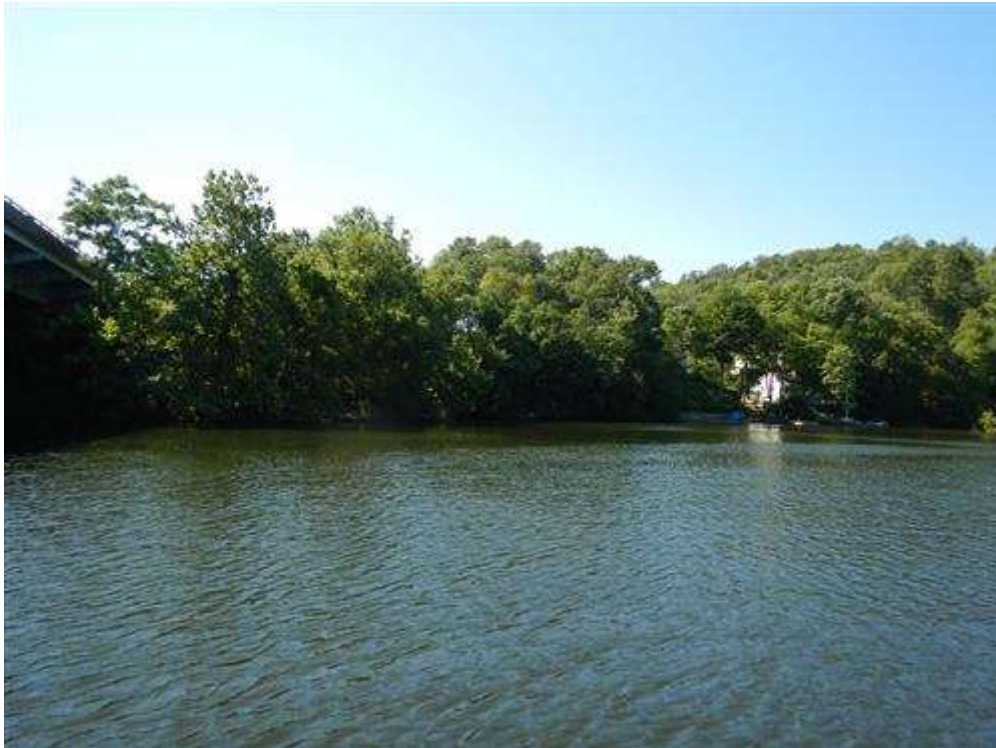
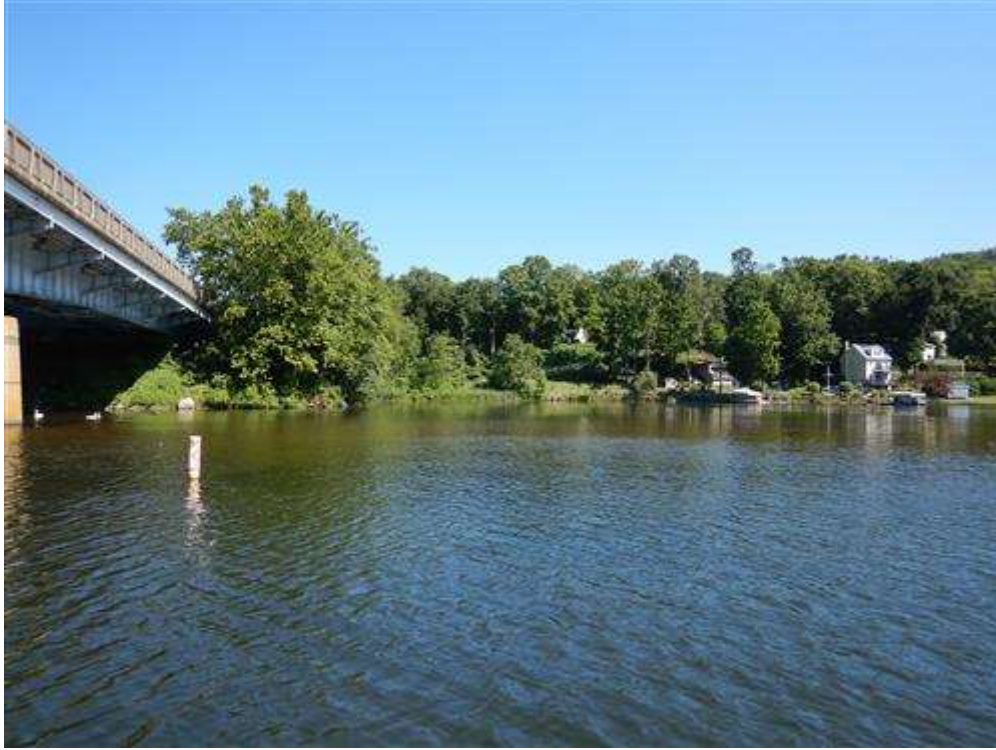
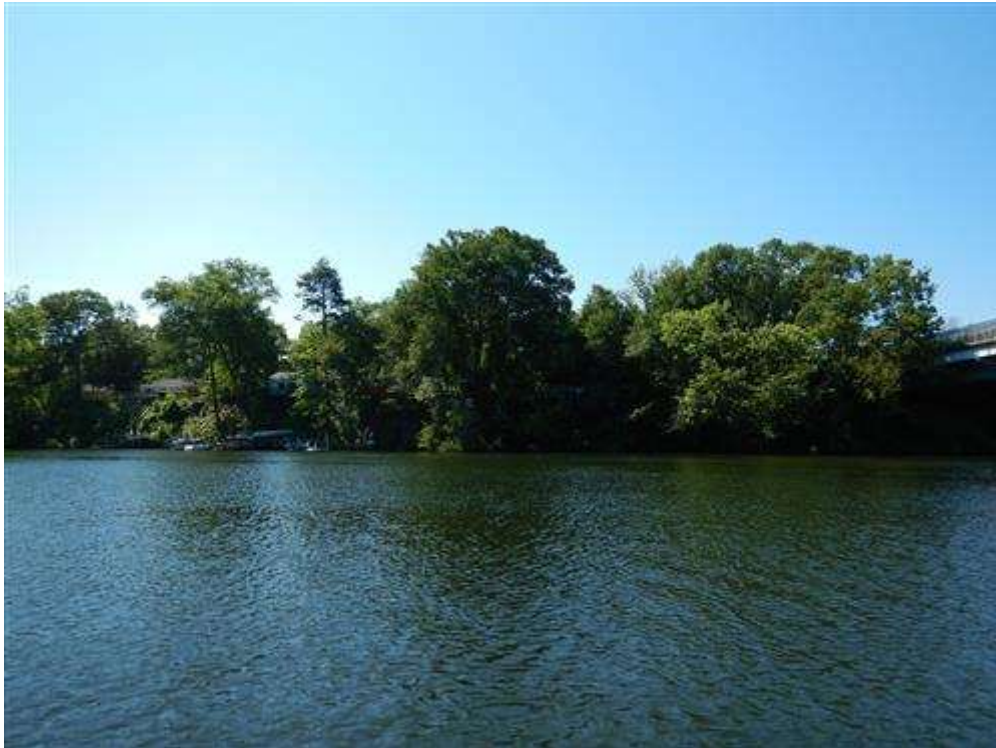
| EMBANKMENT EROSION | 7 | There is no significant erosion along the channel embankments.<br><br>(See Photos 15 - 18) |

Northwest Channel Embankment

Northeast Channel Embankment

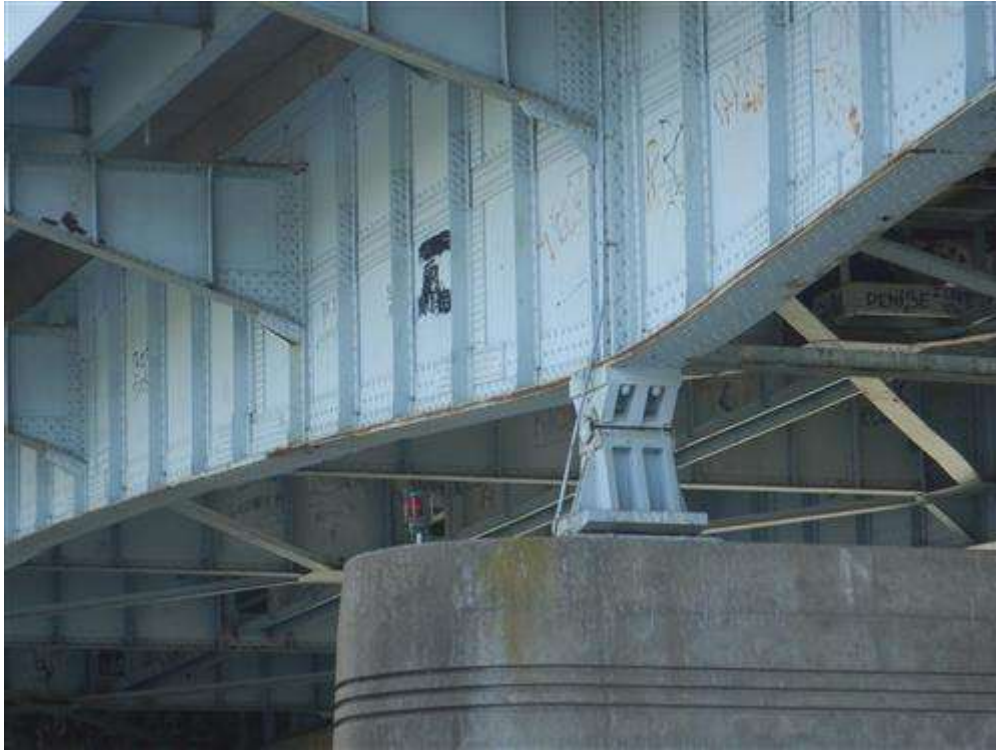
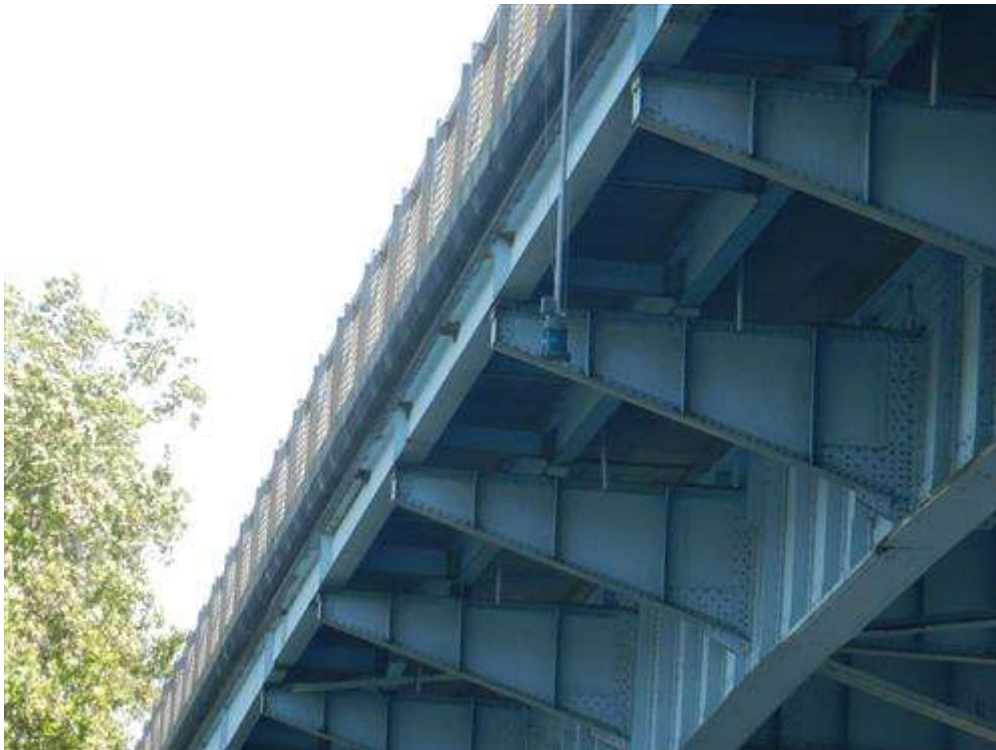
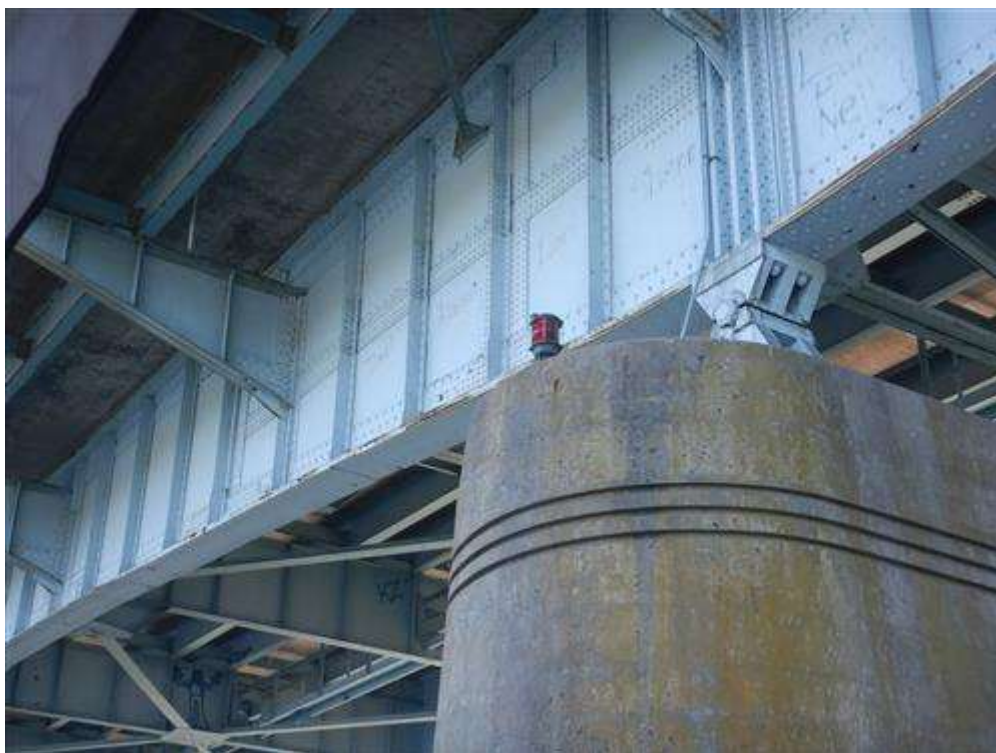
| General Remarks: | | There are navigational lights on Pier 1, center of Span 2 and Pier 2 on the Downstream (East) Fascia. The lights were not on during this inspection.<br><br>(Photos 19 - 21) |

Pier 1 Navigational Light (Downstream)
