## BRIDGE NO.04180

52980 - NEWTOWN  
INTERSTATE 84 WESTBOUND  
over  
HOUSATONIC RIVER

Fracture Critical and Routine Inspection

9/12/2018

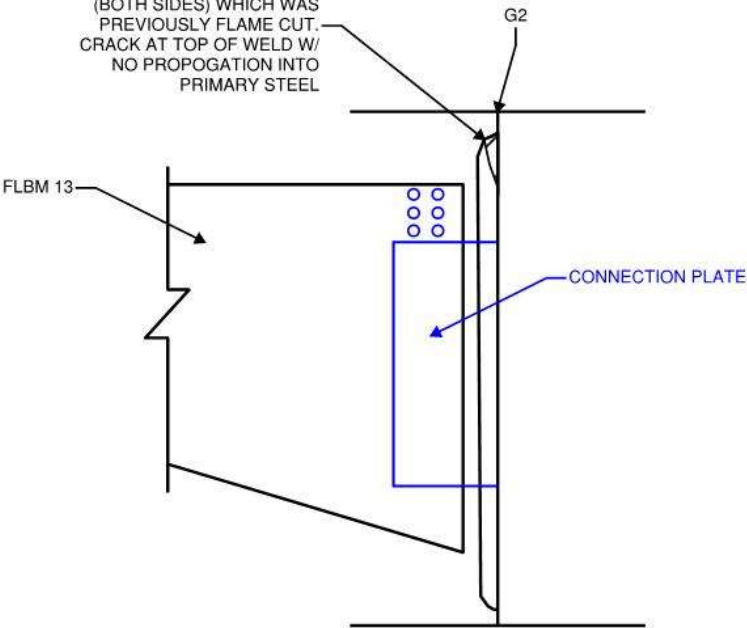
<p>FLBM 13</p><p>G2</p><p>CONNECTION PLATE</p><p><u>FLOOR BEAM 13 EAST CANTILEVER</u> <u>NORTH ELEVATION</u> NTS</p></div>					
SKETCH 17					
REVISION

CREW : RV, ARM		DATE : 11/7/2016		BRIDGE NO. : 04180	
<div><p>2-3/4" CRACK IN VERTICAL WELD OF WEB OF FLBM 13 (BOTH SIDES) WHICH WAS PREVIOUSLY FLAME CUT. CRACK AT TOP OF WELD W/ NO PROPOGATION INTO PRIMARY STEEL</p>

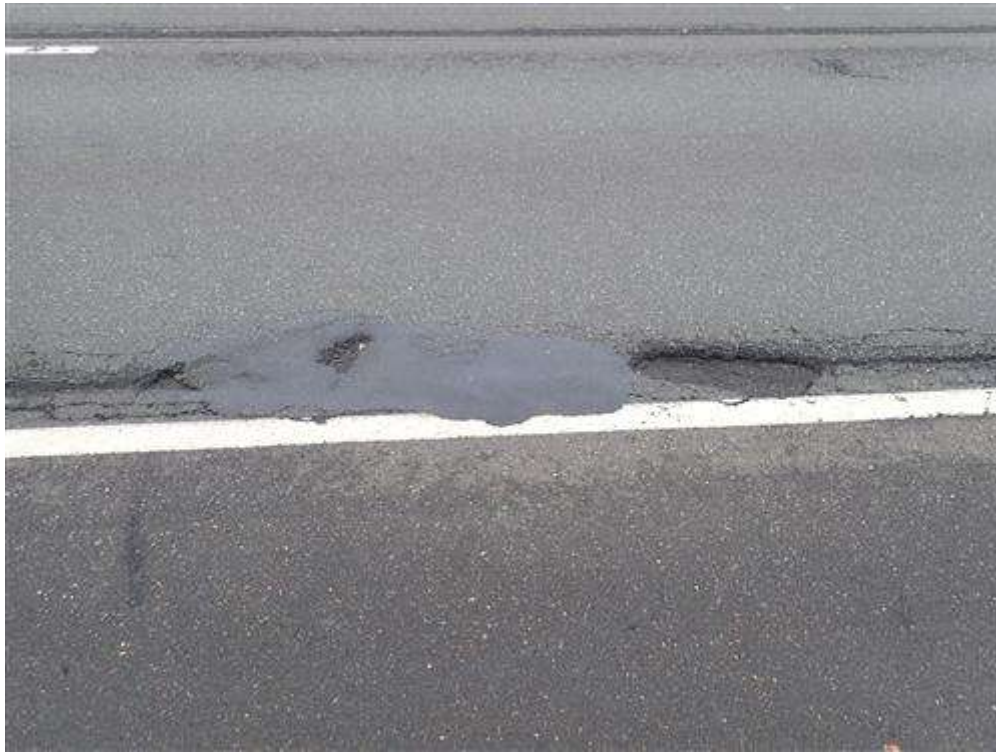
Photo Number: 7

Bituminous Concrete Overlay in Span 2

Note: Failing patch with 2" deep pothole.

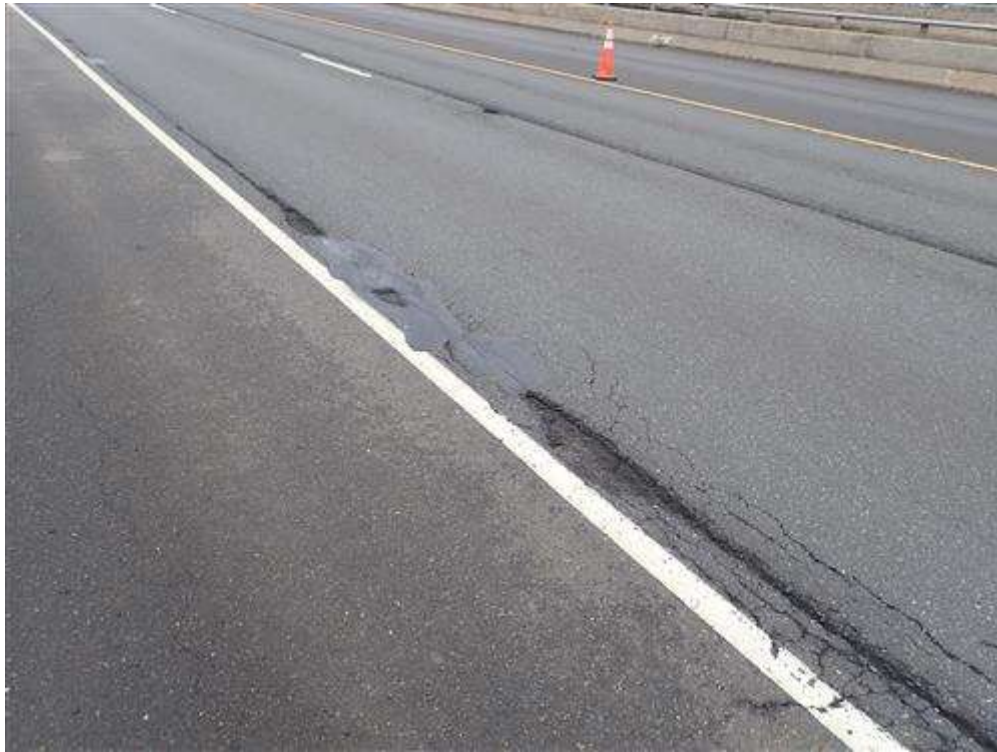
Photo Number: 9

Bituminous Concrete Overlay in Span 2

Note: Failed patch along paving seam with potholes up to 2" deep.

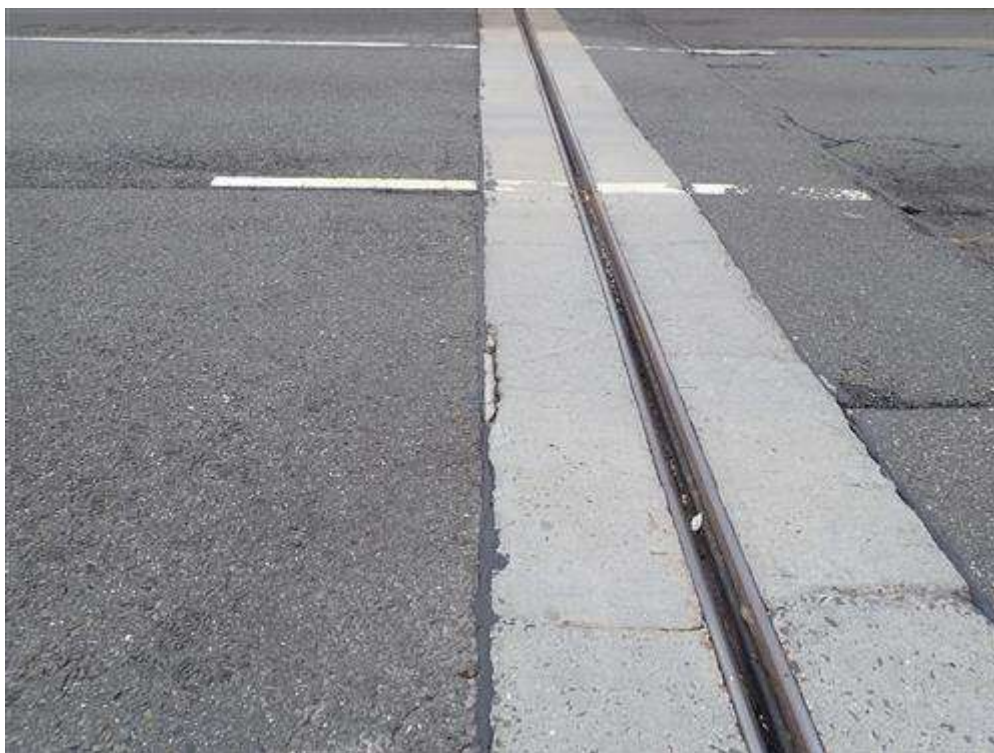
Photo Number: 25

Abutment 1 Header

Note: Crack and potential spall.

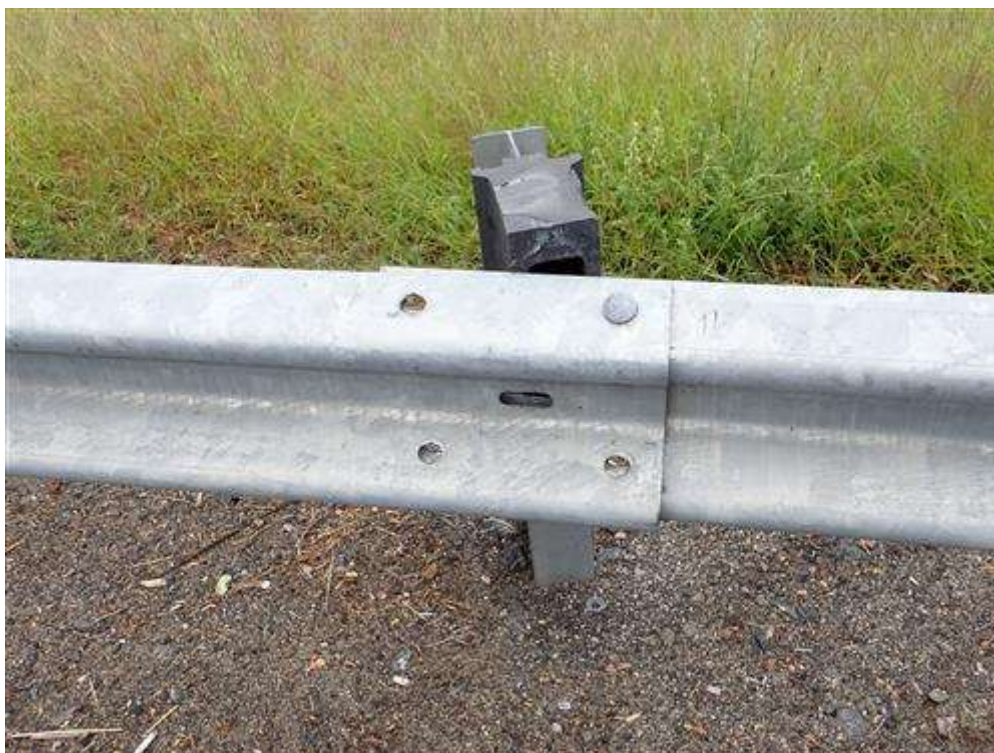
Photo Number: 31

Southeast Approach Guide Rail

Note: Missing splice bolt.

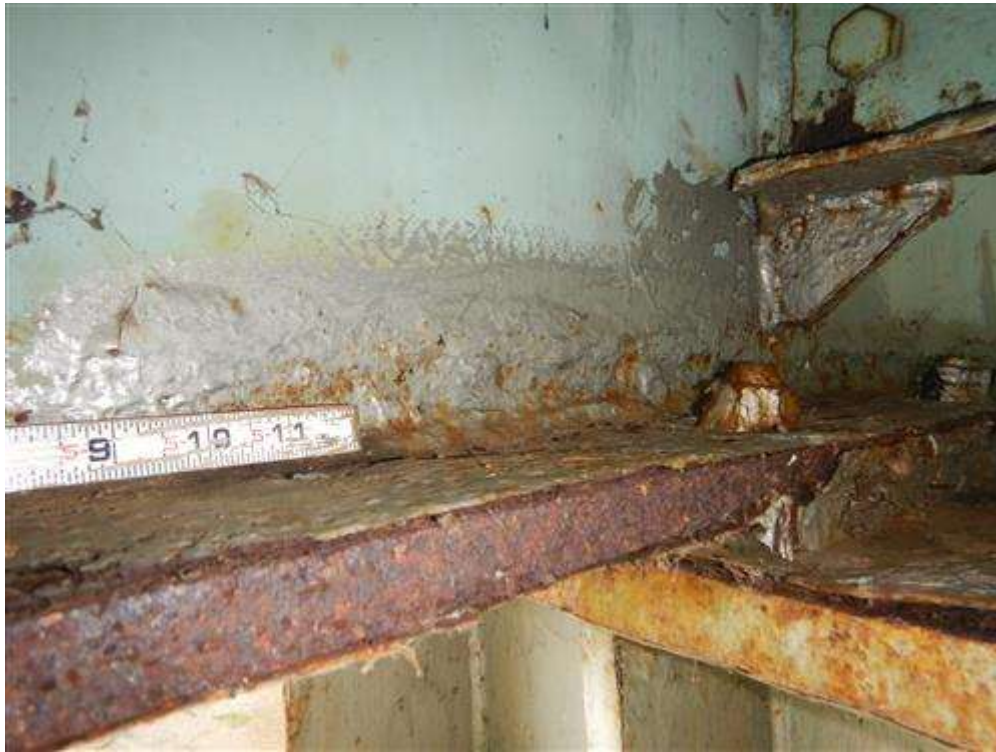
Photo Number: 43

Stringer 8 Left Face at Floor Beam 25

Note: 4' long x up to 2" high x up to 3/16" deep pitting on web.

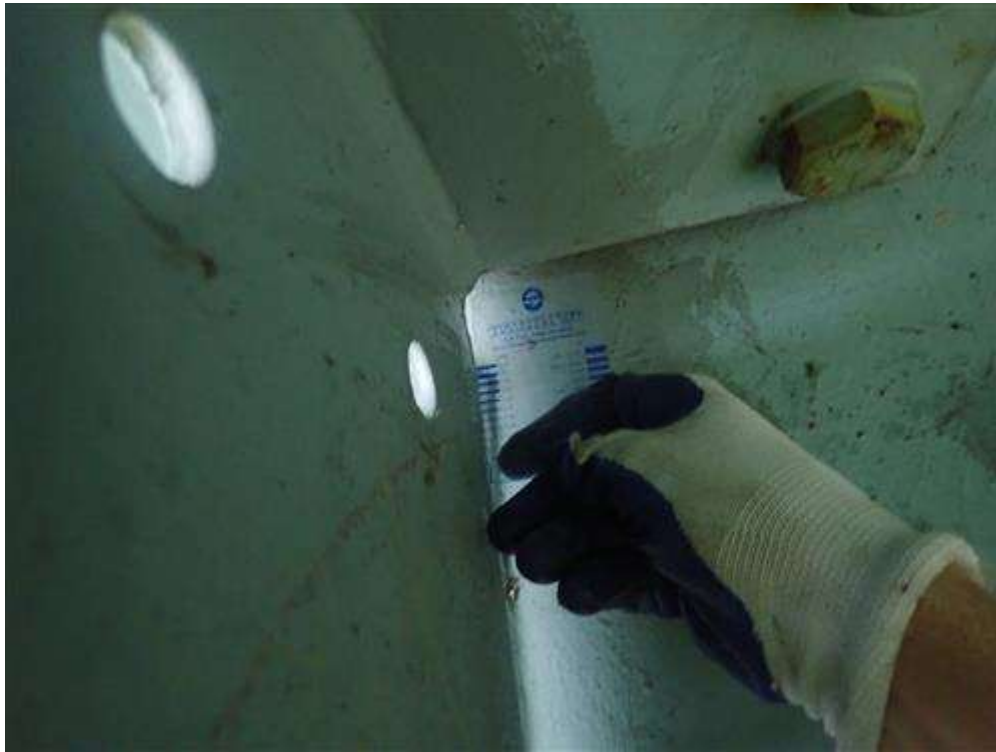
Photo Number: 53

Floor Beam 2 at Girder 2

Note: Floor Beam web bowed 1/4".

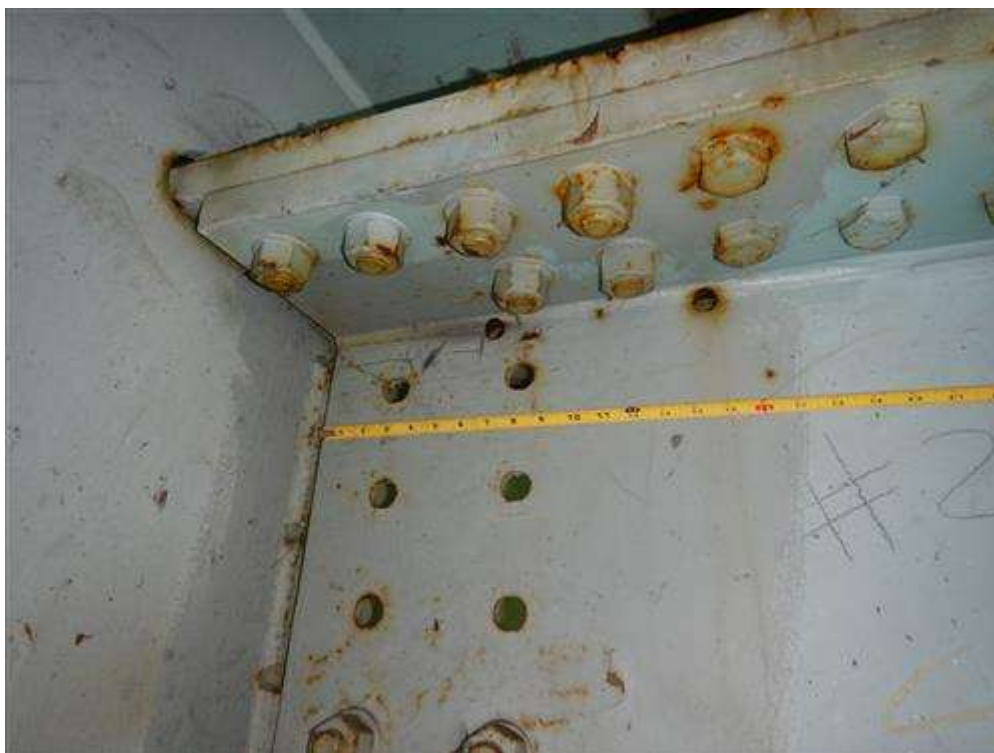
Photo Number: 69

Floor Beam 28 Cantilever at Girder 2

Note: 6" crack in fillet weld between web and top flange with rust.

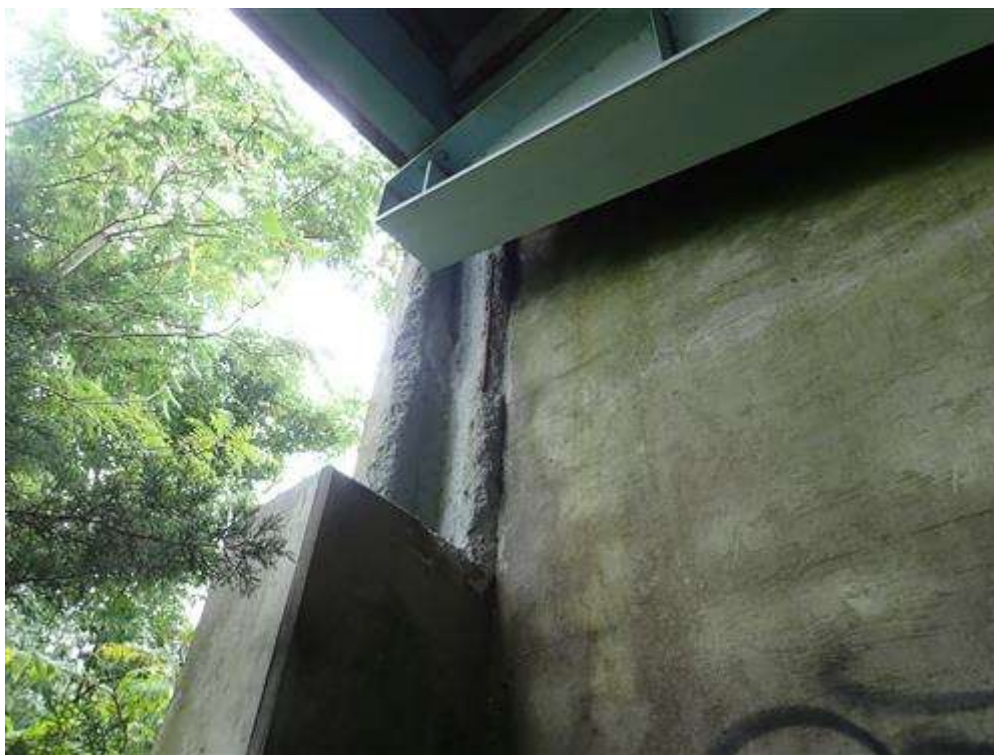
Photo Number: 73

Abutment 1 Right Cheekwall

Note: Spall.
