BRIDGE NO.04180

52980 - NEWTOWN
INTERSTATE 84 WESTBOUND
over
HOUSATONIC RIVER

Underwater Inspection

7/18/2018

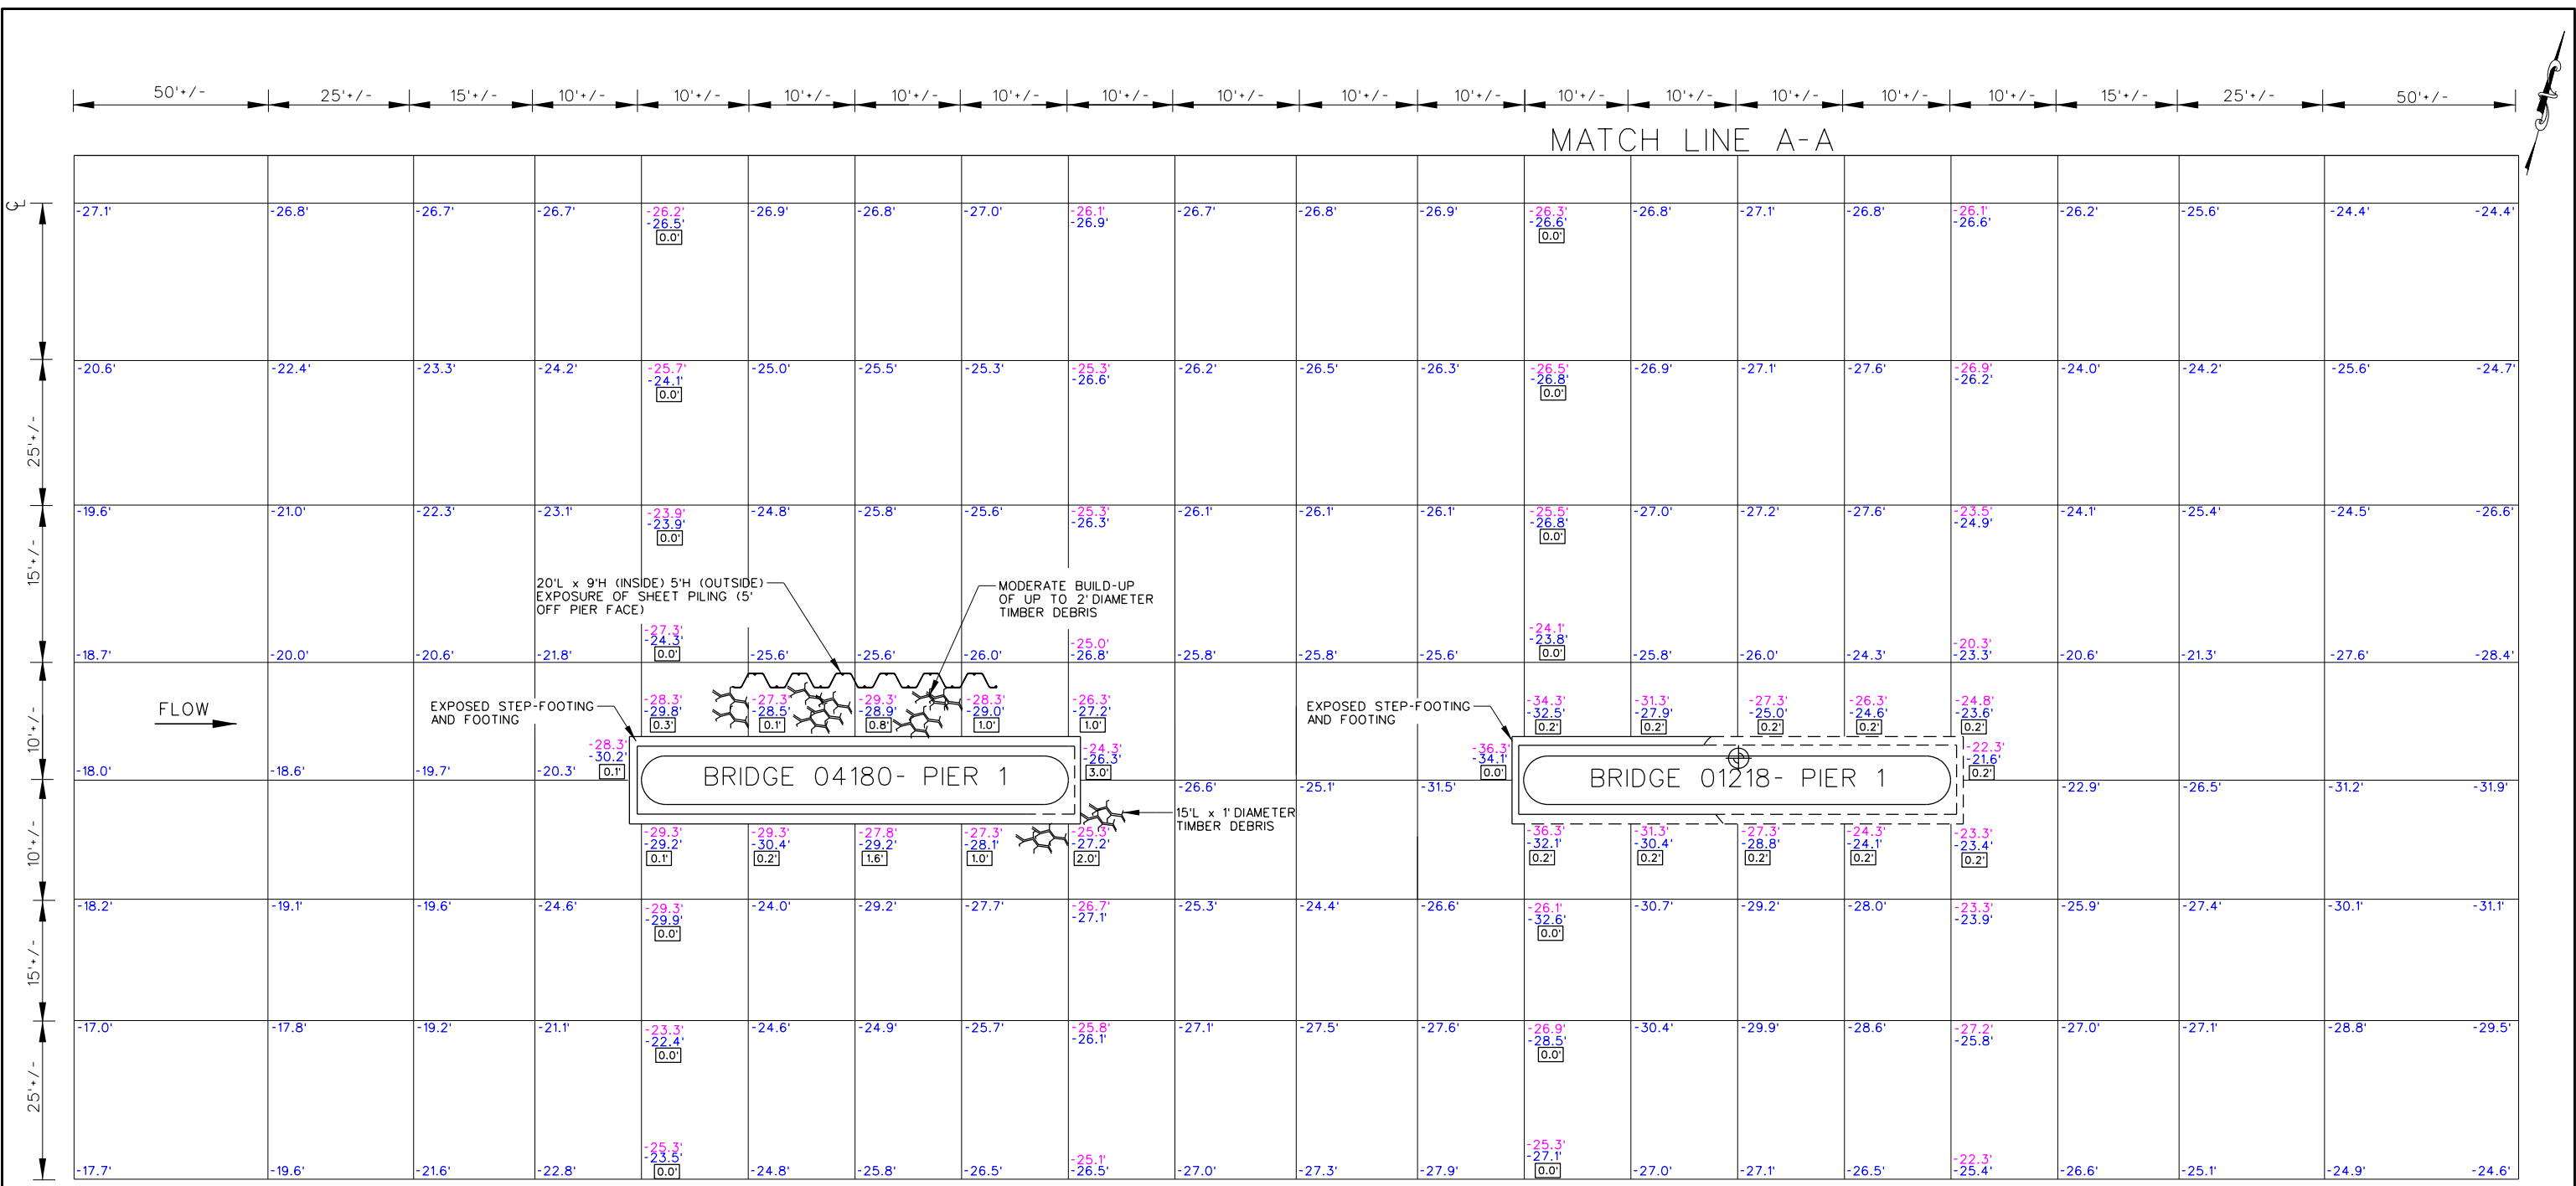
UW DRAWING 1

- Channel bottom elevations along the upstream and downstream fascias have random areas of mostly aggradation up to 4.0' since the 2016 Underwater Inspection.

- There is no apparent change to the channel orientation.
- Bridge No. 01218 is located approximately 40' downstream (East) of the bridge.
- There is approximately a 150' long x 20' wide x 3' high sandbar/area of aggradation located north of Pier 3.

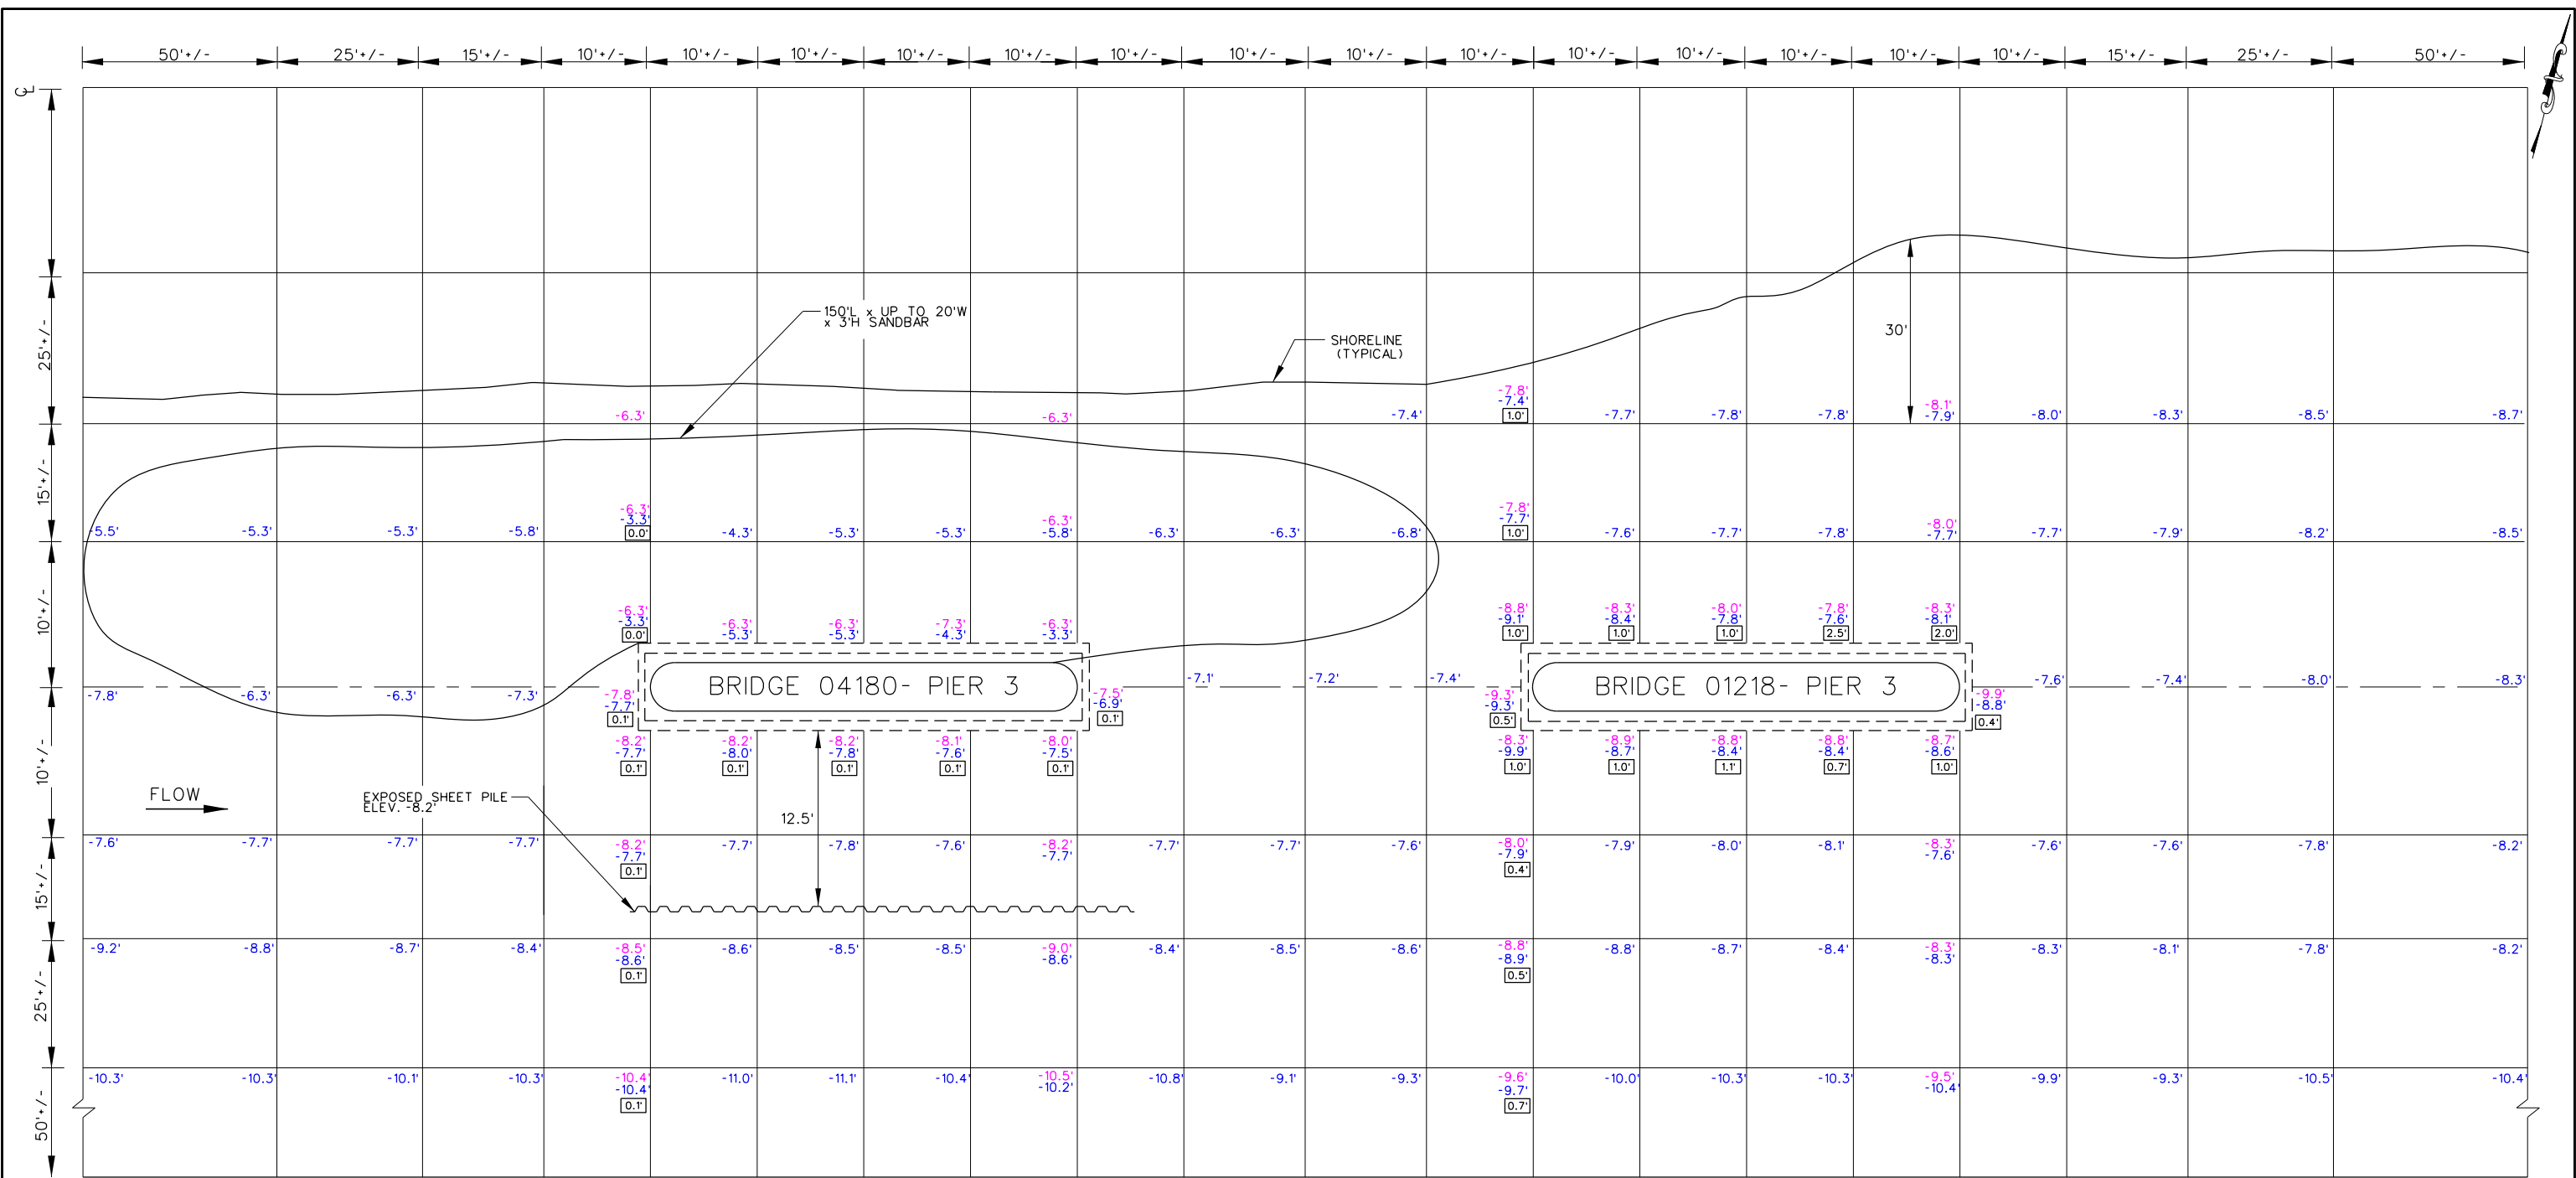
UW DRAWING 3

- There is no exposure of the step footing or footing at the pier.
- There is a section of sheet pile exposed up to 6" high along the south face of the pier approximately 12.5' off the pier face.

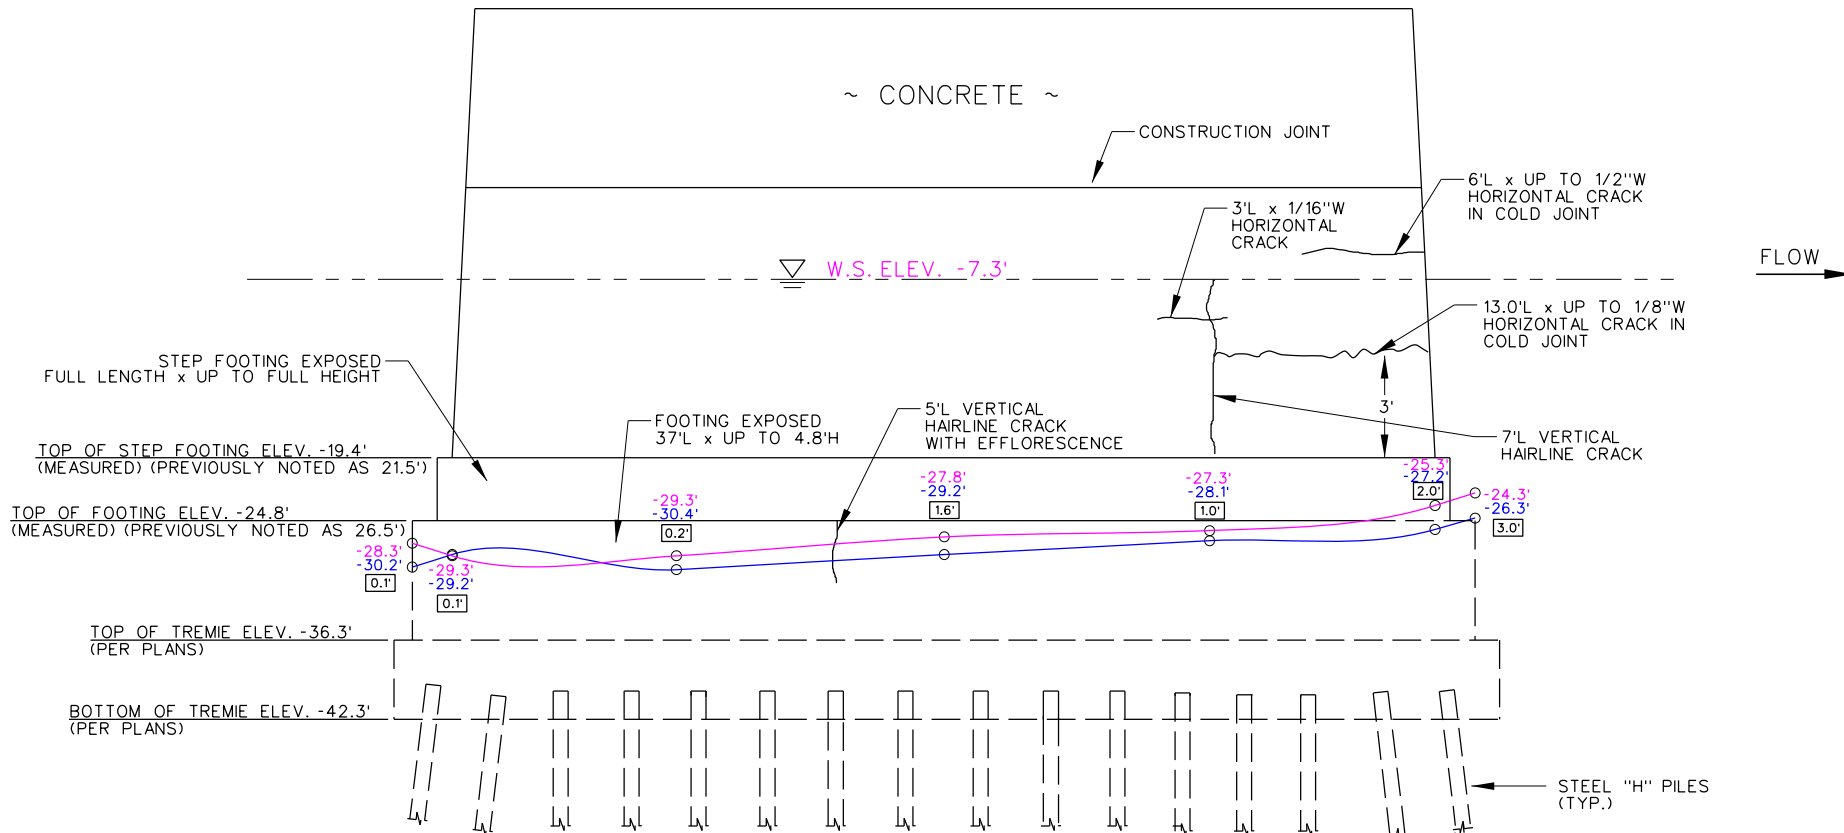
UW DRAWING 5

ITEM	RATING	REMARKS
60. SUBSTRUCTURE	6	REINFORCED CONCRETE ABUTMENTS AND PIERS
ABUTMENT 1:	N	South Abutment. Located out of the channel.
STEM	N	
FOOTING	N	
EROSION	N	
SETTLEMENT	N	
SCOUR	N	
WINGWALLS	N	
General Remarks:		
ABUTMENT 2:	N	North Abutment. Located out of the channel.
STEM	N	
FOOTING	N	
EROSION	N	
SETTLEMENT	N	
SCOUR	N	
WINGWALLS	N	
General Remarks:		
PIER NO. 1	6	
PILES	N	• There is no exposure of the steel H-piles.
STEM	6	The reinforced concrete pier has the following deficiencies: <ul style="list-style-type: none"> • 5' high band of abrasion up to 1/4" deep extending from 1' above to 4' below the water surface. • Horizontal cracks up to 17' long x up to 1/2" wide along the cold joints above and below water. • Near the midpoint of the footing on both faces there is a vertical hairline crack x 5' long with efflorescence. • The north face has isolated vertical hairline cracks x up to 2' long throughout. • Random areas of Zebra mussels up to 50% coverage x 1" thick. (See UW Drawings 5 & 6 and Photos 3 - 5)

FOOTING	6	The step footing has the following deficiencies: <ul style="list-style-type: none"> • Step footing exposed over its full-length x up to full-height (5.4' high) along both faces of the pier. • Footing exposed up to 5.1' vertically over a length of 37' along the pier on both faces with no undermining. • Isolated vertical hairline cracks up to 5' long with efflorescence. (See UW Drawings 5 & 6 and Photos 6 & 7)

SCOUR	6	<ul style="list-style-type: none">• Channel elevations have varied around the pier with an increase by up to 1.9', this is possibly due to the timber surrounding the pier.• Along the north face of the pier, there is a 20' length of sheet pile exposure up to 6' high located 5' off the pier face.• The Step Footing is exposed over its full-length x up to full-height (5.4' high) along both faces of the pier,• Footing has been exposed up to 5.1' vertically (previously 5.0' high) over a length of 37' on both faces of the pier.
-------	---	---

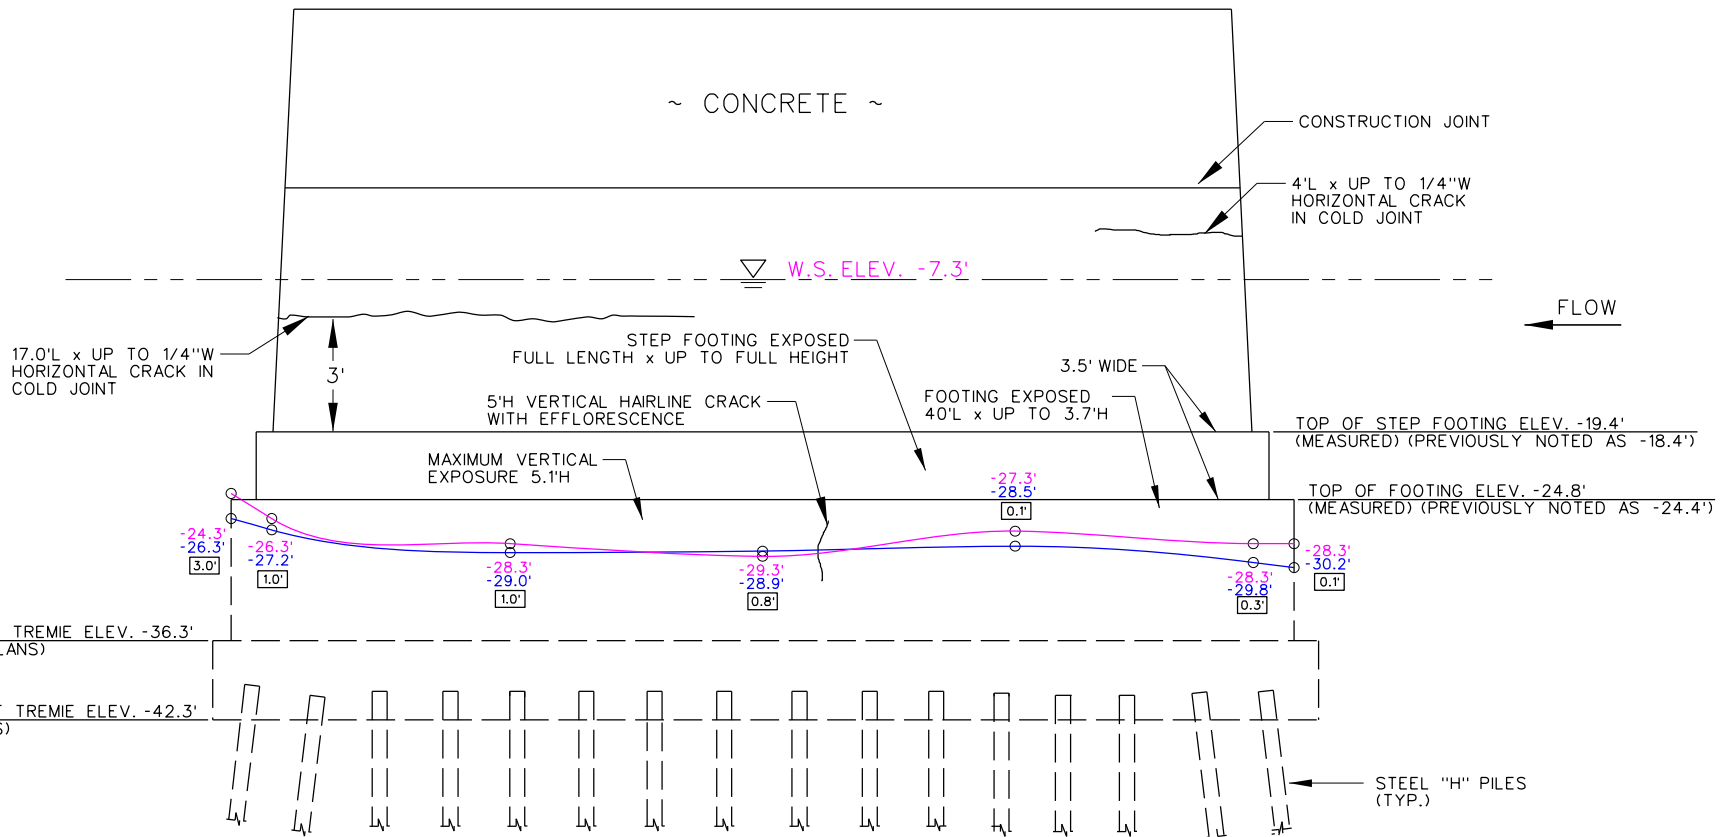
UW DRAWING 6

1. TIMBER DEBRIS UP TO 1' DIA. AT THE UPSTREAM AND DOWNSTREAM NOSE ALONG THE CHANNEL BOTTOM, AND UP TO 2' DIA. ALONG THE SOUTH FACE.
2. ABRASION UP TO 1/4" DEEP FROM 4' BELOW WATER SURFACE TO 1' ABOVE.
3. PIER STEM DISPLAYS ISOLATED VERTICAL HAIRLINE CRACKS UP TO 2' LONG.
4. 20' LONG SHEET PILING 5' OFF OF THE FOOTING UP TO 9' HIGH (INSIDE), 5'H (OUTSIDE).
5. RANDOM AREAS OF ZEBRA MUSSEL UP TO 50% COVERAGE X 1" THICK ON UNDERWATER SUBSTRUCTURE.

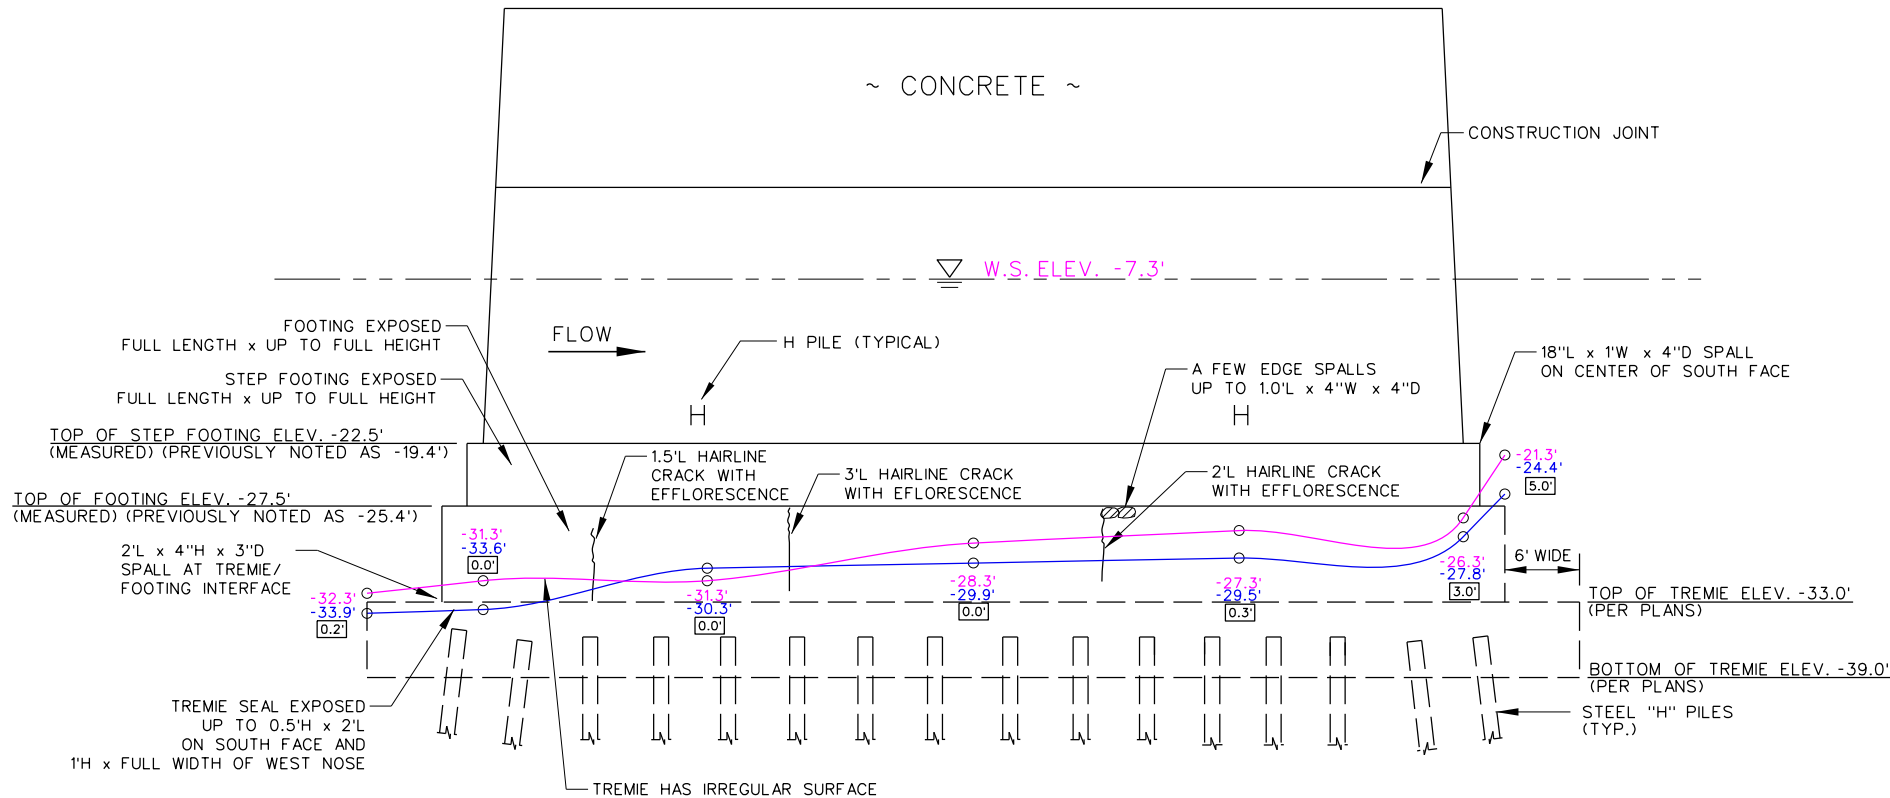
UW DRAWING 7

- 5' high band of abrasion up to 1/4" deep extending from 1' above to 4' below the water surface.
- There are steel H-piles intermittently exposed along the stem located above the step footing (formwork left in place from construction).
- Random areas of Zebra mussels up to 50% coverage x 1" thick.

- The step footing is exposed over its full-length x up to full-height (5.0' high) on both faces of the pier.
- The footing has been exposed full length x up to full-height (5.5' high) on the south face and full length x up to 1.7' high (previously 0.2' high) on the north face of the pier with no undermining.
- The tremie seal has been exposed up to 1.0' long across the full-width of the Upstream (West) Nose and over 2' long x 0.5' high at the southwest corner of the pier.
- Random vertical hairline cracks up to 3' long with efflorescence on the footing.
- Isolated edge spalls on the footing up to 2' long x 4" wide x up to 4" deep.
- At the center of the Downstream (South) face of the step footing there is a spall 18" long x 1' wide x 4" deep.
- At the southwest corner of the footing/tremie interface there is a spall 2' long x 4" high x 3" deep.

SCOUR	5	<ul style="list-style-type: none">• Channel elevations surrounding Pier 2 has had aggradation of up to 3.1' with isolated areas of degradation up to 3.0'.• The step footing is exposed full length x up to full-height (5.0' high) on both faces of the pier.• The footing has been exposed over its full-length x up to full-height (5.5' high) on the south face and full length x up to 1.7' high on the north face of the pier.• The Tremie Seal has been exposed up to 1.0' high (previously 0.9' high) across the full-width of the Upstream (West) Nose and over 2' long x 0.5' high at the southwest corner of the pier.
-------	---	--

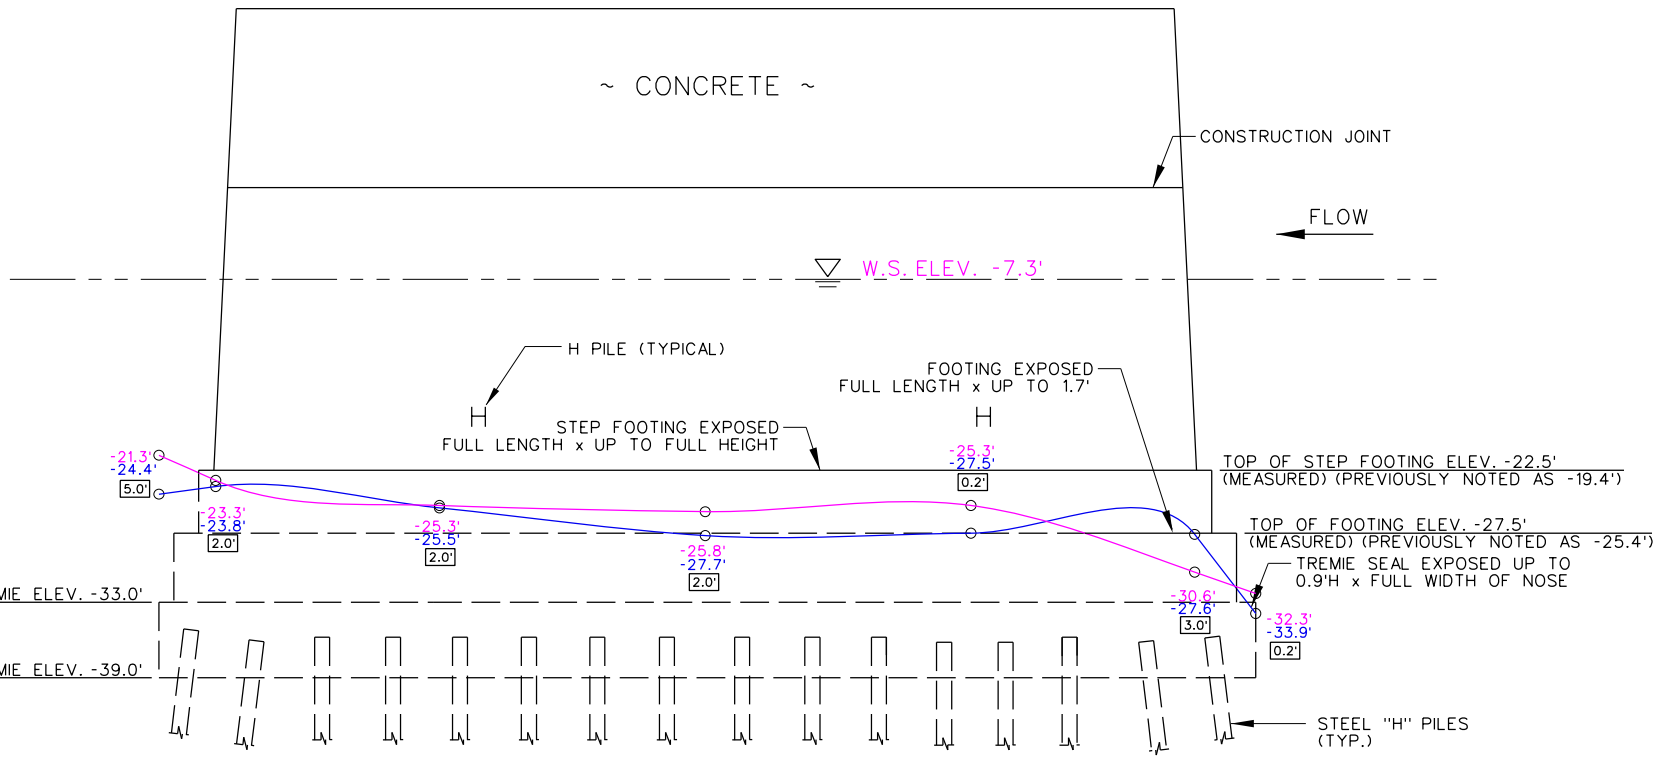
UW DRAWING 8

1. HEAVY TIMBER DEBRIS UP TO 1' DIA. AT THE UPSTREAM NOSE ALONG CHANNEL BOTTOM.
2. ABRASION UP TO 1/4" DEEP FROM 4' BELOW THE WATER SURFACE TO 1' ABOVE.
3. RANDOM AREAS OF ZEBRA MUSSELS UP TO 50% COVERAGE x 1" THICK ON UNDERWATER SUBSTRUCTURE.

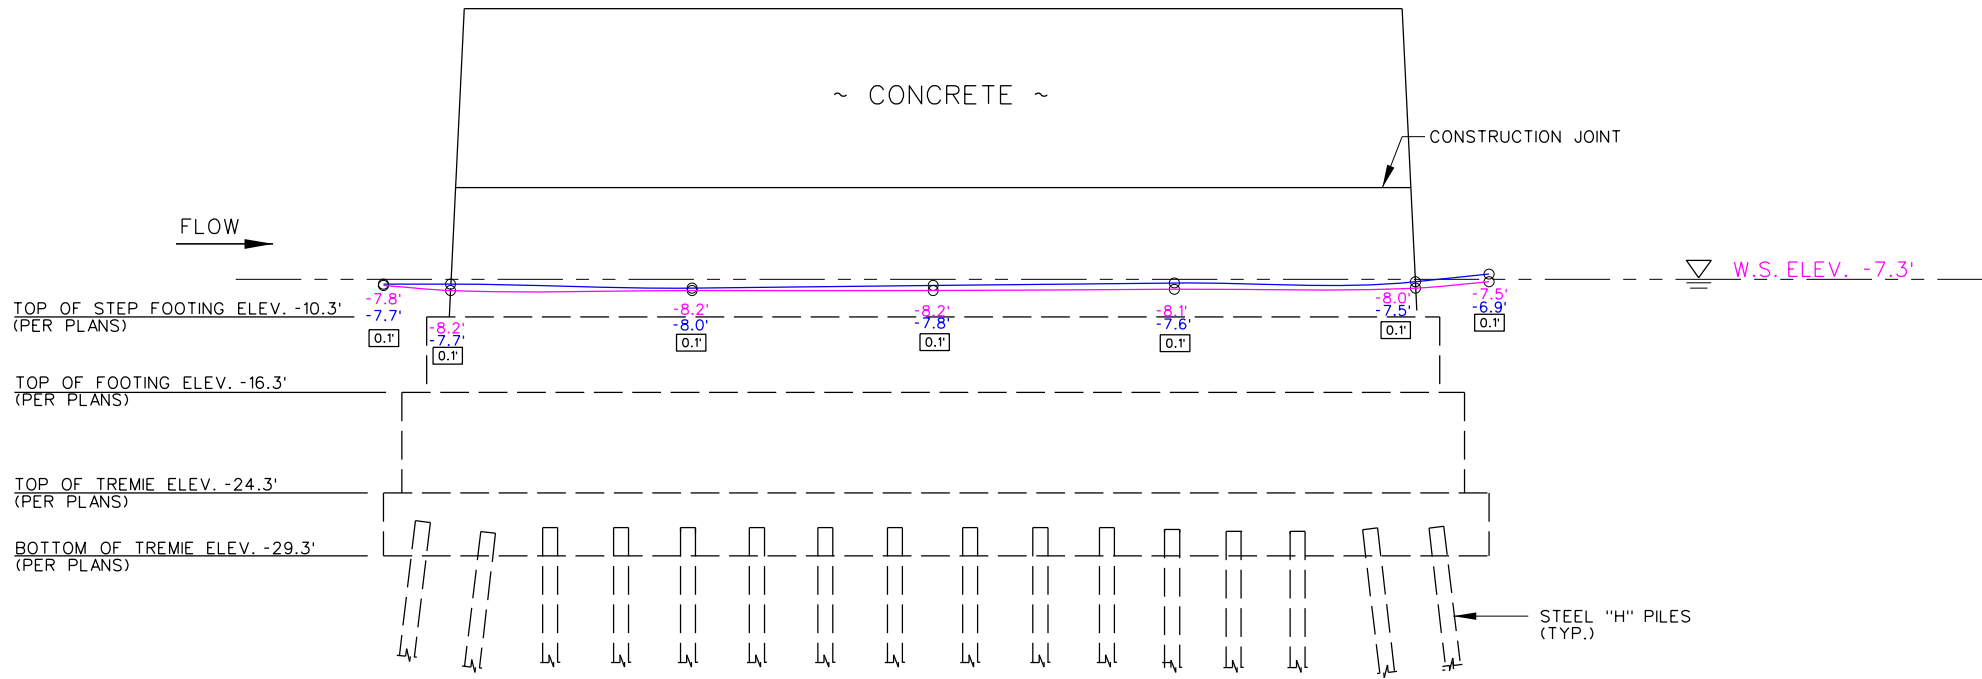
- Band of abrasion up to 1/4" deep extending from 1' above the water surface down to the channel bottom.

- The north face towards the Upstream (West) Nose of the pier there is a 1.7' long vertical hairline crack below the construction joint.

- Channel bottom elevations have remained relatively unchanged (less than 0.6' variations) except for scour up to 3.0' along the north face of the pier since 2016 Inspection.

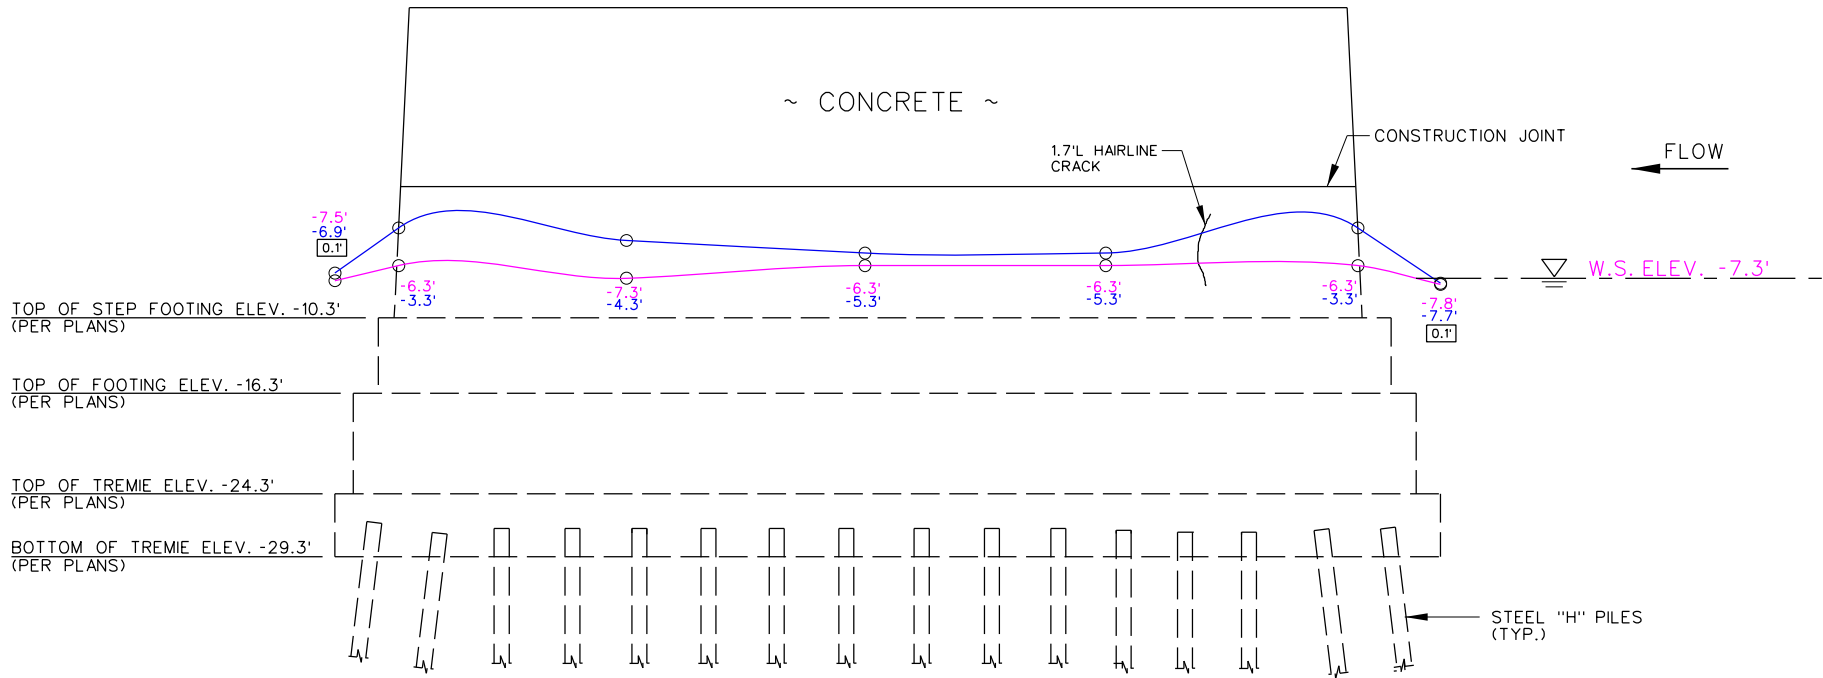
- Channel bottom elevations at Pier 3 show evidence of degradation of up to 3.0' along the north face of the pier most likely due to the sandbar that was noted in the previous 2016 Underwater Inspection.

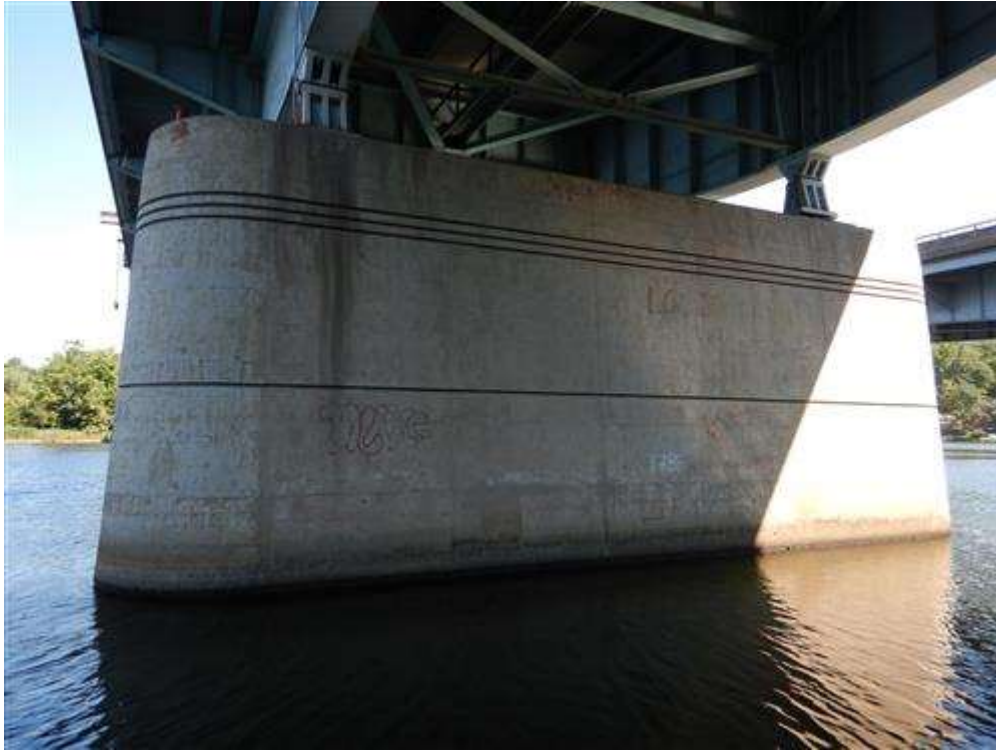
Photo Number: 3

Pier 1 South Elevation

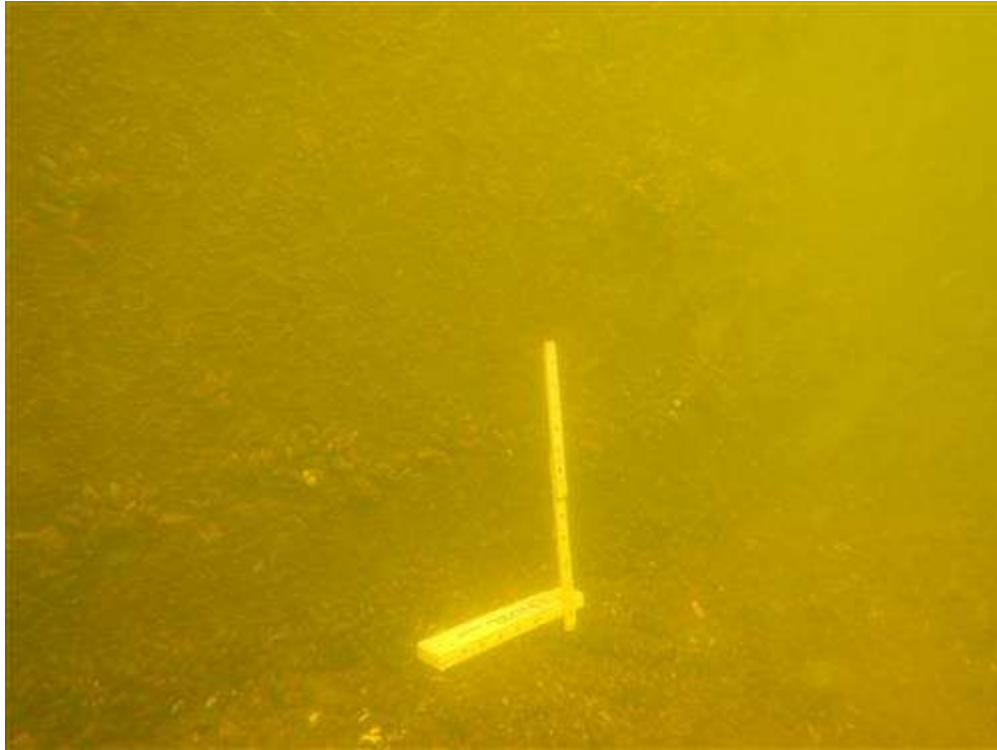
Photo Number: 5

Pier 1 South Elevation Stem

Note: Zebra mussels on pier.

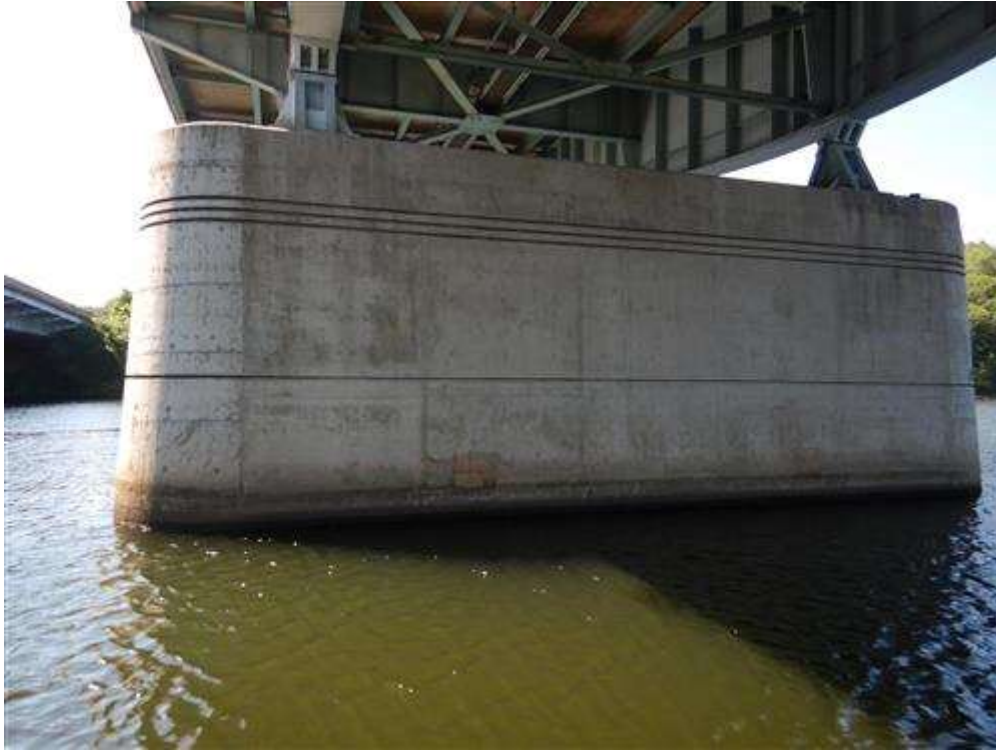
Photo Number: 9

Pier 2 North Elevation

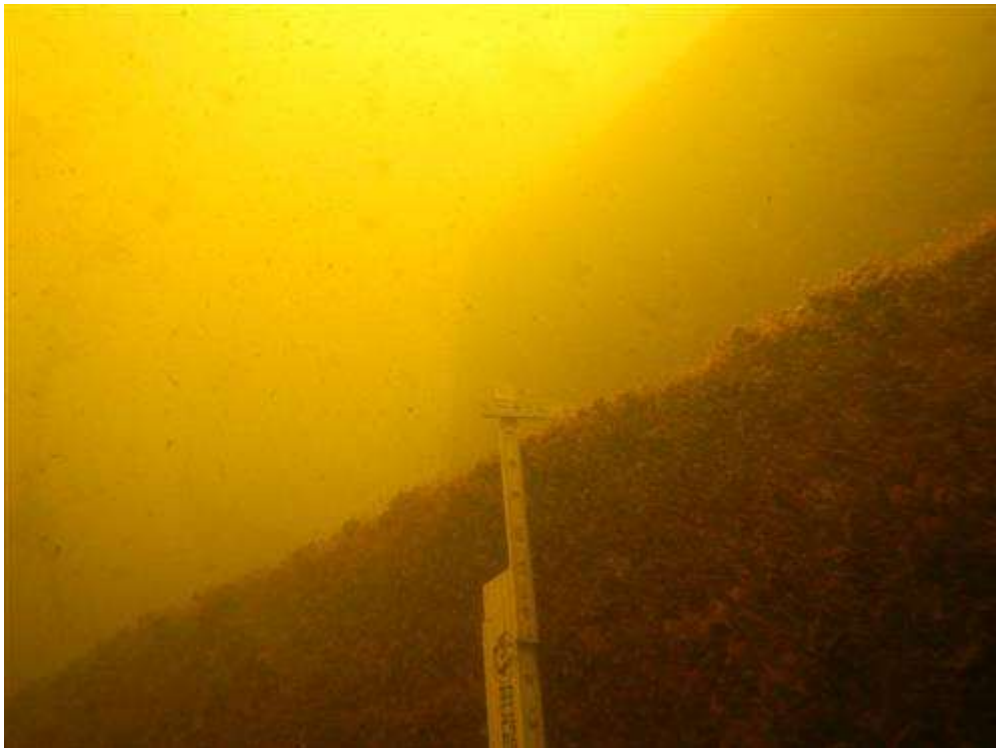
Photo Number: 10

Pier 2 Upstream South Elevation

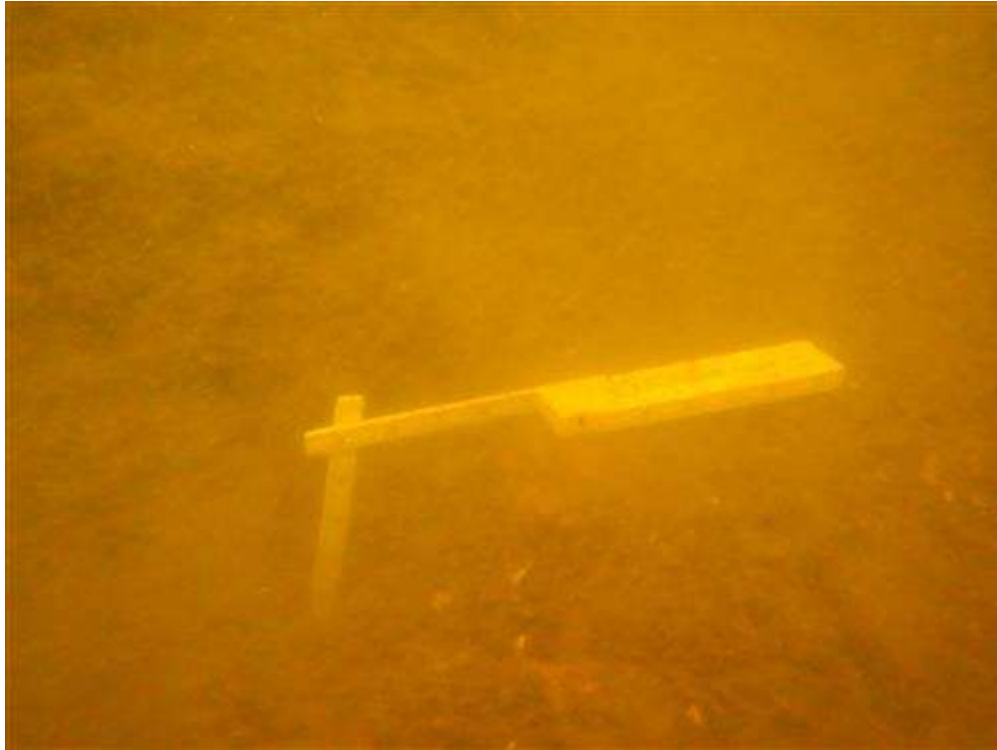
Photo Number: 11

- At Pier 2 the Tremie Seal has been exposed up to 1.0' high (previously 0.9') across the full-width of the upstream (west) nose and over 2' long x up to 0.5' high at the southwest corner of the pier.

Pier 2 Upstream Nose

Note: Exposed tremie.

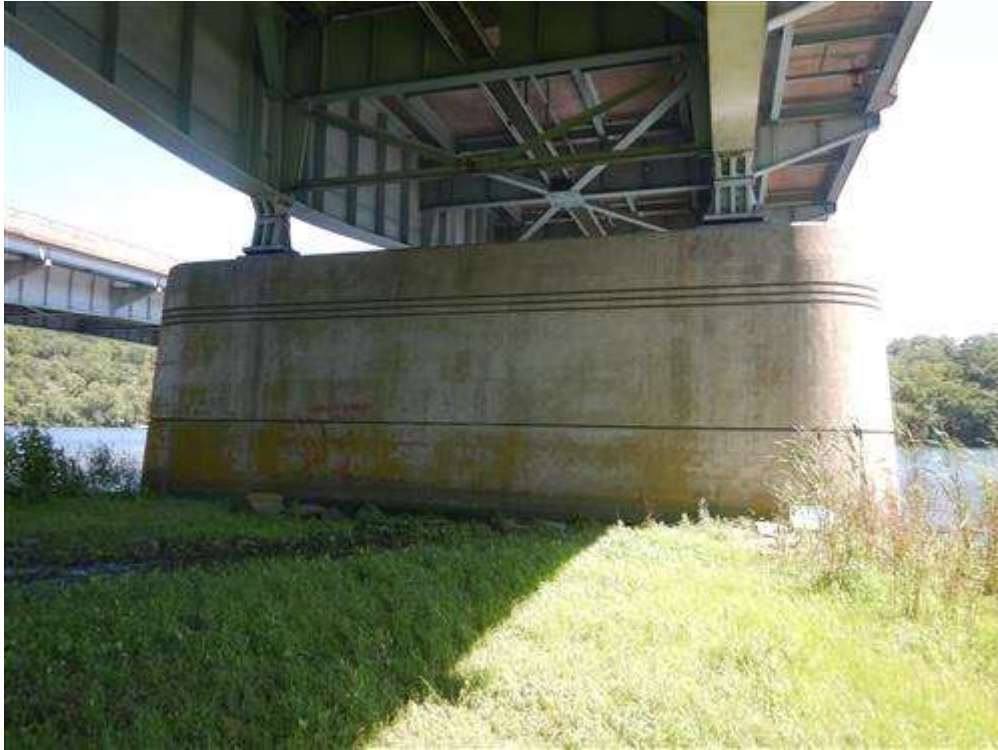
Photo Number: 13

Pier 3 North Elevation

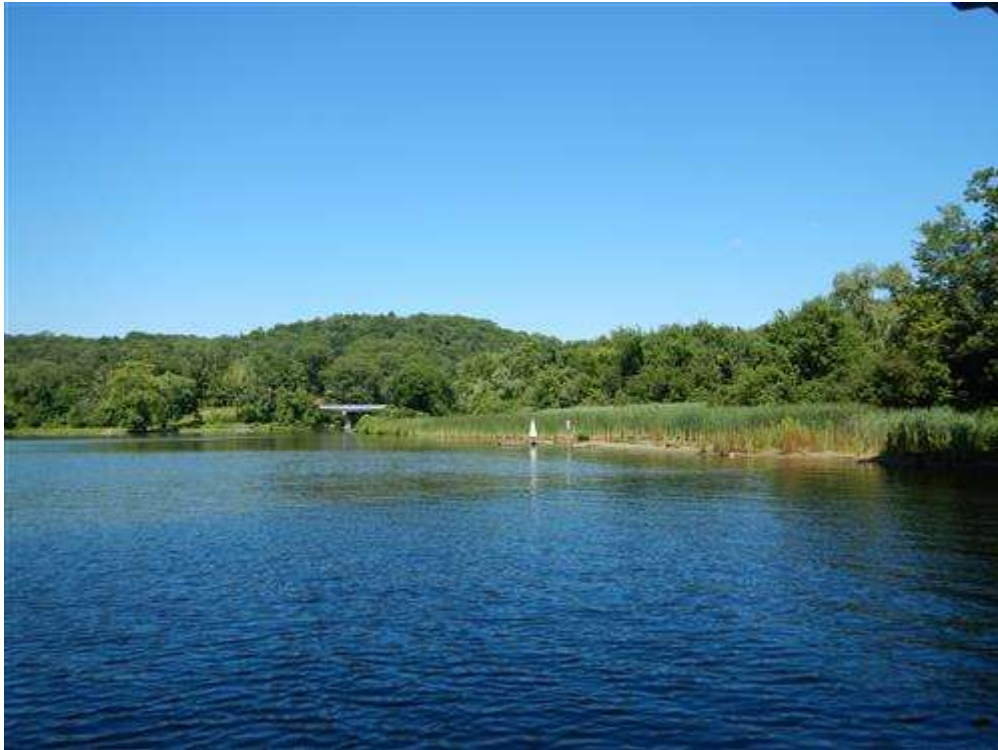
Photo Number: 16

Northwest Channel Embankment

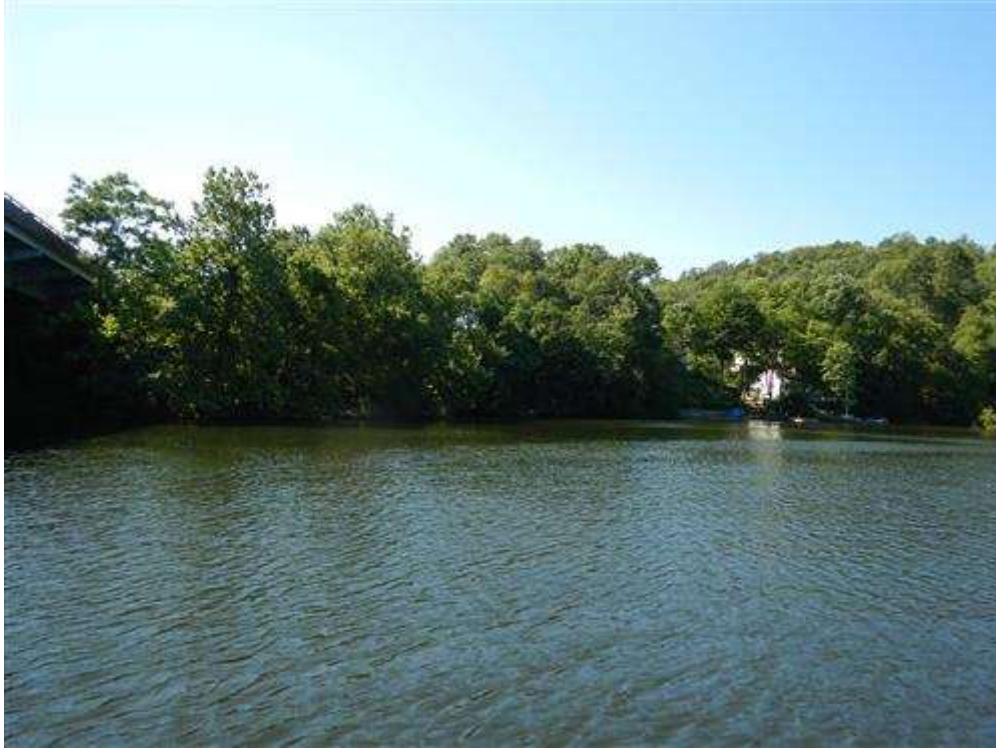
Photo Number: 17

Northeast Channel Embankment

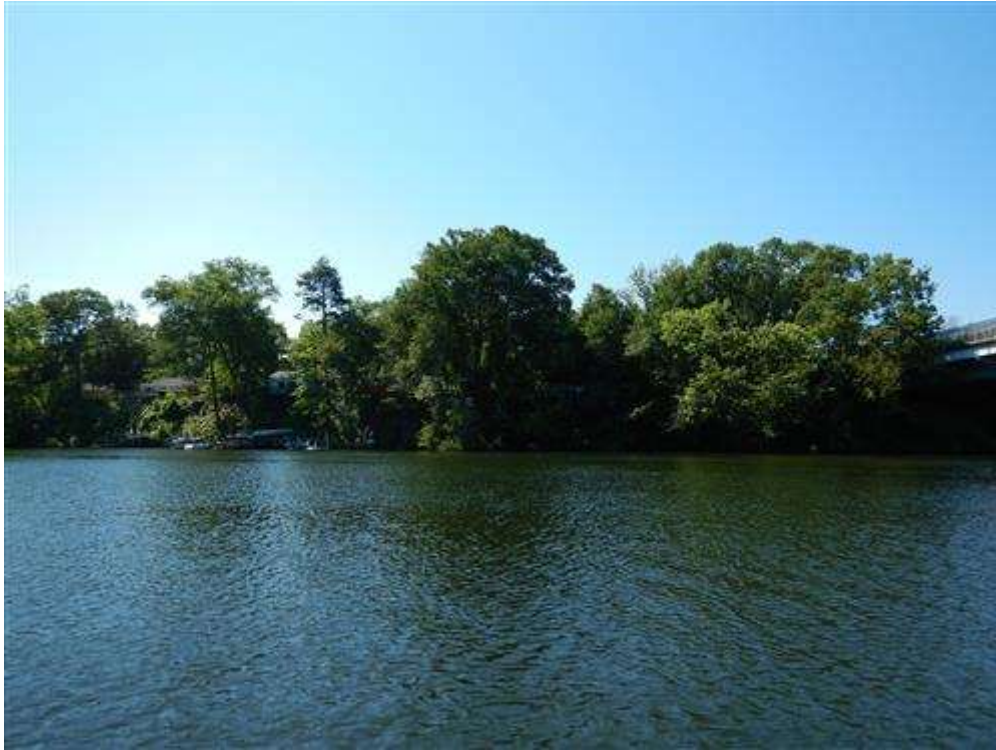
Photo Number: 19

- There is no significant erosion along the channel embankments.

Southeast Channel Embankment
