BRIDGE NO.04180

52980 - NEWTOWN
INTERSTATE 84 WESTBOUND
over
HOUSATONIC RIVER

Underwater Inspection

7/18/2018

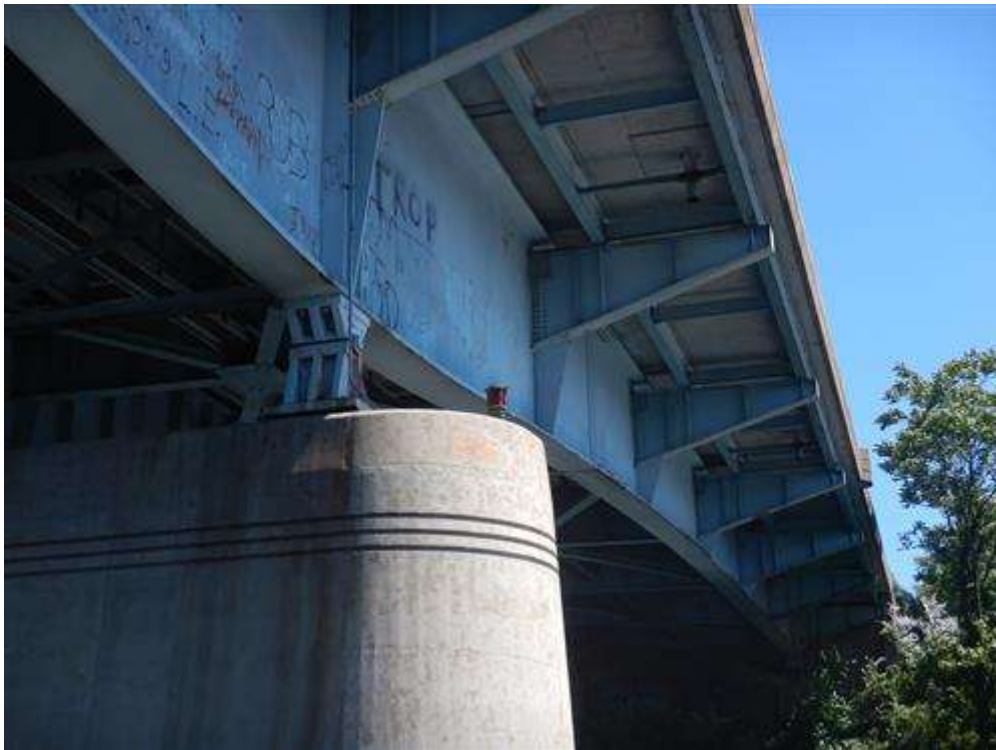
Photo Number: 20

The navigation lights on Pier 1, Span 2 Fascia and Pier 2 and the west bridge fascia appear to be on timers and were not on at the time of the inspection.

Navigational Light Pier 1 (Upstream)

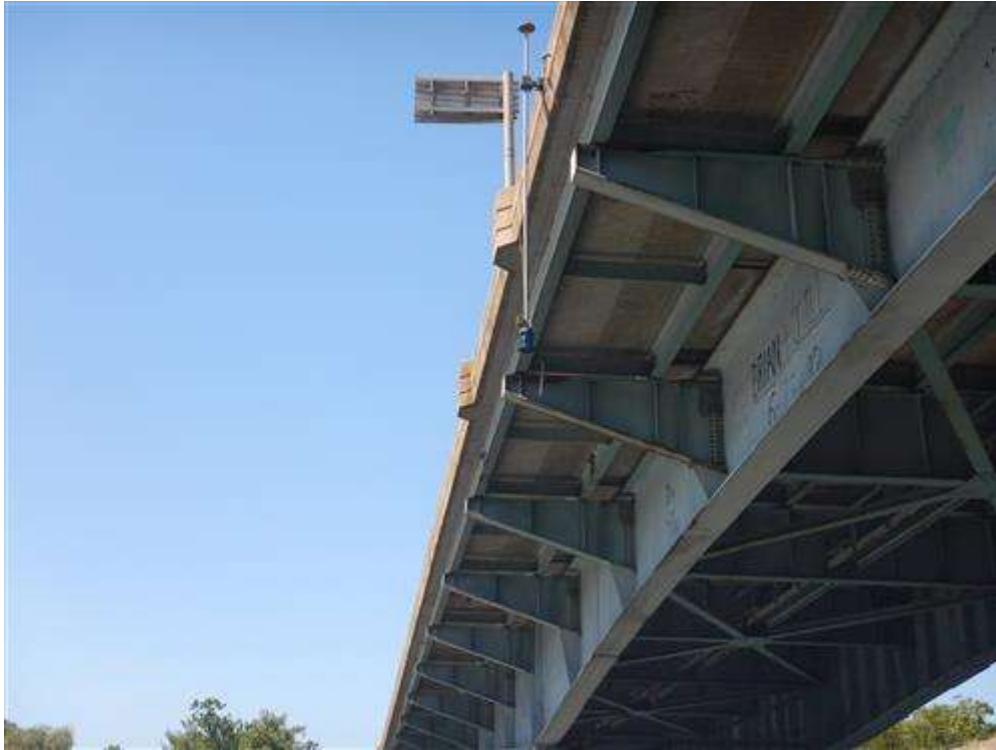
Photo Number: 21

Navigational Light Span 2 (Upstream)
