HazMat Inspection - Bridge No. 06695 (Culvert/ACCMPA), Route 123 over

Rose Brook, New Canaan, CT

ConnDOT Assignment No. 519-5774

ConnDOT Project No. 89-128 TRC Project No. 289951.5774.0710

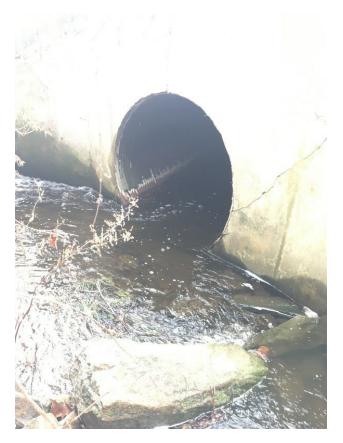
East side

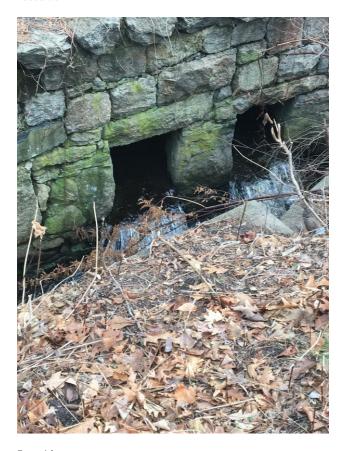
East side

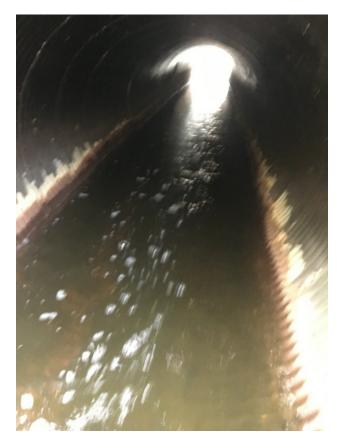
East side looking westward

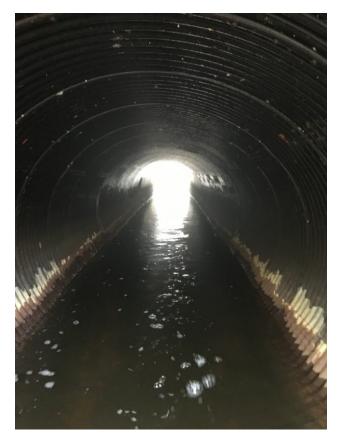
East side looking westward

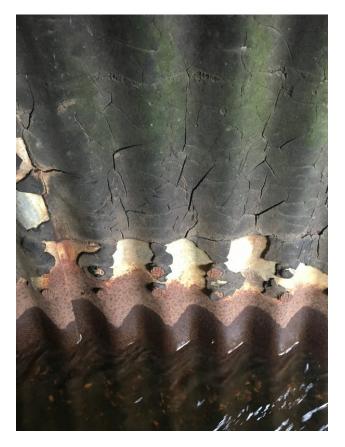
East side at water line

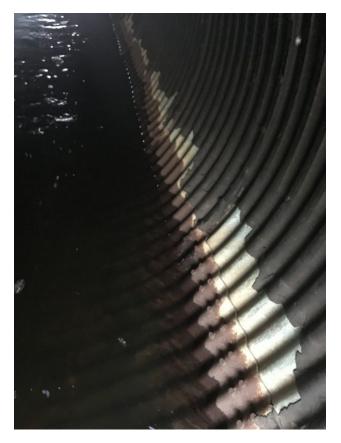
East side

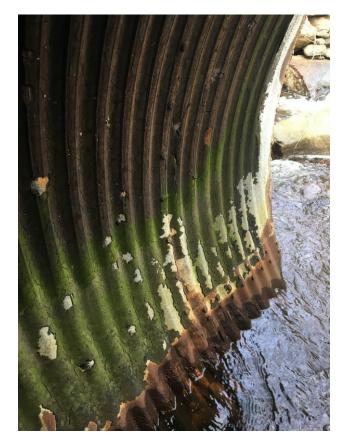
East side

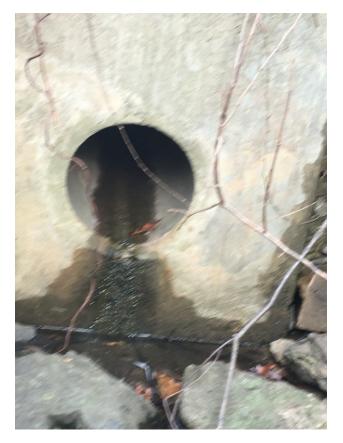
East side

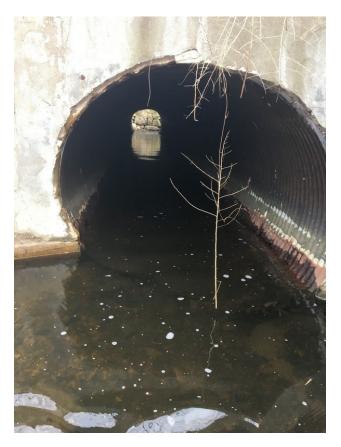
West side of culvert

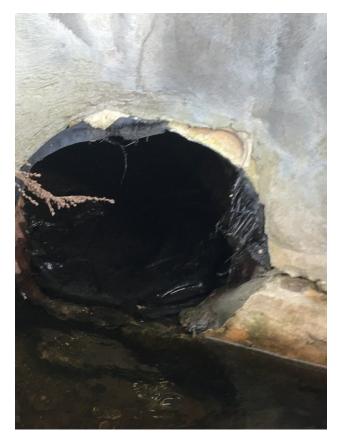
18 inch pipe on west side with fiber lining

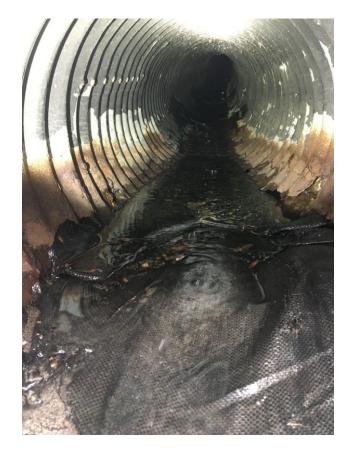
18 inch pipe on west side

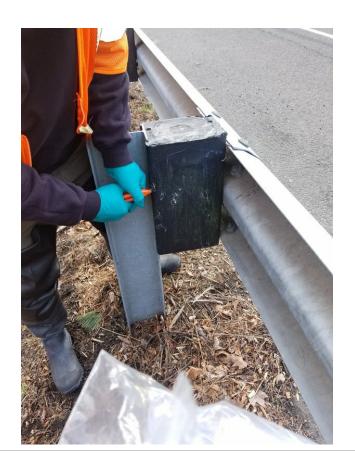
### (2), T1, Tar on guard rail post

Sampled or Assumed?	Sampled
Material Acronym	T1
Material Description	Tar on guard rail post
Is Material a Non-Friable Organically Bound (NOB)	Yes
