**PRE-RENOVATION
INVESTIGATIVE SURVEY FOR
HAZARDOUS BUILDING MATERIALS**

**BROOKFIELD MAINTENANCE FACILITY
MAIN BUILDING
BROOKFIELD, CONNECTICUT
Project No. 34-350**

REVISED
January 2019

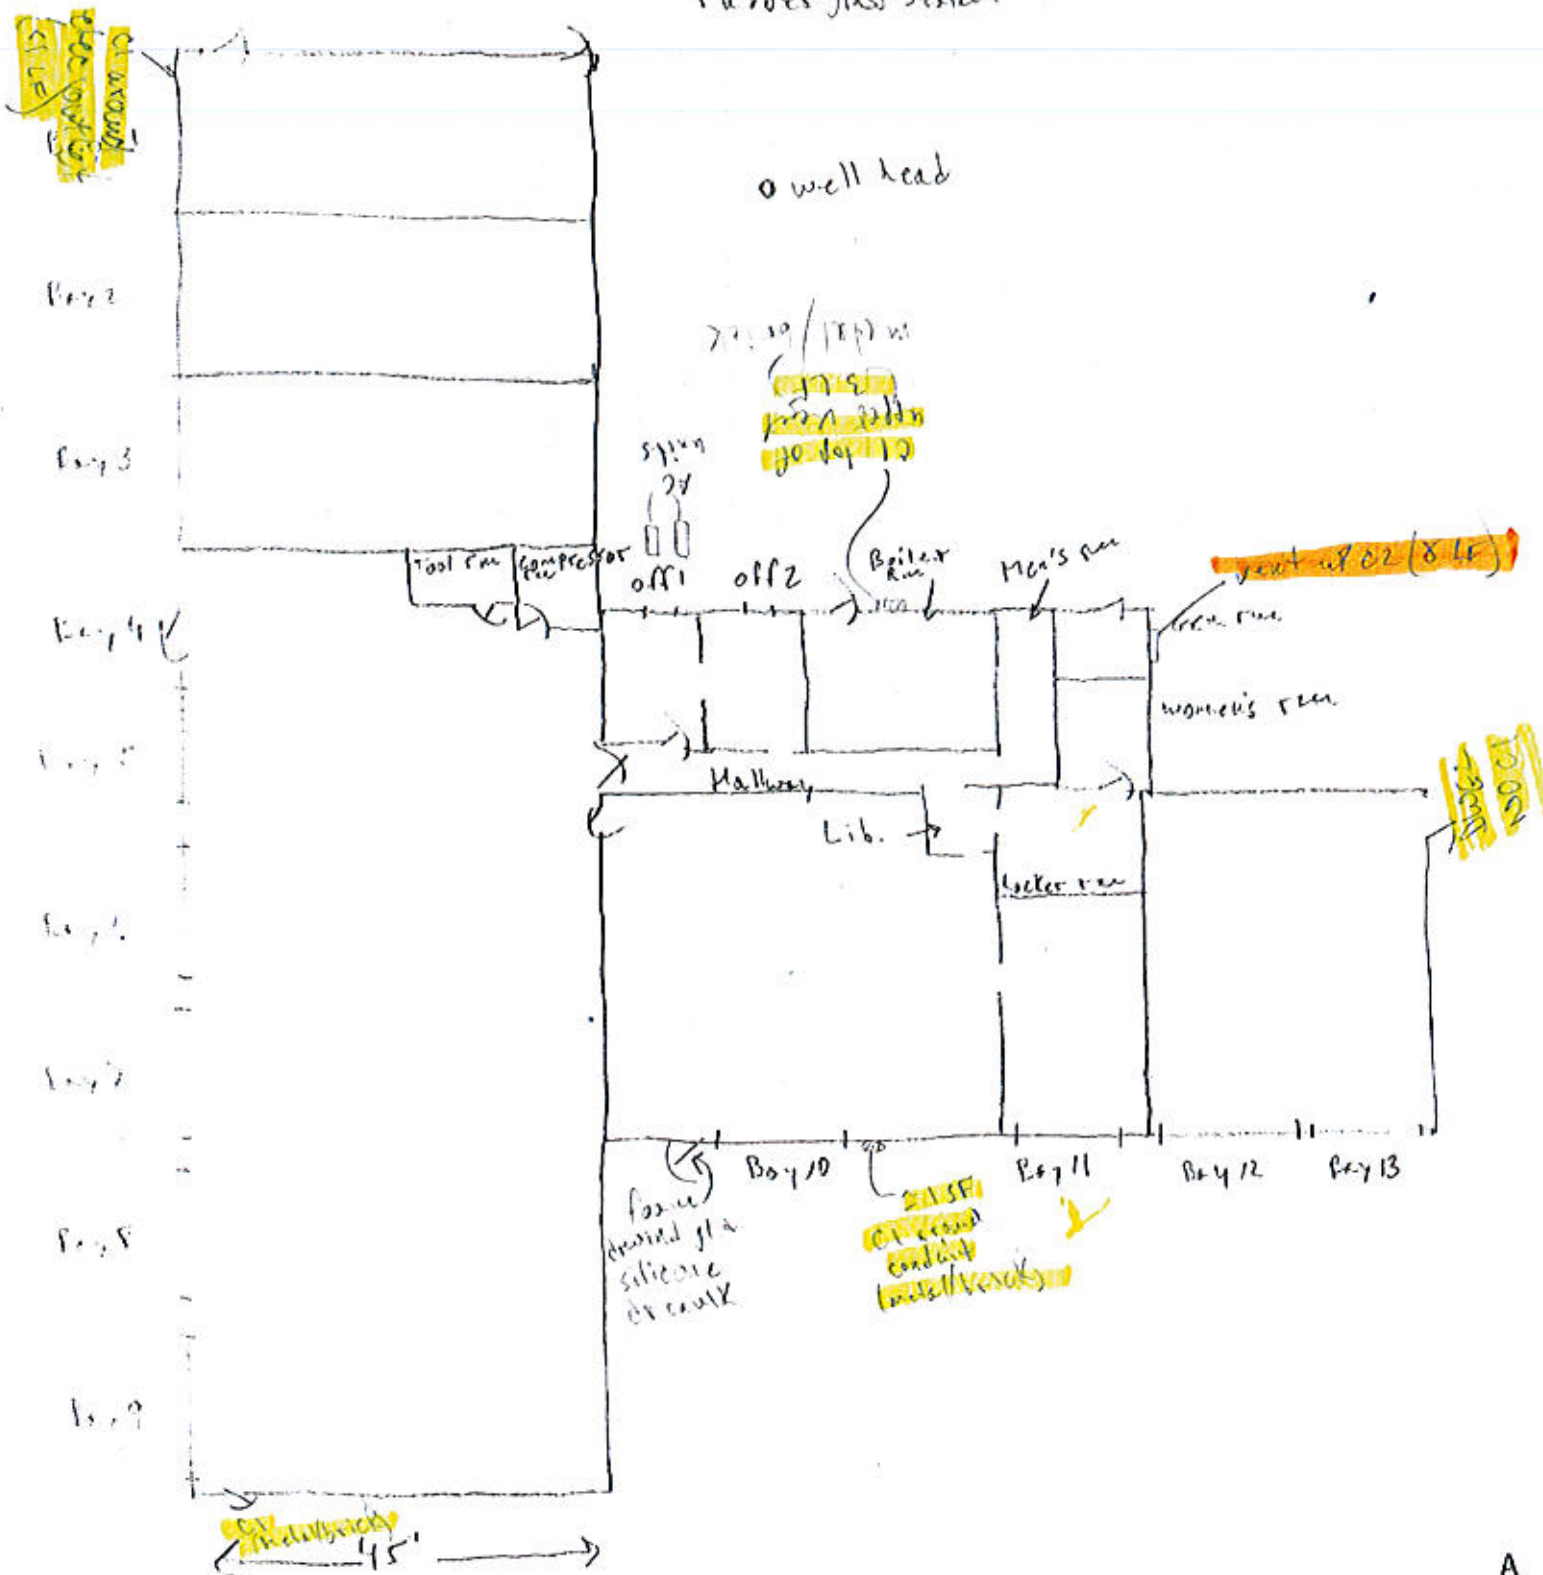
Ext

* All ext windows have silicone caulk & rubber glass sealant

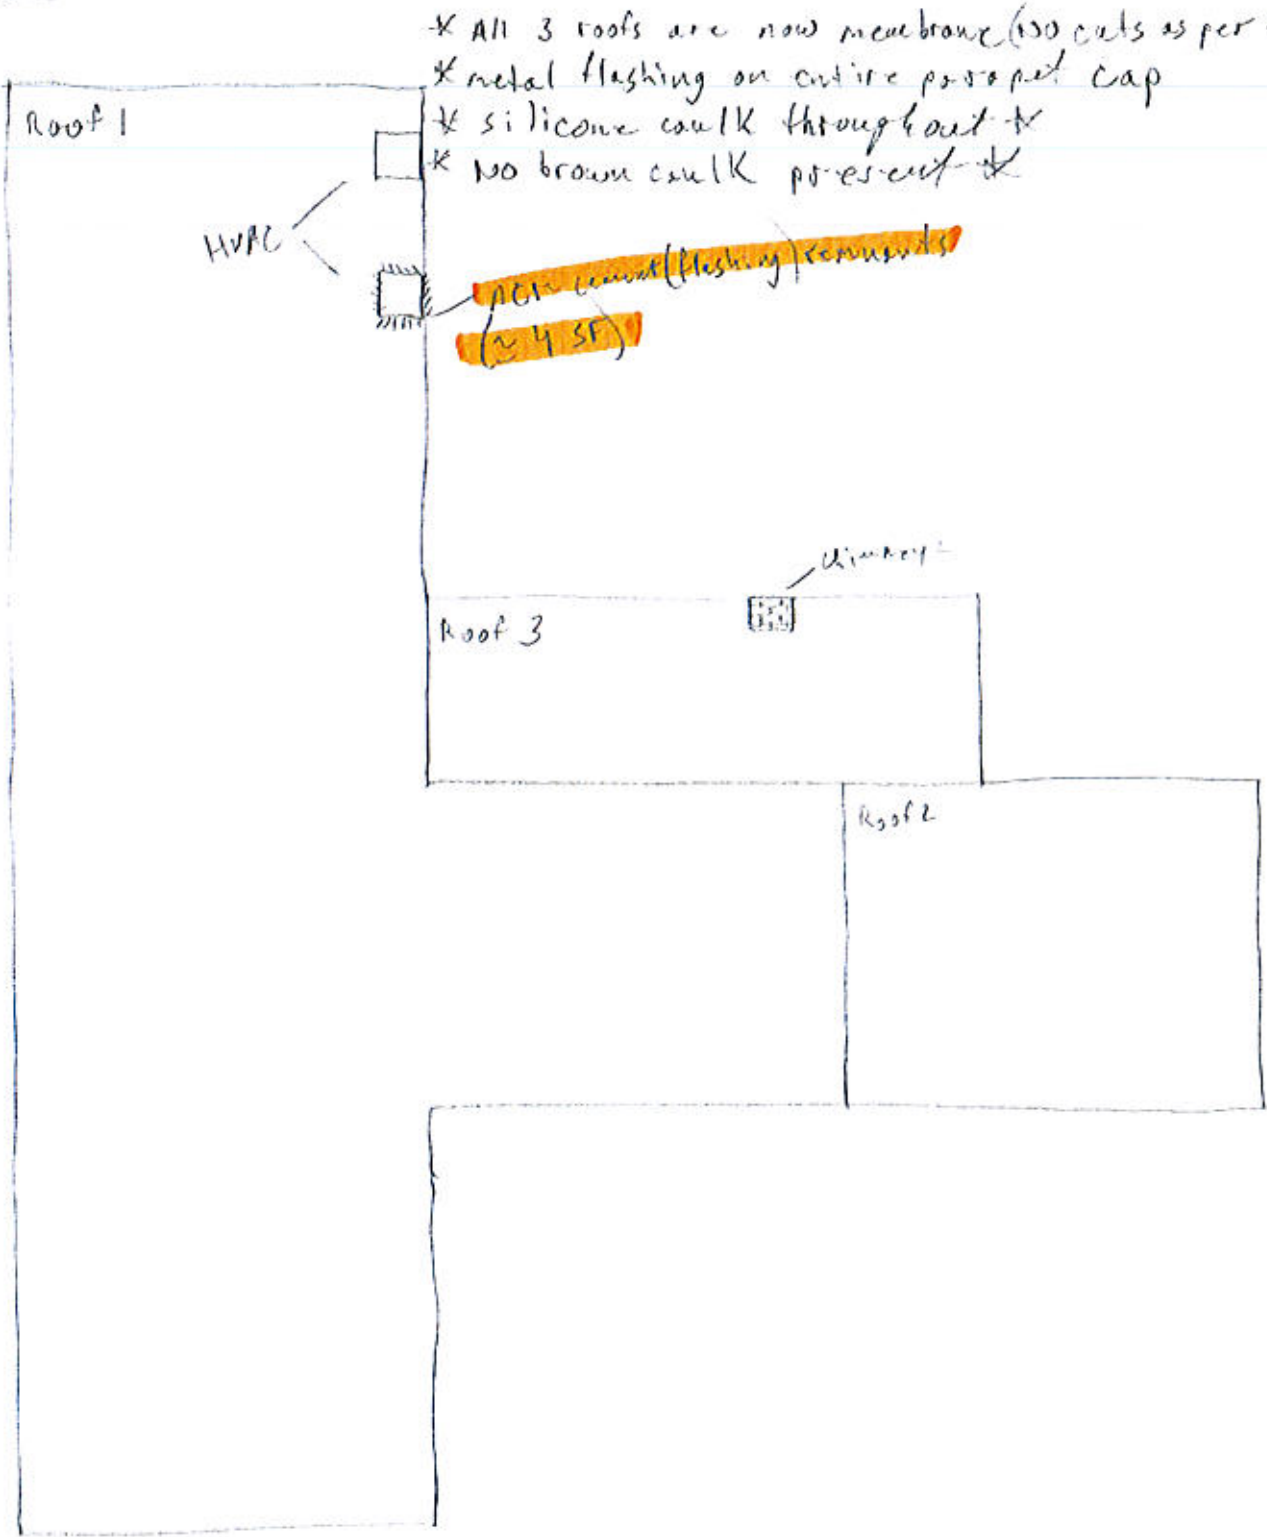
Roof

- * All 3 roofs are now membrane (no cuts as per EP)
- * metal flashing on entire parapet cap
- * silicone caulk throughout
- * no brown caulk present

ACR cement (flashing) remnants
(~ 4 SF)
