May 4, 2020

Subject: On-Call Asbestos, Lead, Air Quality & Demolition Compliance
Agreement No.: 8.07-01 (18)
HazMat Inspection – Route 9, 17 & 82 Highway Resigning & Renumbering, Various
Cities/Town, CT
ConnDOT Assignment No. 519-6178
ConnDOT Project No. 172-473
TRC Project No. 289951.6178.0710

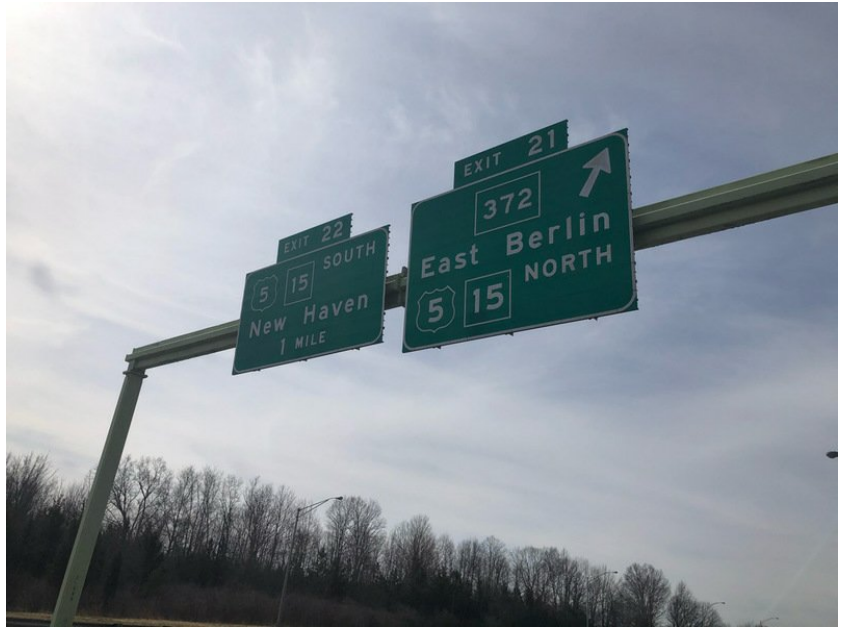
009N-007-31.35A and 009N-007-31.35B on 21033

Bridge/Sign/Light Pole/Traffic Signal No.	21033
General Notes	Replace exit crown only
Accessibility	Accessible
Paint on Structure (s)?	Yes
Paint on what Components/Structure(s)?	Green painted cantilever
Suspect Asbestos Containing Materials Identified on Structure	No
Guano Present?	No
Homeless Activity	No
Bloodborne Pathogen Concerns?	No
Mice/Mouse Nests/Droppings	No

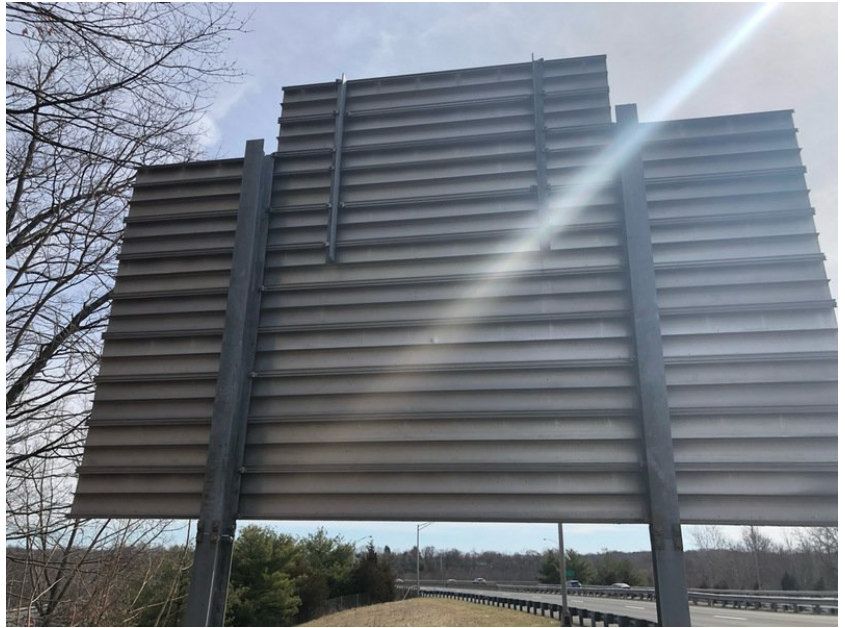
Bridge/Sign/Light Pole/Traffic Signal No.	009N-007-31.75A
General Notes	Replace exit crown only
Accessibility	Accessible
Paint on Structure (s)?	No
Suspect Asbestos Containing Materials Identified on Structure	No
Guano Present?	No
Homeless Activity	No
Bloodborne Pathogen Concerns?	No
Mice/Mouse Nests/Droppings	No

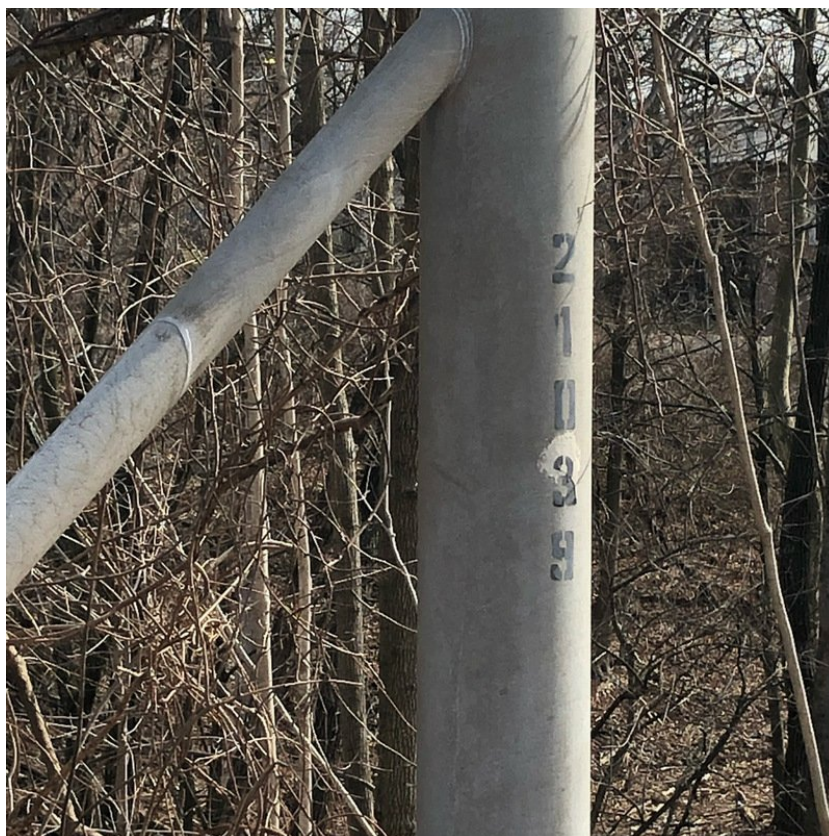
009N-088-34.80-A, 009N-088-34.80-B, 009N-088-34.80-C on 21039

Bridge/Sign/Light Pole/Traffic Signal No.	21039
General Notes	Replace exit crown only 009N-088-34.80A 009N-088-34.80B 009N-088-34.80C
Accessibility	Accessible
Paint on Structure (s)?	No
Suspect Asbestos Containing Materials Identified on Structure	No
Guano Present?	No
Homeless Activity	No
Bloodborne Pathogen Concerns?	No
Mice/Mouse Nests/Droppings	No

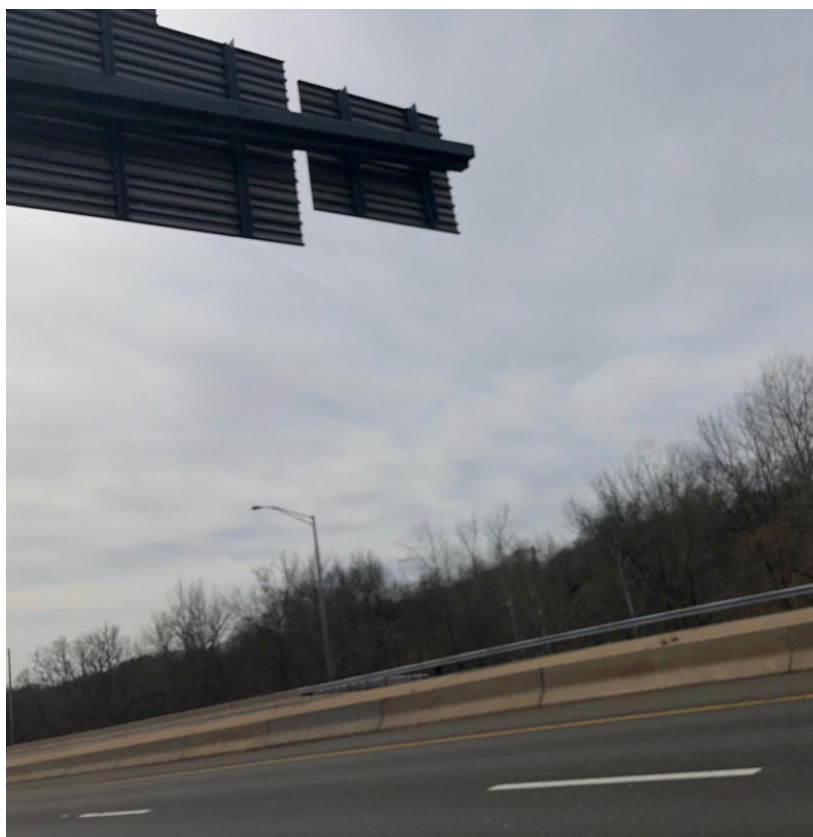
009N-003-38.11-A and 009N-093-38.11-B on 21049

Bridge/Sign/Light Pole/Traffic Signal No.	21049
General Notes	Replace exit crown only 009N-093-38.11-A 009N-093-38.11-B
Accessibility	Accessible
Paint on Structure (s)?	No
Suspect Asbestos Containing Materials Identified on Structure	No
Guano Present?	No
Homeless Activity	No
Bloodborne Pathogen Concerns?	No
Mice/Mouse Nests/Droppings	No

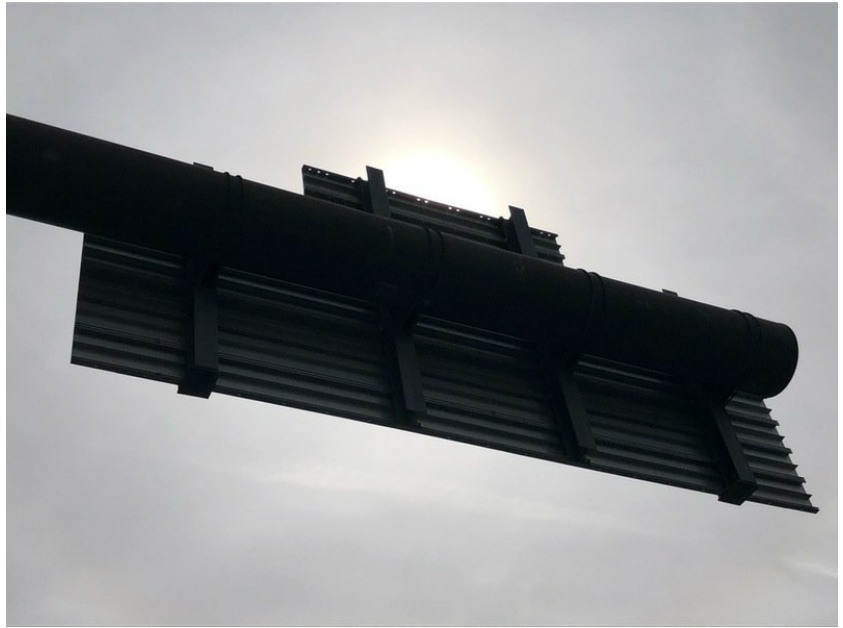
009N-093-39.18-A on 21051

Bridge/Sign/Light Pole/Traffic Signal No.	009N-093-39.18-A
General Notes	Replace exit crown only Mounted on unpainted cantilever 21051
Accessibility	Accessible
Paint on Structure (s)?	No
Suspect Asbestos Containing Materials Identified on Structure	No
Guano Present?	No
Homeless Activity	No
Bloodborne Pathogen Concerns?	No
Mice/Mouse Nests/Droppings	No

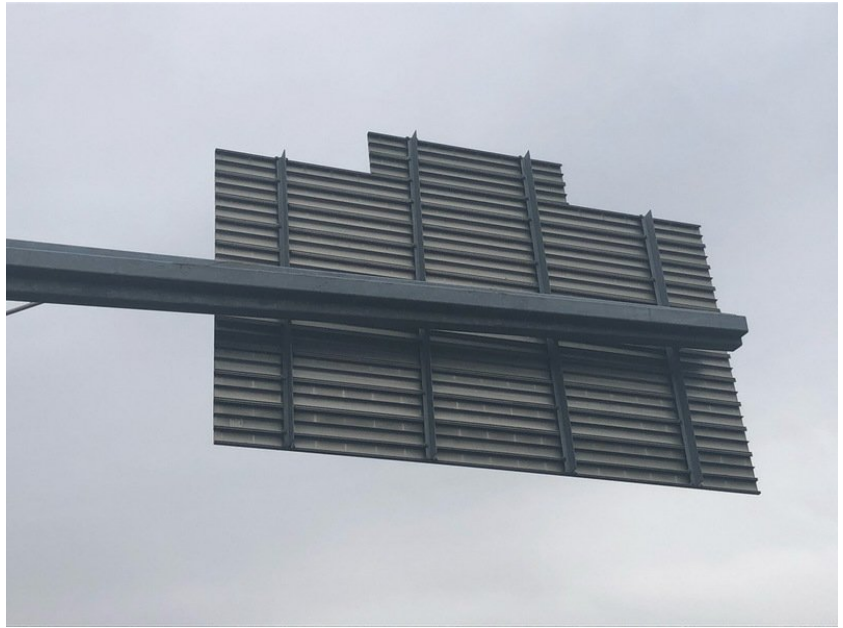
Bridge/Sign/Light Pole/Traffic Signal No.	009S-093-39.03-A
General Notes	Replace exit crown only Sign mounted on unpainted cantilever 21057
Accessibility	Accessible
Paint on Structure (s)?	No
Suspect Asbestos Containing Materials Identified on Structure	No
Guano Present?	No
Homeless Activity	No
Bloodborne Pathogen Concerns?	No
Mice/Mouse Nests/Droppings	No

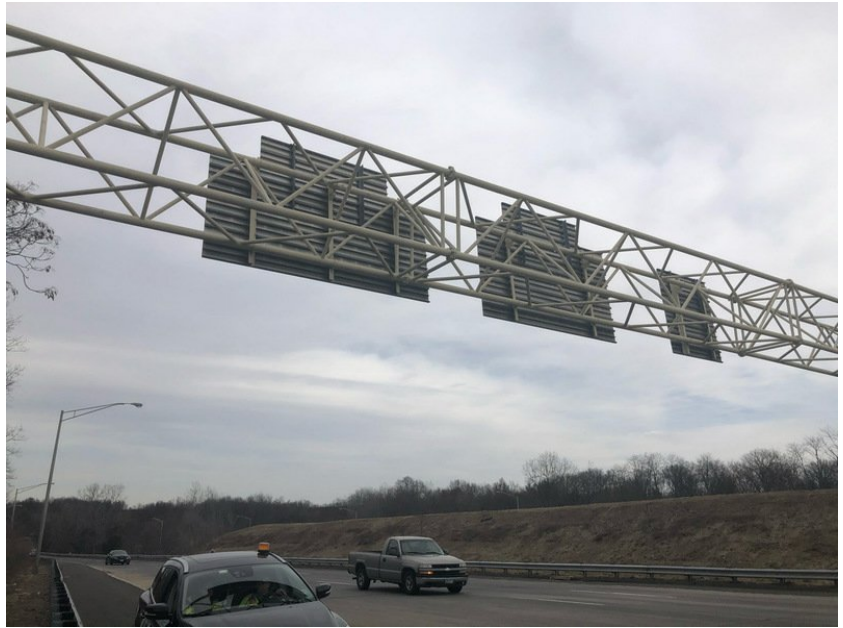
009S-088-37.05-A, 009S-088-37.05-B, and 009S-088-37.05-C on 21059

Bridge/Sign/Light Pole/Traffic Signal No.	21059
General Notes	Replace exit crown only Painted over head structure 009S-088-37.05-A 009S-088-37.05-B 009S-088-37.05-C
Accessibility	Accessible
Paint on Structure (s)?	Yes
Paint on what Components/Structure(s)?	Painted over head structure
Suspect Asbestos Containing Materials Identified on Structure	No
Guano Present?	No
Homeless Activity	No
Bloodborne Pathogen Concerns?	No
Mice/Mouse Nests/Droppings	No
