Subject: On-Call Asbestos, Lead, Air Quality & Demolition Compliance
Agreement No.: 8.07-01 (18)
HazMat Inspection – Statewide Replacement of Overhead Sign Supports on Various Routes,
Various Cities/Towns, CT
ConnDOT Assignment No. 519-6284
ConnDOT Project No. 170-3527
TRC Project No. 289951.6284.0710

TRC performed a limited survey for hazardous building materials associated with the statewide replacement of overhead sign supports on various routes in various cities/towns of Connecticut. Results of the survey identified the following:

ConnDOT, Various Overhead Sign Supports , , , , , Connecticut, United States, ,

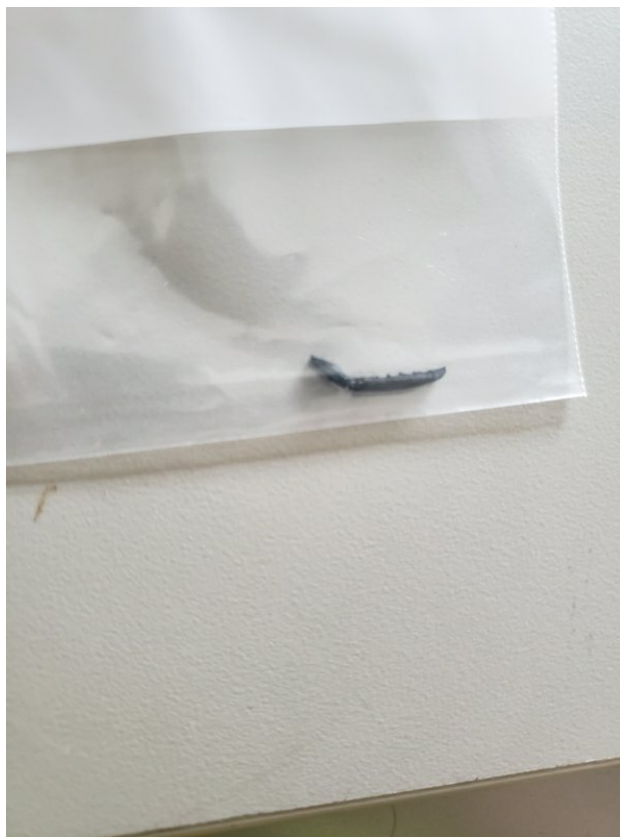
Sign No. 20018 behind small mounted plate

- Thin black tar coating around the base of the sign support at Site No. 1.1 (20013) was sampled and found to contain asbestos. Stretchy black caulking at Site No. 7 (20018) and thick elastic white caulking at Site No. 6 (20740) were sampled and found to contain no detectable amounts of asbestos.

(2), C, 1, Stretchy black caulking , 2

Sampled or Assumed?	Sampled
Material Acronym	C, 1
Material Description	Stretchy black caulking
Is Material a Non-Friable Organically Bound (NOB)	Yes
Total Approximate Quantity	2 lin ft
Total Count	(2)

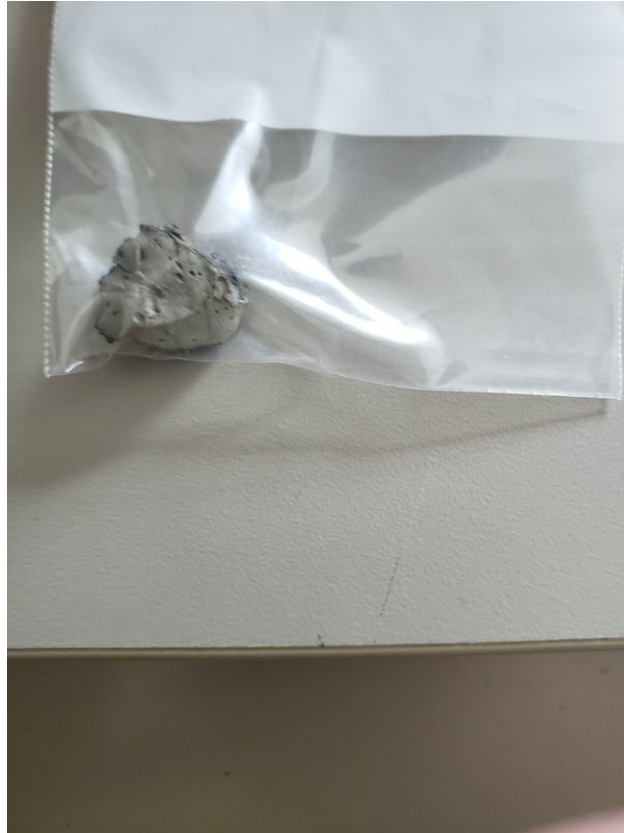
**Sign No. 20740 on nuts mounted to support**

(2), C, 2, Thick, elasticity white caulking , 2

Sampled or Assumed?	Sampled
Material Acronym	C, 2
Material Description	Thick, elasticity white caulking
Is Material a Non-Friable Organically Bound (NOB)	Yes

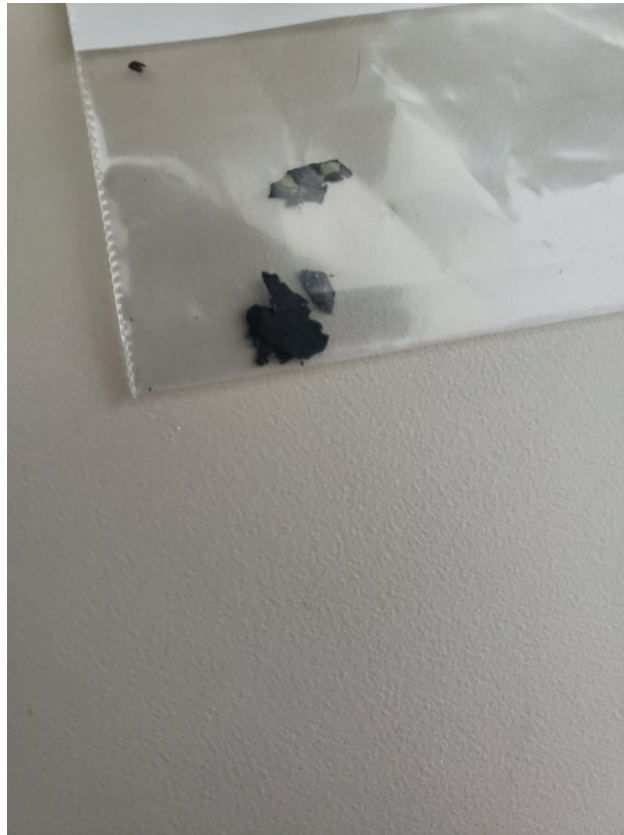
Sign No. 20013 around base of sign support

(2), T1, Thin black tar coating , 2

Material Description	Thin black tar coating
Is Material a Non-Friable Organically Bound (NOB)	Yes
Total Approximate Quantity	3 sqft
Total Count	(2)
Total Count (number only)	2
