**CITY OF NORWICH
PROPERTY REHABILITATION &
LEAD PAINT HAZARD CONTROL
PROGRAMS
Project LP1636-RP1411**

**22-24 Slater Avenue
Norwich, CT. 06360**

PROJECT SPECIFICATION

Lead Paint Inspection Report and Lead Hazard Assessment

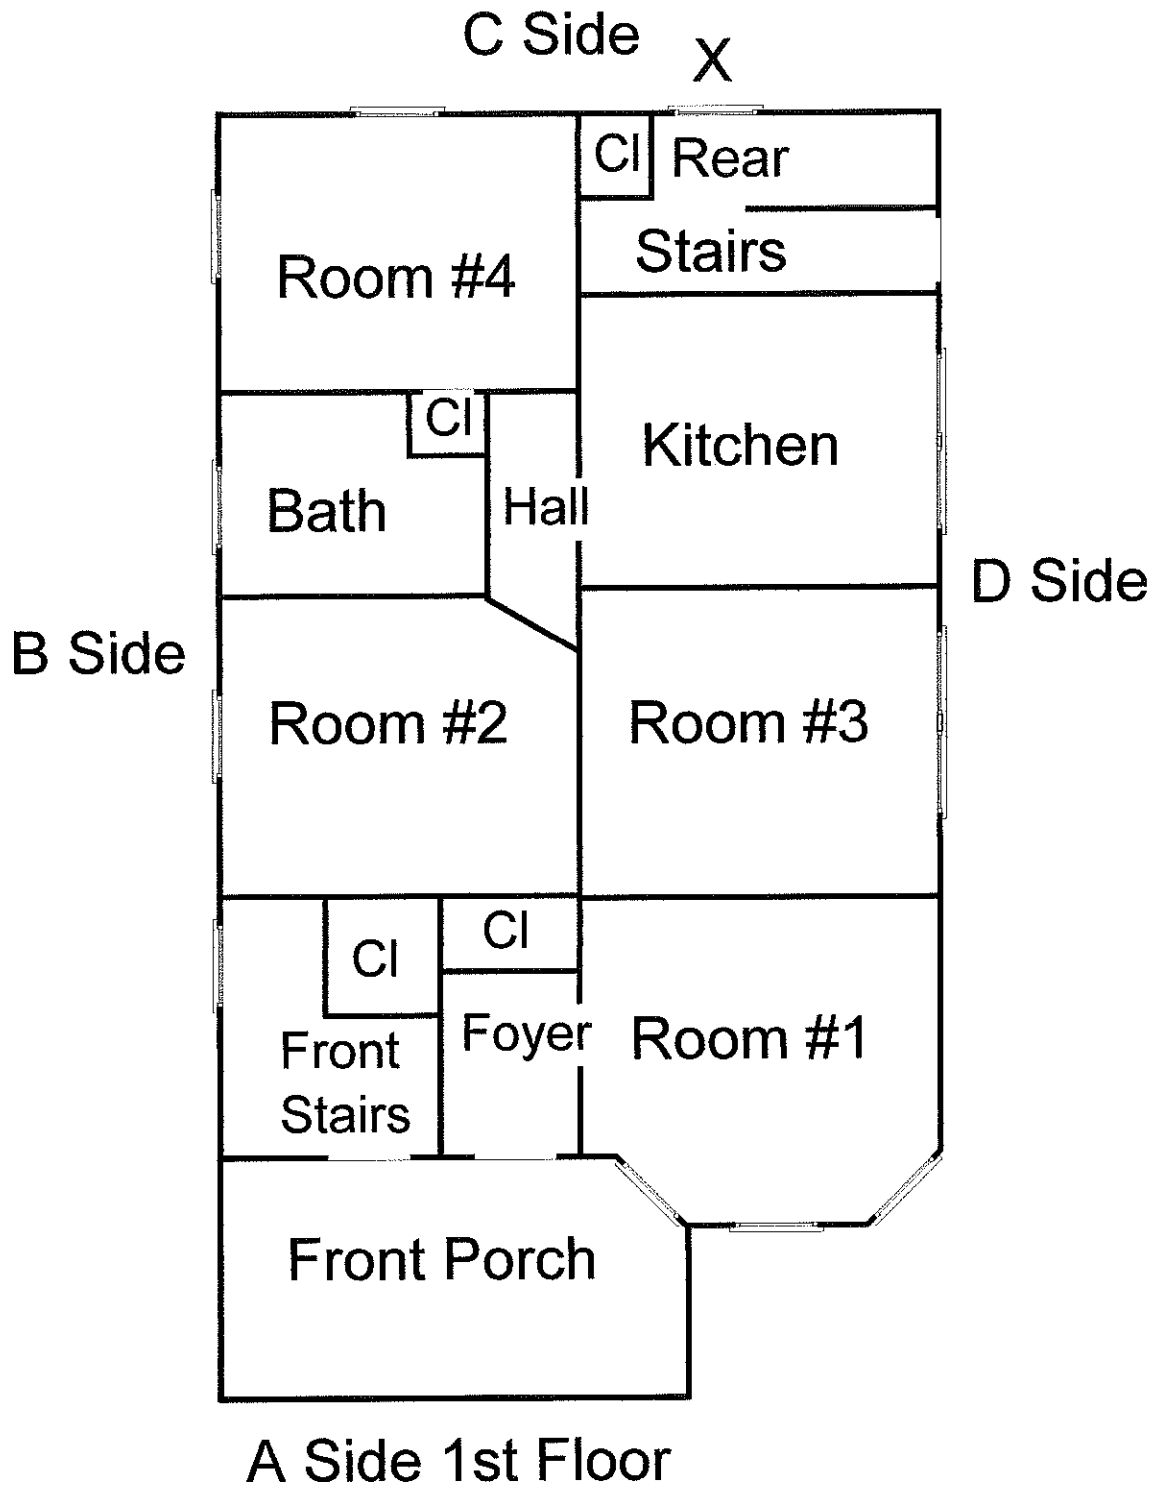
24 Slater Ave, Norwich, CT 06360

X = Pos. wood windows

Cl = Closet

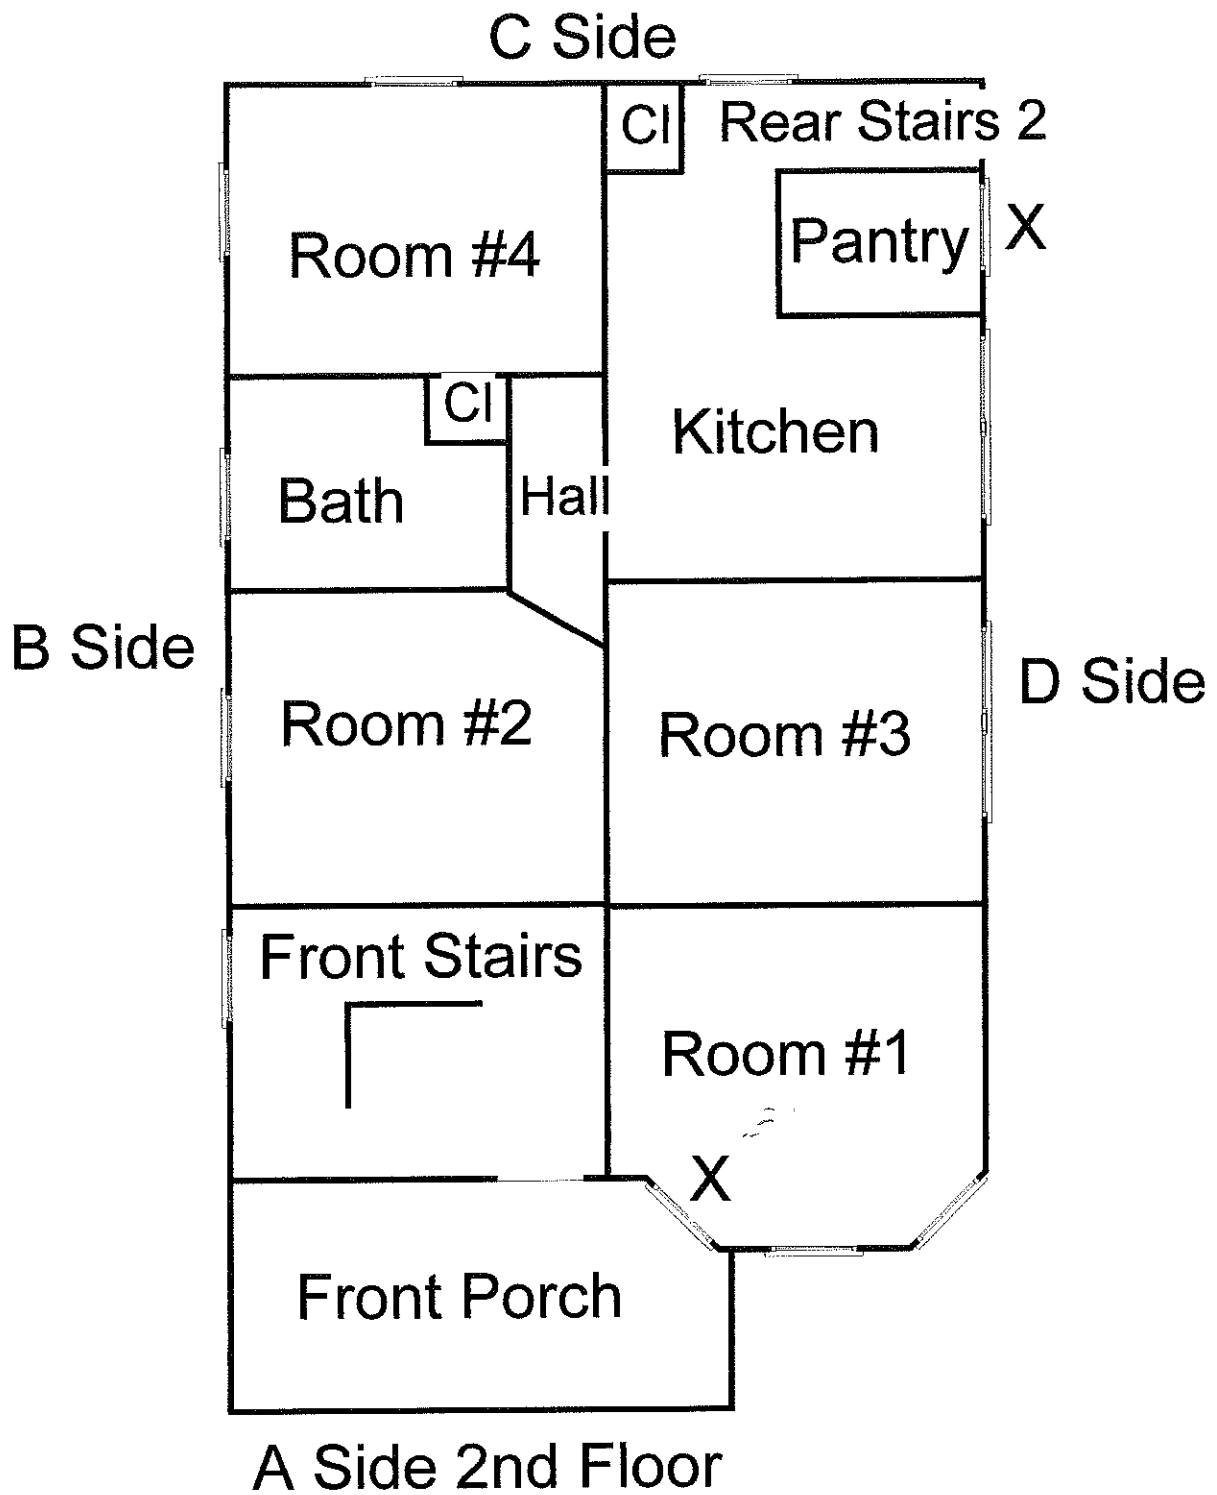
22 Slater Ave, Norwich, CT 06360

X = Pos. wood windows

Cl = Closet
