**TOWN OF HAMDEN
CONNECTICUT
LEGAL NOTICE
REQUEST FOR PROPOSAL #19-12
HAMDEN HILLS DRIVE BRIDGE**

It is the sole responsibility of the responder to see that the proposal is in the hands of the proper authority prior to the opening.

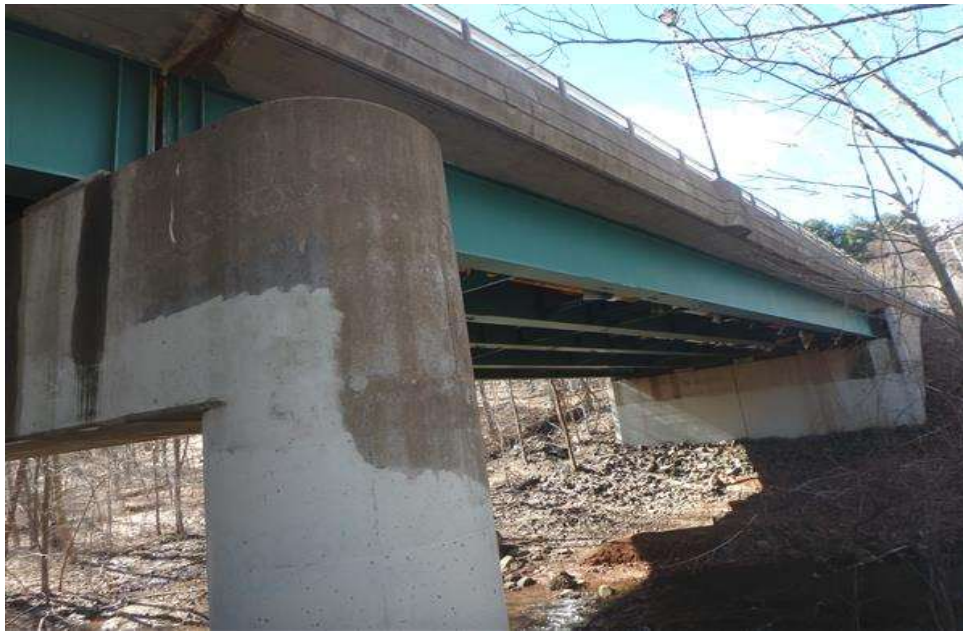
Inspected by: AI Engineers

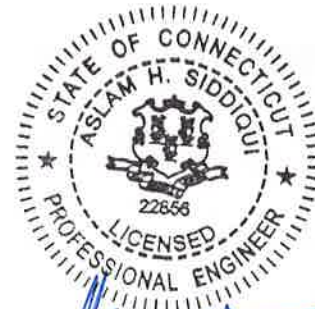
P.E. Signature: _____

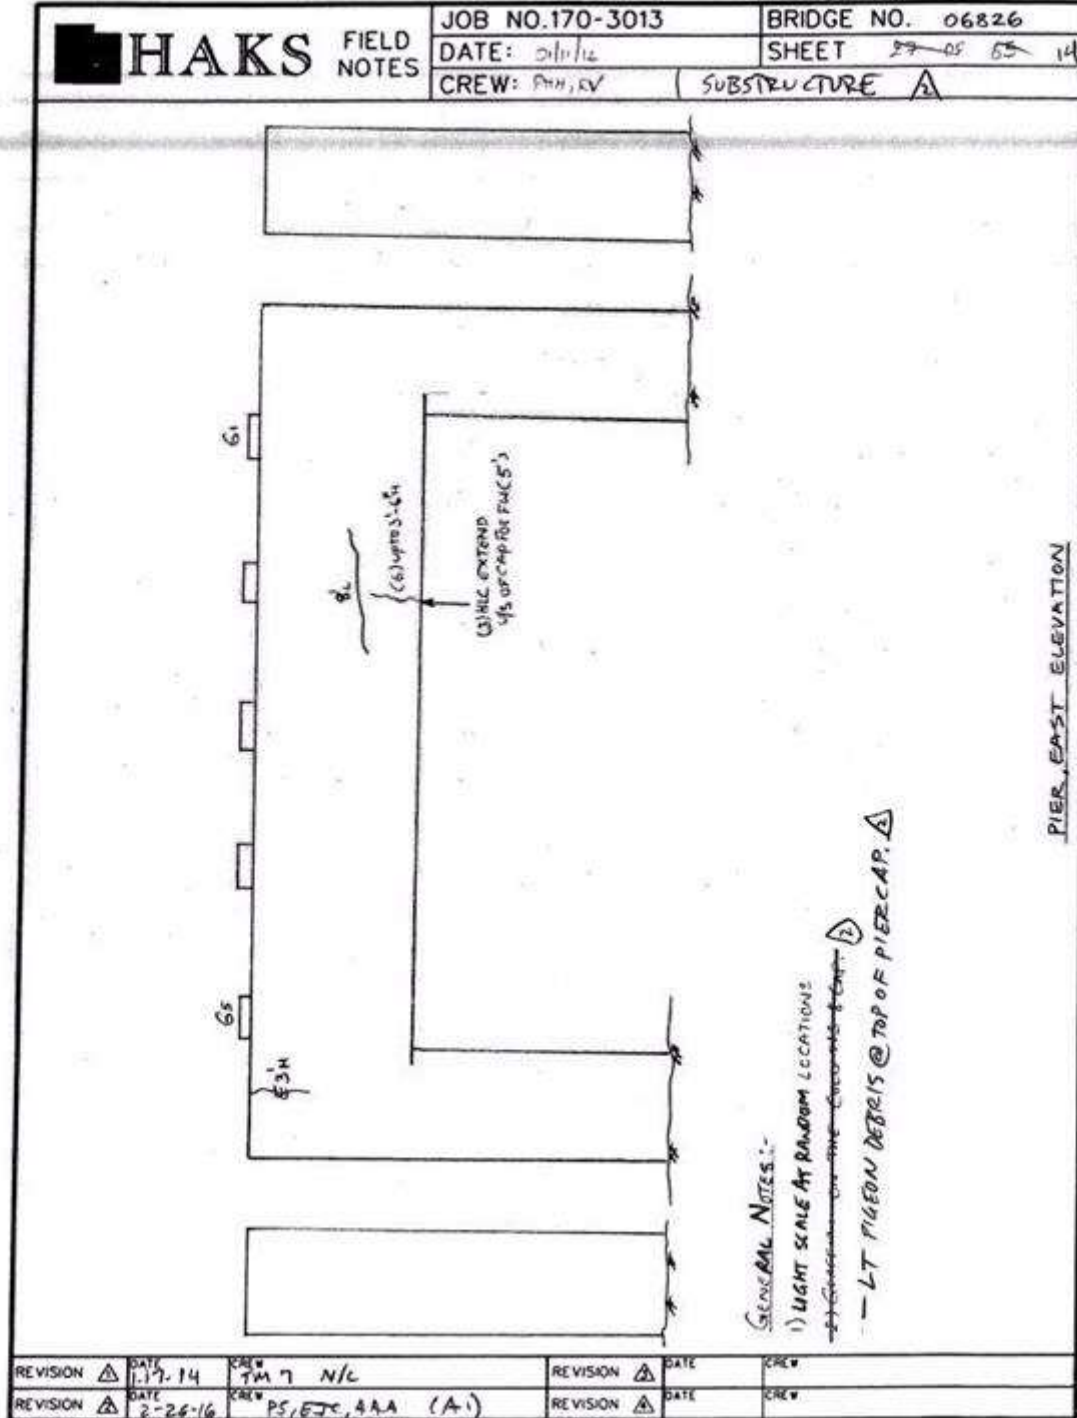
<i>FIELD NOTES</i>		BRIDGE NO. 06826	DATE: 2-26-16
DESCRIPTION: CHANNEL DETERIORATION LEGEND		CREW: PS, EJC, AAA (AI)	SHEET: 15
<p>(A) Minor erosion of the channel embankments at both ends of the stone masonry arch culvert wingwalls.</p> <p>(B) Rip rap eroded with exposed synthetic fabric.</p> <p>(C) Roadway drainage outlet at the embankment located at the southwest end of the bridge exhibits a heavy erosion trough 40' long x 7' wide x 4' deep from the runoff drain. The drain opening is also undermined 7' wide x 3' high x 3' deep penetration.</p>			
Revision \triangle 1	Date:	Crew:	Company:
Revision \triangle 2	Date:	Crew:	Company:
Revision \triangle 3	Date:	Crew:	Company:
Revision \triangle 4	Date:	Crew:	Company:

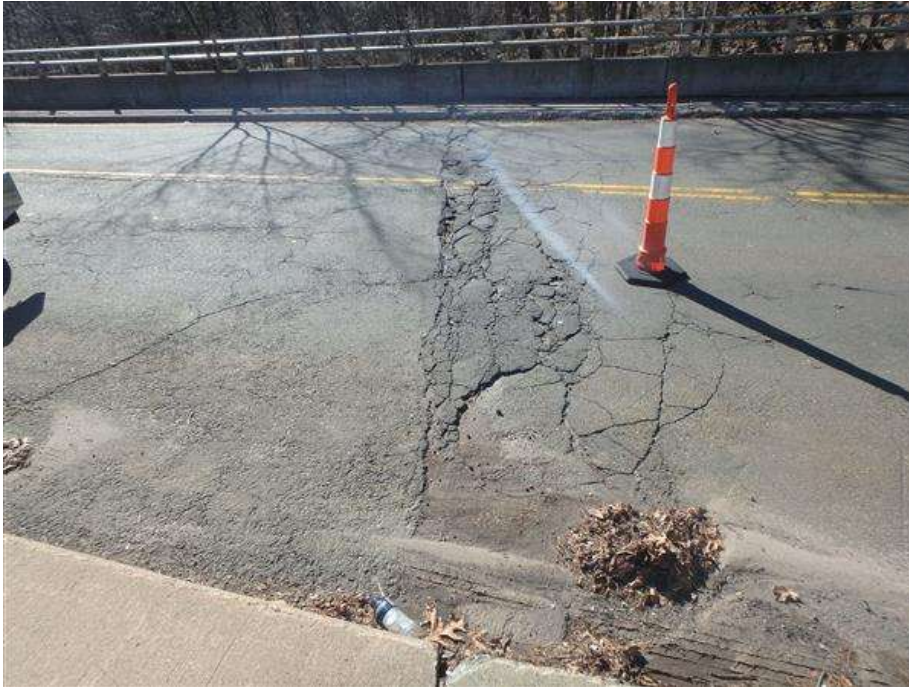
Bituminous concrete overlay in span 1. Note random transverse, longitudinal and map cracks and light to moderate raveling throughout.

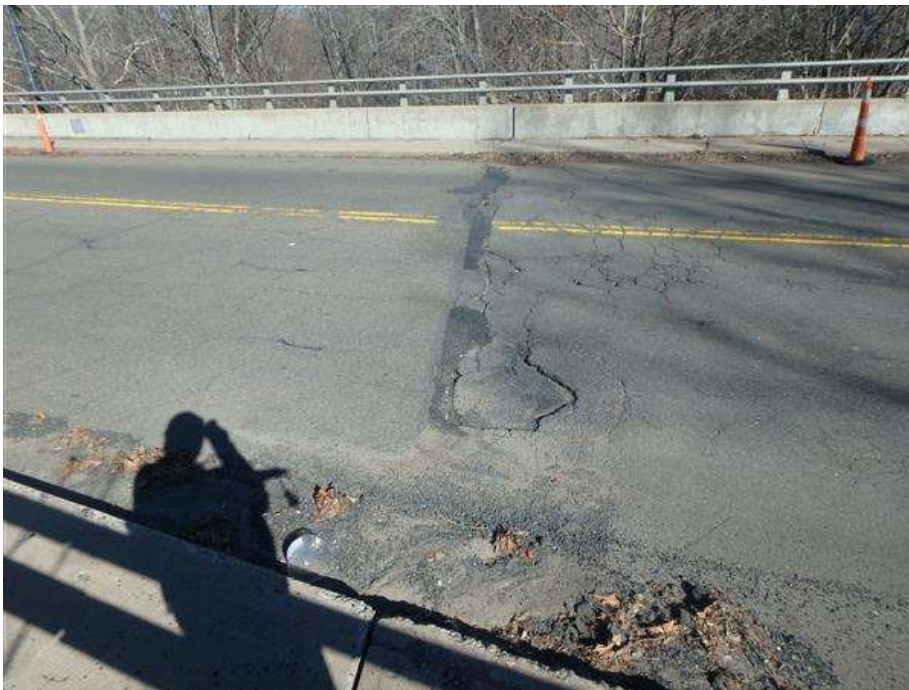
Bituminous concrete overlay over the west abutment joint exhibits severe raveling with full-width map cracks, breaking up bituminous and potholes.

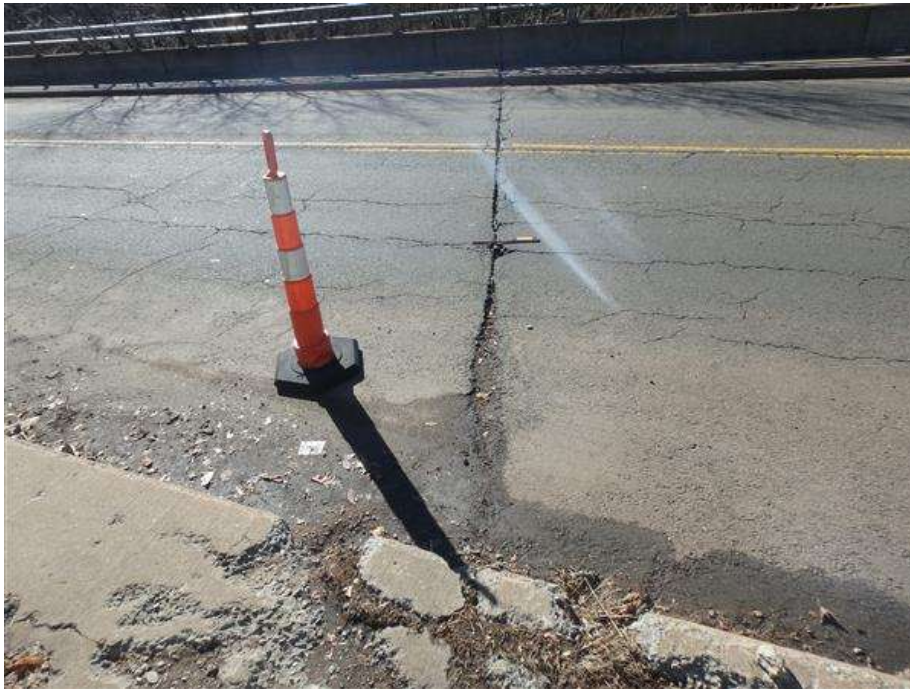
Bituminous concrete overlay over the east abutment joint exhibits severe raveling with full-width map cracks, breaking up bituminous and potholes. Note the partially exposed membrane at the center of joint.

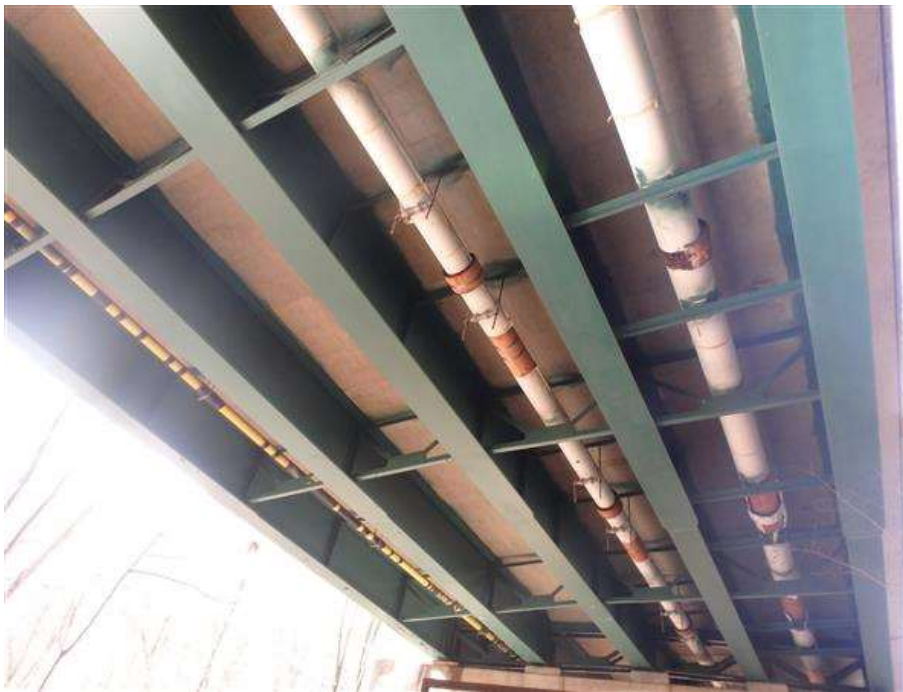
Bituminous concrete overlay along the pier joint exhibits edge spalls and potholes. Note pier joint is open.

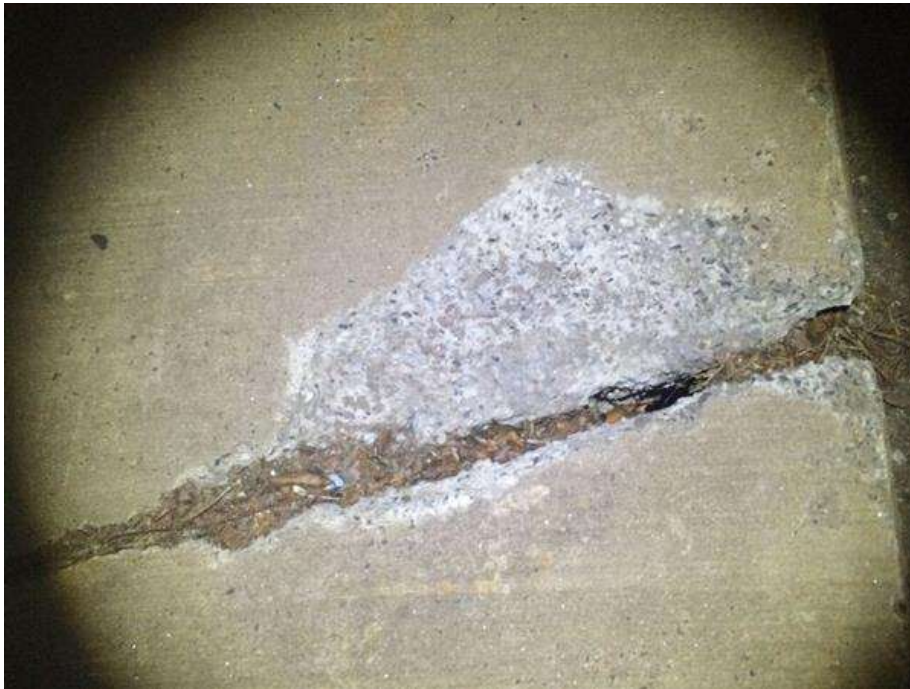
South sidewalk at the west abutment joint exhibits hole through curb with vegetation growth and void under approach sidewalk. There is evidence of past leakage noted below.

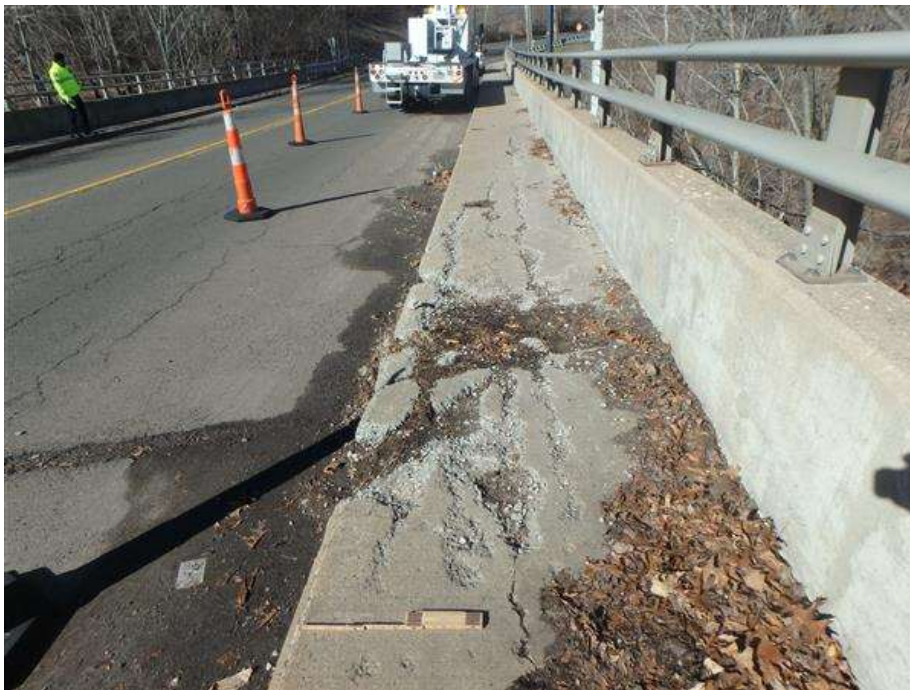
South sidewalk at the pier joint exhibits spall with through hole in joint. Active leakage noted below at the pier cap.

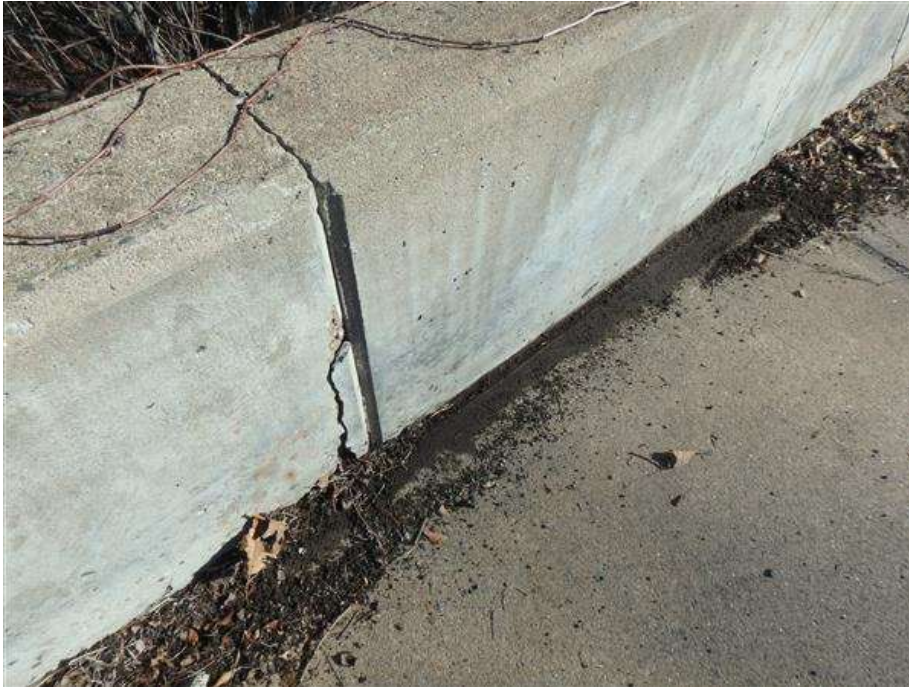
North sidewalk at the pier joint exhibits area of plow damage with longitudinal cracks, spalls, scale, loose concrete, and hollow areas. Note accumulation of debris on sidewalk.

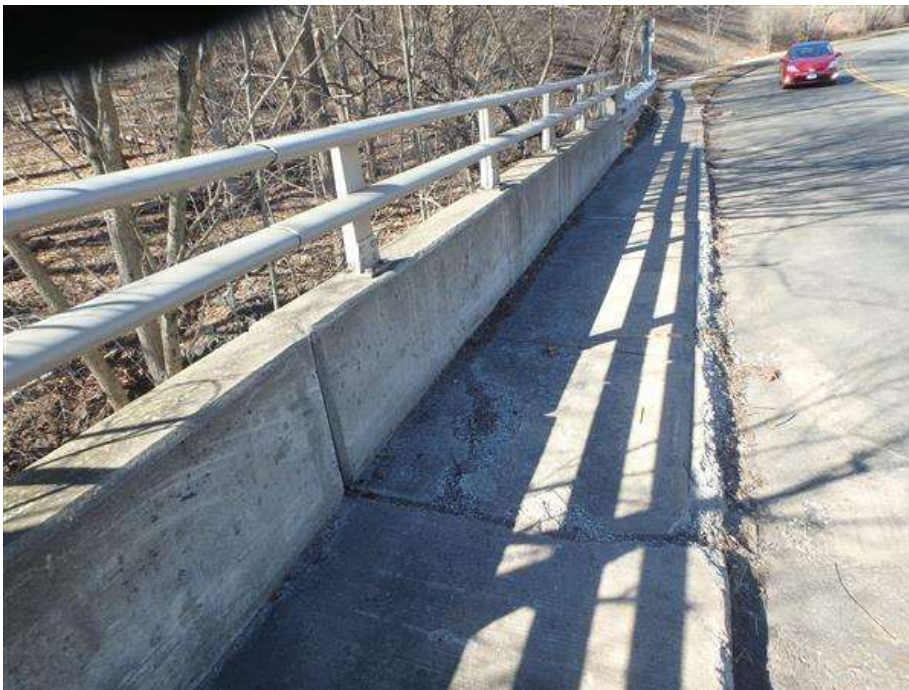
Northeast approach sidewalk exhibits gap between sidewalk and parapet filled with debris. Note parapet with hollow area/potential spall.

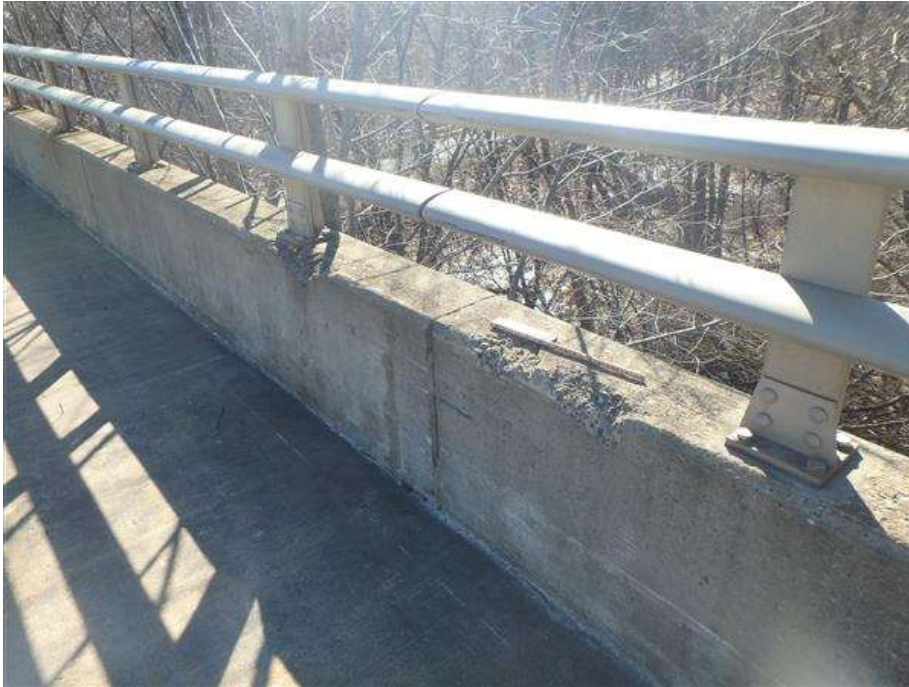
Southwest approach sidewalk exhibits spall and curb exhibits severe scale.

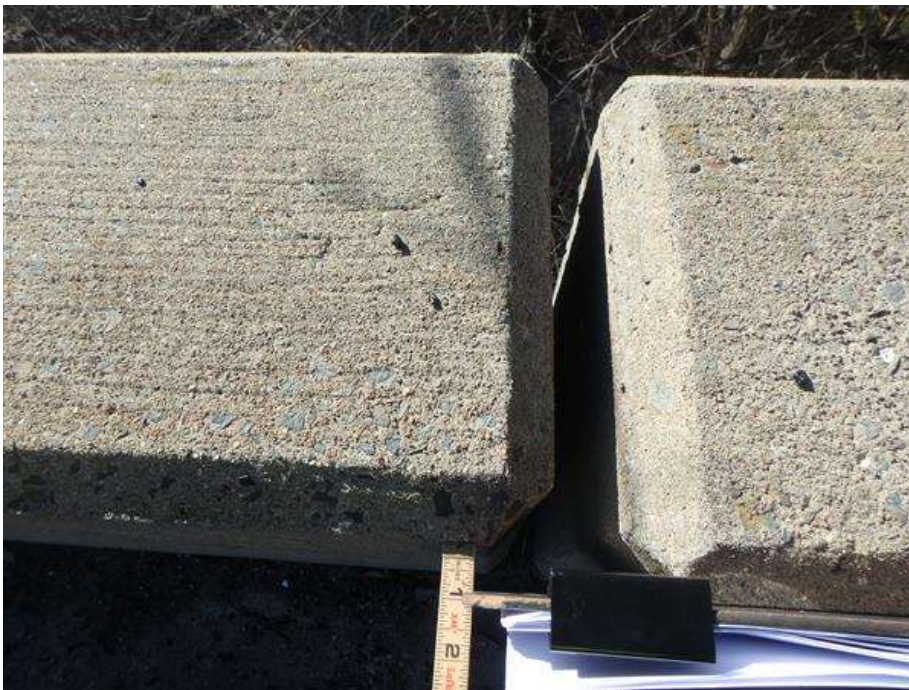
South parapet in span 1 exhibits spalls at top.

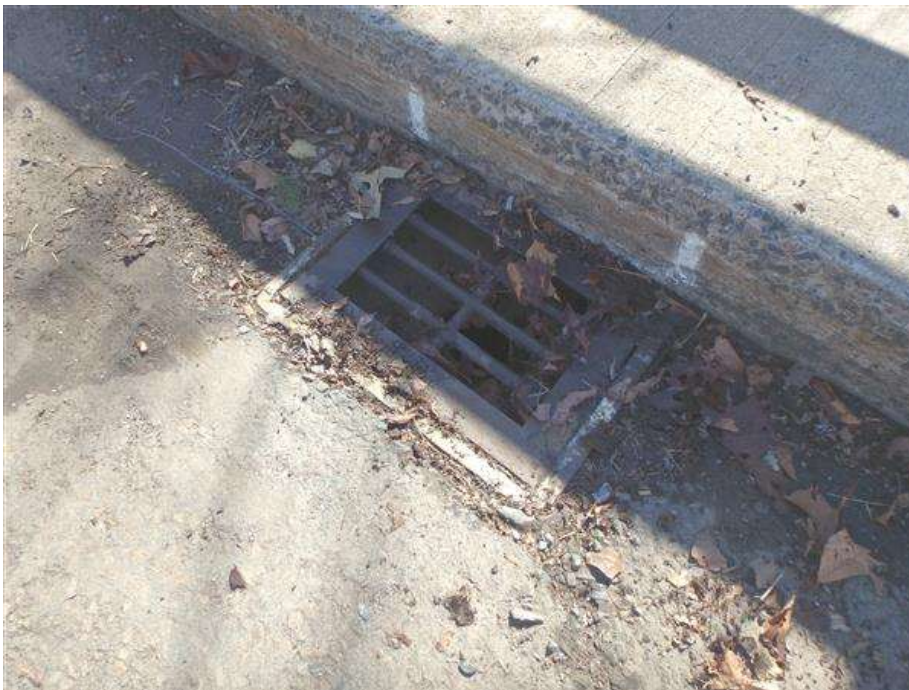
Scupper pipe with heavy surface rust and is disconnected from the coupling in span 1, bay 1 (not draining onto steel). Note PVC weep with missing extension (not draining onto steel).

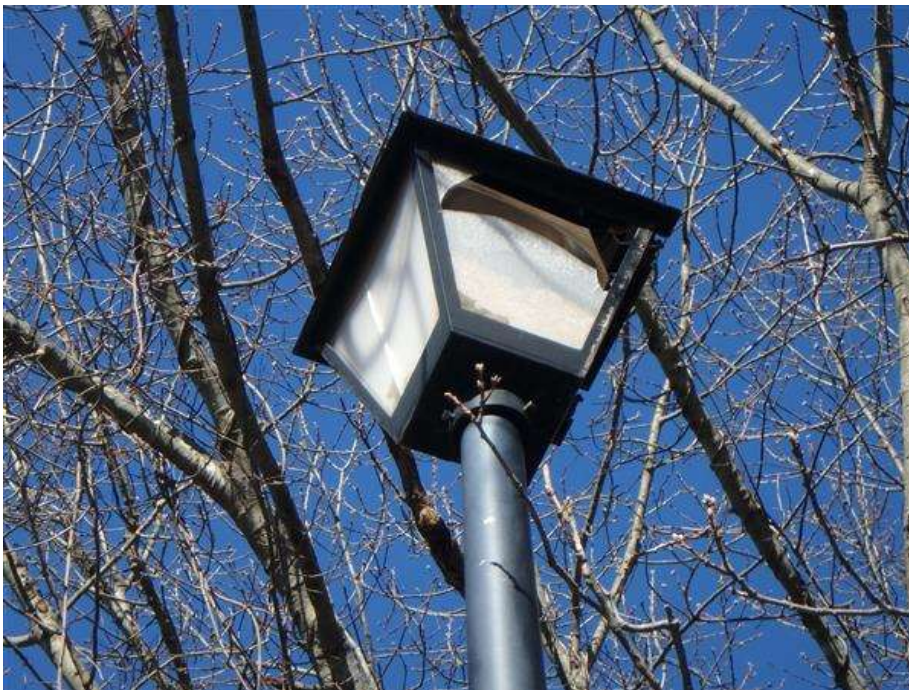
Lighting standard at the north parapet in span 2 exhibits missing anchor bolt covers.

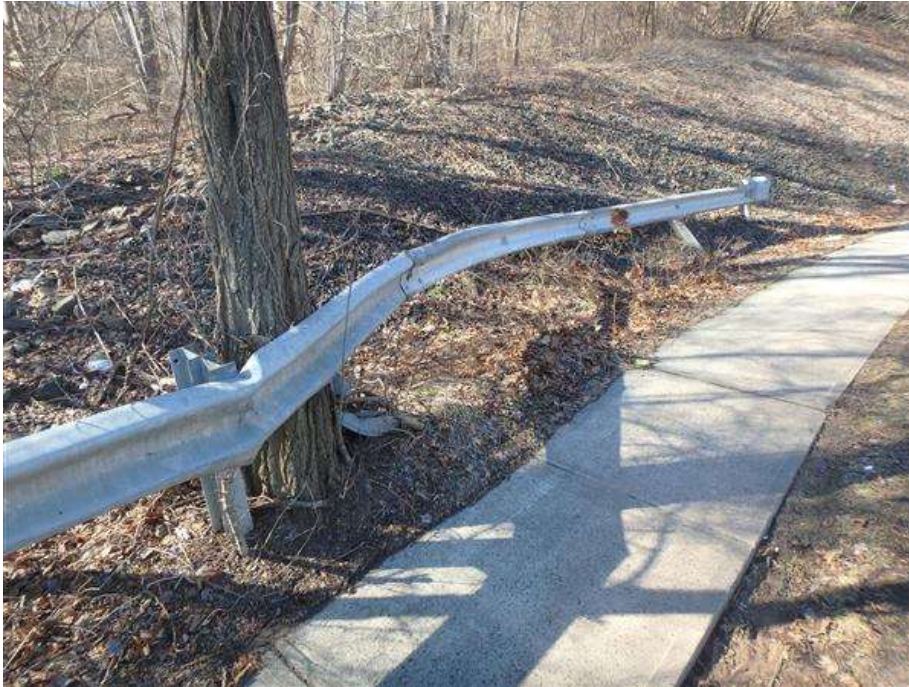
Lighting standard at the north parapet in span 2 exhibits broken/cracked light covers.

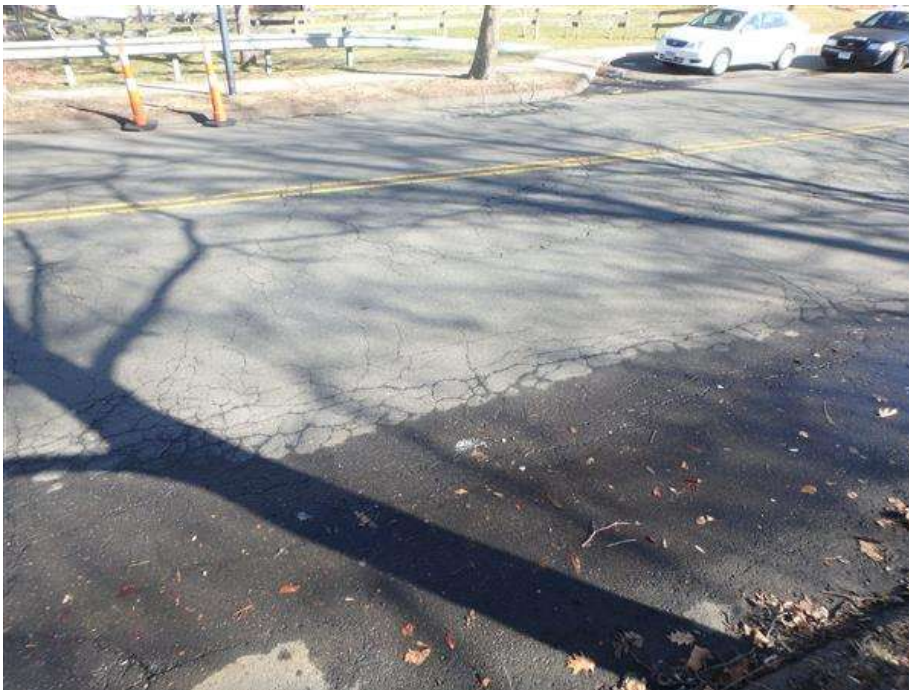
Metal beam guide rail at southwest approach corner exhibits severe collision damage area with bent rail and bent/disconnected posts.

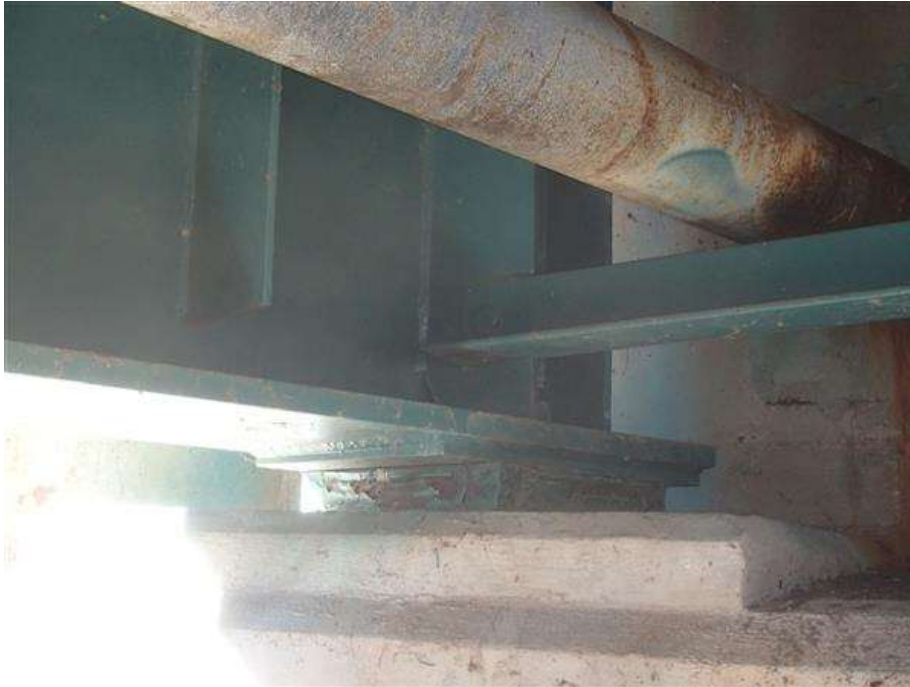
Bituminous concrete pavement at east approach exhibits random transverse, longitudinal and map cracks and moderate to heavy raveling throughout.

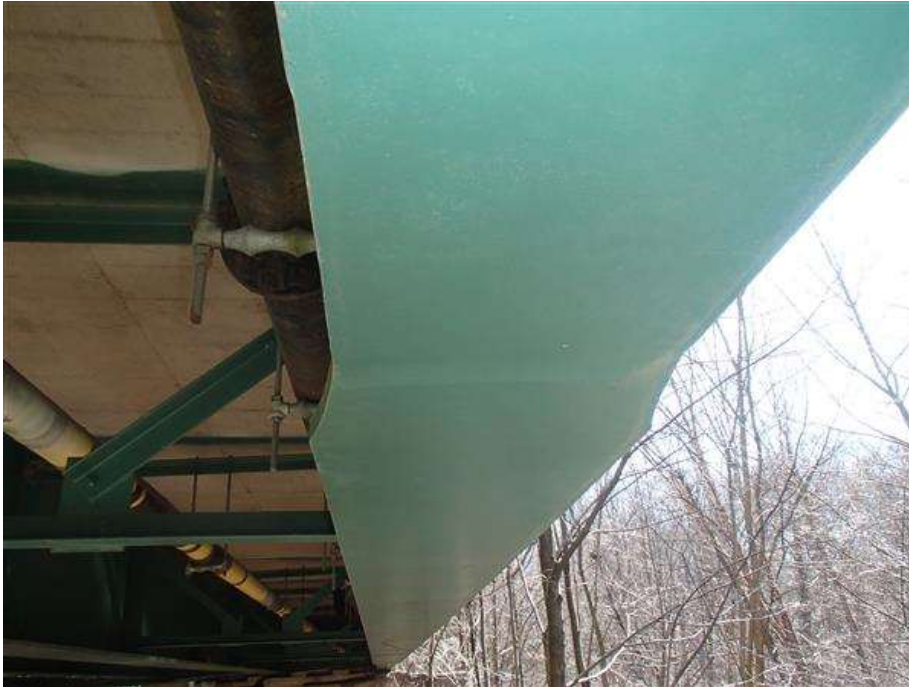
Girder G5 end and adjacent end diaphragm over the pier exhibits peeling paint with isolated light to moderate surface rust due to active leakage.

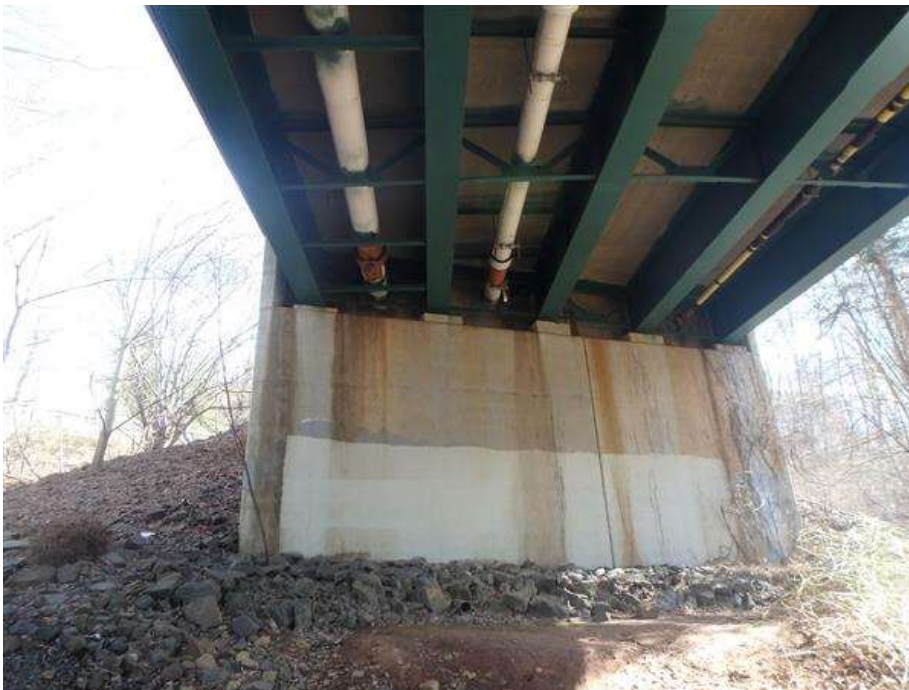
West abutment elevation. Note evidence of past leakage at stem.

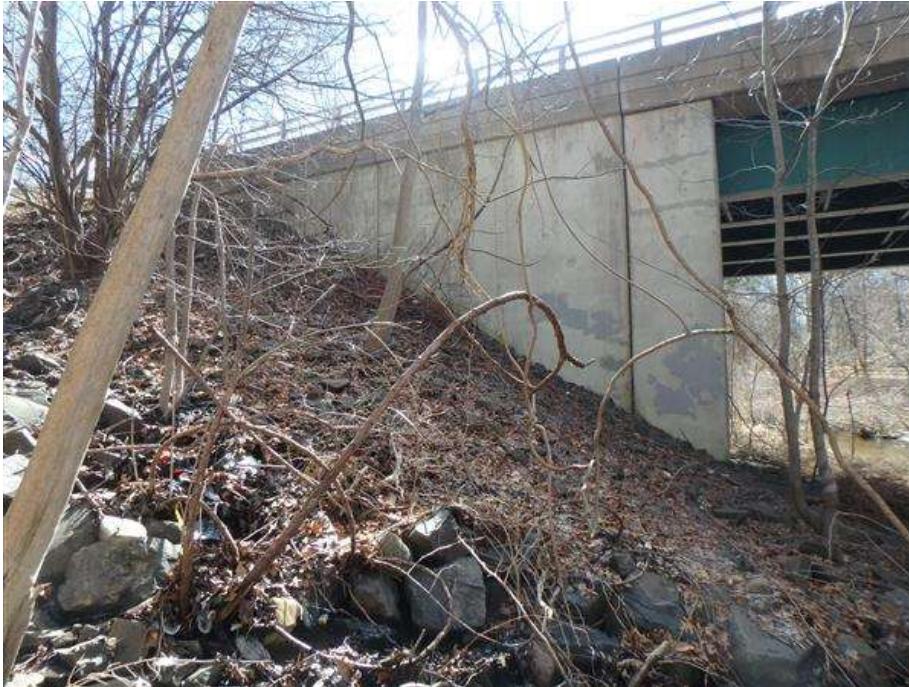
East abutment elevation. Note evidence of past leakage at stem.

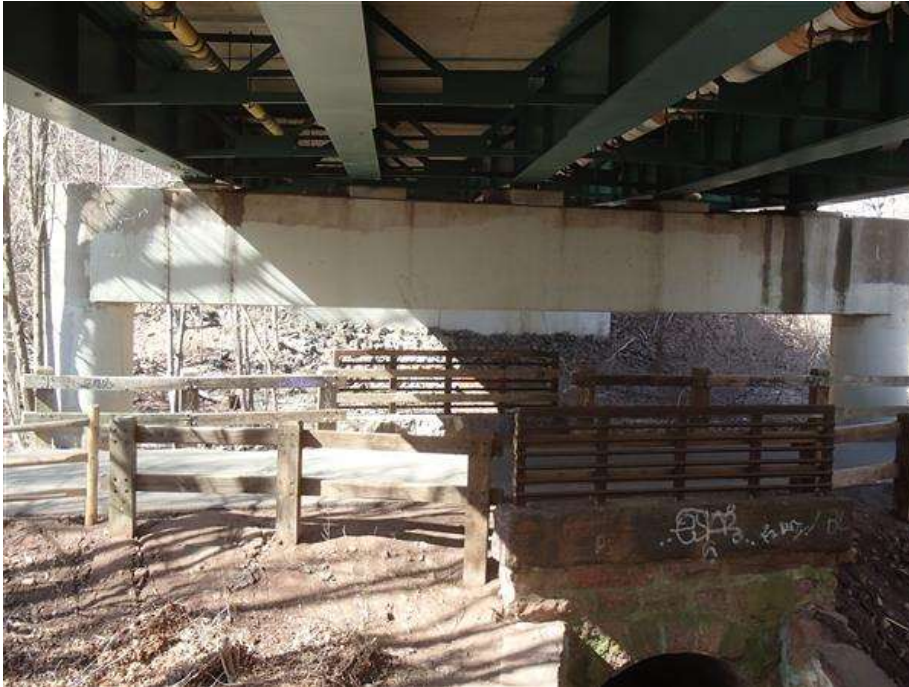
Pier, west elevation. Note active leakage at ends of pier cap. Also note exposed footings.

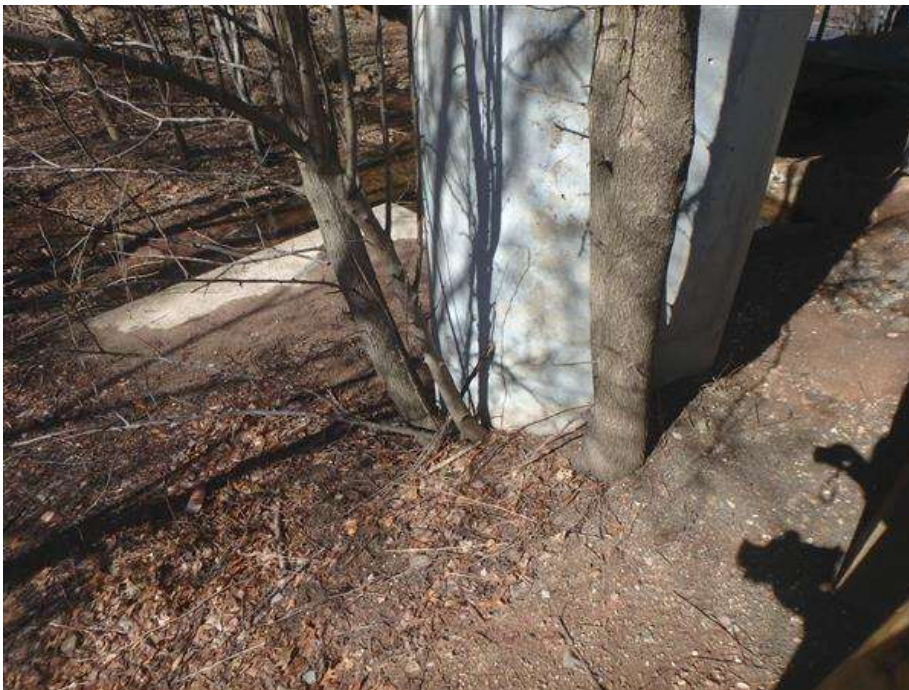
Pier, east elevation. Note active leakage at ends of pier cap.

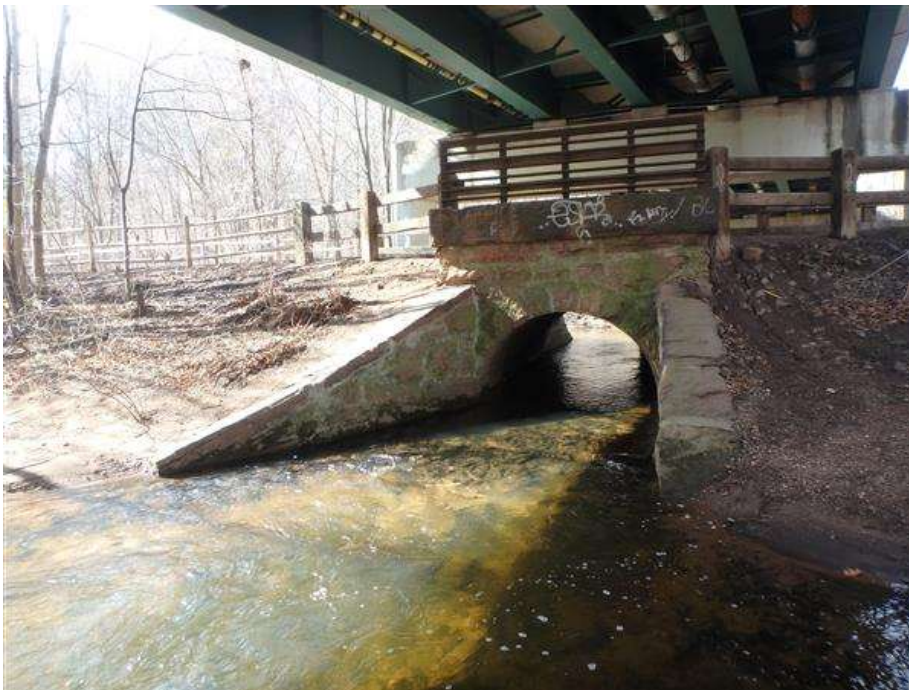
General view of the channel under the bridge at the west side of the pier and the masonry arch culvert. Note rip rap repair at the north pier footing with adjacent tree roots. Also note minor erosion along culvert wingwalls.

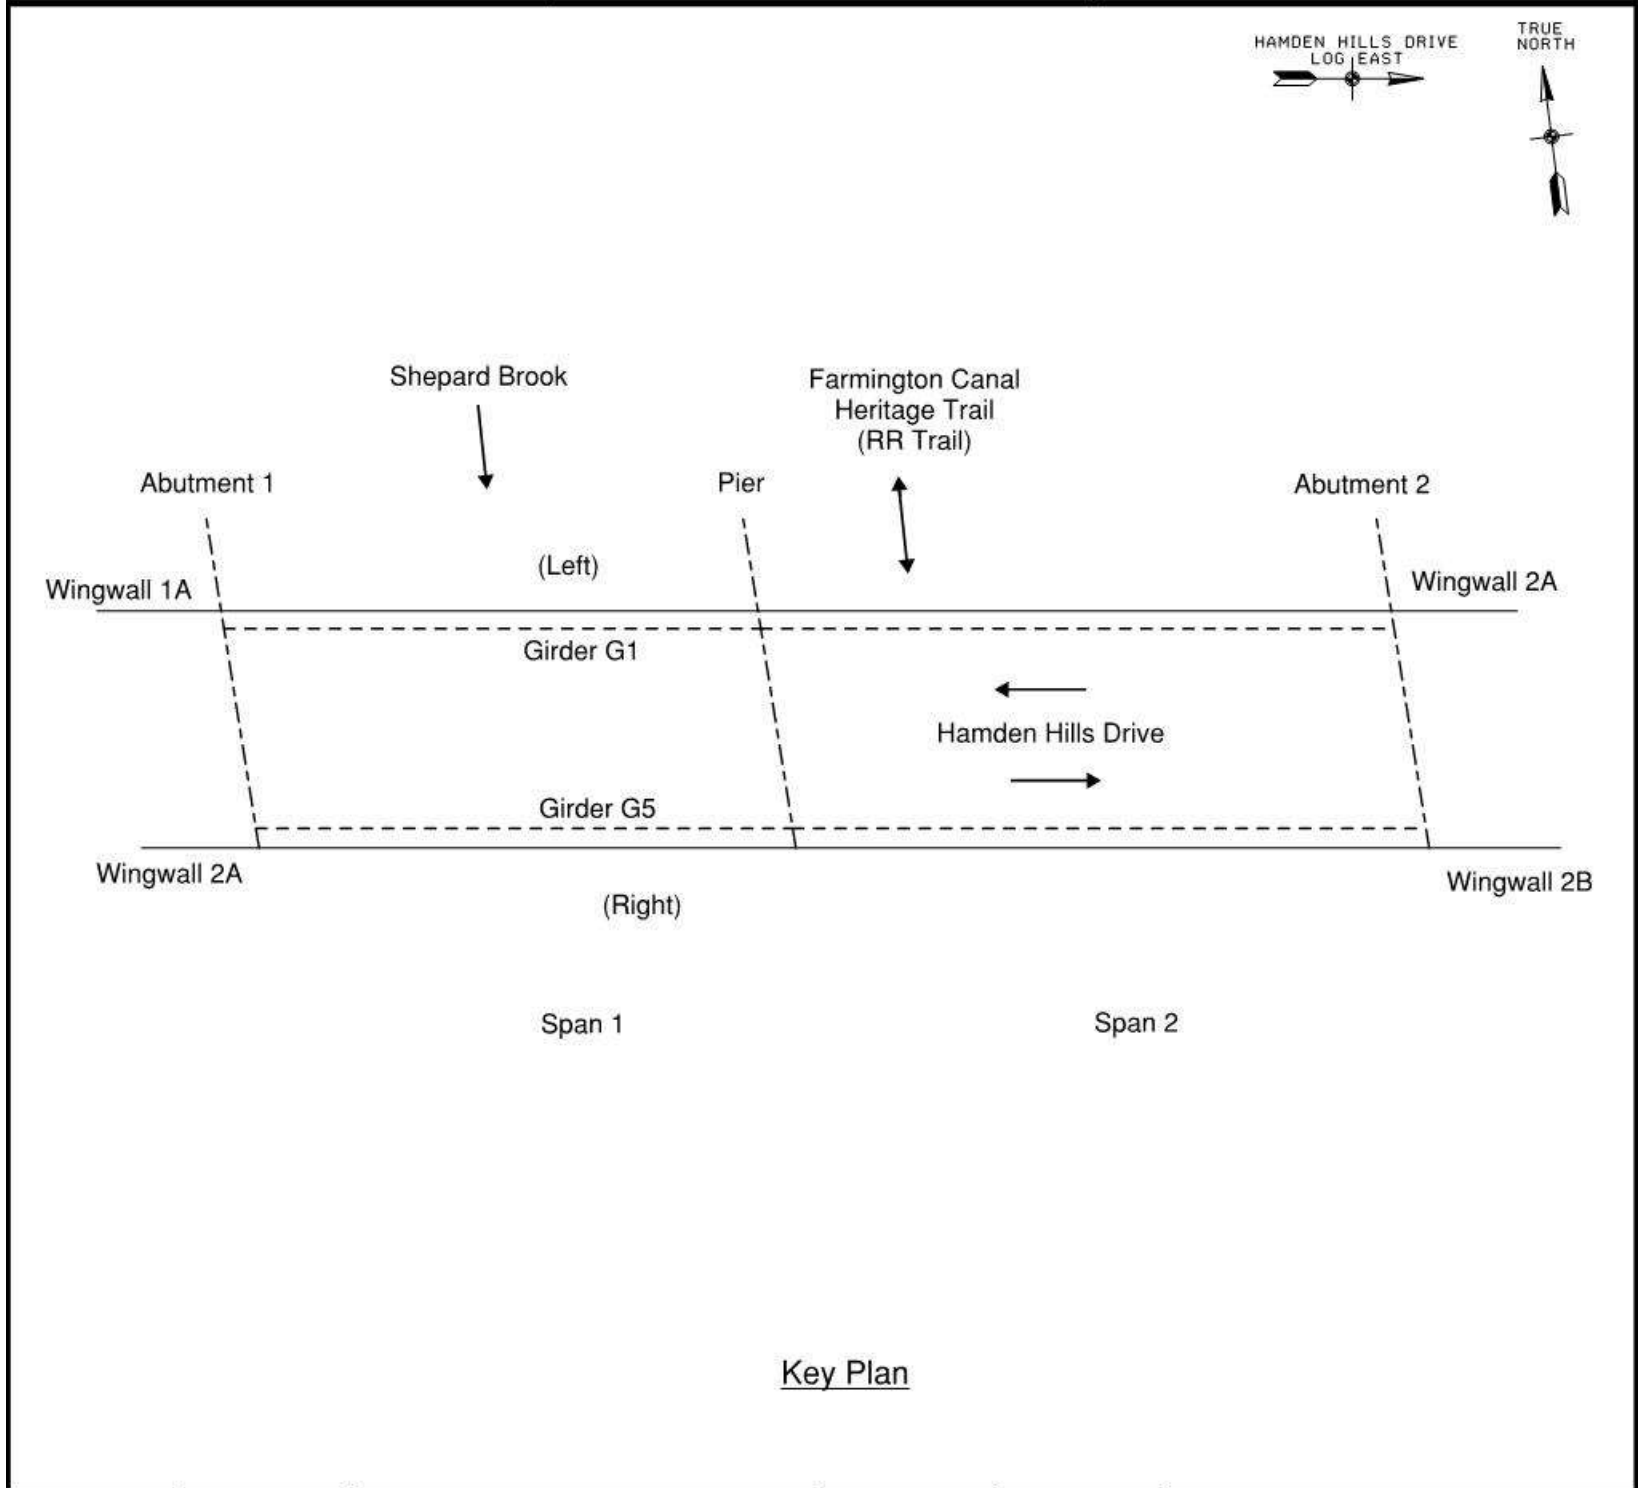
REVISION	DATE:	CREW:	REVISION	DATE:	CREW:
REVISION	DATE:	CREW:	REVISION	DATE:	CREW:

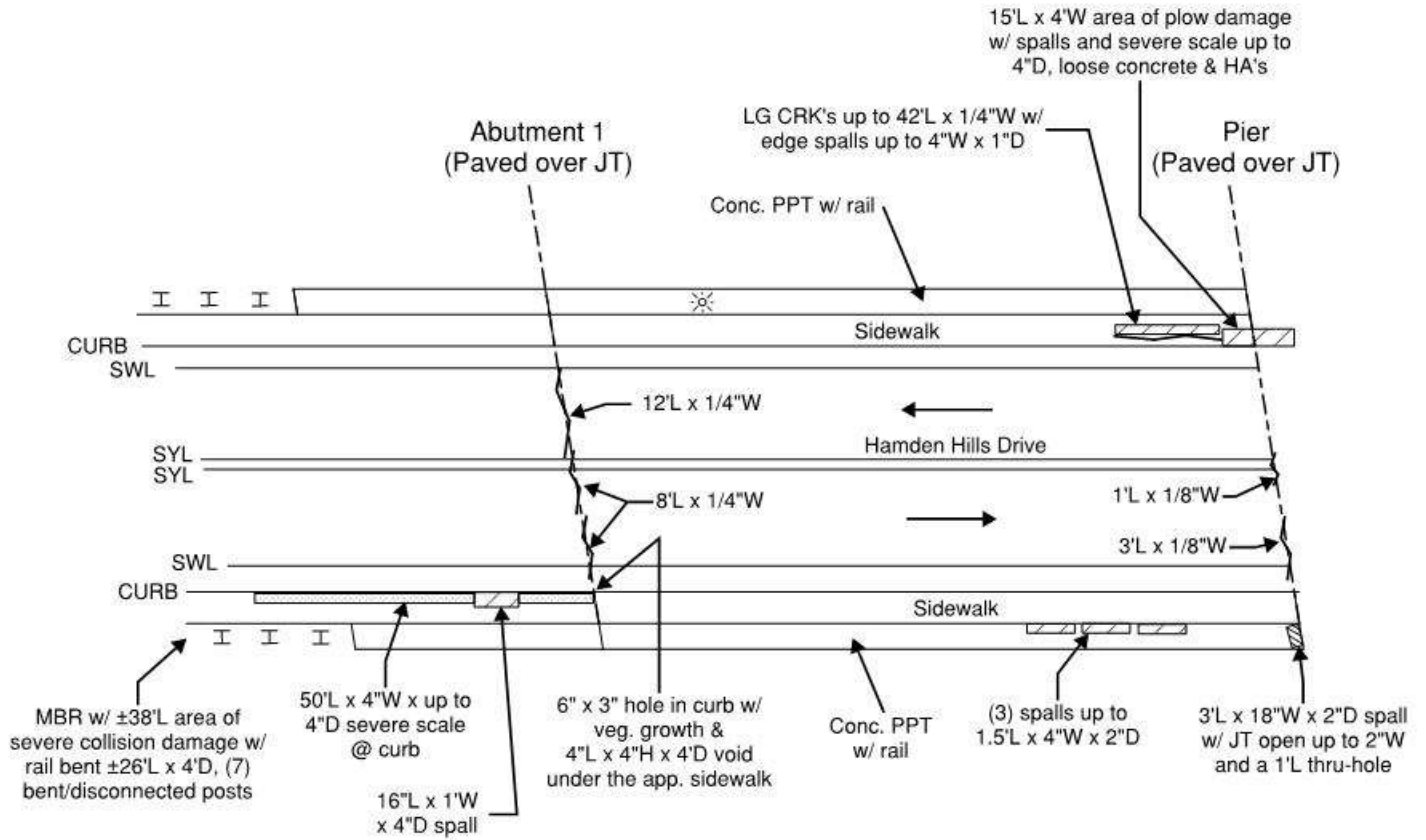
- LEGEND:**
- HOLLOW AREA
 - SHALLOW REBAR
 - SPALL AREA
 - SPALL AREA WITH EXPOSED REBAR
 - MAPCRACKS
 - HAIRLINE CRACKS
 - HONEYCOMB AREA
 - SCALE AREA
 - EFFLORESCENCE PRESENT
 - SWL SOLID WHITE LINE
 - SYL SOLID YELLOW LINE
 - CURB NON-MOUNTABLE
 - METAL BEAM RAIL (MBR)
 - LIGHT POLE

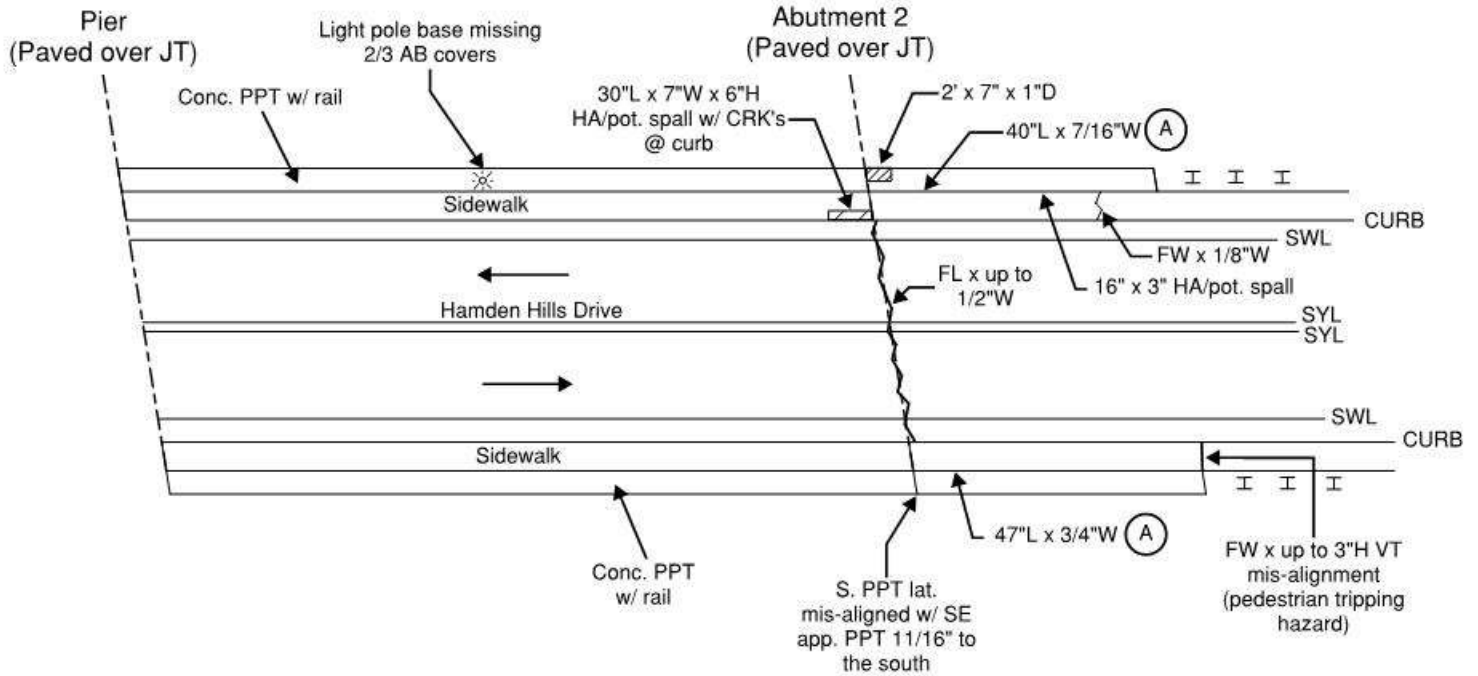
GENERAL NOTES:
 - See Top of Deck Span 1 General Notes.

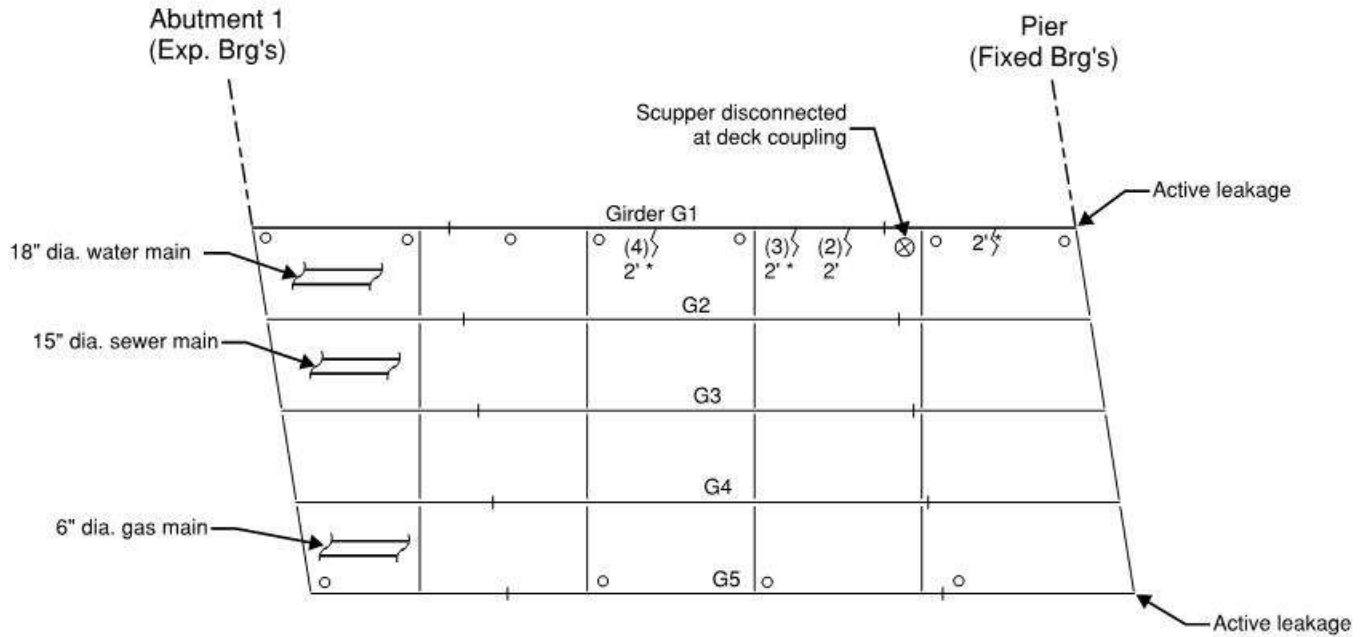
CREW: EJC, ZRI, MRS (AI Engineers)	DATE: 02/14/18	BRIDGE NO.: 06826
------------------------------------	----------------	-------------------

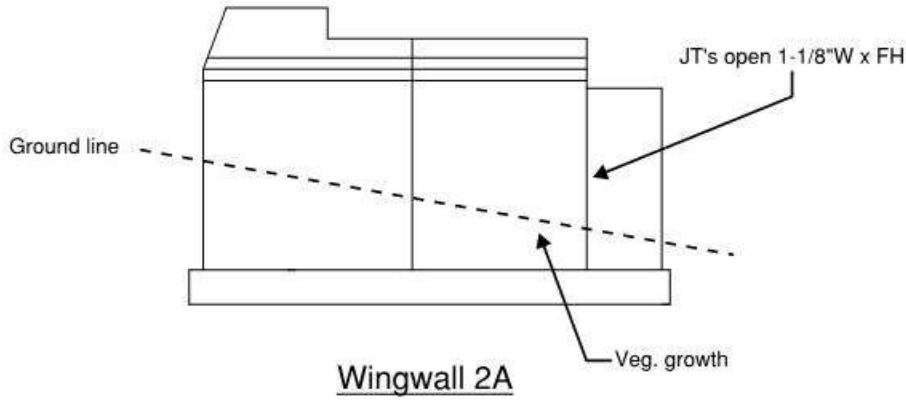
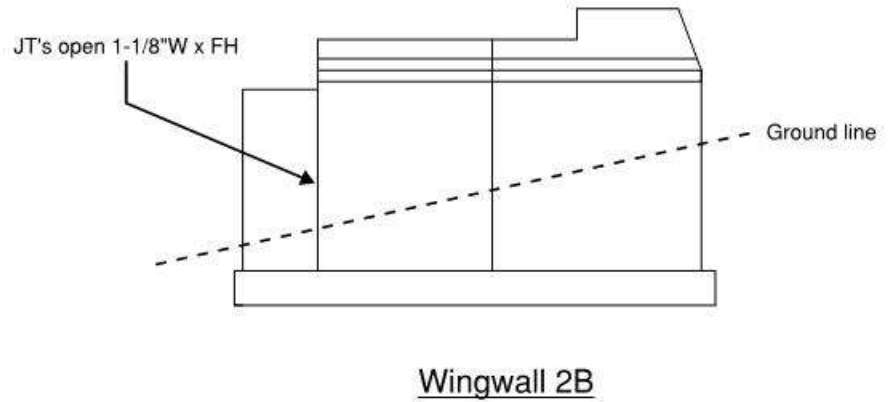
- LEGEND:
- HOLLOW AREA
 - SHALLOW REBAR
 - SPALL AREA
 - SPALL AREA WITH EXPOSED REBAR
 - MAPCRACKS
 - HAIRLINE CRACKS
 - HONEYCOMB AREA
 - SCALE AREA
 - EFFLORESCENCE PRESENT

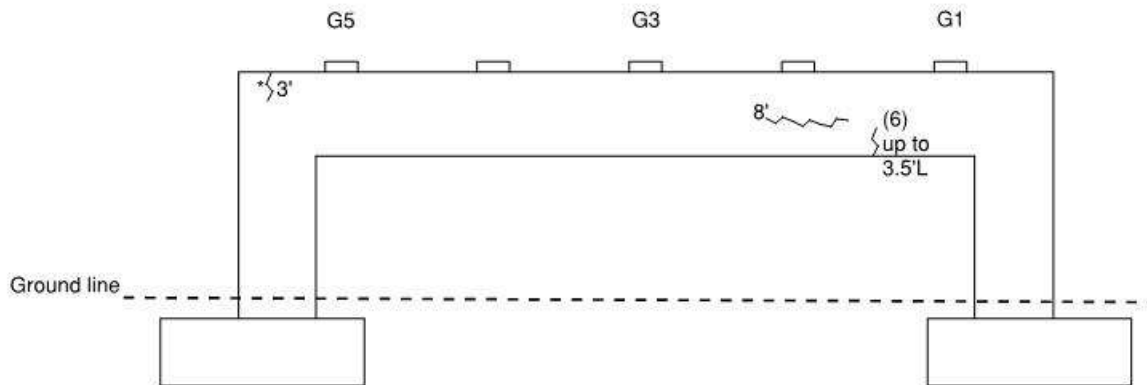
Pier - East Elevation
