**TOWN OF HAMDEN
CONNECTICUT
LEGAL NOTICE
REQUEST FOR PROPOSAL #19-12
HAMDEN HILLS DRIVE BRIDGE**

It is the sole responsibility of the responder to see that the proposal is in the hands of the proper authority prior to the opening.

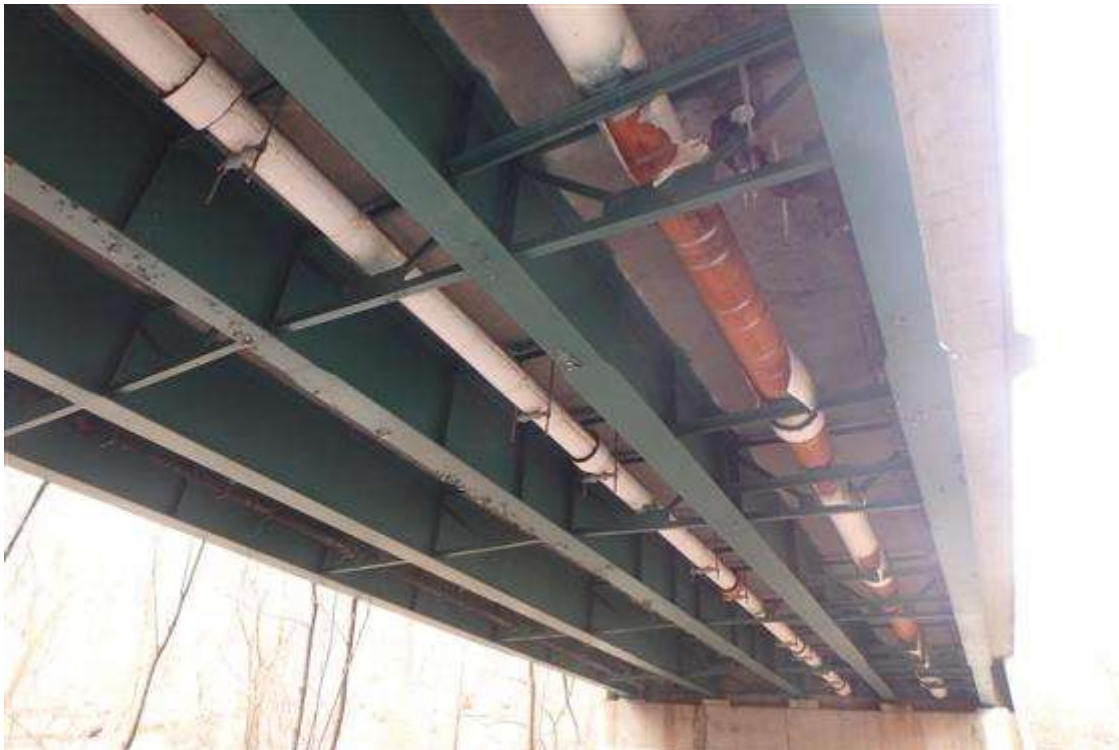
Bituminous concrete overlay (new since last inspection) over the abutment 2 joint exhibits transverse cracks.

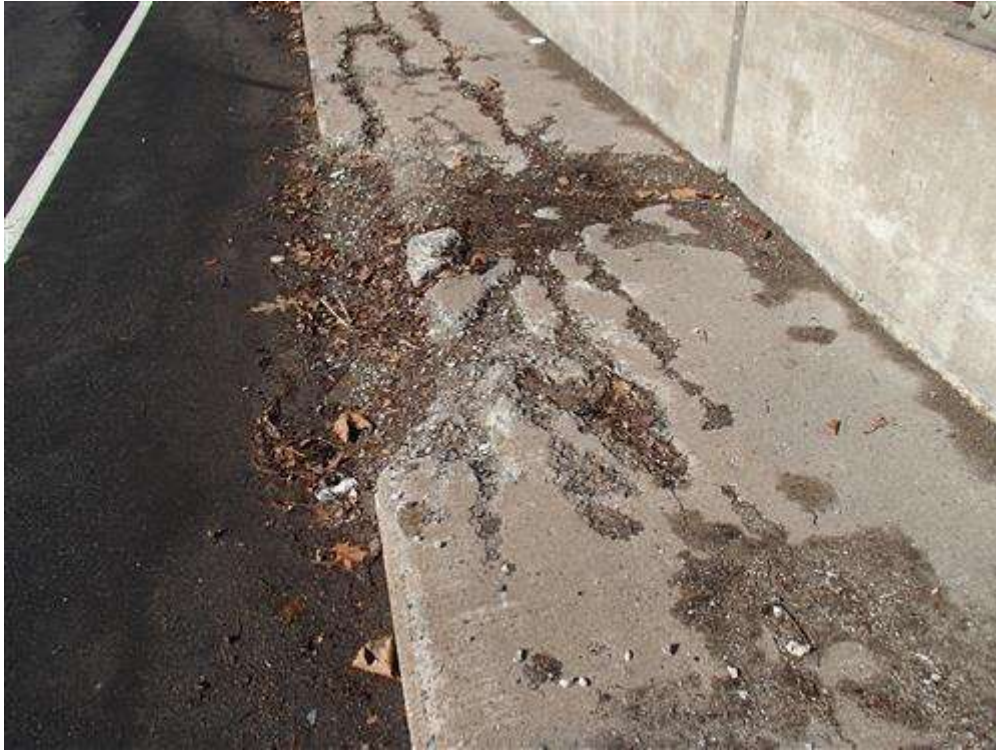
South sidewalk at the pier joint exhibits spall with hole through joint.

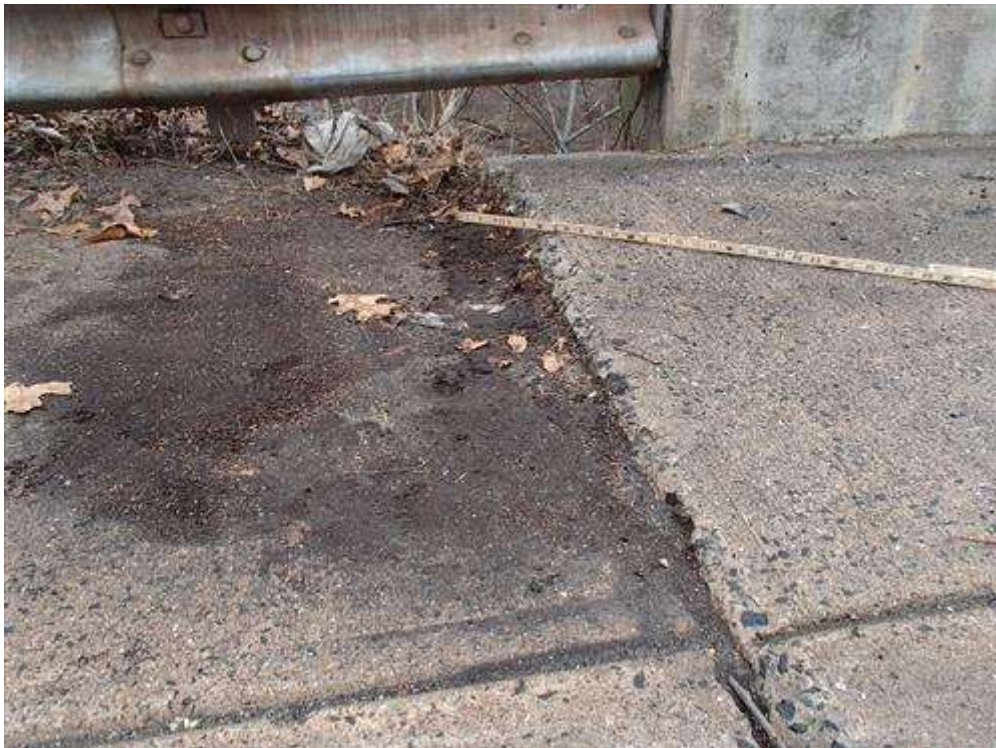
North sidewalk at the pier joint exhibits area of plow damage with longitudinal cracks, spalls, scale, loose concrete, and hollow areas.

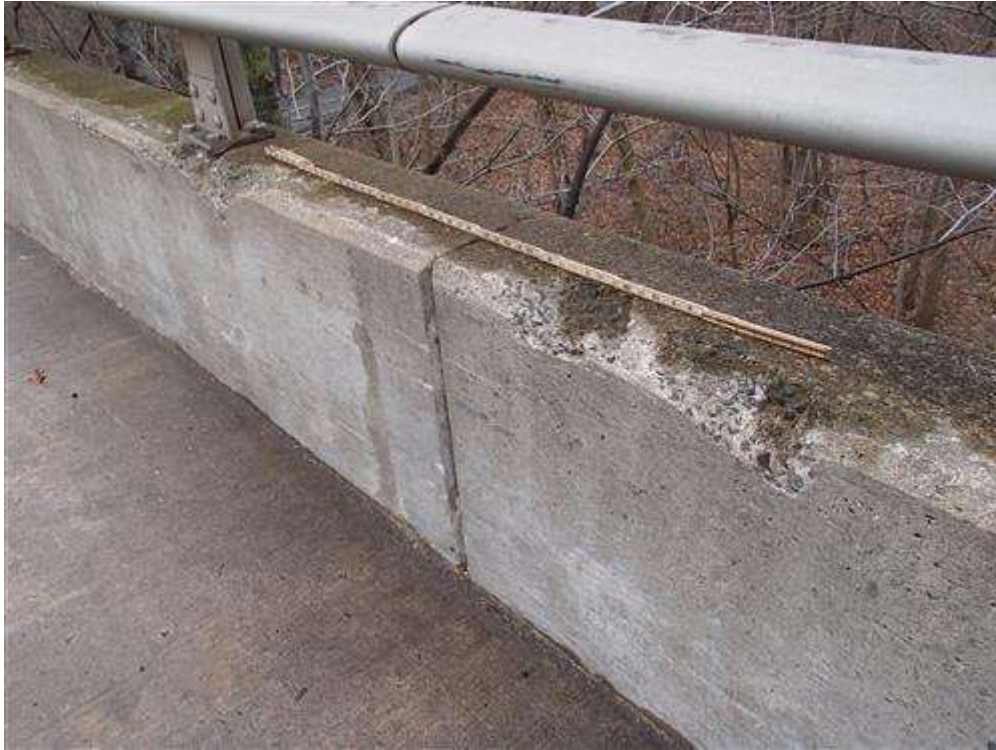
Southeast approach sidewalk exhibits vertical mis-alignment between segments (pedestrian tripping hazard).

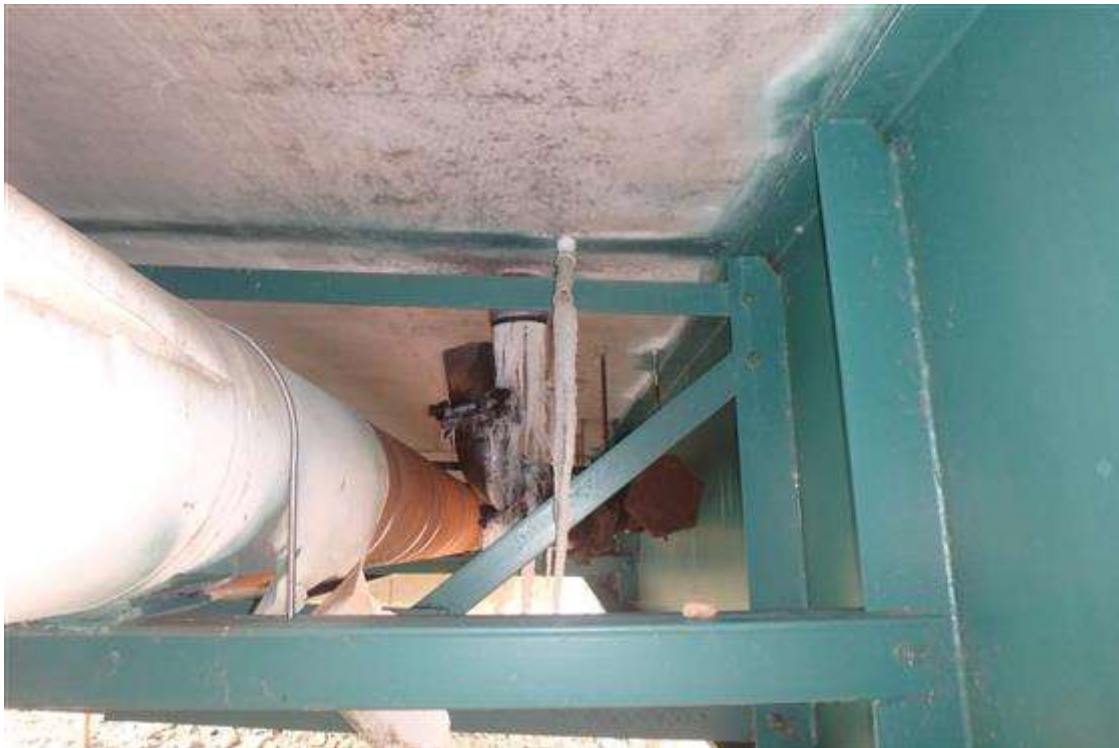
South parapet in span 1 exhibits spalls at top.

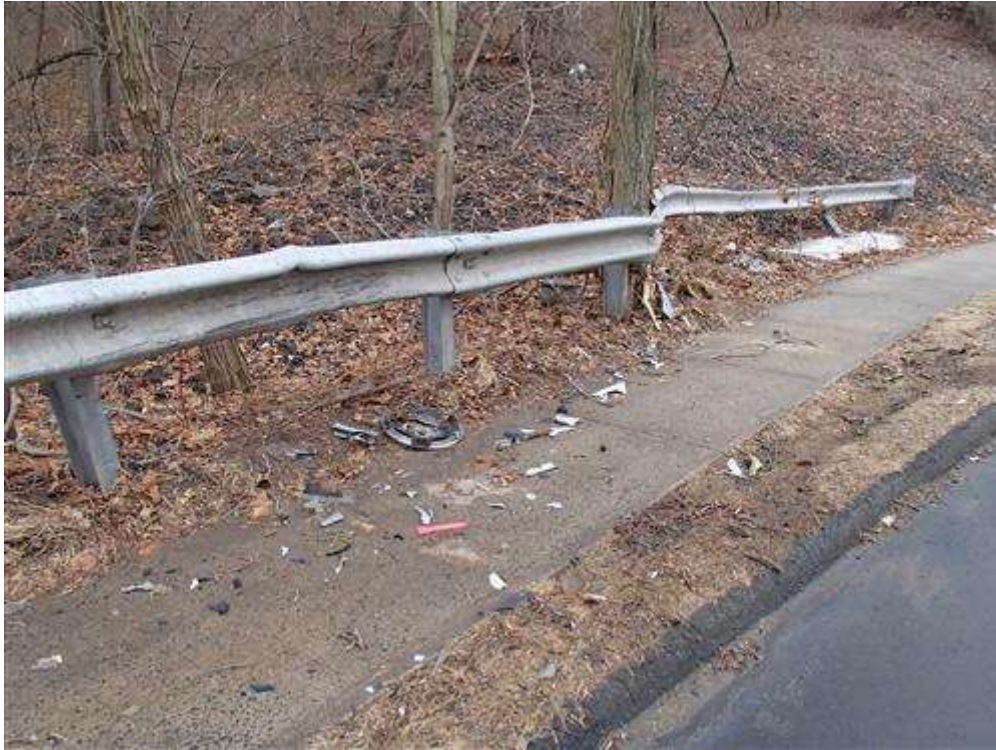
Scupper pipe with heavy surface rust and is disconnected from the coupling in span 1, bay 1. Note PVC weep with missing extension.

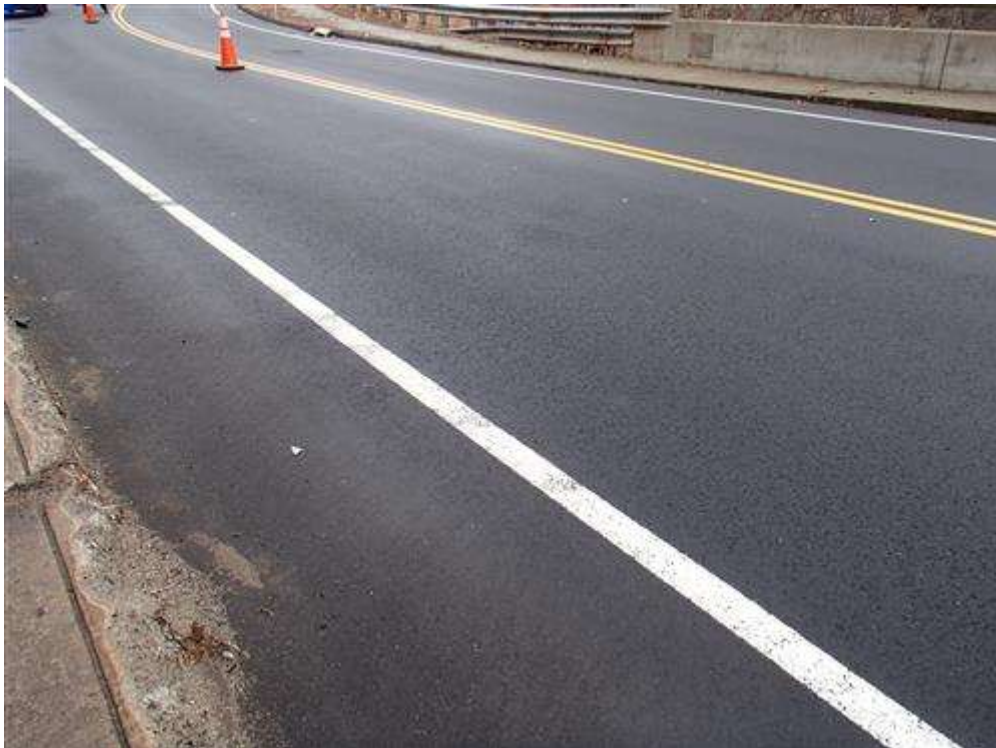
Metal beam guide rail at southwest approach corner exhibits collision damage with bent rail and broken/disconnected posts.

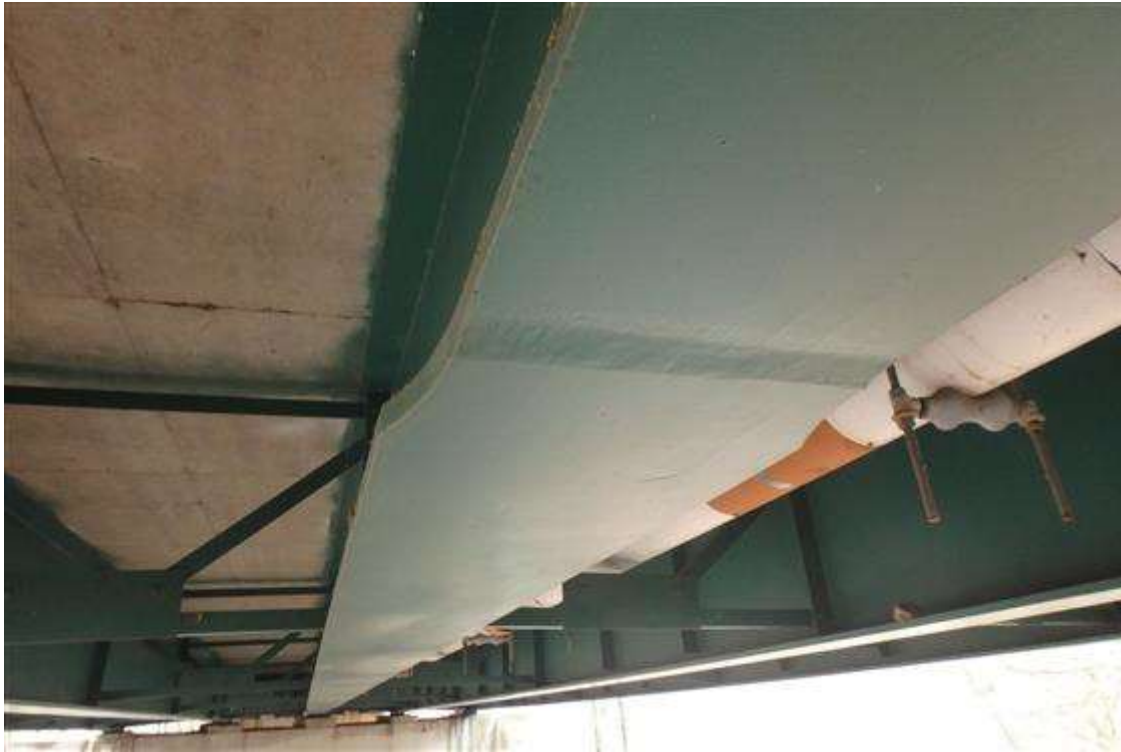
Girder G1 elastomeric fixed bearing at the pier in span 1 exhibits minor bulging. Note girder end and stiffener with isolated light to moderate surface rust due to active leakage through the joint.

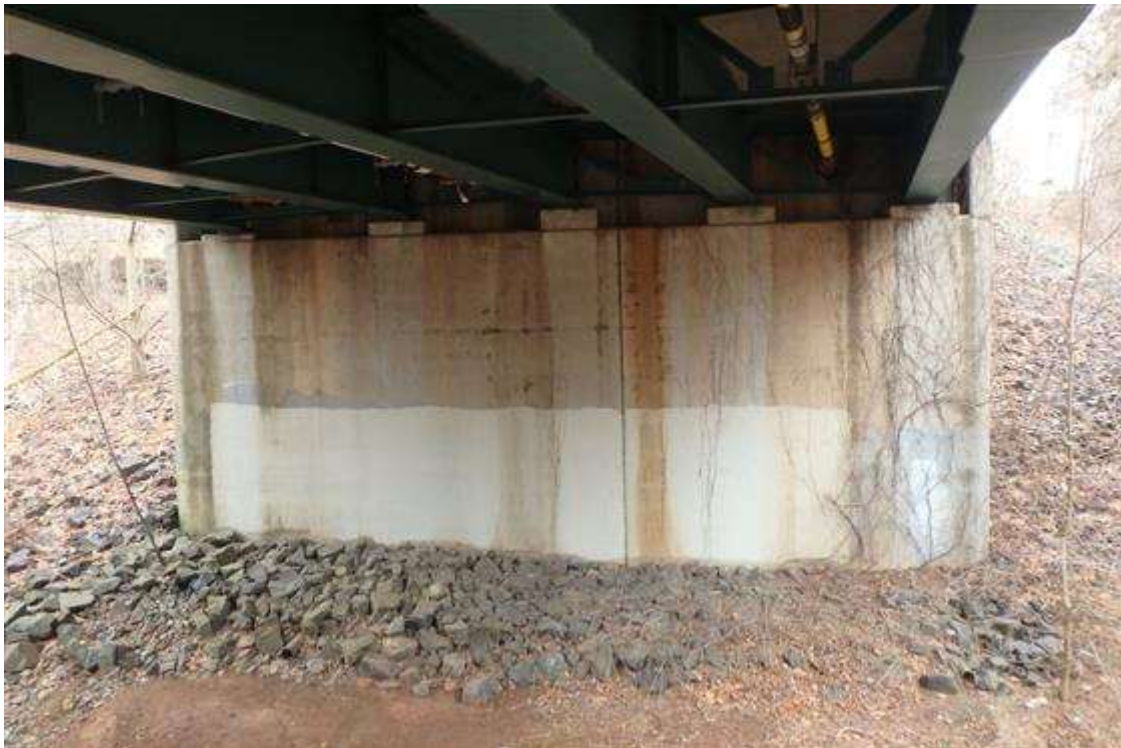
Abutment 1 elevation. Note evidence of past leakage at stem.

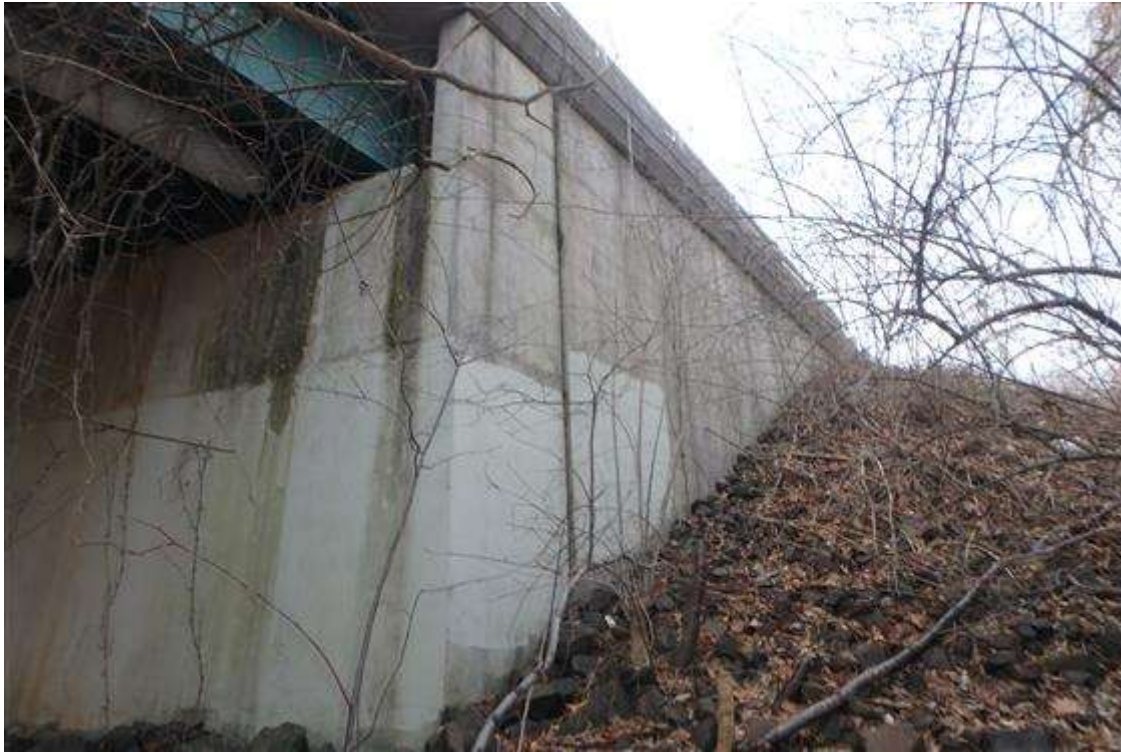
Abutment 2 elevation. Note evidence of past leakage at stem.

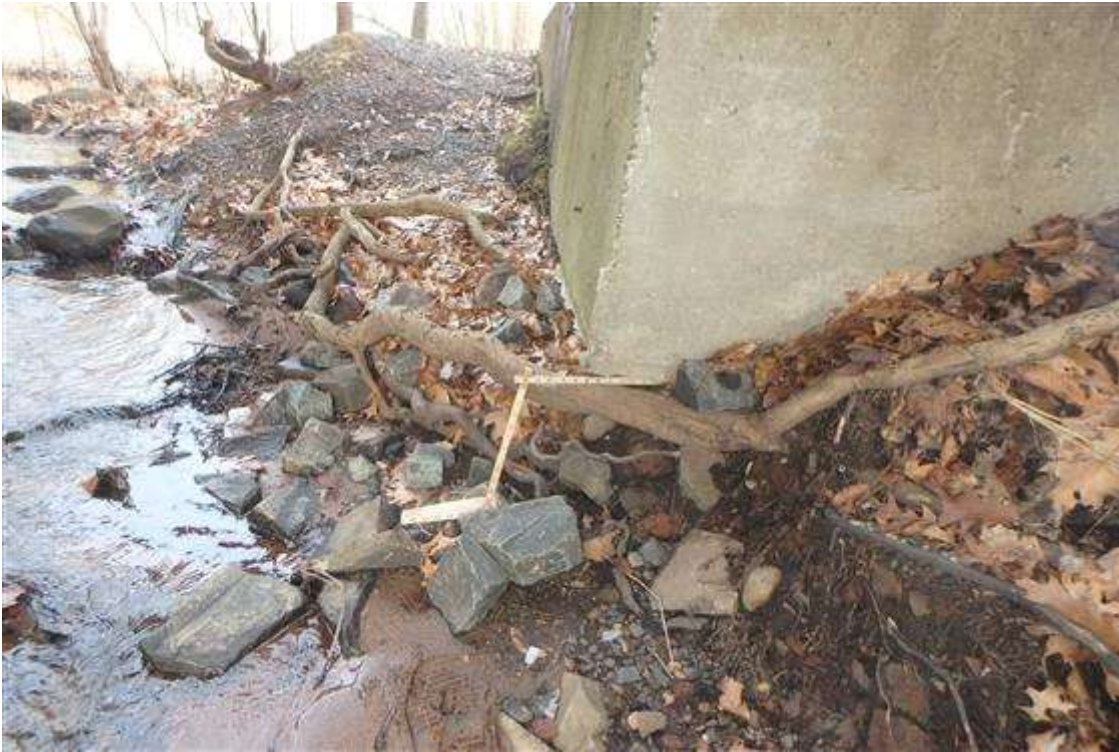
Pier, west elevation. Note active leakage at north end of pier cap and exposed footings. Also note channel under bridge with minor erosion along culvert wingwalls.

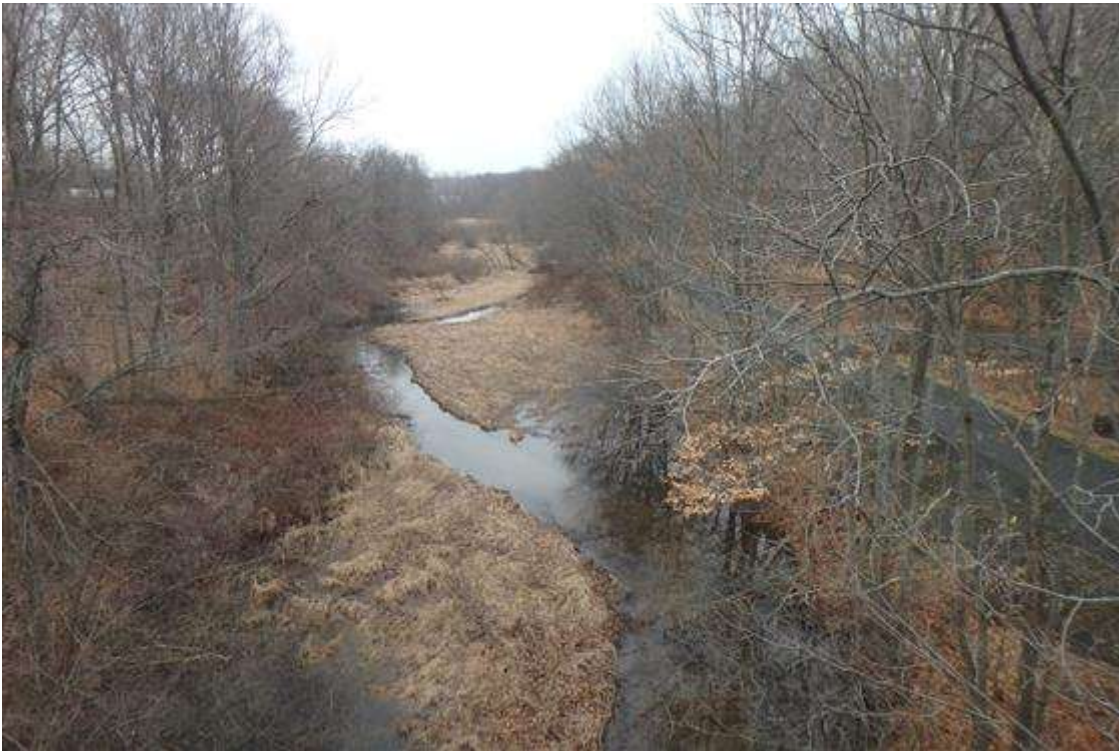
Pier, west elevation at the north exposed footing, exhibits area of scour causing undermining of the footing with tree root growth below (re-occurring condition; previously placed rip rap displaced).

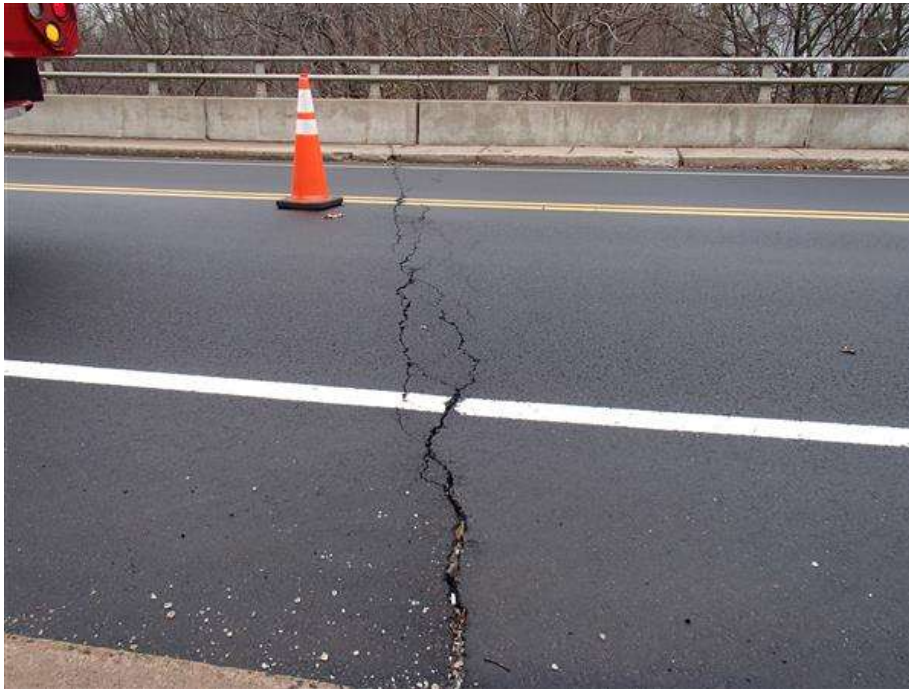
Bituminous concrete overlay (new since last inspection) over the abutment 2 joint exhibits transverse cracks.

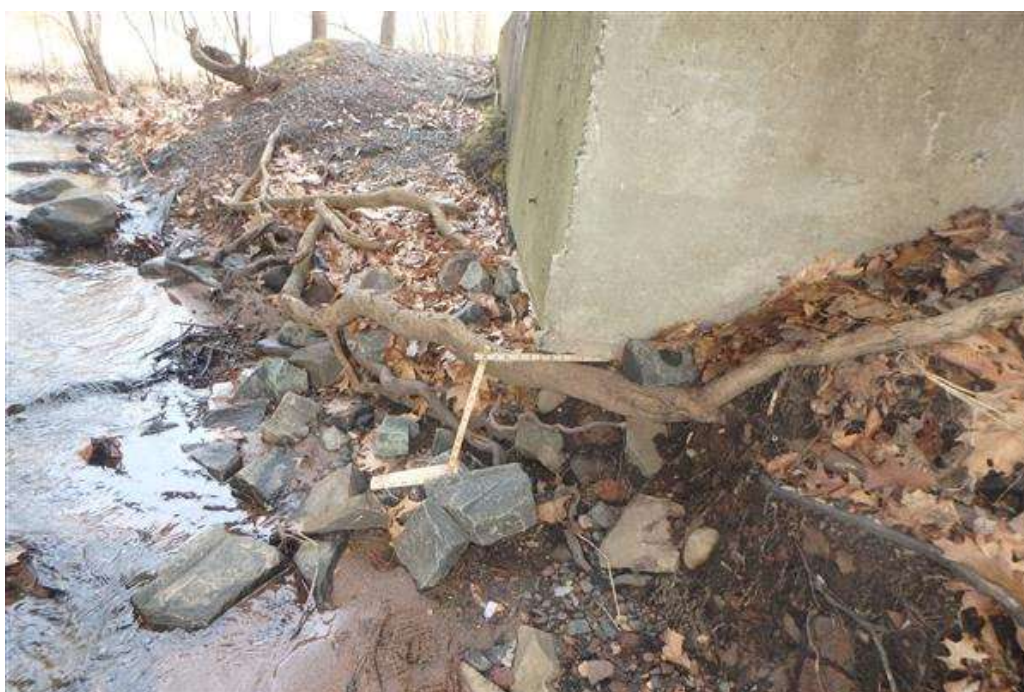
Pier, west elevation at the north exposed footing, exhibits area of scour causing undermining of the footing with tree root growth below (re-occurring condition; previously placed rip rap displaced).

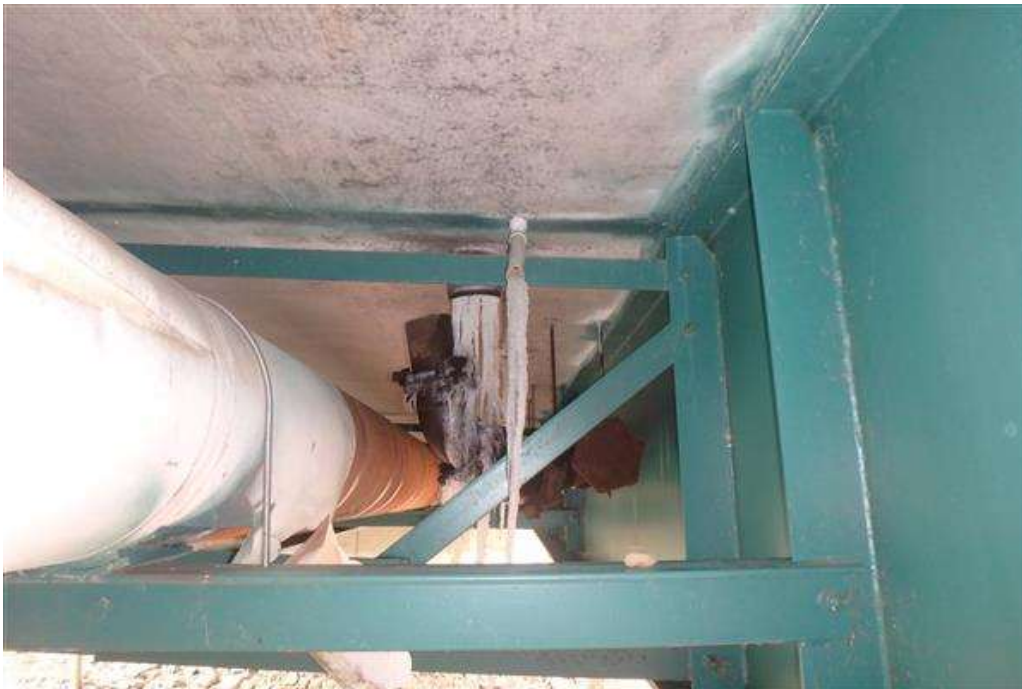
Scupper pipe with heavy surface rust and is disconnected from the coupling in span 1, bay 1. Note PVC weep with missing extension.

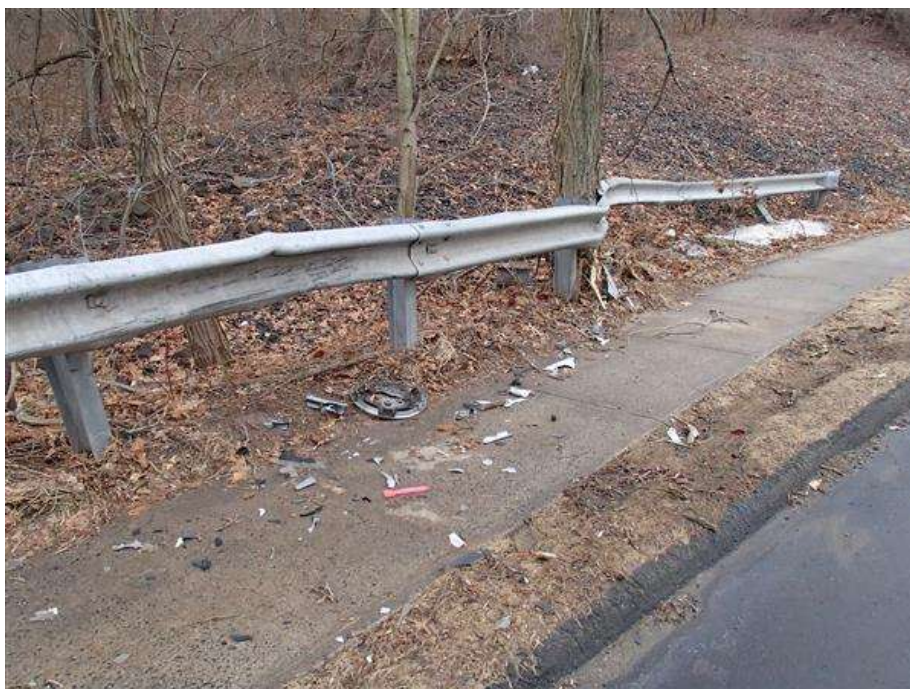
Metal beam guide rail at southwest approach corner exhibits collision damage with bent rail and broken/disconnected posts.

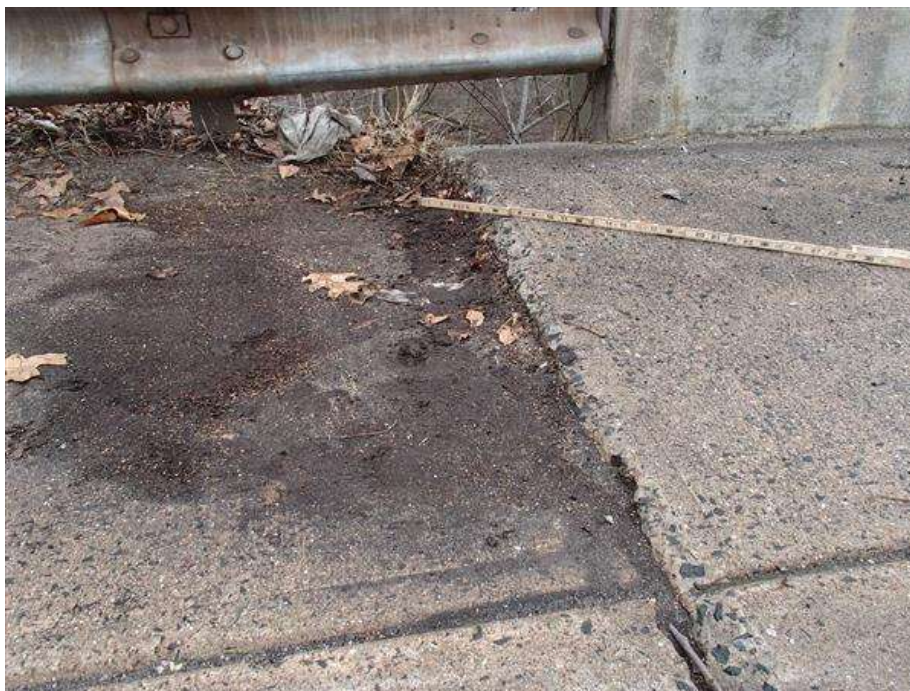
Southeast approach sidewalk exhibits vertical mis-alignment between segments (pedestrian tripping hazard).

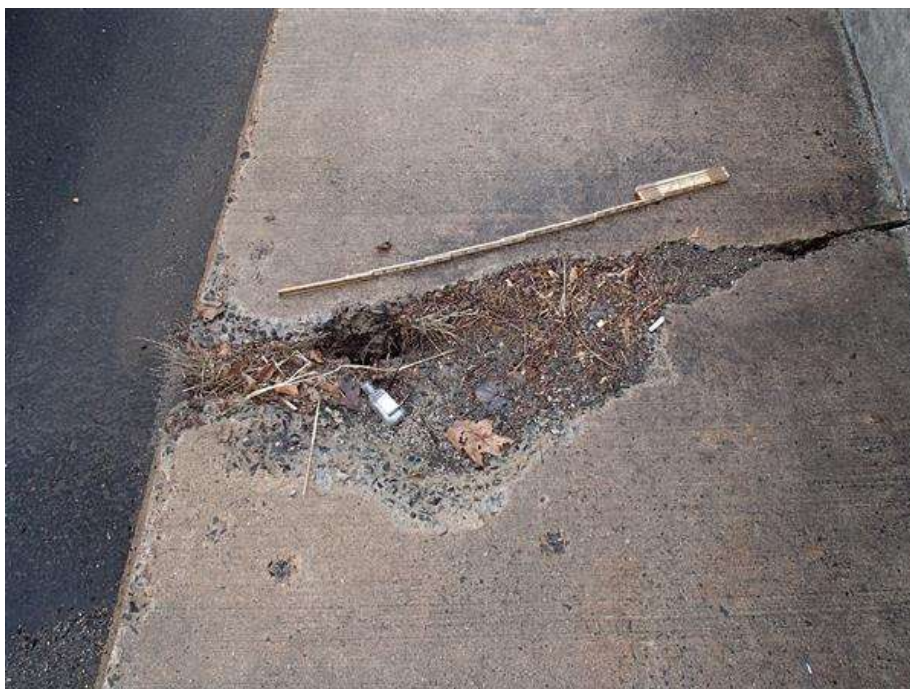
South sidewalk at the pier joint exhibits spall with hole through joint.

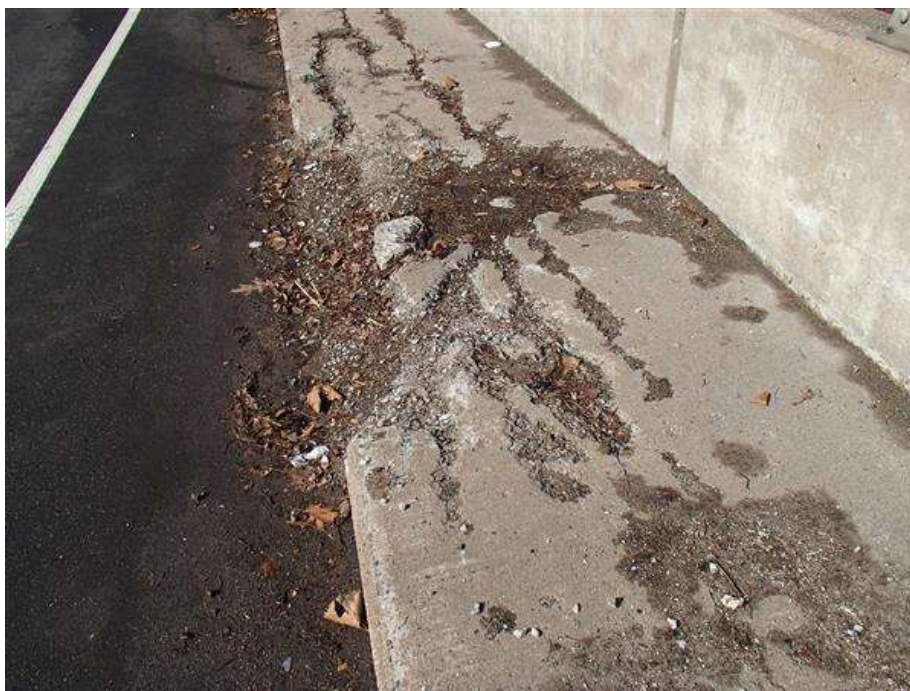
North sidewalk at the pier joint exhibits area of plow damage with longitudinal cracks, spalls, scale, loose concrete, and hollow areas.

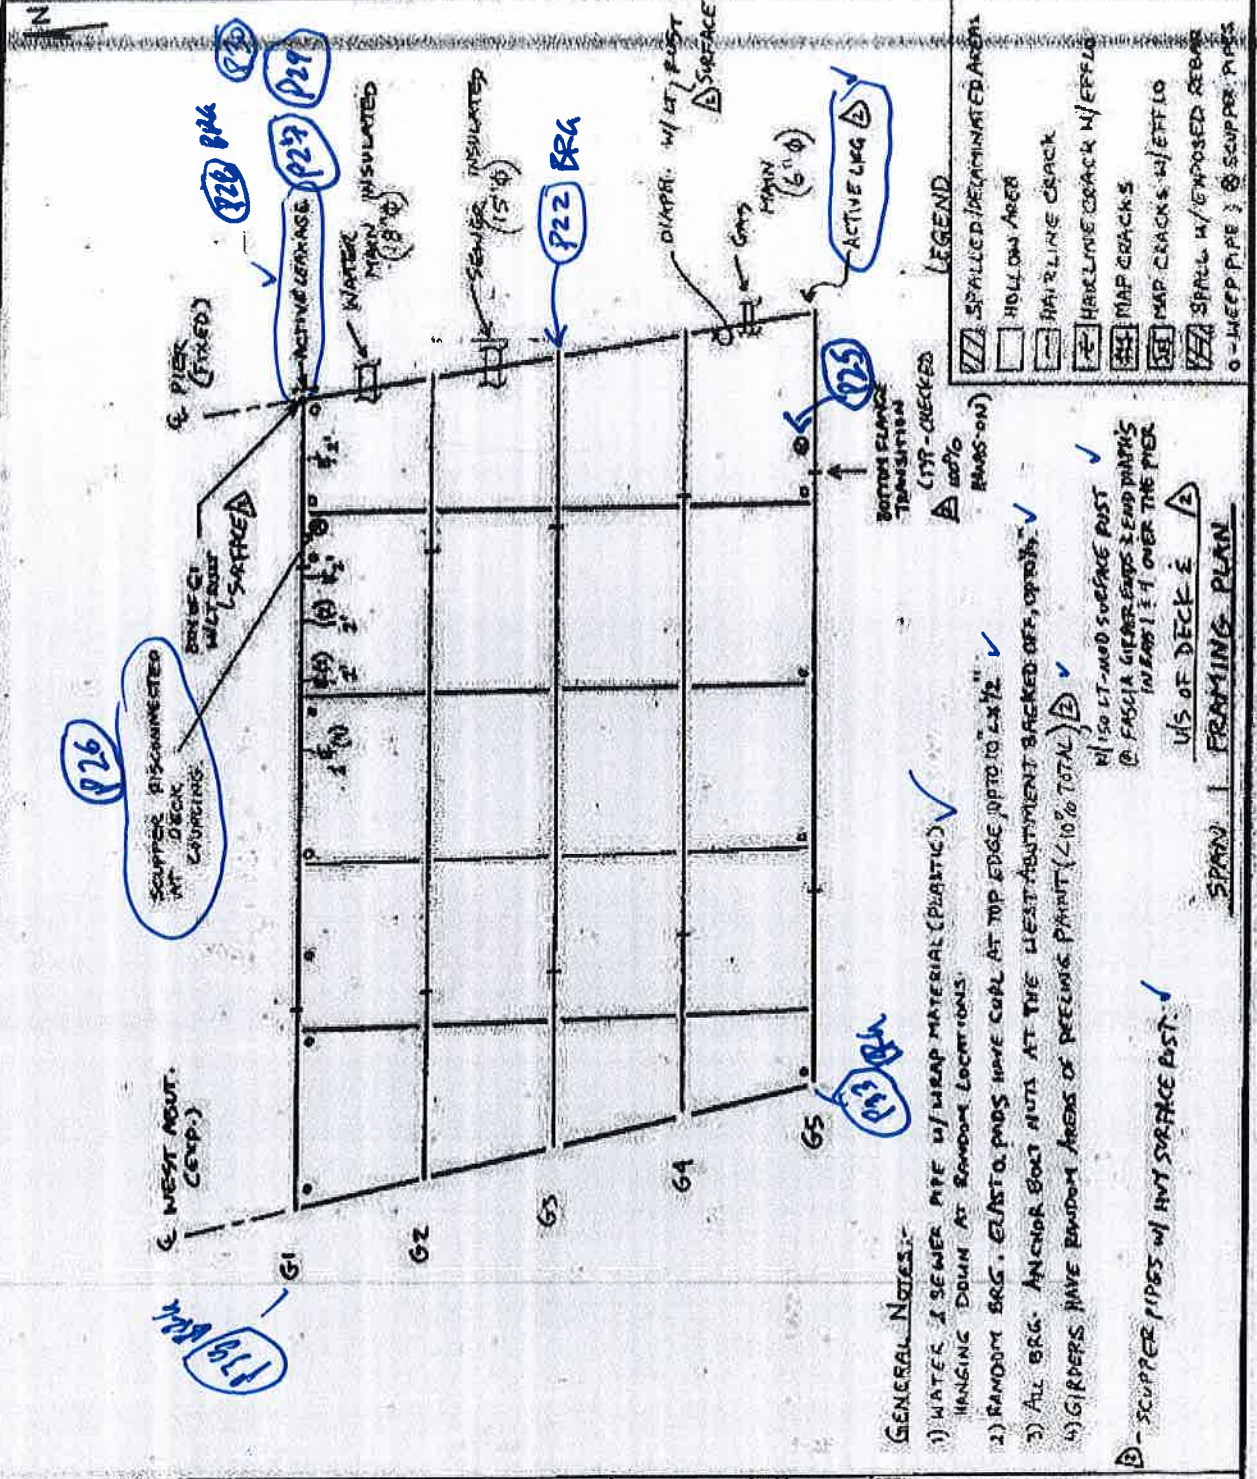
REVISION	DATE	CREW	REVISION	DATE	CREW
	1-17-14	TM7 N/C			
	2-26-10	PS, ETC, AAA (A1)

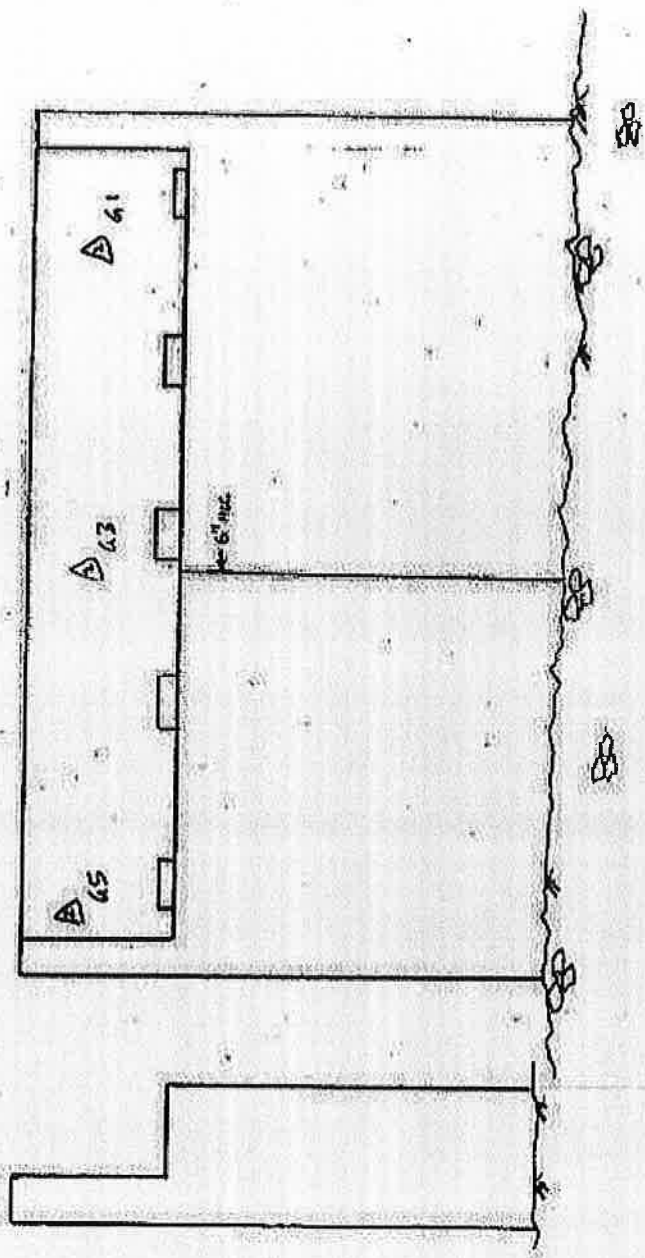
- GENERAL NOTES:-
- 1) RANDOM AREA OF LIGHT SCALING
 - 2) ABUTMENT STEM/BACKWALL W/ EVID. OF LEAKAGE
 - 3) LIGHT PIGEON DEBRIS ON SEAT
 - 4) ~~1-5\"/>~~
