BRIDGE NO. 03903

34250 - GROTON
MOSHER STREET
over
AMTRAK RAILROAD

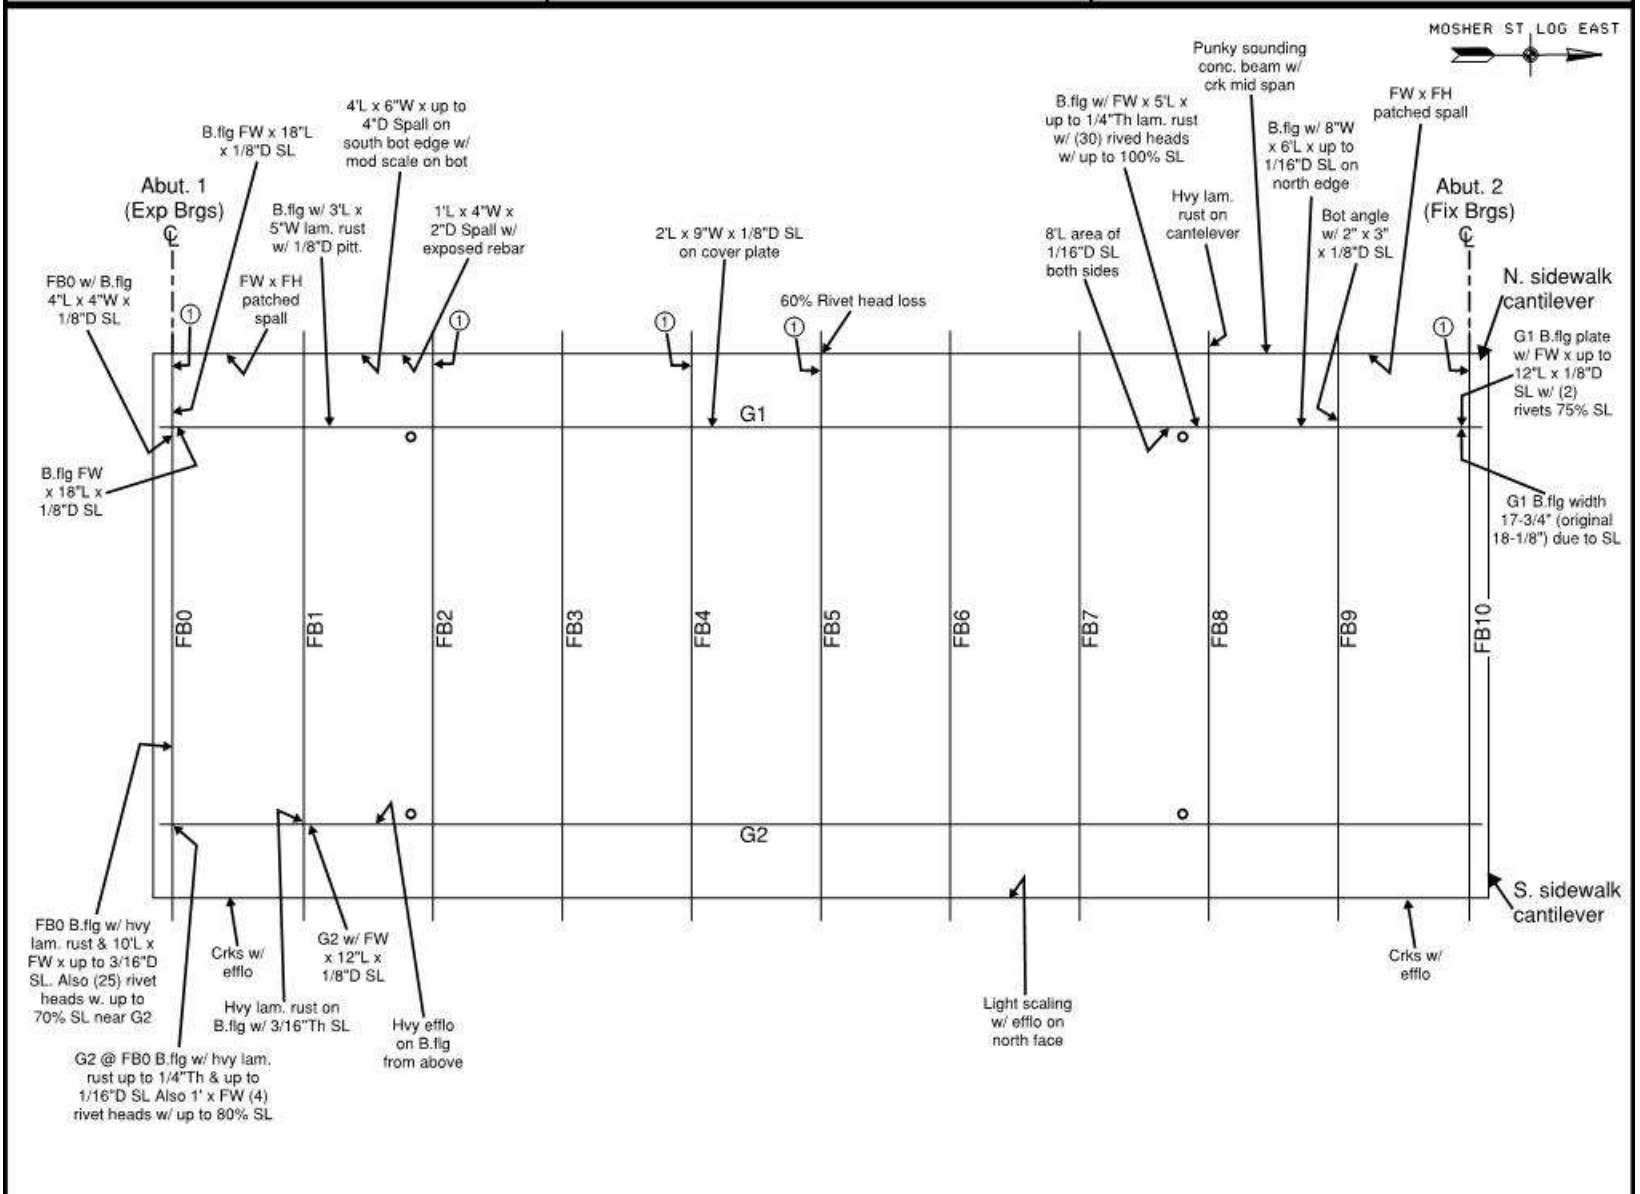
Deterioration Legend:

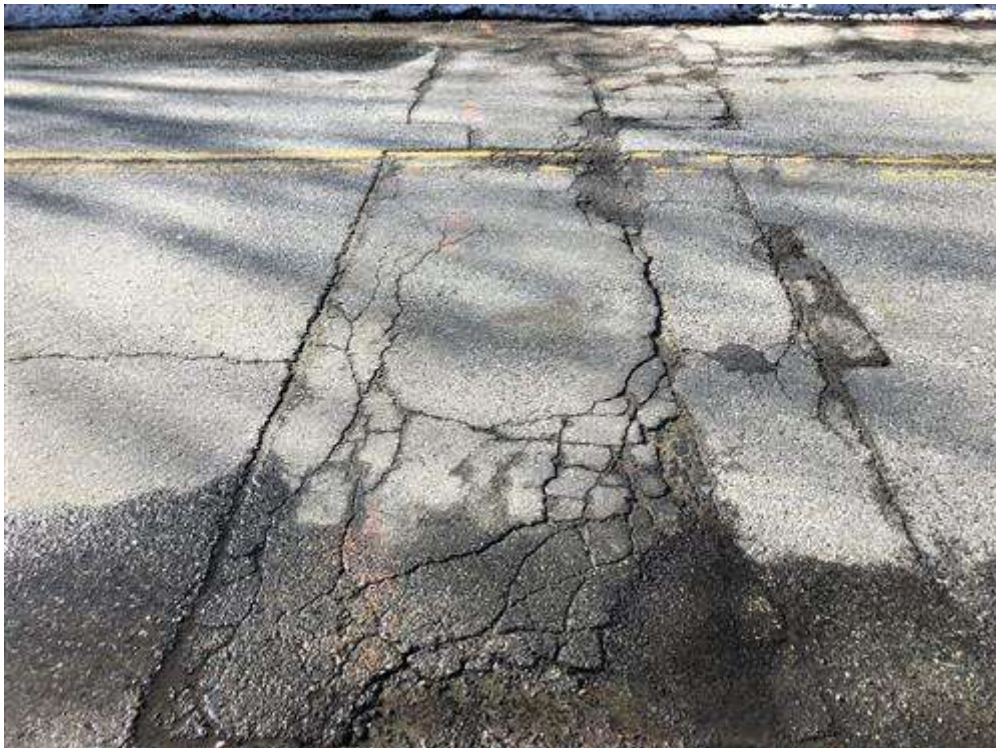
General view of the overlay. Note the cracks.

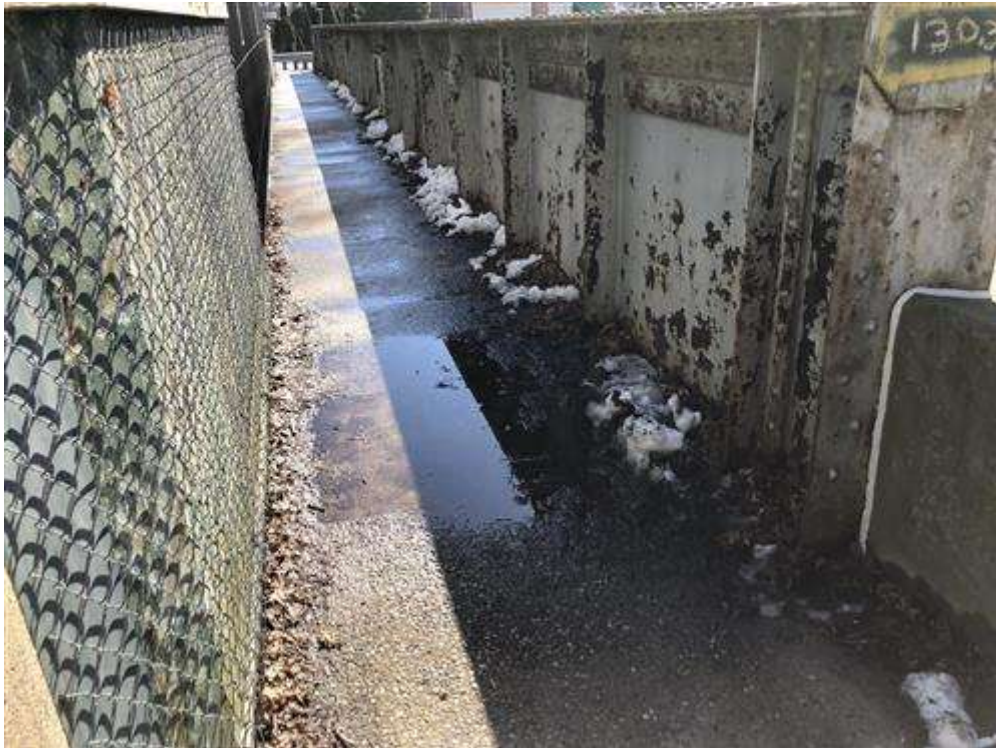
Underside of deck between floorbeams 3 and 4. Note the spall with exposed rebar and one (1) debonded rebar.

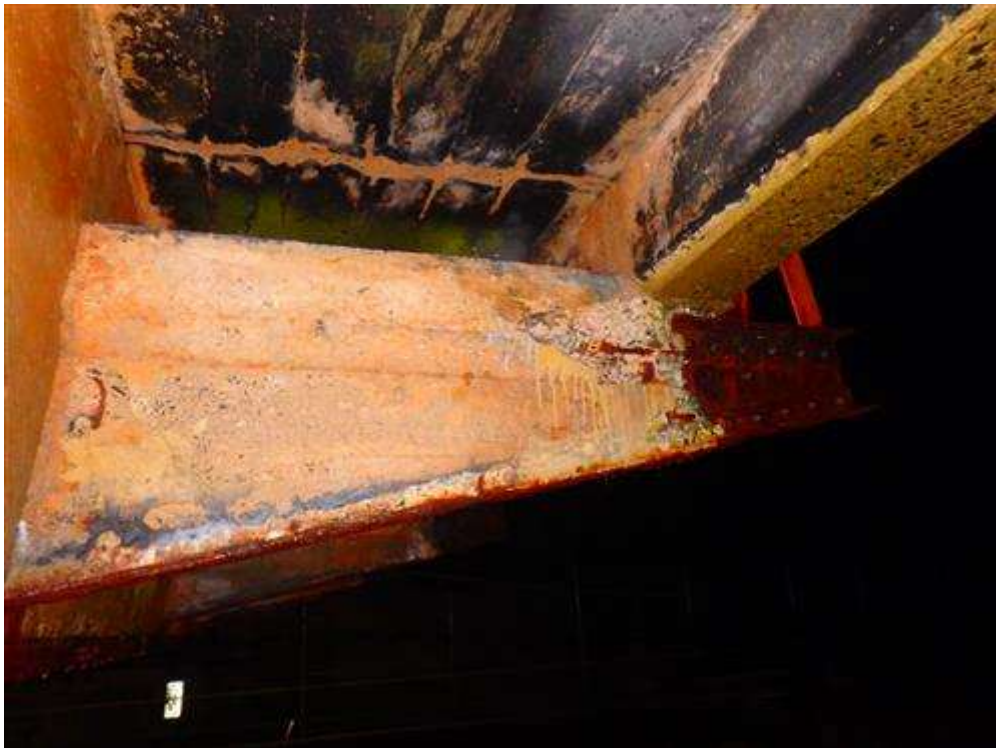
Underside of sidewalk concrete edge beams between floorbeams 1 and 2 north side. Note the spall with exposed rusted rebar.

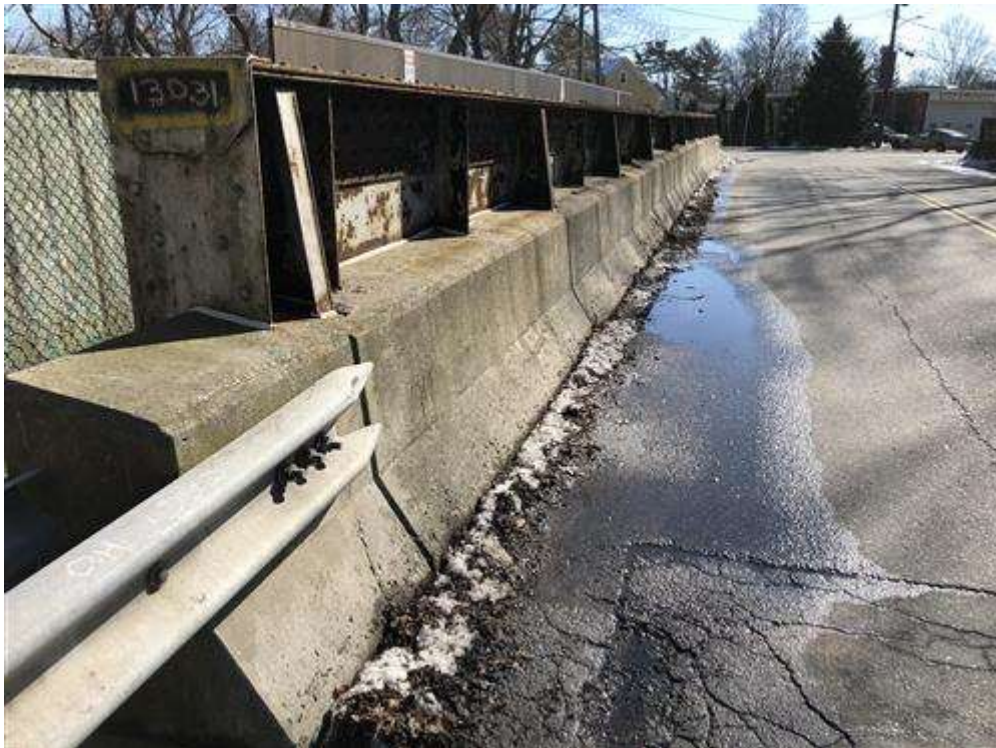
Underside of north floorbeam FB8 sidewalk support. Note the exposed and rusted steel bottom flange angles.

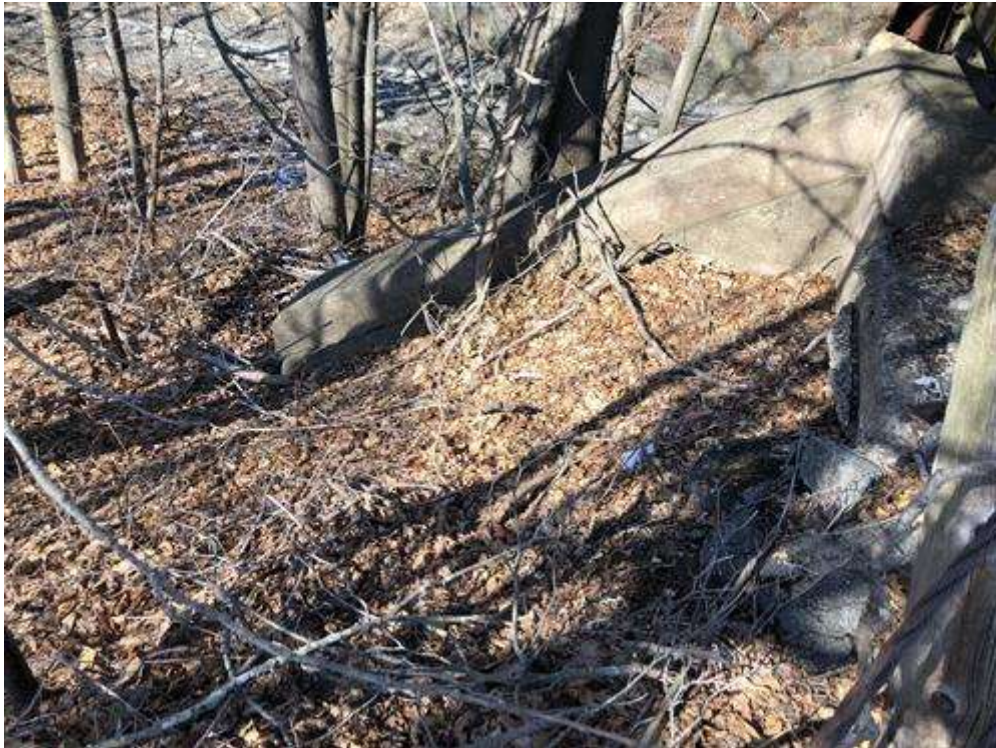
General view of the east approach pavement. Note the cracks and potholes with and without patches.

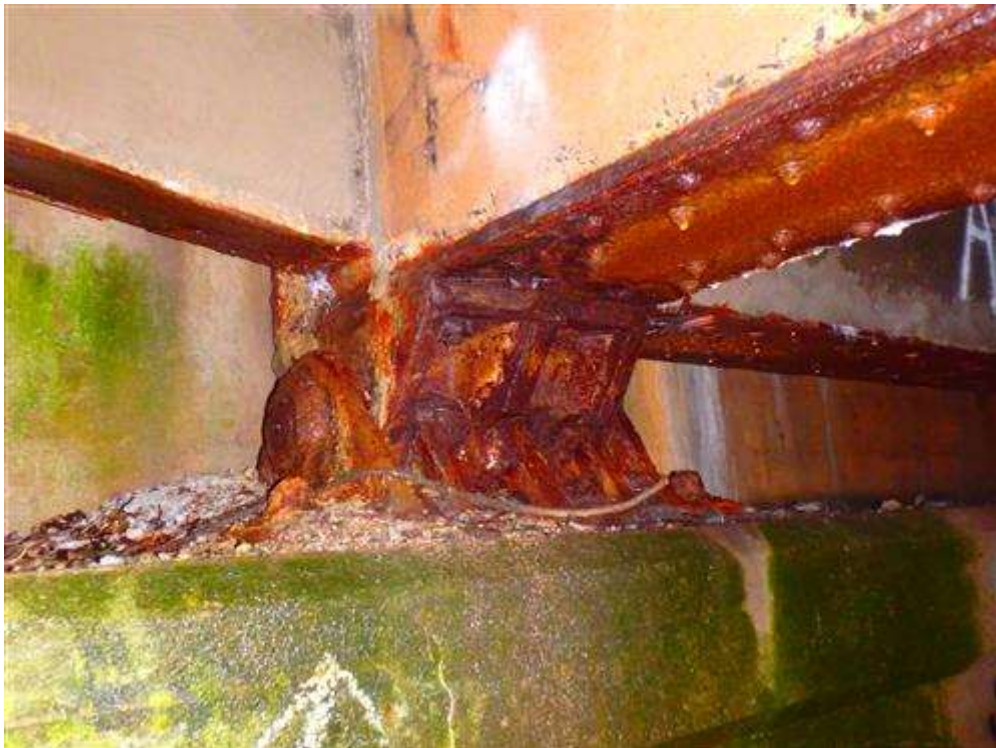
Girder G1 expansion bearing at abutment 1. Note the heavy rust and section loss at bearing components.

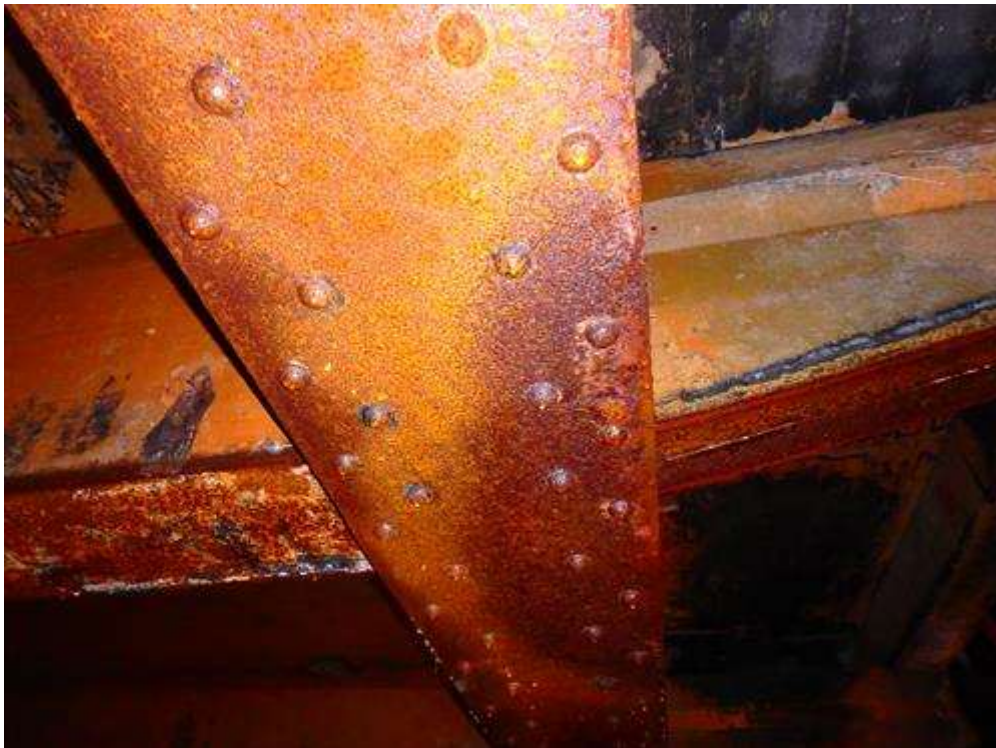
Girder G2 bottom flange near abutment 1. Note the efflorescence and the pack rust between plates.

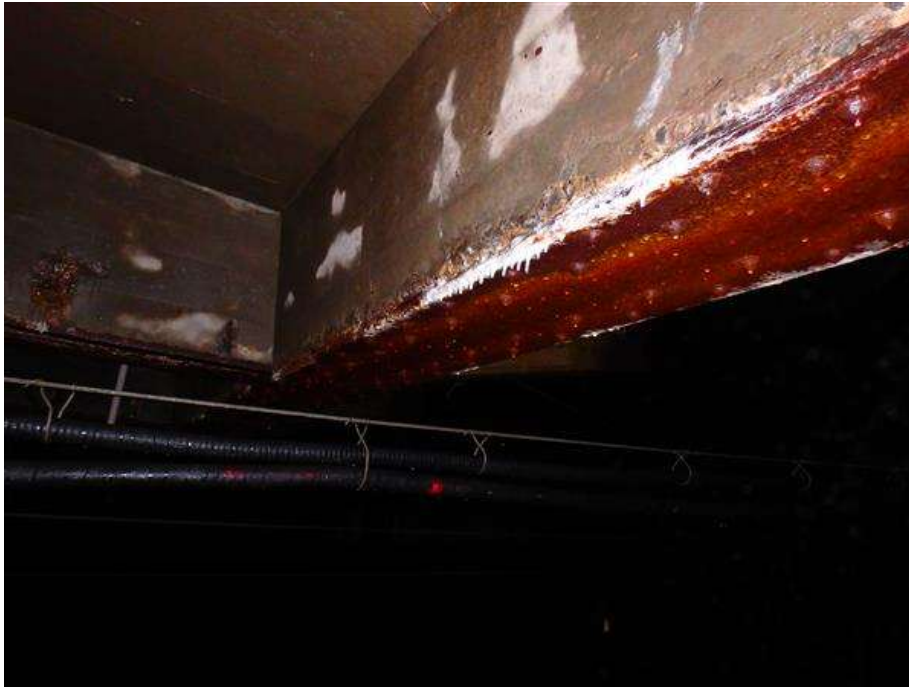
Girder G2 bottom flange near abutment 1. Note the efflorescence and the pack rust between plates.

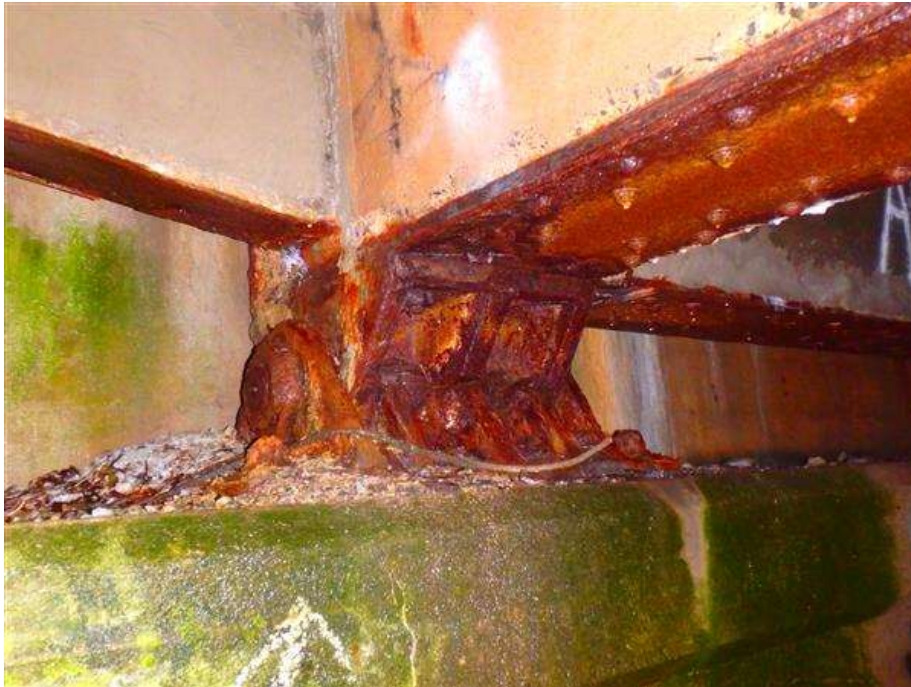
Girder G1 fixed bearing at abutment 2. Note the laminated rust and section loss at the bearing components. Also, note debris on the abutment seat.

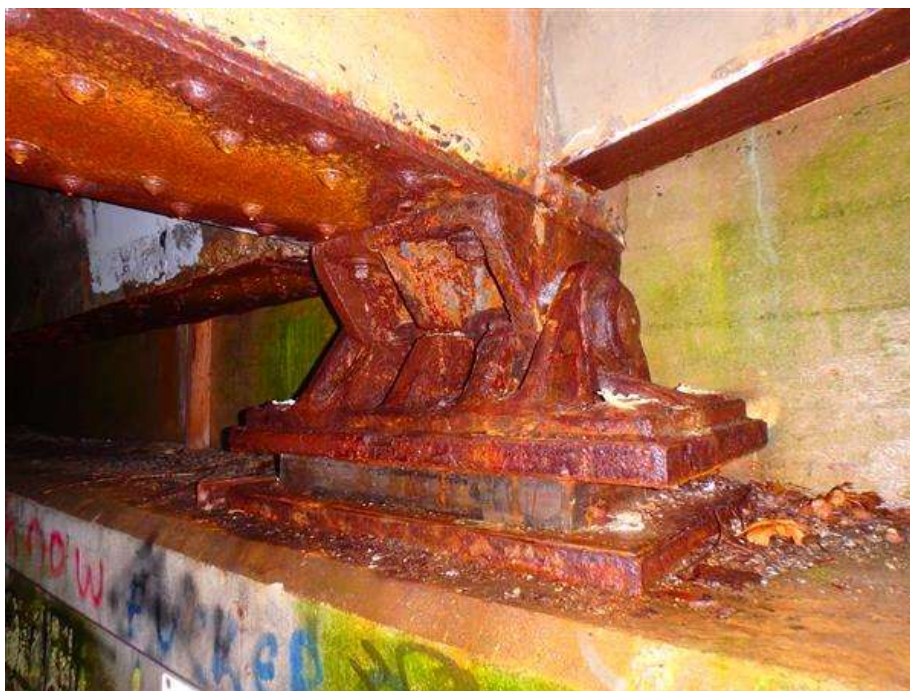
Girder G1 expansion bearing at abutment 1. Note the heavy rust and section loss at bearing components.
