# Task 210

# Subsurface Site Investigation Report ConnDOT Project Number 173-468

August 2019

# Stratford Signalization Project

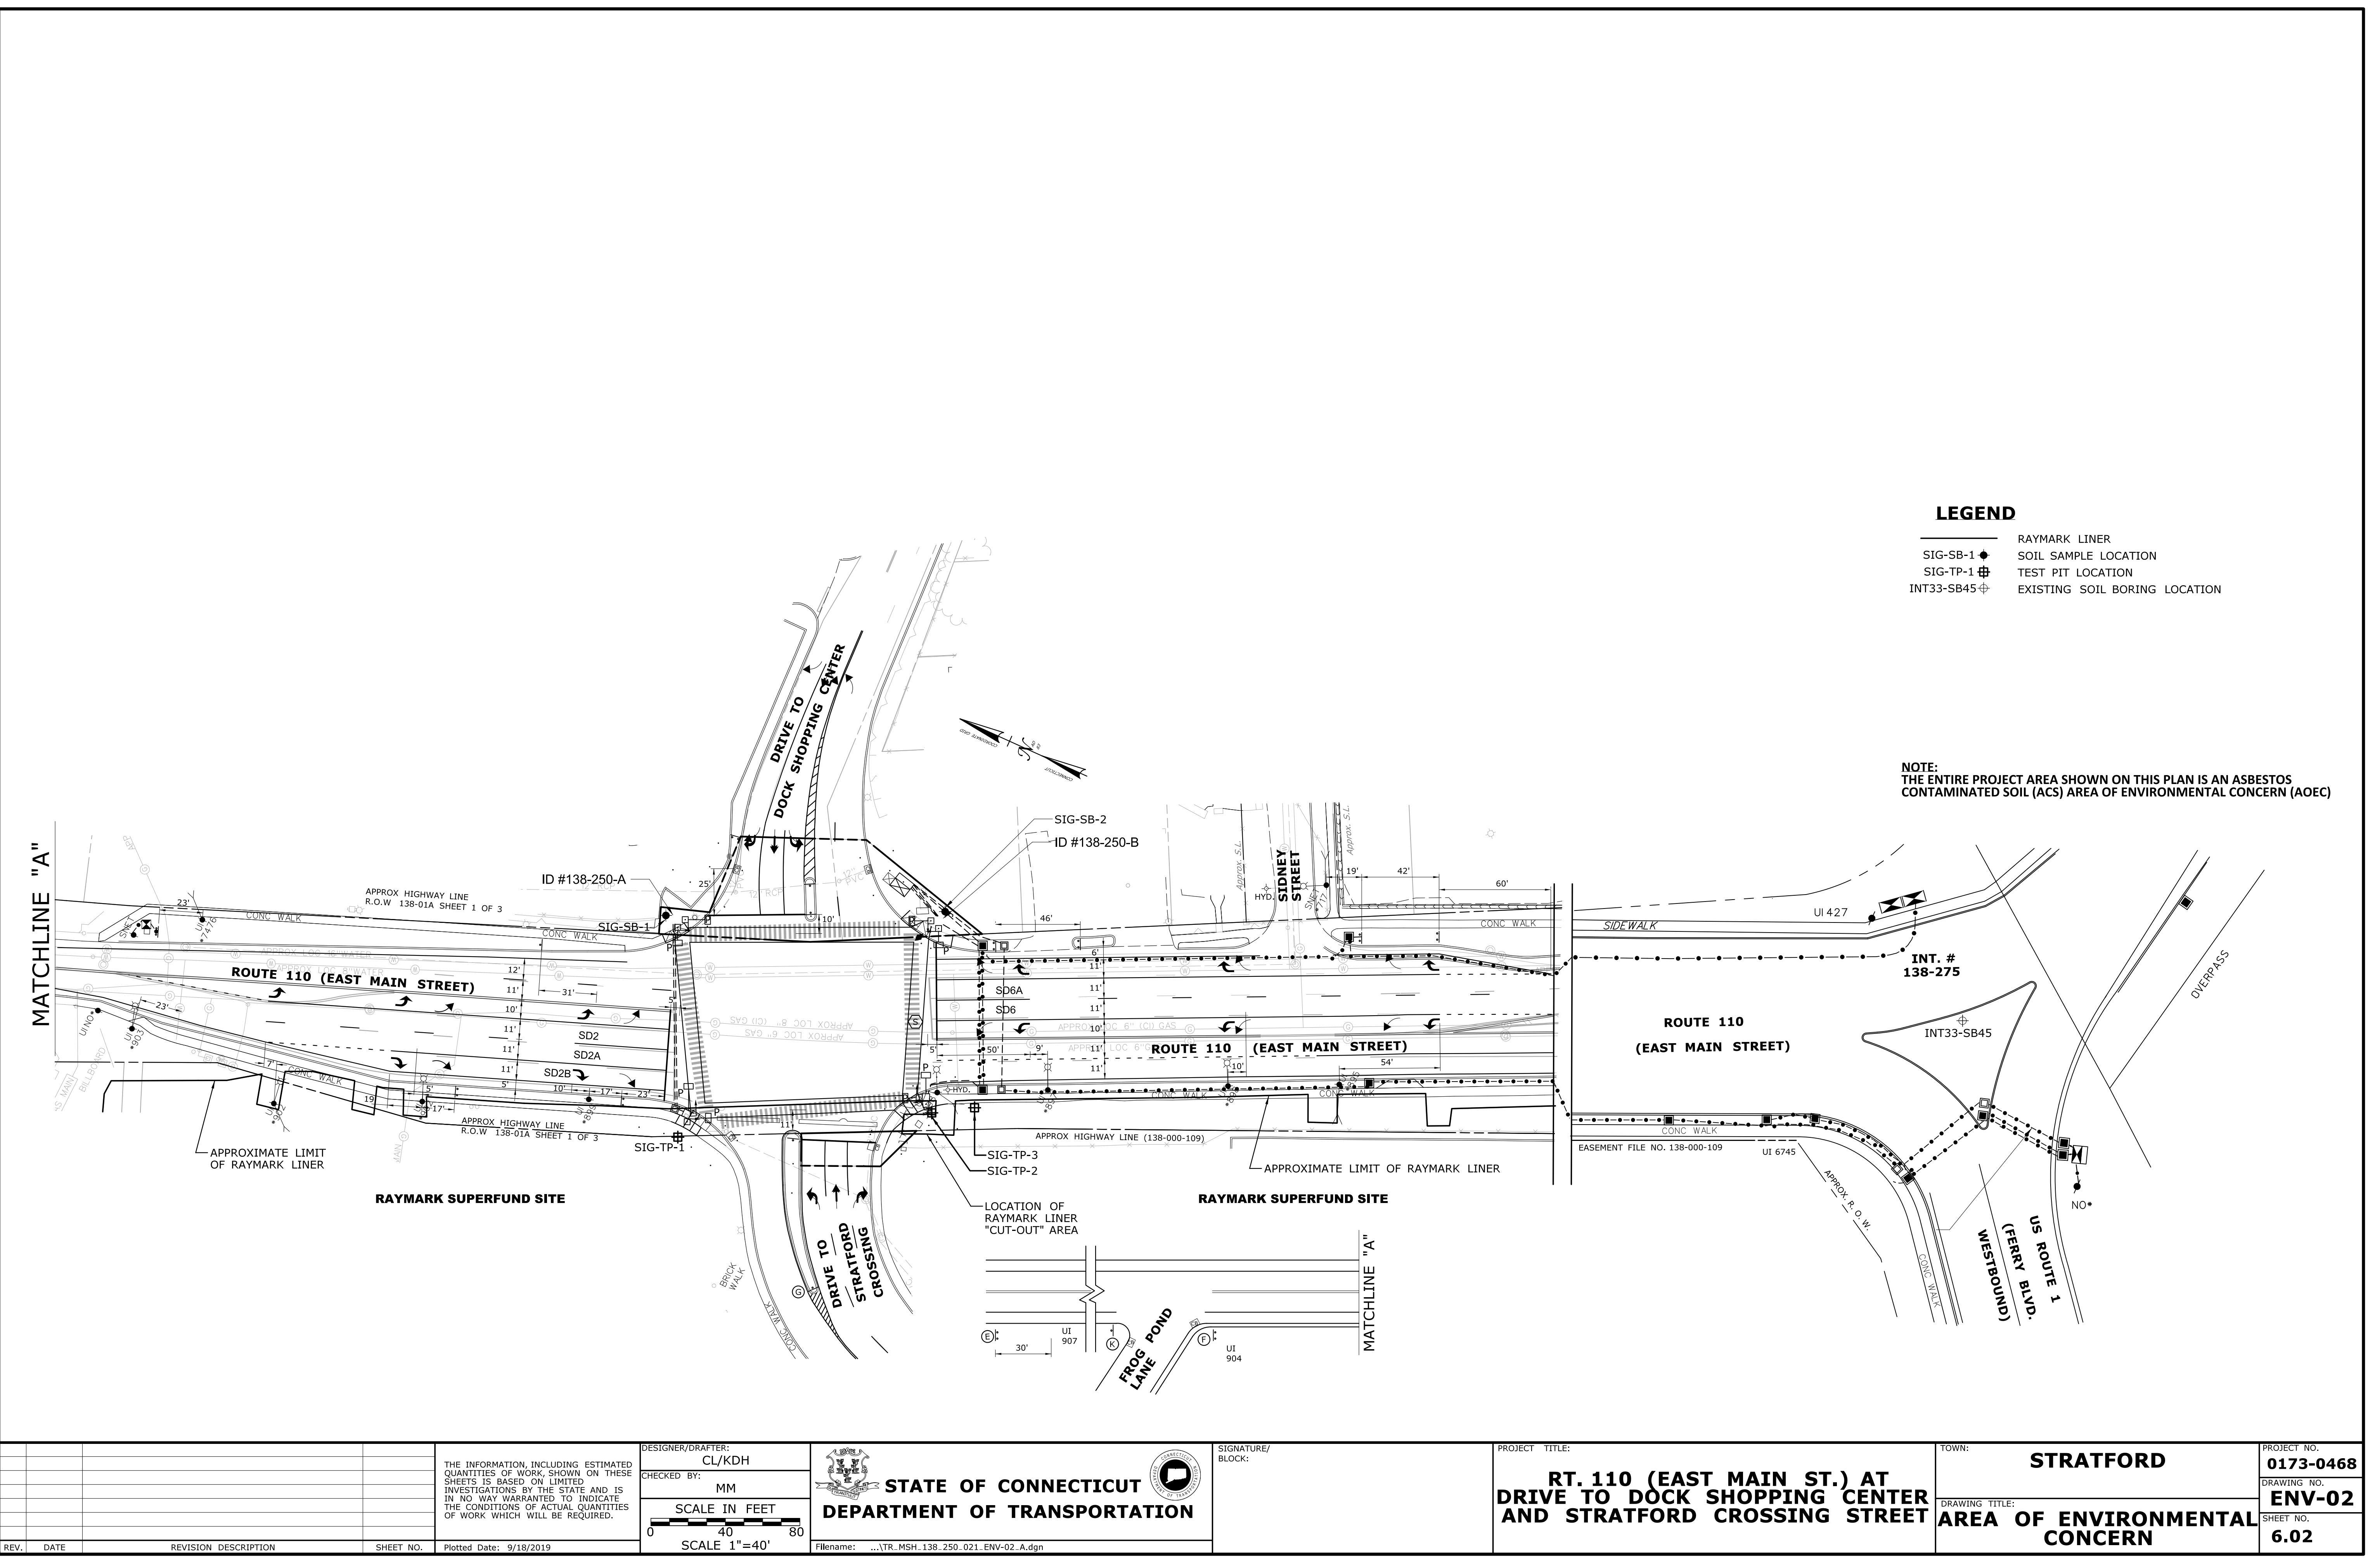
Figure 1 – Site Location Map ENV-02 – Environmental Sample Locations

Soils within the test pits and each four-foot soil core was logged with respect to soil characteristics (i.e., grain size, moisture content and any other physical characteristics) and indications of potential impacts (e.g., stains and odors). In addition, soils from the test pits and cores were field-screened using a photo ionization detector (PID) prior to the collection of soil samples for analysis. Test pit / soil boring logs are presented in Appendix A. The test pit / soil boring locations are shown on ENV-02.
