Request for Qualifications for Architectural & Engineering Services Development of a Repair and Rehabilitation Plan for Maintenance and Administrative Facility at 840 Sherman Avenue, Hamden, CT GNHTD RFQ # 01-2020

Amendment No. 2

Building Inspection Report

Asset Description: Greater New Haven Transit - 235

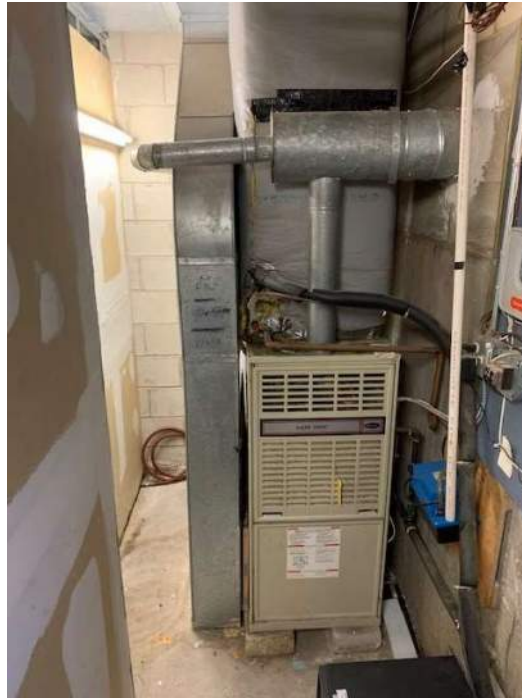
PHOTO 41

Furnaces:	1	3	3	No	1990	18	-61.11	(1) Carrier Super Saver, NG furnace (see photo 41)
Unit Heaters:	1	1	1	Yes	1990	13	-123.08	7-Modine, PA130AB, NG, 130 MBH
Radiant/Infrared Heaters:	N/A	1	N/A					
HVAC Finned Tube Radiation and Convectors:	5	1	5	Yes	1990			Mixed hot water and electric baseboard
HVAC Air Terminals - Diffusers, Grilles, Registers:	3	1	3	Yes	1990			Condition varies based on age
HVAC Air Terminals - Induction and Fan Coil Units, VAV and Double-Duct Boxes:	N/A	1	N/A					
HVAC Air Curtains:	4	1	4	No	2010	20	55	1-Global, air curtain for drivers lounge - approx. age
HVAC Fans - Centrifugal:	1	1	1	Yes	1990	25	-16	2-Bathroom ceiling fans
HVAC Fans - Axial:	5	1	5	No	2015	20	80	1-Fantech FR140, inline fan - approx. age
HVAC Fans - Propeller:	1	1	1	Yes	1990	15	-93.33	12-ceiling fans in repair garages
HVAC Coils:	N/A	1	N/A					
HVAC Heat Exchangers - Shell-and-Tube:	N/A	3	N/A			24		
HVAC Reciprocating Compressors:	N/A	2	N/A			20

Description Interior View - Furnace

adequately, which was confirmed with on-site staff. Recommend servicing Boiler and burner and replacing any worn or deteriorated components that won't last through 2022. Estimated time frame for this work is 2 weeks at an estimated cost of \$3,500.

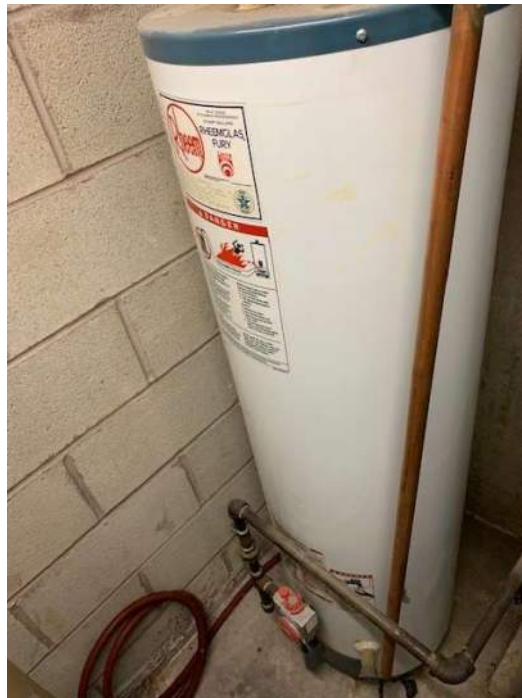
PHOTO 42

Description Interior View - Water Heater

1. Replace Water Heater: Recommend replacement of this unit within the next year. The water heater is past its useful life and failure could cause damage to adjacent equipment or finishes. Estimated time frame for replacement is 2 weeks at an estimated cost of \$19,000.
2. Domestic Hot Water Recirculating Pump: This unit is past its useful life, but appears to be functioning adequately, which was confirmed with on-site staff. No improvements recommended for this item since a new building is planned for GHNT.
