Subject: On-Call Asbestos, Lead, Air Quality & Demolition Compliance
Agreement No. 04.27-01(15)
HazMat Inspection – Sign Supports at Twenty Three (23) Sites, I-95, Groton, Stonington & North
Stonington, CT
ConnDOT Assignment No. 514-5281
ConnDOT Project No. 172-342
TRC Project No. 222165.5281.00710

TRC performed a limited survey for hazardous building materials associated with sign support removals at 23 Sites on I-95 in Groton, Stonington and North Stonington, Connecticut. Results of the survey identified the following on the sign support surfaces at the following Sites:

PROJECT 172-324 LIST OF OVERHEAD SIGN SUPPORT REMOVAL SITES - PAGE 1

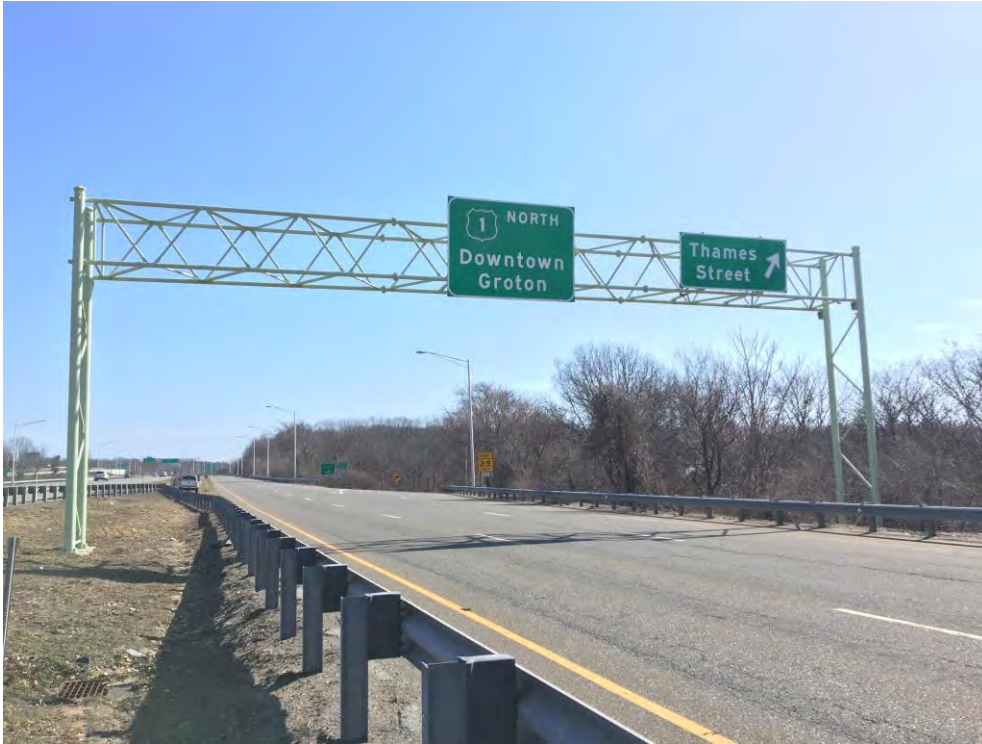
PHOTO 1
Site No. 1 – Sign Support No. 21193

✓ #21193 (Site 1) - supports + overhead
 - Green painted, over road I 95 NB, attached to conc. support post (unpainted)
 - XRF = 0.13 + 0.23
 - top of posts 8' x 2' depth unk.
 - before ex 86 (white) Acum caulk

0.89
 Yes -
 Ph
 TCLP
 XRF
 Acum
 Non-Haz

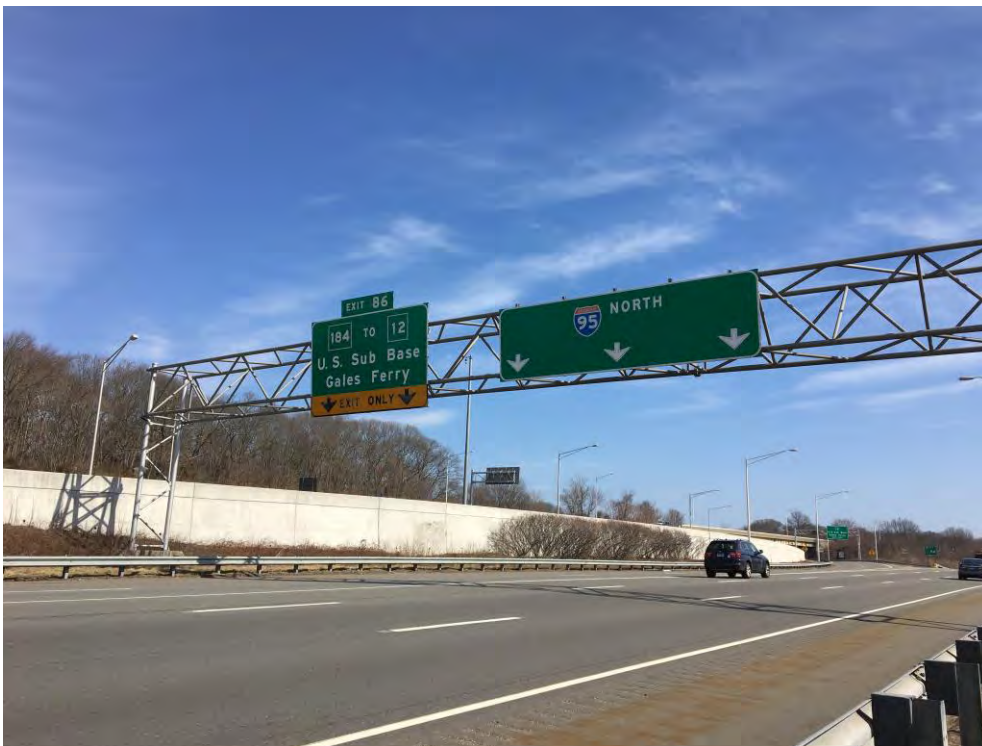
PHOTO 2
Site No. 2 – Sign Support No. 21194

✓ #21194 (Site 2)
 - Silver/Grey supports only Pb ~ 3.3. no paint overhead, Pb ~ 6.2
 - on concrete posts 8' x 2' depth unknown
 - over I 95 NB. before ex 86
 - sampled support column caulk (Acum?) (white) 1" x 1" extreme attachment x 4

83
 Yes -
 Ph
 TCLP
 XRF
 Acum

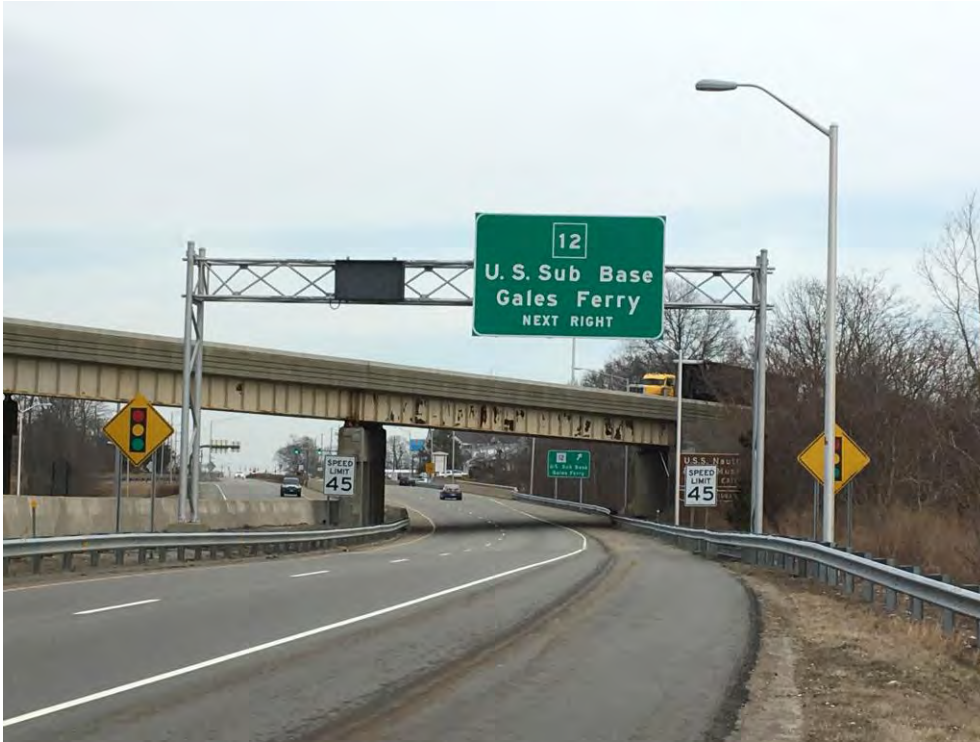
PHOTO 3
Site No. 3 – Sign Support No. 21195

✓ #21195 (Site 3)
 - silver/grey painted support columns + overhead
 - XRF Pb ~ 51
 - on conc. posts 8' x 2' depth unk. (Ex 86 RTE 184)
 - sampled support column caulk (Acum?) 1" x 1" base @ column (Grey)
 - has lighted "Stop Ahead" Flushing sign
 - column prior post has silicone sealant

77
 Yes -
 Ph
 TCLP
 XRF
 Acum

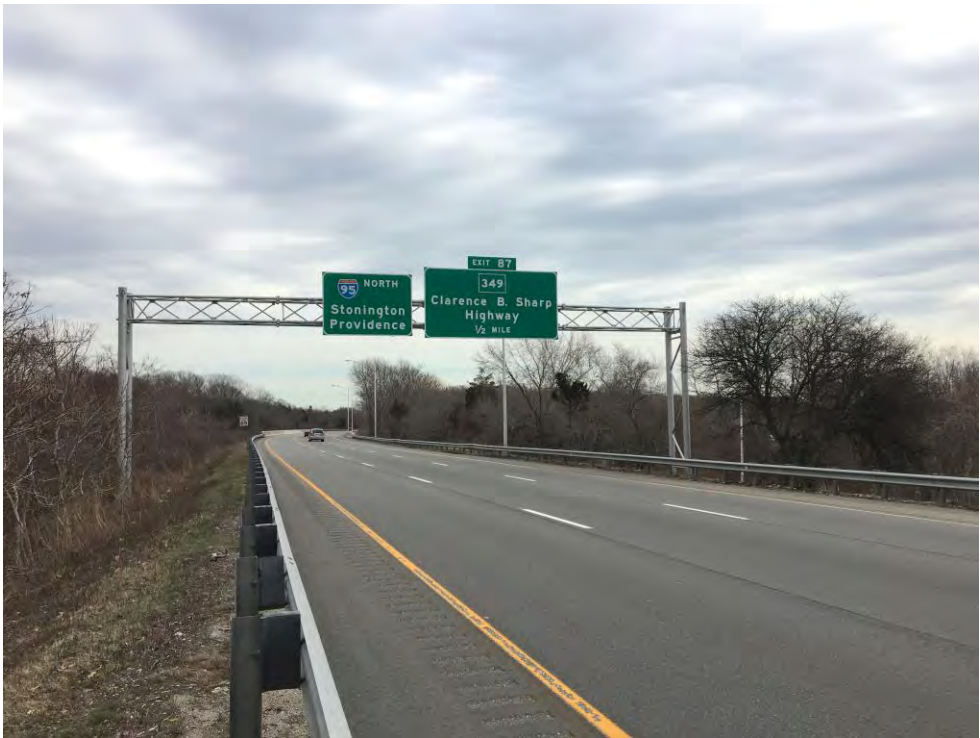
PHOTO 4
Site No. 4 – Sign Support No. 21197

✓ #21197 (Site 4)
 - silver/grey painted support columns + overhead
 - XRF ~ 41
 - on concrete unpainted top 2.5' x 10' Depth visible up to 5'
 - sample support column caulk (Acum) North column (off-white)

75
 Yes -
 Ph
 TCLP
 XRF
 Acum

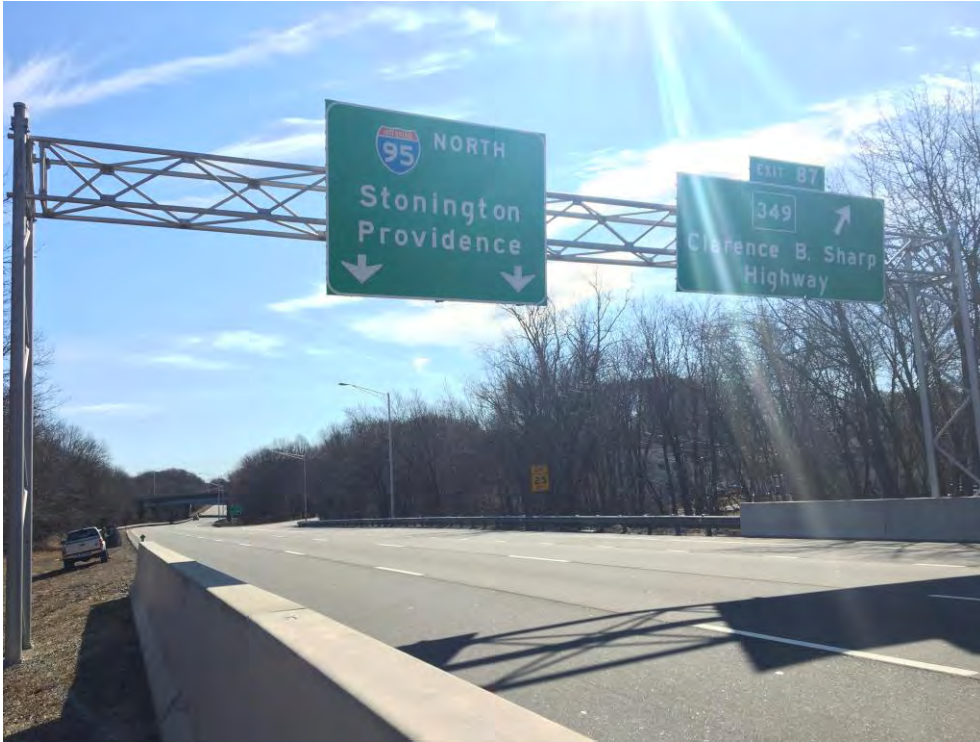
PHOTO 5
Site No. 5 – Sign Support No. 21198

✓ #21198 (Site 5)

- silver/gray paint XRF ~4+ paint on columns + overhead I-95 NB
- Attached to conc. support pads no paint
- sampled support column caulk () 1'x1' base

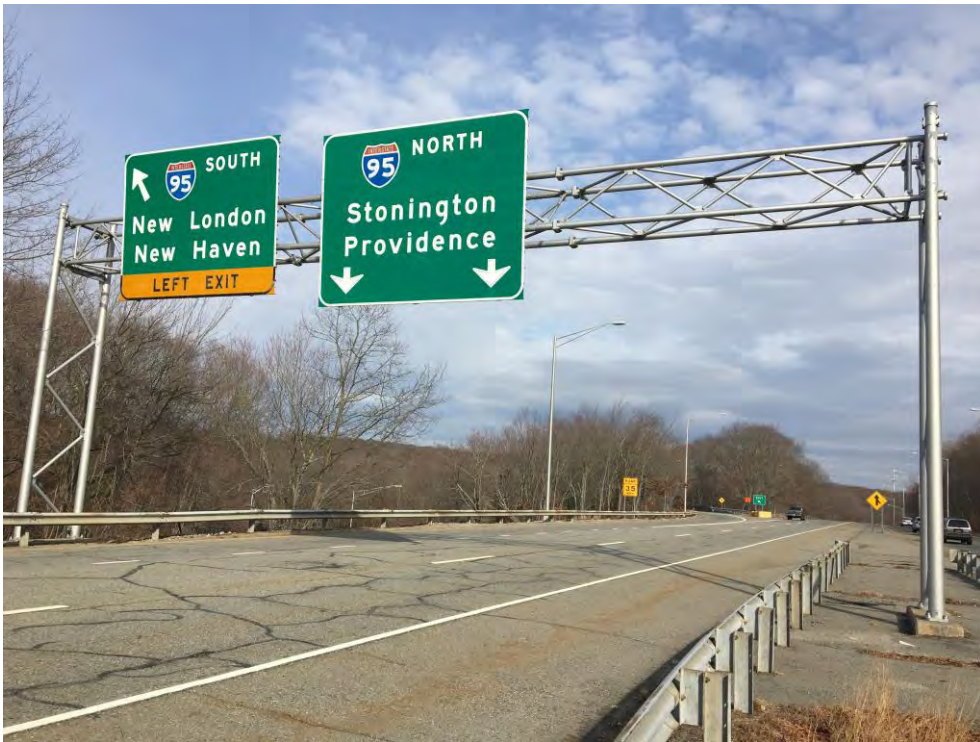
PHOTO 20
Site No. 21 – Sign Support No. 21293

✓ #21293 (Site 21)

- Silver/gray paint XRF ~4+ paint on columns + overhead
- 394 NB
- Attached to conc. support pad (no paint)
- sampled support column caulk gray material 1'x1' each X4

0.096 -
Yes -
Ph
TCLP
Acid
XRF

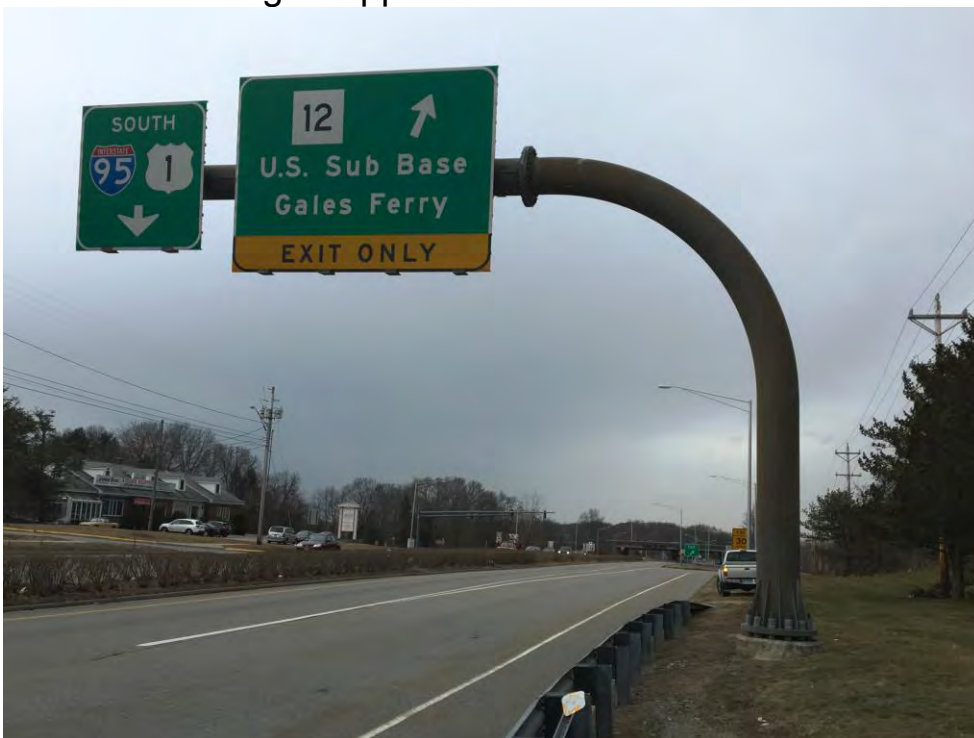
PHOTO 22
Site No. 23 – Sign Support No. 21954

✓ #21954 (Site 23)
 - hot dipped galvanized no paint + cantilever sign support
 - base conc. column 4' dia. depth unk. no paint
