Subject: On-Call Asbestos, Lead, Air Quality & Demolition Compliance  
Agreement No. 04.27-01(15)  
HazMat Inspection – Ten (10) District 1 Traffic Signal Intersections, Nine (9) Cities/Towns,  
CT  
ConnDOT Assignment No. 514-5709  
ConnDOT Project No. 171-402  
TRC Project No. 222165.5709.0710

TRC performed a limited survey for hazardous building materials associated with traffic signals and pedestrian control equipment at 10 Traffic Signal Intersection Sites in 9 cities/towns (Bloomfield, Cheshire, East Hartford, New Britain, Plainville, Rocky Hill, Southington, Wethersfield & Windsor Locks) in District 1, Connecticut. Results of the survey identified the following at the traffic signal span poles, mast arms, pedestals, crosswalk signal hoods/push buttons and controller cabinet replacements at the following Intersections:

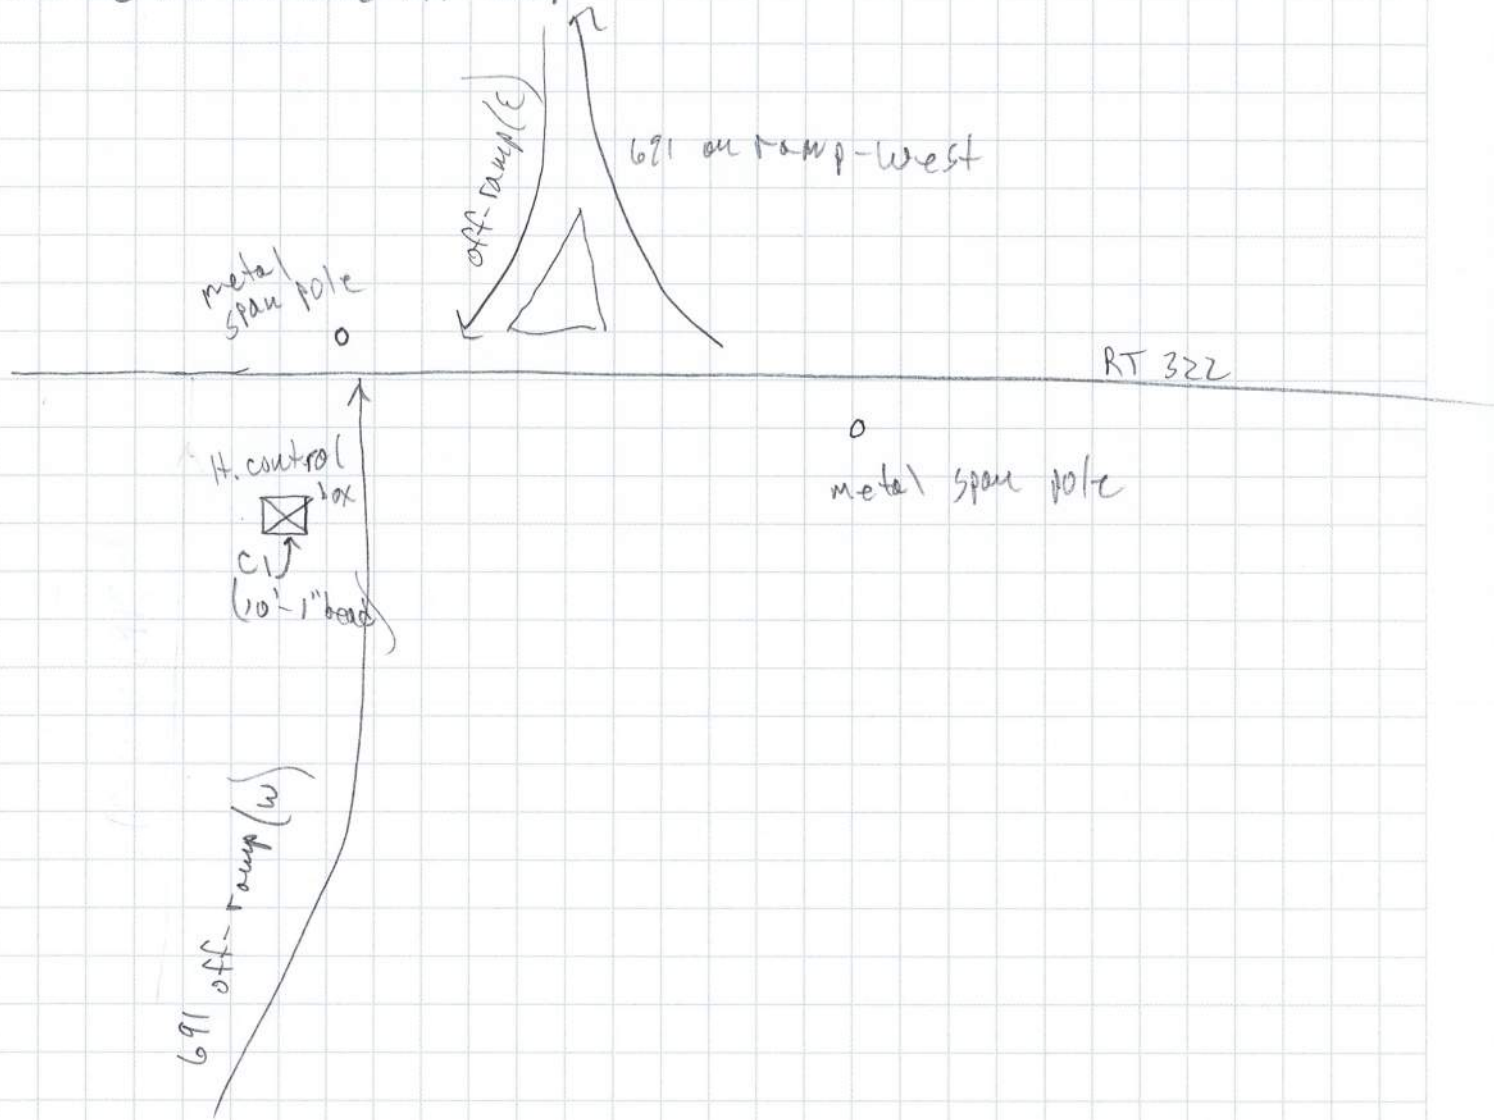
# 131-233, Southington  
RT 322 @ 691 westbound off-ramp

C1 - black/grey, flexible control box caulk

- No detectable amounts of lead in paint were found on the three (3) grey painted metal span poles. There were no pedestrian crosswalk pedestals/hoods. The paint associated with the metal traffic lights themselves are presently presumed to be lead containing. No detectable amounts of lead were identified on the painted metal controller cabinet.
- Since no detectable amounts of lead were present on painted metal surfaces of the grey painted span poles and the controller cabinet, any paint waste generated would be classified as non-hazardous, non-RCRA waste.
- Any paint waste generated from the metal traffic lights themselves should be tested for TCLP lead to determine waste disposal.
- Black/grey flexible caulking at the base of the controller cabinet was sampled and found to be non-ACM.
