**SELECTIVE EXTERIOR  
PAINT COLOR INVESTIGATION**

**Lake Avenue Bridge  
Greenwich, CT**

*Prepared by:*  
Jablonski Building Conservation, Inc.  
40 West 27th Street, Suite 1201  
New York, NY 10001

September 21, 2011

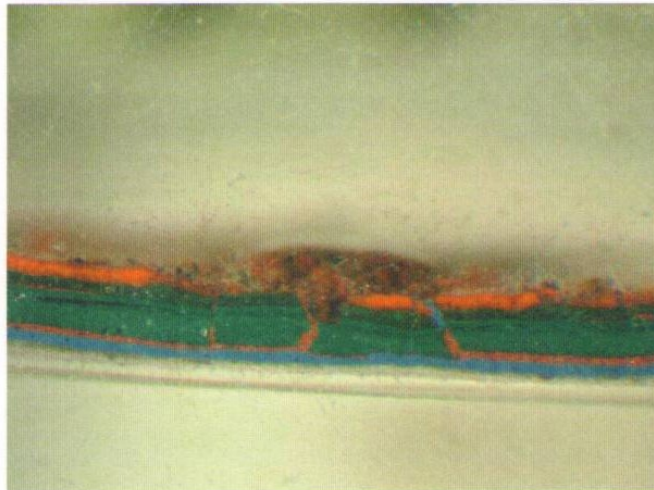
SAMPLE NUMBER: LAB-01  
 LOCATION: Field behind Spandrel Panels  
 SUBSTRATE: Iron

Color	Coat	Sheen	Characterization	Munsell Match	Commercial Match
1. reddish brown	Primer	Semi-gloss			
2. black	Finish	Semi-gloss		N1	BM RM Black
3. orange	Primer	Semi-gloss			
4. dark green	Primer	Semi-gloss			
5. dark green	Finish	Semi-gloss			
6. reddish brown	Primer	Semi-gloss			
7. moderate green	Primer	Semi-gloss			
8. moderate green	Primer	Semi-gloss			
9. moderate green	Finish	Semi-gloss			
10. reddish orange	Primer	Semi-gloss			
11. blue	Primer	Semi-gloss			
12. blue	Finish	Semi-gloss

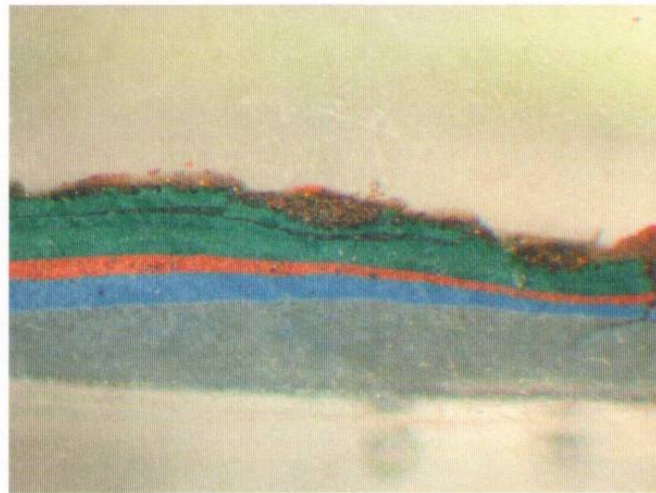
SAMPLE NUMBER: LAB-04, LAB-06, LAB-11  
 LOCATION: Spandrel Panel – Torch Handle  
 Spandrel Panel – Shield  
 Railing Post – Bolt Cover  
 SUBSTRATE: Iron

Color	Coat	Sheen	Characterization	Munsell Match	Commercial Match
1. reddish brown	Primer	Semi-gloss			
2. grayish brown	Base	Semi-gloss	Waxy	10YR 3/2	BM HC-68
3. gold metallic	Finish	Metallic			
4. yellow	Varnish	Glossy			
5. dark green	Primer	Semi-gloss			
6. dark green	Finish	Semi-gloss			
7. silver	Finish	Metallic			
8. moderate green	Primer	Semi-gloss			
9. moderate green	Finish	Semi-gloss			
10. orange	Primer	Semi-gloss			
11. blue	Finish	Semi-gloss

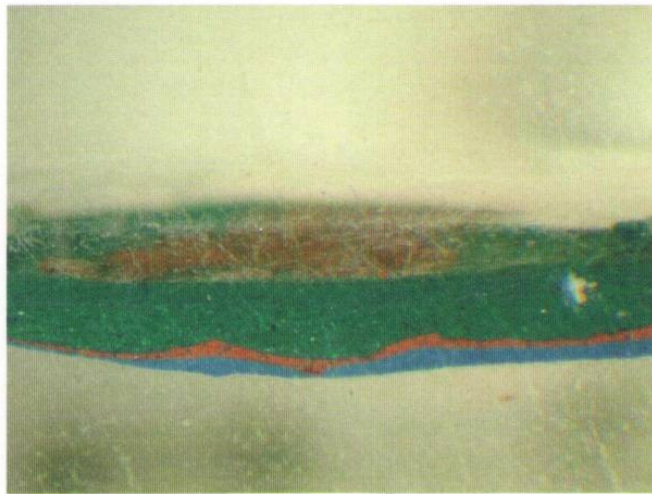
SAMPLE NUMBER: LAB-07, LAB-08  
 LOCATION: Spandrel Panel – Leaves  
 Spandrel Panel – Grapes  
 SUBSTRATE: Iron

Color	Coat	Sheen	Characterization	Munsell Match	Commercial Match
1. orange	Primer	Semi-gloss			
2. grayish brown	Base	Semi-gloss		10YR 3/2	BM HC-68
3. dark green	Primer	Semi-gloss			
4. dark green	Primer	Semi-gloss			
5. dark green	Primer	Semi-gloss			
6. dark green	Finish	Semi-gloss			
7. moderate green	Primer	Semi-gloss			
8. moderate green	Finish	Semi-gloss			
9. orange	Primer	Semi-gloss			
10. blue	Finish	Semi-gloss

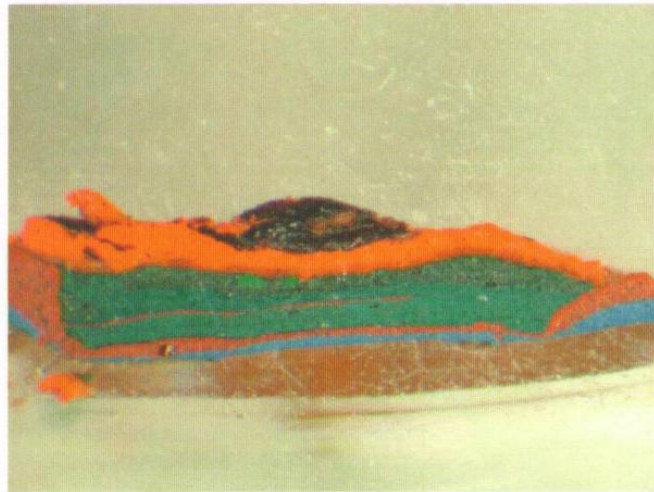
SAMPLE NUMBER: LAB-09, LAB-21  
 LOCATION: Spandrel below Ornamental Panels  
 Columns  
 SUBSTRATE: Iron

Color	Coat	Sheen	Characterization	Munsell Match	Commercial Match
1. black	Finish	Semi-gloss		N1	BM RM Black
2. orange	Primer	Semi-gloss			
3. dark green	Primer	Semi-gloss			
4. dark green	Finish	Semi-gloss			
5. dark red	Primer	Semi-gloss			
6. moderate green	Primer	Semi-gloss			
7. moderate green	Primer	Semi-gloss			
8. moderate green	Primer	Semi-gloss			
9. moderate green	Finish	Semi-gloss			
10. orange	Primer	Semi-gloss			
11. blue	Finish	Semi-gloss

Note: Layer 5 only appears on Sample LAB-21

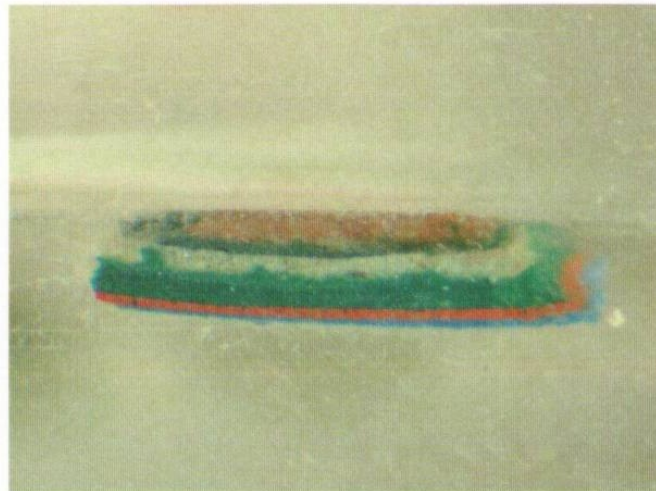
SAMPLE NUMBER: LAB-10  
 LOCATION: Railing Post  
 SUBSTRATE: Iron

Color	Coat	Sheen	Characterization	Munsell Match	Commercial Match
1. orange	Primer	Semi-gloss			
2. grayish brown	Finish	Semi-gloss		10YR 3/2	BM HC-68
3. dark green	Finish	Semi-gloss			
4. grayish white	Finish	Semi-gloss			
5. moderate green	Primer	Semi-gloss			
6. moderate green	Primer	Semi-gloss			
7. moderate green	Primer	Semi-gloss			
8. moderate green	Finish	Semi-gloss			
9. orange	Primer	Semi-gloss			
10. blue	Finish	Semi-gloss

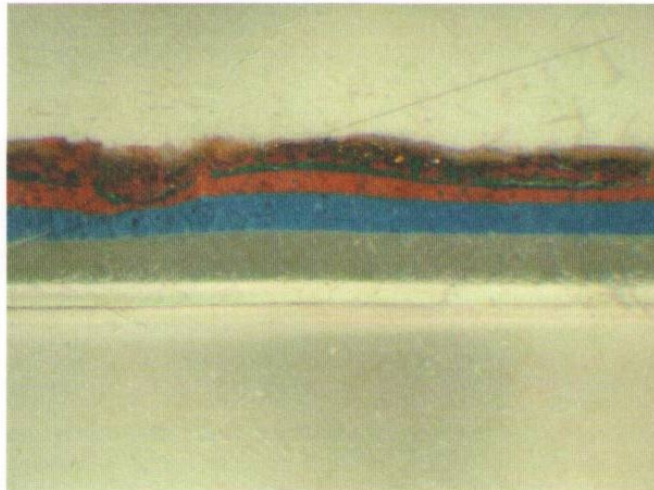
SAMPLE NUMBER: LAB-12, LAB-15, LAB-18  
 LOCATION: Pier Panel – Urn Base  
 Pier Panel – Urn Field  
 Pier Panel – Grapes  
 SUBSTRATE: Iron

Color	Coat	Sheen	Characterization	Munsell Match	Commercial Match
1. orange	Primer	Semi-gloss			
2. grayish brown	Base	Semi-gloss		10YR 3/2	BM HC-68
3. gold	Finish	Metallic			
4. yellow	Varnish	Glossy			
5. dark red	Primer	Semi-gloss			
6. dark green	Finish	Semi-gloss			
7. silver	Finish	Metallic			
8. moderate green	Finish	Semi-gloss			
9. orange	Primer	Semi-gloss			
10. blue	Finish	Semi-gloss

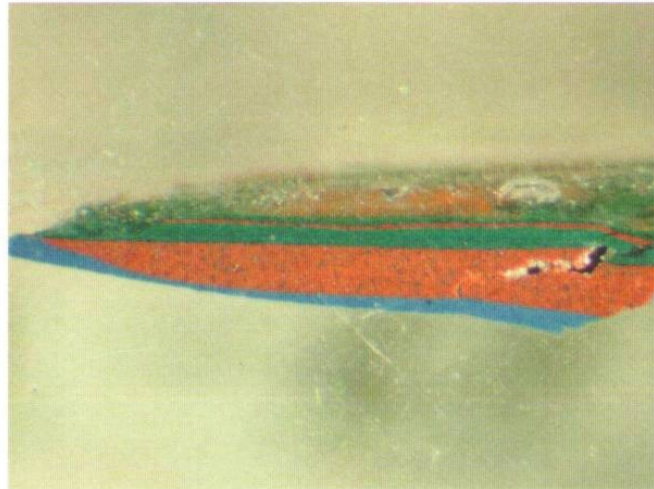
SAMPLE NUMBER: LAB-14  
 LOCATION: Pier Panel – Rosette below Urn  
 SUBSTRATE: Iron

Color	Coat	Sheen	Characterization	Munsell Match	Commercial Match
1. orange	Primer	Semi-gloss			
2. grayish brown	Finish	Semi-gloss		10YR 3/2	BM HC-68
3. dark green	Finish	Semi-gloss			
4. dark red	Primer	Semi-gloss			
5. moderate green	Primer	Semi-gloss			
6. moderate green	Primer	Semi-gloss			
7. moderate green	Finish	Semi-gloss			
8. orange	Primer	Semi-gloss			
9. blue	Finish	Semi-gloss

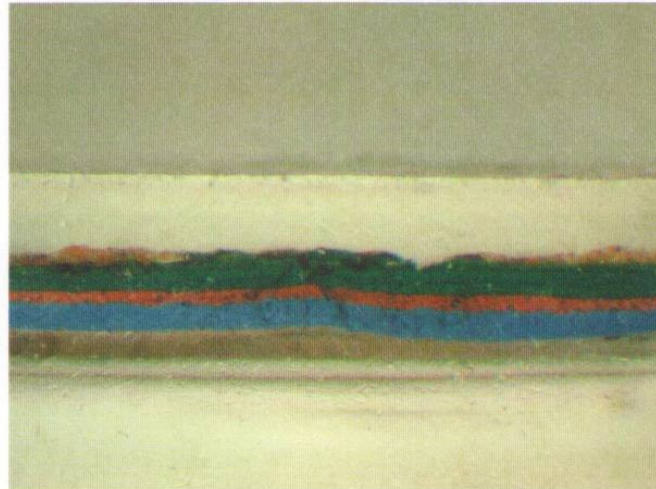
SAMPLE NUMBER: LAB-17, LAB-19  
 LOCATION: Pier Panel – Vines  
 Pier Panel – Base  
 SUBSTRATE: Iron

Color	Coat	Sheen	Characterization	Munsell Match	Commercial Match
1. orange	Primer	Semi-gloss			
2. grayish brown	Finish	Semi-gloss	Waxy	10YR 3/2	HC-68
3. dark green	Primer	Semi-gloss			
4. dark green	Primer	Semi-gloss			
5. dark green	Finish	Semi-gloss			
6. moderate green	Primer	Semi-gloss			
7. moderate green	Finish	Semi-gloss			
8. orange	Primer	Semi-gloss

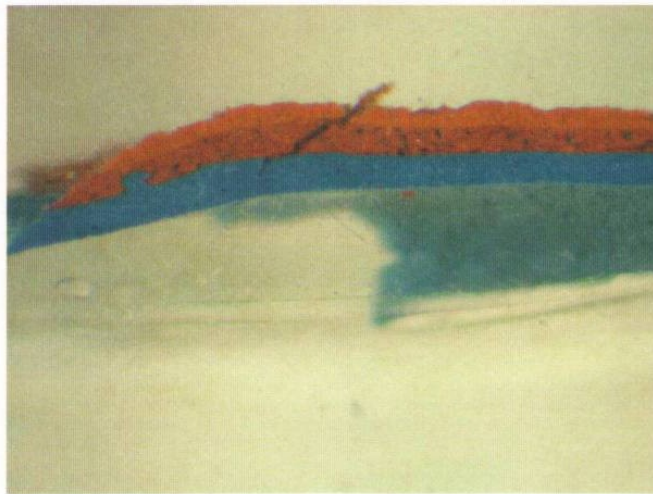
SAMPLE NUMBER: LAB-20  
LOCATION: Pier from Lake Avenue Street Level  
SUBSTRATE: Iron

Color	Coat	Sheen	Characterization	Munsell Match	Commercial Match
1. orange	Primer	Semi-gloss			
2. orange	Primer	Semi-gloss			
3. blue	Finish	Semi-gloss

Note: Original layers lost.
