# **SURVEY REPORT**

## **PRE-DEMOLITION INVESTIGATIVE SURVEY FOR HAZARDOUS BUILDING MATERIALS**

### **EAST HAMPTON PERSONNEL SHELTER EAST HAMPTON, CONNECTICUT**

Project No. 41-119

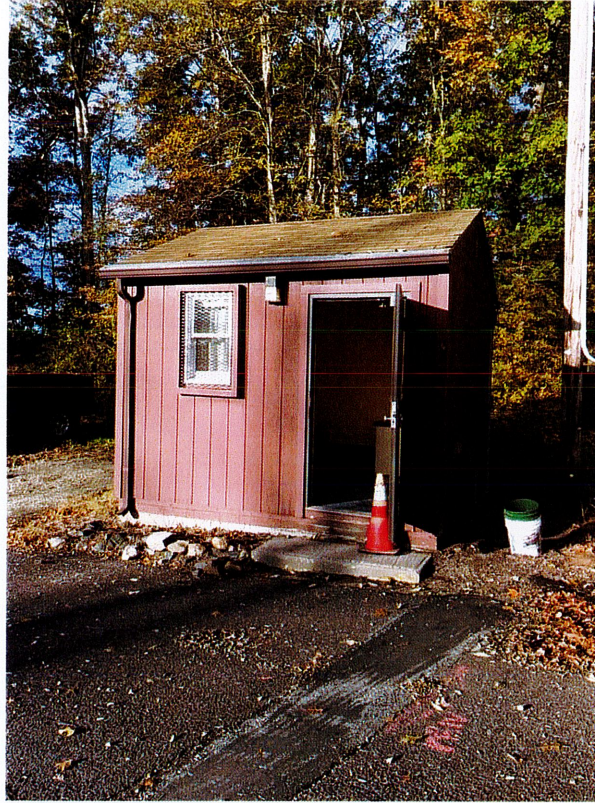
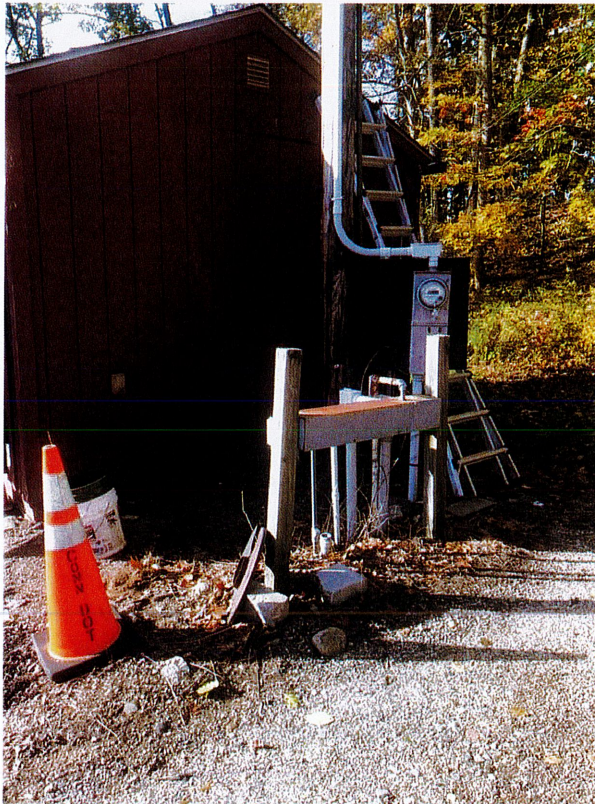
Overview Photo

Site Name East Hampton Personnel Shed  
Address 2-98 Public Works Dr  
East Hampton, CT 06424  
TRC Project Number 222165.5751.0710  
Project Manager Erik Plimpton  
Inspector(s) David Heelon, Jonathan Gentile  
Client ConnDOT  
Type of Asbestos Survey Reno/Demo  
Additional Analysis for NOB Materials (Calc) TEM NY NOB 198.4  
PLM Turnaround Time (TAT) 48-hour  
TEM Turnaround Time (TAT) 48-hour  
Date 2018-10-30  
General Notes Demo survey of small wooden personnel shed on East Hampton Salt Shed property. Wood structure with Sheetrock walls, plywood floor and Asphalt Shingles. Structure sits on concrete slab base. No lead found so no TCLP required.

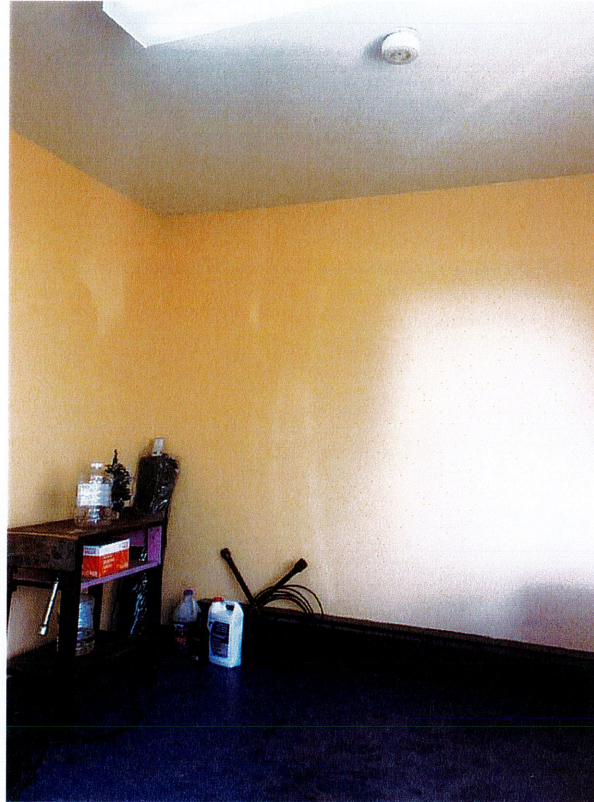
**01, B Side Wall**

**( 2 ), SHR, 1, Lt Grey Sheetrock/White Joint Compound**

Sample Number	01
Sample Location	B Side Wall
Analyze by Layer	Yes
Asbestos Bulk Analysis	PLM EPA 600/R93/116
Grab or Composite	Grab
Date	2018-10-30
Time	08:55

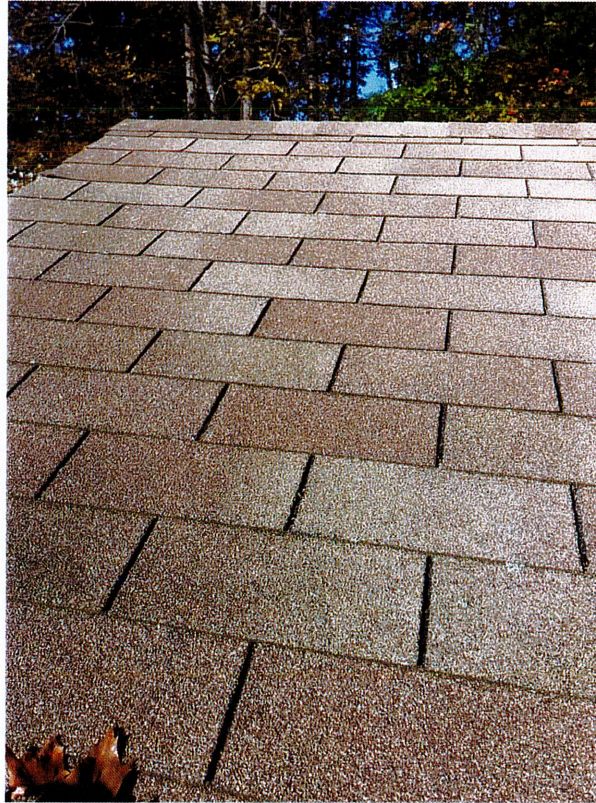
**03, Roof**

**( 2 ), AS, 1, Brown Asphalt Shingles**

Sample Number	03
Sample Location	Roof
Analyze by Layer	No
Asbestos Bulk Analysis	PLM EPA 600/R93/116
Grab or Composite	Grab
Date	2018-10-30
Time	09:12

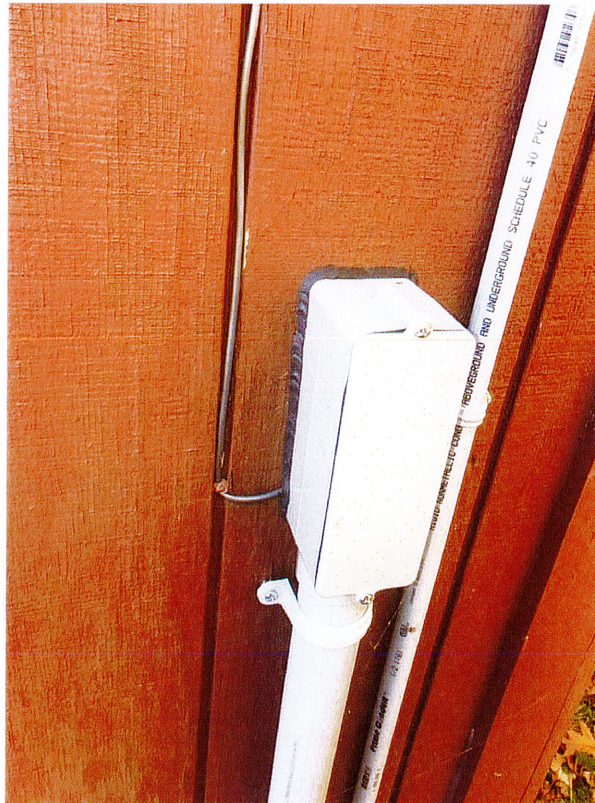
**07, D Side**

**( 2 ), C, 1, Dk Grey Rubbery Caulk**

Sample Number	07
Sample Location	D Side
Analyze by Layer	No
Asbestos Bulk Analysis	PLM EPA 600/R93/116
Grab or Composite	Grab
Date	2018-10-30
Time	09:20

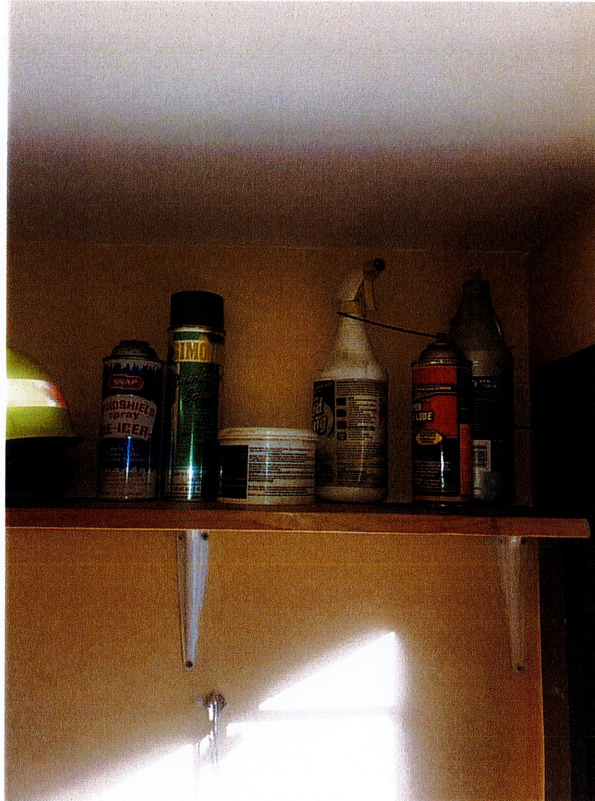
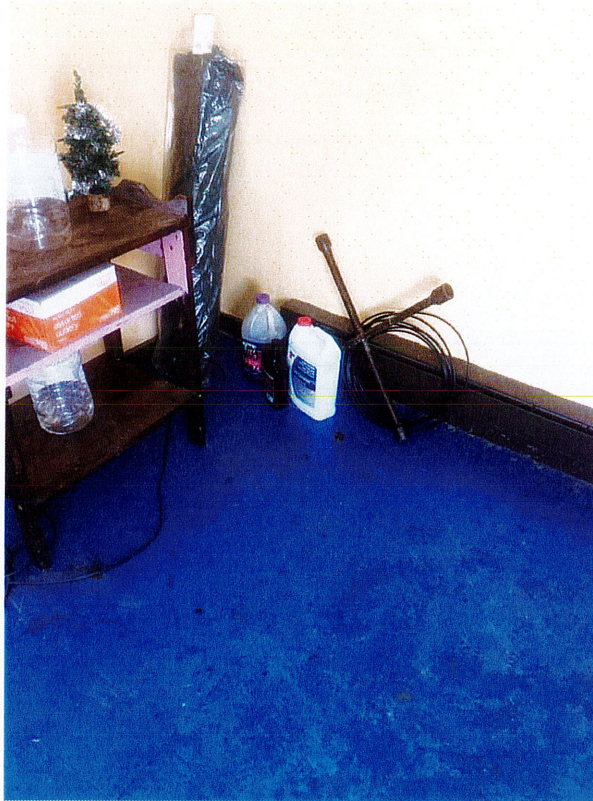
HAZMAT Item Photo

HAZMAT Item Description	Miscellaneous, Various cleaning supplies & chemicals
HAZMAT Item Common Name	Various sm qty of cleaners/household chemicals probably will be taken for re-use prior to demo.
HAZMAT Item Quantity	9
