**PROJECT MANUAL
VOLUME 2 OF 2**

**ADDITIONS AND RENOVATIONS
NEW LONDON HIGH SCHOOL
JEFFERSON AVE. & CHESTER ST.
NEW LONDON, CT**

PHASE 2 EARLY HAZ-MAT PACKAGE

STATE PROJECT # 095-0090MAG/N

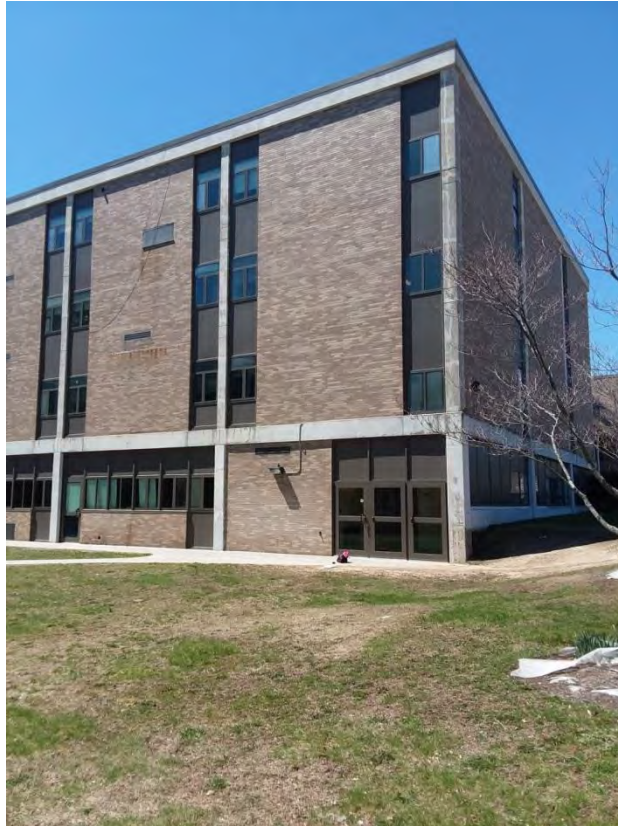
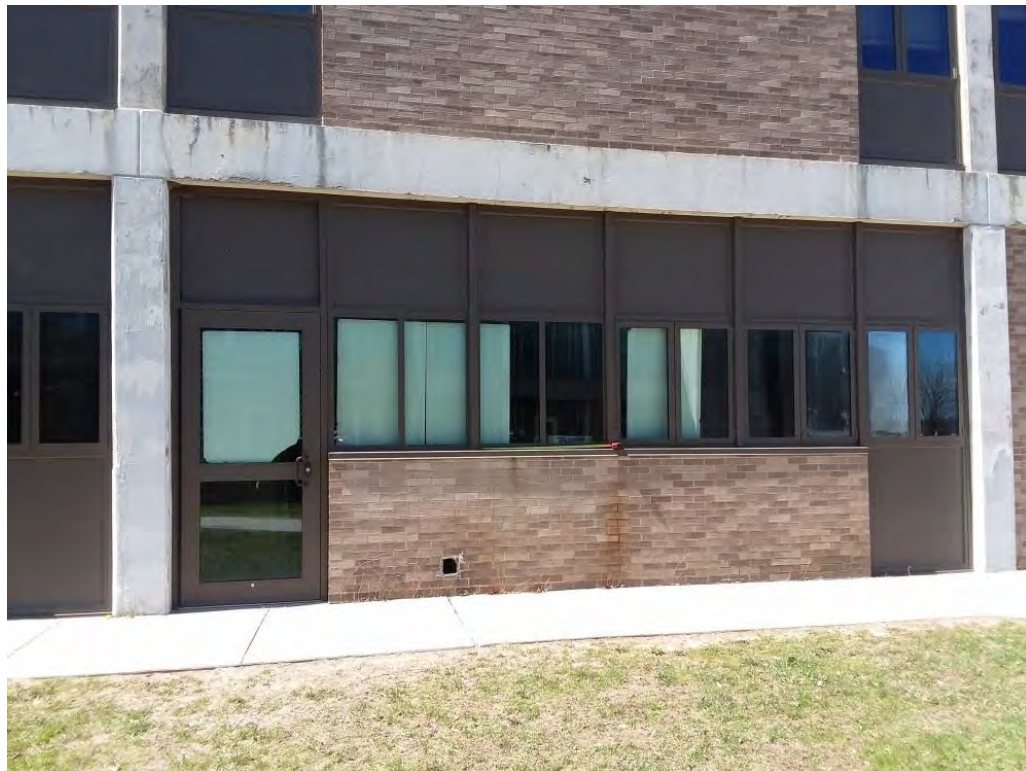
Photo depicting Replacement Exterior Windows at Administrative office

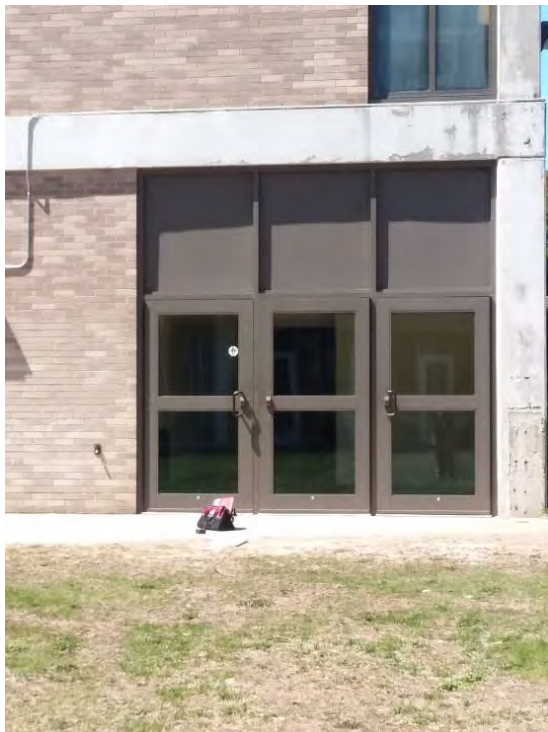
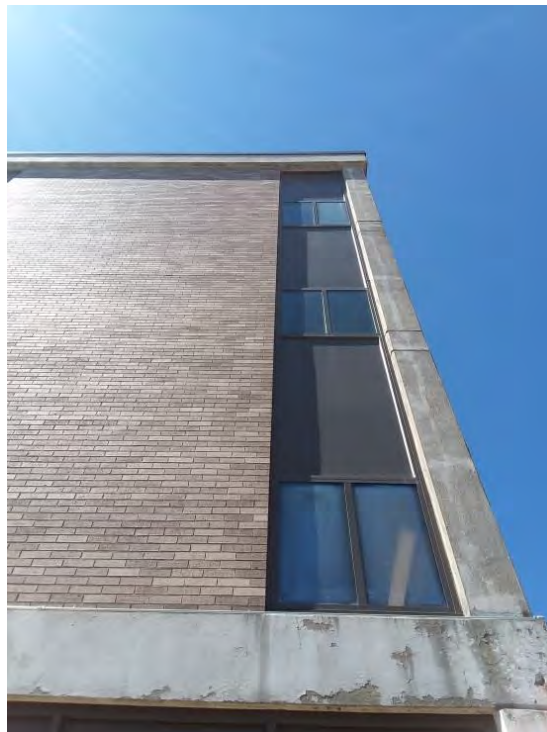
Photo depicting Lower Replacement Exterior Doors at stairwell and Upper Original Exterior Windows and panels within stairwell

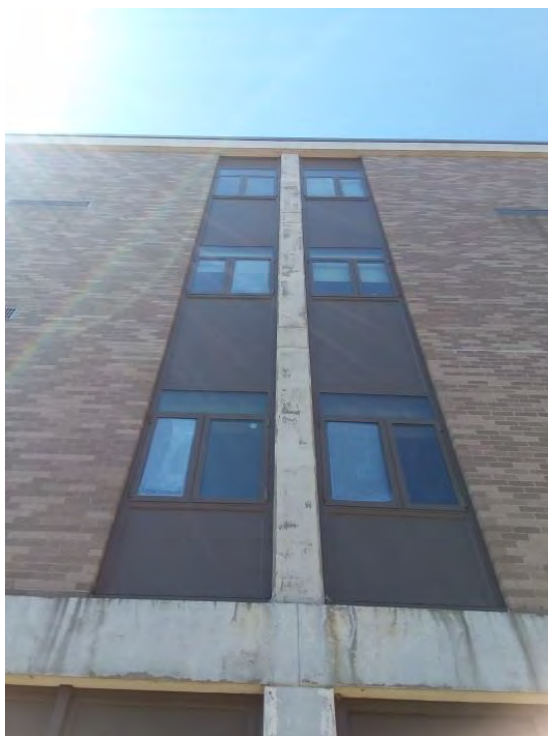
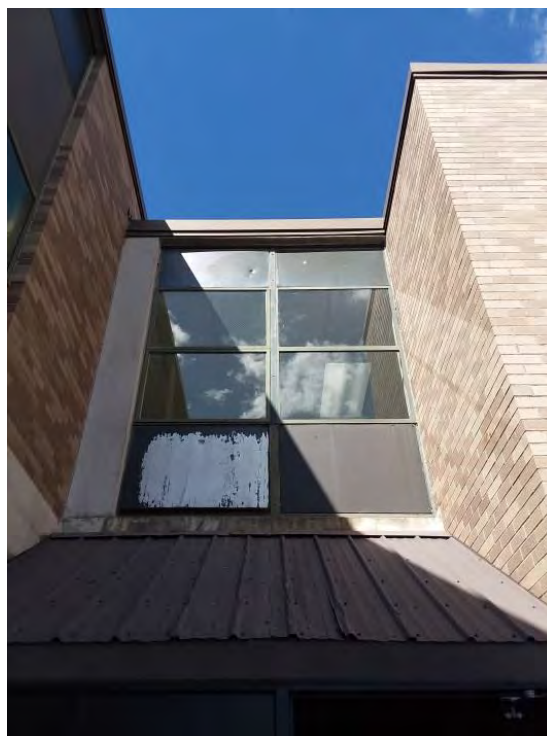
Photo depicting Connecting Airwalk Original Exterior Windows (Typical) and Original Exterior Classroom Windows (Typical)

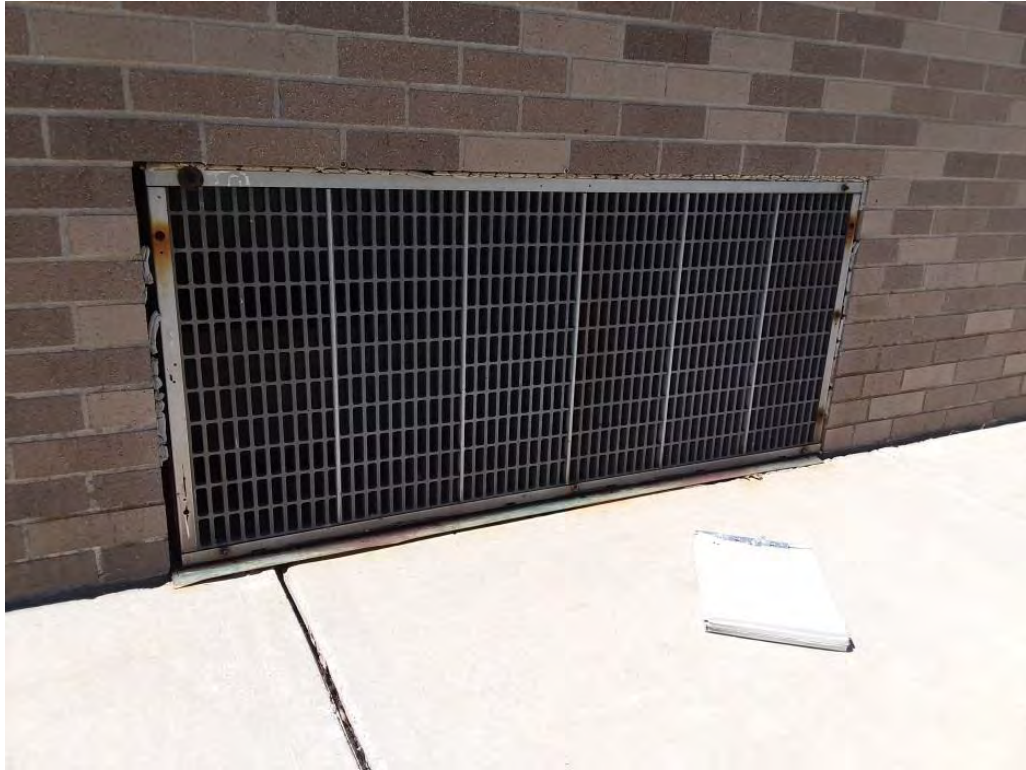
Photo depicting Exterior Vent beneath Exterior Windows (Typical)

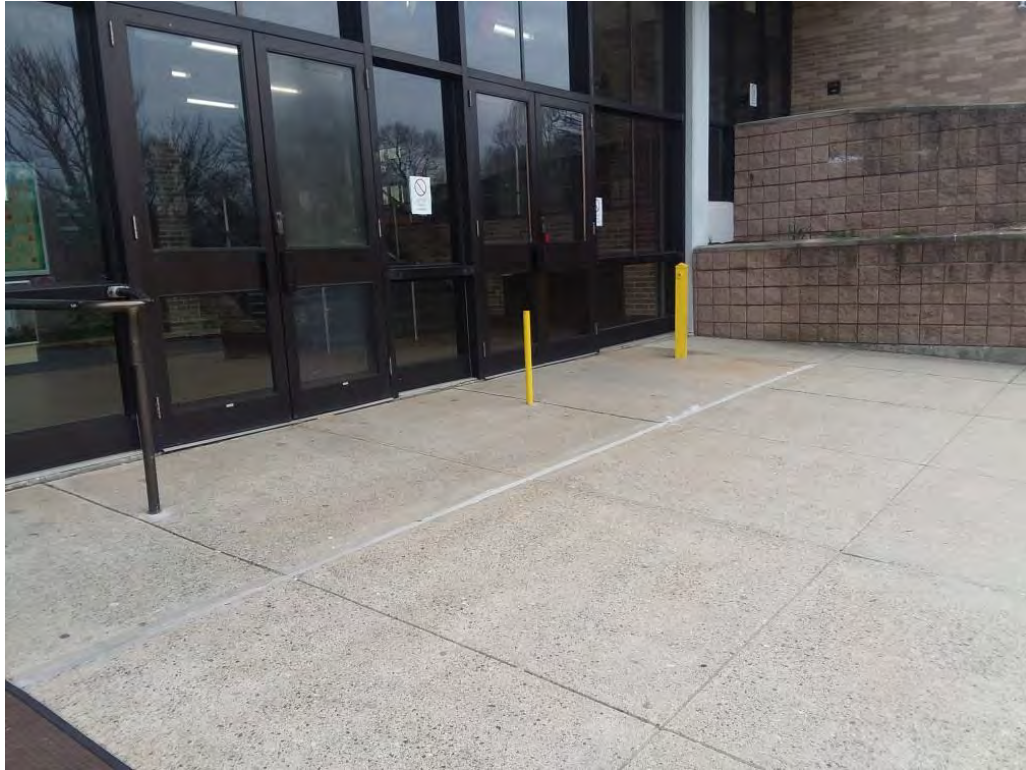
Photo depicting Storefront Window System and Concrete Sidewalk with Expansion Joint Caulking

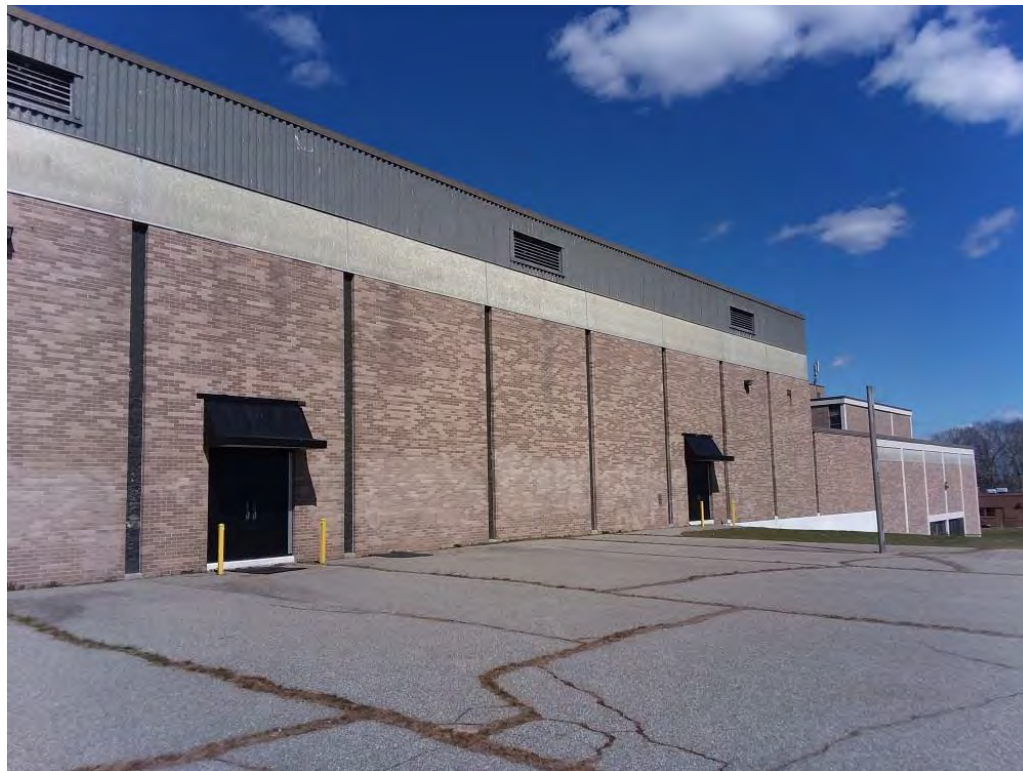
Photo depicting rear elevation of Gymnasium with Upper Exterior Windows and Vertical Expansion Joints

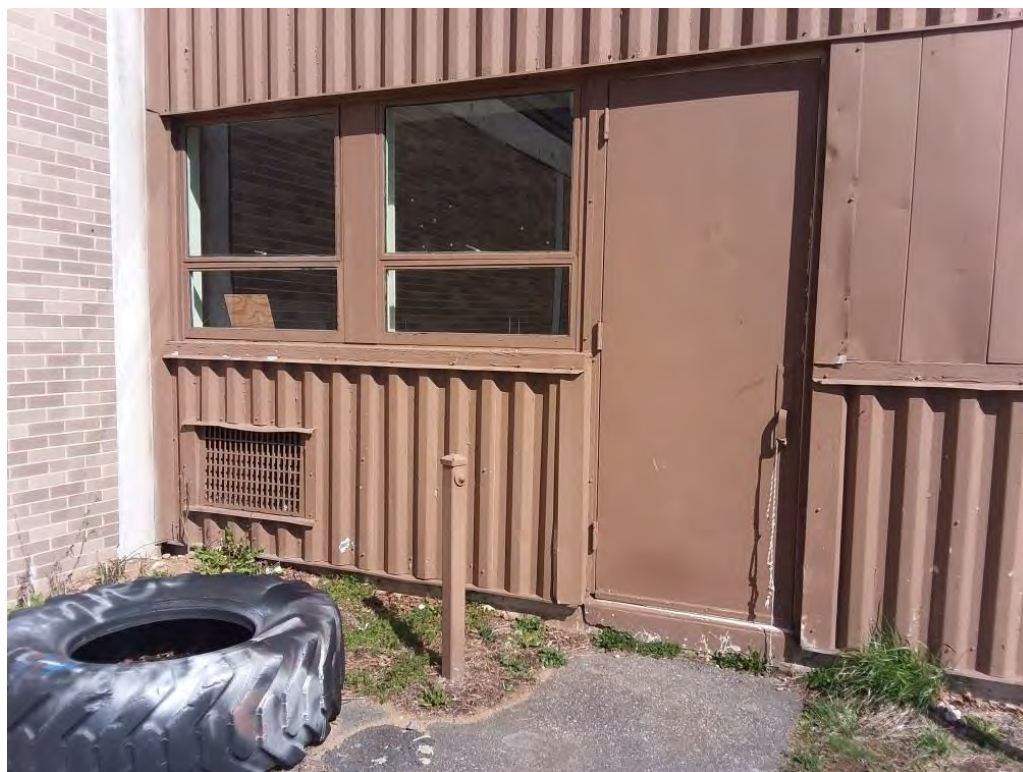
Photo depicting Exterior Windows and Doors and Corrugated Metal Panel Exterior Walls at Shop Wing

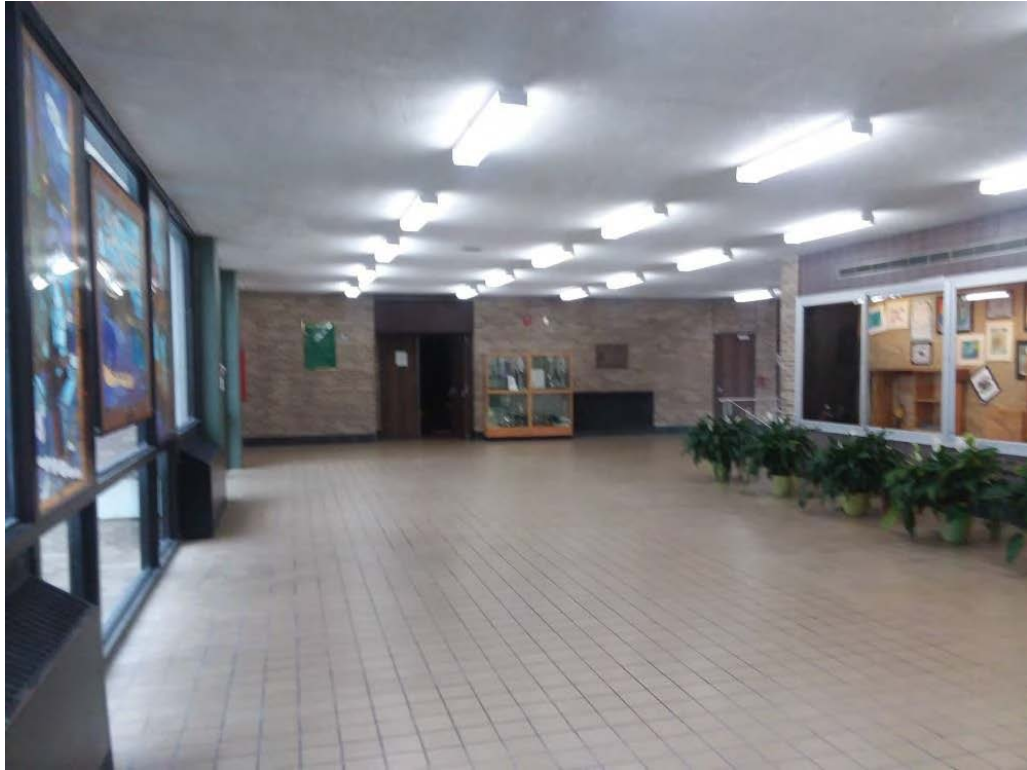
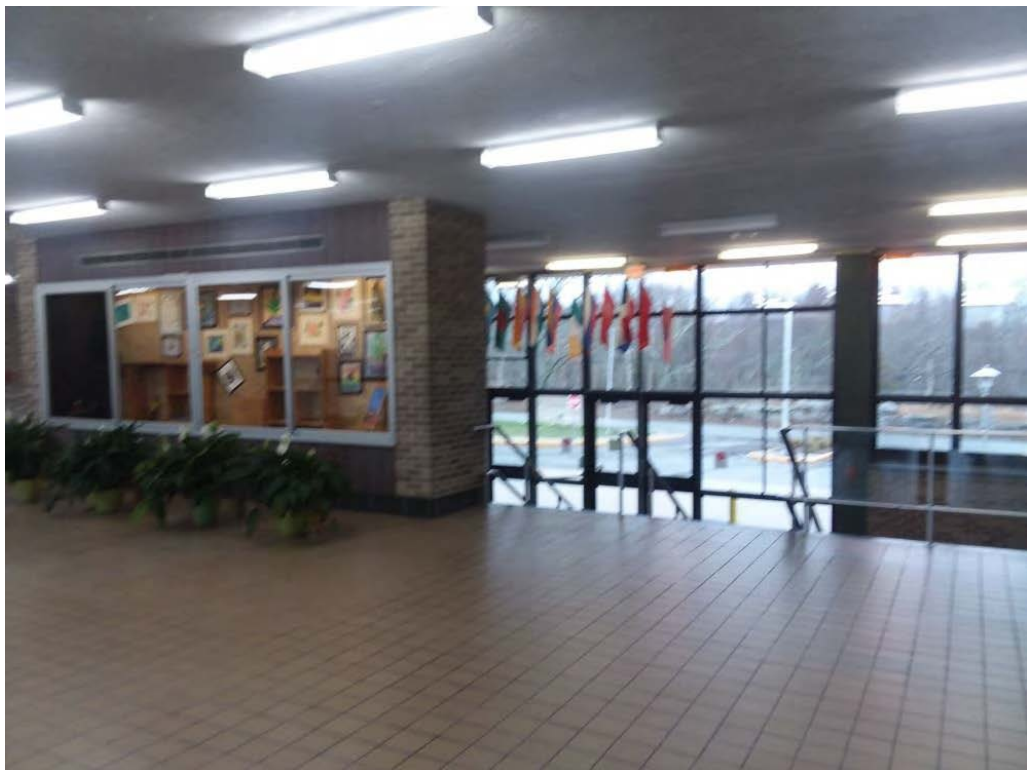
Photos depicting Tan Quarry Tile, Soft Textured Ceiling Material, and Interior Brick Walls throughout Lobby of Main Entrance.

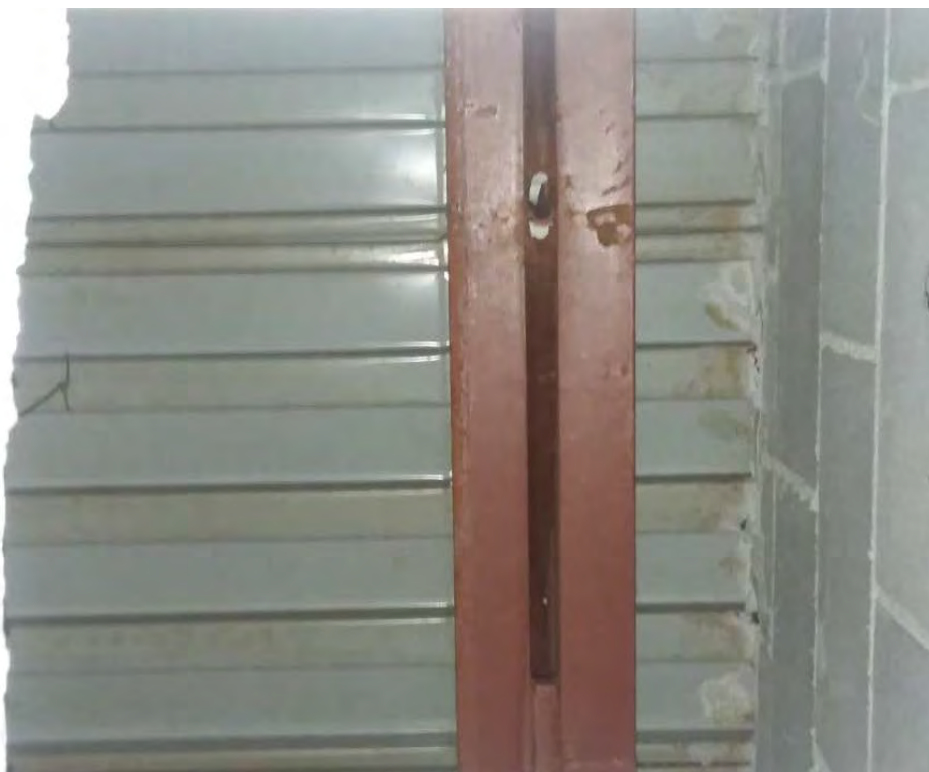
Photo depicting Underside of Corrugated Steel Roof Deck (above ceiling grid)
No mastics or spray-on present. (Typical)

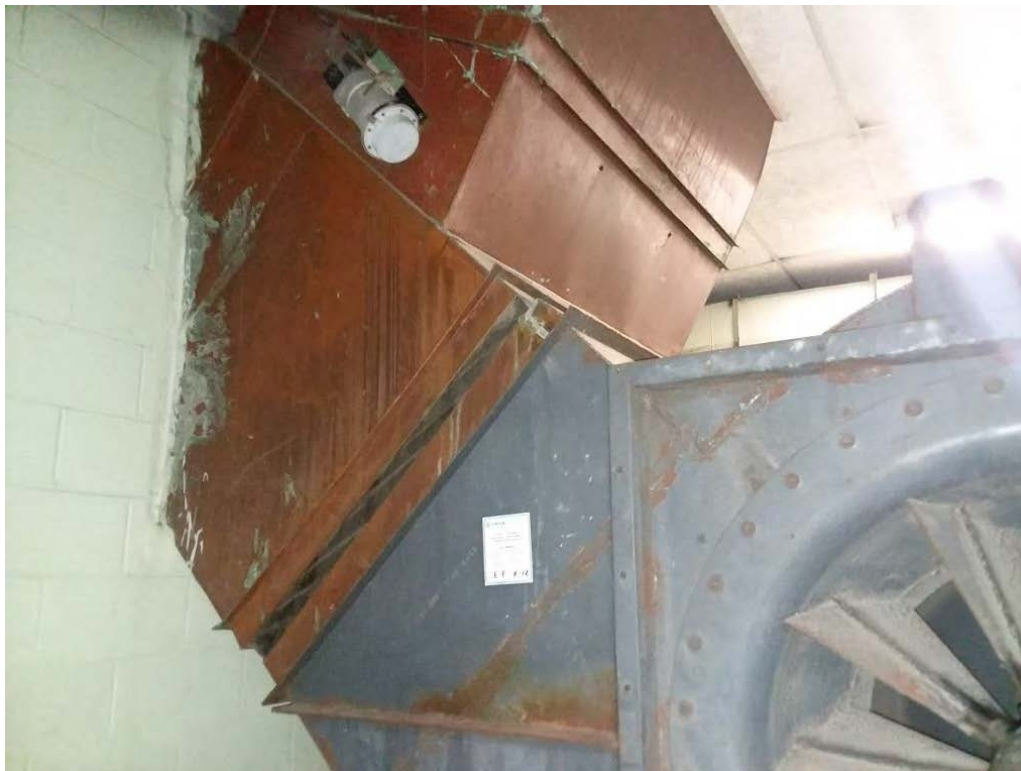
Photo depicting ductwork at air handling unit; Vibration Dampening Cloth present; no seam sealants.

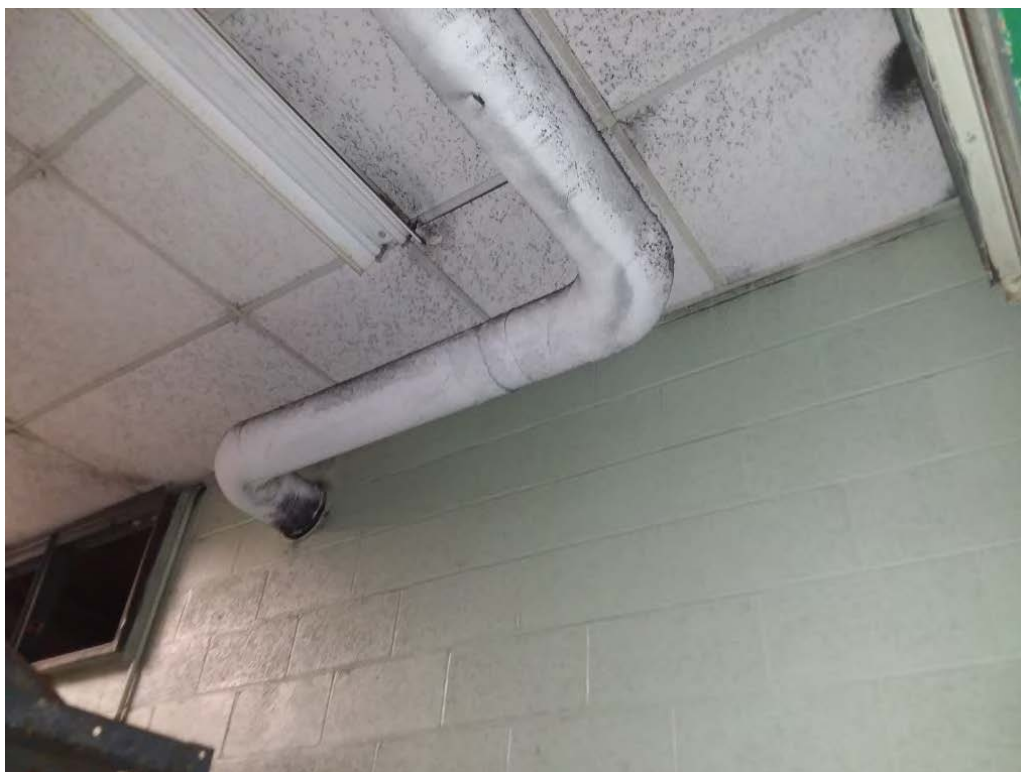
Photo depicting pipe insulation beneath ceiling grid

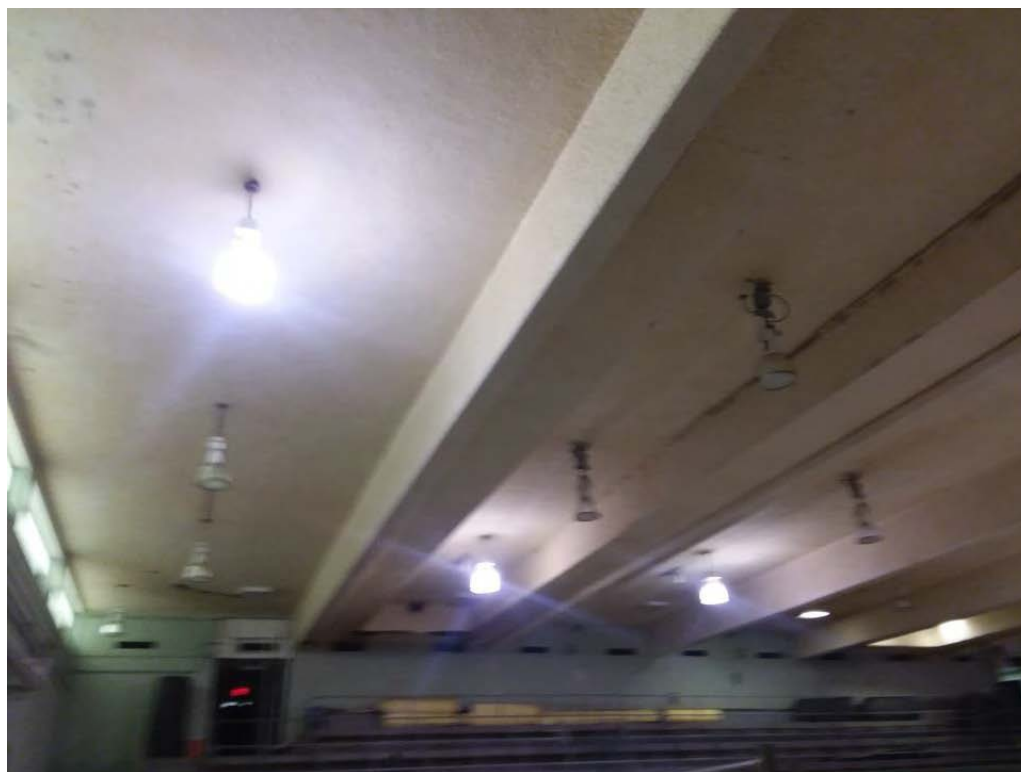
Photo depicting Surfacing Materials on Structural Tees at Pool Ceiling

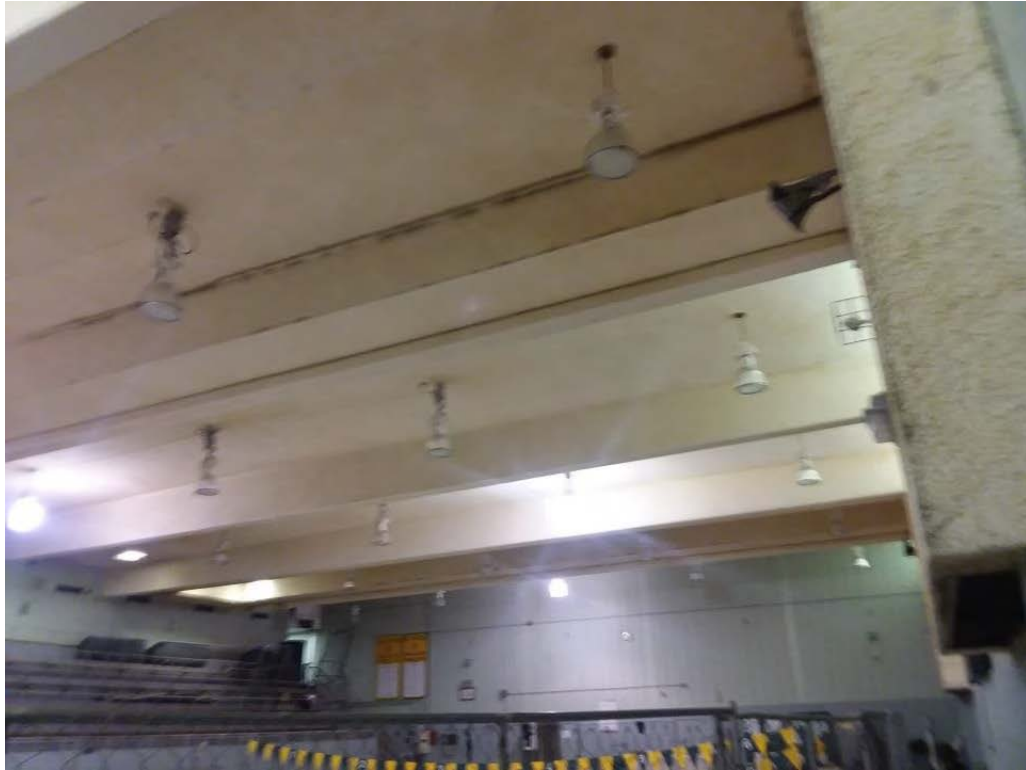
Photo depicting Surfacing Materials on Structural Tees at Pool Ceiling

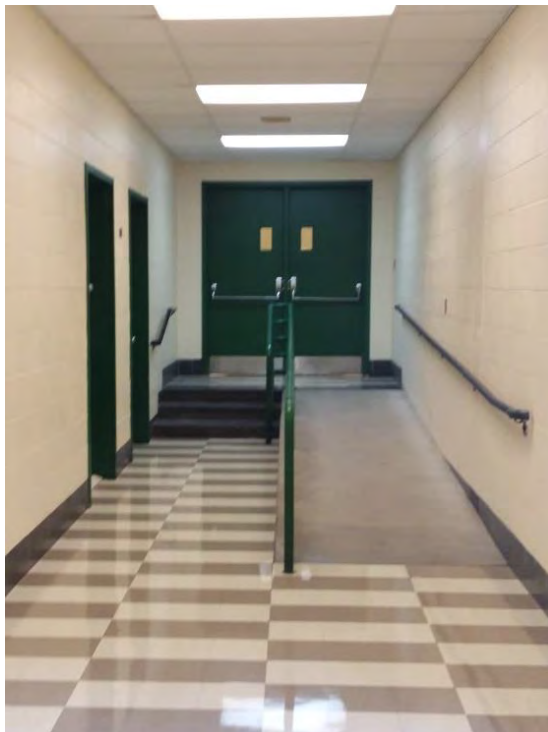
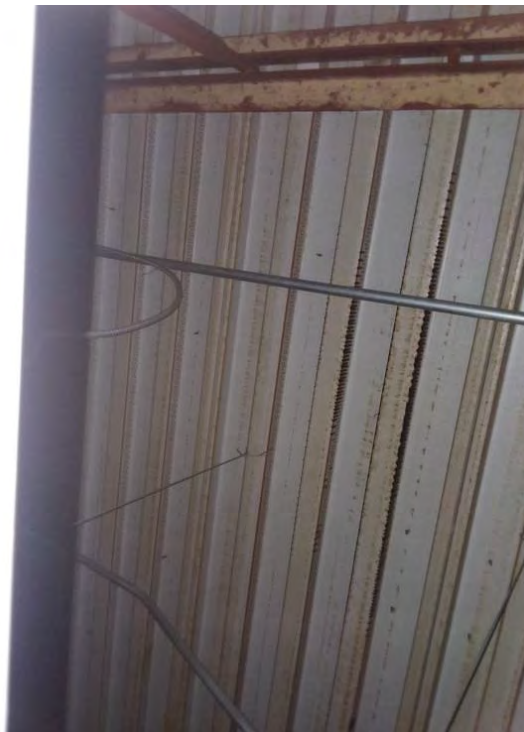
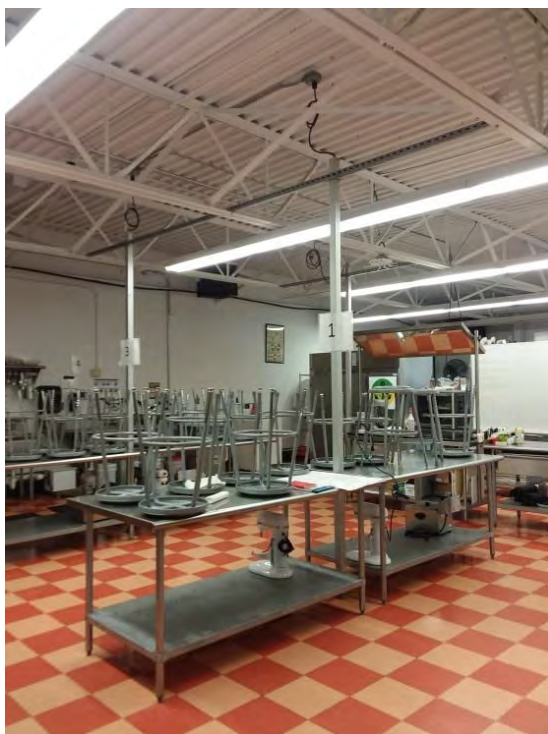
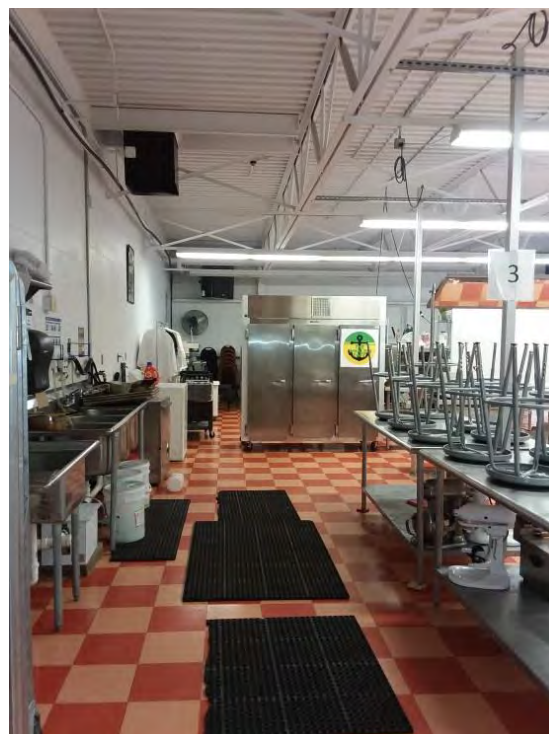
Photos depicting Ceiling, Wall, and Flooring Finishes in Shop Wing (Typical)
Ceiling- Painted Underside of Corrugated Steel Roof Deck – No Spray-On Observed
Walls- Painted CMU Block
Floors- 12" x 12" and 9" x 9" Floor Tile Various Colors

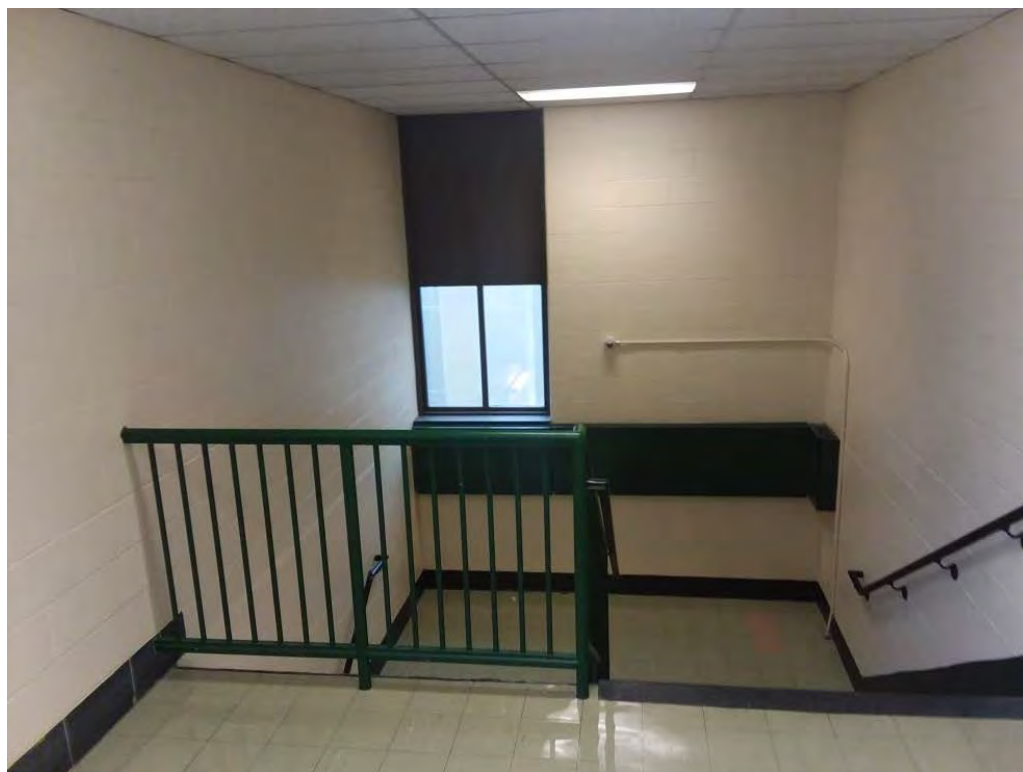
Photo depicting 12" x 12" Ceiling Tiles (with glue daubs) in Stairwell (Typical)

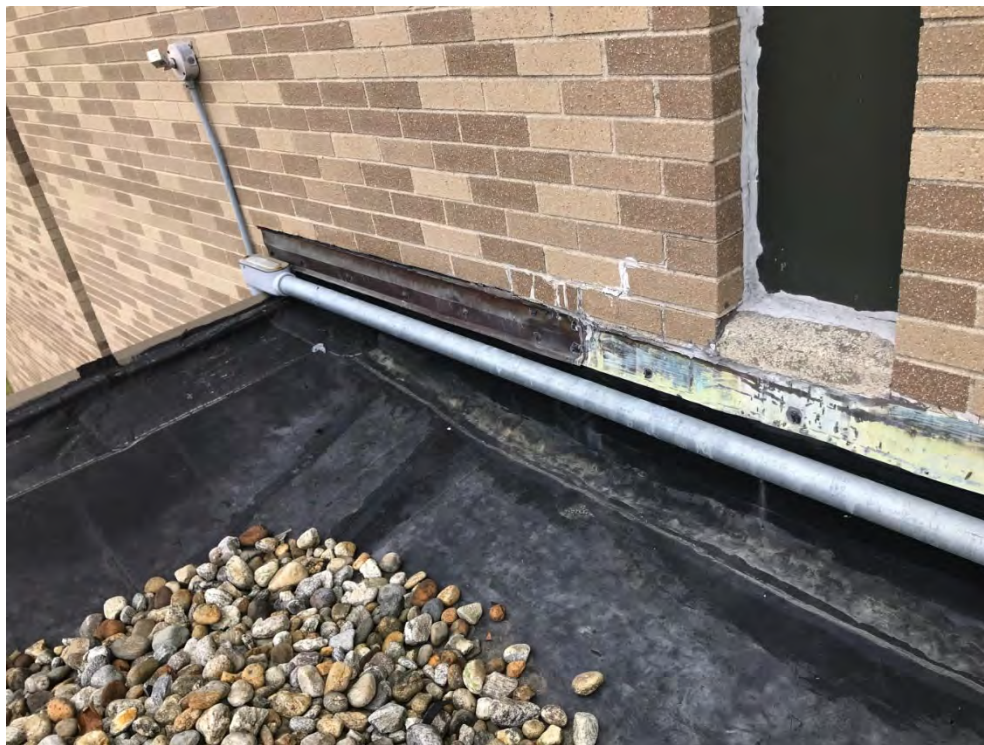
Darker patch flashing on roof 3

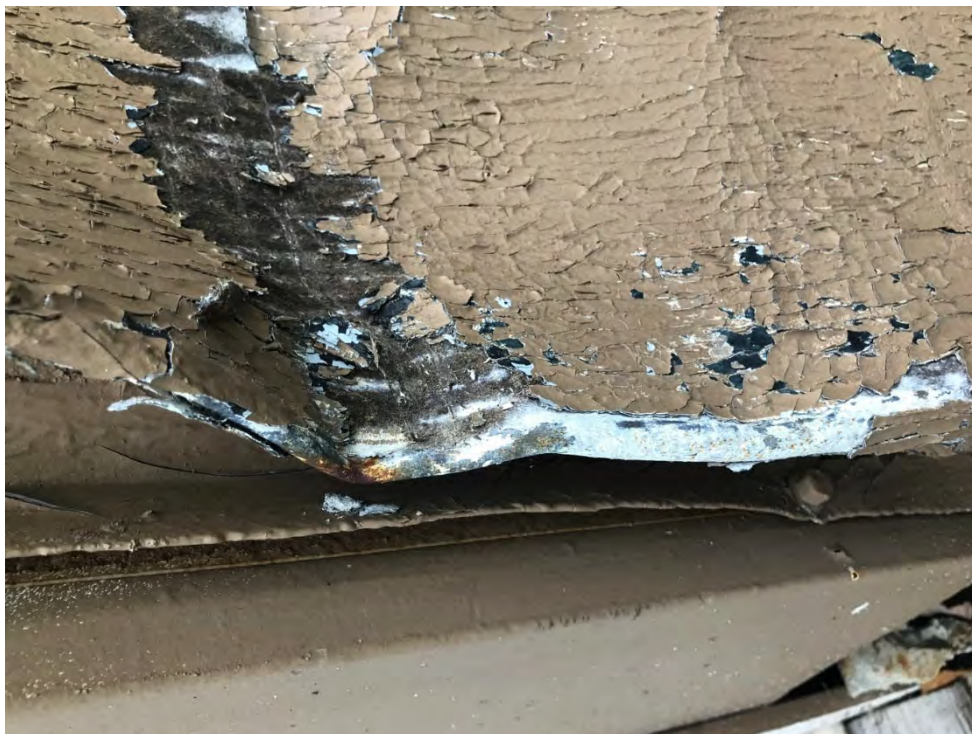
Corrugated metal siding with thick paint coating

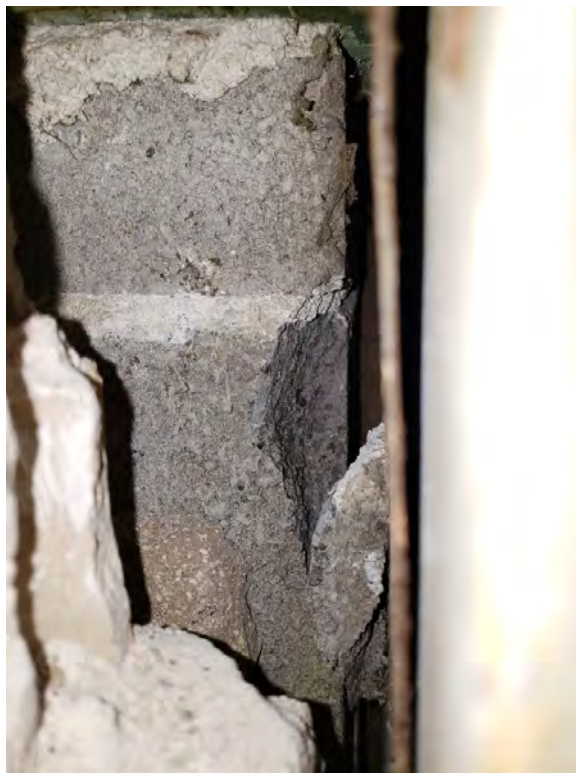
Storage Room behind brick wall – no paper observed
