Subject: On-Call Asbestos, Lead, Air Quality & Demolition Compliance
Agreement No. 04.27-01(15)
HazMat Inspection - Bridge No. 00524, Arrigoni Bridge, Middletown, CT
ConnDOT Assignment No. 514-5158
ConnDOT Project No. 82-312
TRC Project No. 222165.5158.0710

TRC performed a limited survey for hazardous building materials associated with the rehabilitation of Bridge No. 00524 (Arrigoni Bridge) in Middletown, Connecticut. Results of the survey identified no detectable levels of lead in the painted structural steel/metal bridge components of Bridge No. 00524. Since no detectable amounts of lead in paint were identified on the structural steel/metal bridge components, any paint waste generated would be characterized as non-hazardous, non-RCRA waste. Lead paint was identified on the 3' concrete posts associated with the railing system on the east side of the bridge. Results obtained from TCLP waste stream sampling and analysis for leachable lead from the paint on the concrete posts characterized the paint waste stream as non-hazardous, non-RCRA waste. At Bridge No. 00524, various caulking on the bridge were sampled and found to contain no asbestos. Potential Universal Waste (UW) and Con

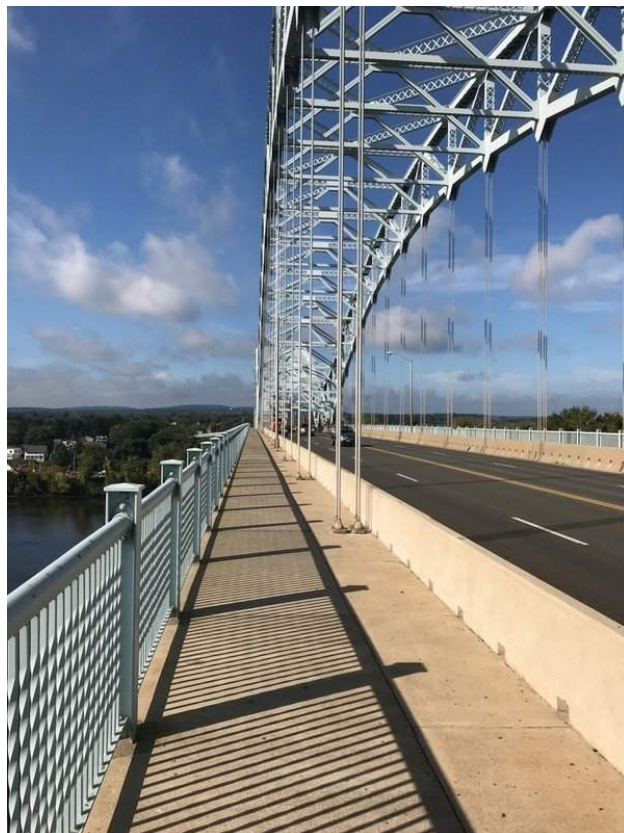
Overview Photo

Site Name	Arrigoni Bridge
Address	1-23 Main St Portland, CT 06480
TRC Project Number	222165.5158.0710
Project Manager	Erik Plimpton
Inspector(s)	Brian Behrens, Tom Martin
Client	ConnDOT
Type of Asbestos Survey	Reno/Demo
Additional Analysis for NOB Materials (Calc)	TEM NY NOB 198.4
PLM Turnaround Time (TAT)	3-day
TEM Turnaround Time (TAT)	5-day
Date	2018-10-10
General Notes	Poison ivy on one of the underside vertical supports. Topside between bridge supports, there is silicone between the jersey barriers. Also, no suspect ACM on bridge bearings

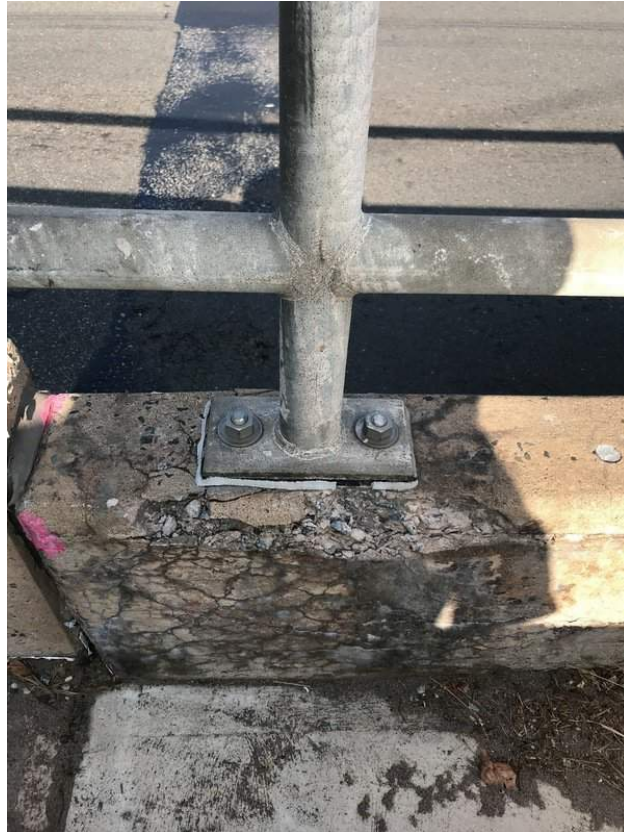
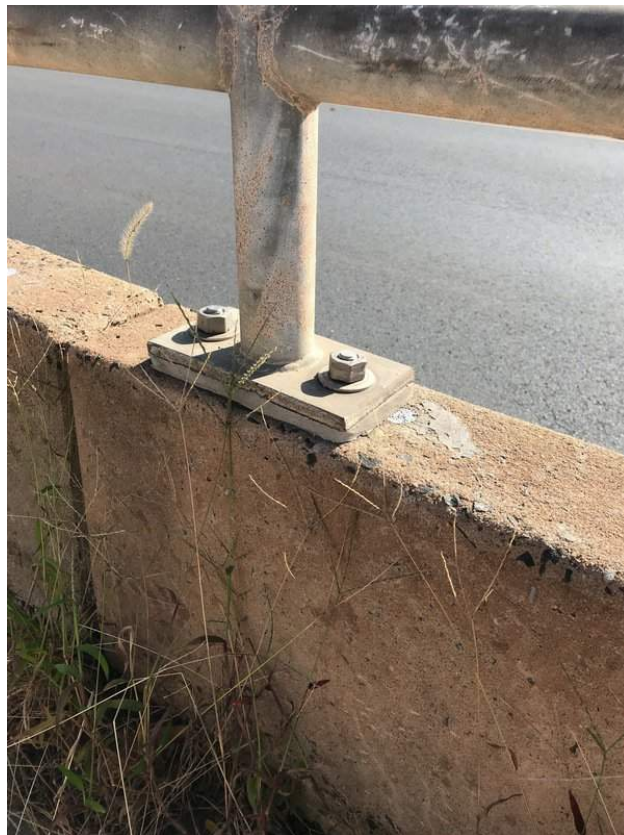
Representative Photos

(2), C, 1, Railing support caulk-flexible, grey

Sampled or Assumed?	Sampled
Material Acronym	C, 1
Material Description	Railing support caulk-flexible, grey
Is Material a Non-Friable Organically Bound (NOB)	Yes
Homogeneous Area	Top side
Total Approximate Quantity	>50 LF
Total Count	(2)

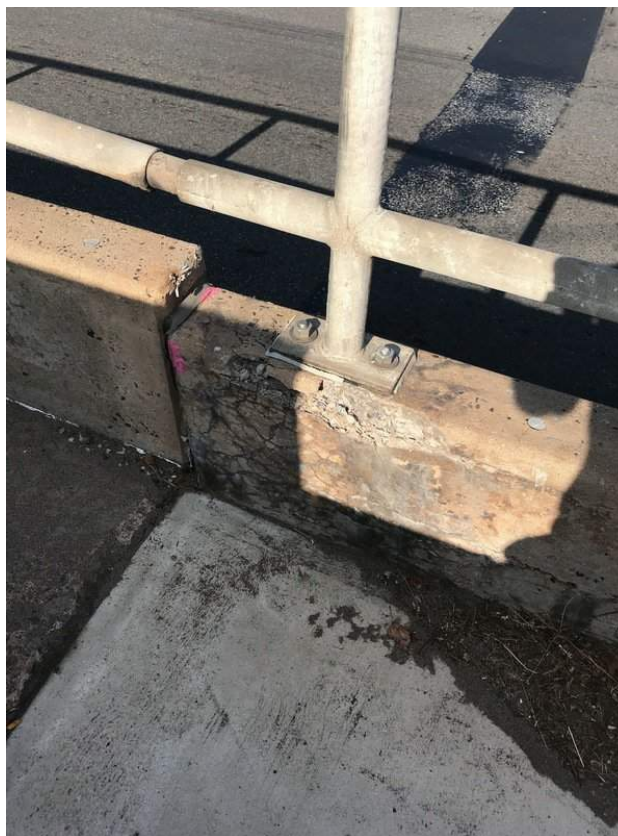
Sample Location Photo

1, Top side: east

Sample Number	1
Sample Location	Top side: east
Analyze by Layer	No
Asbestos Bulk Analysis	PLM EPA 600/R93/116
Grab or Composite	Grab
Date	2018-10-10
Time	10:01

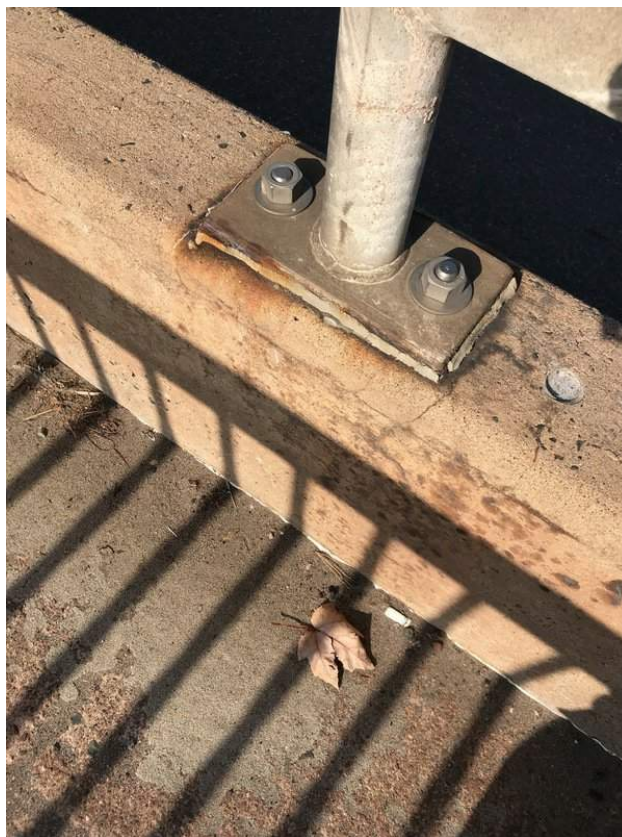
Sample Location Photo

2, Top side: east

Sample Number	2
Sample Location	Top side: east
Analyze by Layer	No
Asbestos Bulk Analysis	PLM EPA 600/R93/116
Grab or Composite	Grab
Date	2018-10-10
Time	10:04

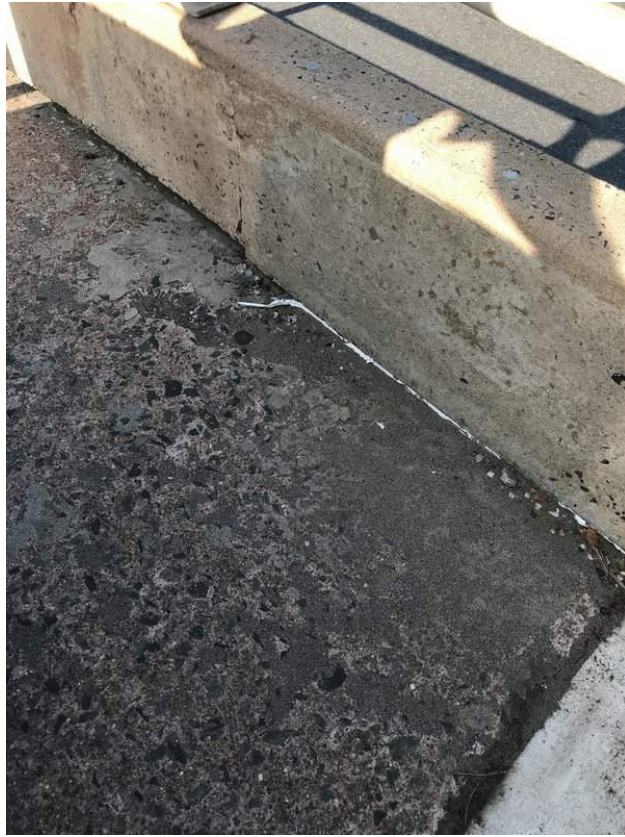
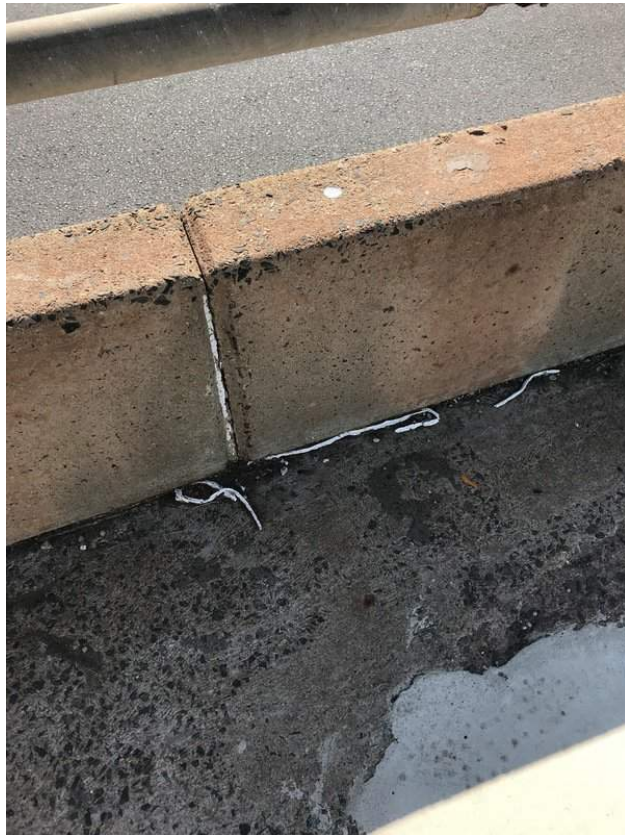
Representative Photos

(2), C, 2, White flexible caulk at sidewalk/jersey barrier junction

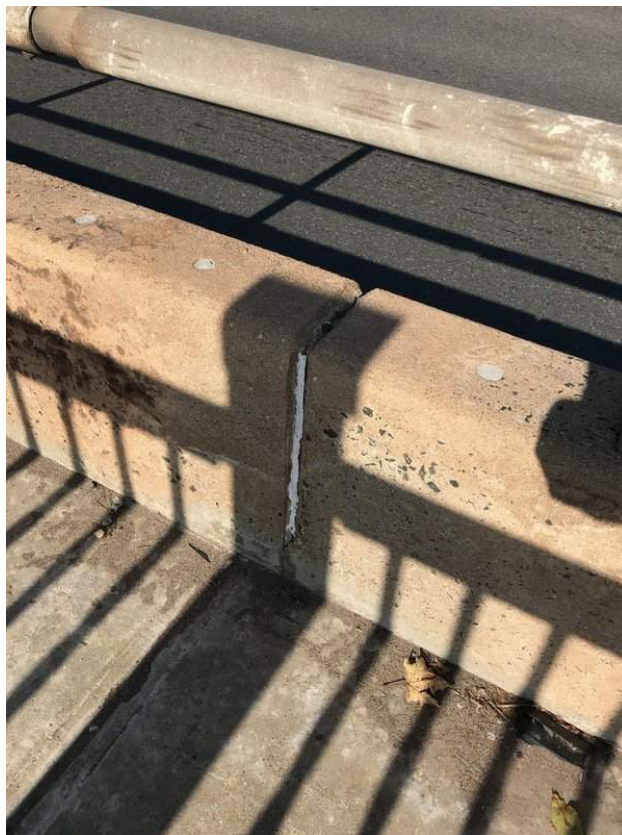
Sample Location Photo

3, Top side east

Sample Location	Top side east
Analyze by Layer	No
Asbestos Bulk Analysis	PLM EPA 600/R93/116
Grab or Composite	Grab
Date	2018-10-10
Time	10:10

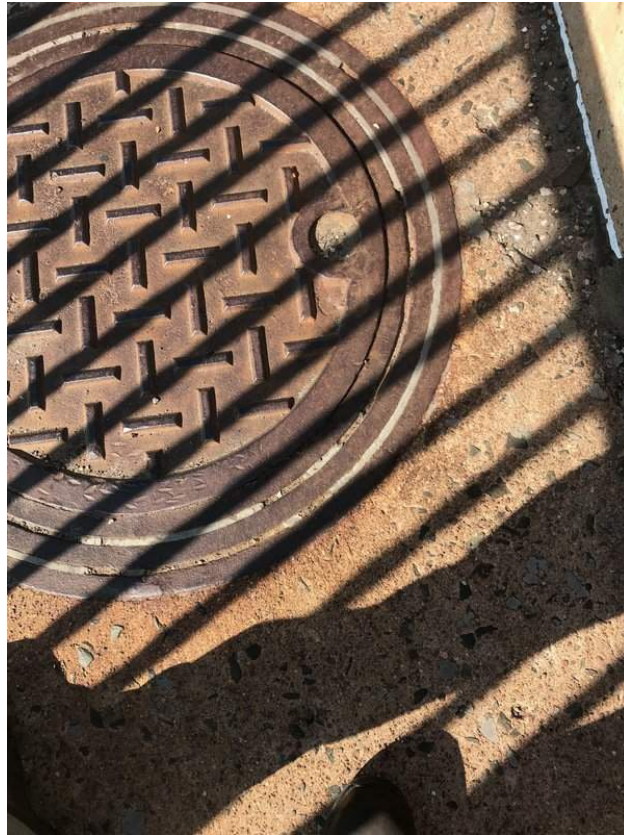
Representative Photos

(2), C, 3, Manhole cover caulk-hard grey

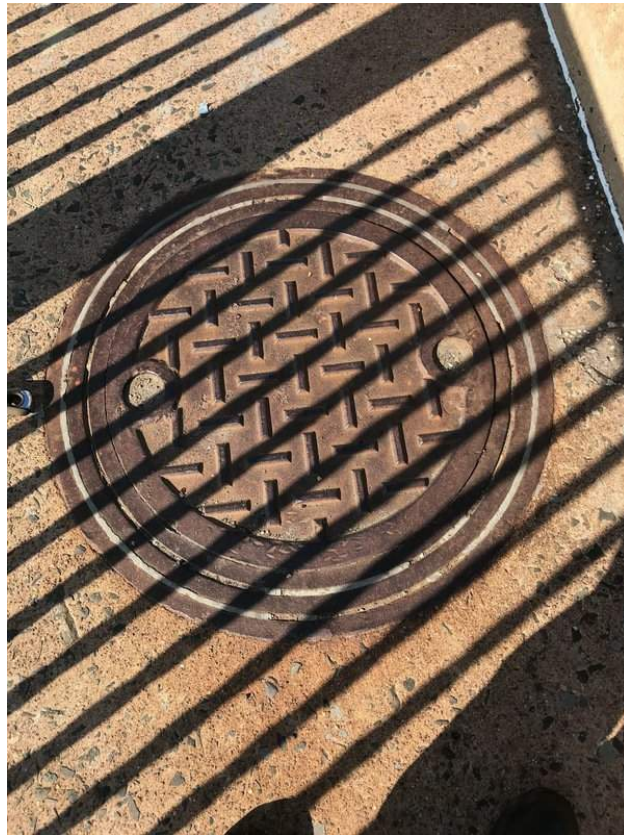
Sample Location Photo

5, Topside east

Sample Number	5
Sample Location	Topside east
Analyze by Layer	No
Asbestos Bulk Analysis	PLM EPA 600/R93/116
Grab or Composite	Grab
Date	2018-10-10
Time	10:22
