Subject: On-Call Asbestos, Lead, Air Quality & Demolition Compliance
Agreement No.: 8.07-01 (18)
HazMat Inspection - Bridge No. 00980B, I-84 TR -826 WB at Exit 51 over Connecticut
River, Hartford, CT
ConnDOT Assignment No. 519-5929
ConnDOT Project No. 63-712
TRC Project No. 289951.5929.0710

TRC performed a limited survey for hazardous building materials associated with the rehabilitation of Bridge No. 00980B, I-84 TR -826 WB at Exit 51 over Connecticut River in Hartford, Connecticut. Results of the survey identified lead paint to be present on the structural steel/metal bridge components of Bridge No. 00980B. Results obtained from TCLP waste stream sampling and analysis for leachable lead from the paint on the structural steel/metal bridge components characterized the paint waste stream at Bridge No. 00980B as CTDEEP/RCRA hazardous waste. Grey/white barrier seam caulk, black curb seam caulk, red pipe seam caulk and black road tar were sampled and found to be non-detect for asbestos. Bloodborne pathogens (BBP) concerns (homeless activity, human feces, etc.) were identified at Bridge No. 00980B. No bird/pigeon guano accumulations or other hazardous/regulated items were identified. A

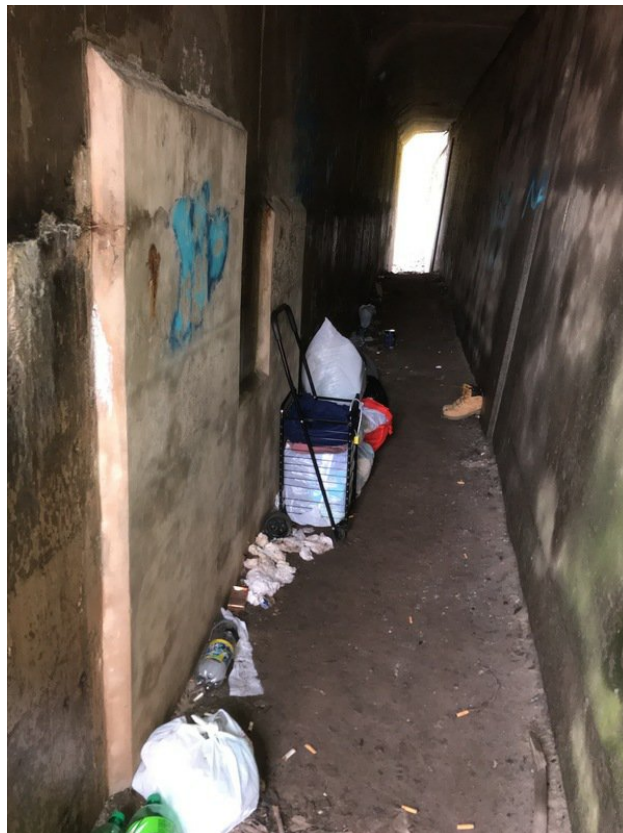
Overview Photo

Site Name	Bridge 00980B
Address	Exit 51 Bridge Hartford, CT 06120
TRC Project Number	289951.5929.0710
Project Manager	Stephen Arienti
Inspector(s)	Brendan McClure, Carmen Jacko, Hilton Hernandez
Client	ConnDOT
Type of Asbestos Survey	Reno/Demo
Additional Analysis for NOB Materials (Calc)	TEM NY NOB 198.4
PLM Turnaround Time (TAT)	48-hour
TEM Turnaround Time (TAT)	48-hour
Date	2019-04-19

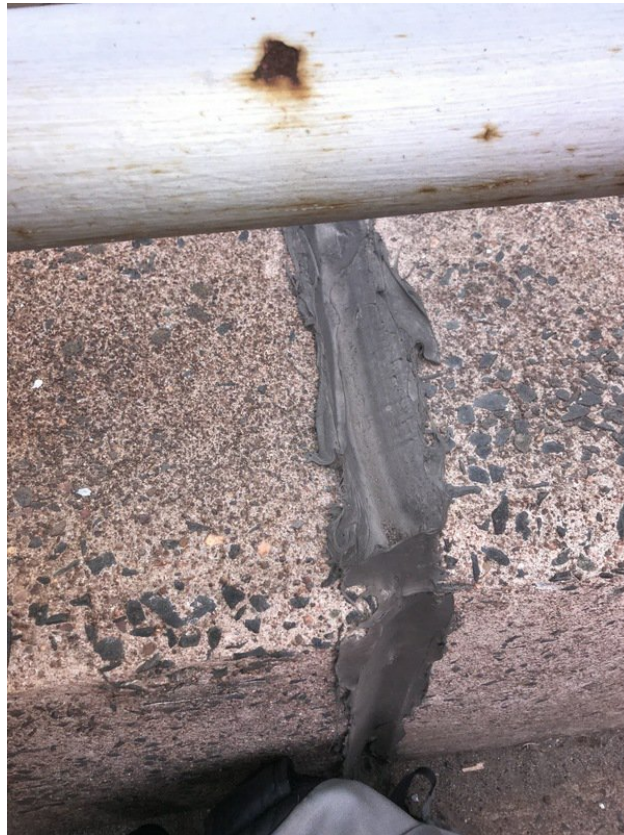
(2), C, 1, Grey/white barrier seam caulk , 2

East barrier seam caulk

West barrier seam caulk

Sampled or Assumed?	Sampled
Material Acronym	C, 1
Material Description	Grey/white barrier seam caulk
Is Material a Non-Friable Organically Bound (NOB)	Yes
Total Approximate Quantity	20LF
Total Count	(2)

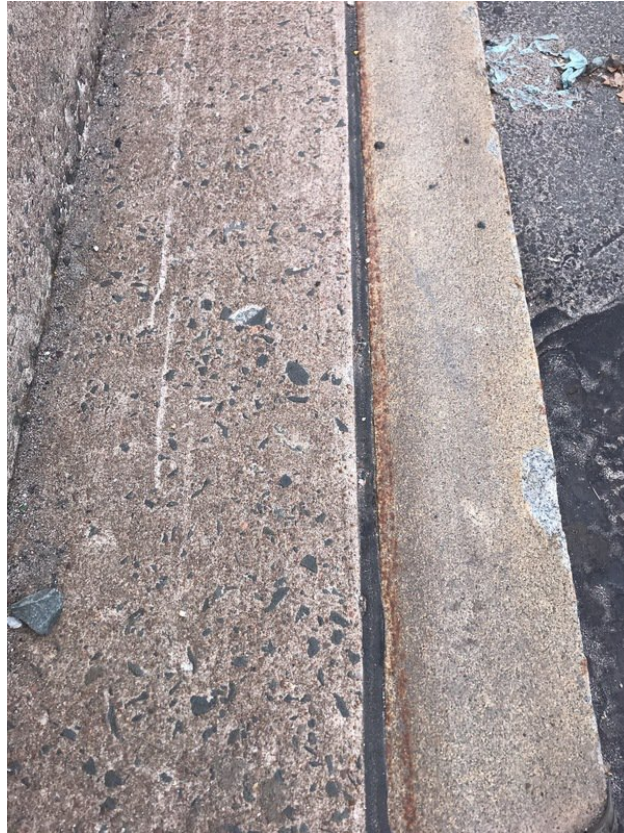
(2), C, 2, Black curb seam caulk , 2

**East curb**

West curb

Sampled or Assumed?	Sampled
Material Acronym	C, 2
Material Description	Black curb seam caulk
Is Material a Non-Friable Organically Bound (NOB)	Yes

Total Approximate Quantity	Length of bridge. Both sides
Total Count	(2)
Total Count (number only)	2

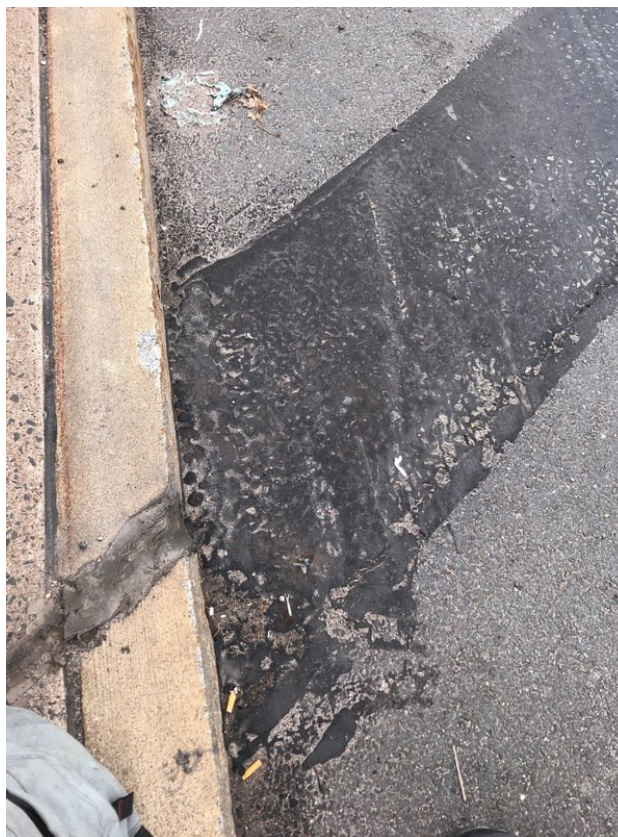
(2), RT1, Black road tar, 2

East side

West side

Material Description	Black road tar
Is Material a Non-Friable Organically Bound (NOB)	Yes
Total Approximate Quantity	25'x2'x3
Total Count	(2)
Total Count (number only)	2

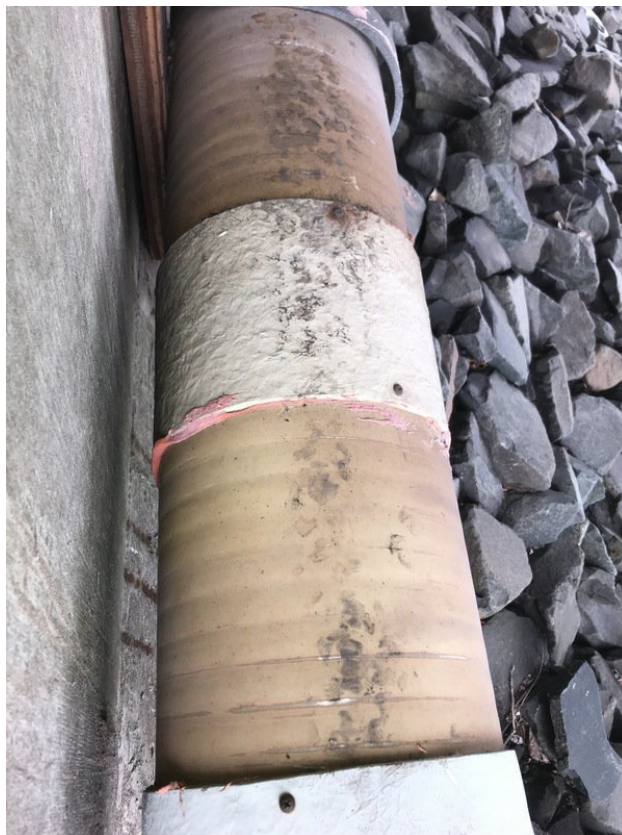
(2), C, 3, Red pipe seam caulk , 2

Drain pipe under bridge

Sampled or Assumed?	Sampled
Material Acronym	C, 3
Material Description	Red pipe seam caulk
Is Material a Non-Friable Organically Bound (NOB)	Yes
Total Count	(2)
Total Count (number only)	2

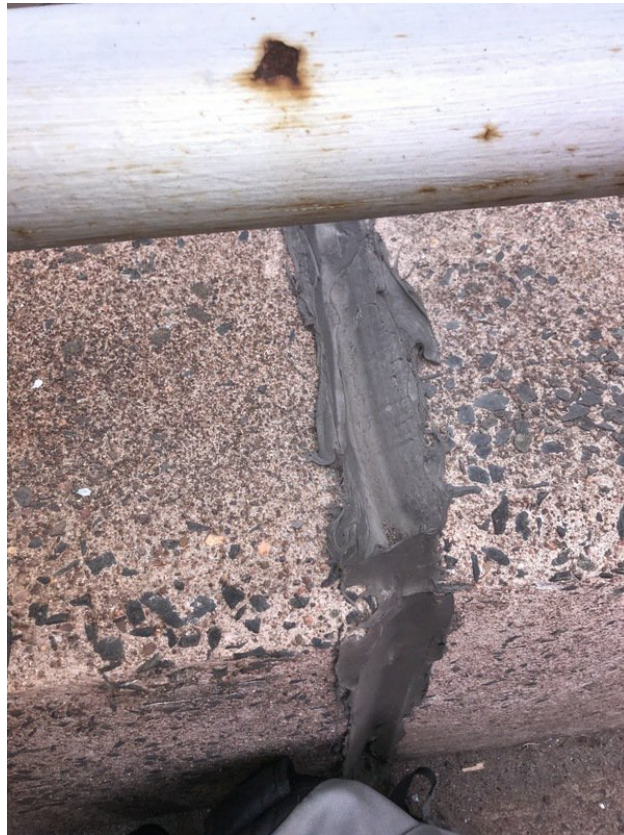
TCLP/SPLP/Total Lead Sample Description	Grey paint on metal railings
Type of Analysis	TCLP Lead
Sample Number	1
Grab or Composite	Grab
Date	2019-04-19
Time	09:30
