## BRIDGE NO. 03903

34250 - GROTON  
MOSHER STREET  
over  
AMTRAK RAILROAD

Special Inspection

2/15/2019

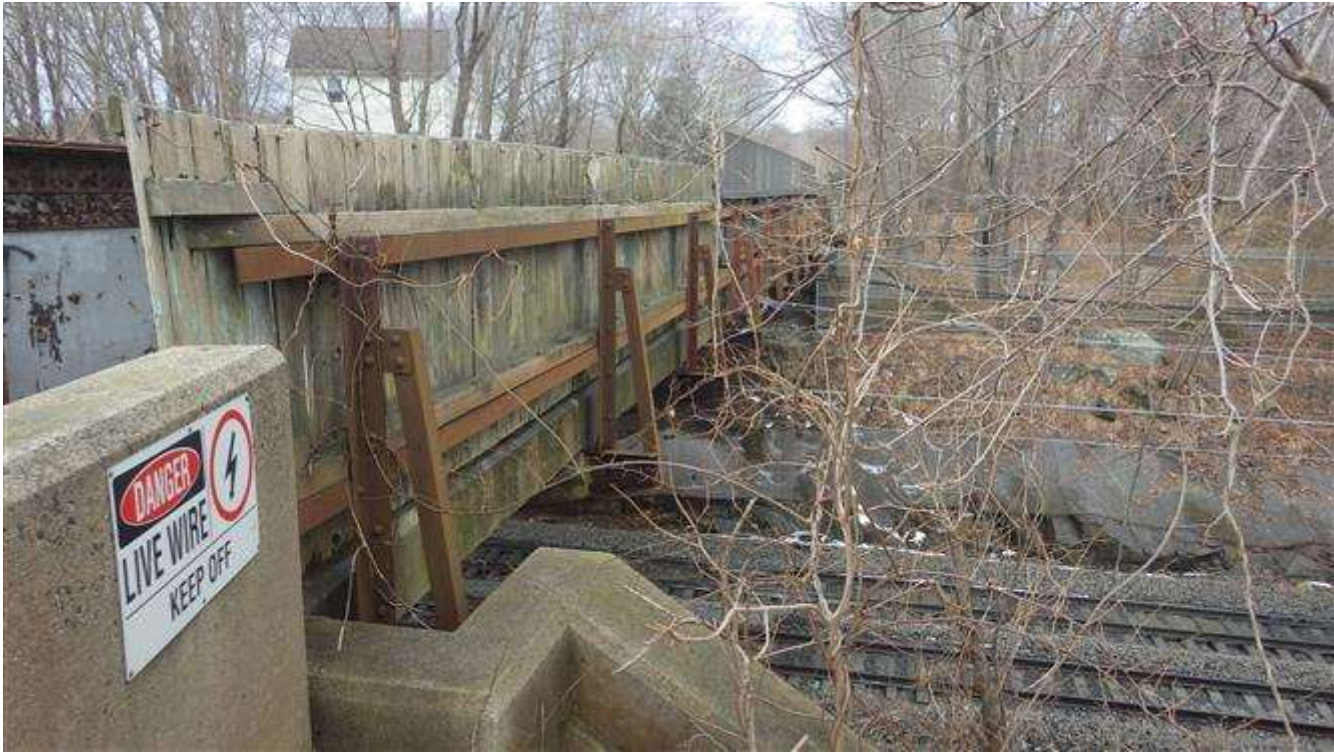
Photo Number: 1

North elevation.

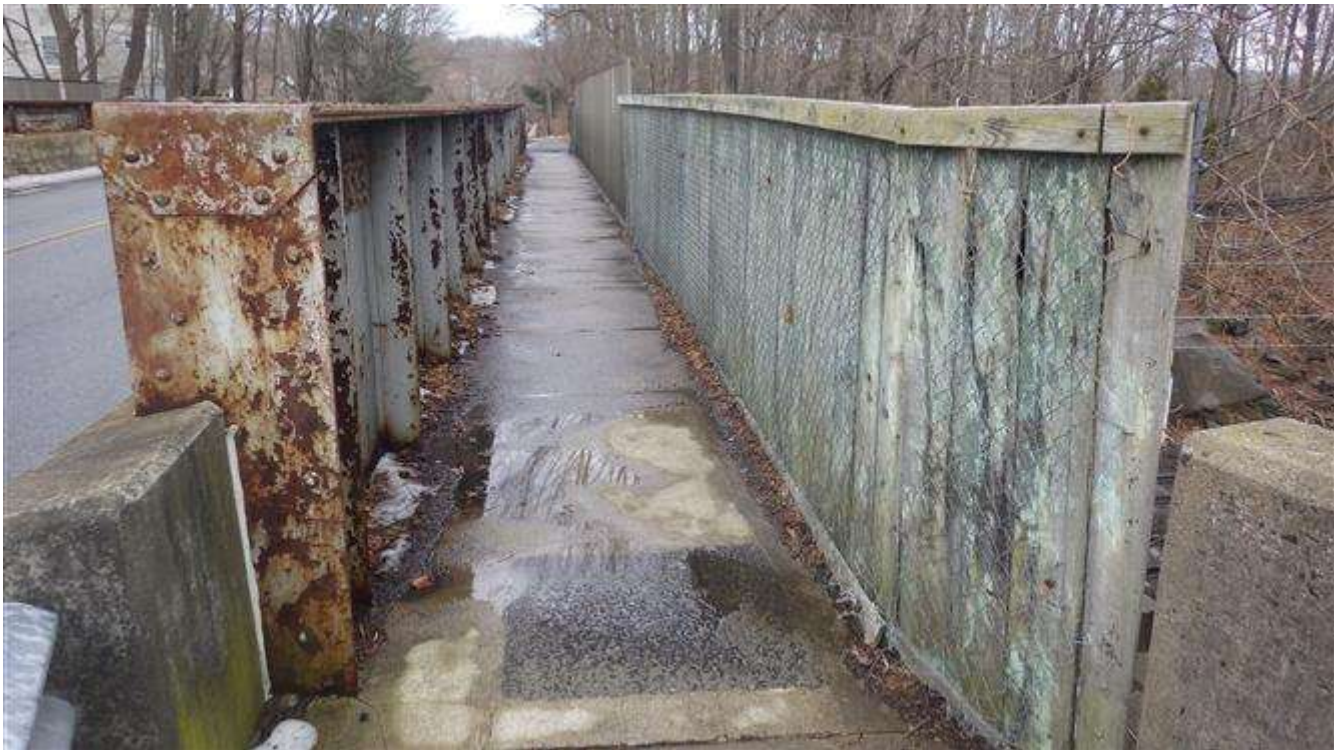
Photo Number: 2

General view of north sidewalk.

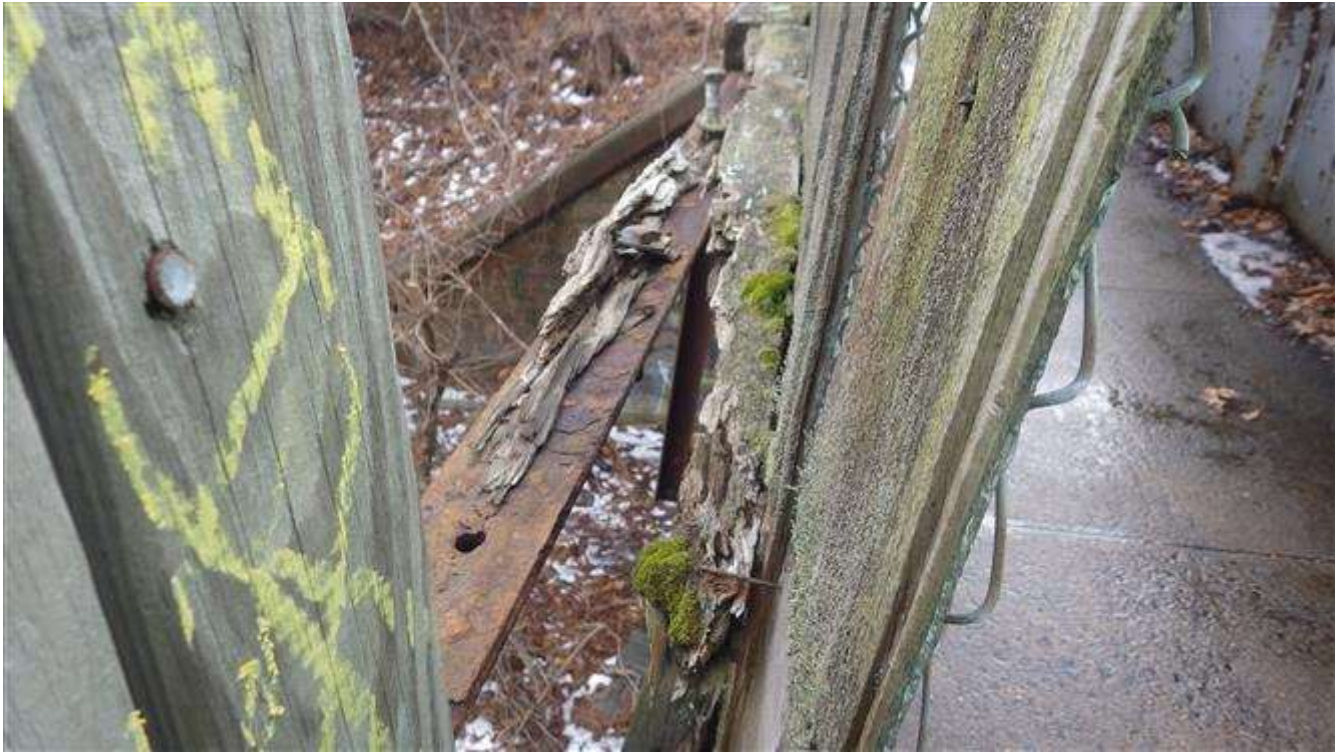
Photo Number: 3

**Inspection Results:**  
-Rotted and disconnected section of wood (safety) fence at the east end of the north sidewalk.

Rotted and disconnected section of (safety) fence at the east end of north sidewalk.

Work Item#03903-2019-0007 submitted wood safety fence

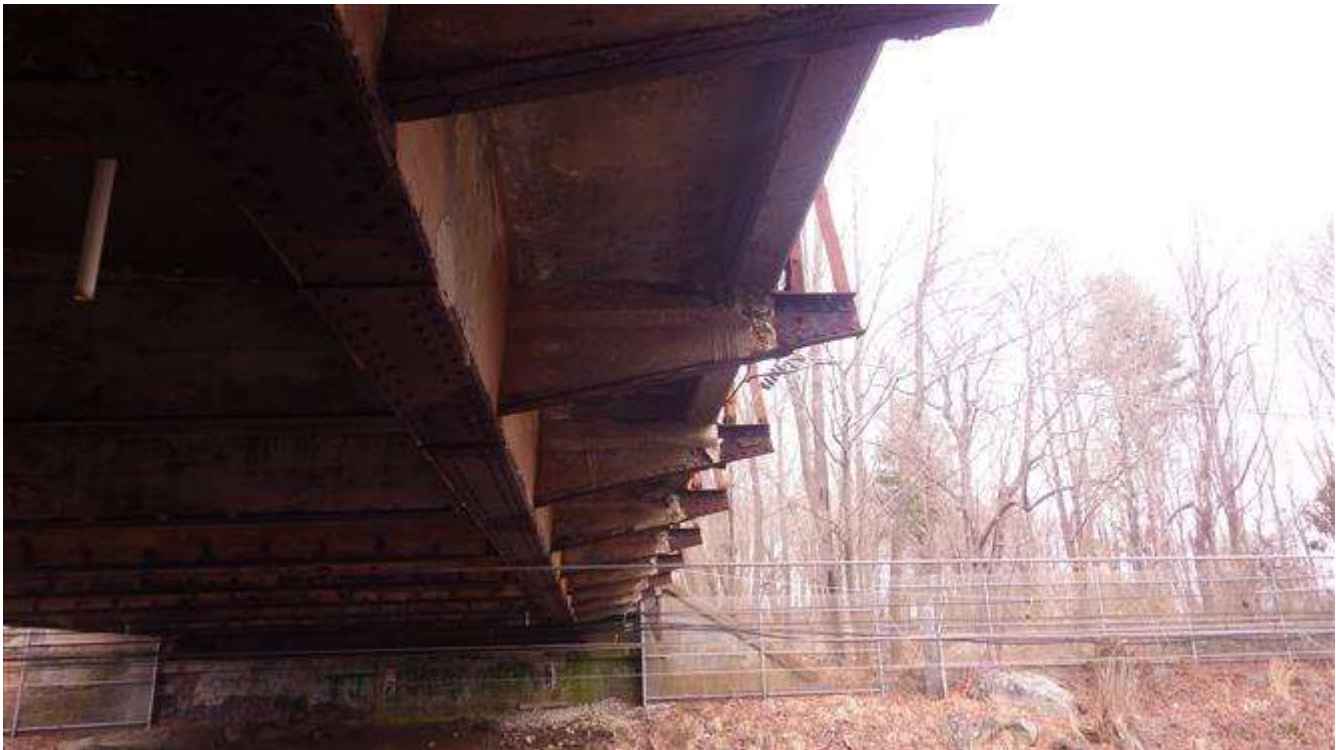
Photo Number: 4

-Concrete appears punky with possible potential spalls at the ends of random supports over tracks.

-Perforations in webs of sidewalk supports # 4,# 5 and # 6 appear unchanged as best can be determined.

General view of north sidewalk cantilever supports.

**Action To Be Taken:**  
Continue to monitor until construction starts.

Open Work Items; sidewalk supports, bearings, underside deck exposed rebar and rivet heads section loss, will be addressed on Project #58-336 with an estimated Advertising Date of 9-18-19
