June 19, 2019

Subject: On-Call Asbestos, Lead, Air Quality & Demolition Compliance
Agreement No.: 8.07-01 (18)
HazMat Inspection – Bridge No. 03903, Mosher Street over Amtrak Railroad, Groton, CT
ConnDOT Assignment No. 519-5793
ConnDOT Project No. 58-336
TRC Project No. 289951.5793.0710

Created	2019-01-25 11:39:03 EST by Zac Smith
Updated	2019-05-17 10:45:25 EDT by Stephen Arienti
Location	41.32697212048, -71.9887014292851
Status	■ Survey Complete

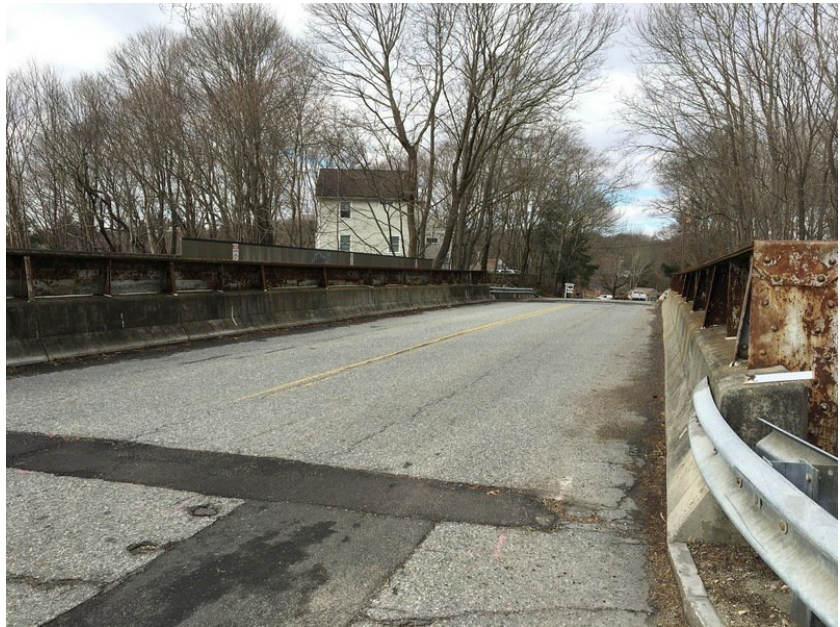
Overview Photo

Site Name	Bridge 03903
Address	70 Mosher St Groton, CT 06340
TRC Project Number	289951.5793.0710
Project Manager	Erik Plimpton, Stephen Arienti
Inspector(s)	Zac Smith, Dennis Ryder
Client	ConnDOT
Type of Asbestos Survey	Reno/Demo
Additional Analysis for NOB Materials (Calc)	TEM NY NOB 198.4
Date	2019-01-25
General Notes	Concrete on metal bridge. Bridge runs over train tracks. One abutment is inaccessible due to fencing. Metal conduit on west side sidewalk. Multiple painted surfaces.

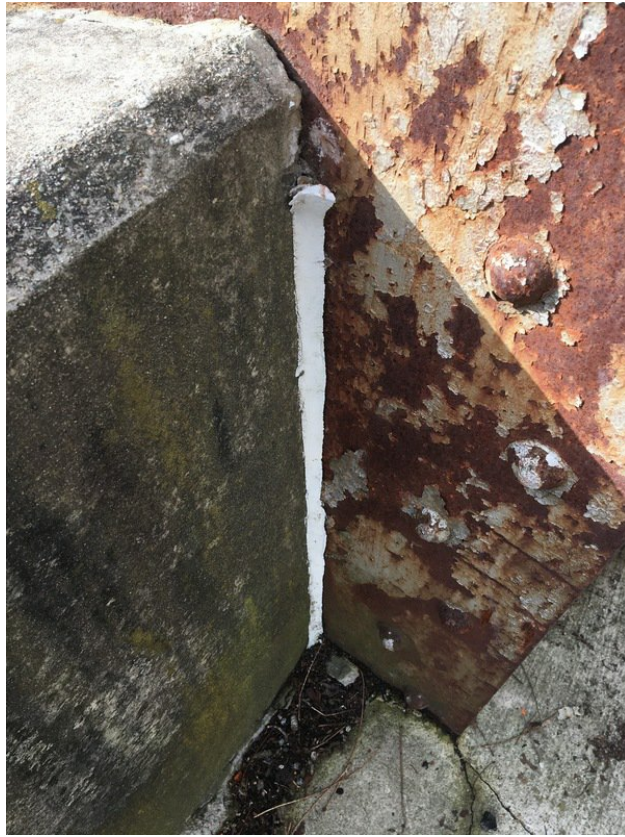
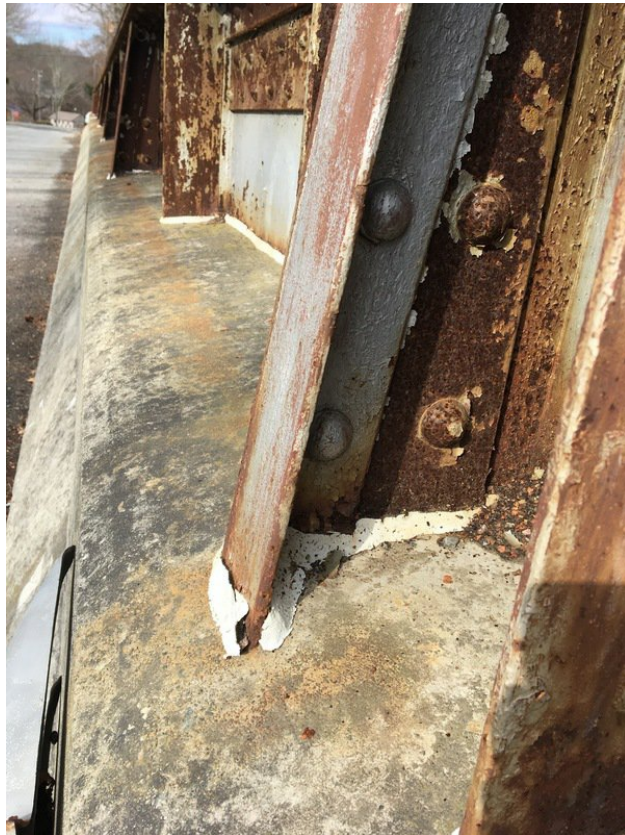
(2), C, 1, Hard white caulk

01, Road barrier

02, Road barriers

Sampled or Assumed?	Sampled
Material Acronym	C, 1
Material Description	Hard white caulk
Is Material a Non-Friable Organically Bound (NOB)	Yes
Total Approximate Quantity	175 linear ft
Total Count	(2)

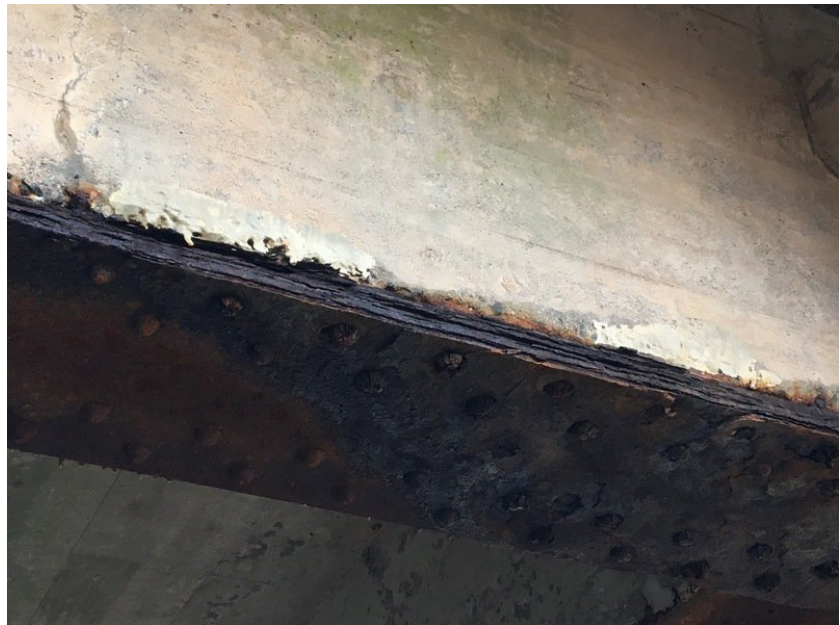
(2), PC1 , Tan patching caulk

05, Underside of bridge

06, Underside of bridge.

Sampled or Assumed?	Sampled
Material Acronym	PC1
Material Description	Tan patching caulk
Is Material a Non-Friable Organically Bound (NOB)	Yes
Homogeneous Area	Various spots around structure

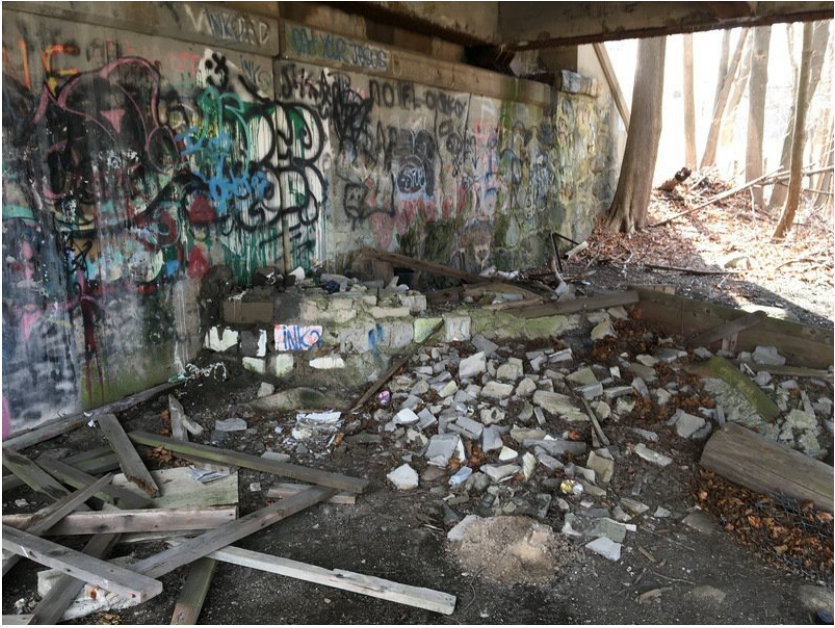
Bridge/Sign/Light Pole/Traffic Signal No.	03903
General Notes	Concrete on metal structure. Over train tracks. One abutment was not accessible due to fence.
Accessibility	Accessible
Paint on Structure (s)?	Yes
Paint on what Components/Structure(s)?	Bridge road barrier. Bridge sidewalk fencing. Metal conduit. Metal underside of bridge.
Suspect Asbestos Containing Materials Identified on Structure	Yes
Guano Present?	No
Homeless Activity	Yes
Homeless Activity Locations	Underside of south side of bridge.
Homeless Activity Photos

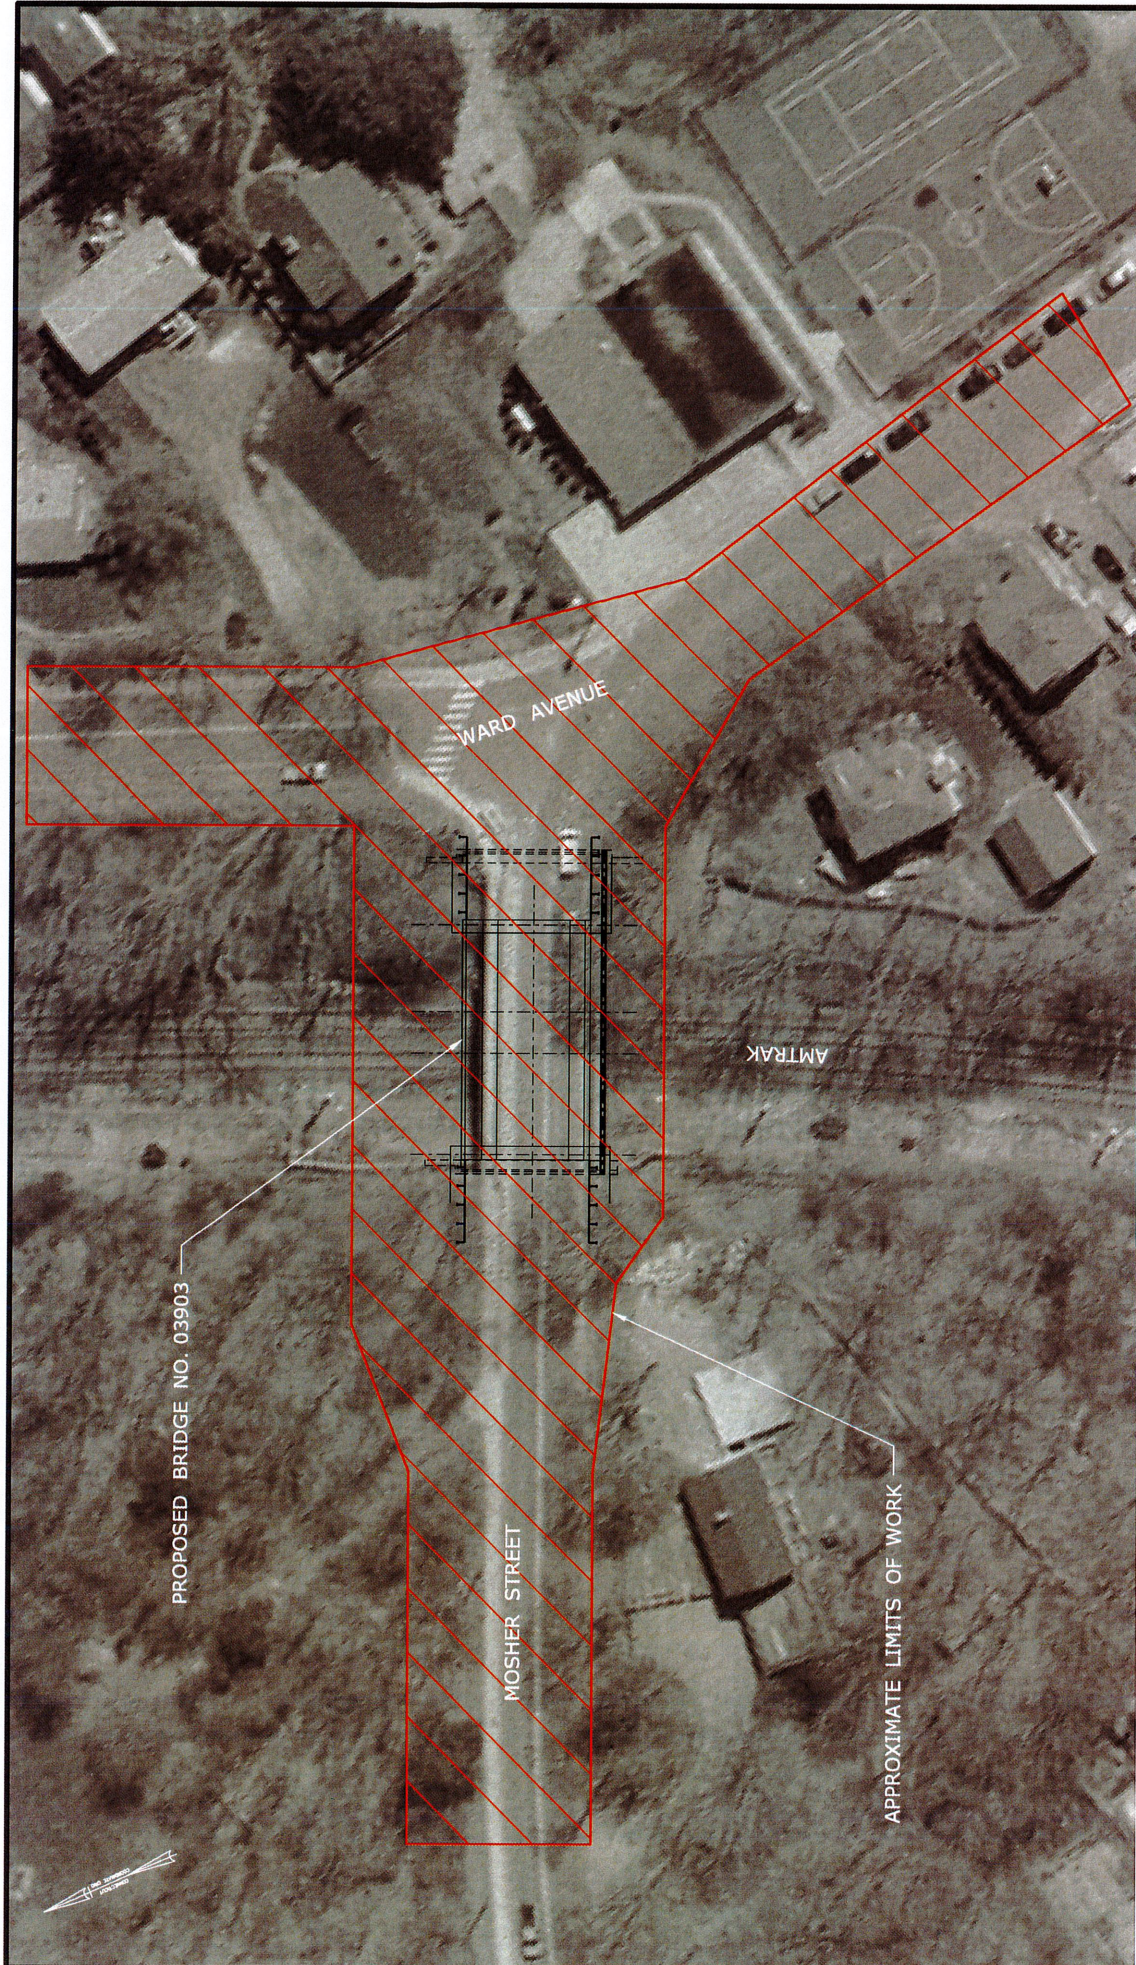
DRAWING TITLE:
**PROPOSED
WORK ZONE AND
STAGING AREA**

- Superstructure replacement of the existing bridge
- Repair of the existing abutments
- Installation of an adjacent box beam with composite deck superstructure
- Inclusion of a wider curb-to-curb width of 34'-0" with a 5'-6" sidewalk on the north side

Excavation is anticipated for the replacement of Bridge No. 03903. The existing bridge superstructure will be demolished and removed with the abutments to remain. The bridge span is the same as the existing bridge, but the curb-to-curb width will increase from 27'-0" to 34'-0". Additionally, the centerline of the roadway will be raised. Excavation will be necessary on Mosher Avenue and Ward Avenue to accommodate the vertical adjustment, horizontal widening, and installation of sidewalks on the approaches. Additionally, a temporary bridge will be constructed north of the existing bridge, which will require the installation of new abutments. Excavation will be required for the abutments and the temporary roadway.
