Subject: On-Call Asbestos, Lead, Air Quality & Demolition Compliance  
Agreement No. 04.27-01(15)  
HazMat Inspection - Bridge No. 00325, Route 1 over Stillman Pond, Bridgeport, CT  
ConnDOT Assignment No. 514-5658  
ConnDOT Project No. 15-248  
TRC Project No. 222165.5658.0710

TRC performed a limited survey for hazardous building materials associated with the replacement of Bridge No. 00325, Route 1 over Stillman Pond in Bridgeport, Connecticut. Results of the survey identified no detectable levels of lead in the paint to be present on the metal structural steel/metal bridge components ( $0.0 \text{ mg/cm}^2/\text{ND} < 0.10\%$  by weight), therefore any paint waste generated would be considered non-RCRA, non-hazardous waste. Suspect asbestos containing materials in the form of tar at penetrations, black rubbery pipe wrap, thin white sealant around pipe fitting, grey pipe wrap around pipe fitting, large grey spot pipe sealant & black tar expansion joint were sampled and found to contain no asbestos. Presumed asbestos containing pipe insulation/mudded fittings & pipe flange gaskets are assumed to be in adjacent underground utility tunnel that runs under Route 1 as well as the util

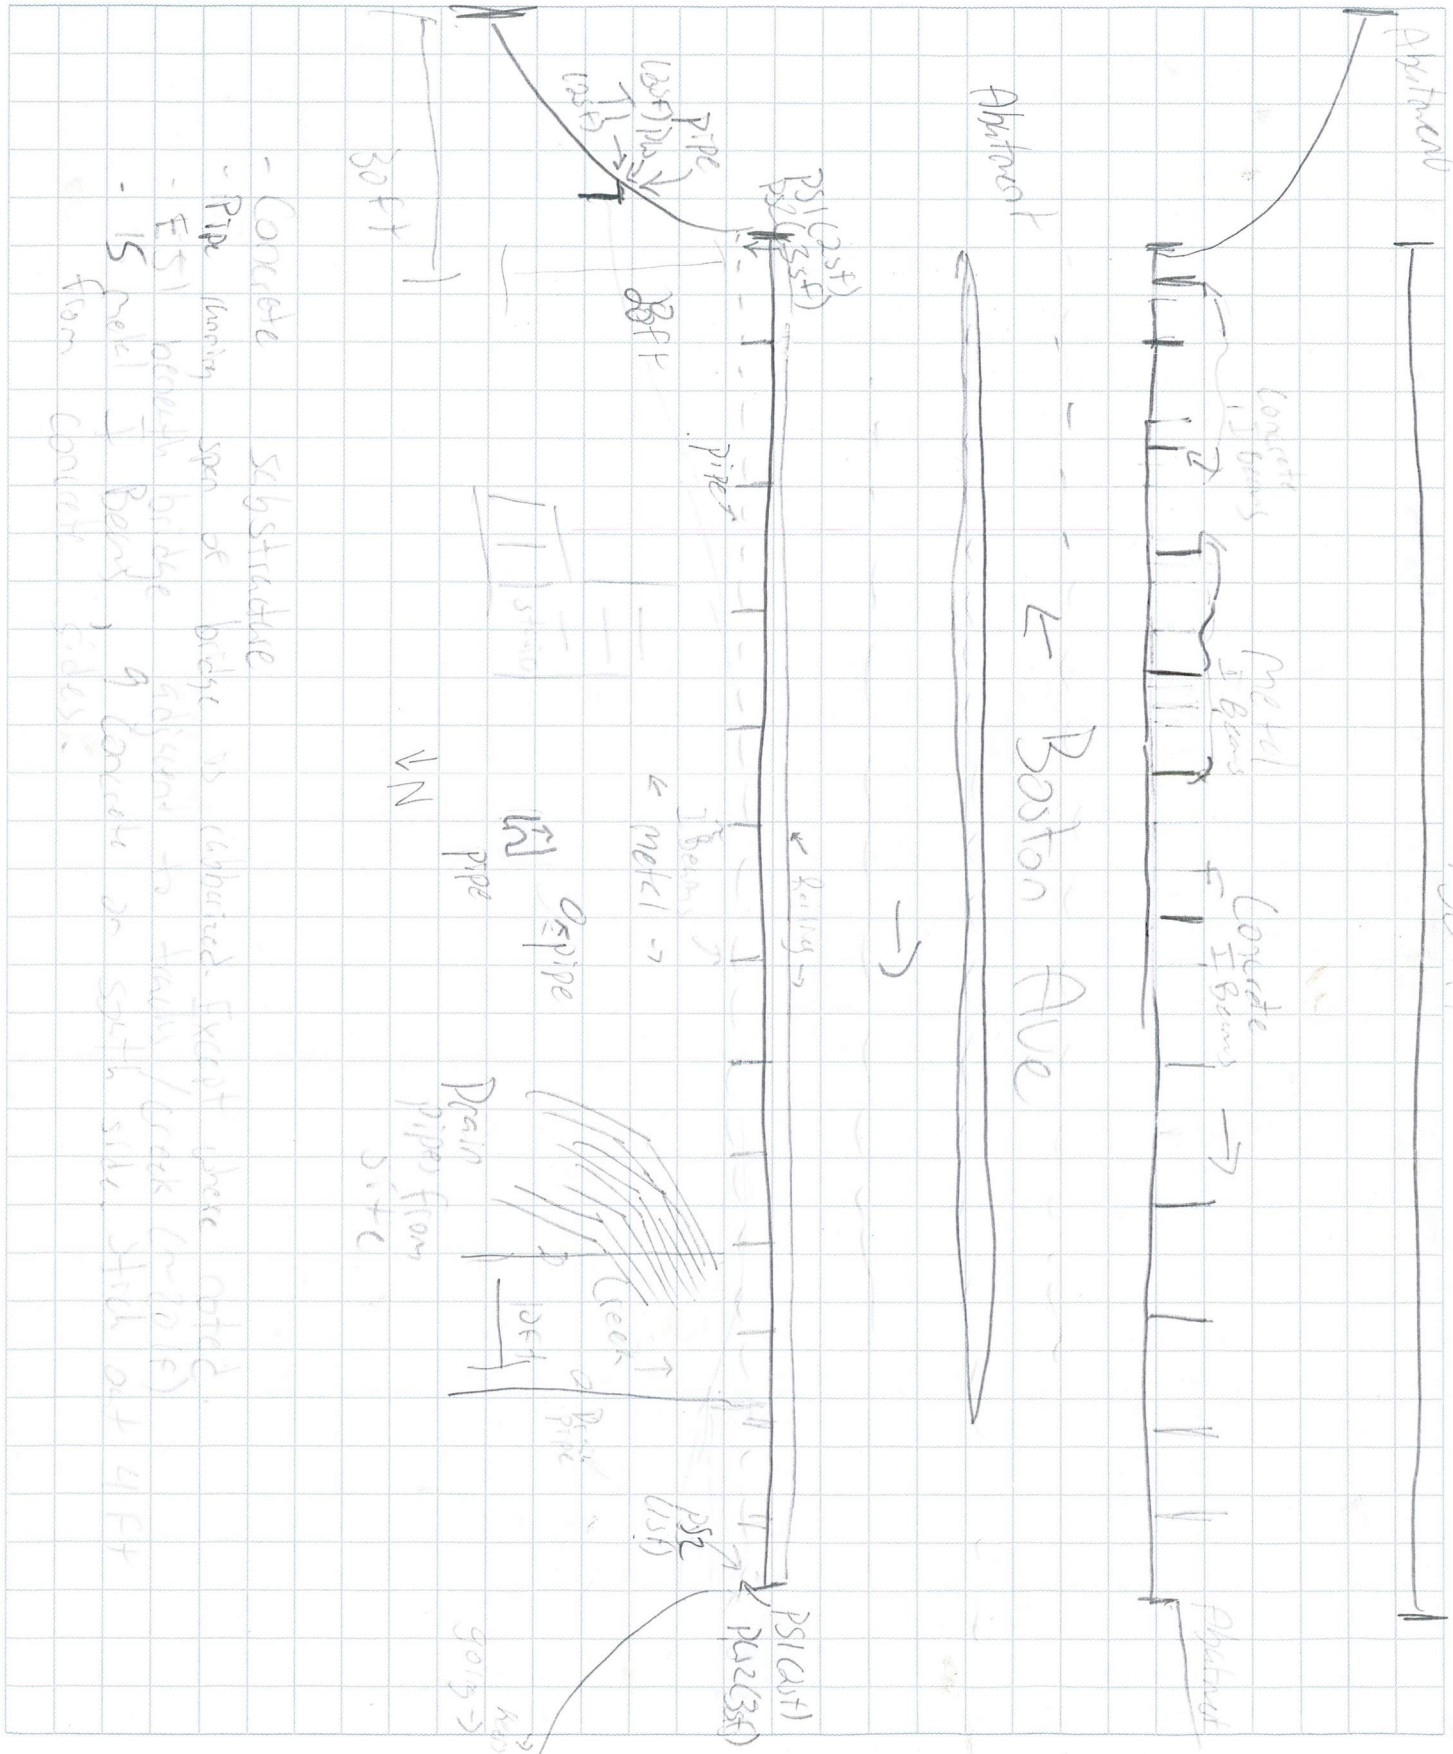
SUBJECT Bridge 325 Bridgeport

- Concrete Substructure
- Pipe running span of bridge is supported. Except where noted.
- ESI break bridge supports to main creek (in 10 ft)
- 15' net I Beam concrete on south side, shall out 4 FT from cover sides.

130 FT
