Subject: On-Call Asbestos, Lead, Air Quality & Demolition Compliance
Agreement No. 04.27-01(15)
HazMat Inspection – I-84 Safety & Capacity Improvements (Bridge Nos. 01743A, 01743B, 01744, 01745, 01746, 01747, 03486, 03489 & 03490 and Sign Support Nos. 21579, 21580, 21581, 21682, 21683, 21684 & 21685) West Hartford, CT
ConnDOT Assignment No. 514-5716
ConnDOT Project No. 155-171
TRC Project No. 222165.5716.0710

TRC performed a limited survey for hazardous building materials associated with the I-84 Safety & Capacity Improvements in West Hartford, Connecticut which included Bridge Nos. 01743A, 01743B, 01744, 01745, 01746, 01747, 03486, 03489 & 03490 and Sign Support Nos. 21579, 21580, 21581, 21682, 21683, 21684 & 21685.

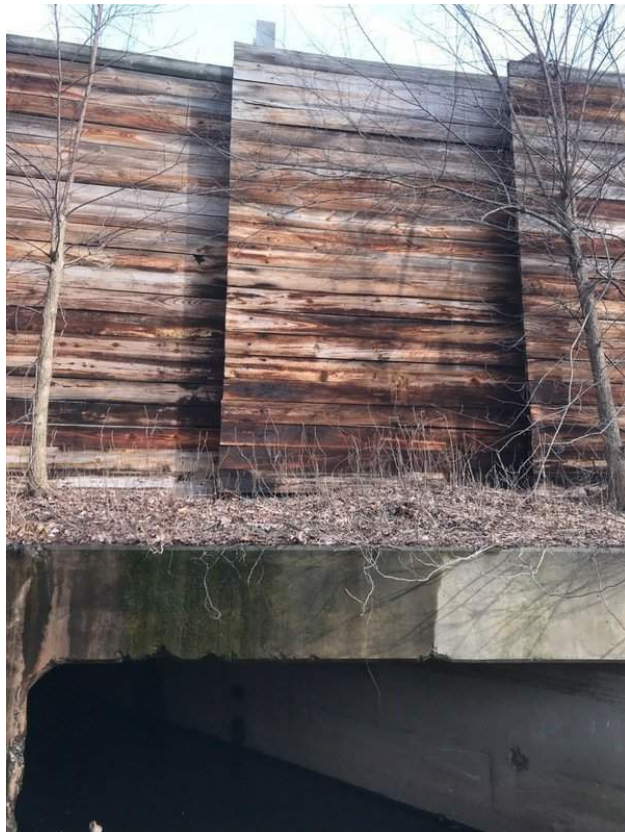
Dry underside 01746

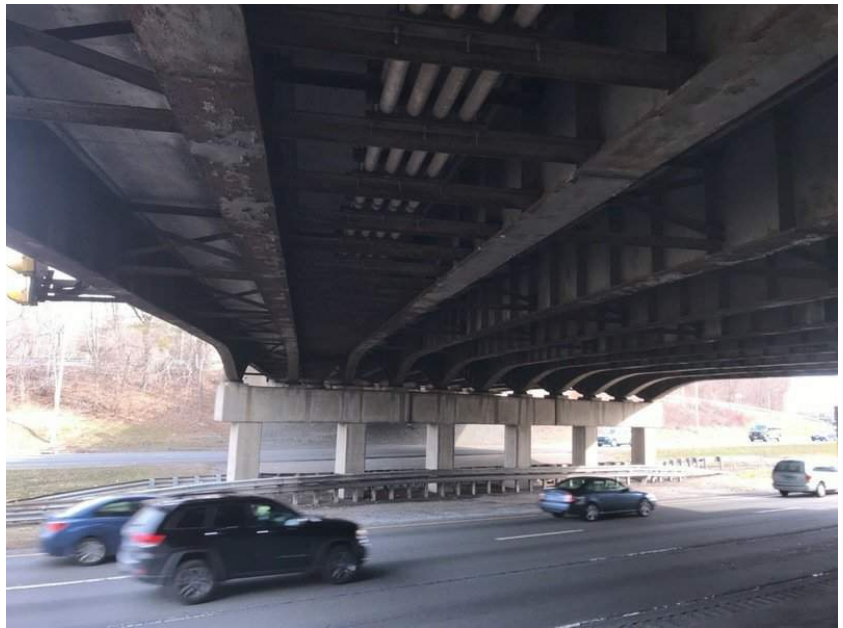
01747 8 Transite pipes

Bridge/Signs/Light Pole/Traffic Signal No.	Bridge 01747
Bridge/Signs/Light Pole/Traffic Signal General Notes	Limited inspection, 11 girders run length of bridge, 33 rocker pads, 6 concrete pillar supports, 8 transite pipes run length of bridge. No access to painted girders or transite due to embankment and highway. Assume paint is lead (suspect old deteriorated Grey paint).
Guano Present?	No
Homeless Activity	No
Bloodborne Pathogen Concerns?	No
Mice/Mouse Nests/Droppings	No

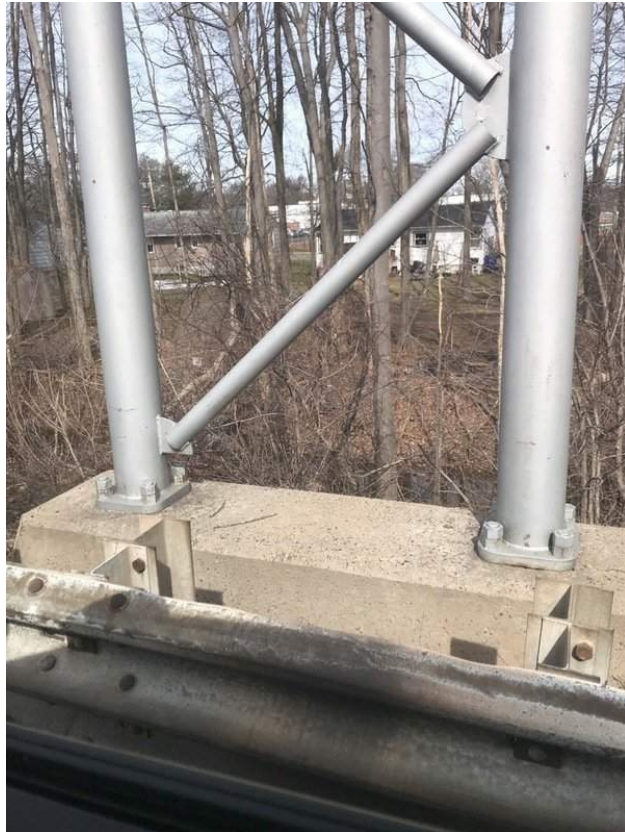
21682 support

Light grey brittle caulking around the base supports of the metal railing systems at Bridge Nos. 01743B, 01744 & 01745 and off-white brittle caulking at the base of Sign Support Nos. 21682, 21683 & 21685 were sampled and found to contain asbestos. Also, light grey brittle caulking around the base supports of the metal railing systems at Bridge Nos. 01743A, eight (8) asbestos cement pipes (transite) under Bridge No. 01747 and tar-like pipe penetrations at Bridge No. 01746 (box culvert) were identified and/or presumed to be ACM, however they are not projected to be impacted by the project. Other various caulks and tars at the above mentioned sites were sampled and found to contain no detectable levels of asbestos.

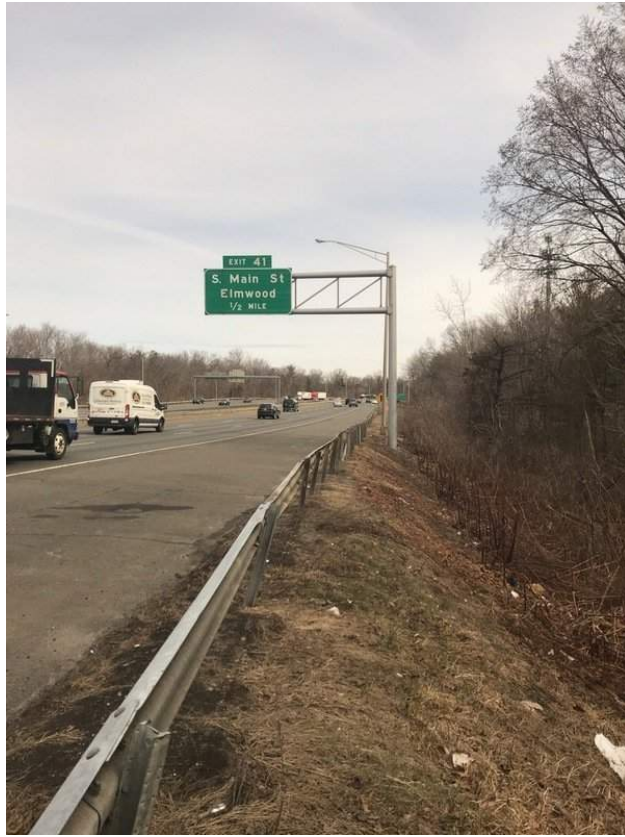
Bridge/Signs/Light Pole/Traffic Signal No.	Sign Pole 21683
Bridge/Signs/Light Pole/Traffic Signal General Notes	Inaccessible due to width of shoulder. Same caulk and paint scheme as 21682 was observed
Guano Present?	No
Homeless Activity	No
Bloodborne Pathogen Concerns?	No
Mice/Mouse Nests/Droppings	No

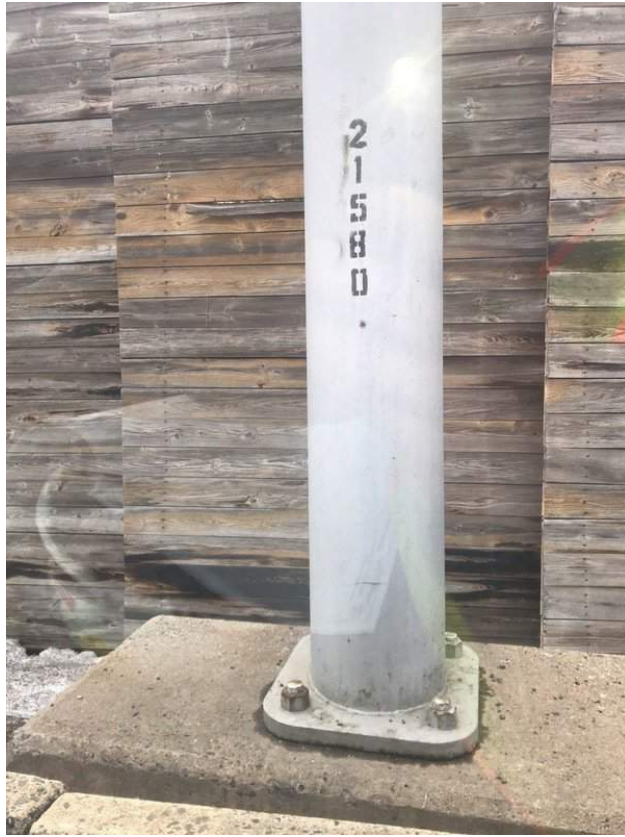
21579 base

Detectable amounts of lead in paint were identified on the supports of Sign Nos. 21579, 21580 & 21581. No lead paint was detected on the supports of Sign No. 21682, 21683 & 21685. Sign Nos. 21684 was galvanized (unpainted), therefore no lead paint was identified.
