Subject: On-Call Asbestos, Lead, Air Quality & Demolition Compliance  
Agreement No.: 8.07-01 (18)  
HazMat Inspection - Bridge No. 03295, Route 190 over CT River, Suffield/Enfield, CT  
ConnDOT Assignment No. 519-5980  
ConnDOT Project No. 139-113  
TRC Project No. 289951.5980.0710

TRC performed a limited survey for hazardous building materials associated with the rehabilitation of Bridge No. 03295, Route 190 over Connecticut River in Suffield/Enfield, Connecticut. Results of the survey identified lead paint to be present on the structural steel/metal bridge components of Bridge No. 03295. Results obtained from TCLP waste stream sampling and analysis for leachable lead from the paint on the structural steel/metal bridge components characterized the paint waste stream at Bridge No. 03295 as CTDEEP/RCRA hazardous waste. Black flashing tar joint material on the bridge wingwalls was sampled and found to contain asbestos, however the material is not projected to be impacted by the project. Bearing pads, various bridge caulking, corrugated drain pipes, glues, black tar pipe wrap and vapor barriers were also sampled and found to contain no asbestos. Potential universal waste (UW) and Co

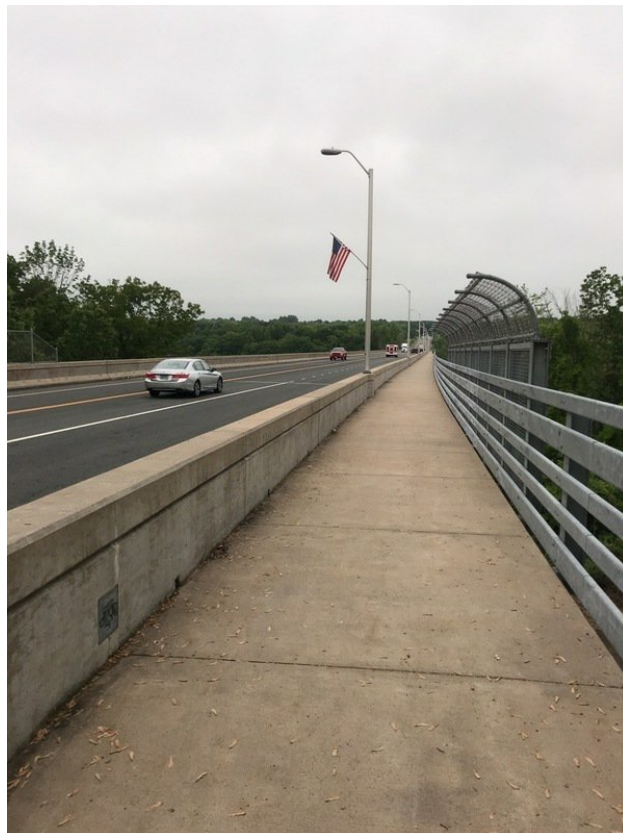
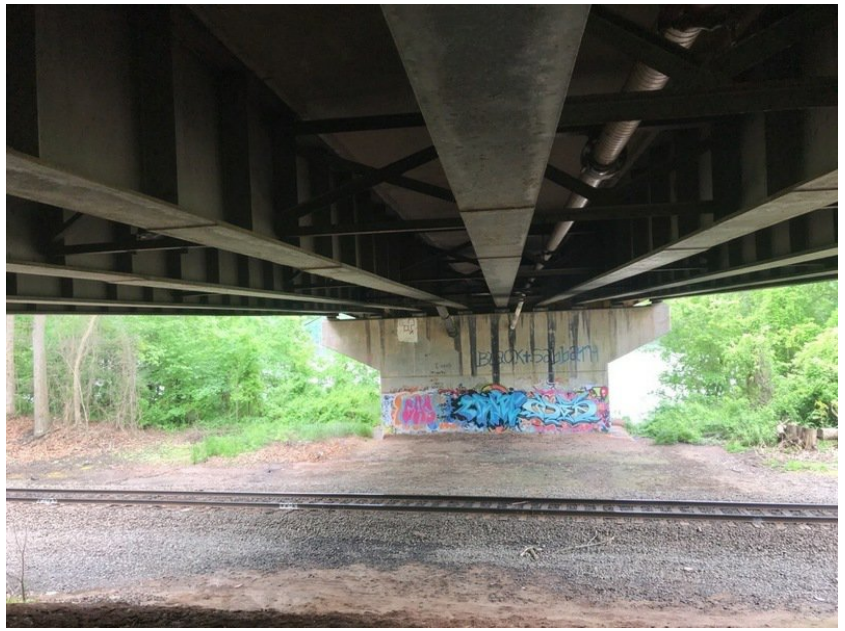
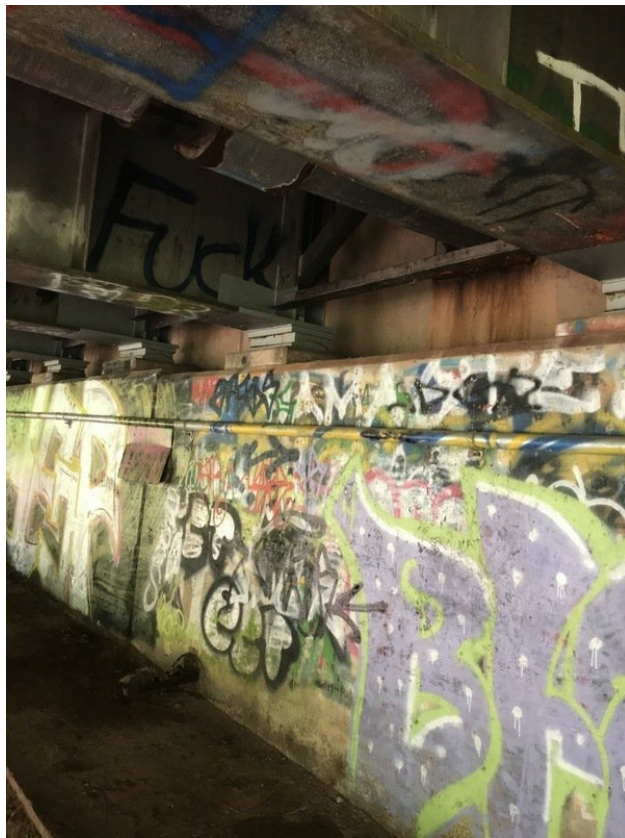
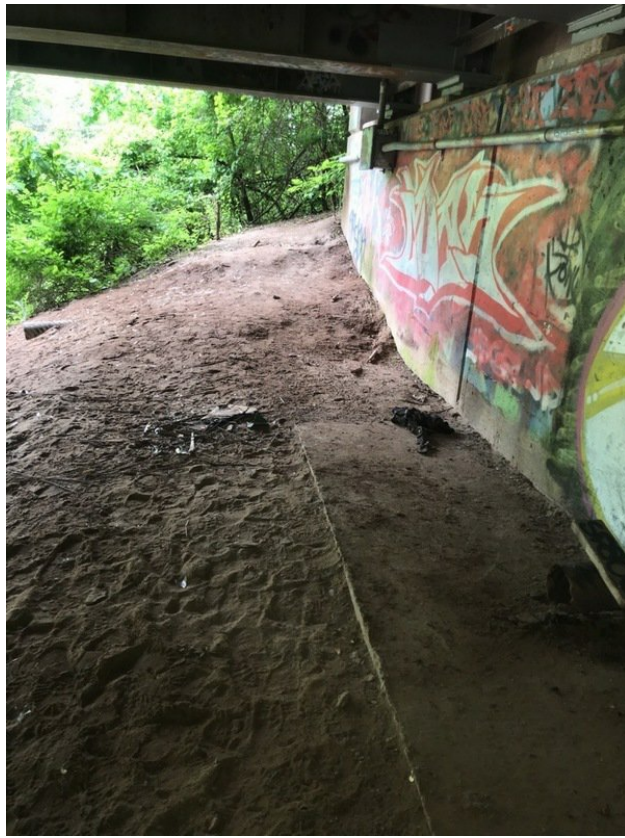
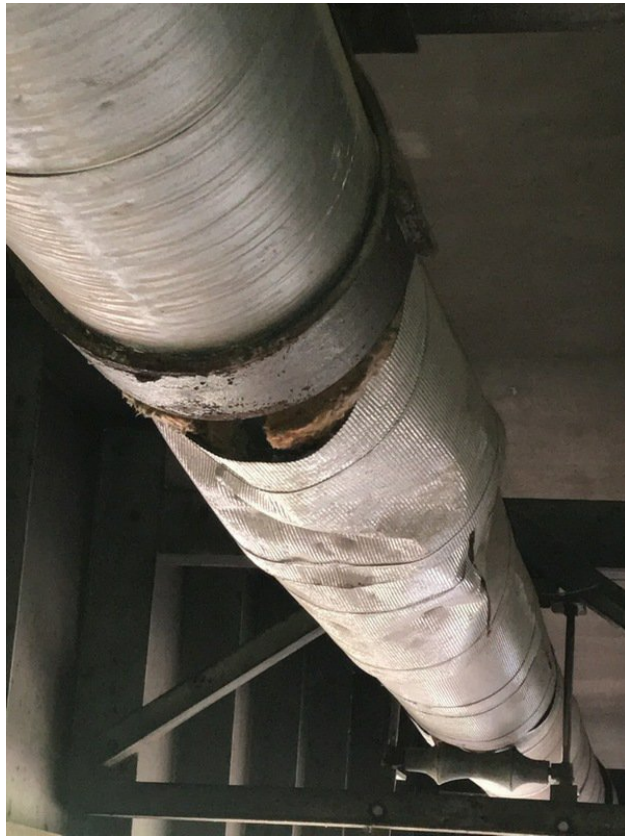
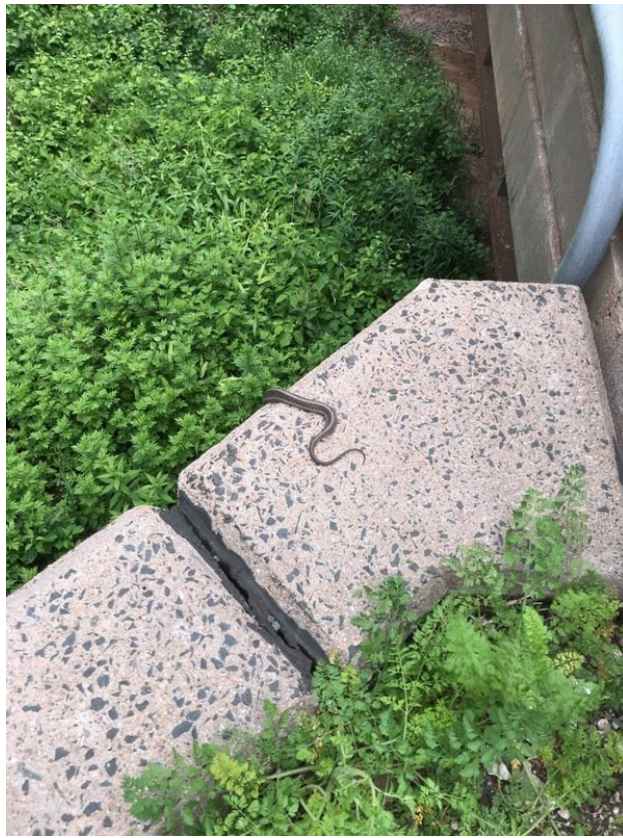
Overview Photo

Site Name	Bridge 3295
Address	Rt 190 Enfield/Suffield , CT
TRC Project Number	289951.5980.0710
Project Manager	Erik Plimpton, Stephen Arienti
Inspector(s)	Jonathan Gentile
Client	ConnDOT
Type of Asbestos Survey	Reno/Demo
Additional Analysis for NOB Materials (Calc)	TEM NY NOB 198.4
PLM Turnaround Time (TAT)	48-hour
TEM Turnaround Time (TAT)	48-hour
Date	2019-05-30
General Notes	Bridge over CT River b/w Enfield and Suffield. Limited access to to height, river, poison ivy, etc.

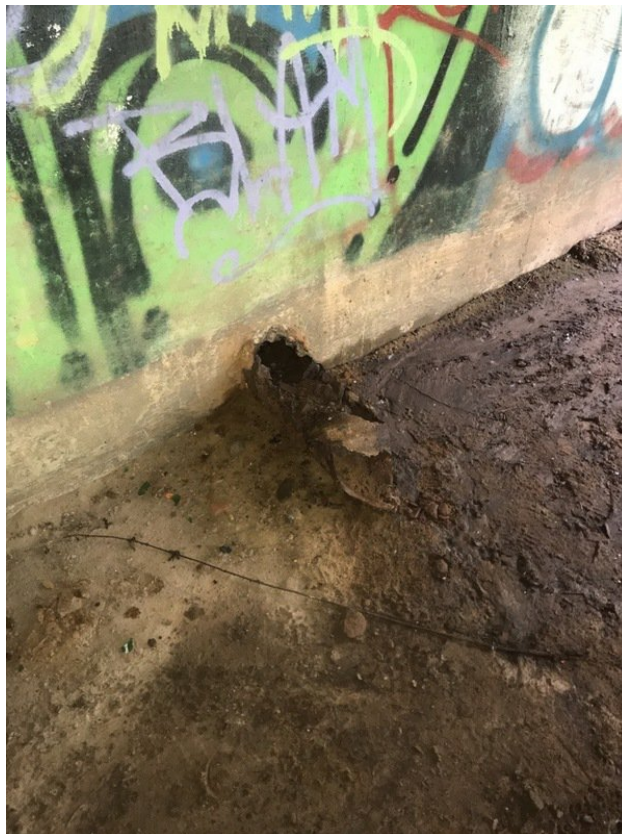
## ( 2 ), CDP1, Corrugated Drain Pipe, 2

Sampled or Assumed?	Sampled
Material Acronym	CDP1
Material Description	Corrugated Drain Pipe
Is Material a Non-Friable Organically Bound (NOB)	Yes
Homogeneous Area	Below bridge at abutment

Total Approximate Quantity	16 LF visible
Total Count	( 2 )
Total Count (number only)	2

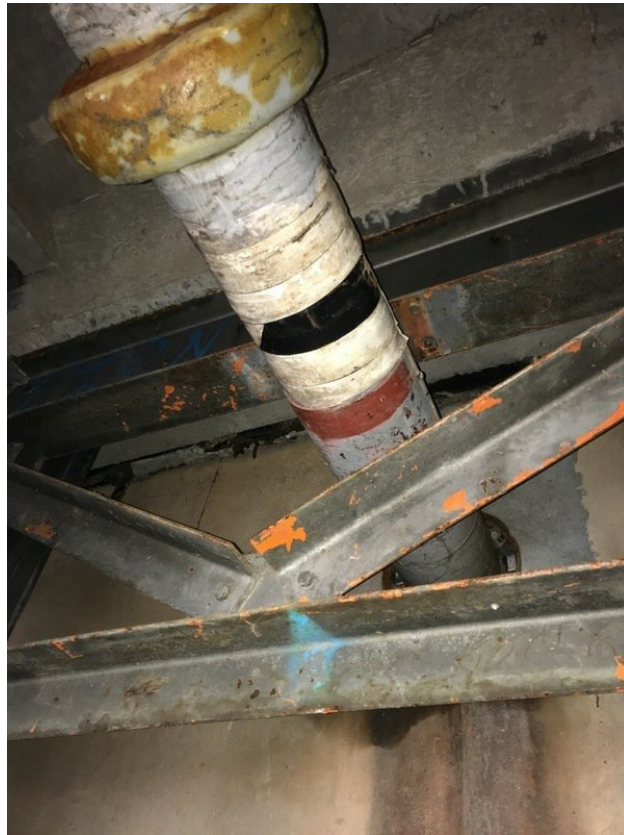
**( 2 ), PW1, Black Tar Paper Pipe Wrap, 2**

Material Description	Black Tar Paper Pipe Wrap
Is Material a Non-Friable Organically Bound (NOB)	Yes
Homogeneous Area	Below Bridge
Total Approximate Quantity	1400 LF
Total Count	( 2 )
Total Count (number only)	2

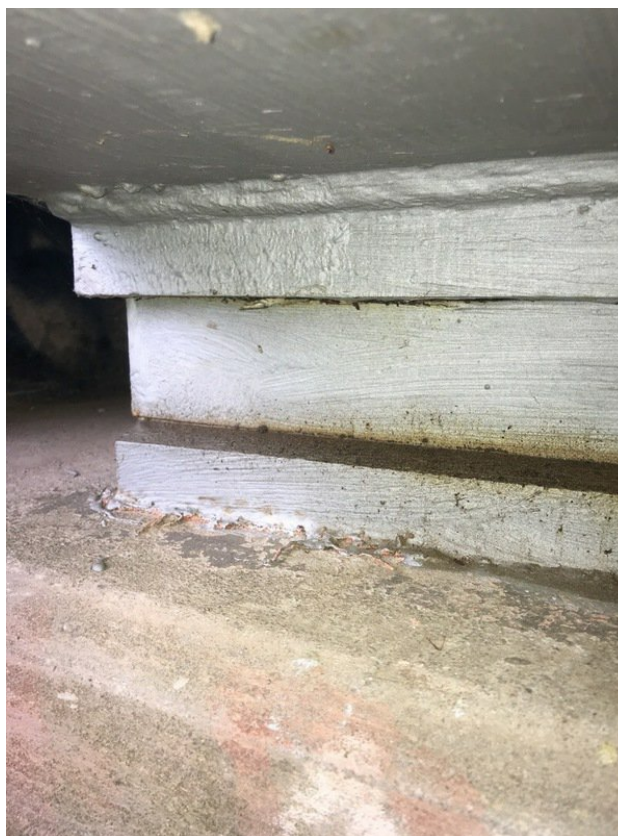
**( 2 ), BP1, Bearing Pad, 2**

Sampled or Assumed?	Sampled
Material Acronym	BP1
Material Description	Bearing Pad
Is Material a Non-Friable Organically Bound (NOB)	No
Homogeneous Area	Bridge Bearings
Total Approximate Quantity	180 SF
Total Count	( 2 )
Total Count (number only)	2

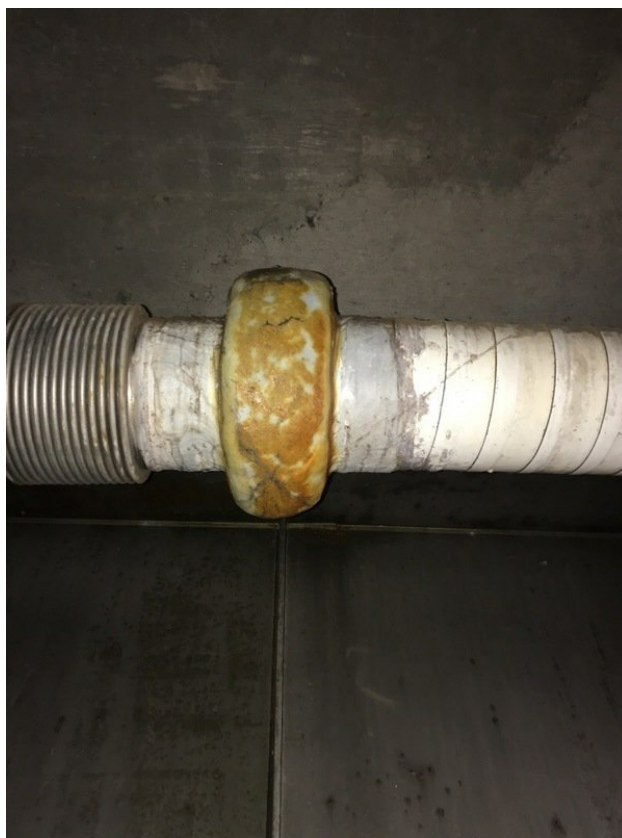
## ( 2 ), G, 1, Grey Gummy Glue, 2

Sampled or Assumed?	Sampled
Material Acronym	G, 1
Material Description	Grey Gummy Glue
Is Material a Non-Friable Organically Bound (NOB)	Yes
Total Approximate Quantity	4 SF
Total Count	( 2 )
Total Count (number only)	2

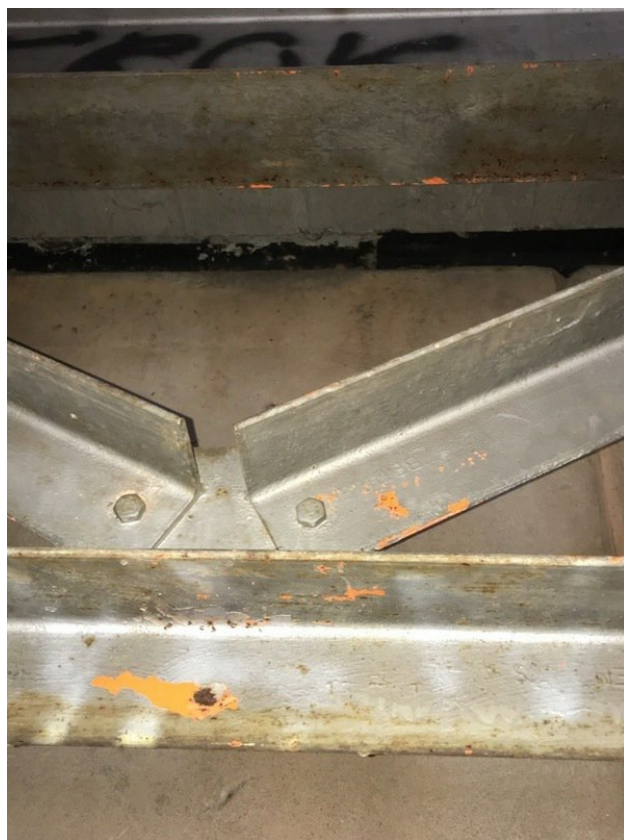
**( 2 ), VB, 1, Tar Paper Vapor Barrier , 2**

Sampled or Assumed?	Sampled
Material Acronym	VB, 1
Material Description	Tar Paper Vapor Barrier
Is Material a Non-Friable Organically Bound (NOB)	Yes
Total Approximate Quantity	150 SF
Total Count	( 2 )
Total Count (number only)	2

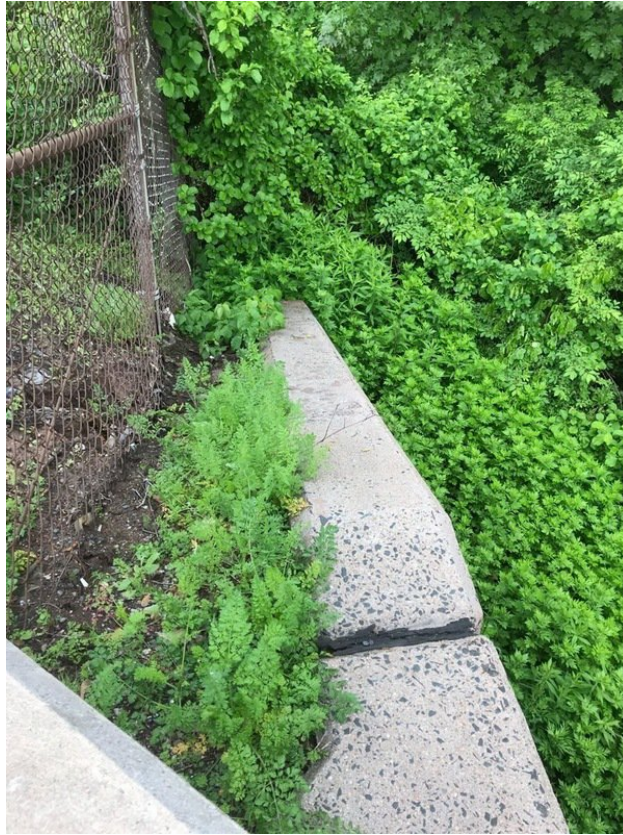
### ( 2 ), T1, Flashing Tar-Like Joint Material, 2

Sampled or Assumed?	Sampled
Material Acronym	T1
Material Description	Flashing Tar-Like Joint Material
Is Material a Non-Friable Organically Bound (NOB)	Yes
Homogeneous Area	Corners of Abutments
Total Approximate Quantity	16 LF Total

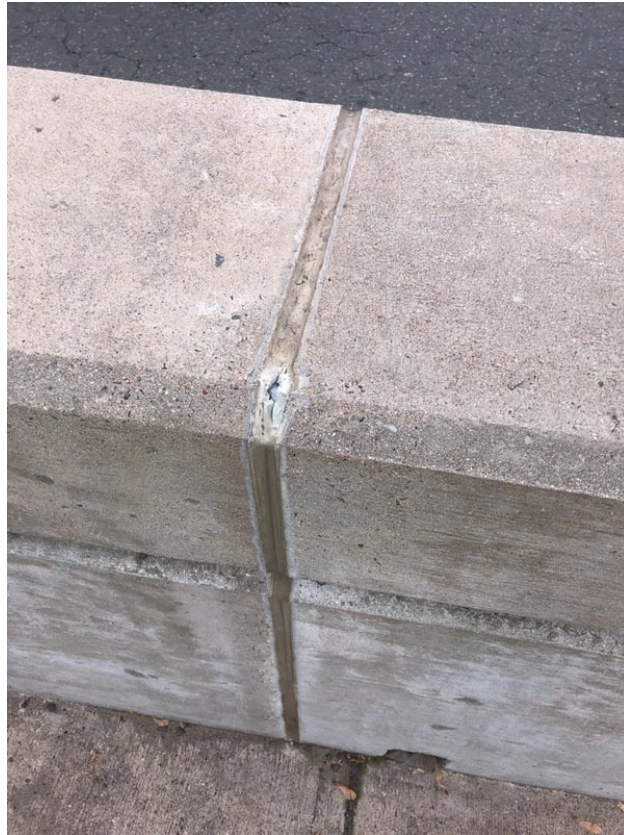
**( 2 ), C, 2, White Rubbery Joint Caulk, 2**

Sampled or Assumed?	Sampled
Material Acronym	C, 2
Material Description	White Rubbery Joint Caulk

Is Material a Non-Friable Organically Bound (NOB)	Yes
Homogeneous Area	Between Barrier Wall Sections
Total Approximate Quantity	8 LF/Section 162 Sections
Total Count	( 2 )
Total Count (number only)	2
