Subject: On-Call Asbestos, Lead, Air Quality & Demolition Compliance
Agreement No.: 8.07-01 (18)
HazMat Inspection – Bridge Nos. 01218 & 04180, I-84 EB & WB over Housatonic River,
Newtown/Southbury, CT
ConnDOT Assignment No. 519-5769
ConnDOT Project No. 96-201
TRC Project No. 289951.5769.0710

TRC performed a limited survey for hazardous building materials associated with the replacement of Bridge Nos. 01218 & 04180, I-84 EB & WB over Housatonic River in Newtown/Southbury, Connecticut. Results of the survey identified lead paint to be present on the structural steel/metal bridge components of Bridge Nos. 01218 and 04180. Waste stream sampling results of the structural steel/metal bridge components of Bridge No. 01218 characterized that paint waste stream as non-hazardous, non-RCRA waste. Waste stream sampling results of the structural steel/metal bridge components of Bridge No. 04180 characterized that paint waste stream as CTDEEP/RCRA hazardous waste. At Bridge No. 01218, grey brittle caulking at the base of the walkway safety fencing supports was sampled and found to contain asbestos. Expansion joint caulking, black expansion joint fillers and other various caulking at Bridge Nos

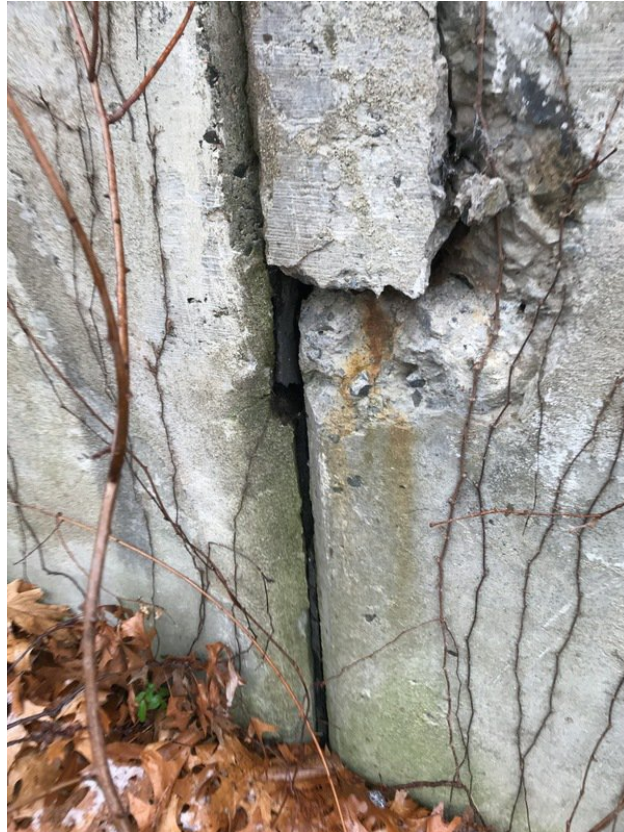
1, Wing wall foundation on SW side

Sample Number	1
Sample Location	Wing wall foundation on SW side
Analyze by Layer	No
Asbestos Bulk Analysis	PLM EPA 600/R93/116
Grab or Composite	Grab
Date	2018-12-24
Time	11:09

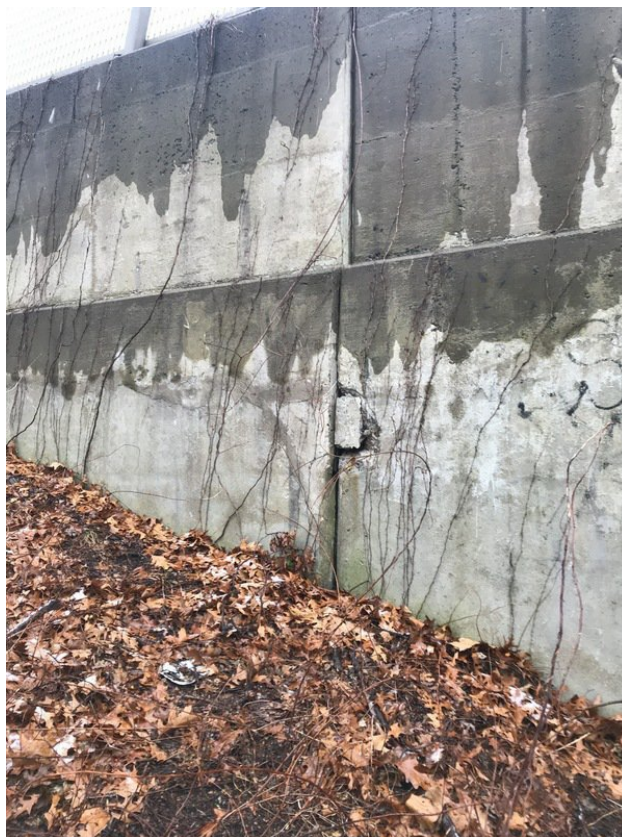
2, Wing wall foundation SW side

Sample Number	2
Sample Location	Wing wall foundation SW side
Analyze by Layer	No
Asbestos Bulk Analysis	PLM EPA 600/R93/116
Grab or Composite	Grab
Date	2018-12-24
Time	11:10

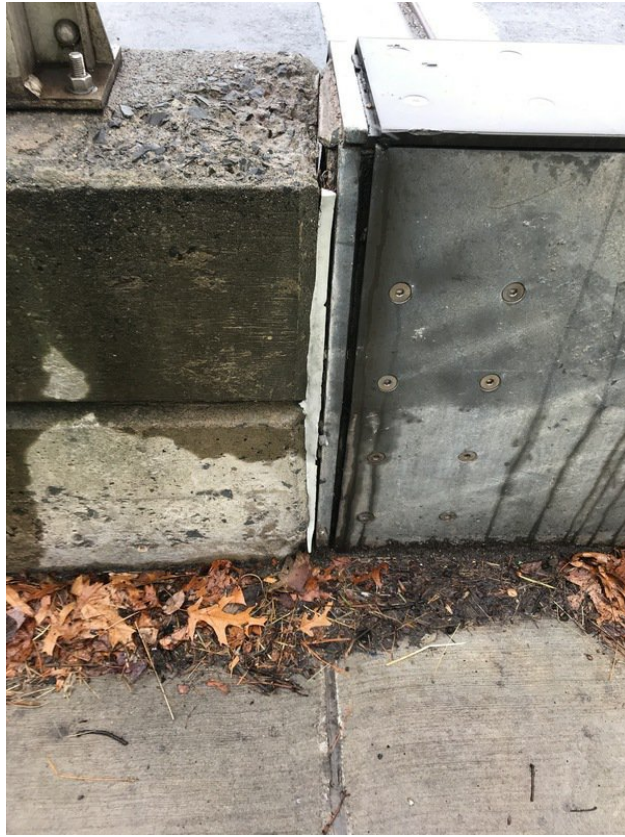
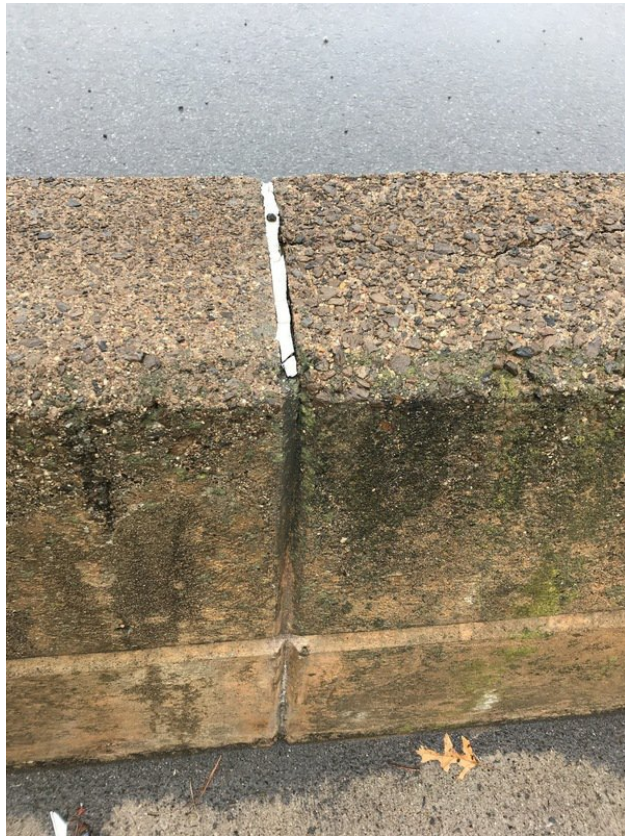
3, Top west side

Sample Location	Top west side
Analyze by Layer	No
Asbestos Bulk Analysis	PLM EPA 600/R93/116
Grab or Composite	Grab
Date	2018-12-24
Time	11:31

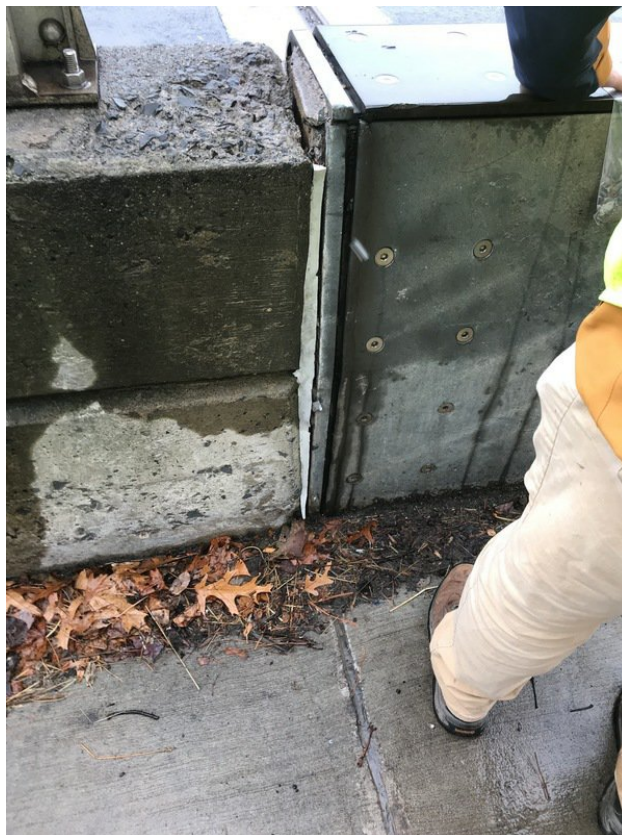
4, Top west side

Sample Number	4
Sample Location	Top west side
Analyze by Layer	No
Asbestos Bulk Analysis	PLM EPA 600/R93/116
Grab or Composite	Grab
Date	2018-12-24
Time	11:32

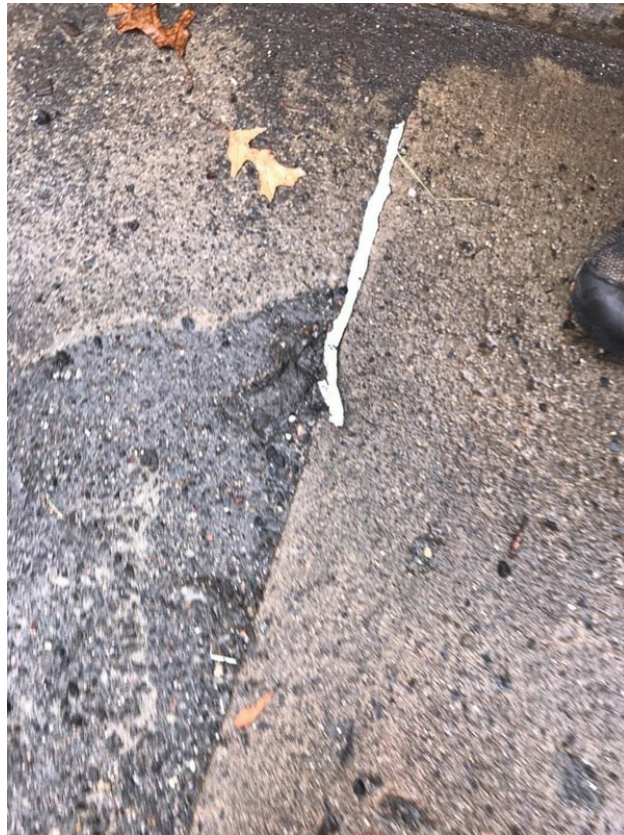
06, Pedestrian walk

Sample Number	06
Sample Location	Pedestrian walk
Analyze by Layer	No
Asbestos Bulk Analysis	PLM EPA 600/R93/116
Grab or Composite	Grab
Date	2018-12-24
Time	11:37

Sampled or Assumed?	Sampled
Material Acronym	C, 1
Material Description	Grey flex caulk
Is Material a Non-Friable Organically Bound (NOB)	Yes

Homogeneous Area	Between the concrete slabs of the walkway
Total Approximate Quantity	40 Inft
Total Count	(2)

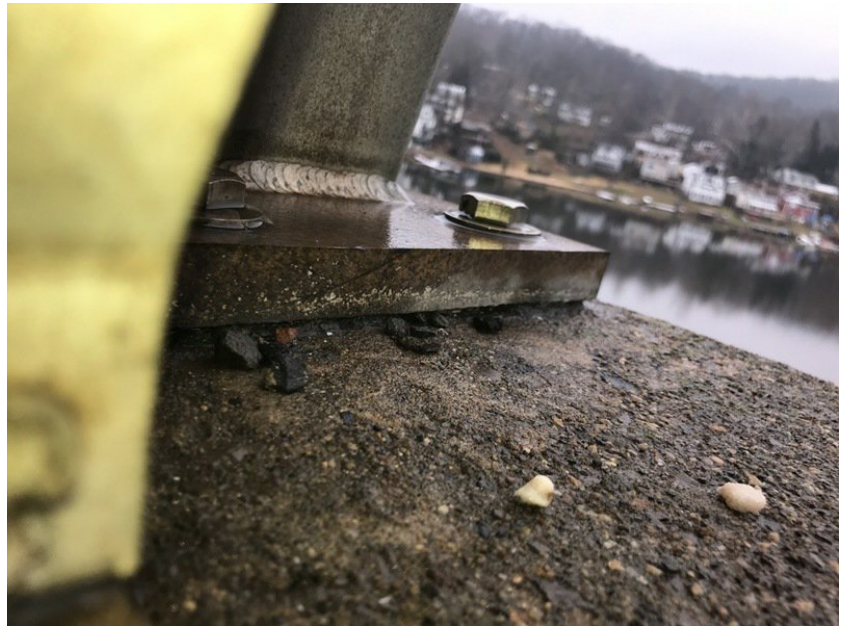
7, Walk way safety fence

Sample Number	7
Sample Location	Walk way safety fence
Analyze by Layer	No
Asbestos Bulk Analysis	PLM EPA 600/R93/116
Grab or Composite	Grab
Date	2018-12-24
Time	11:47

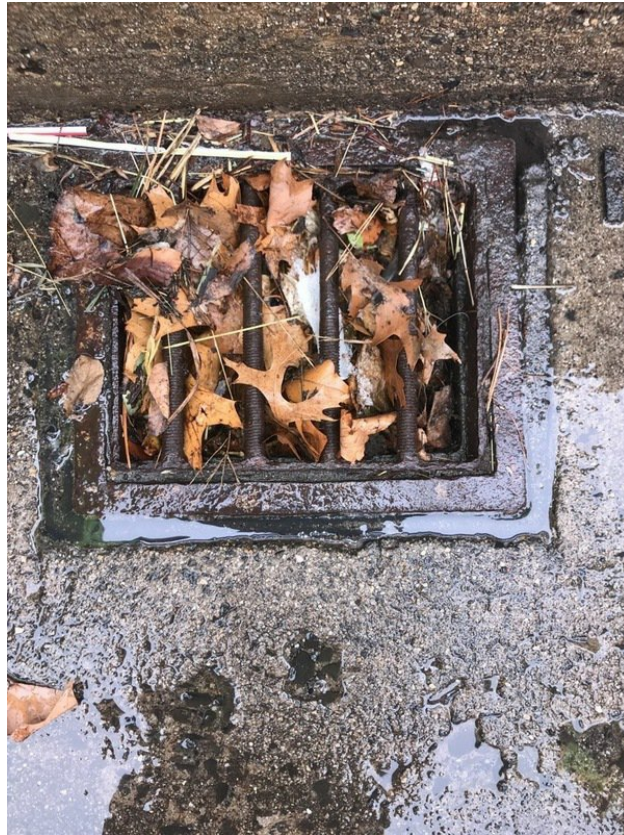
09, Pedestrian walk way

Sample Number	09
Sample Location	Pedestrian walk way
Analyze by Layer	No
Asbestos Bulk Analysis	PLM EPA 600/R93/116
Grab or Composite	Grab
Date	2018-12-24
Time	12:04
