Subject: On-Call Asbestos, Lead, Air Quality & Demolition Compliance
Agreement No.: 8.07-01 (18)
HazMat Inspection - Bridge No. 02929, Route 80 over Deep River, Deep River, CT
ConnDOT Assignment No. 519-6001
ConnDOT Project No. 122-103
TRC Project No. 289951.6001.0710

TRC performed a limited survey for hazardous building materials associated with the replacement of Bridge No. 02929, Route 80 over Deep River in Deep River, Connecticut. Results of the survey identified lead paint to be present on the structural steel/metal bridge components of Bridge No. 02929. Results obtained from TCLP waste stream sampling and analysis for leachable lead from the paint on the structural steel/metal bridge components characterized the paint waste stream at Bridge No. 02929 as CTDEEP/RCRA hazardous waste. Grey brittle guard rail caulking and black padding material under the railing pedestals were sampled and found to be non-detect for asbestos. No bird/pigeon guano accumulations, bloodborne pathogen (BBP) concerns or other hazardous/regulated items were identified in accessible areas of Bridge No. 02929. Associated laboratory data, TRC Mobile Data Solutions report and project description/site map a

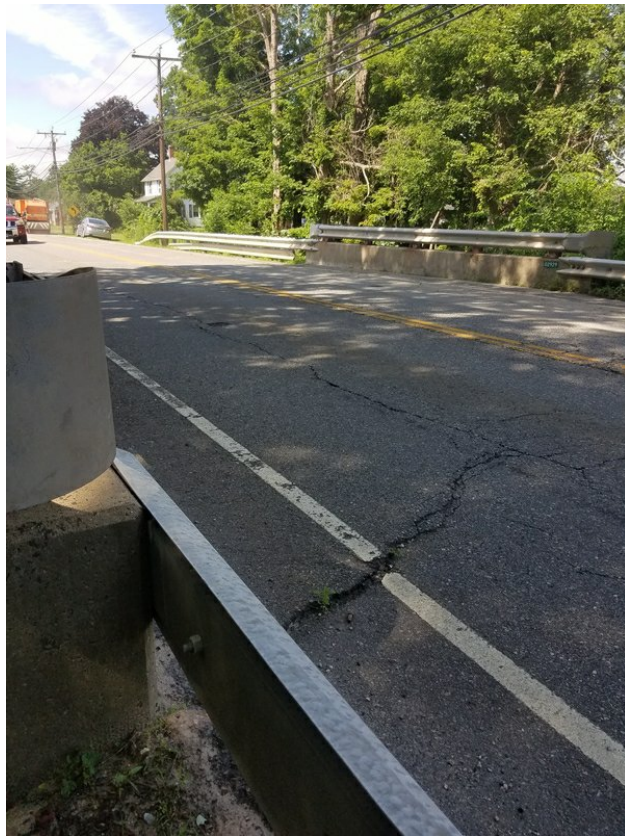
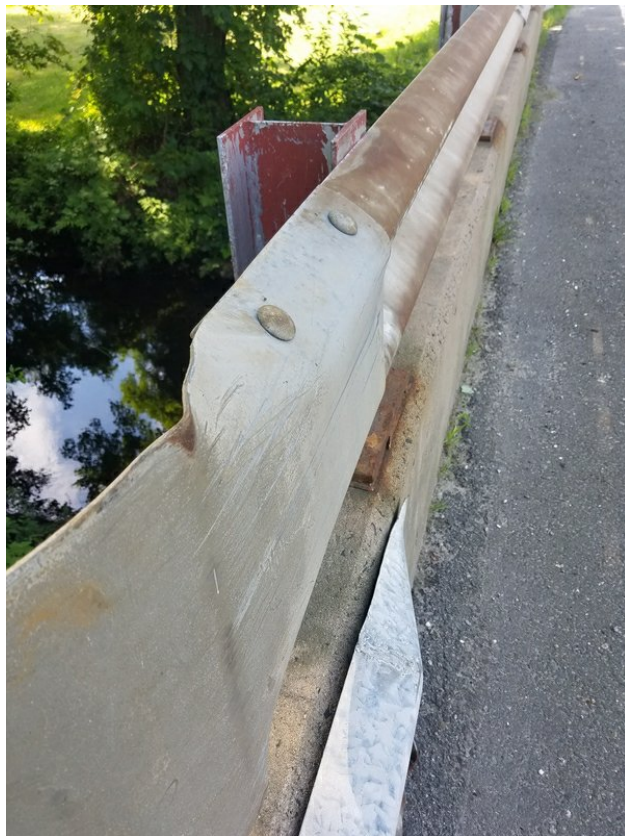
silver and red paint on railing

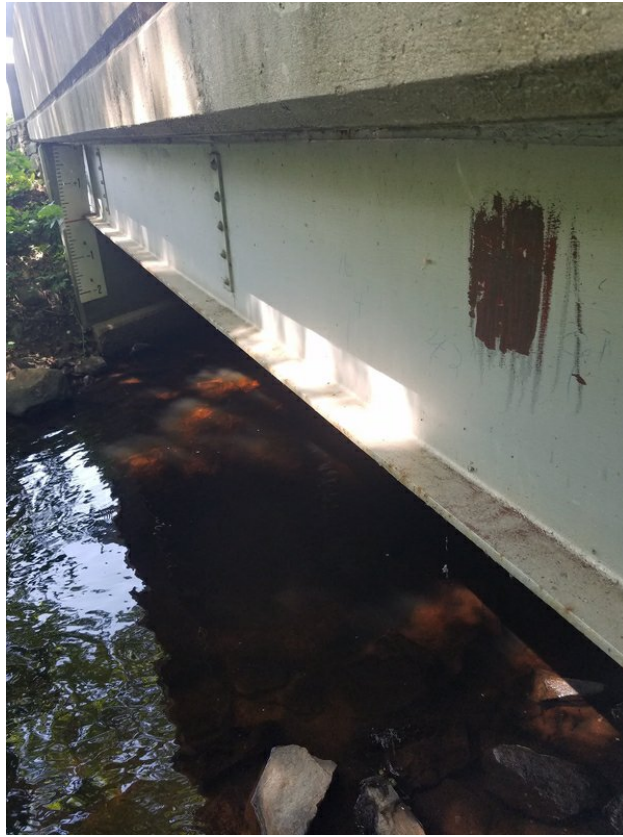
silver and red paint on ibeam

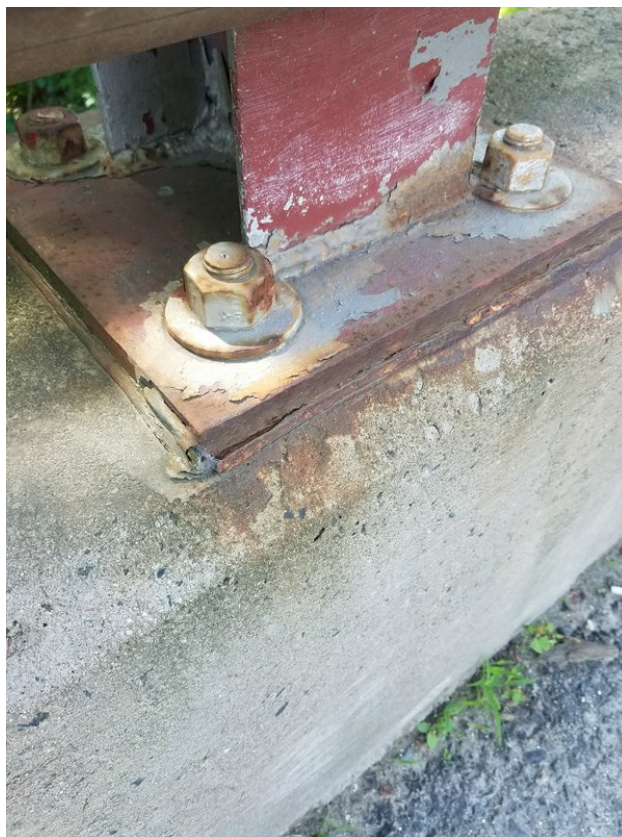
(2), C, 1, Brittle grey caulk , 2

Sample Location	Railing base
Analyze by Layer	No
Asbestos Bulk Analysis	PLM EPA 600/R93/116
Grab or Composite	Grab
Date	2019-07-05
Time	10:12

Sampled or Assumed?	Sampled
Material Acronym	C, 1
Material Description	Brittle grey caulk
Is Material a Non-Friable Organically Bound (NOB)	Yes
Total Approximate Quantity	40lf
Total Count	(2)
Total Count (number only)	2

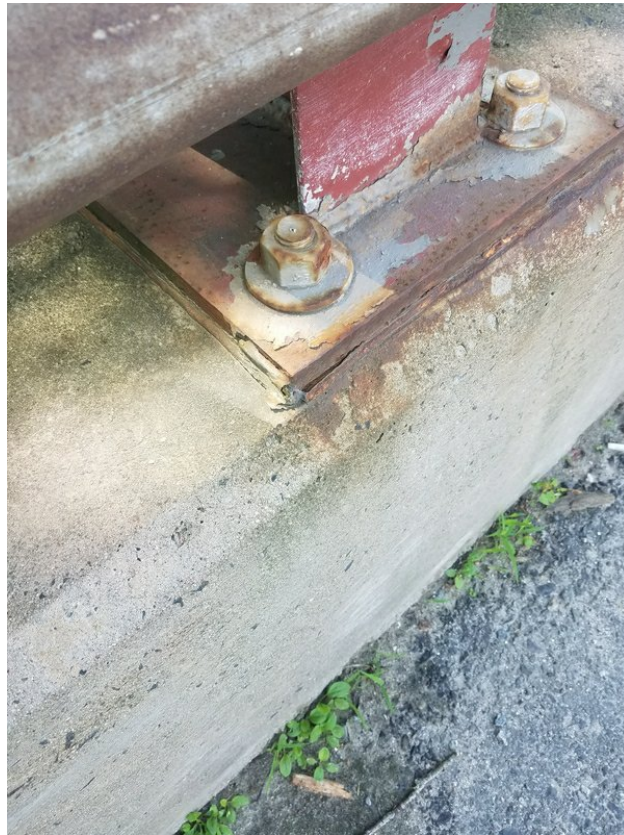
Sample Location	Railing base
Analyze by Layer	No
Asbestos Bulk Analysis	PLM EPA 600/R93/116
Grab or Composite	Grab
Date	2019-07-05
Time	10:14

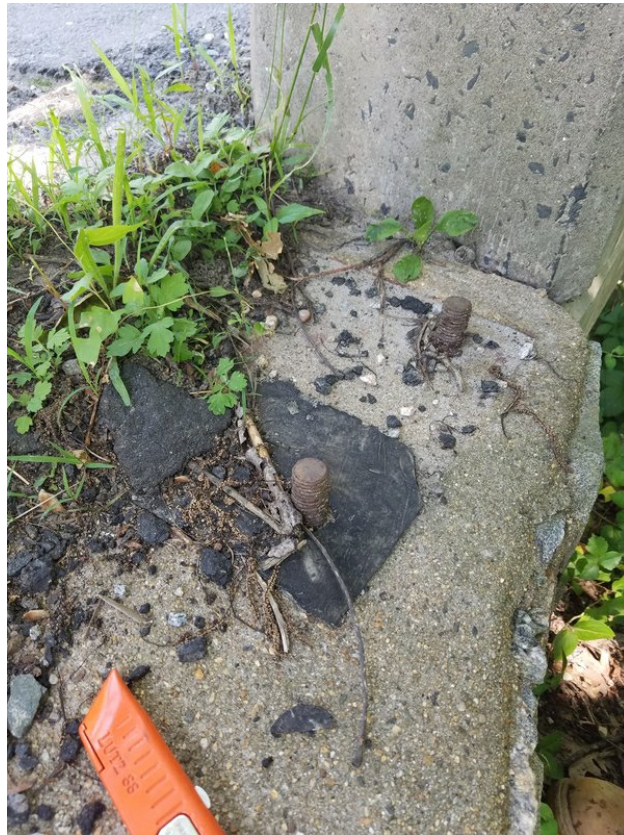
(2), P1, Black padding material, 2

Sample Location	Under railing pedestal
Analyze by Layer	No
Asbestos Bulk Analysis	PLM EPA 600/R93/116
Grab or Composite	Grab
Date	2019-07-05
Time	11:58

Sampled or Assumed?	Sampled
Material Acronym	P1
Material Description	Black padding material
Is Material a Non-Friable Organically Bound (NOB)	Yes
Total Approximate Quantity	20sqft
Total Count	(2)
