SURVEY REPORT

PRE-RENOVATION INVESTIGATIVE SURVEY FOR HAZARDOUS BUILDING MATERIALS

PUTNAM MAINTENANCE FACILITY PUTNAM, CONNECTICUT

Project No. 115-121

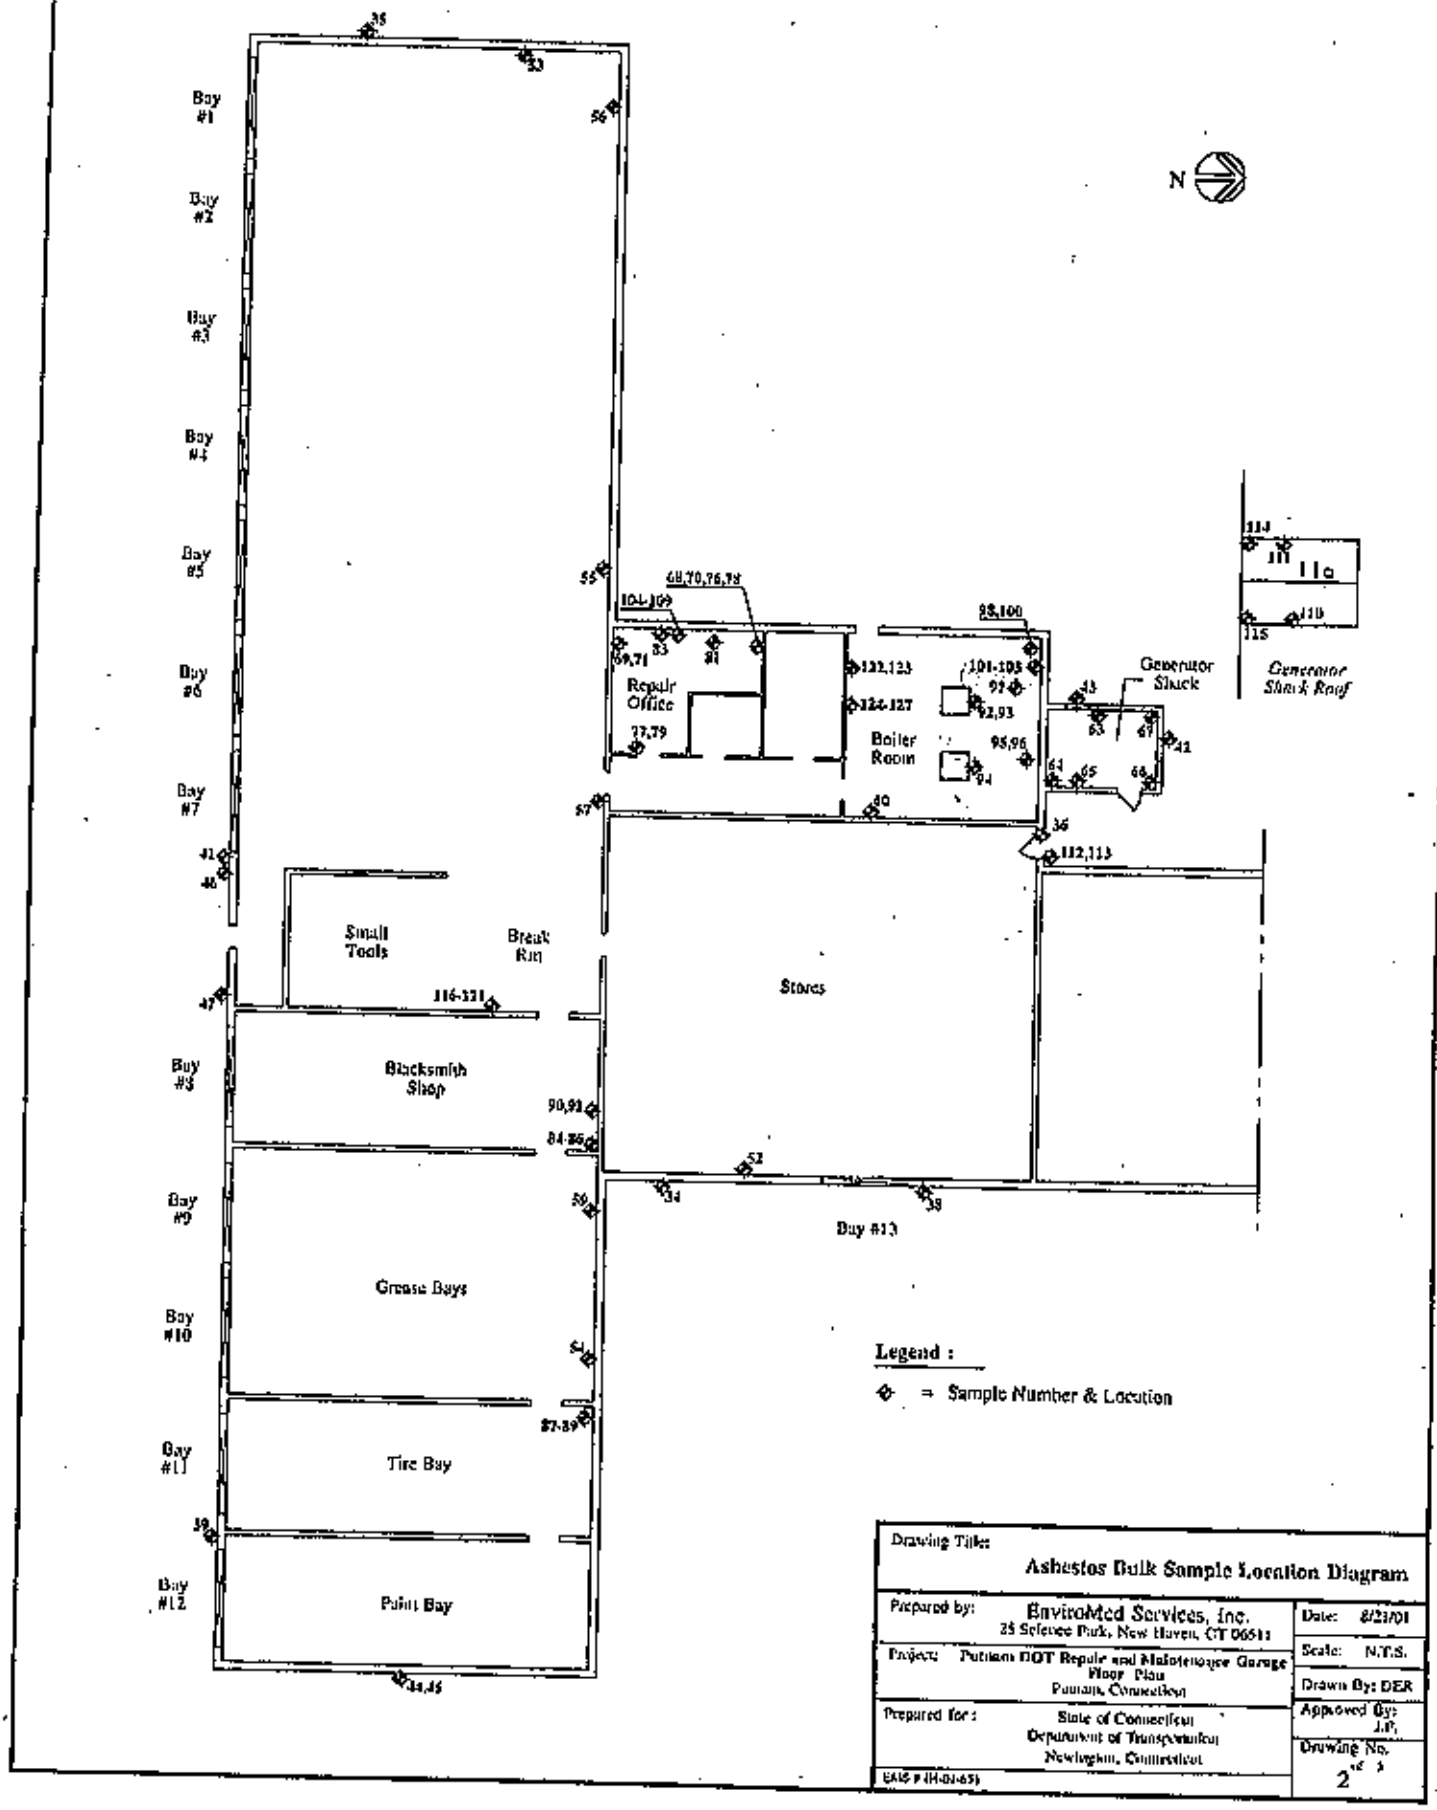
There is approximately 2 square feet of type-I chimney breeching cement located in the blacksmith shop. This material was found to contain 50-60 percent asbestos.
