Subject: On-Call Asbestos, Lead, Air Quality & Demolition Compliance
Agreement No.: 8.07-01 (18)
HazMat Inspection - Merritt Parkway Bridge Nos. 00723, 00724, 00725 & the 4x4 box culvert at Exit 40B, Norwalk & Westport, CT
ConnDOT Assignment No. 519-5716
ConnDOT Project No. 102-368
TRC Project No. 289951.5716.0710

TRC performed a limited survey for hazardous building materials associated with the rehabilitation of Bridge Nos. 00723, 00724, 00725 and the 4x4 box culvert at Exit 40B on the Merritt Parkway in Norwalk & Westport, Connecticut. No lead paint or asbestos containing materials (ACM) were identified on the 3 bridges or the 4x4 box culvert. Further, no other hazardous/regulated items, bird/pigeon guano accumulations or bloodborne pathogens (BBP) concerns were identified at Bridge Nos. 00723, 00724, 00725 or the 4x4 box culvert. Associated laboratory data, TRC Mobile Data Solutions report and project site map are attached.

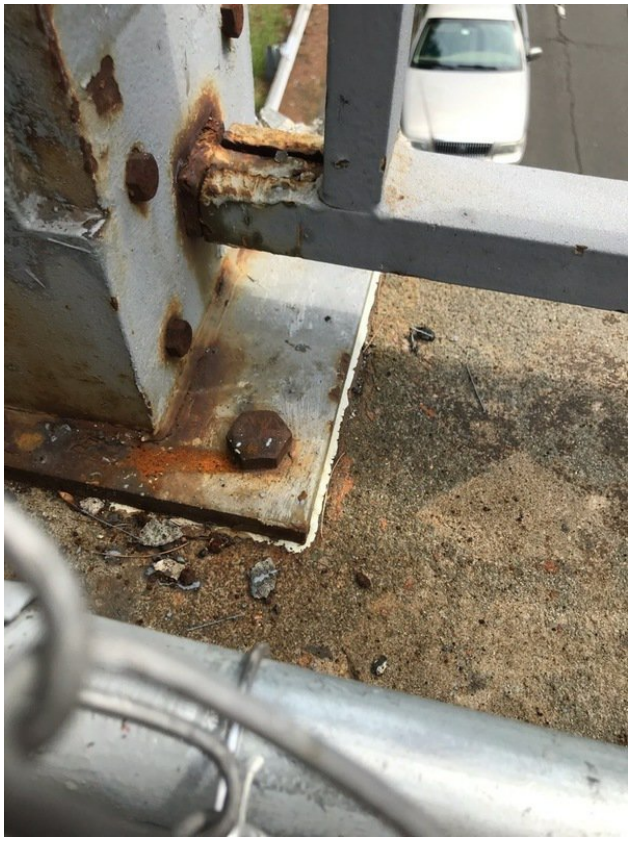
(2), C, 21, Rubbery white railing caulk, 2

Sample Location	Bridge 00724 east side
Analyze by Layer	No
Asbestos Bulk Analysis	PLM EPA 600/R93/116
Grab or Composite	Grab
Date	2019-05-17
Time	11:01
