PROJECT No. 301-0175
PROJECT LOCATION
MILFORD CULVERT
REPLACEMENT

Drainage Path Downstream of Culvert
at Railroad Mile Post 65.60

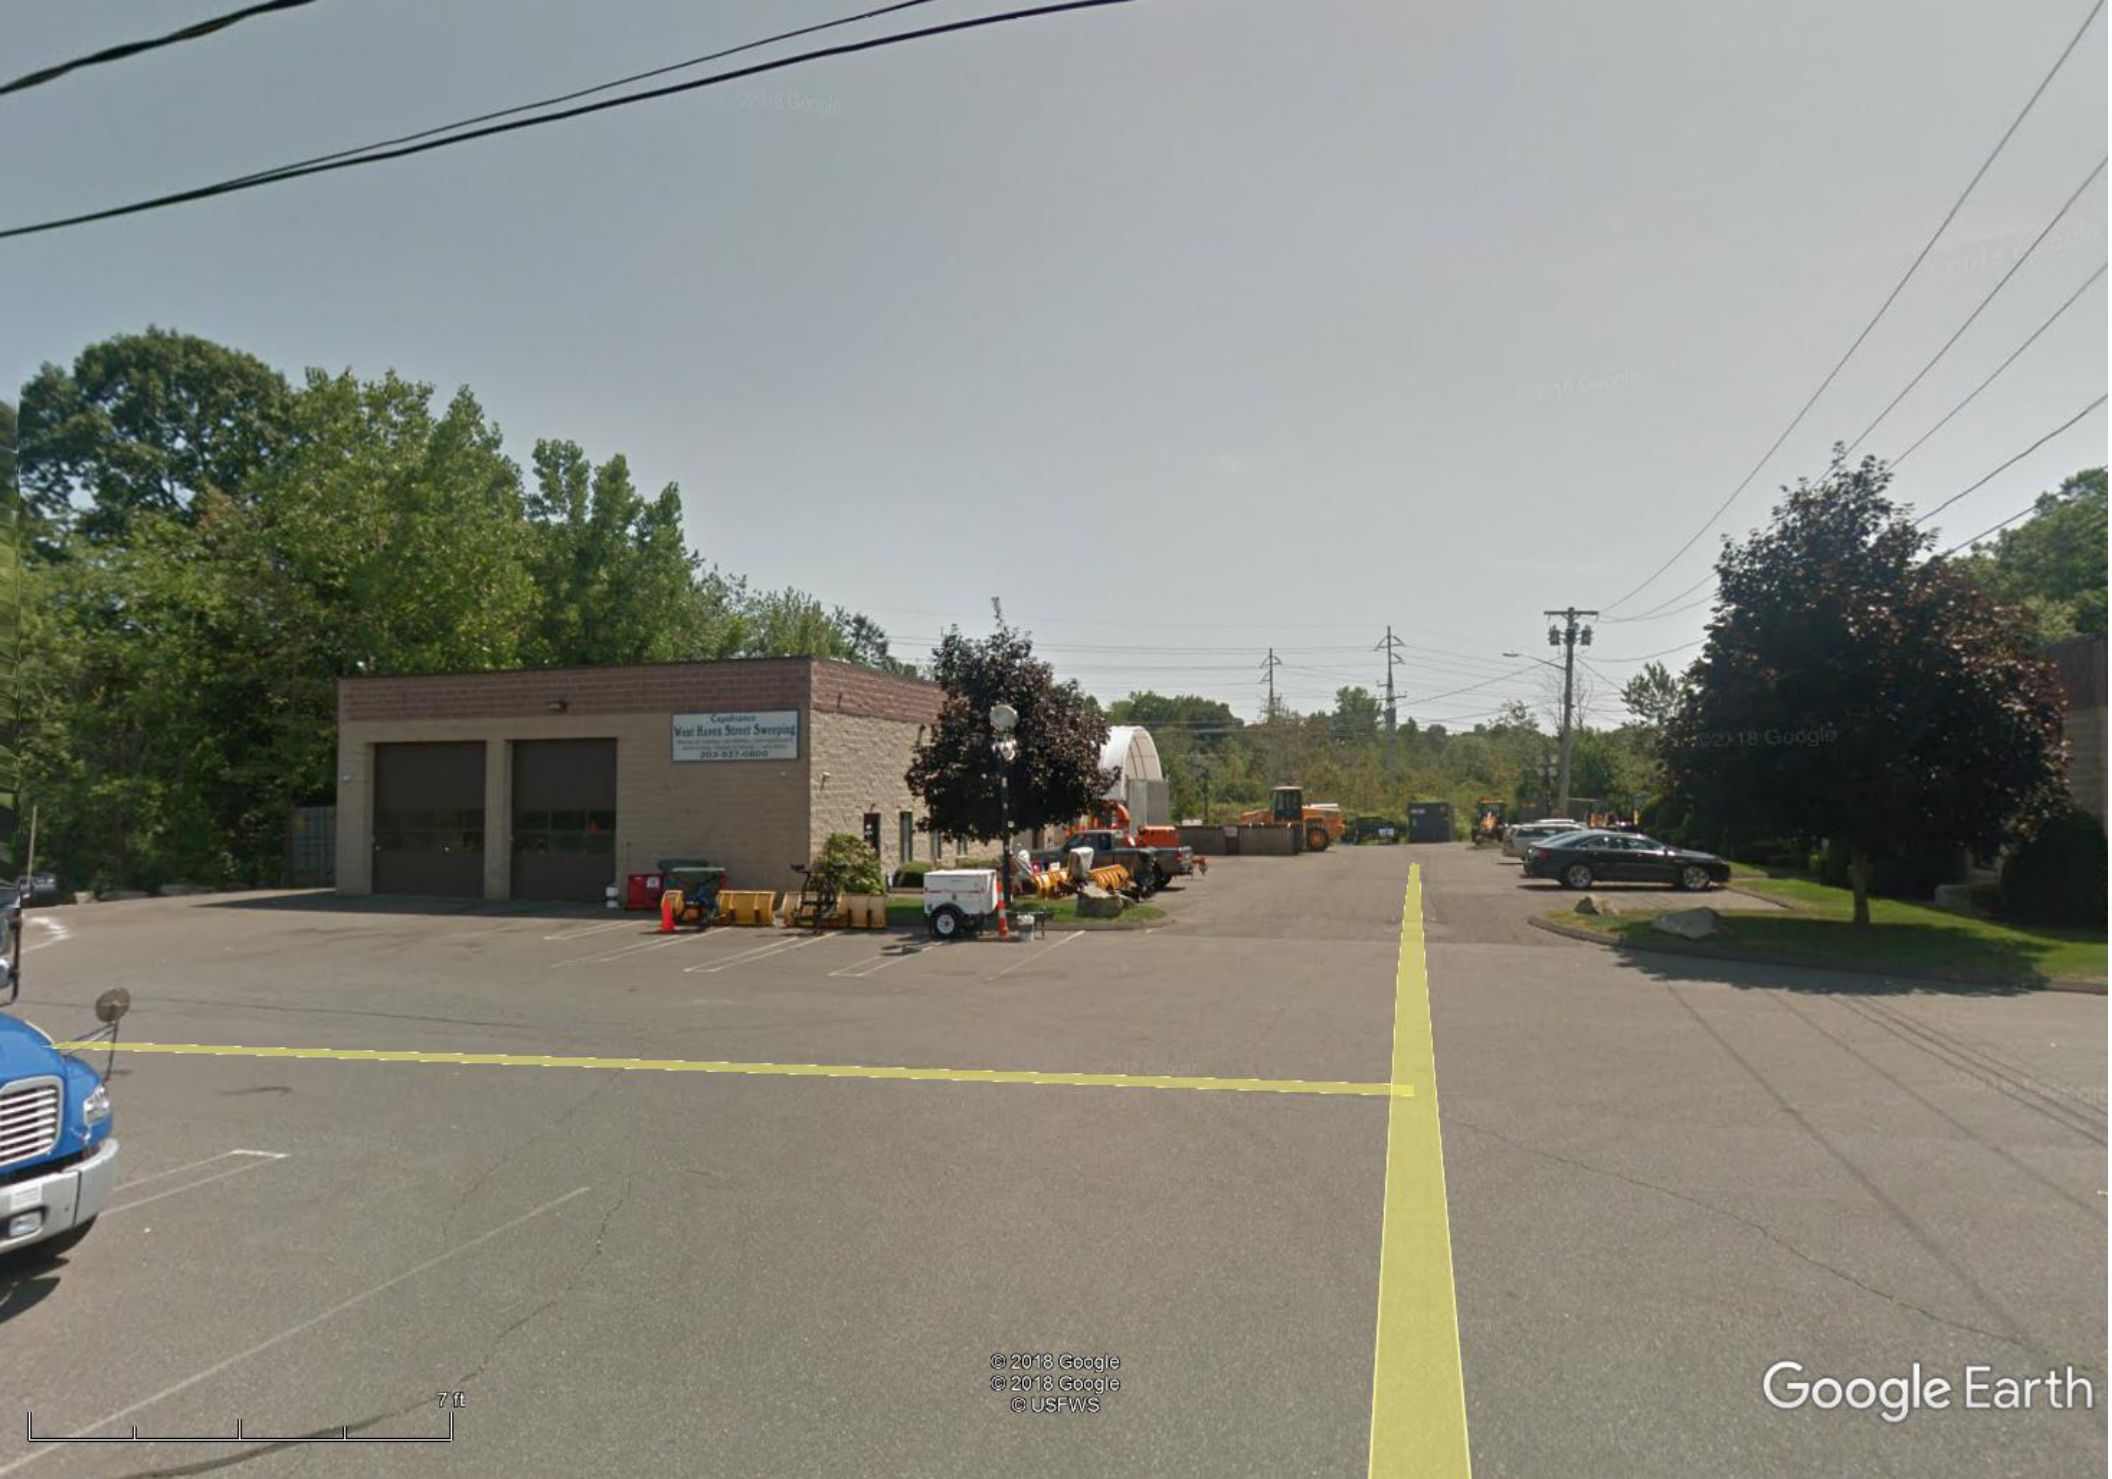
View 3/4 of the way down the access path through the complex, almost to the north side of the railroad at the inlet of the railroad culvert.
