**PRE-RENOVATION
INVESTIGATIVE SURVEY FOR
HAZARDOUS BUILDING MATERIALS**

**MARLBOROUGH MAINTENANCE
FACILITY
MARLBOROUGH, CONNECTICUT**
Project No. 41-119

Issued
November 2018

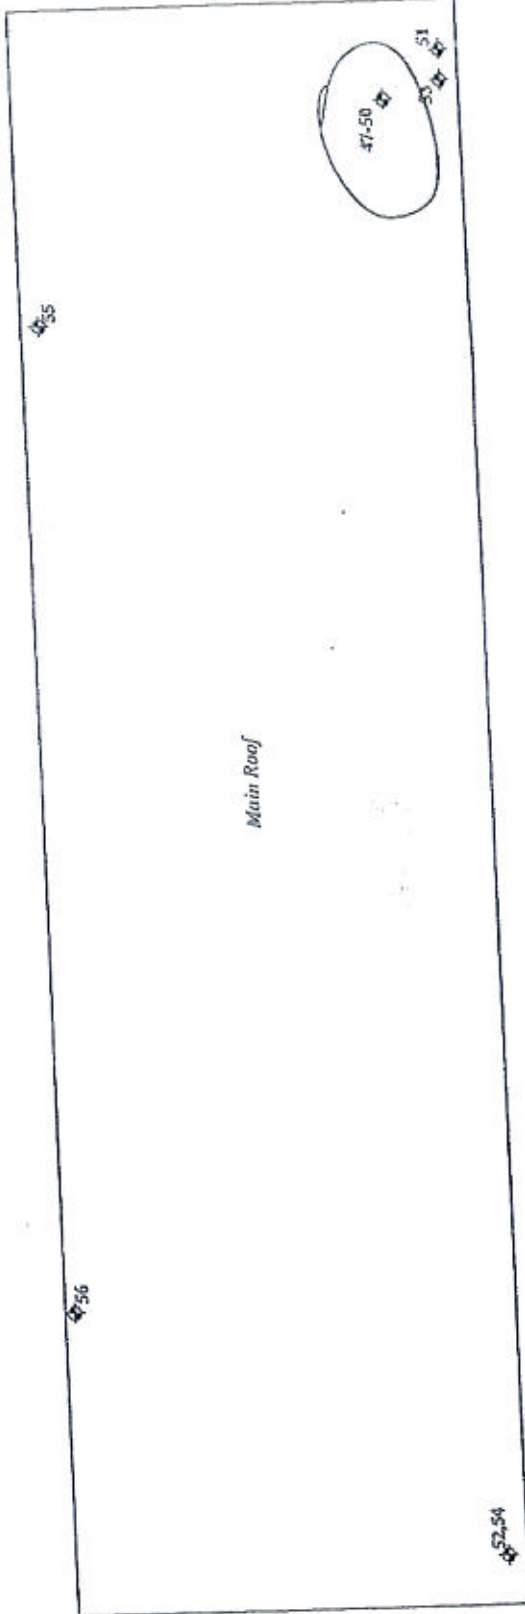
Sample Number	Location	Material Sampled	Percent Asbestos
50	main building roof	built-up roofing material bottom layer - cement gray felt paper flashing	NAD
51	main building roof	gray felt paper flashing	55
52	main building roof	gray flashing cement	40
53	main building roof	gray flashing cement	40
54	main building exterior	gutter sealer	NAD
55	main building exterior	gutter sealer	NAD
56	shed 1 roof	tan asphalt roof shingle	NAD
57	shed 1 roof	tan asphalt roof shingle	NAD
58	shed 1 roof	siding felt paper	NAD
59	shed 1 roof	siding felt paper	NAD
60	shed 2 roof	gray asphalt roof shingle	NAD
61	shed 2 roof	gray asphalt roof shingle	NAD
62	shed 2 roof	felt paper under roof shingles	NAD
63	shed 2 roof	felt paper under roof shingles	NAD
64	shed 2 roof	felt paper under roof shingles	NAD

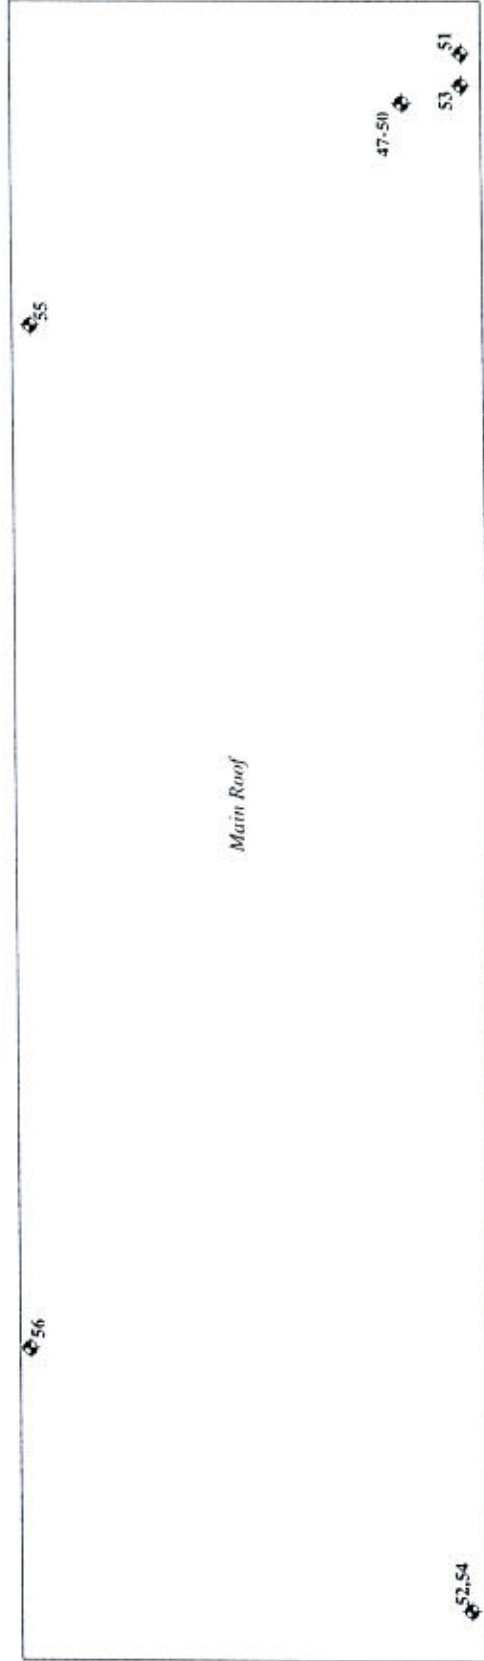
Sample Number	Location	Material Sampled	Percent Asbestos
50	main building roof	built-up roofing material bottom layer - cement	NAD
51	main building roof	gray felt paper flashing	55
52	main building roof	gray felt paper flashing	55
53	main building roof	gray flashing cement	40
54	main building roof	gray flashing cement	40
55	main building exterior	gutter sealer	NAD
56	main building exterior	gutter sealer	NAD
57	shed 1 roof	tan asphalt roof shingle	NAD
58	shed 1 roof	tan asphalt roof shingle	NAD
59	shed 1 roof	siding felt paper	NAD
60	shed 1 roof	siding felt paper	NAD
61	shed 2 roof	gray asphalt roof shingle	NAD
62	shed 2 roof	gray asphalt roof shingle	NAD
63	shed 2 roof	felt paper under roof shingles	NAD
64	shed 2 roof	felt paper under roof shingles	NAD

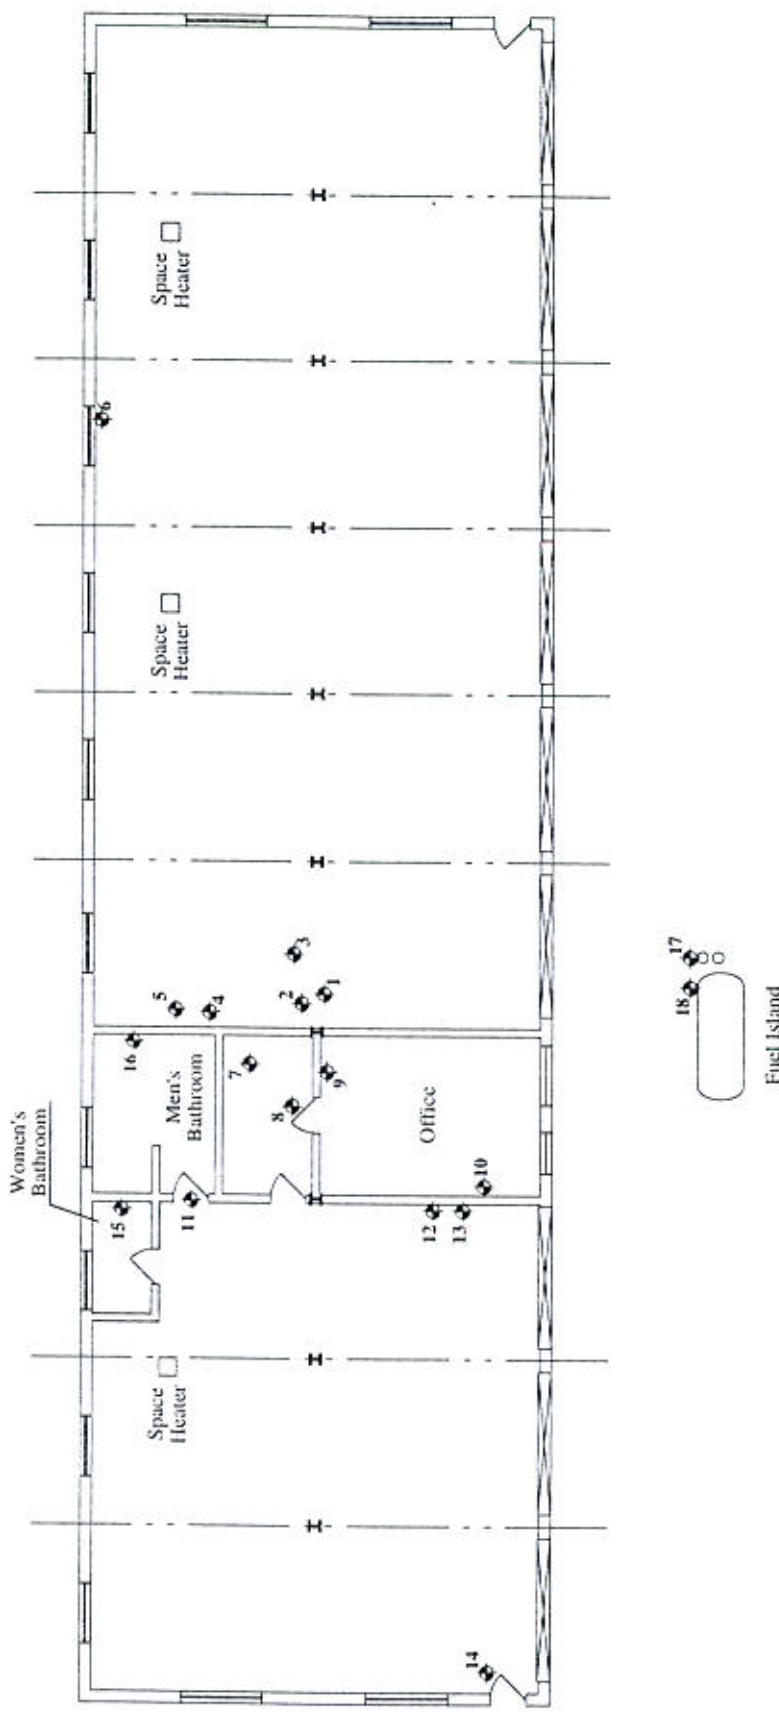
<i>Sample Number</i>	<i>Sample Location</i>	<i>Component (s) Tested</i>	<i>Results (mg/cm²)</i>
17	Bay 2 exterior	lolly column	2.4
18	Bay 2	gas island foundation	2.2
19	Exterior - Shed 2	wall	2.3
